## Architect's Field Report

20 June 2020

18053-Vicksburg Junior High School / Report Number 013

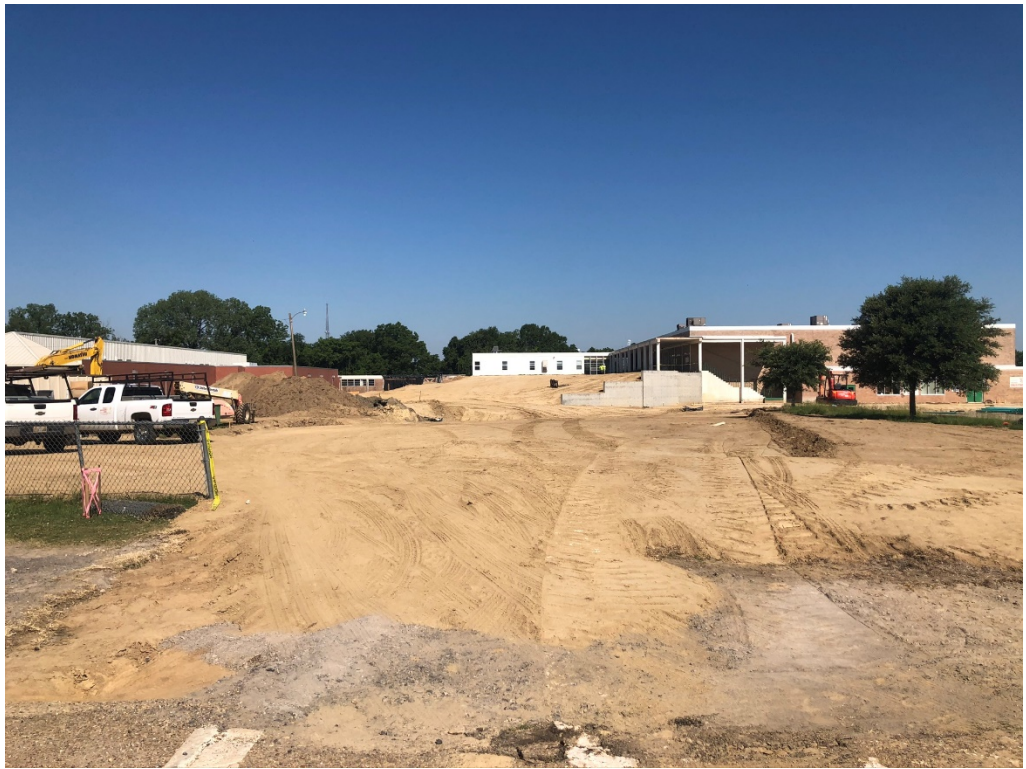
Figure 1 – Site Work is Ongoing

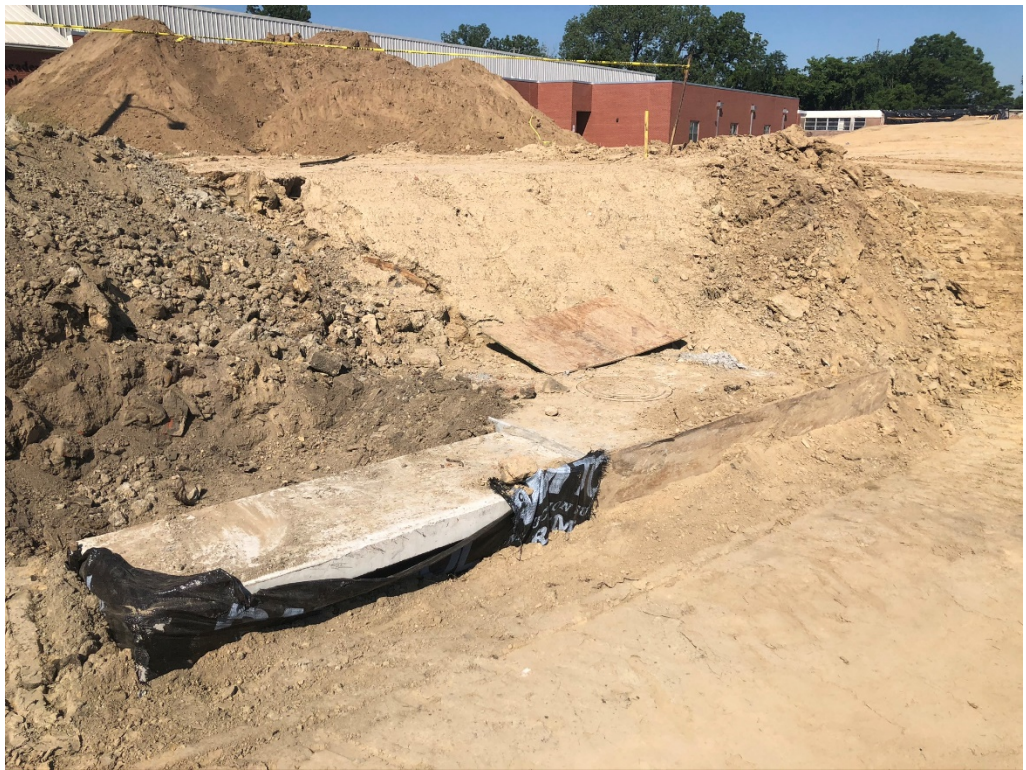
Figure 2 – Storm Sewer Installed

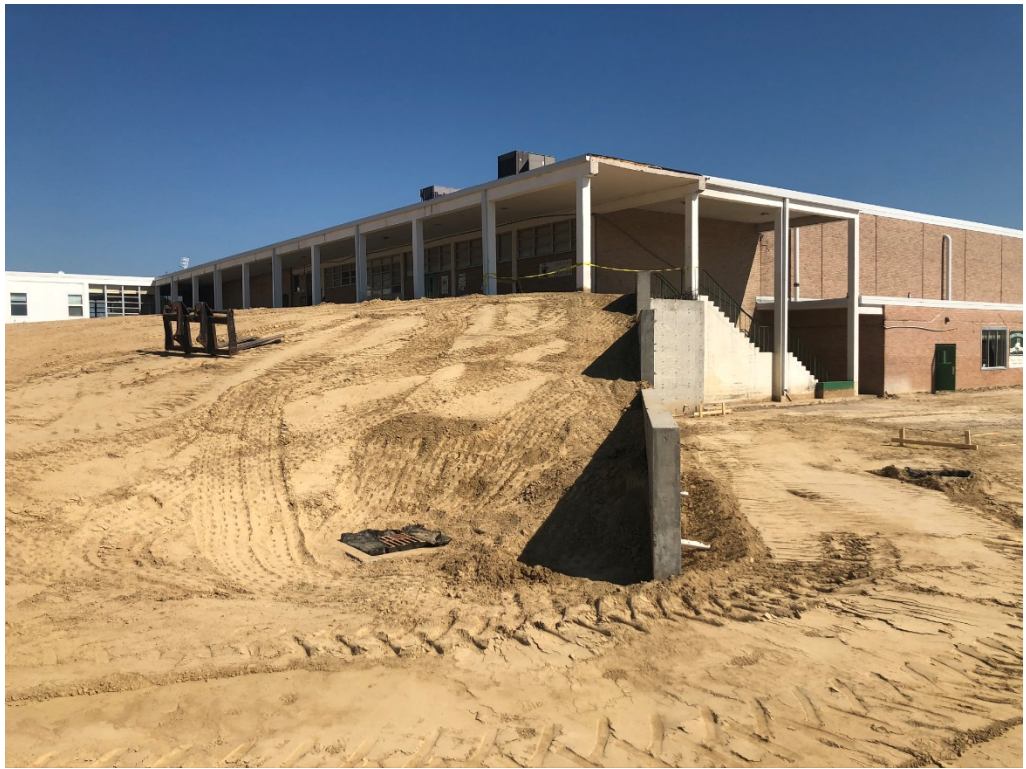
Figure 3 – Backfill Completed at Retaining Wall

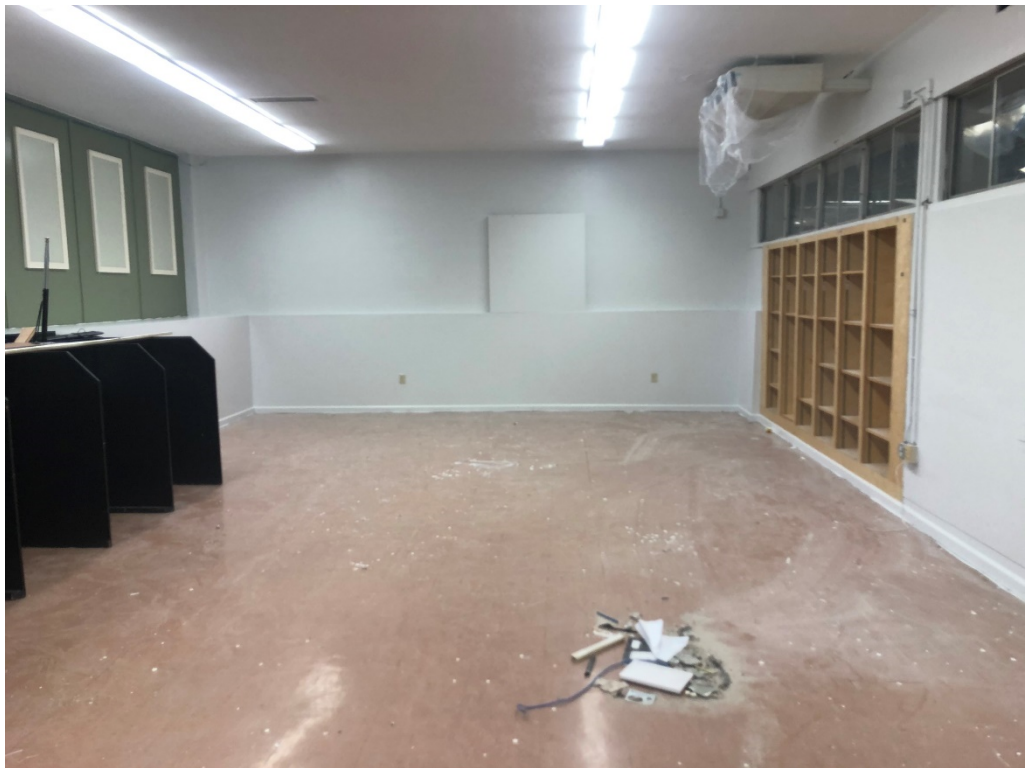
Inside, I walked the main hall and noted painting has begun in the east wing as well as flooring install.

Figure 4 – Paint work in the East Hall Classrooms

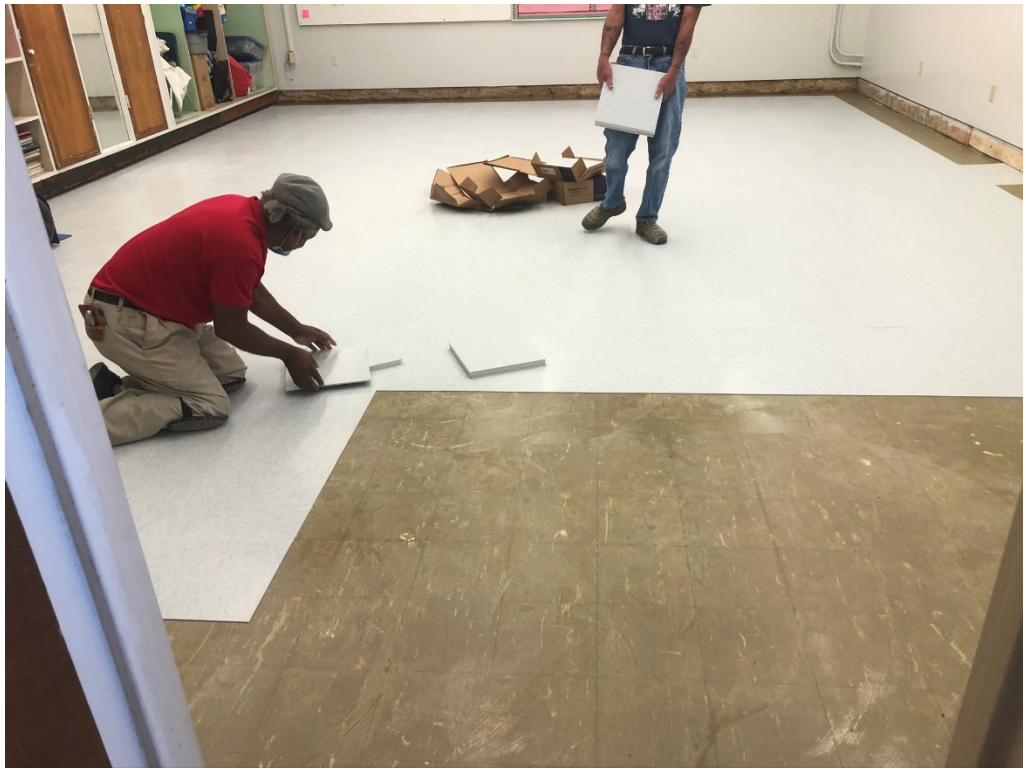
Figure 5 – Flooring at the East Hall

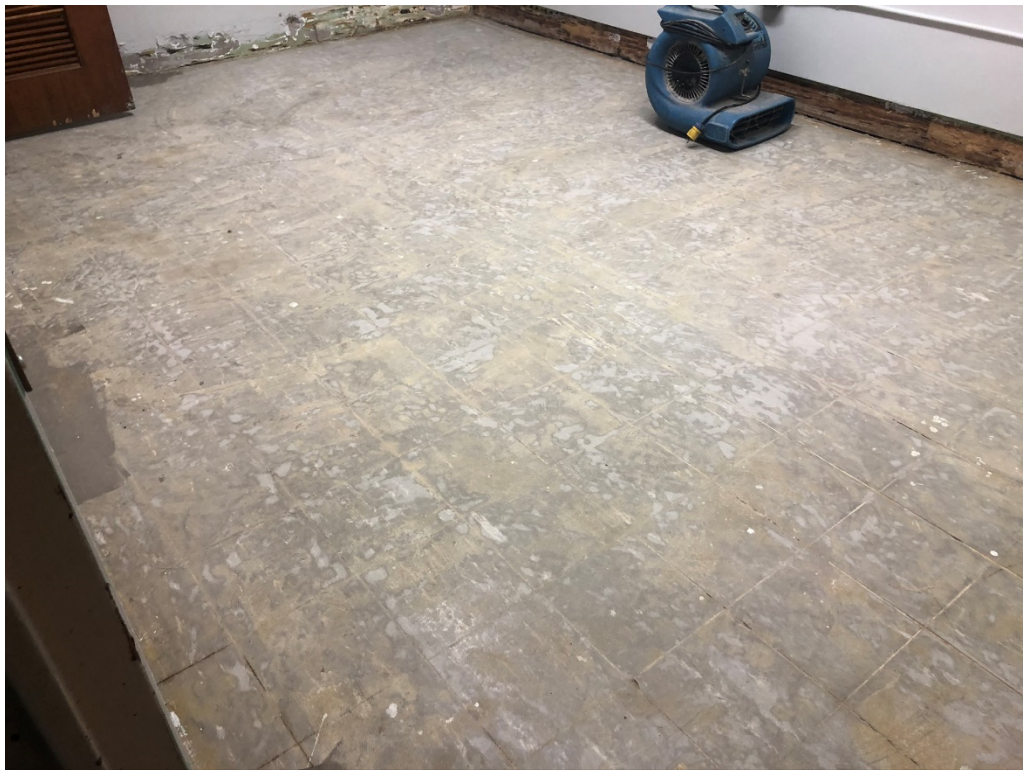
Figure 6 – Flooring Prep after Paint

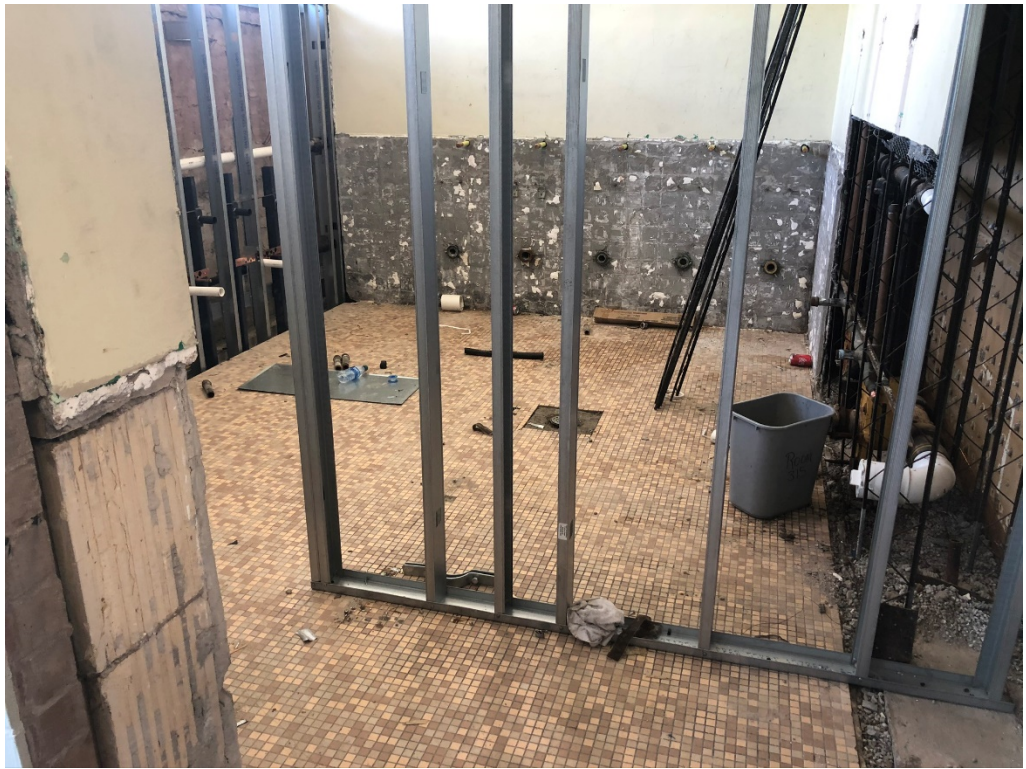
Continued work on the east bathrooms is ongoing. Framing has been performed and plumbing in ongoing in these areas.

Figure 7 – East Bathrooms

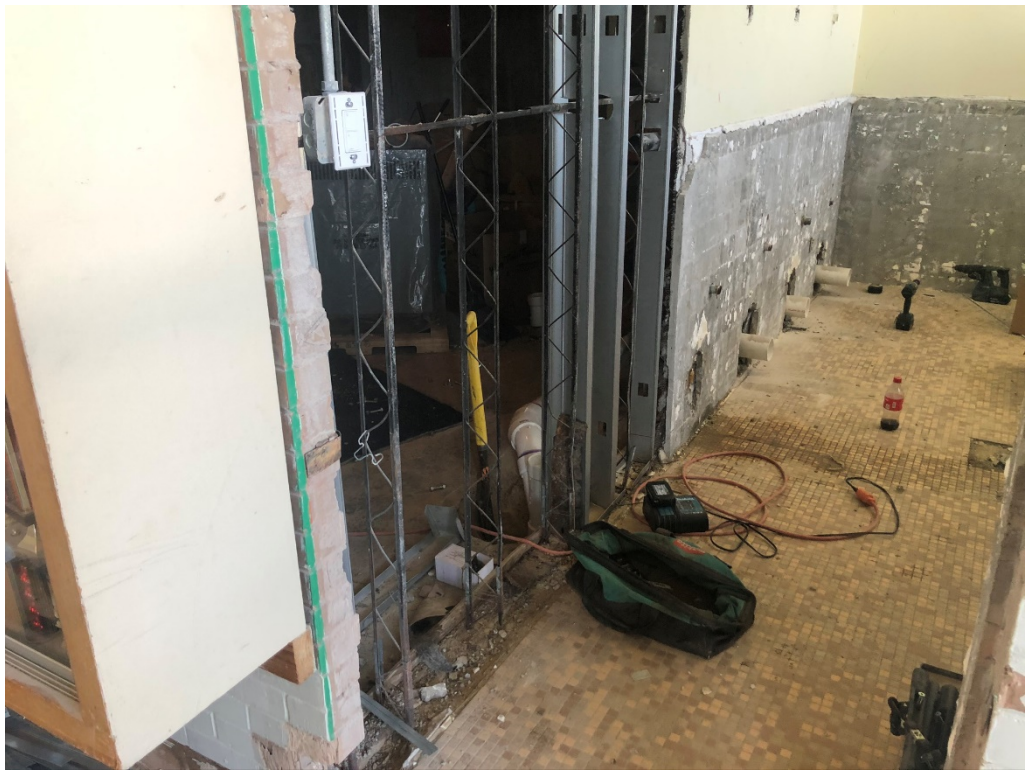
Figure 8 – East Bathrooms

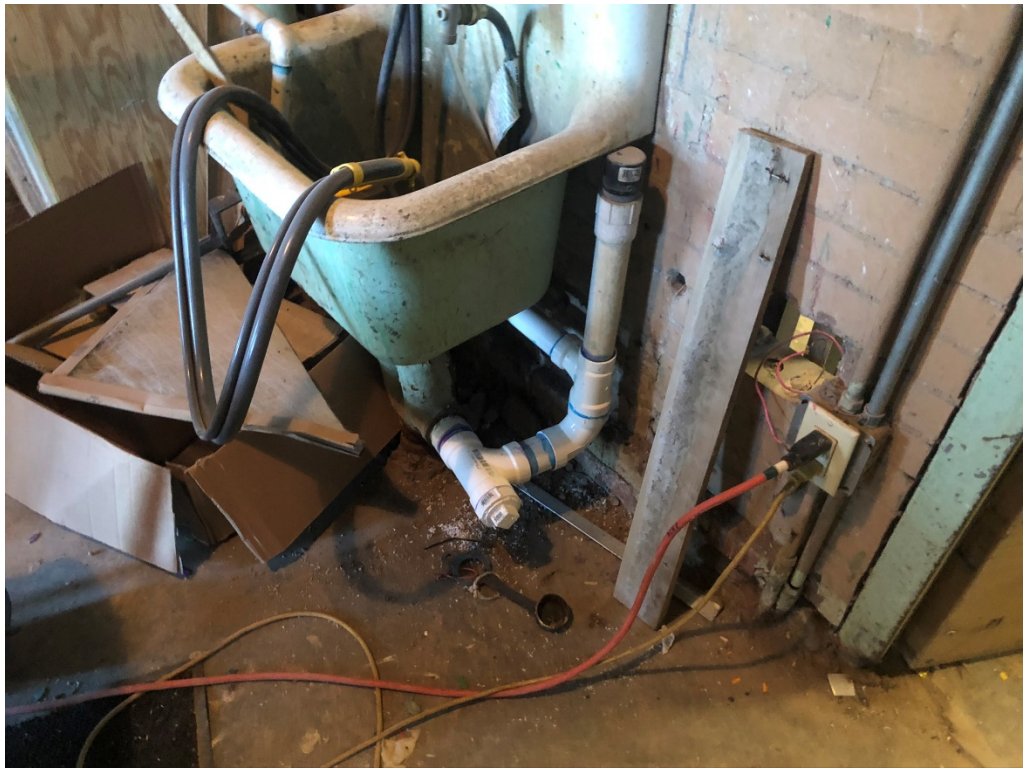
Figure 9 – Plumbing in MECH 215-B

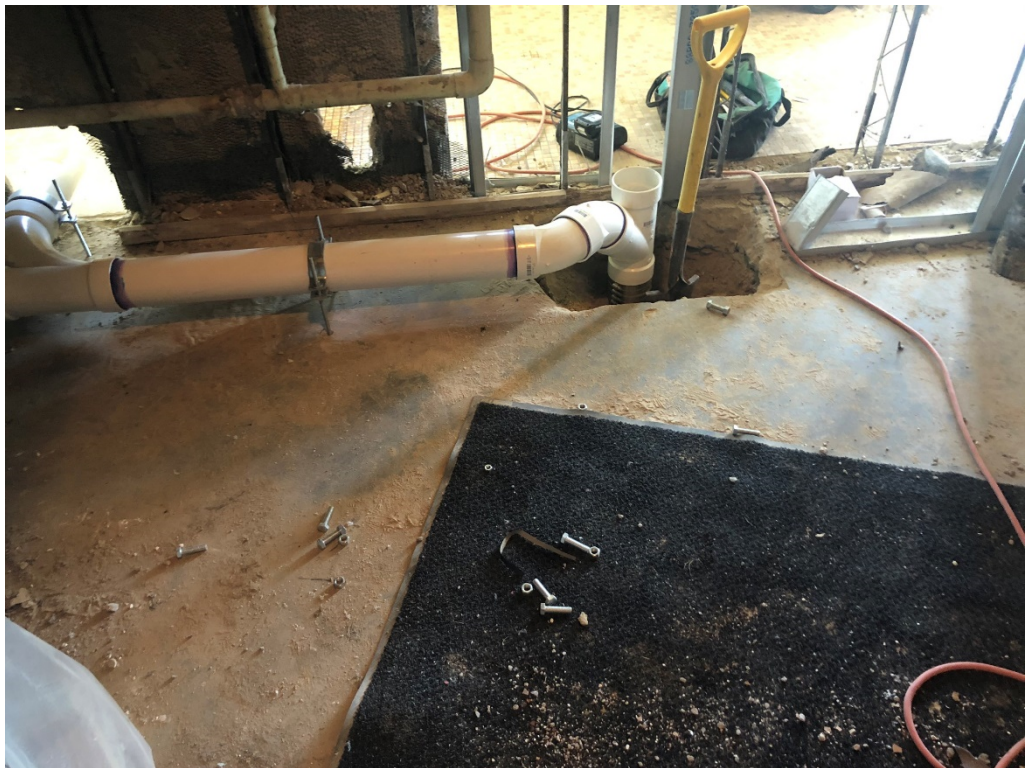
Figure 10 – Plumbing in MECH 215-B

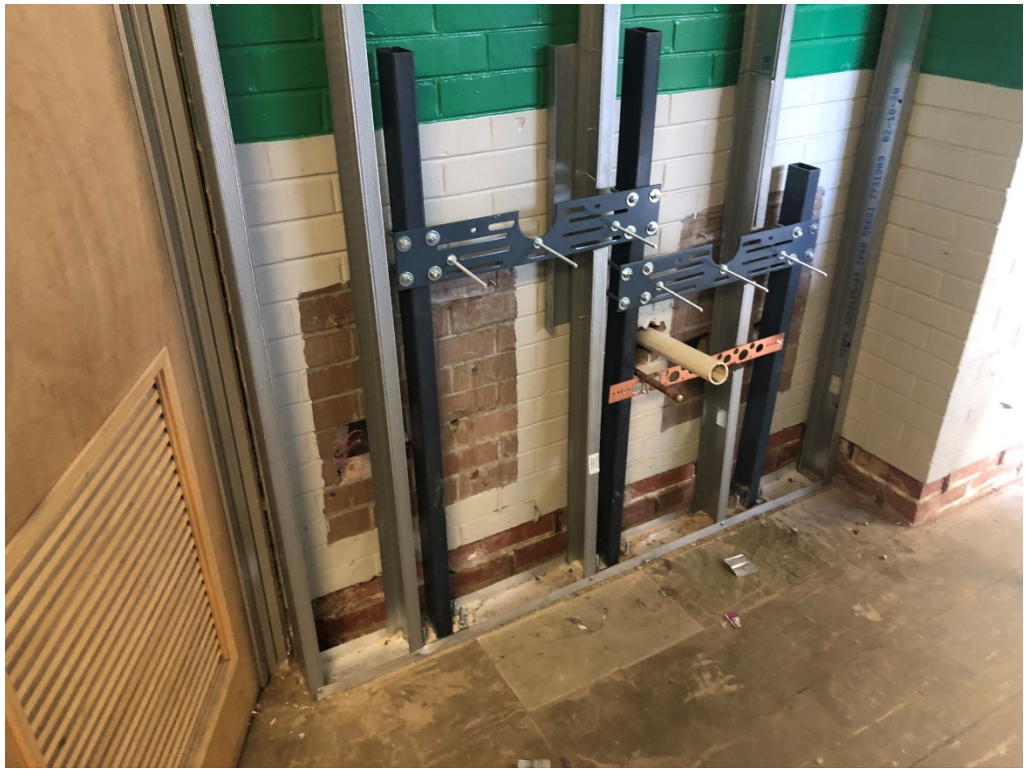
Figure 11 – New Wall at EDF's out side of MECH 215-B

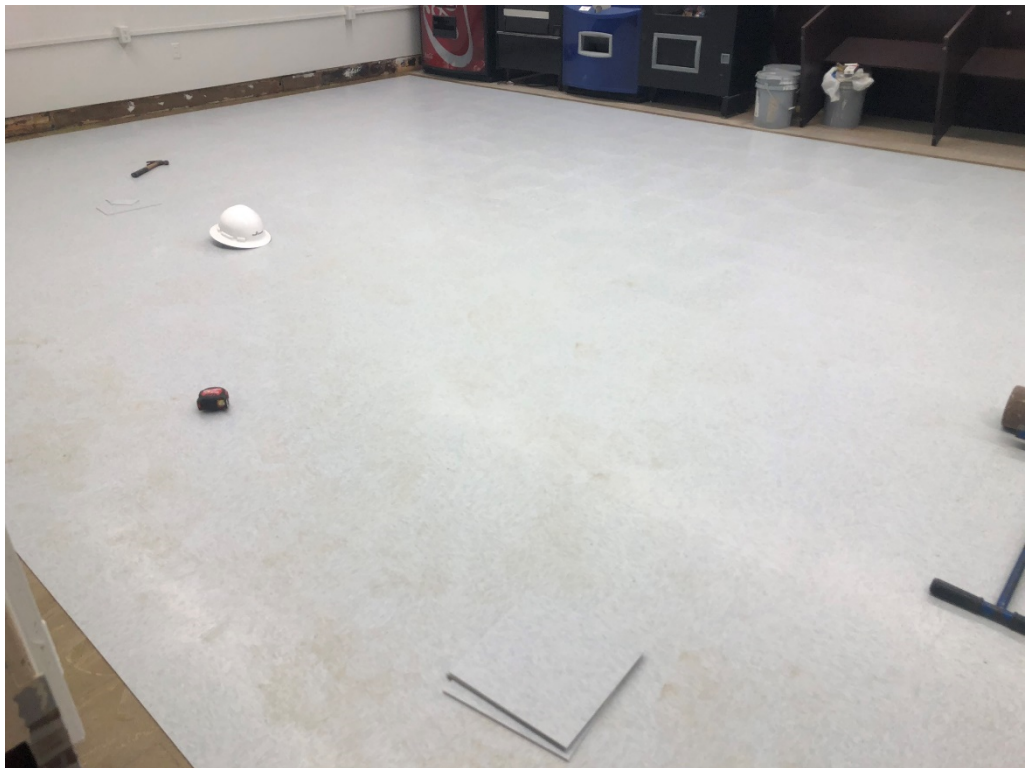
Figure 12 – Flooring at the East Hall

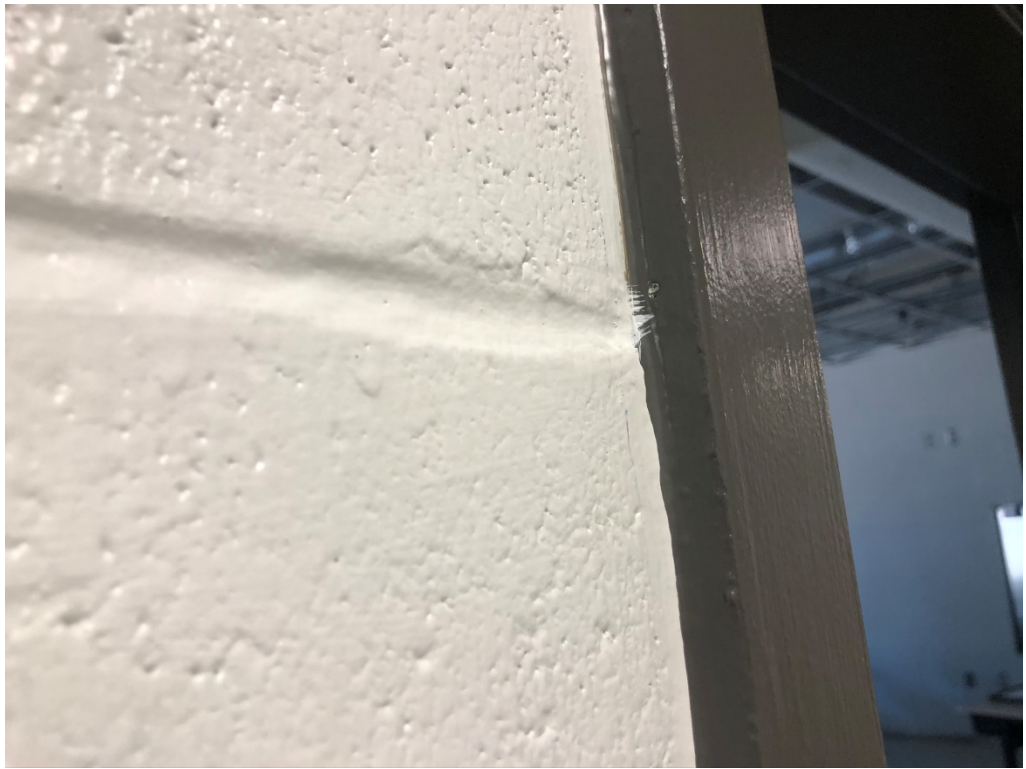
Walking the south hall, I reviewed paint work. There are many touch ups required as well as the cleaning of fixture plates. There are some coverage issues in several areas and many door jambs need to be re cut. I have included pictures in this report as examples, but this is not an exhaustive list.

Figure 13 – South Hall Door Jambs Need Touch Up

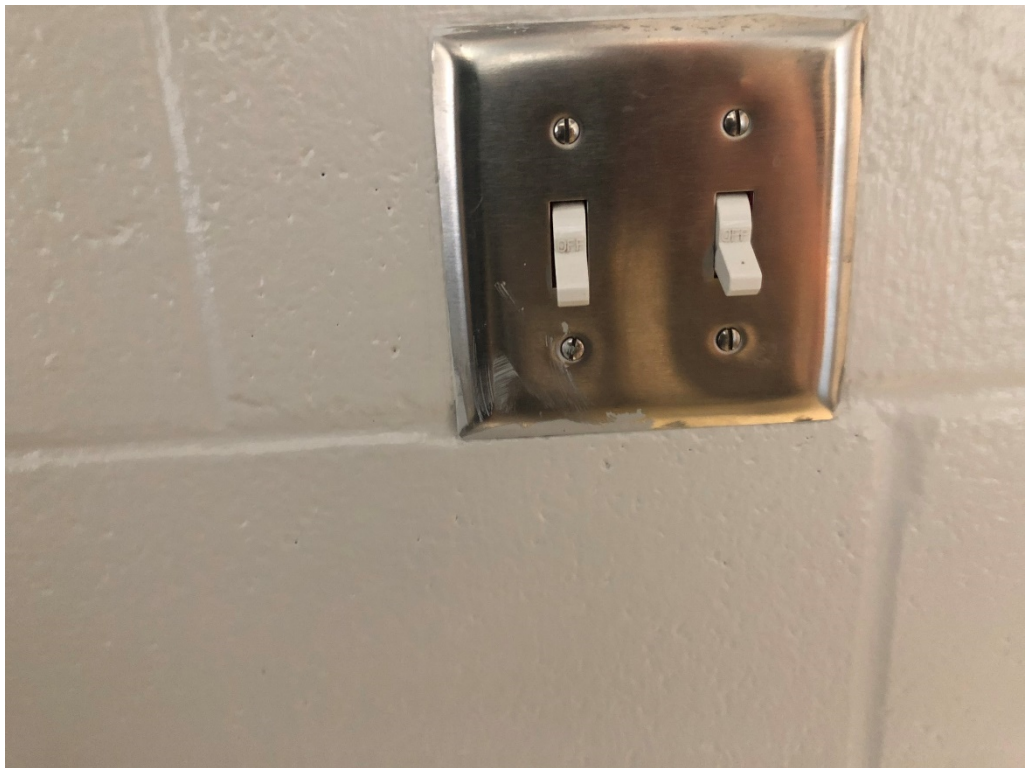
Figure 14 – Paint on Light Switch Covers (typical)

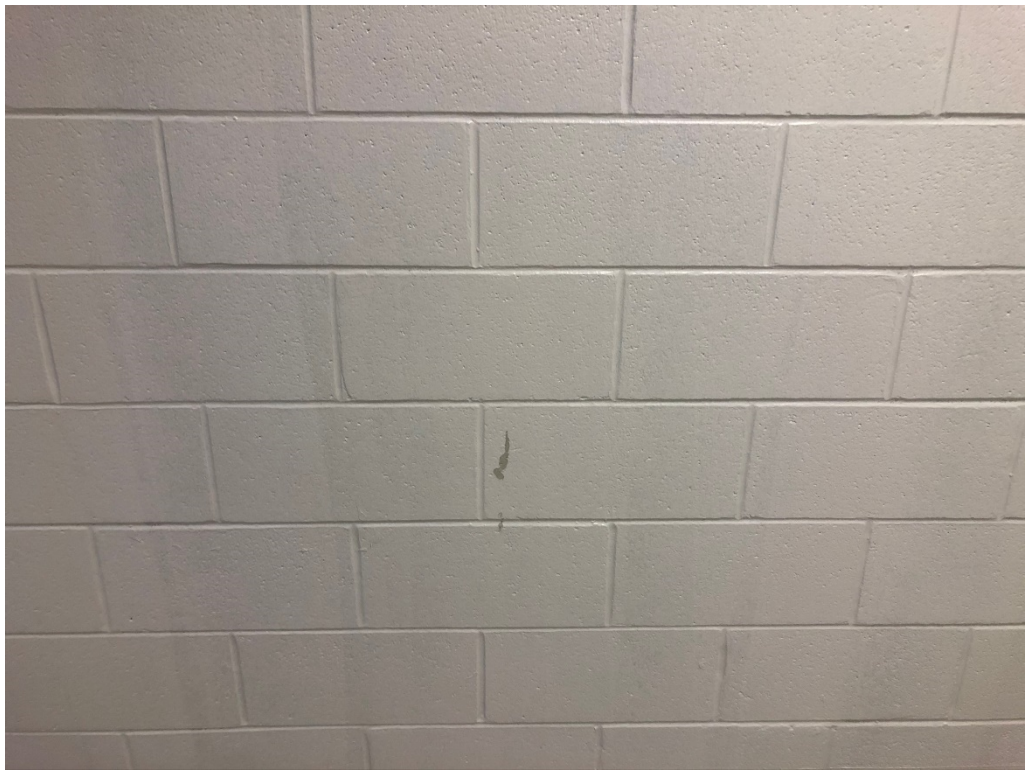
Figure 16 – Non-Matching Colors at Many Wall Surfaces

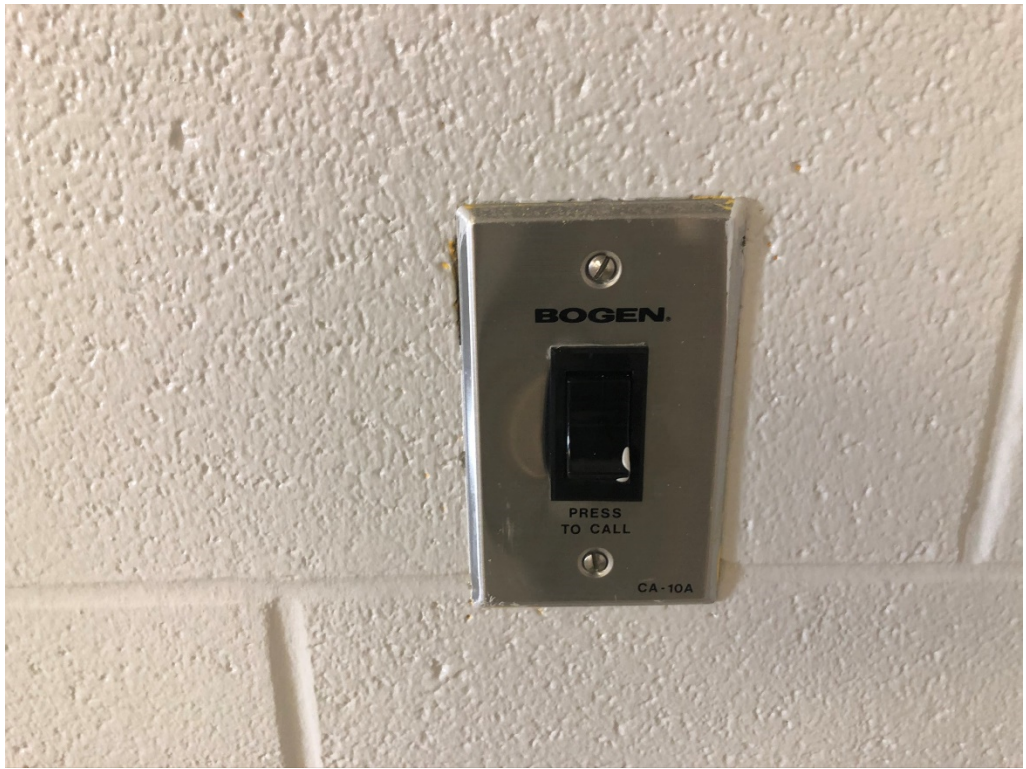
Figure 17 – Paint on Light Switch Covers (typical)

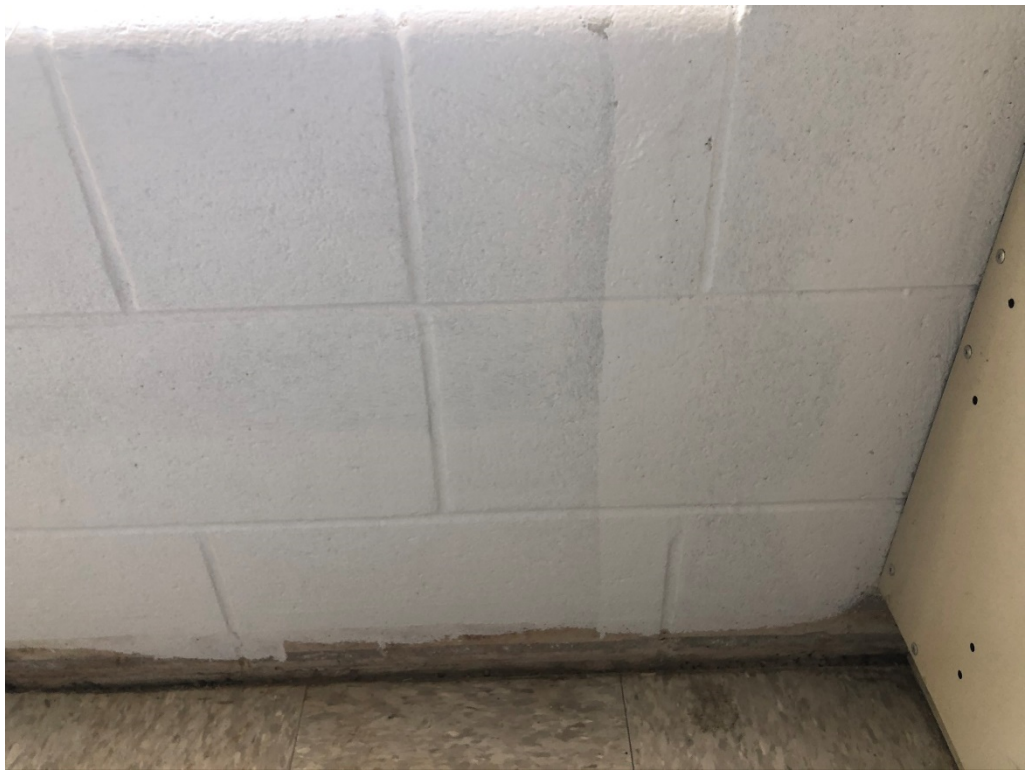
Figure 18 – Pour Coverage Below Windows

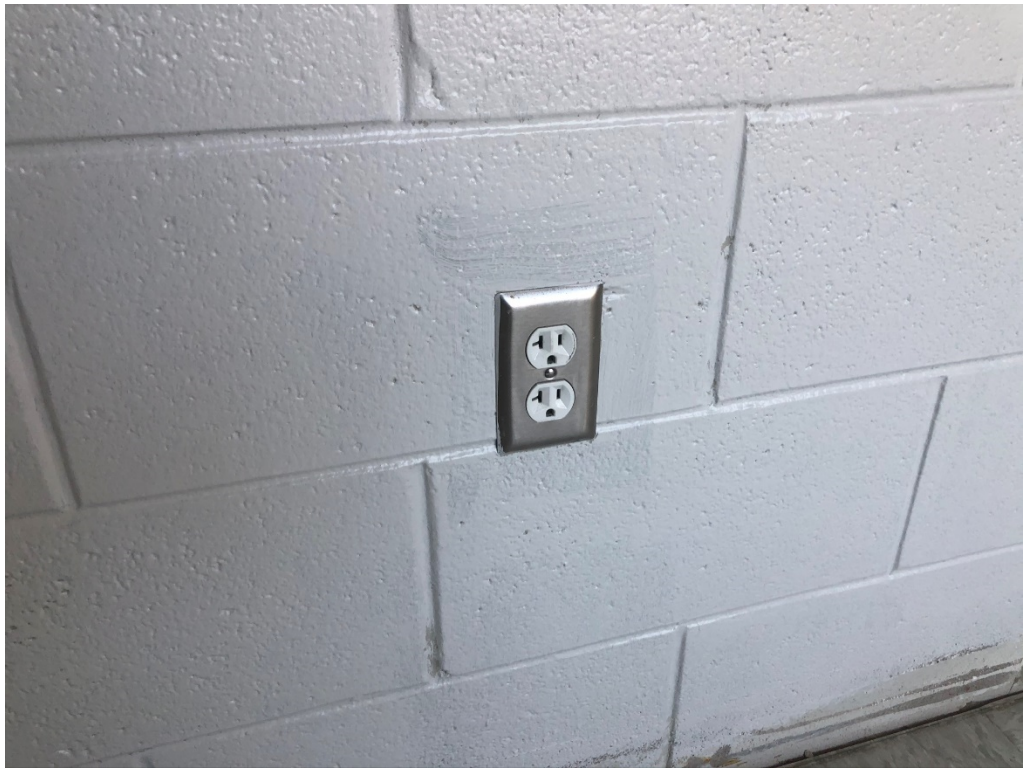
Figure 19 – Incomplete Coverage in many places

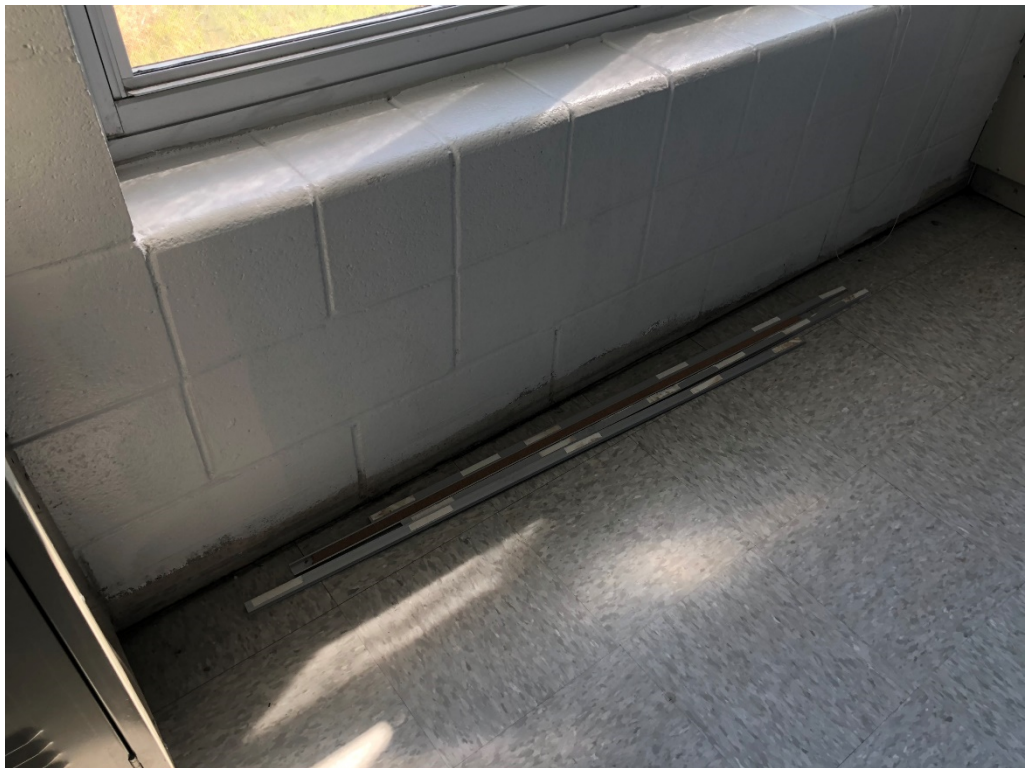
Figure 20 – Pour Coverage Below Windows

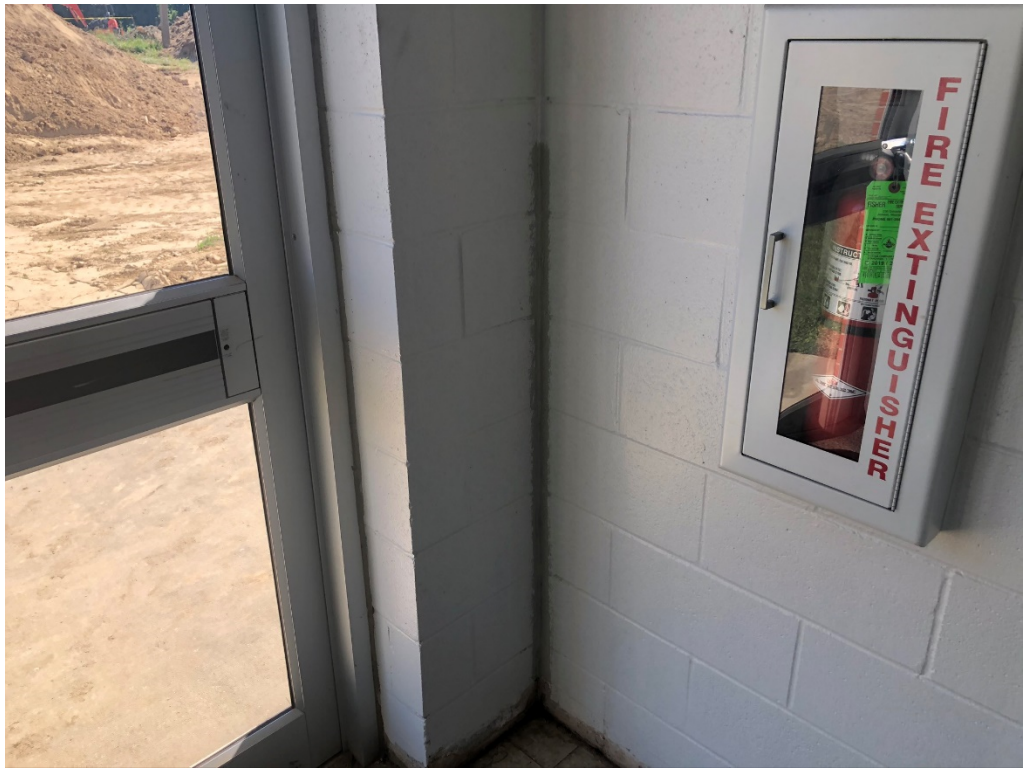
Figure 21 – Pour Coverage

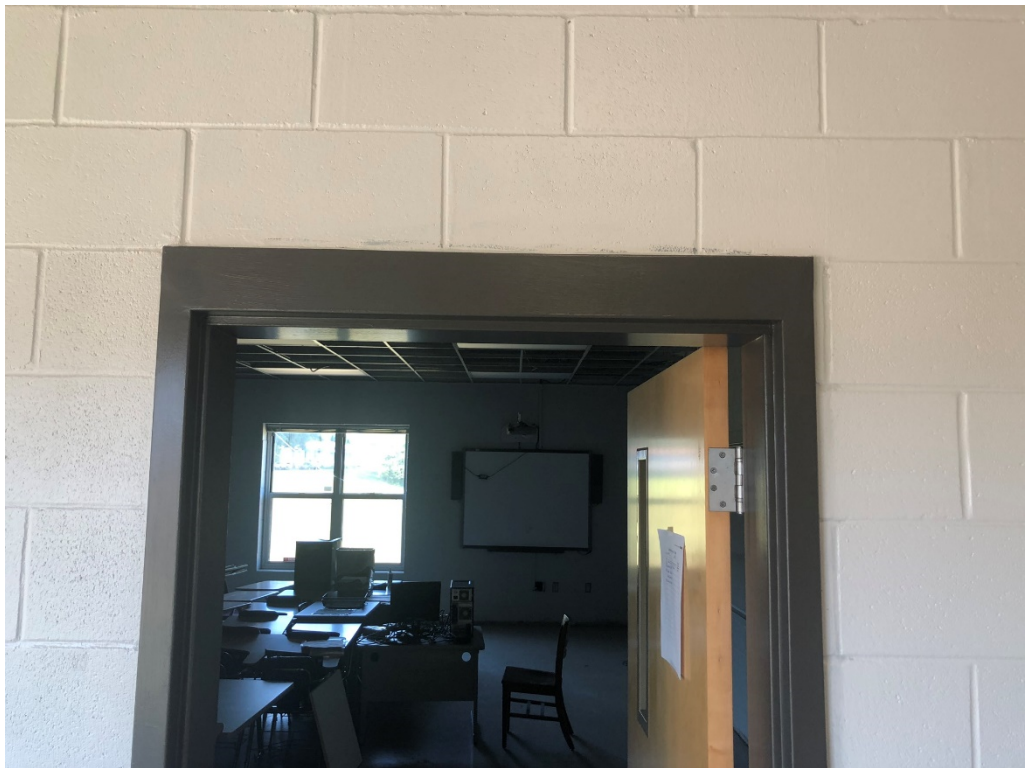
Figure 22 – Pour Coverage Above Door
