Architect's Field Report

24 July 2020

18053-Vicksburg Junior High School / Report Number 015

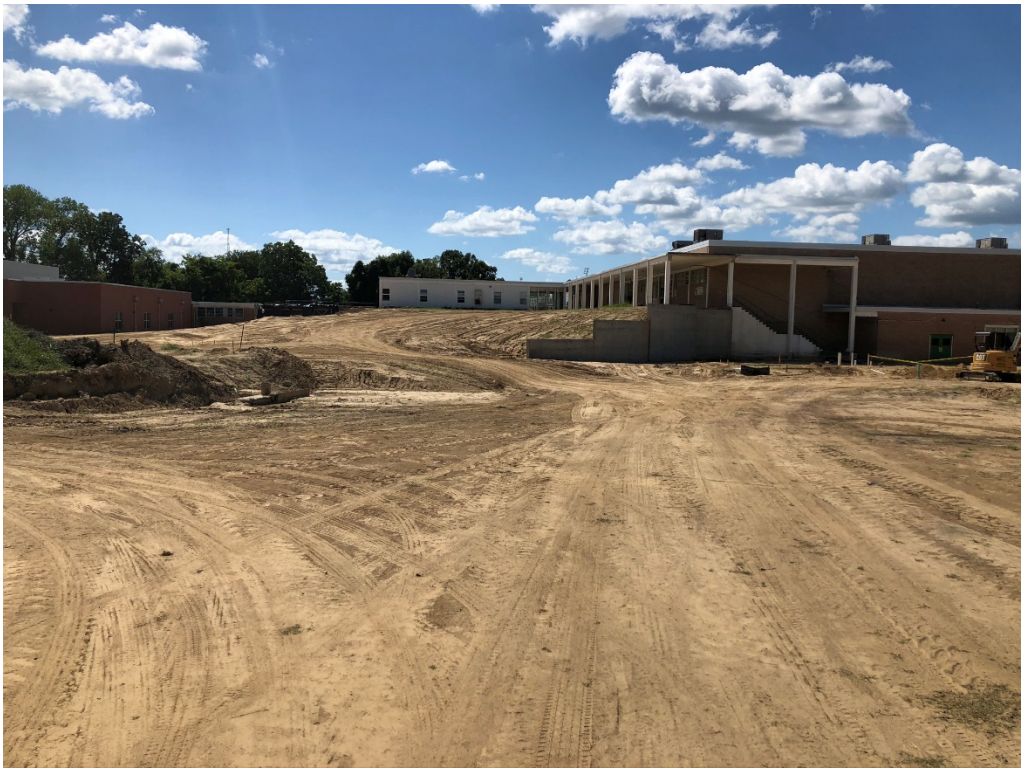
Figure 1 – Site from Job Site Trailer

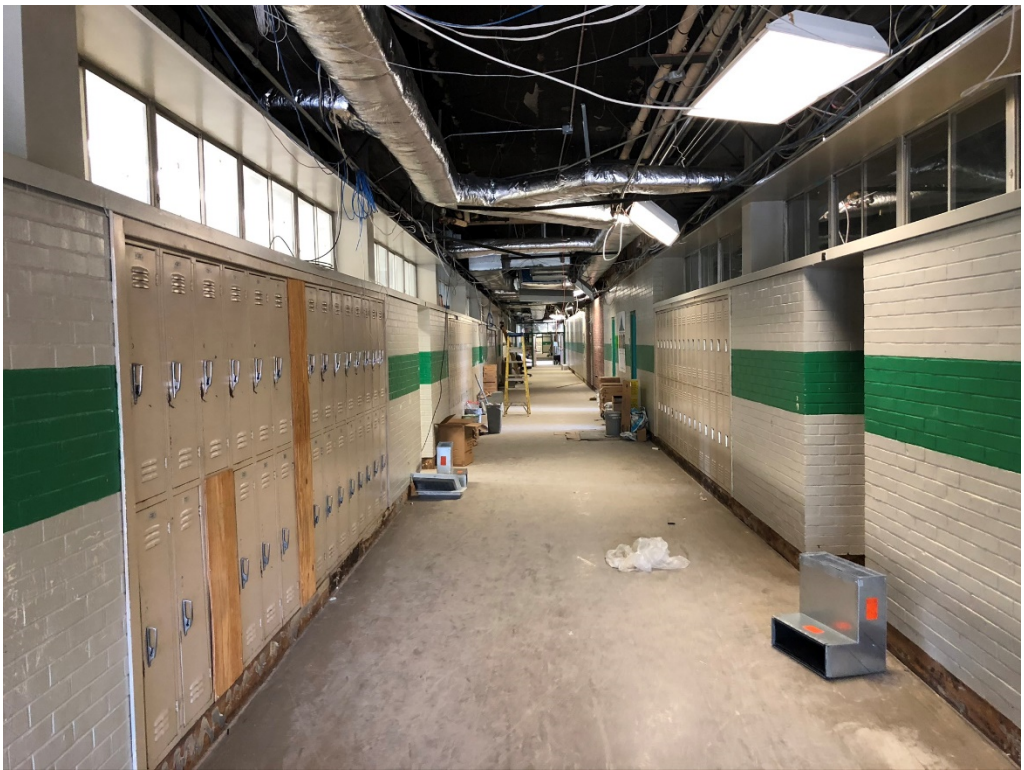
Observations I entered the site through the south hall; hallways at the west hall have been cleared and items moved into classrooms. HVAC laborers were working at the hall.

Figure 2 – Hallways are clearing out

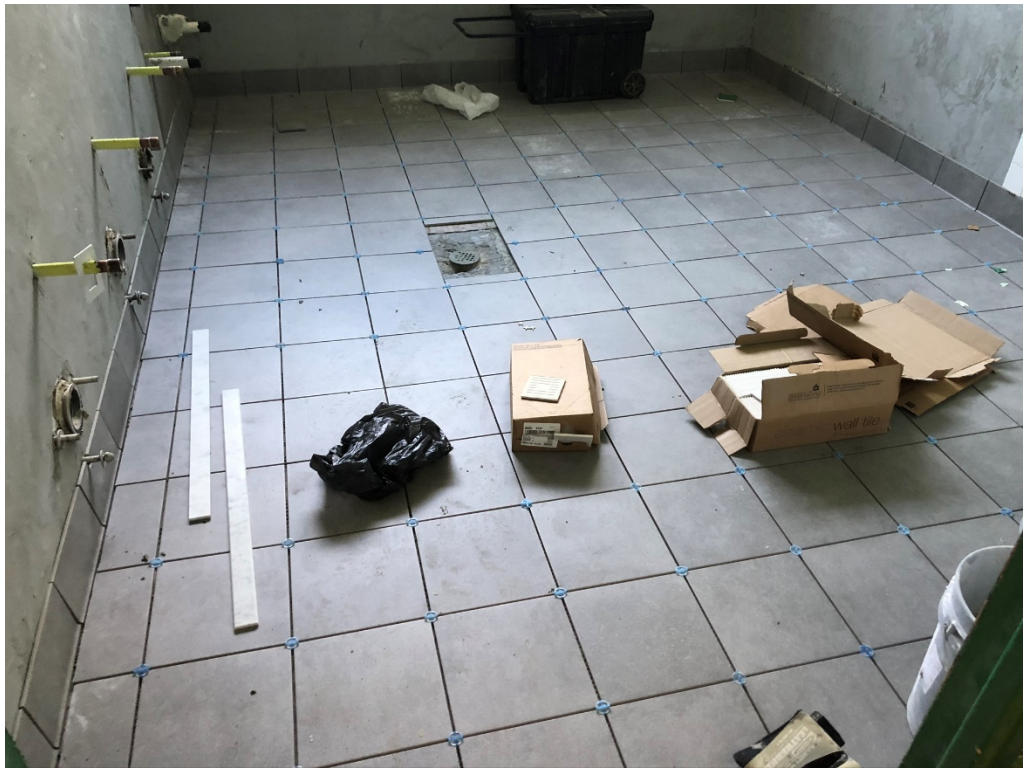
At restroom E-226C, tile work is ongoing; E-226B had workers installing substrate at plumbing walls.

Figure 3 – E-226C Bathroom Tile

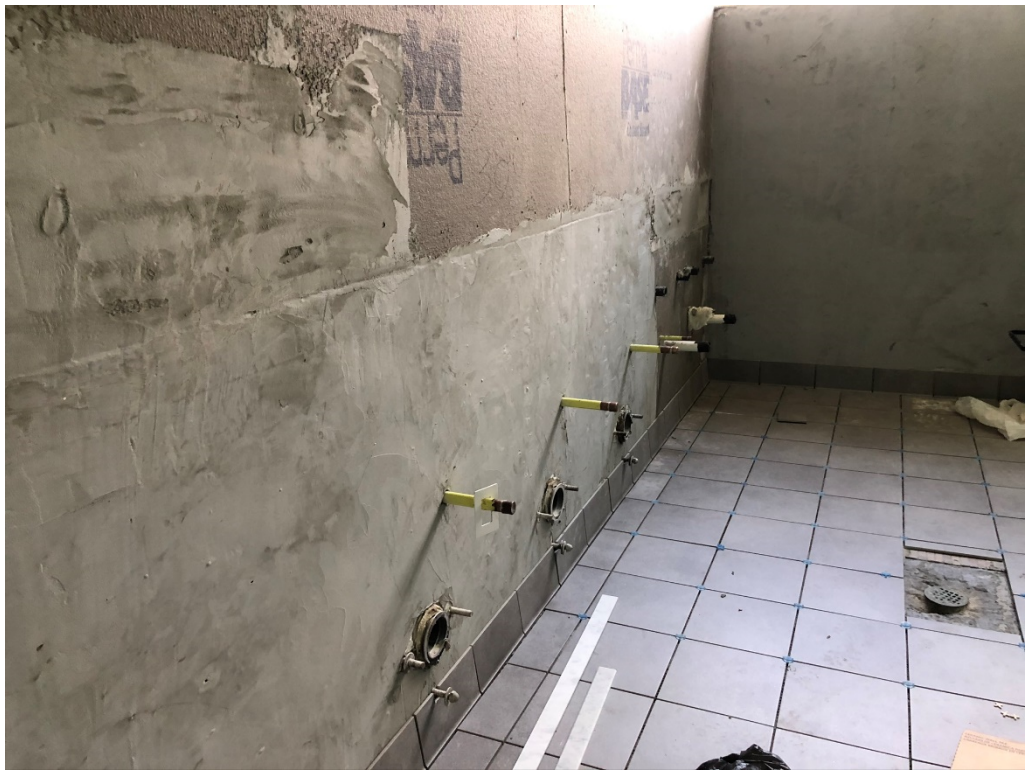
Figure 4 – E-226C Bathroom

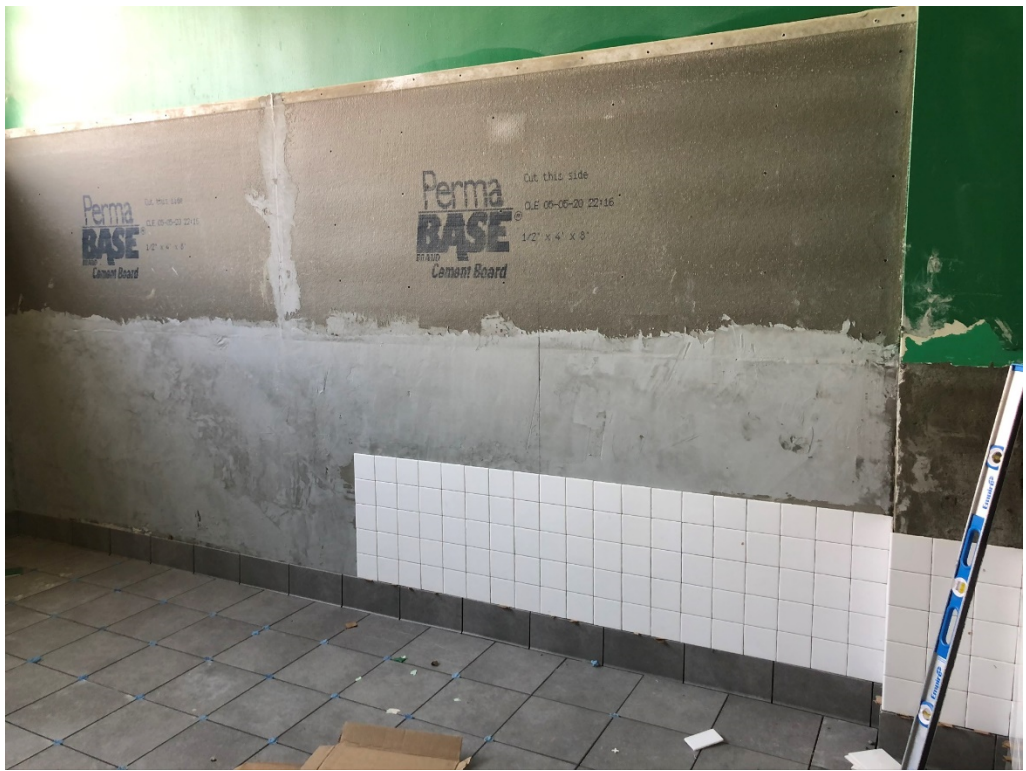
Figure 5 – E-226C Bathroom Tile

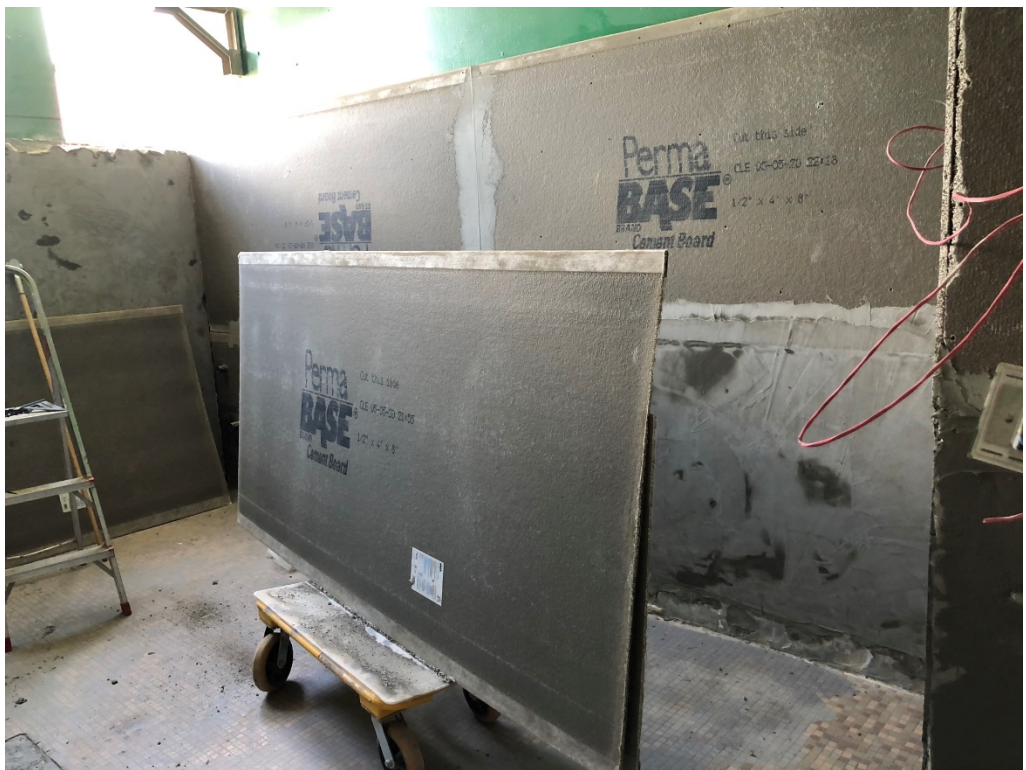
Figure 6 – E-226B Bathroom

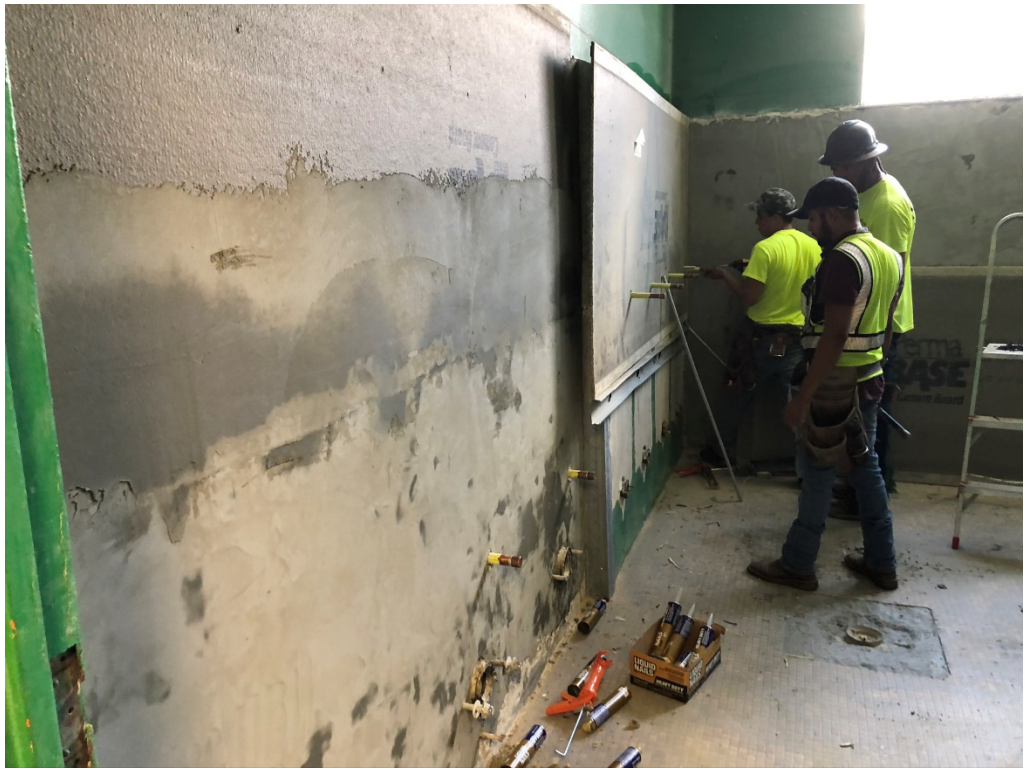
Figure 7 – E-226B Bathroom

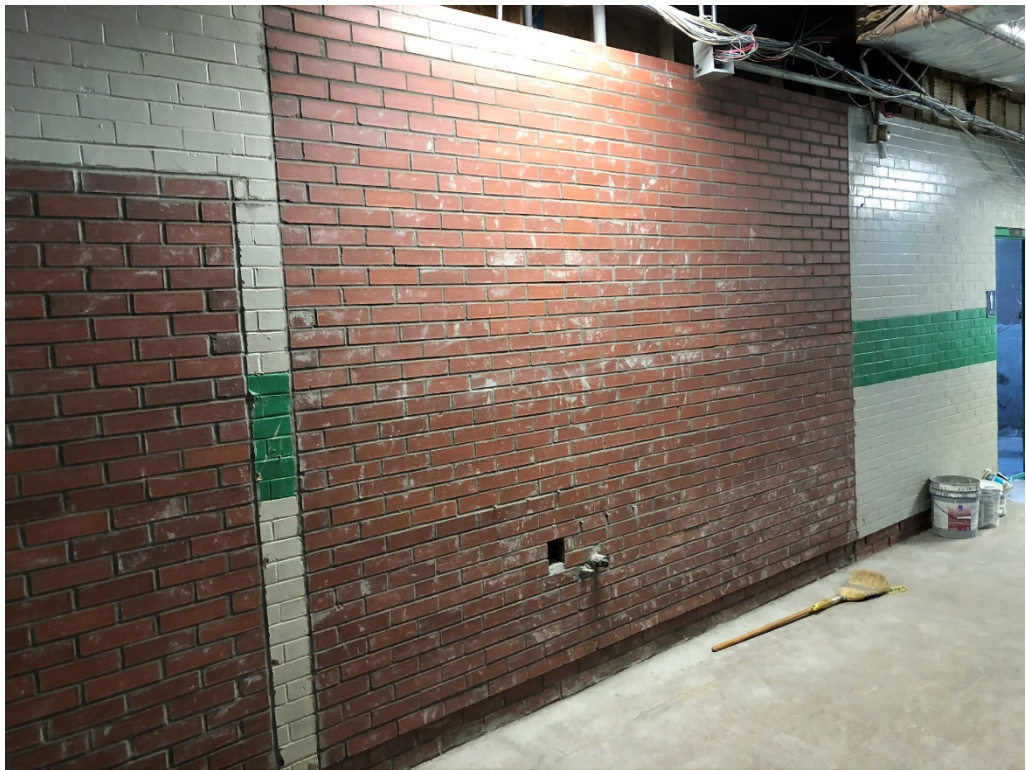
Figure 8 – New Brick at Chase in Corridor Wall

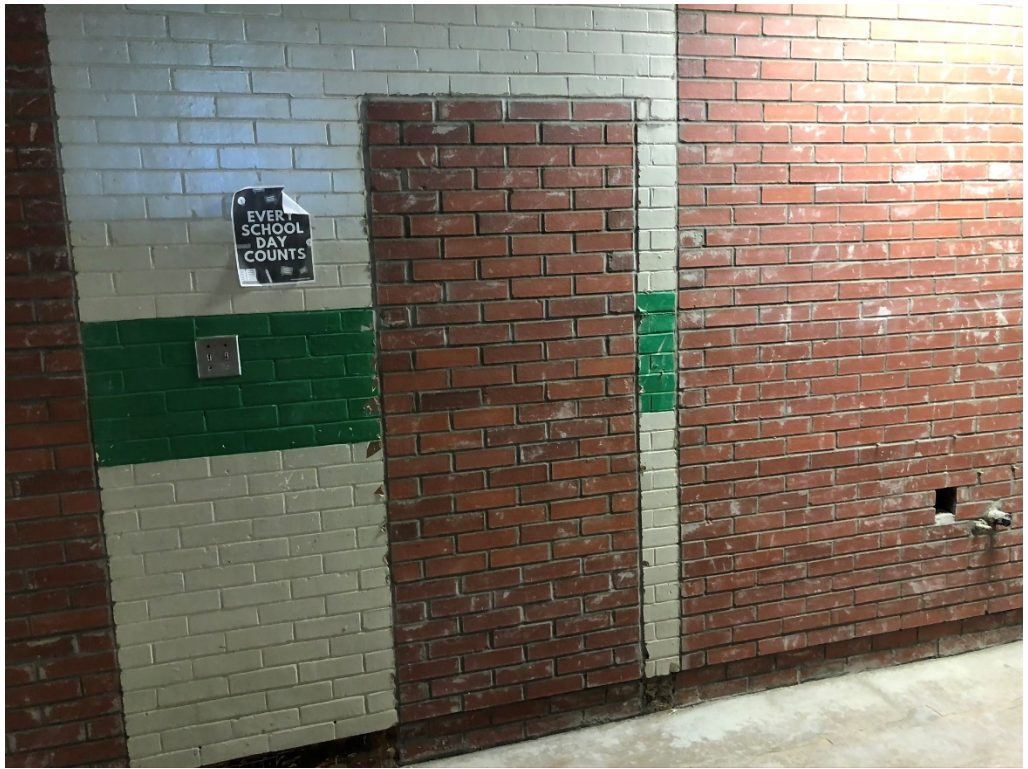
Figure 9 – New Brick at Chase in Corridor Wall

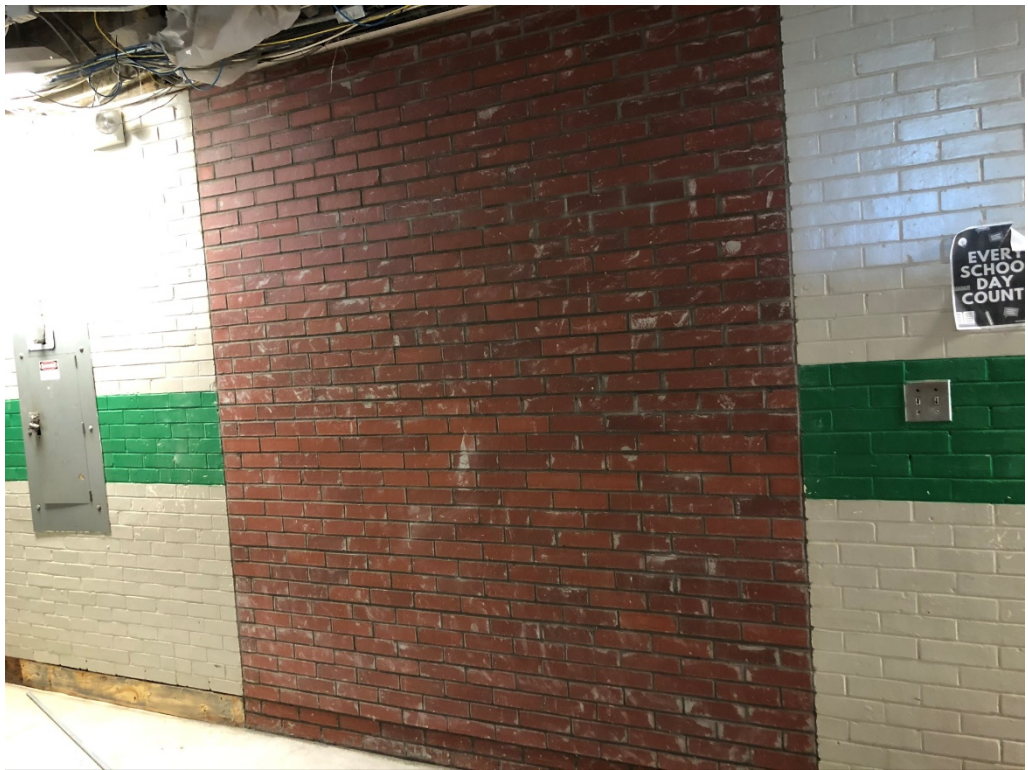
Figure 10 – New Brick at Chase in Corridor Wall

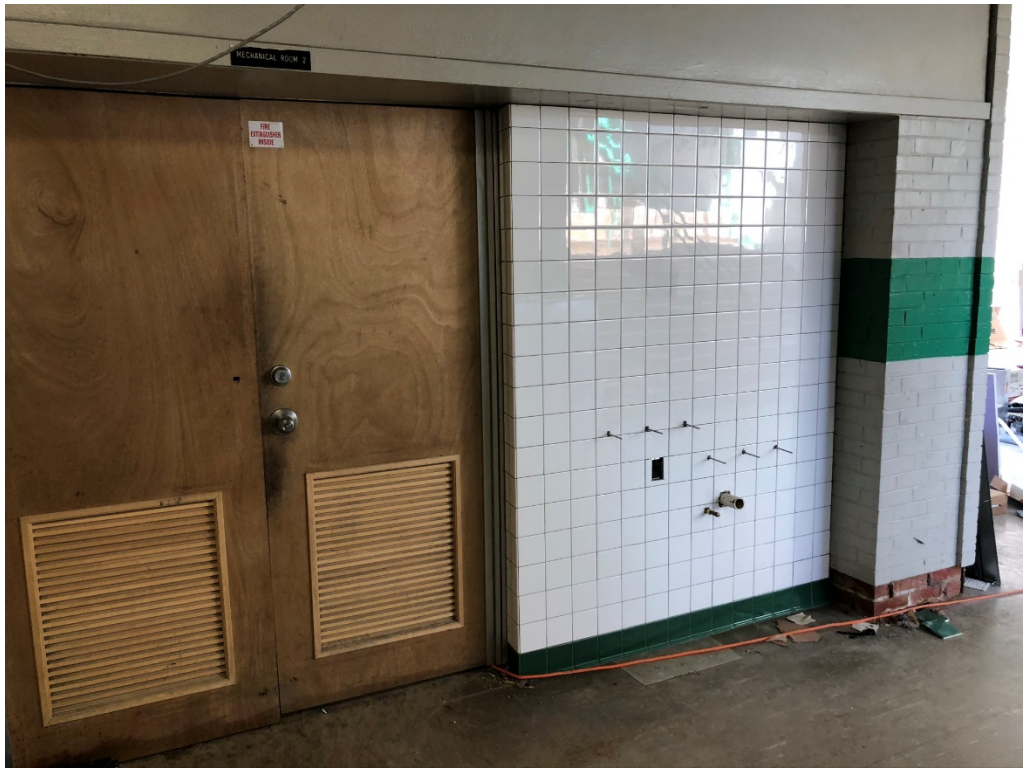
Figure 11 – New Tile at EDF's

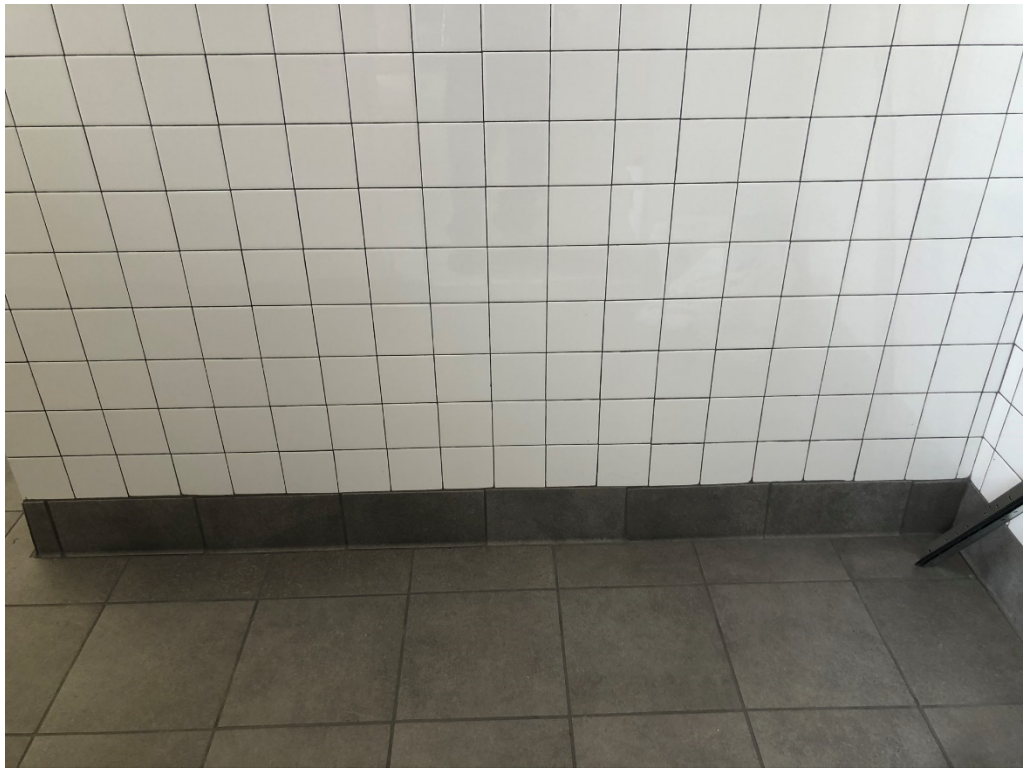
Tile work is complete in the western-most bathrooms at this level. A few tiles need to be reset, but for the most part, the work is acceptable.

Figure 15 – E217A Bathroom (crooked tile base needs to be reset for flush appearance)

Action Required Reset Some Tiles

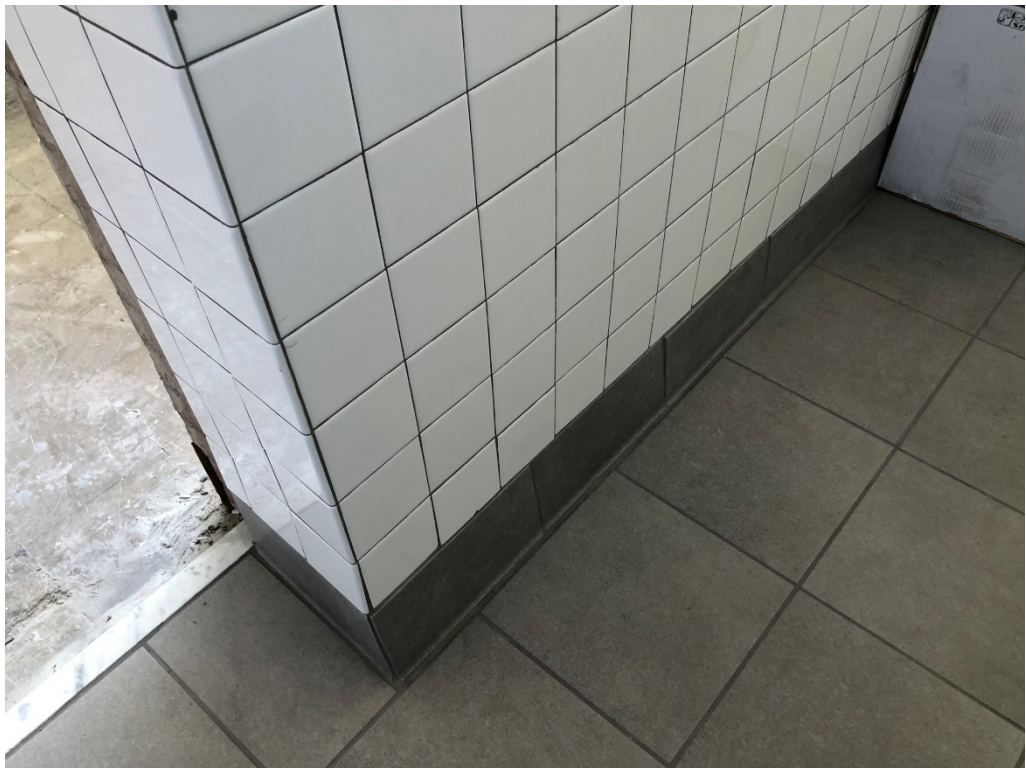
Figure 16 – Tile Base needs to be reset and floor tile need a sliver of tile to make up gap

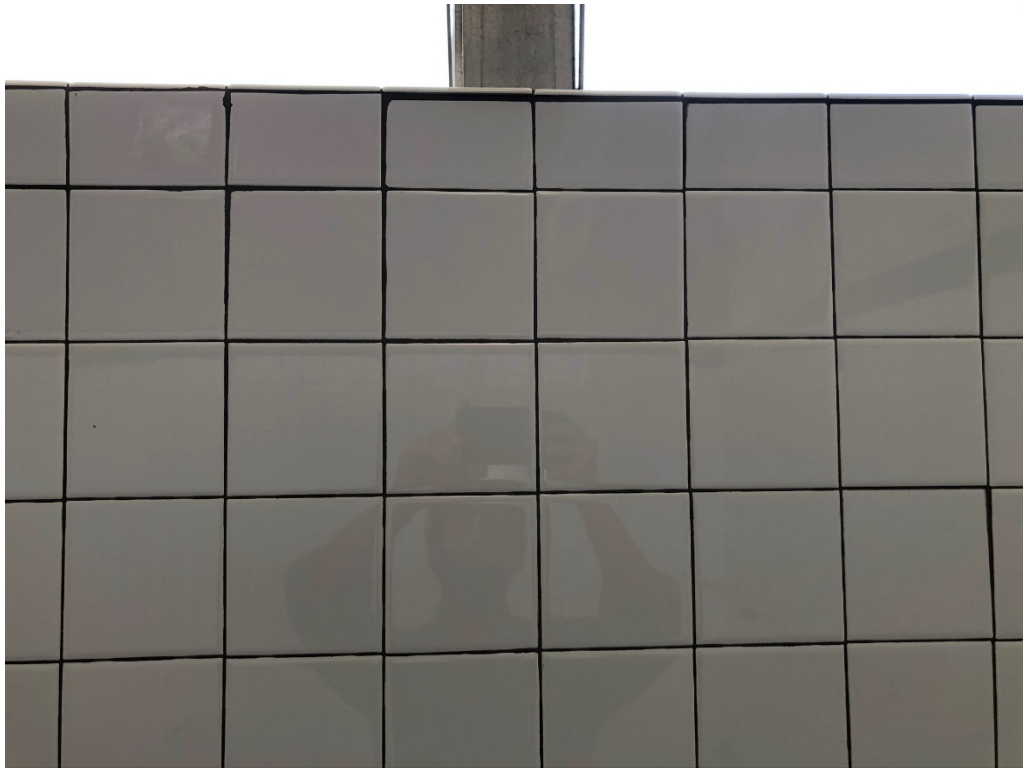
Figure 19 – E217A Bathroom (tile at top of wall needs to be reset)

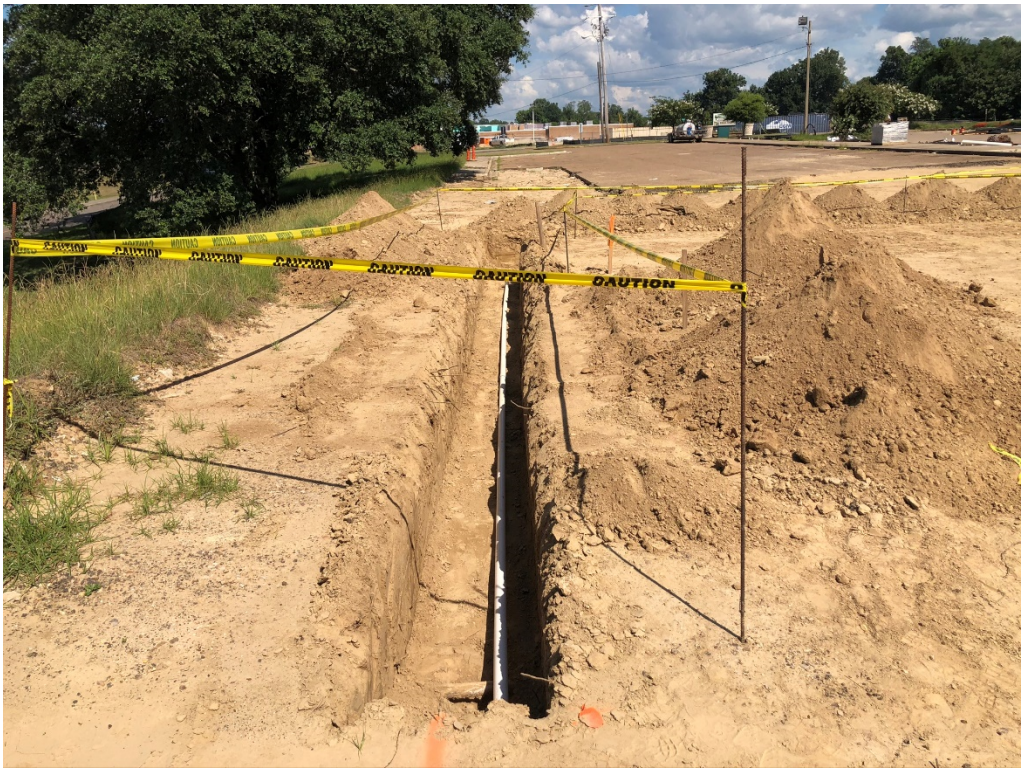
Figure 21 –Pipe Installed

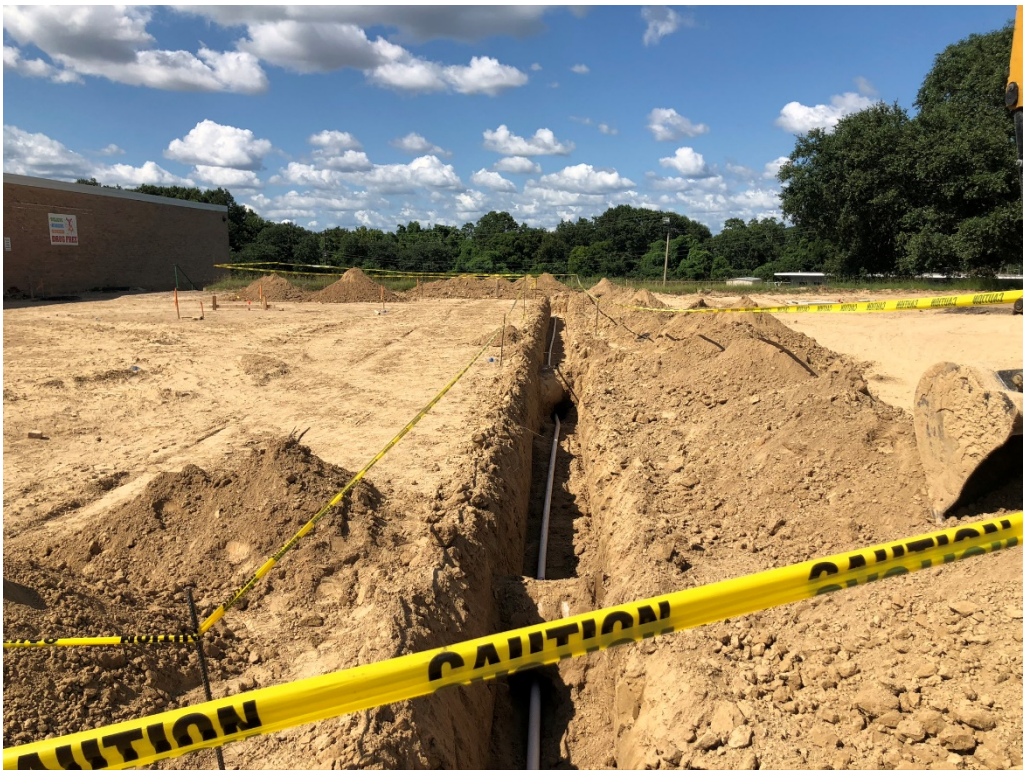
Figure 22 –Pipe Installed
