## Architect's Field Report

21 October 2020

18053-Vicksburg Junior High School / Report Number 022

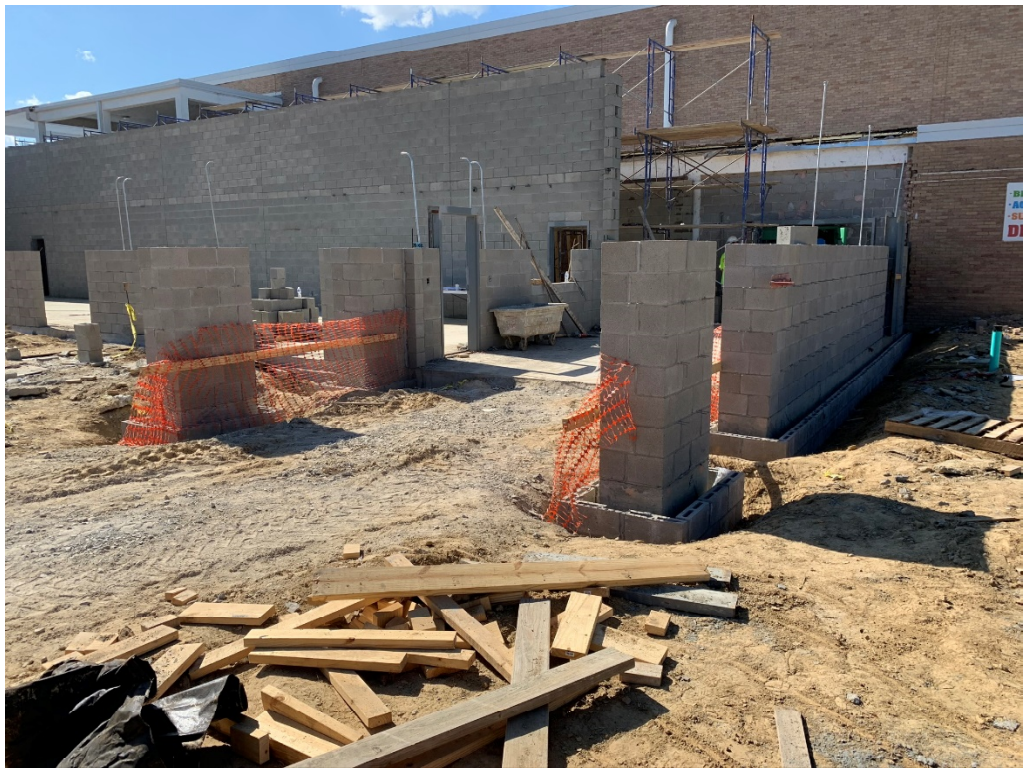
Figure 2 – Block Work at NE Corner

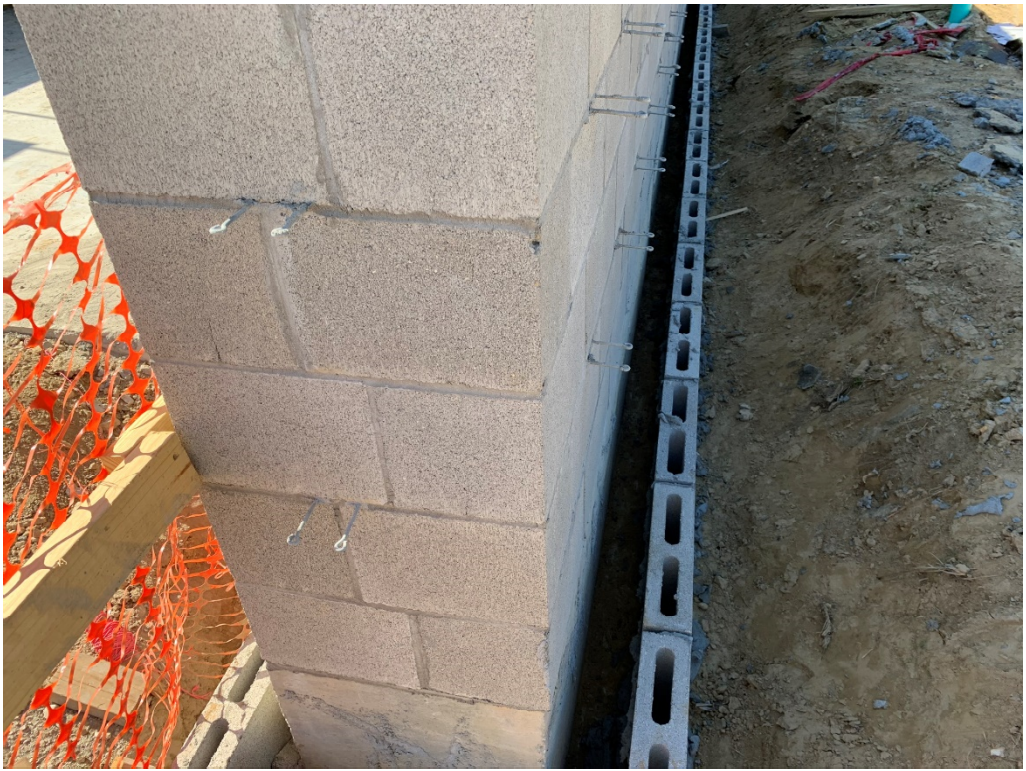
Figure 3 – Block Cavity at Footing

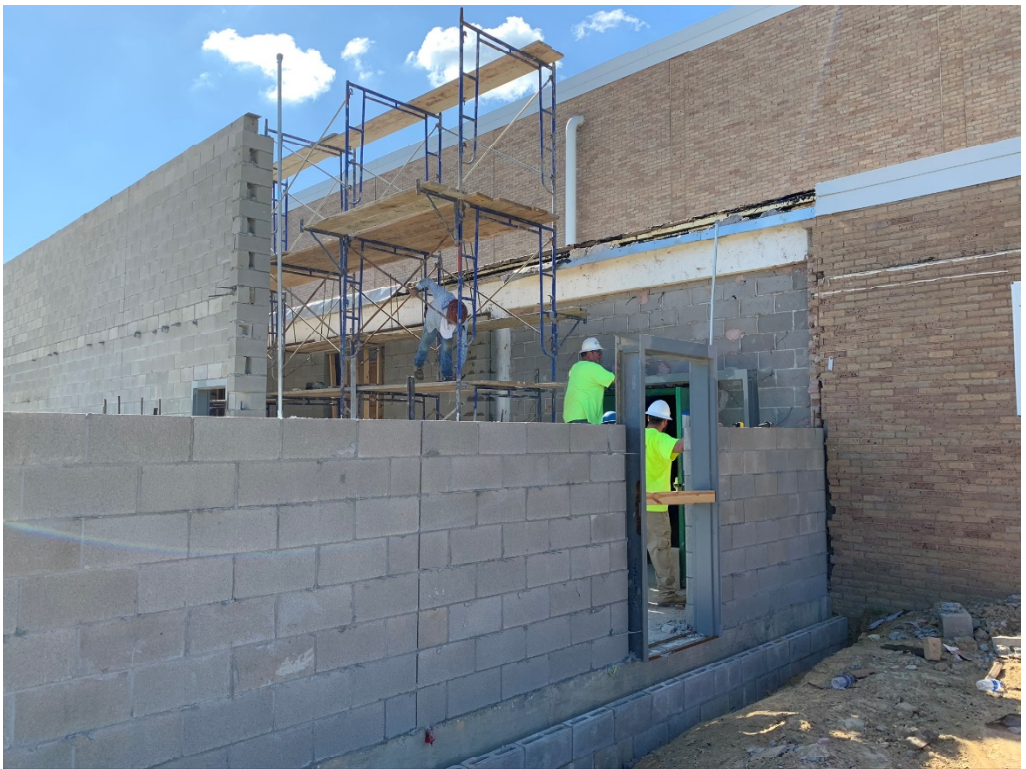
Figure 4 – Block Work Ongoing

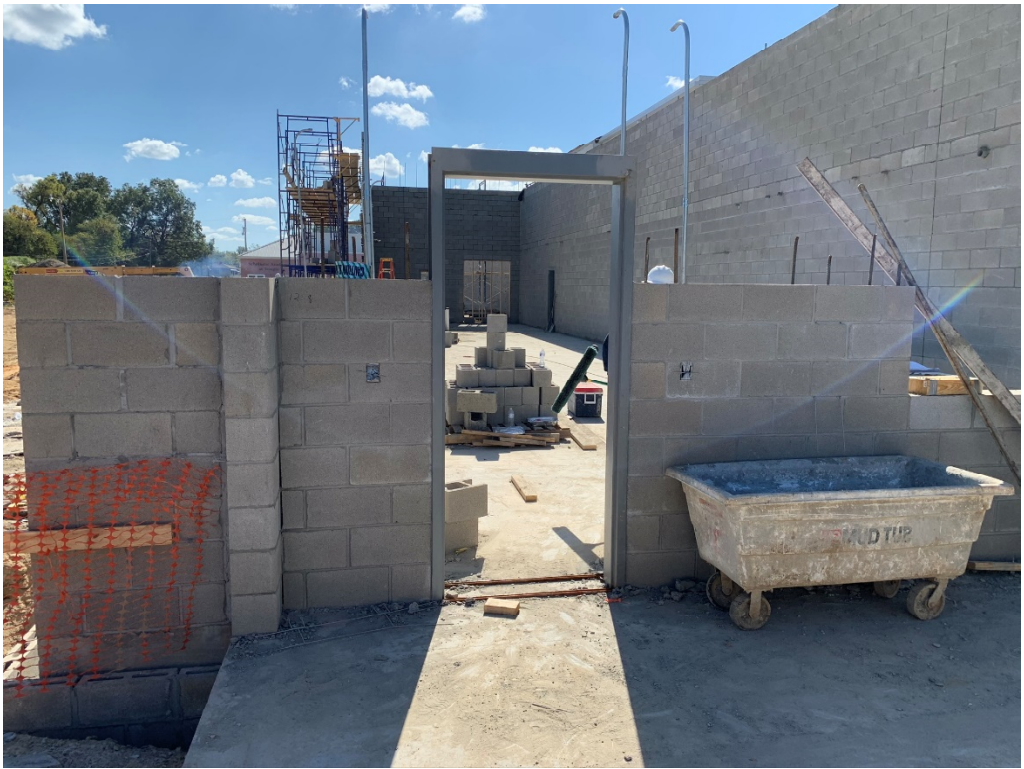
Figure 5 – Block Work Ongoing

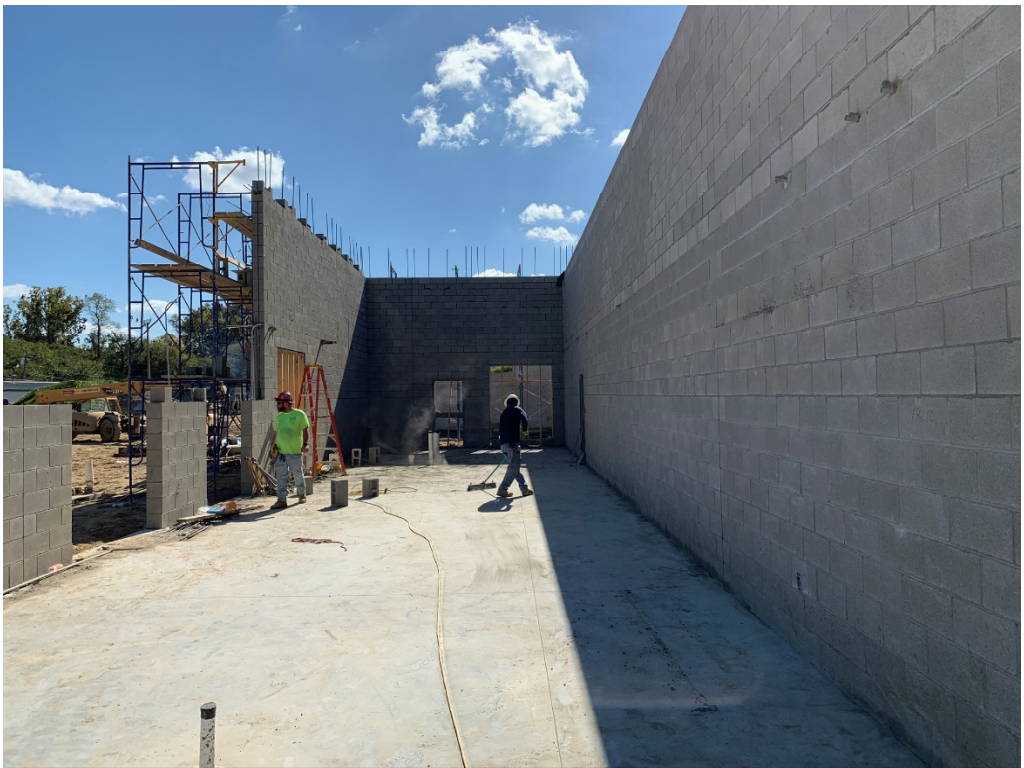
Figure 6 – Block Work Ongoing

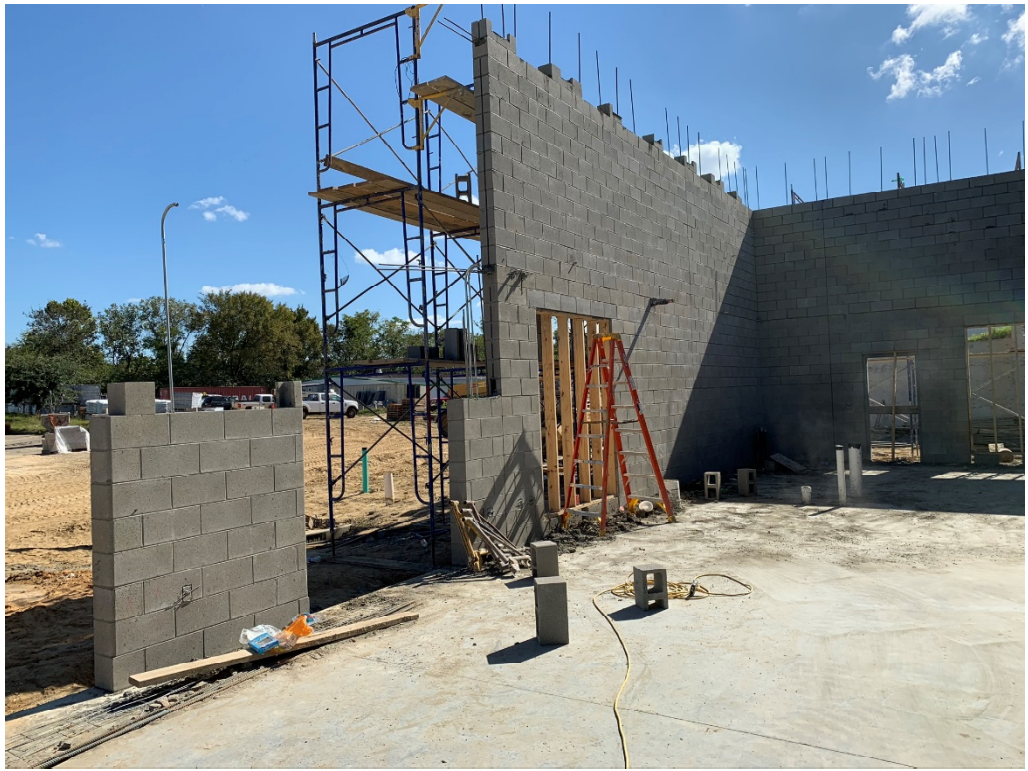
Figure 7 – Block Work Ongoing

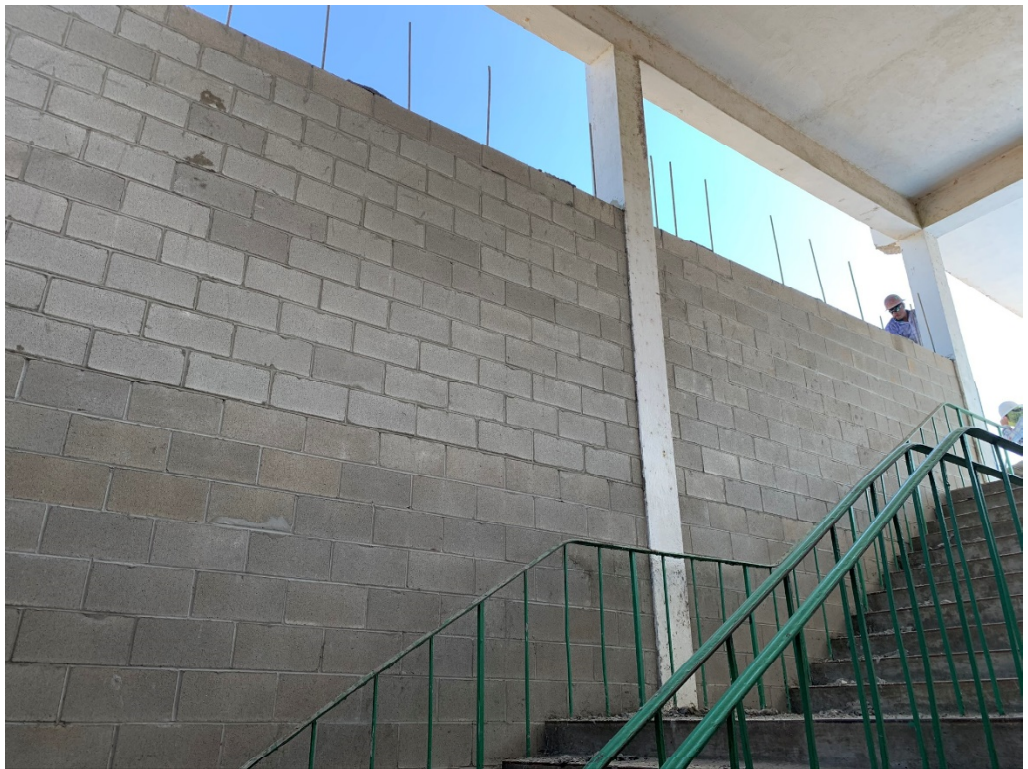
Figure 8 – Block Work Between Columns at Existing Stair

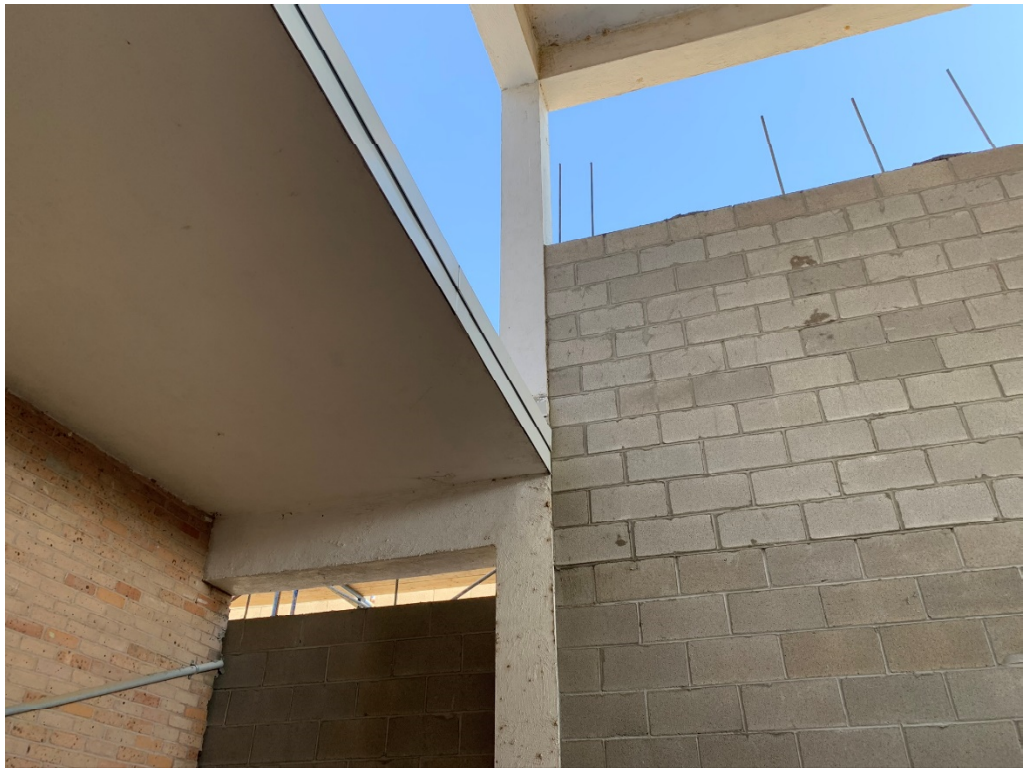
Figure 9 – Block Work Between Columns at Existing Stair

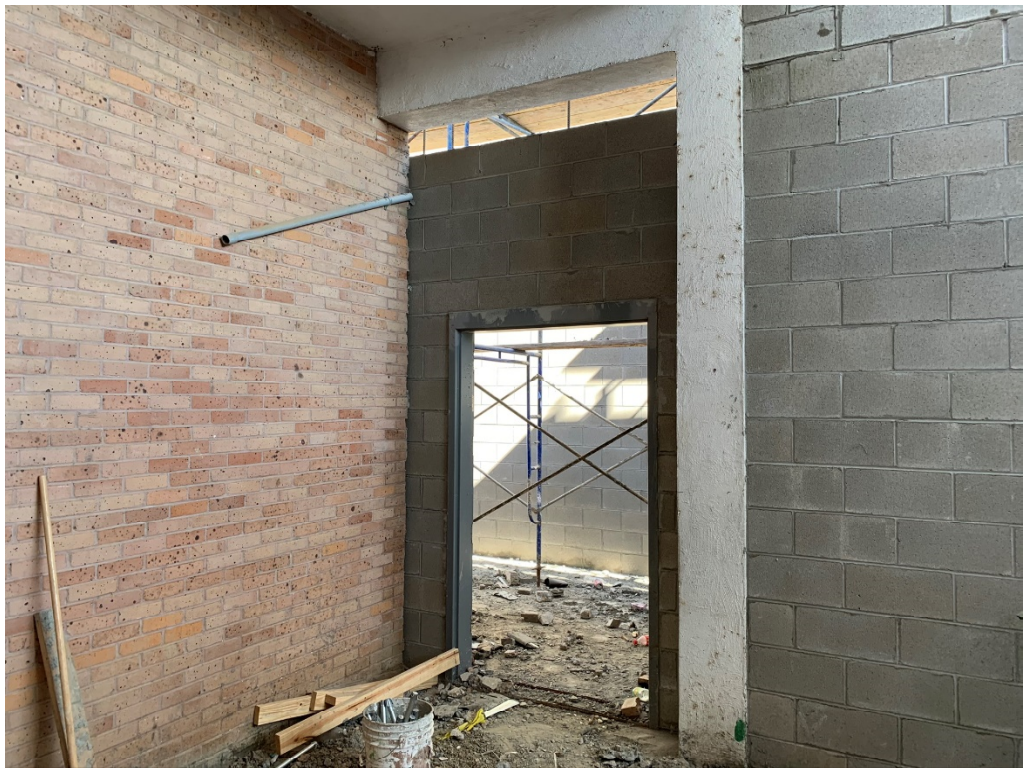
Figure 10 – Block Work Between Columns at Existing Stair

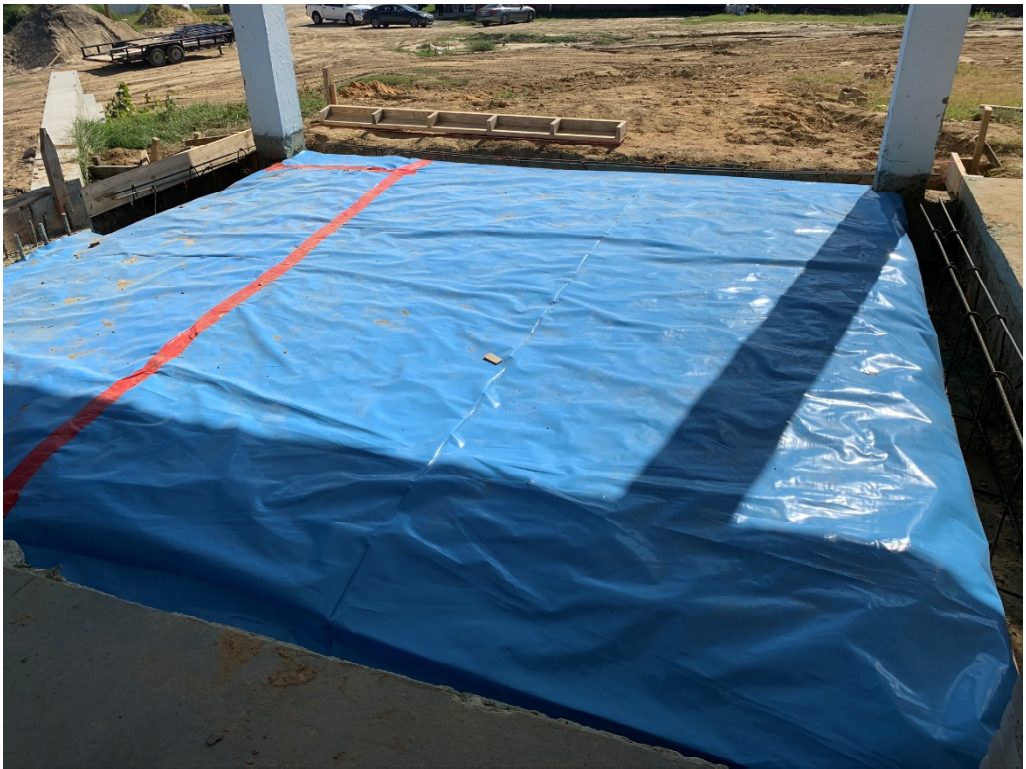
Figure 11 – Slab Prep at Upper Landing of Existing Stair

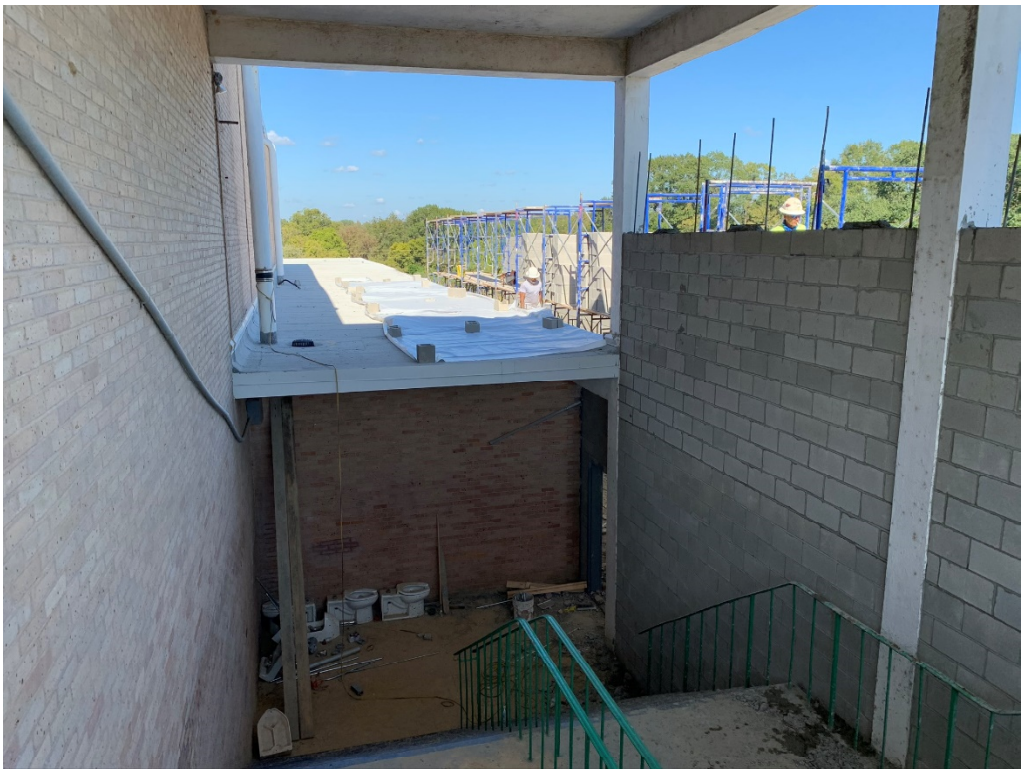
Figure 12 – Block Work at Stair

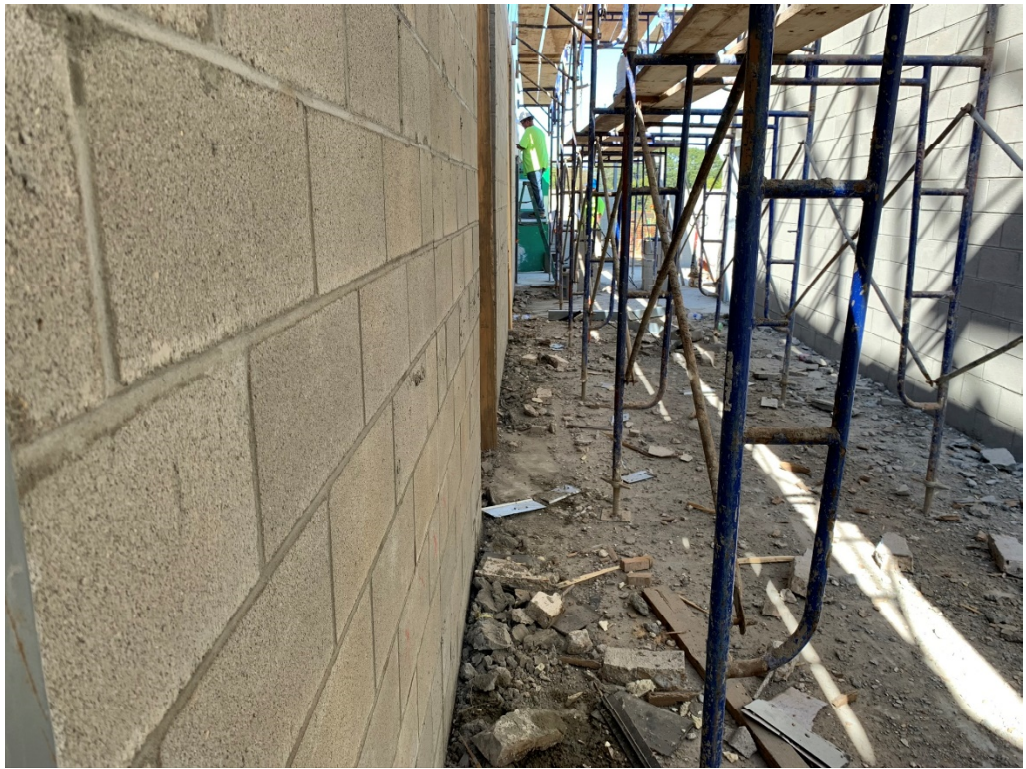
Figure 13 – Scaffold at CMU Work
