Architect's Field Report

201 Park Court, Suite B Ridgeland, MS 39157 P 601.790.9432 F 888.281.0547	31 October 2020 18053-Vicksburg Junior High School / Report Number 023
One Jackson Place, Suite 250 188 East Capitol Street Jackson, MS 39201-2100 P 601.352.5411 F 601.352.5362	Contract Paul Jackson & Son Date / Time 30 October 2020 / 12:00 PM Weather / Temp Clear / 60 ° F Est % Complete 48% Sched Conformance + 00 days Work in Progress CMU Block Work Metal Frame Installation
161 Lameuse Street, Suite 201 Biloxi, MS 39530 P 228.374.1409 F 228.374.1414	Present at Site Jeff Porter, PJS Paul Purser, DBA Observations On site, masons were at work installing block. At the main entry, a covered entrance has been erected for use by school attendees. Block work is nearing completion. At the interior, grid has been installed for over half of the hallway. There are some issues with coordination between the new ducting and lighting in at least 3 locations at the already installed grid. One instance occurs with existing conduit. The others have to do with newly installed ducting.

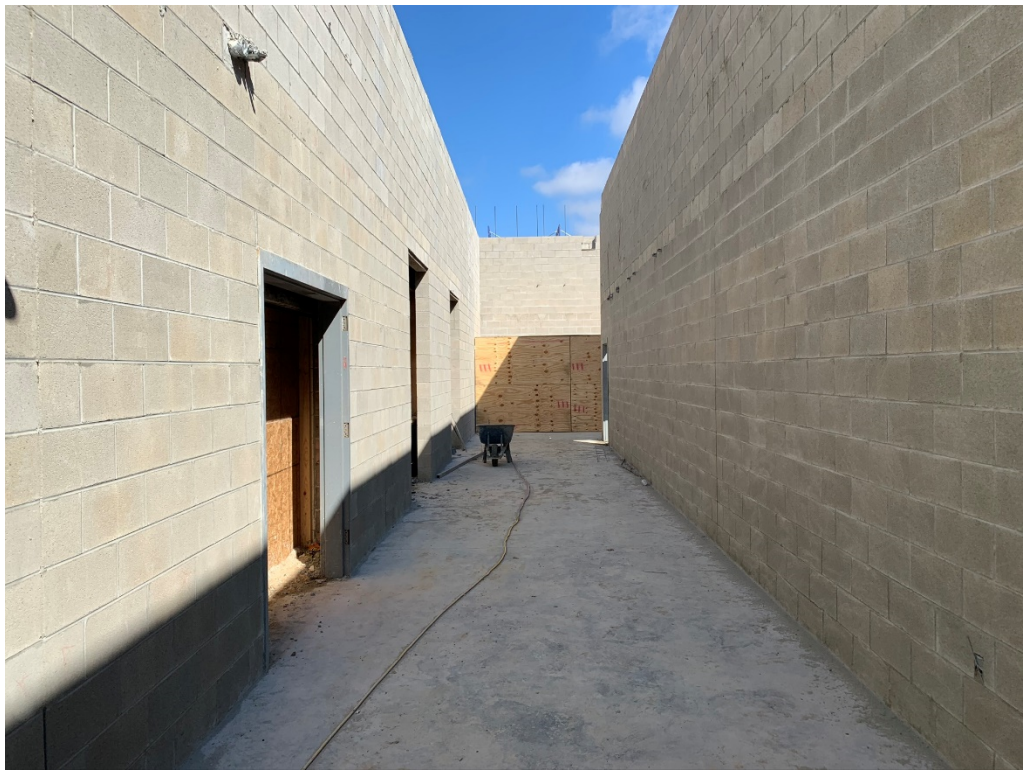
Figure 4 – Corridor A-202 Blocked In

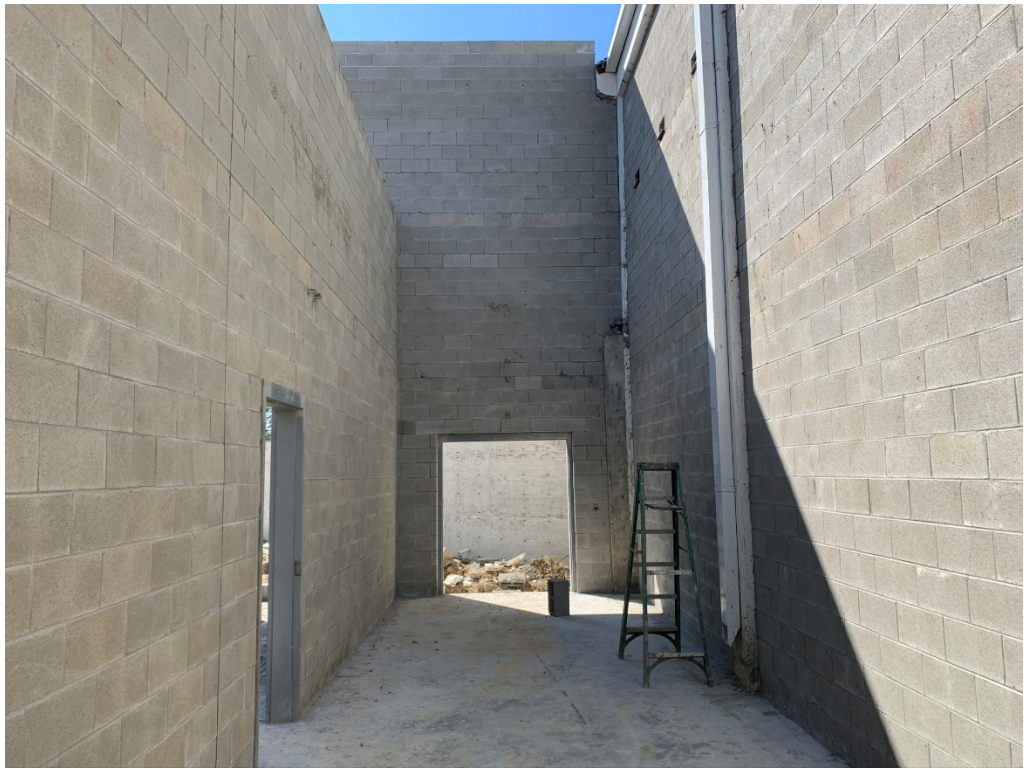
Figure 5 – Corridor A-202 Blocked In

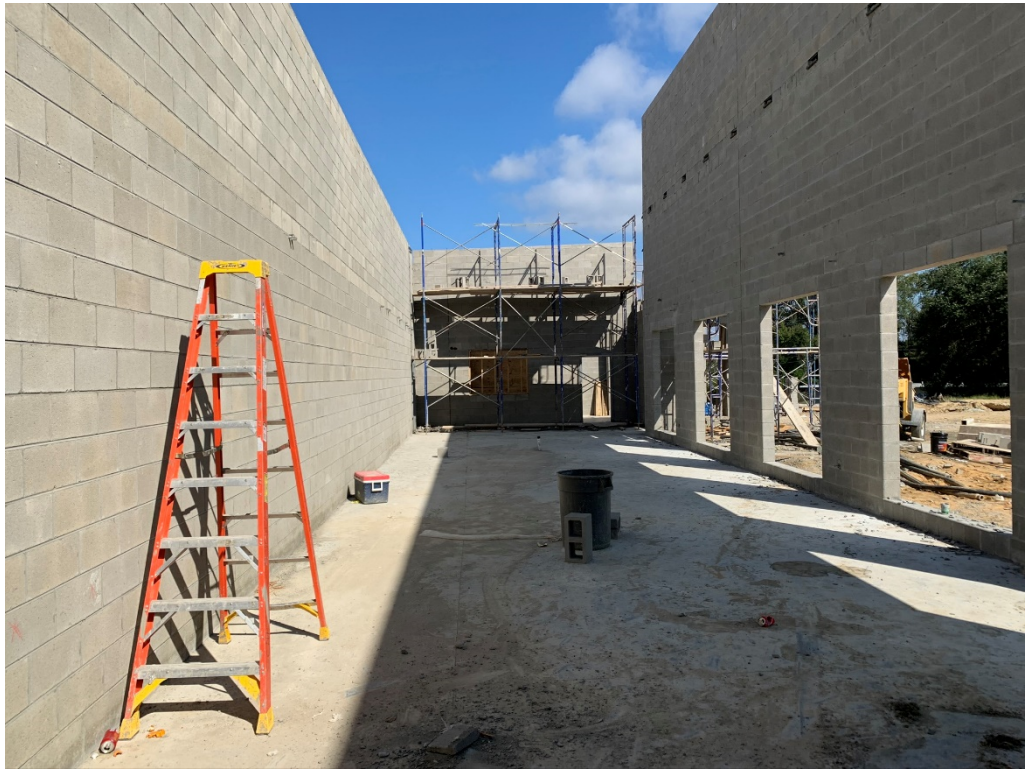
Figure 7 – Main Office Area Blocked IN

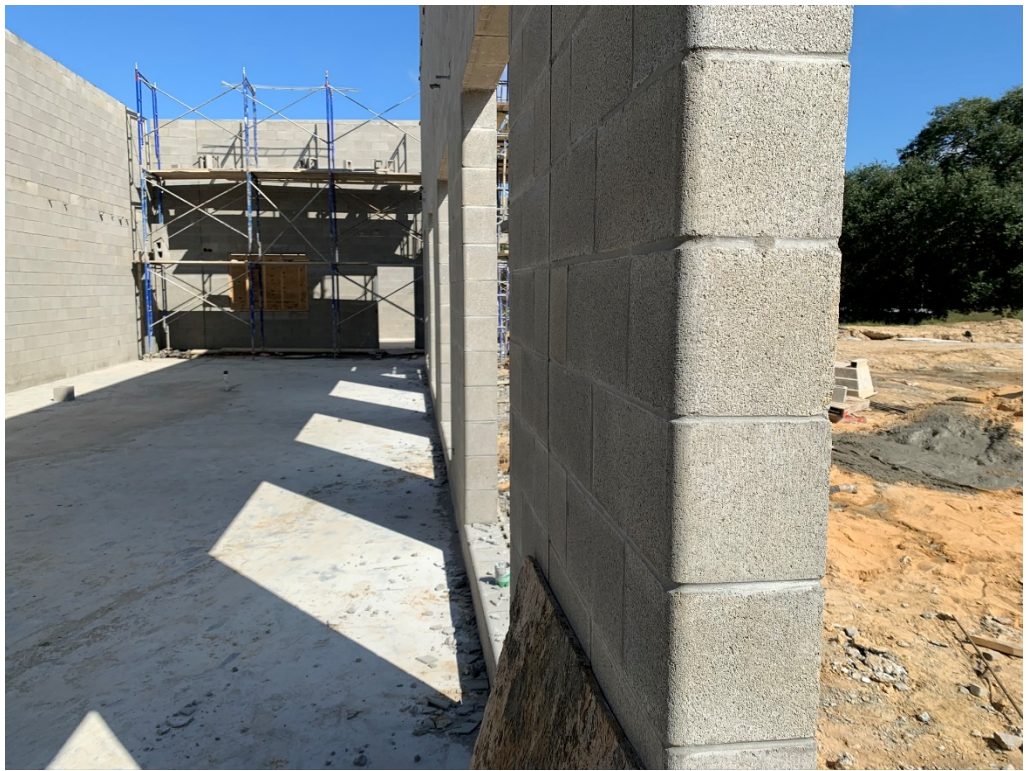
Figure 8 – Exterior Window Block Detail

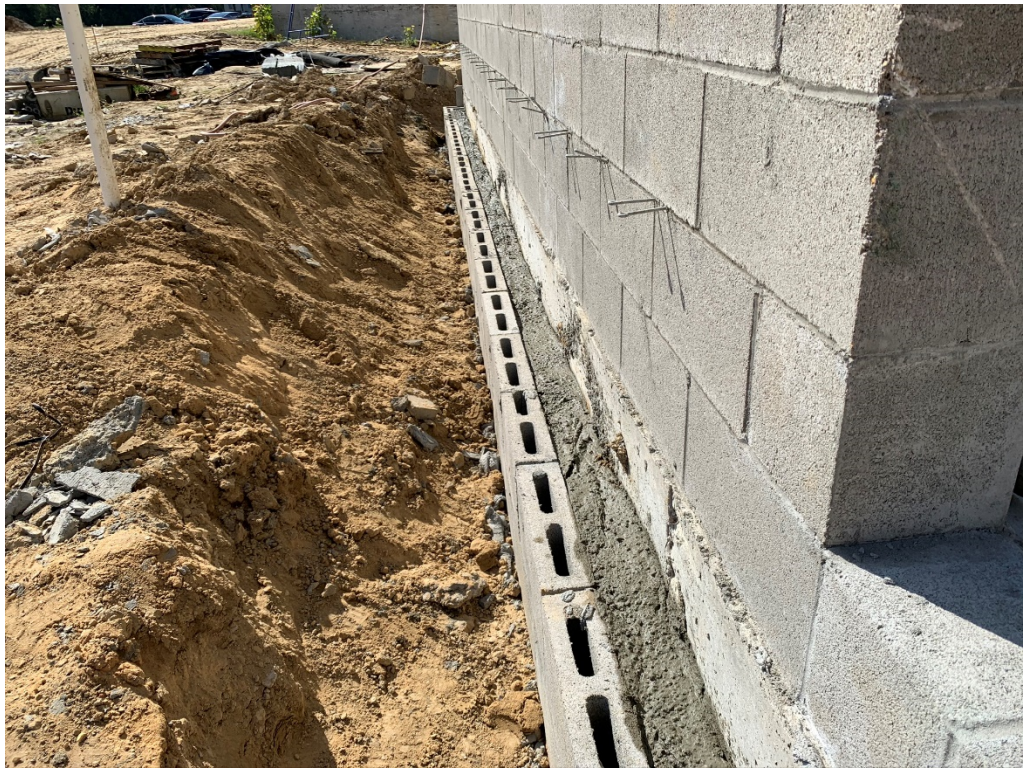
Figure 9 – Block Cavity Filled Below Grade

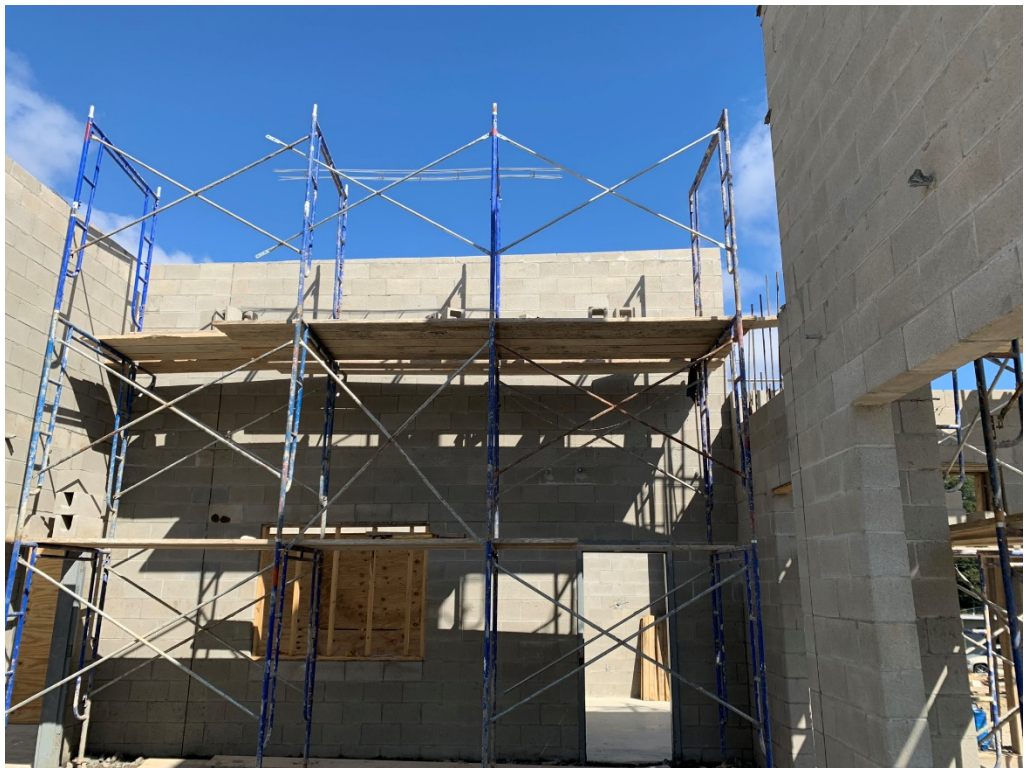
Figure 10 – Sloped CMU Block at Top of Wall

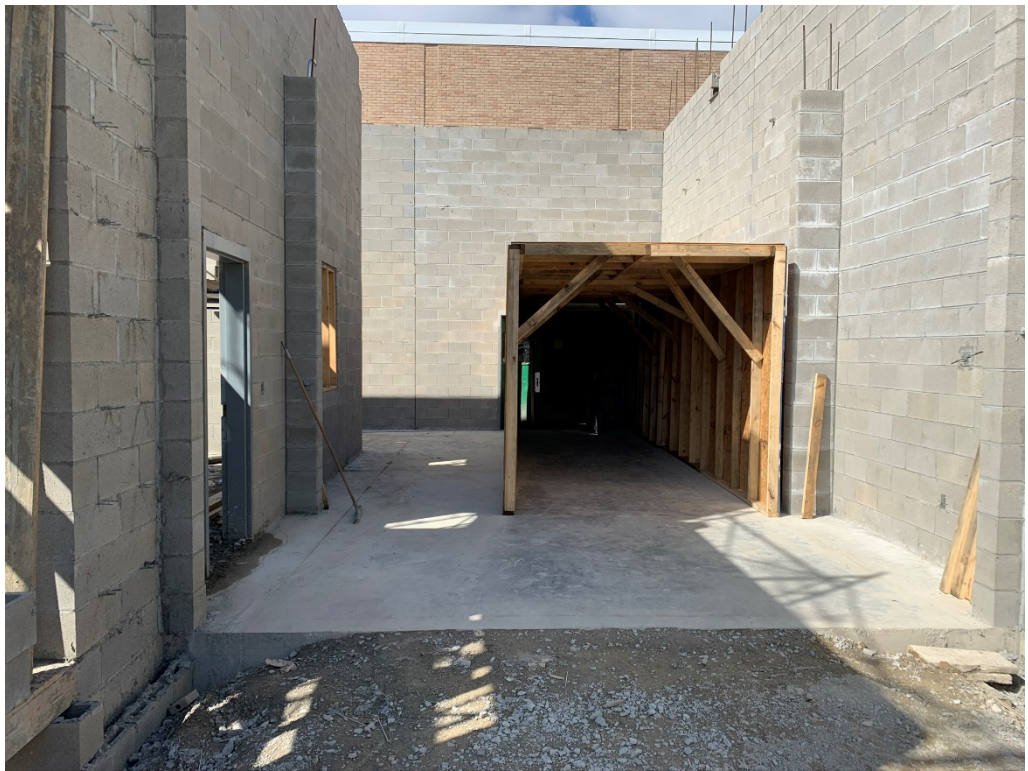
Figure 11 – Temporary Enclosure for Useable Entry at Existing Building

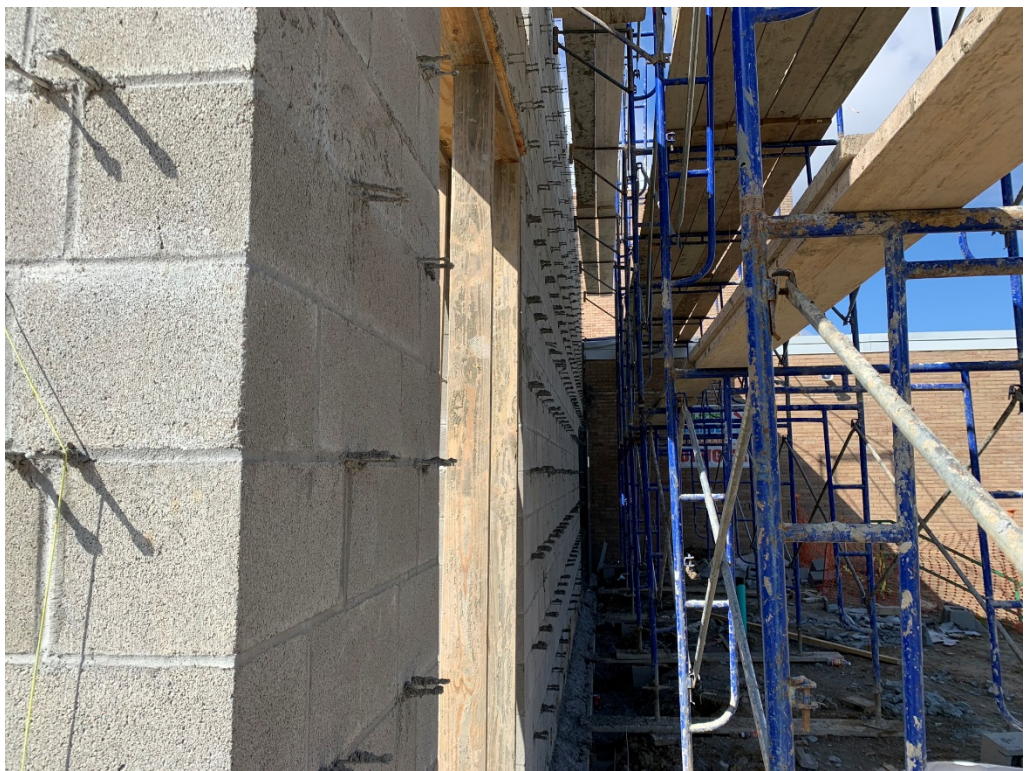
Figure 12 – Exterior Blocking at North of Addition

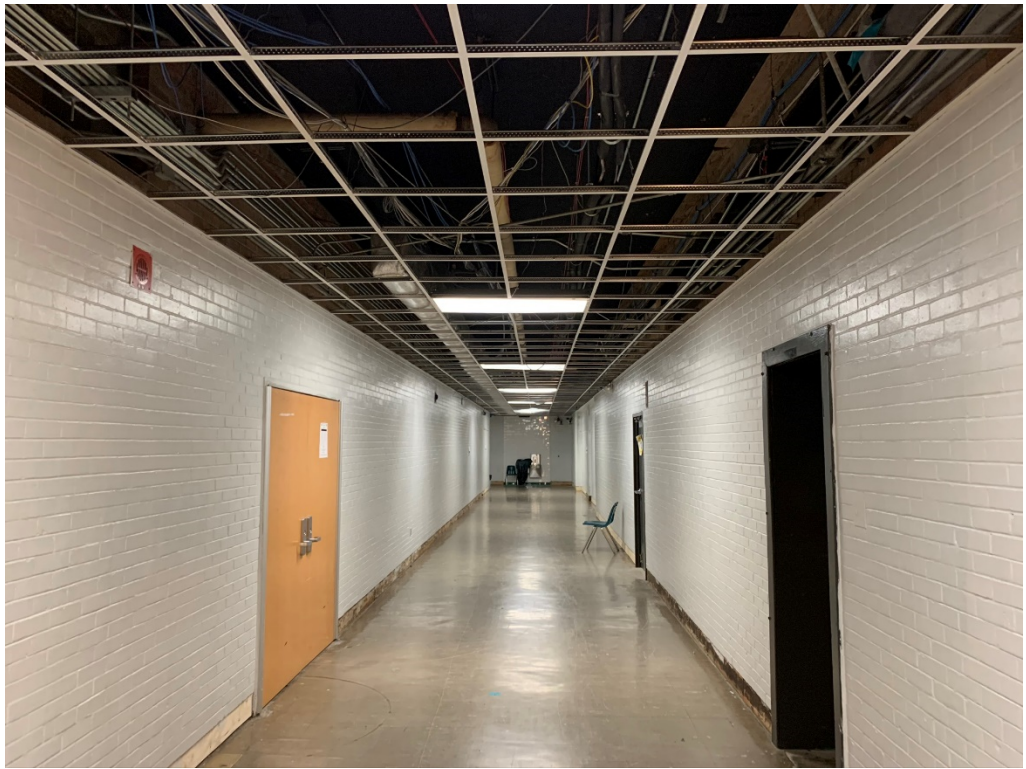
Figure 13 – Interior Grid Installed at Corridor E-200

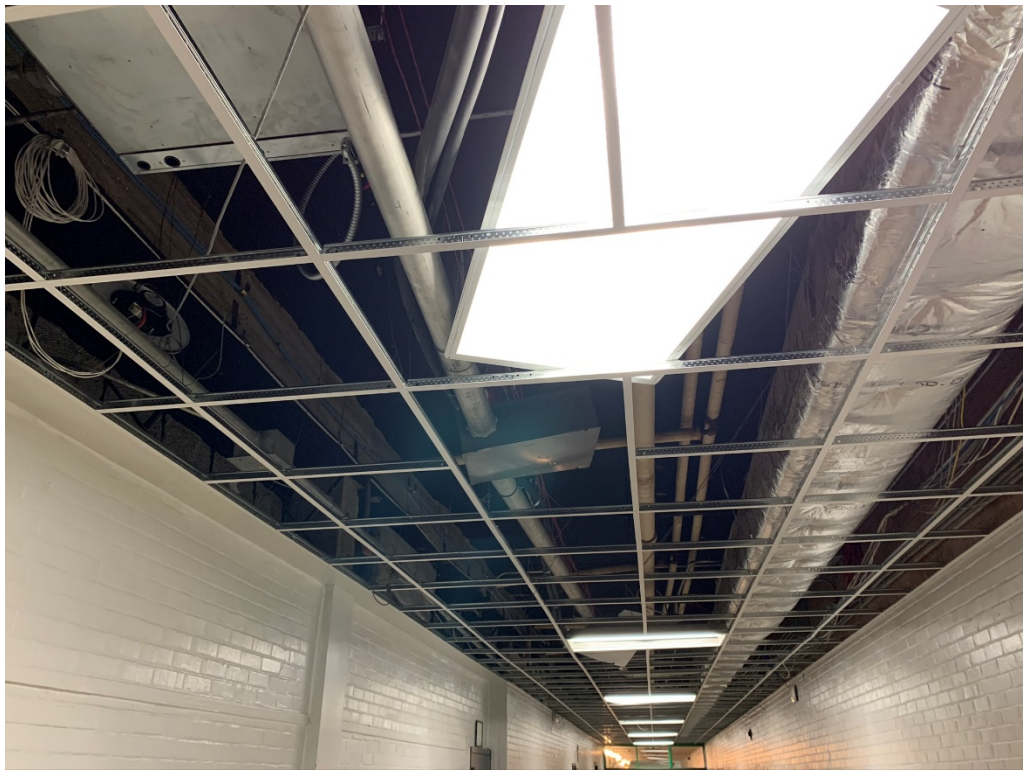
Figure 14 – Existing Conduit in Way of Light Install (Can this conduit be raised?)

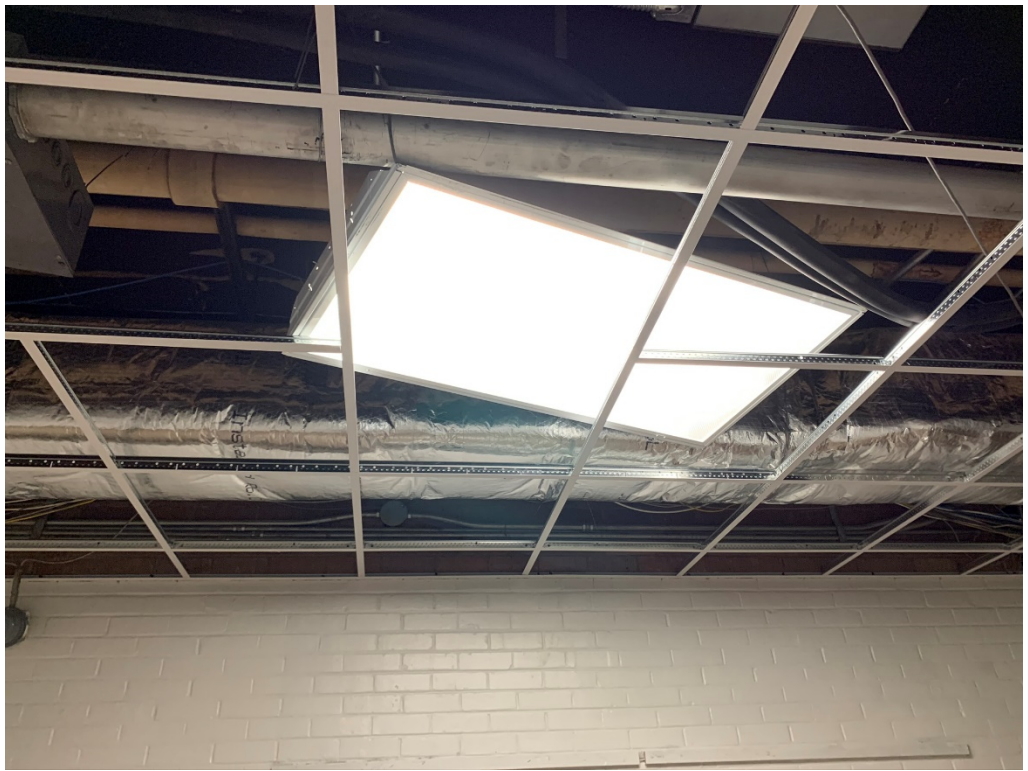
Figure 16 – New Ducting has not been Coordinated with Lighting Layout (limited to 2 place so far)

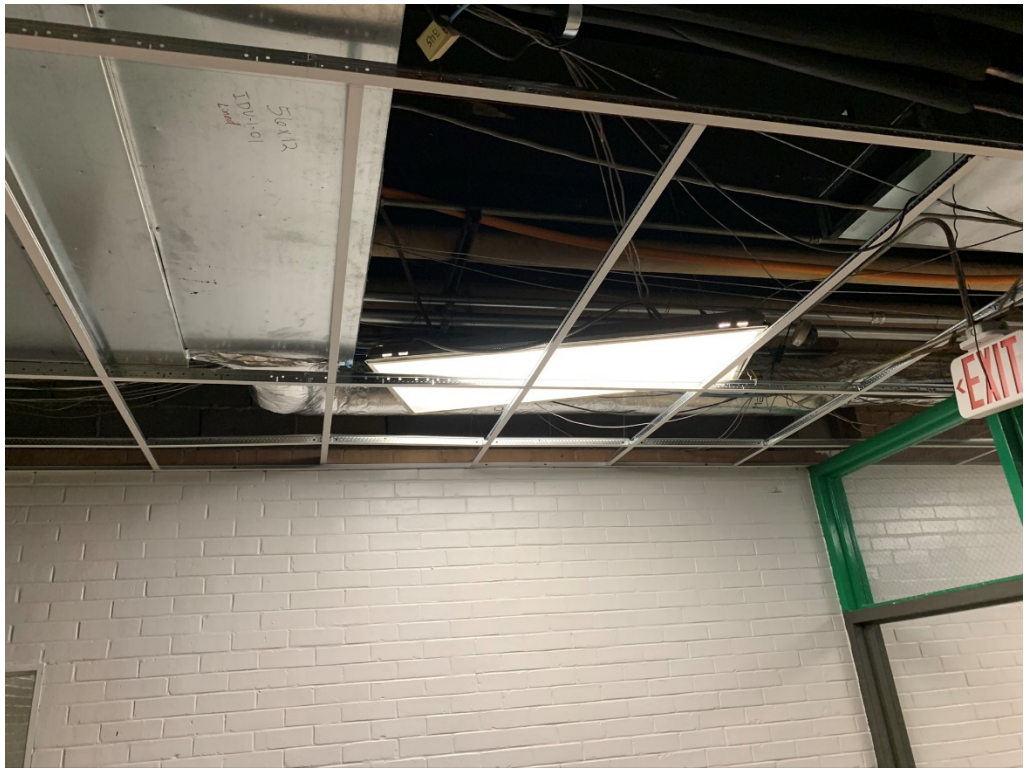
Figure 17 – New Ducting has not been Coordinated with Lighting Layout (limited to 2 place so far)

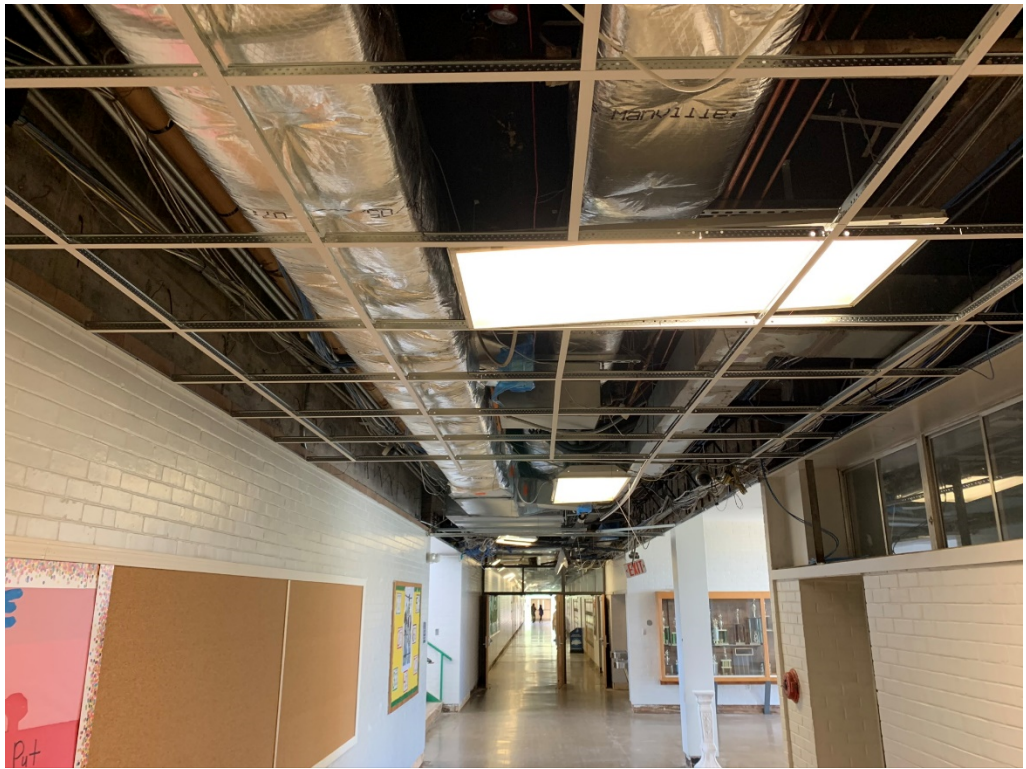
Figure 19 – Corridor E-215 New Ducting is Not Coordinated with Lighting Layout

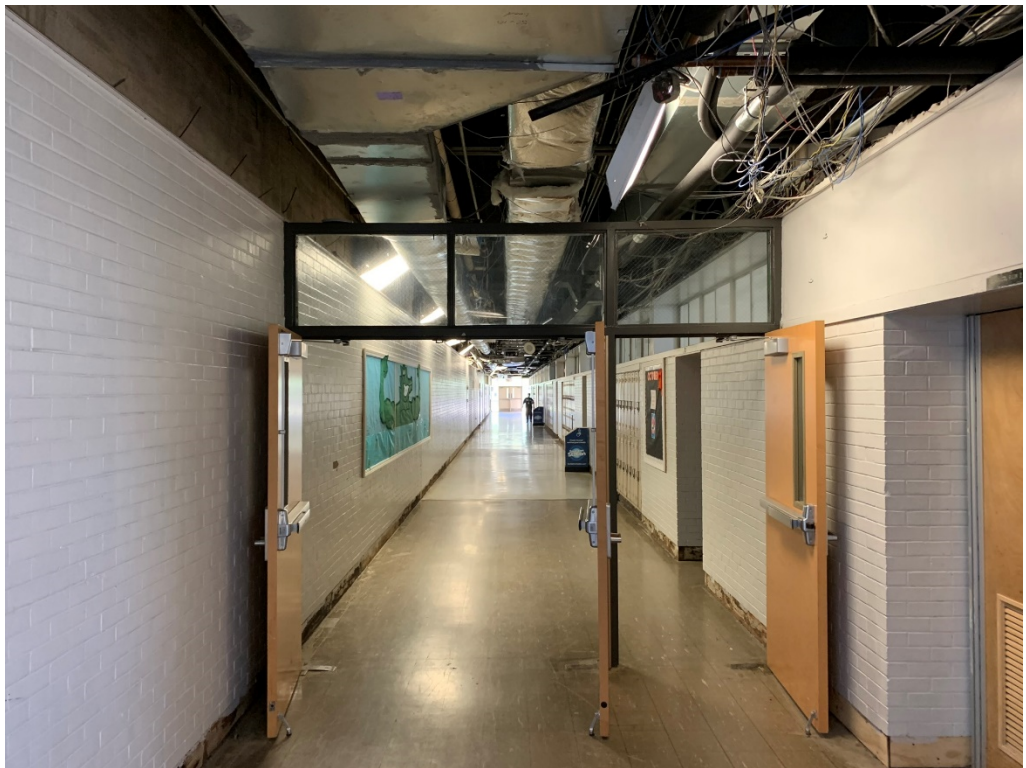
Figure 20 – Corridor E-215 New Ducting will Still be an Issue for the Second half of this Hallway
