Architect's Field Report

18053-Vicksburg Junior High School / Report Number 026

29 December 2020 / 1:30 PM

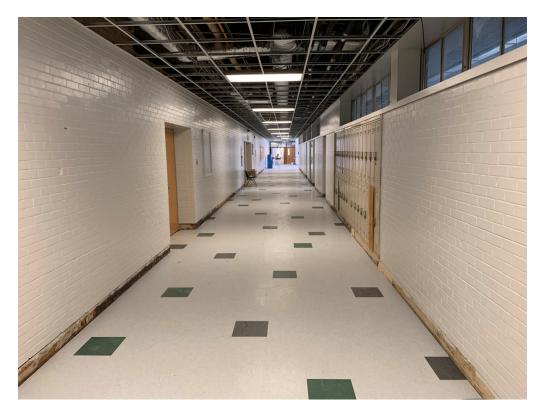
Figure 10 – Interior Hall Paint is Ongoing

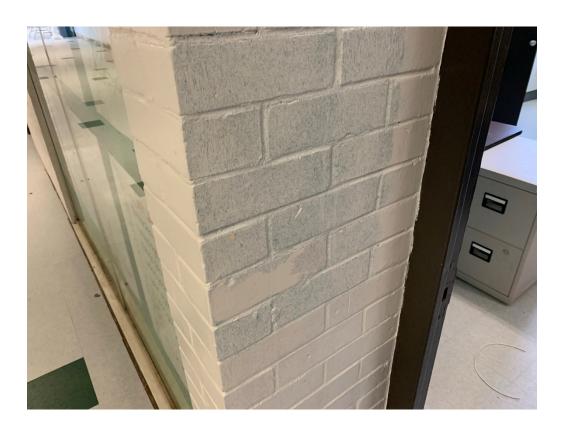
Figure 11 – Interior Hall Paint is Ongoing

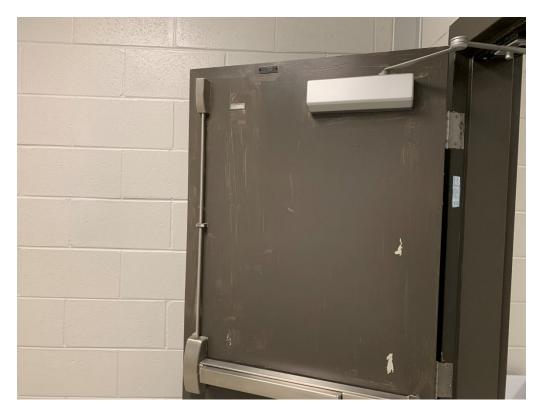
Figure 12 – Interior Hall Paint is Ongoing
