Architect's Field Report

15 January 2021

18053-Vicksburg Junior High School / Report Number 027

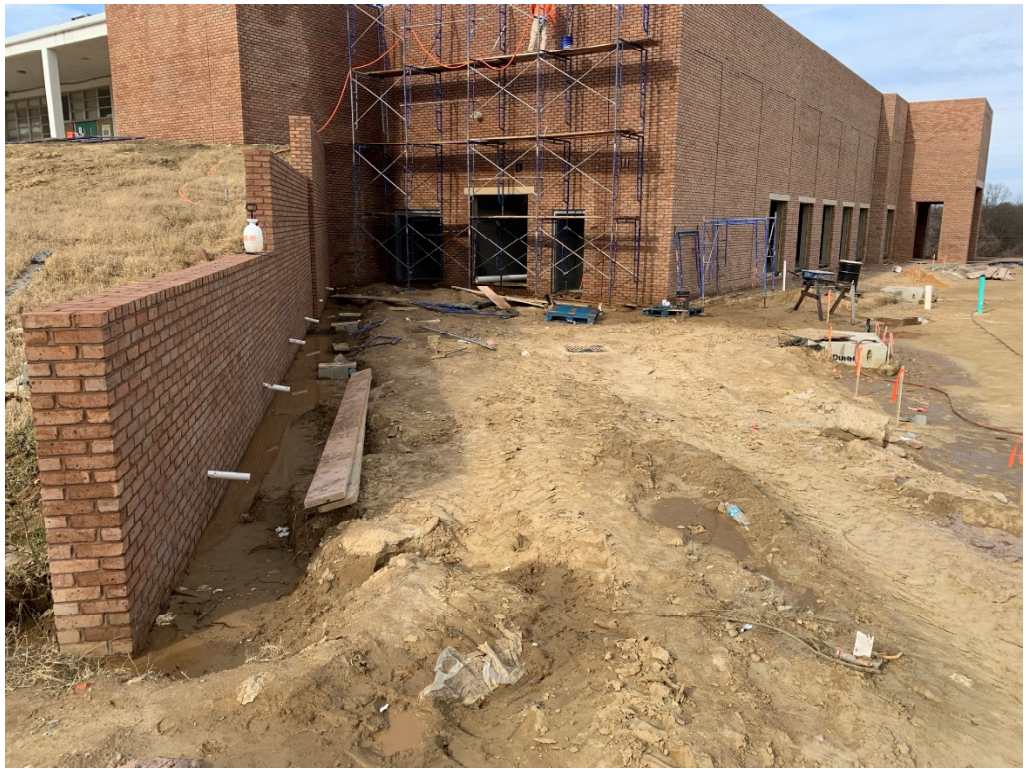
Observations Arriving on site, I walked the addition first. Brick work appears complete and in good condition at the exterior of the addition as well as the retaining wall attached to the addition. Work has been performed in the parking area as well. Both grading and curb staking have been ongoing. I spoke with Jeff Porter, PJS, who mentioned that curbs were to be poured soon.

Figure 1 – Brick Work Appears Complete and Acceptable

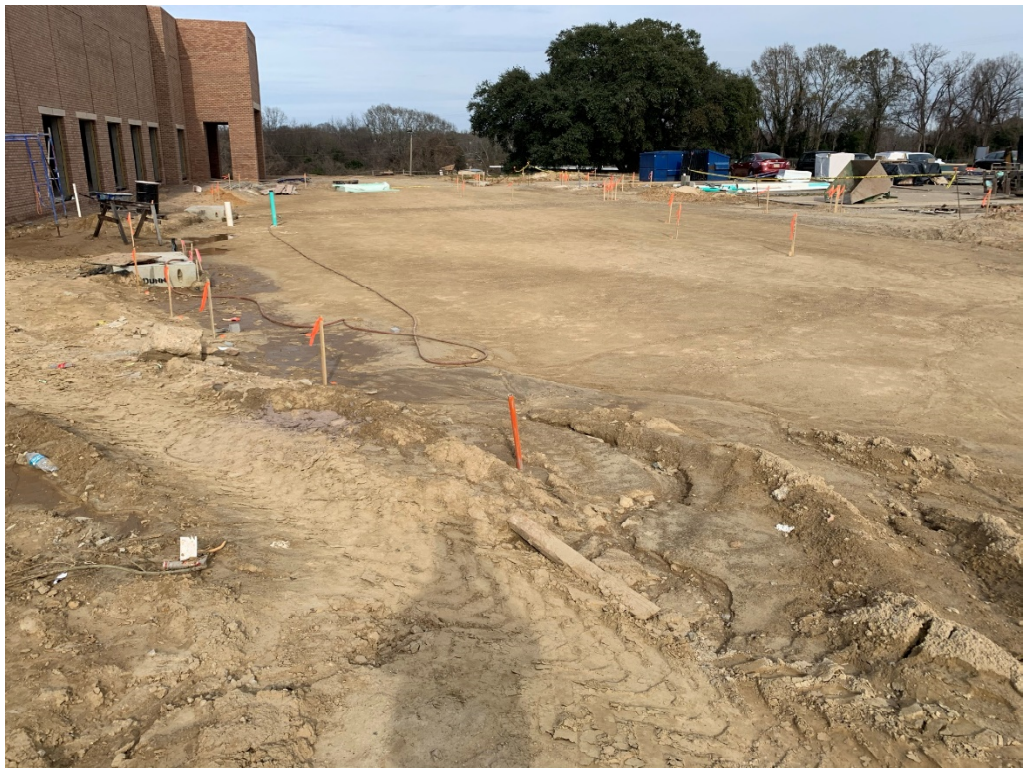
Figure 2 – Curbs Staked Out and Ready for Concrete

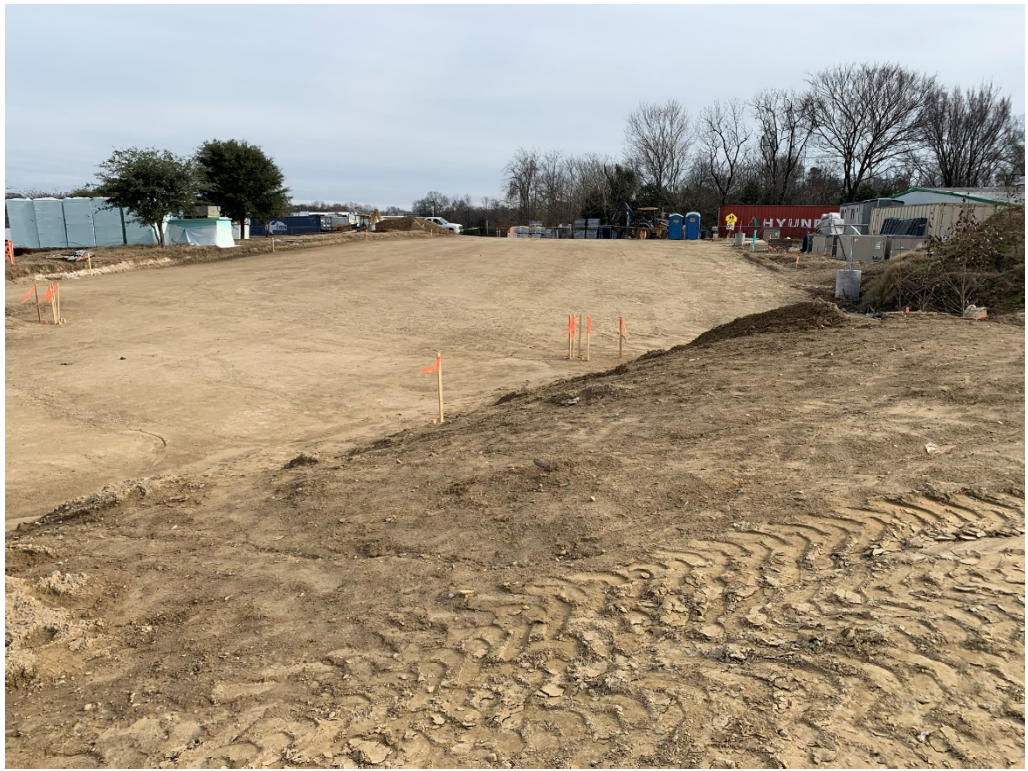
Figure 3 – Grading and Curbs at Parking Lot

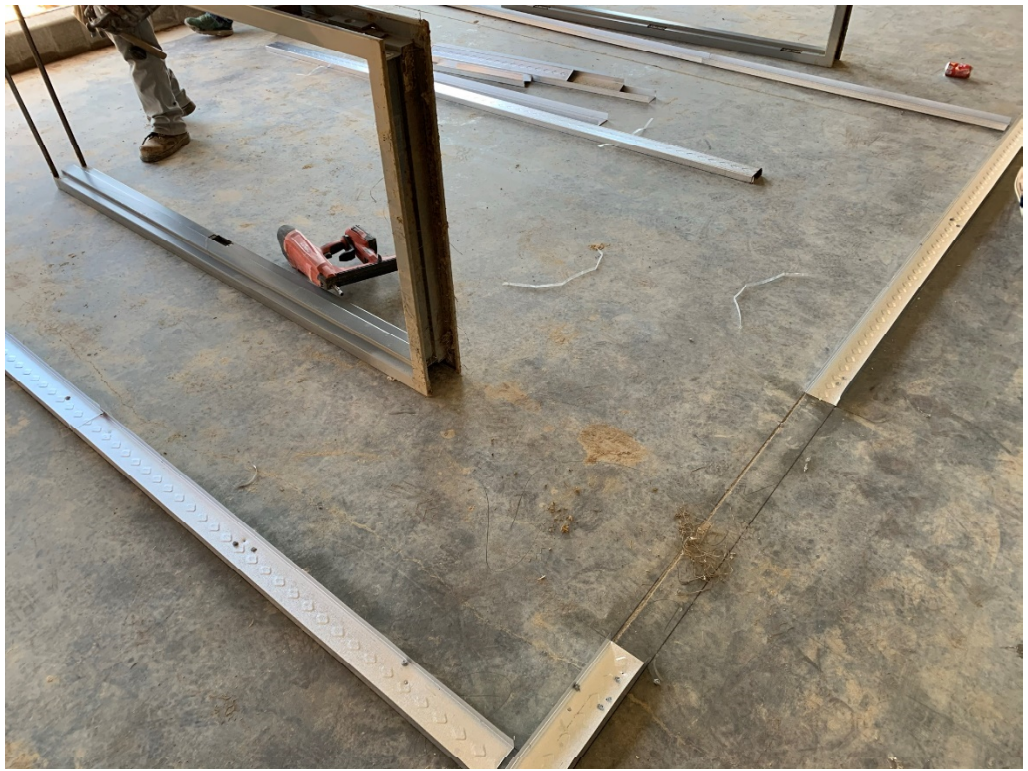
Figure 4 – Interior Framing Has Begun

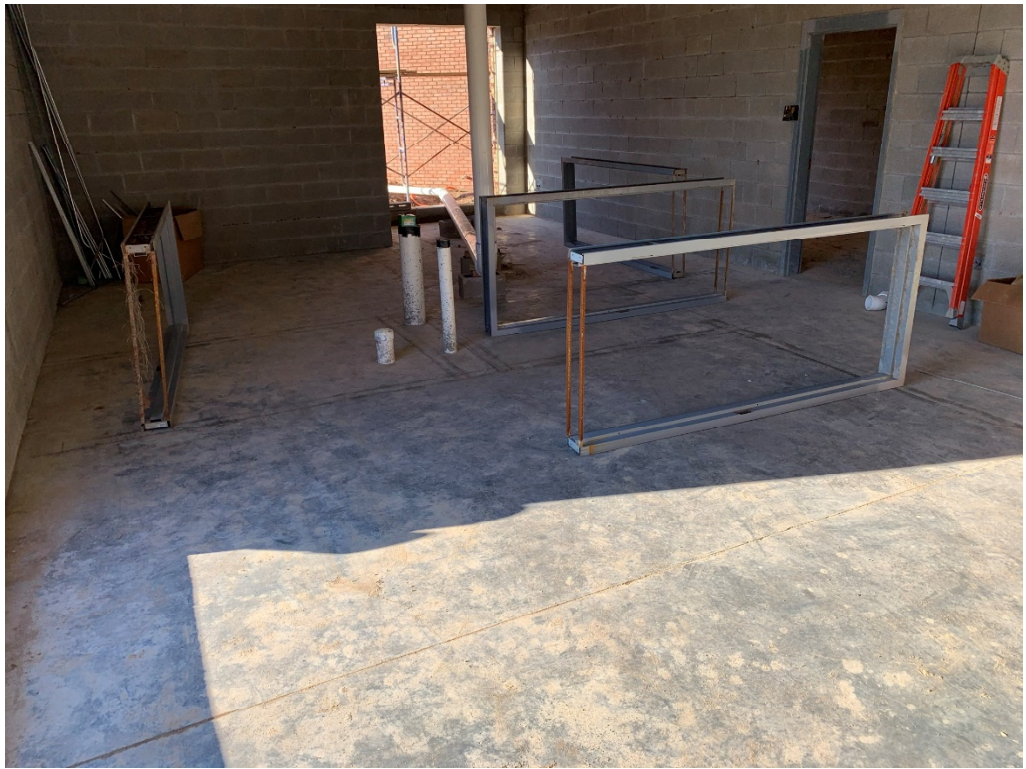
Figure 5 – Interior Doors Ready to be Set

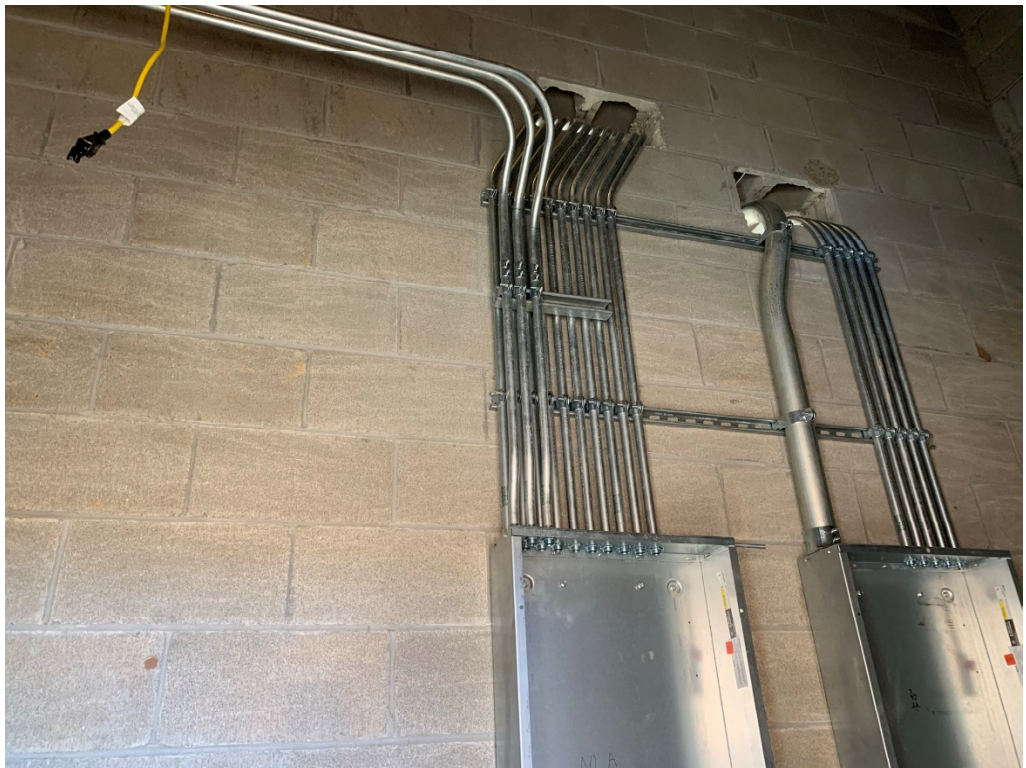
Figure 6 – Panel Boxes Installed with Conduit

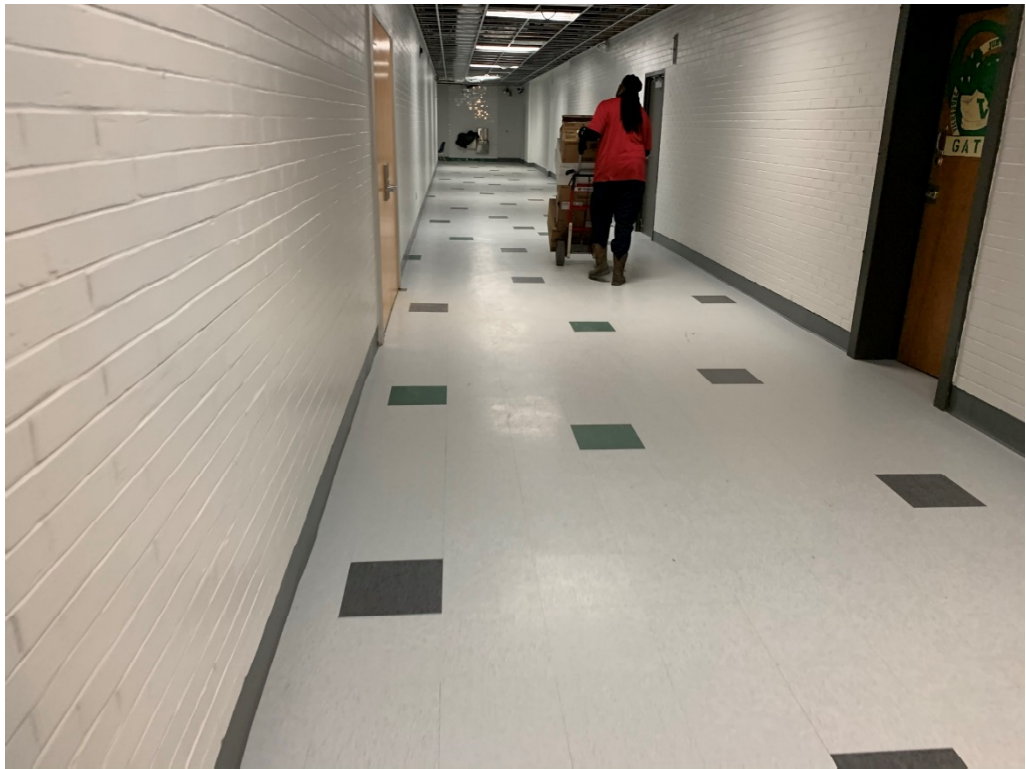
Figure 7 – New Flooring Installed

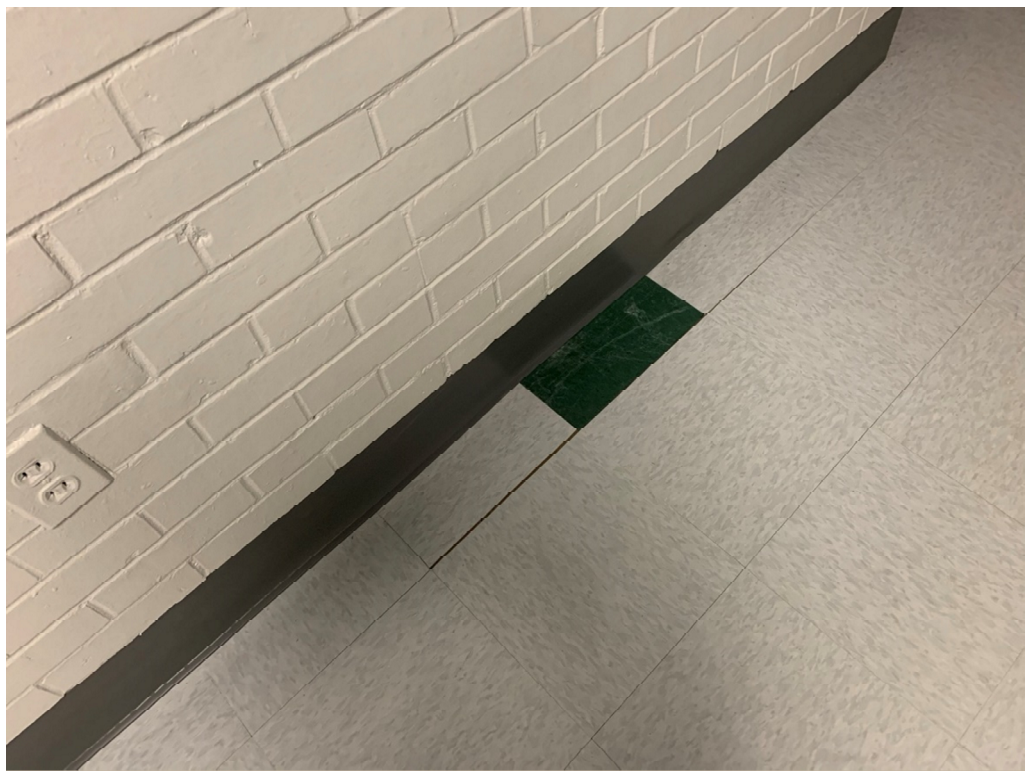
At the main building, flooring has been installed. Mr. Porter mentioned that waxing would be done closer to the end of the project, during the summer when school is out. There are a few locations that need repair in the flooring. Also, base is missing required outside corners.

Figure 8 – Some Tiles need to be reset so that there is no gap

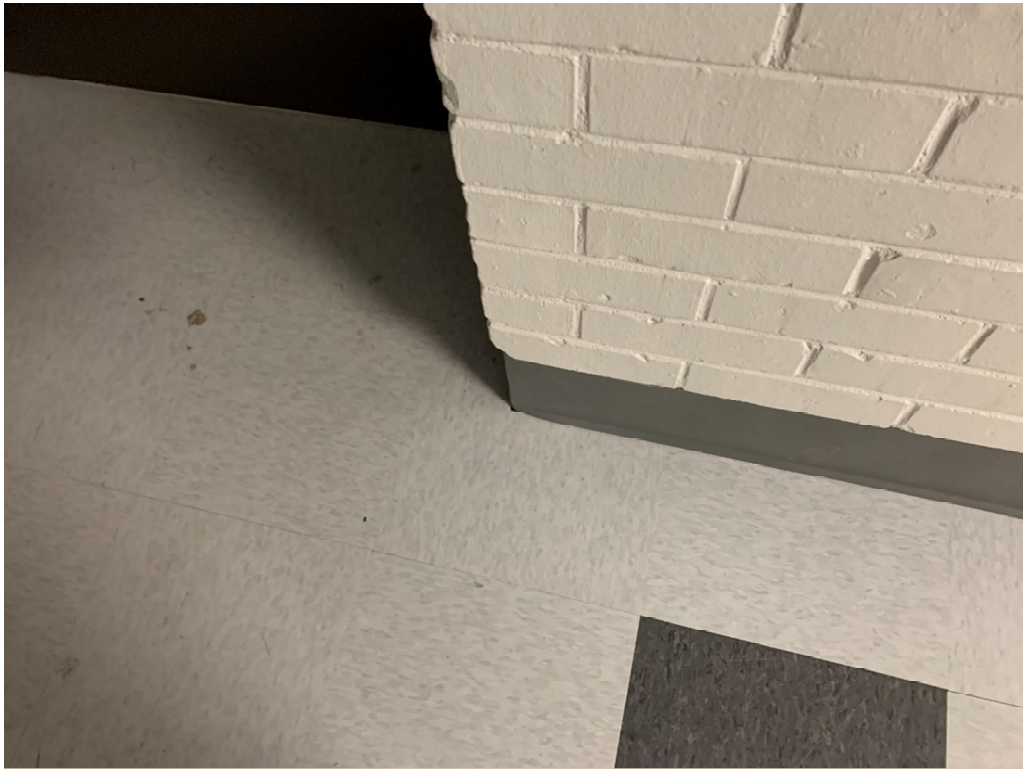
Figure 9 – Pre-Formed Corners are Required per Contract Documents at all Outside Corners

Items to Verify None
Action Required Install Base Corners

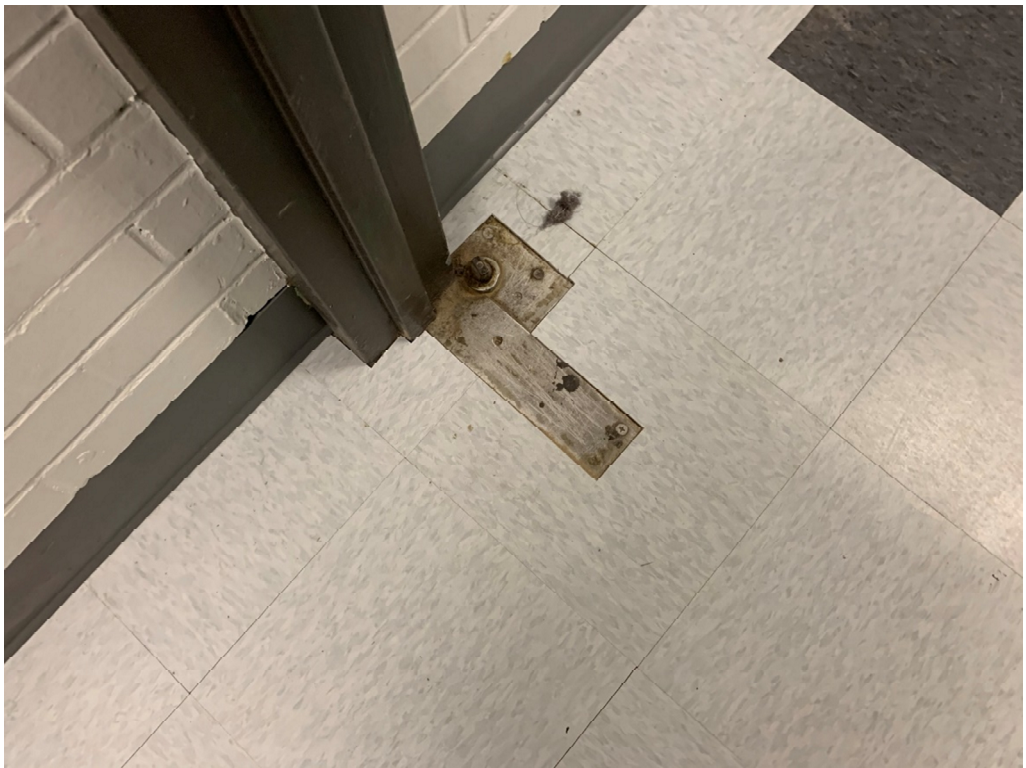
Figure 10 – VCT Should Overlay this Inset Piece of Hardware (at multiple locations)

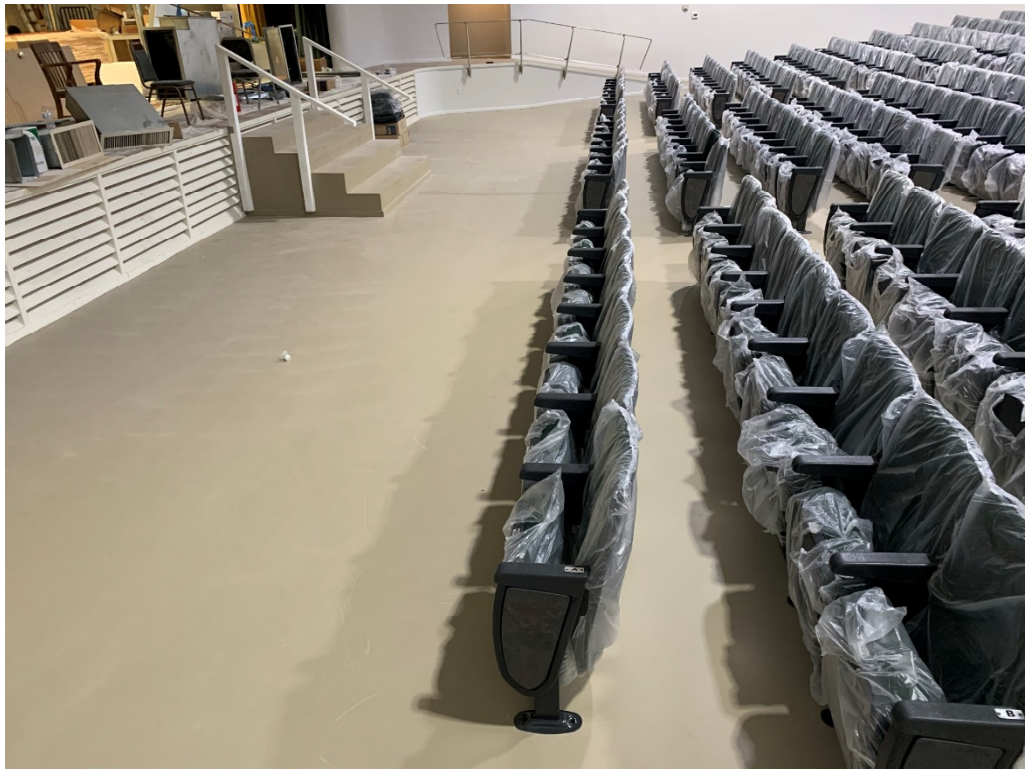
Figure 11 – Flooring in Auditorium

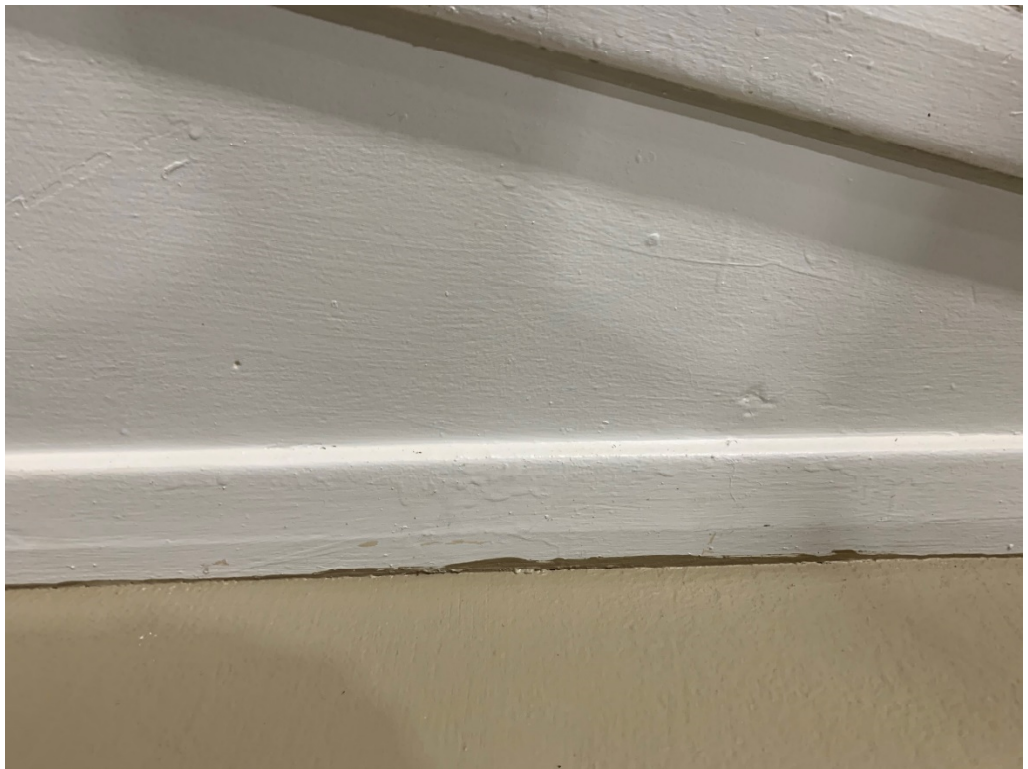
Figure 12 – Paint Touchups required at Base Throughout

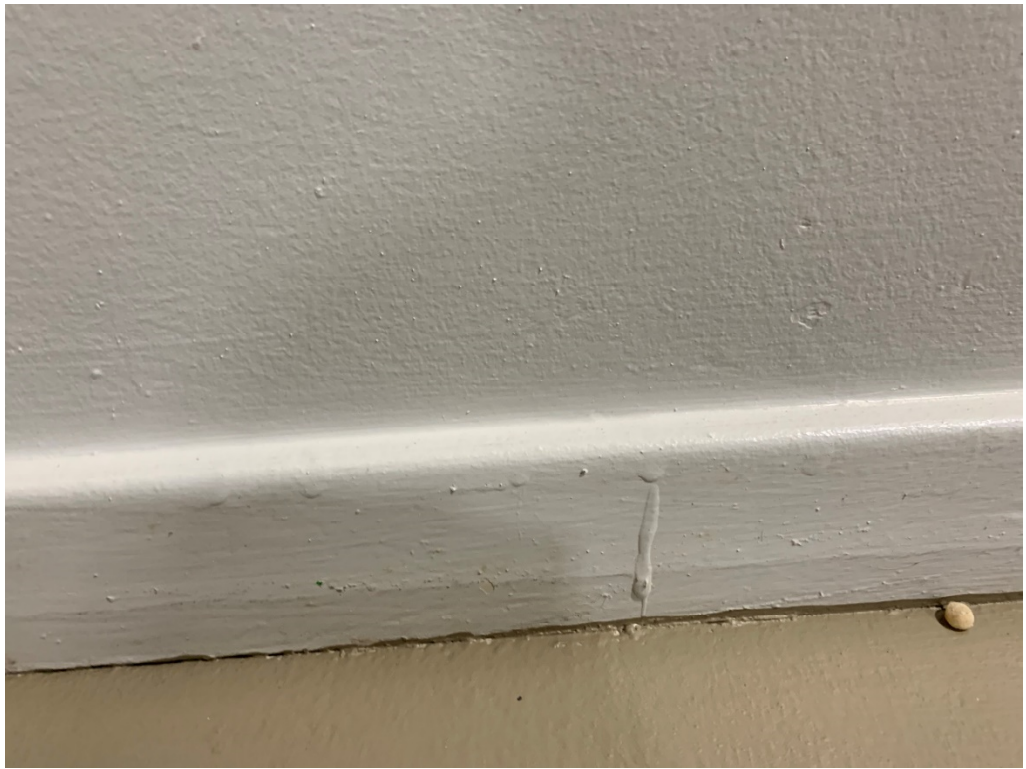
Figure 13 – Existing Drips Should be scraped/removed before new paint is applied

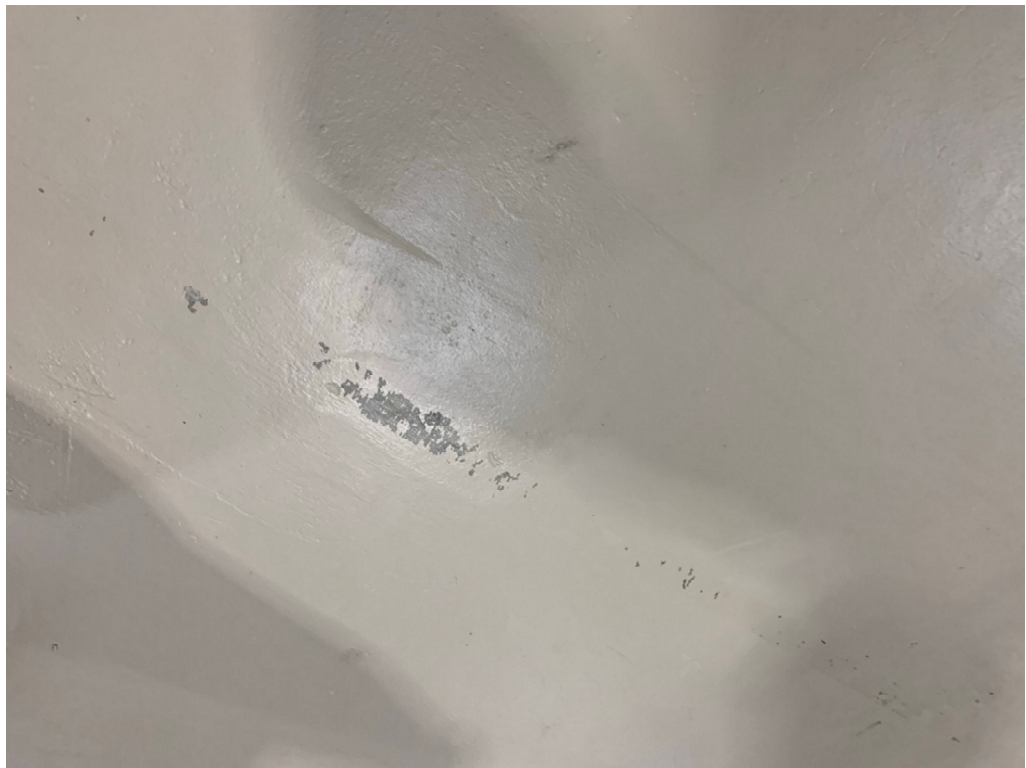
Figure 14 – Damage at Flooring in Auditorium
