Architect's Field Report

18053-Vicksburg Junior High School / Report Number 028

04 February 2021 / 3:00 PM

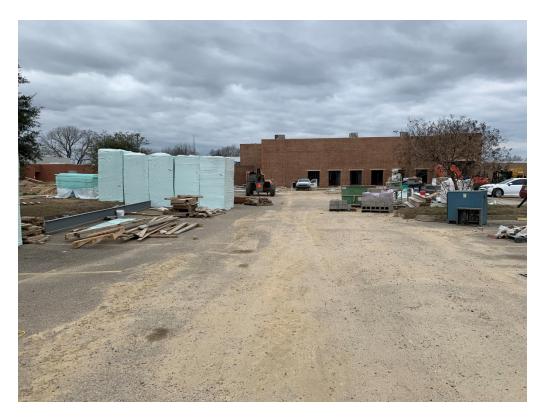
Figure 1 – Storage Area at Parking Lot

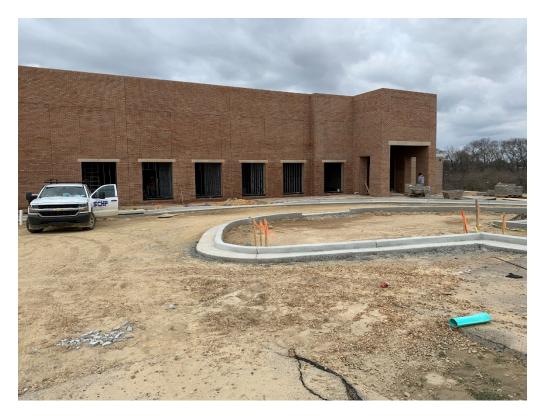
Figure 2 – East Elevation

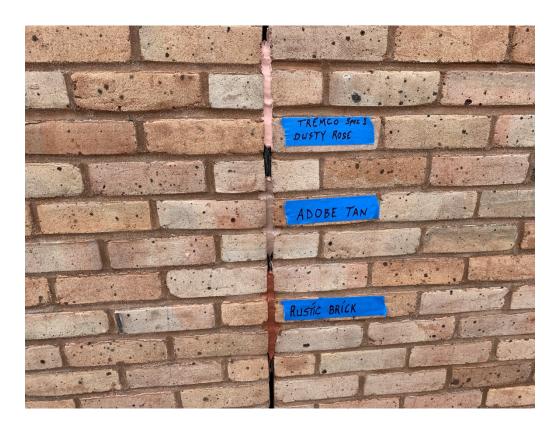
Figure 3 – Test Sealant Colors at Exterior Brick

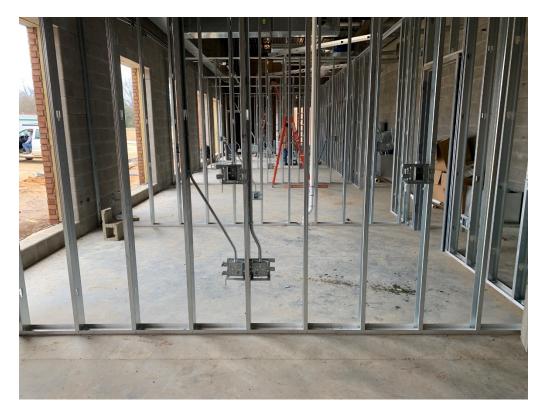
Arriving on site, I entered from the new addition's entrance. Continued

rough of services is ongoing here. At the new concession area, CMU has $\,$

Figure 4 – Electrical Rough In is Ongoing

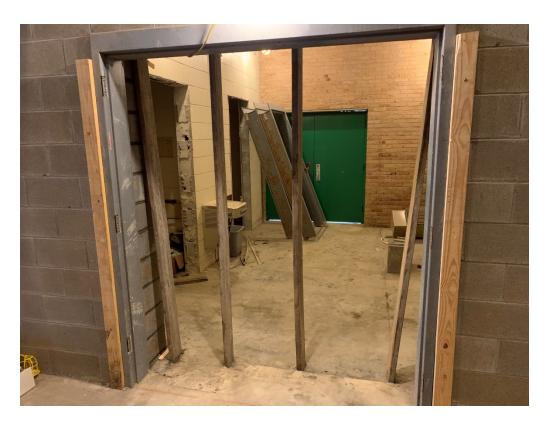
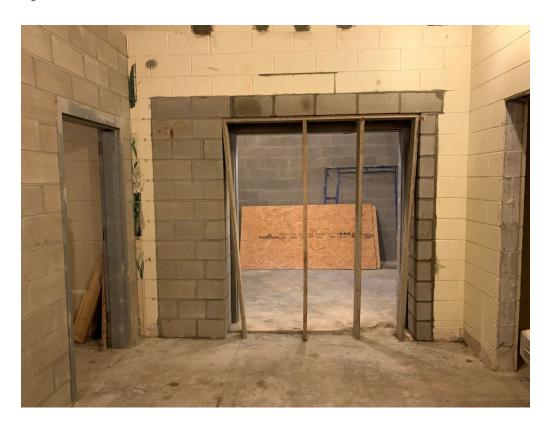
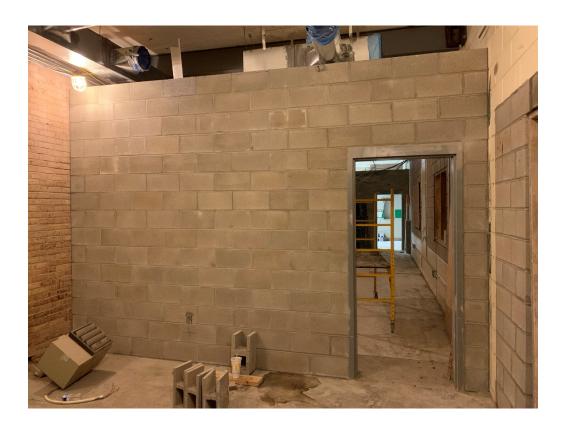
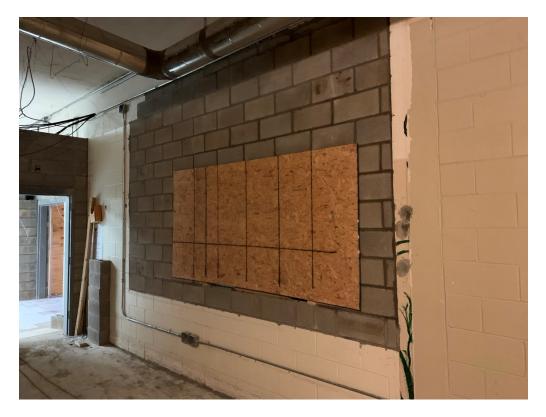
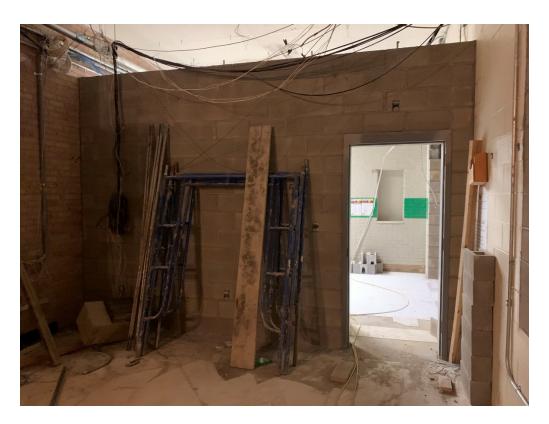
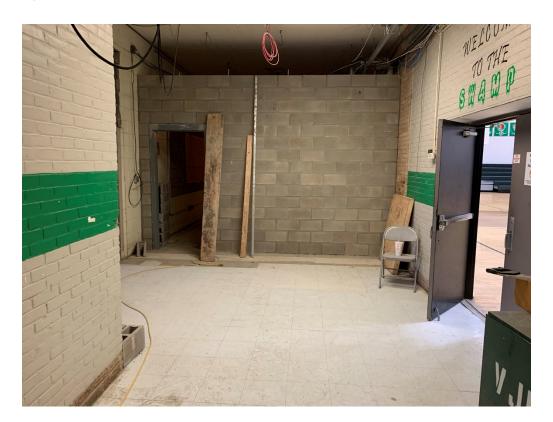
been installed and looks in good order.

Figure 5 – Block work at new concessions area

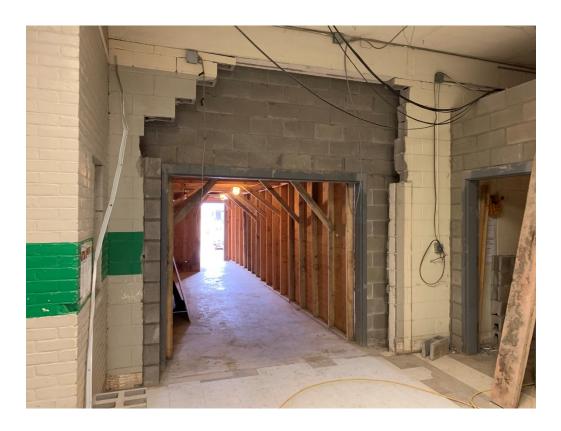
Figure 11 – Addition Entry from Main building

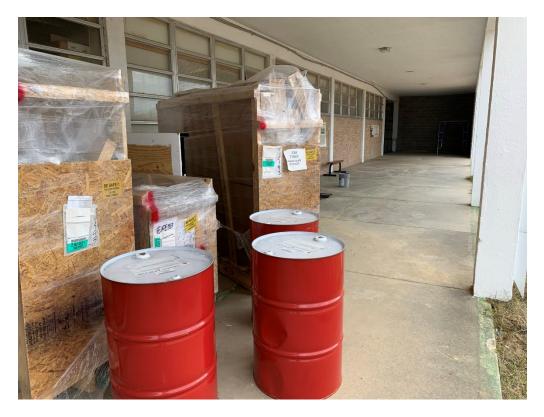
Figure 12 – Upstairs Storage Outside of Library

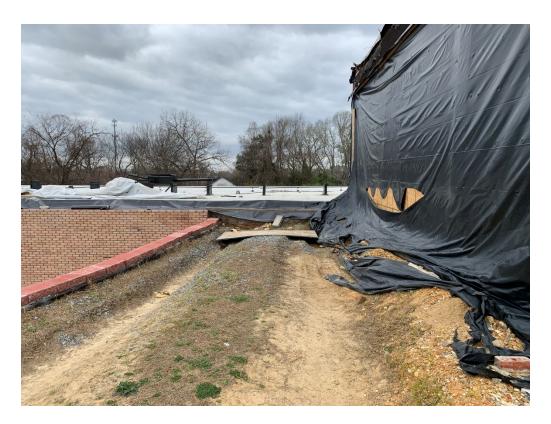
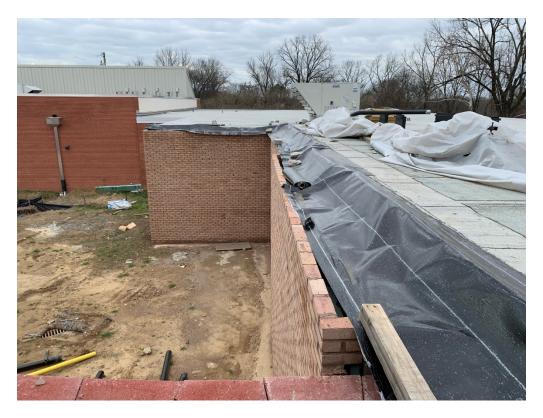
Figure 13 – Roof Awaiting Tie In
