Architect's Field Report

12 March 2021

18053-Vicksburg Junior High School / Report Number 030

11 March 2021 / 9:00 AM

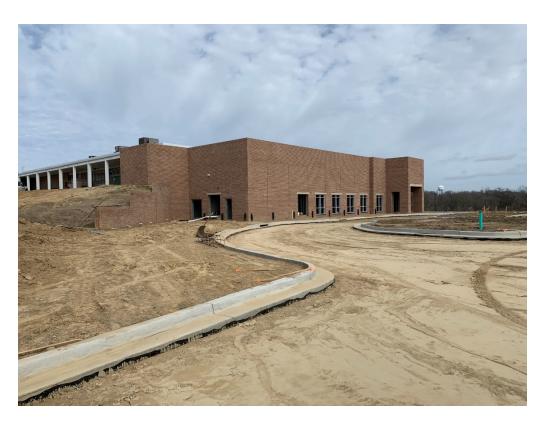
Figure 1 – Southeast Looking NW

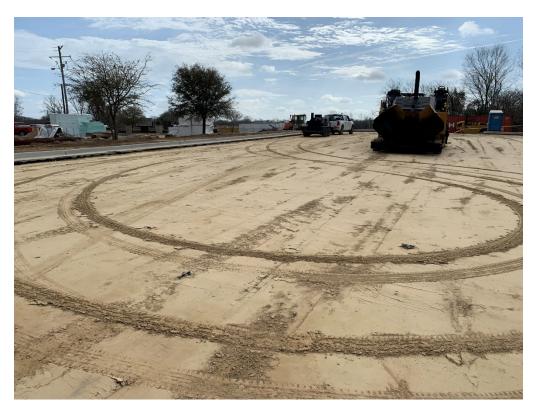
rework per Civil. Compaction is also to be verified after Ice event.

Figure 2 – Parking Lot Compacted (per OAC meeting requires additional verification of compaction after Weather Event)

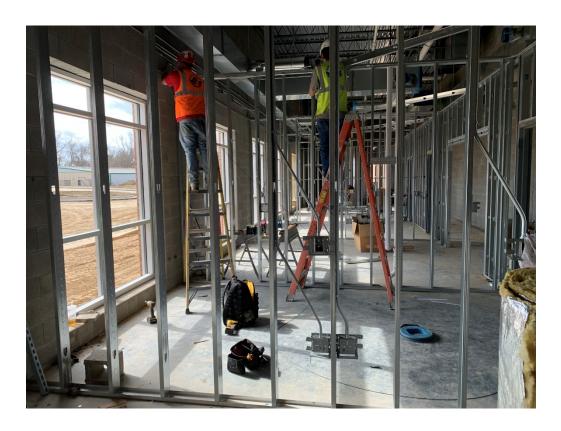
Interior Service work is ongoing. Electricians are roughing in still and

Figure 3 – Interior Service work is Ongoing

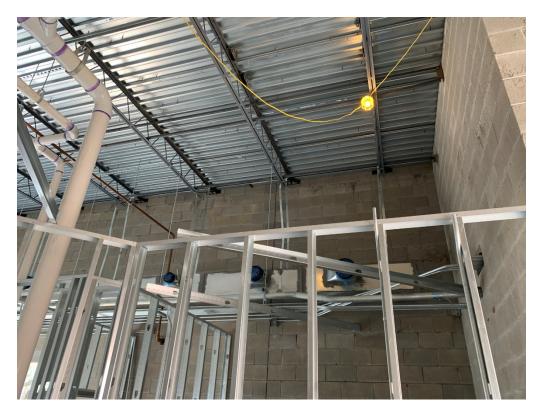
Figure 4 – Interior Service work is Ongoing

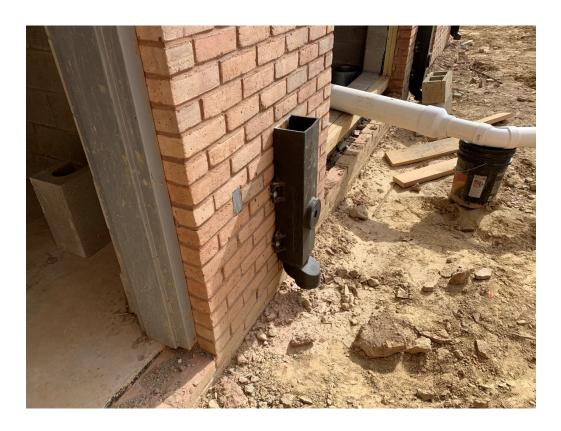
Figure 5 – Cast Iron Boots Installed

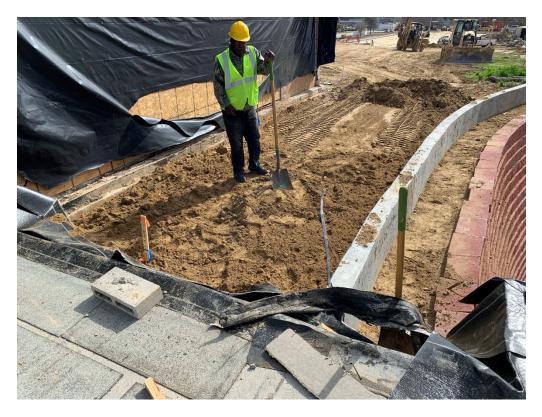
Figure 6 – Grading near Roof Edge

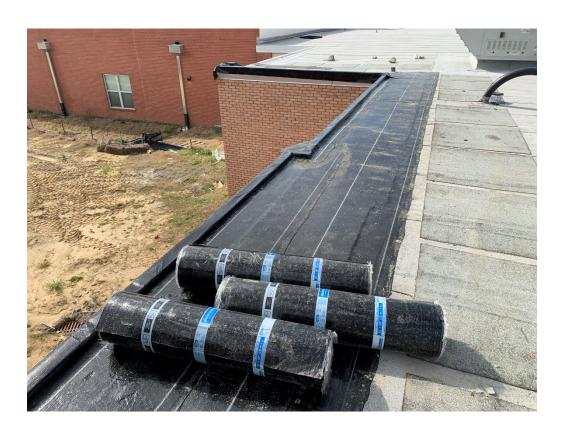
Figure 7 – Roof Work at Remodeled Wall

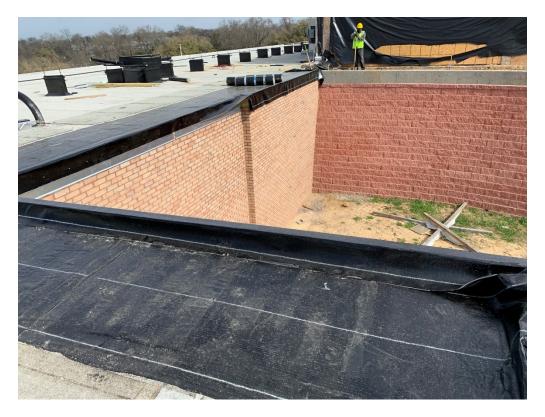
Figure 8 – Roof Work at Remodeled Wall

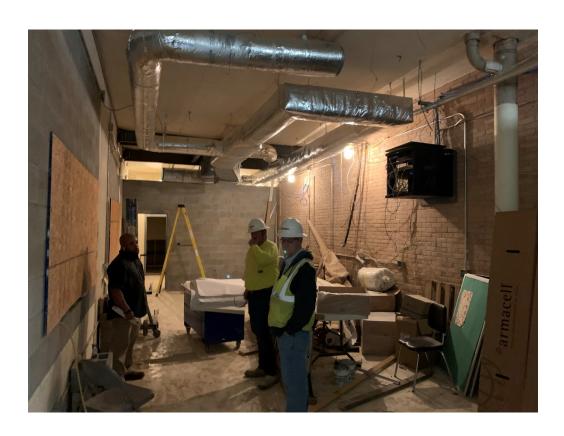
Figure 9 – Interior at Concessions

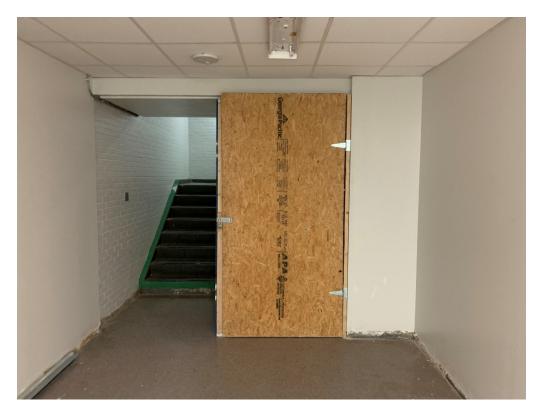
Figure 10 – Elevator work to wrap up ASAP
