Architect's Field Report

12 March 2021

18053-Vicksburg Junior High School / Report Number 030

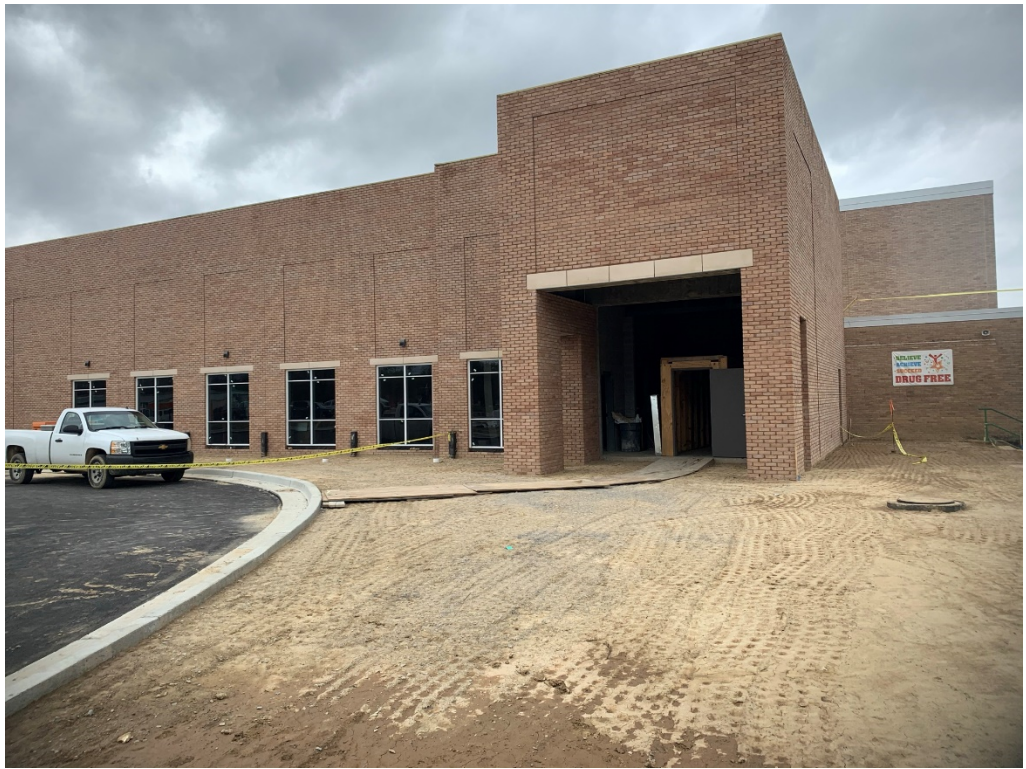
Storefront has been partially installed at the addition. Presumably the glazing is only partially installed in an effort to dry in for the drywall finish work that has been done at the interior. Moisture levels are high as it is April and an effort should be made to further dry in the addition to prevent against mold at the gypsum products.

Figure 1 – Storefront Installed

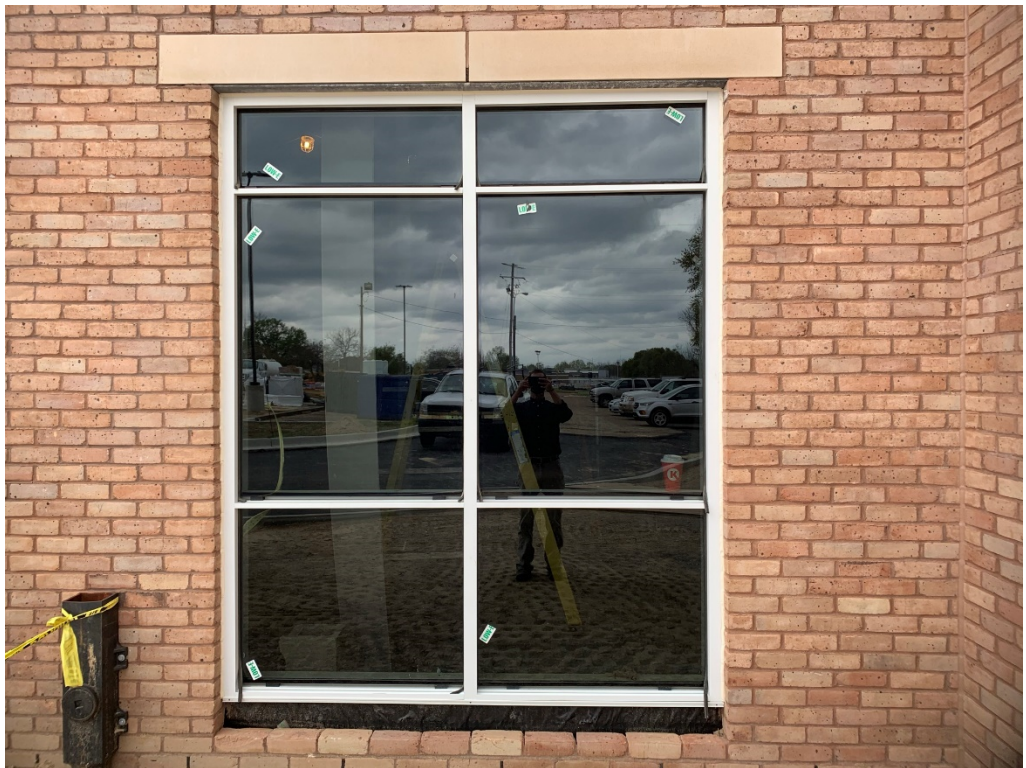
Figure 2 – Storefront Installed

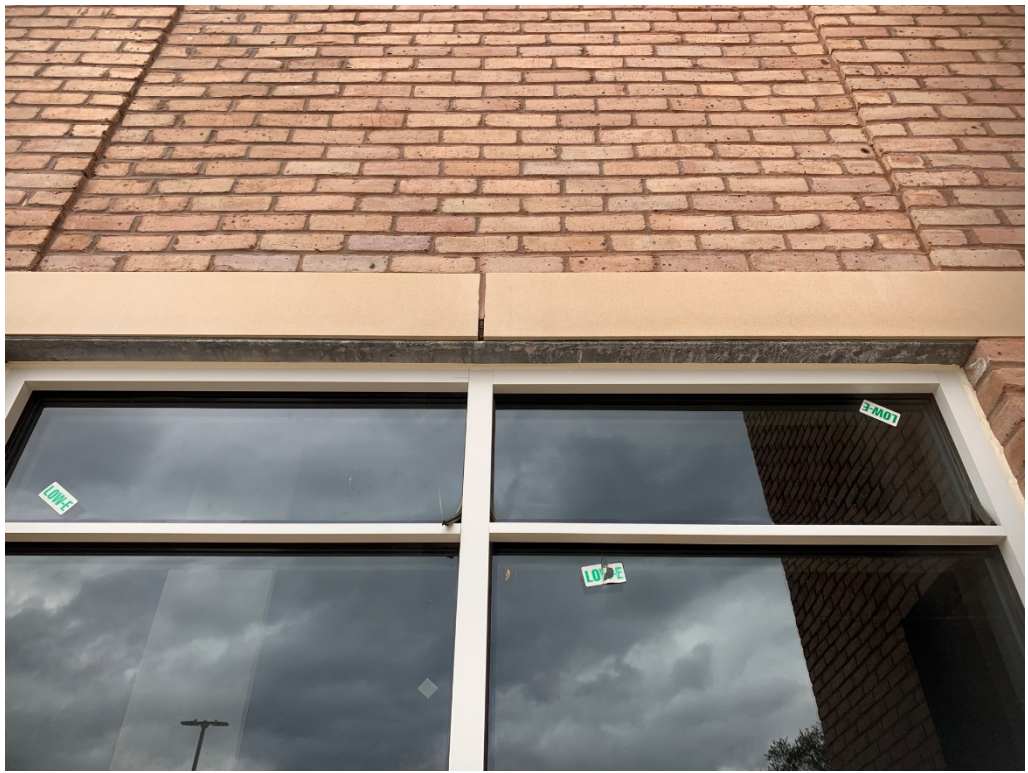
Figure 3 – Storefront Installed

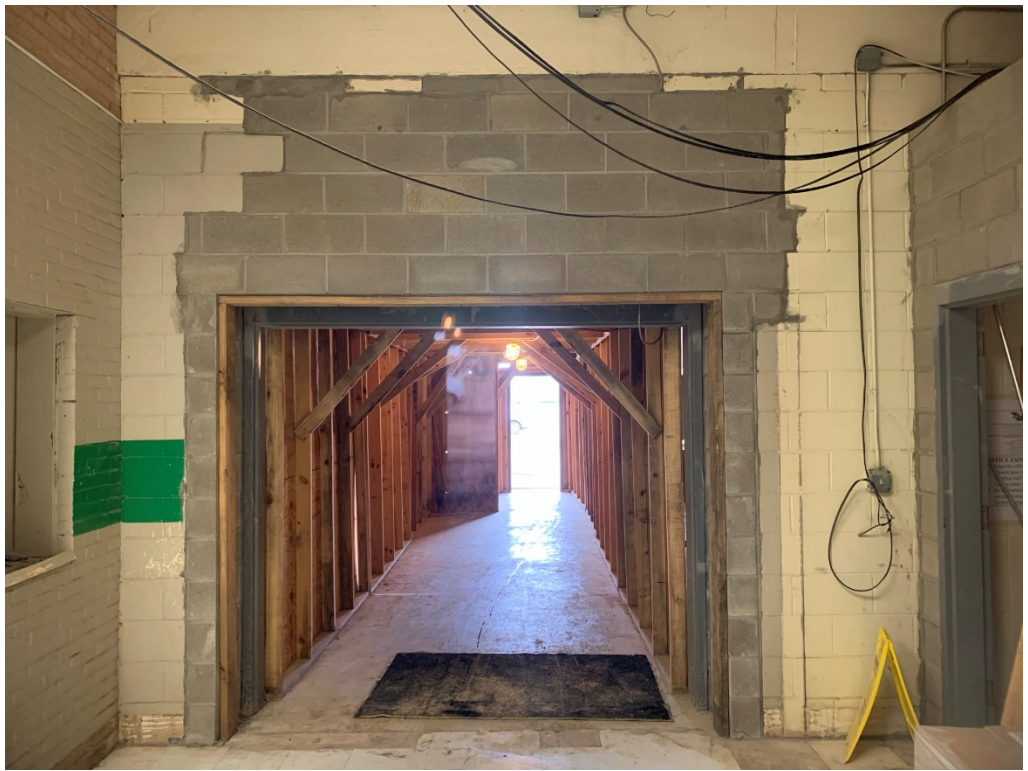
Figure 4 – Interior Service work is Ongoing

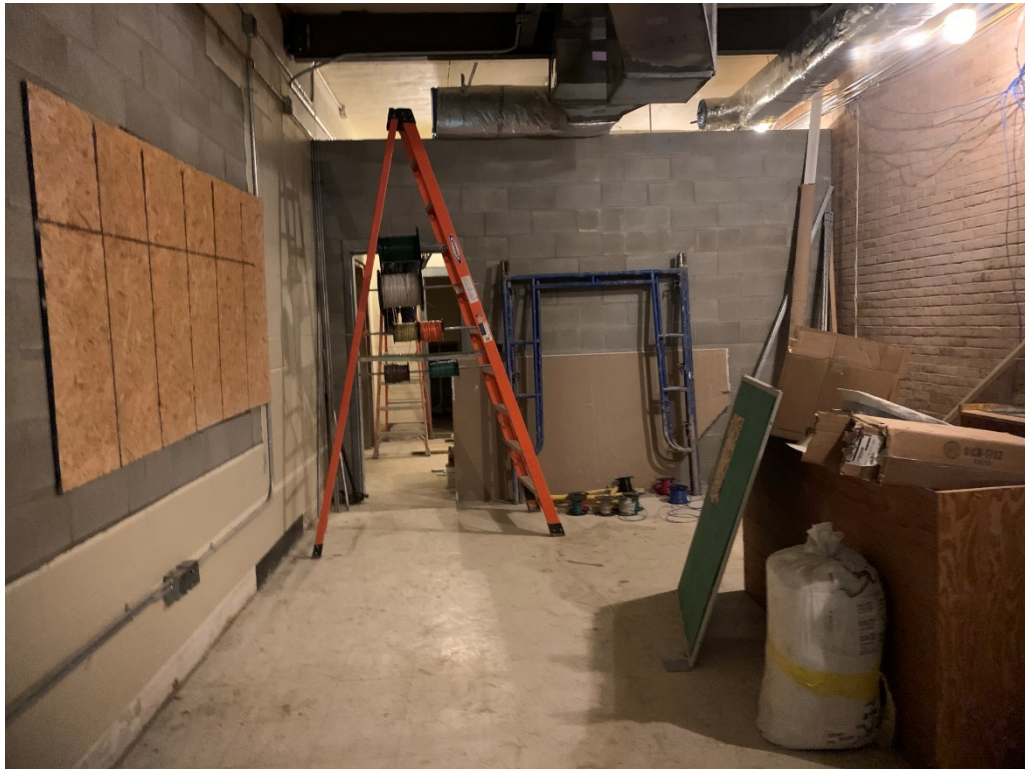
Figure 5 – Electricians On Site

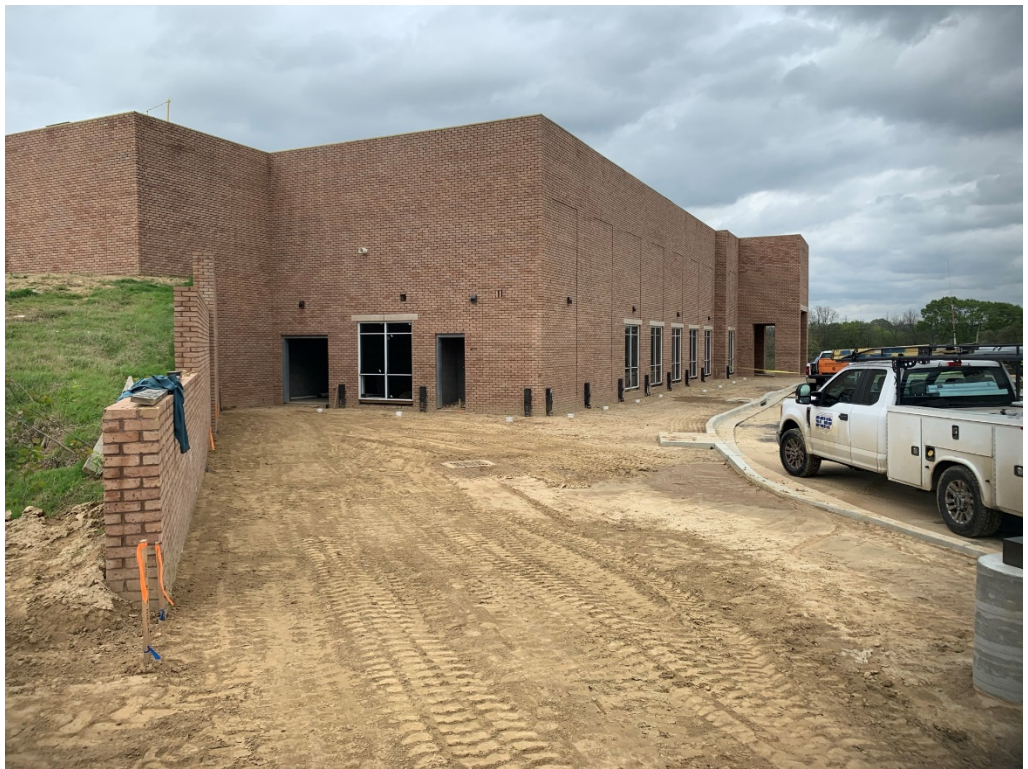
Figure 16 – Storefront Installed

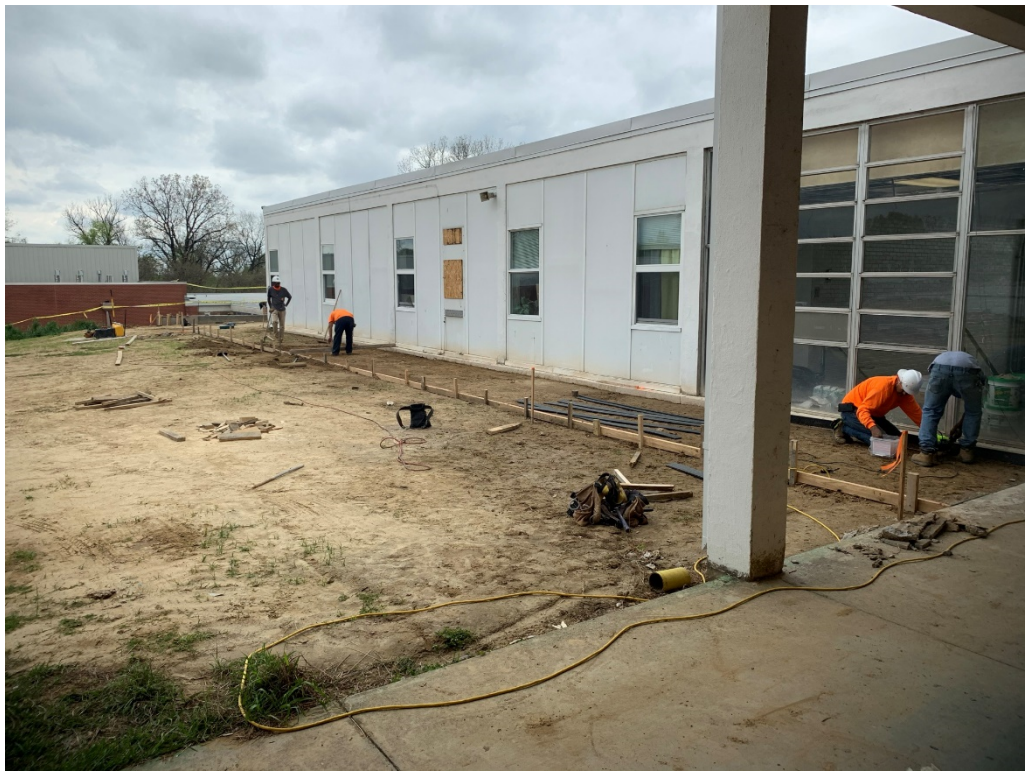
Observations On site, workers were laying out formwork for concrete and planning new sidewalk. I spoke with Jeff Porter who mentioned that a gas pipe is preventing them from moving forward on some of the site work and that the city has been contacted about moving it.

Figure 17 – Forms for new Sidewalk

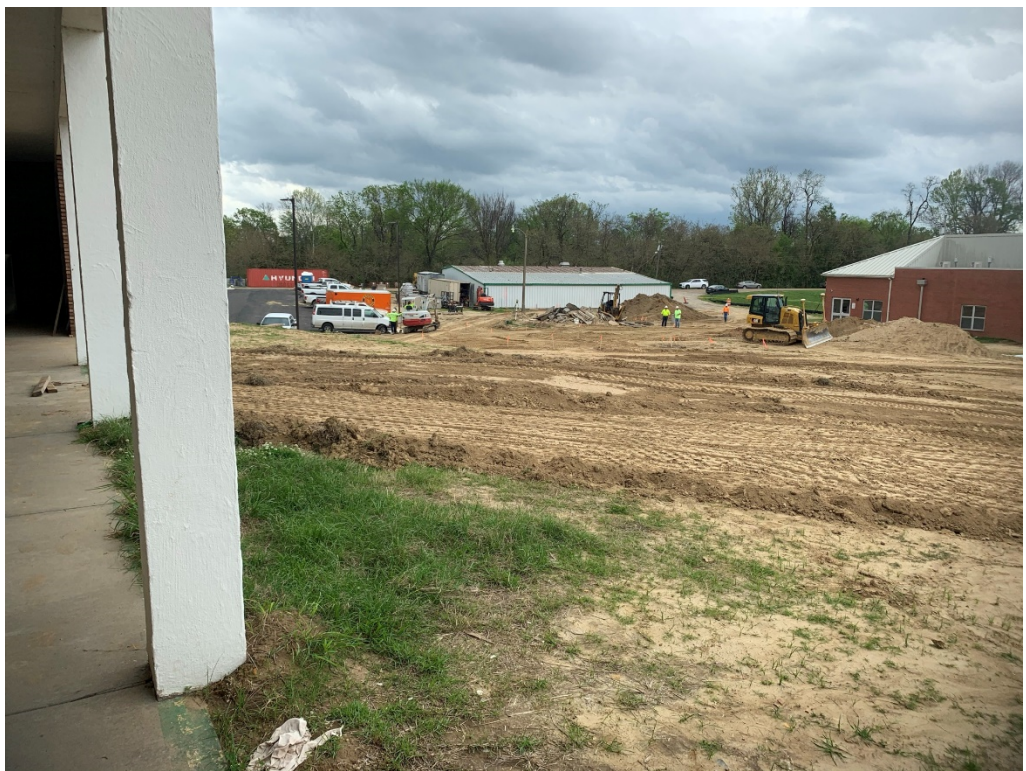
Figure 18 – Contractor Reviewing Grading
