## Architect's Field Report

28 May 2021

18053-Vicksburg Junior High School / Report Number 033

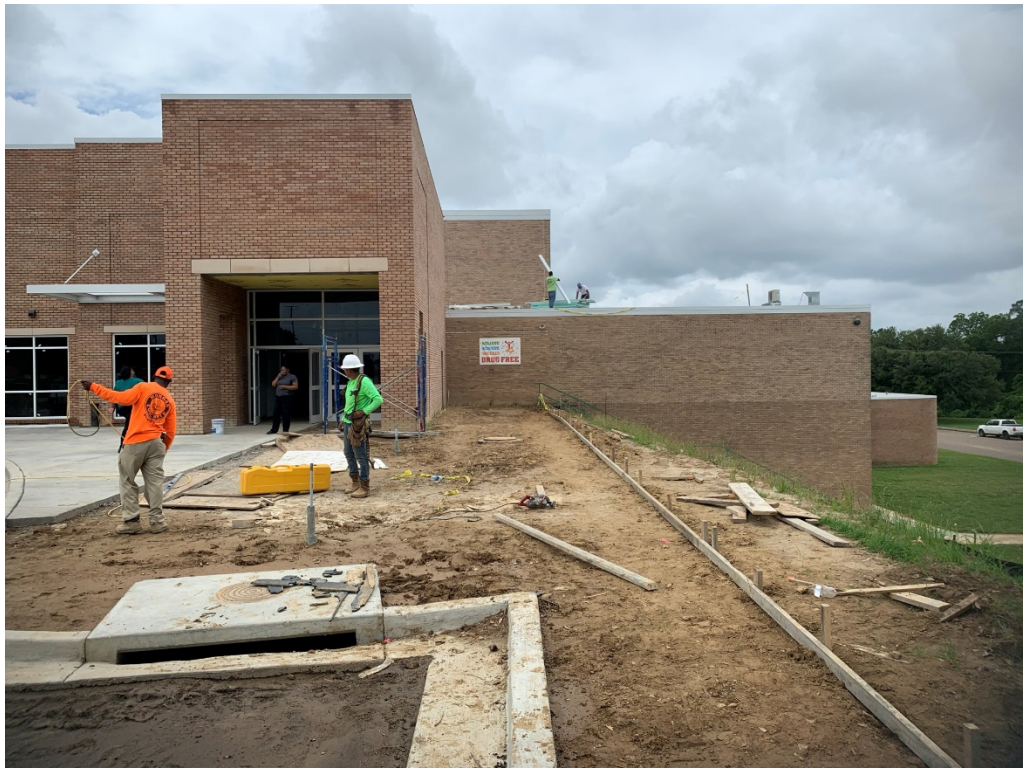
Figure 1 – Roof Work is nearing completion

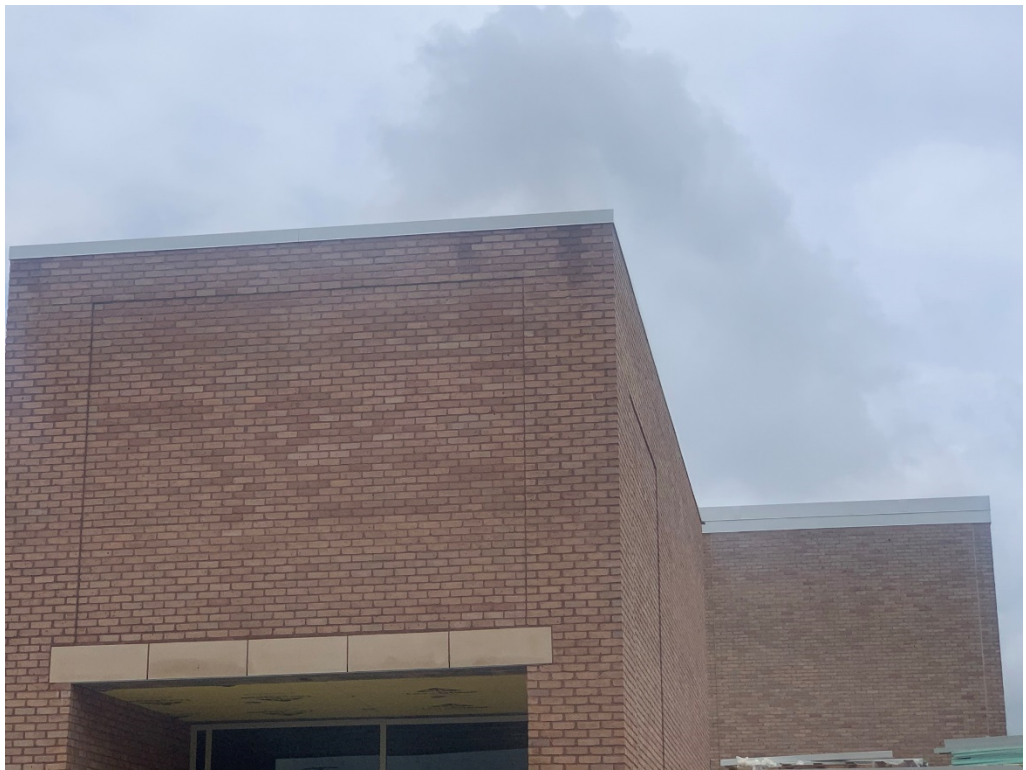
Figure 2 – Roof Trim Installed at parapet

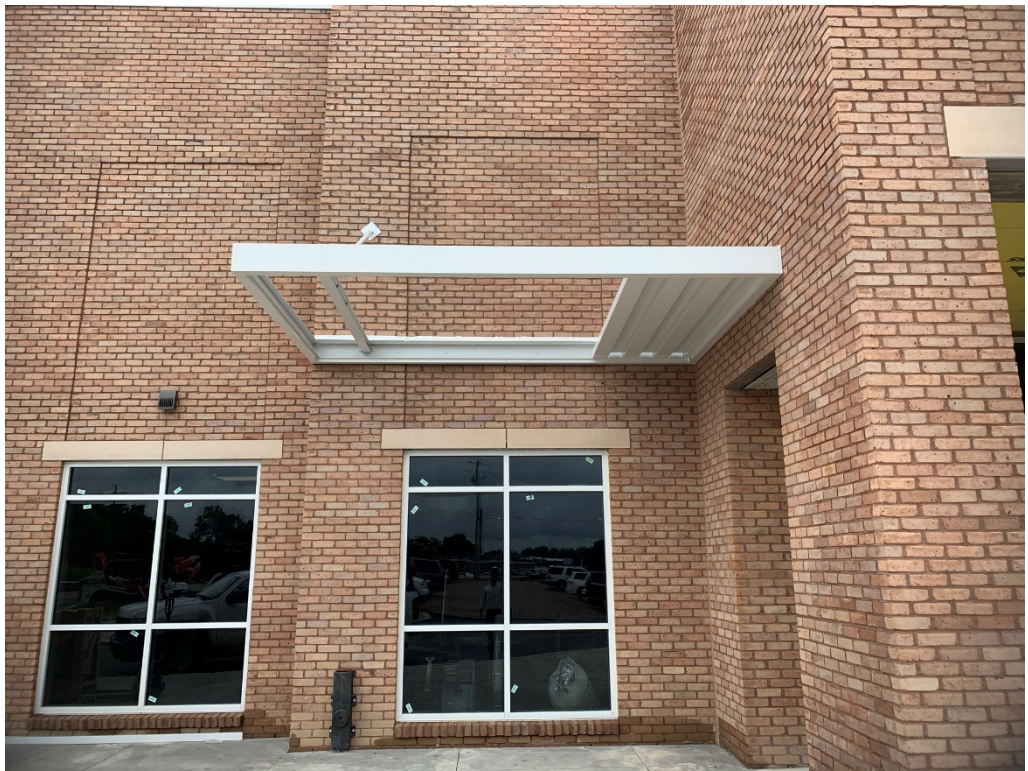
Figure 3 – Metal Awning Install has begun

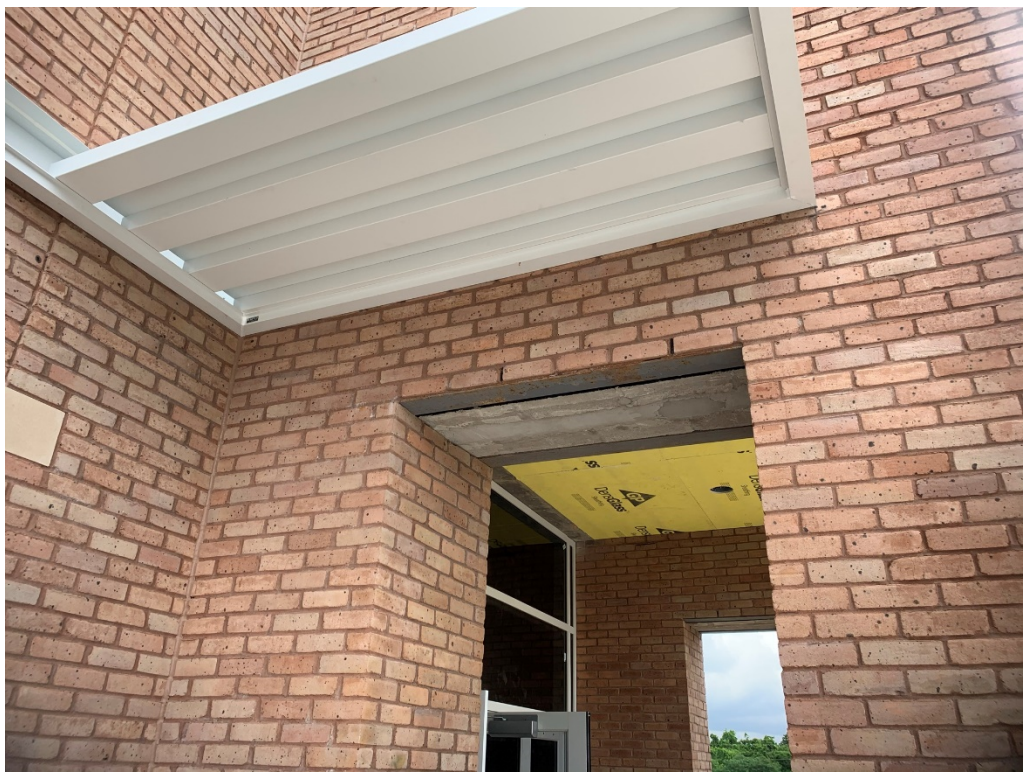
Figure 4 – Metal Awning Install has begun

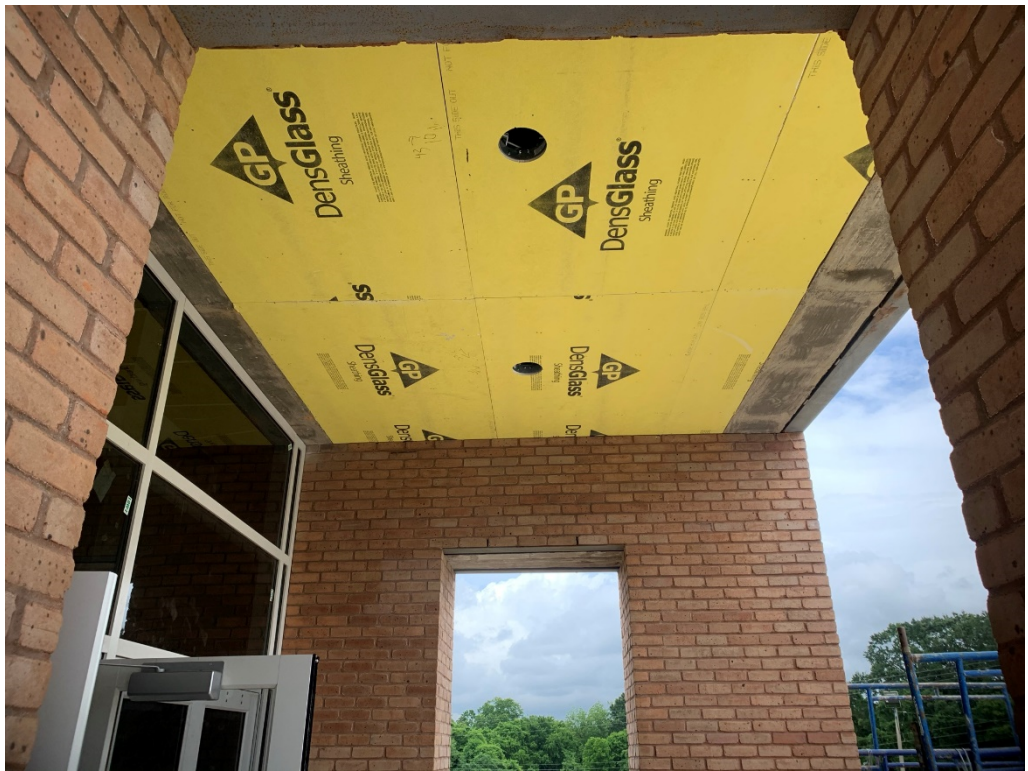
Figure 5 – Gypsum Ceiling Installed

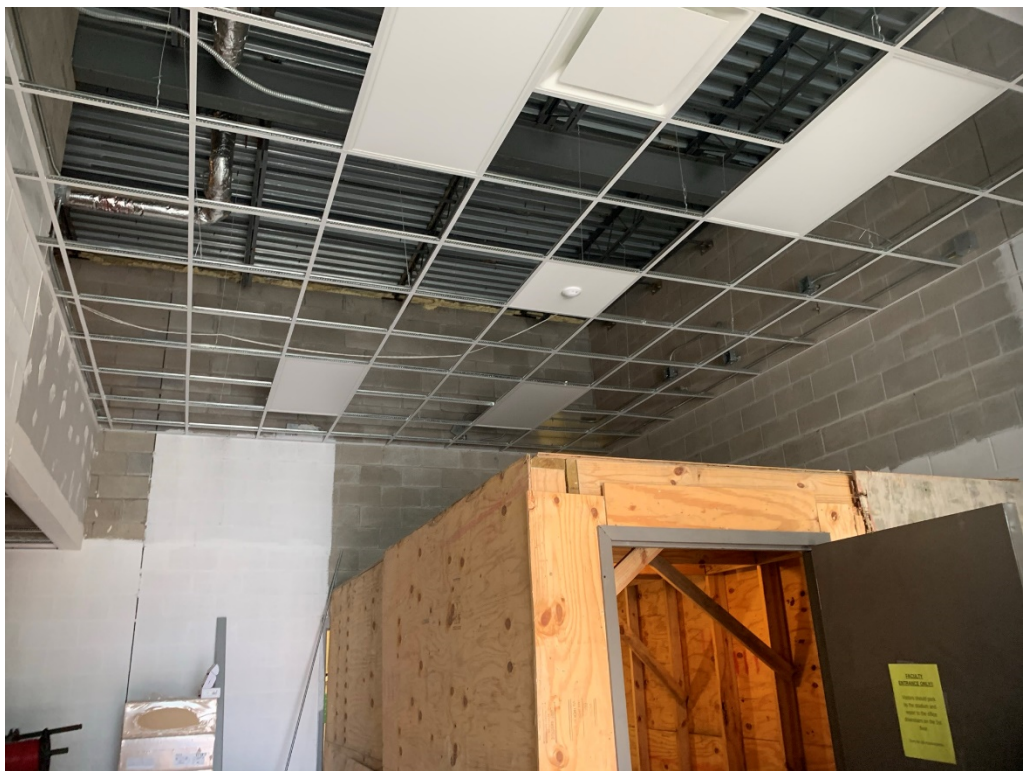
Figure 6 – Ceiling Grid Install at Entry

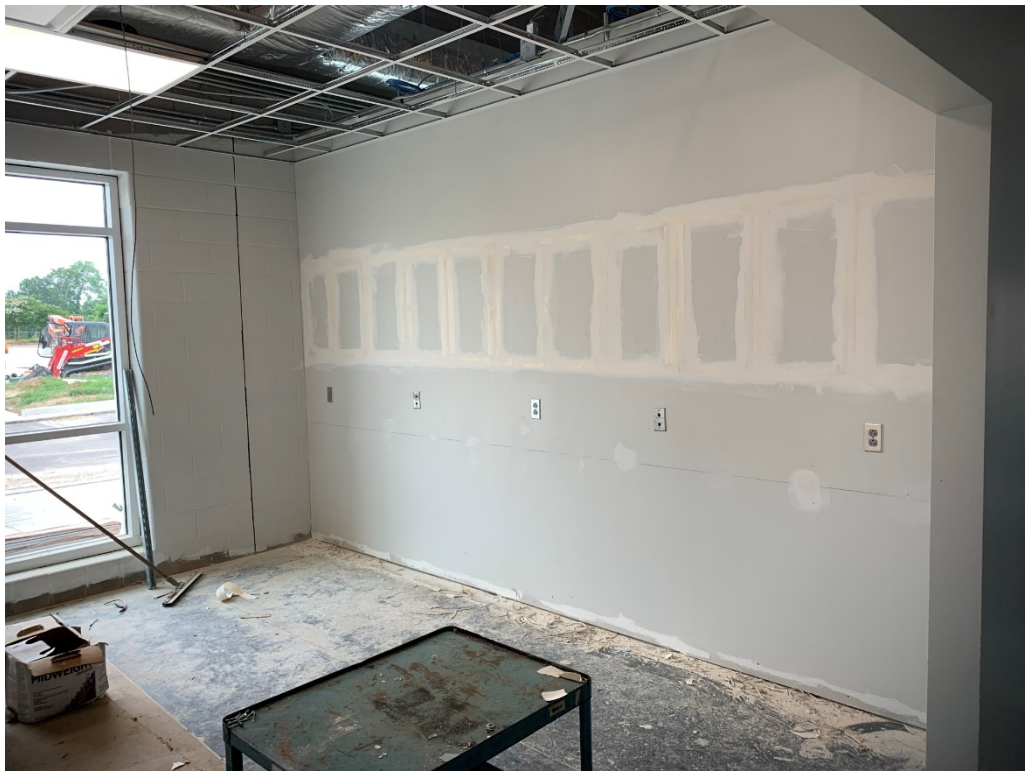
Figure 7 – Drywall Repair at Work Room

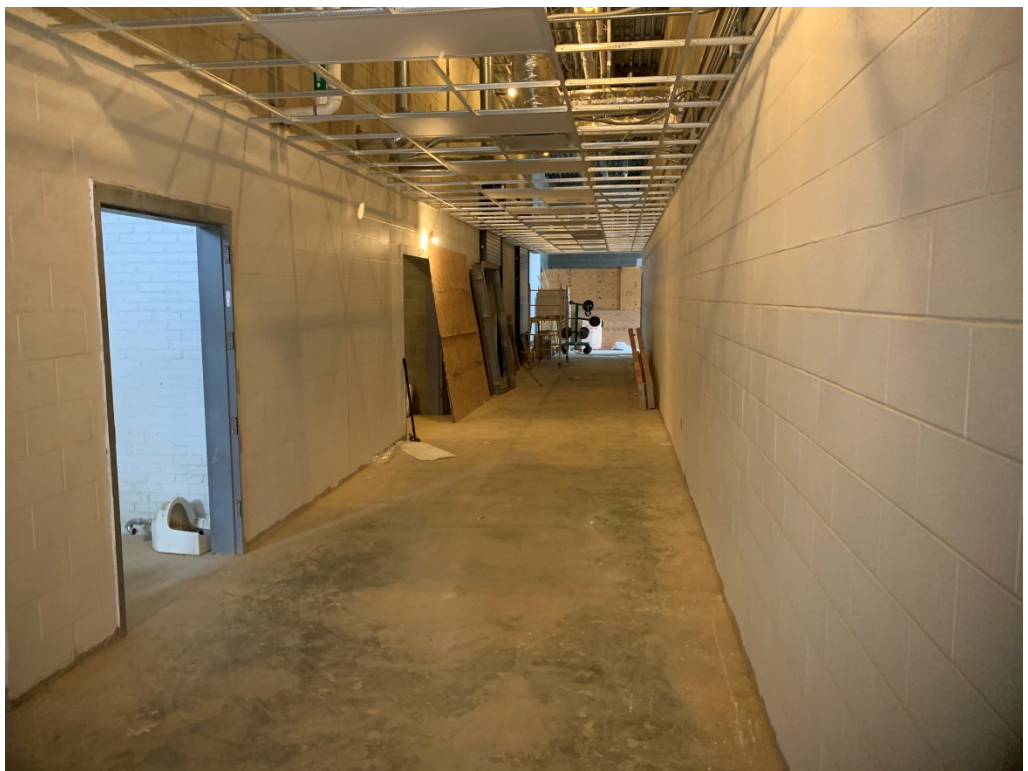
Figure 8 – Ceiling Grid installed at Hall

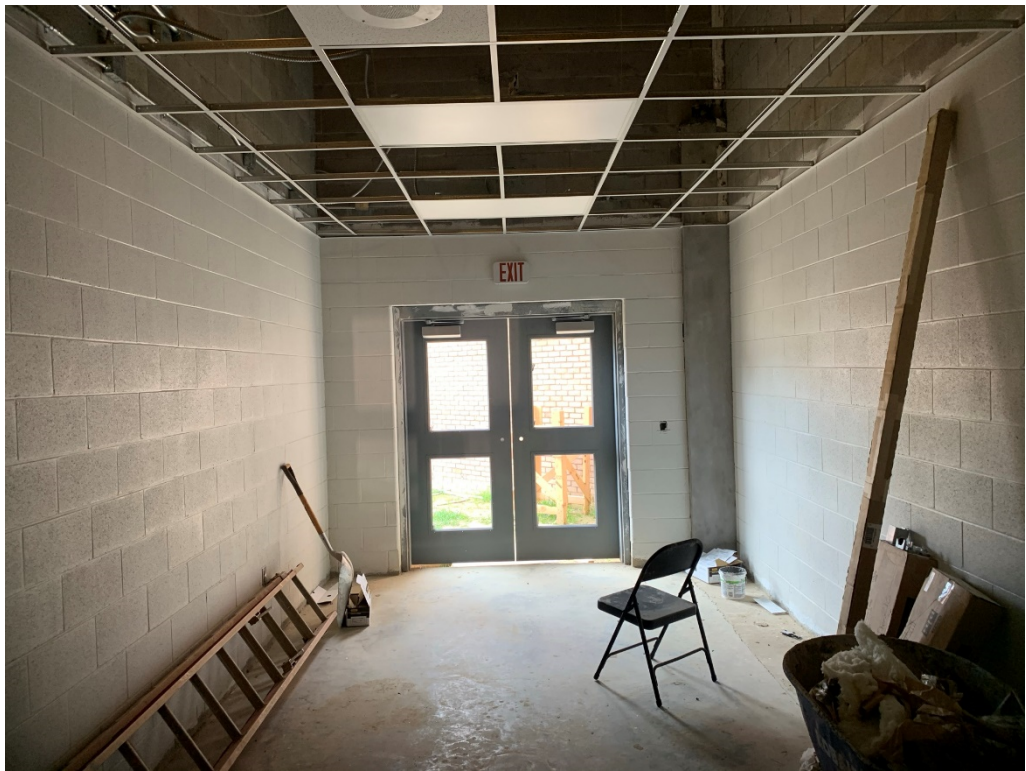
Figure 9 – Exit Doors Installed

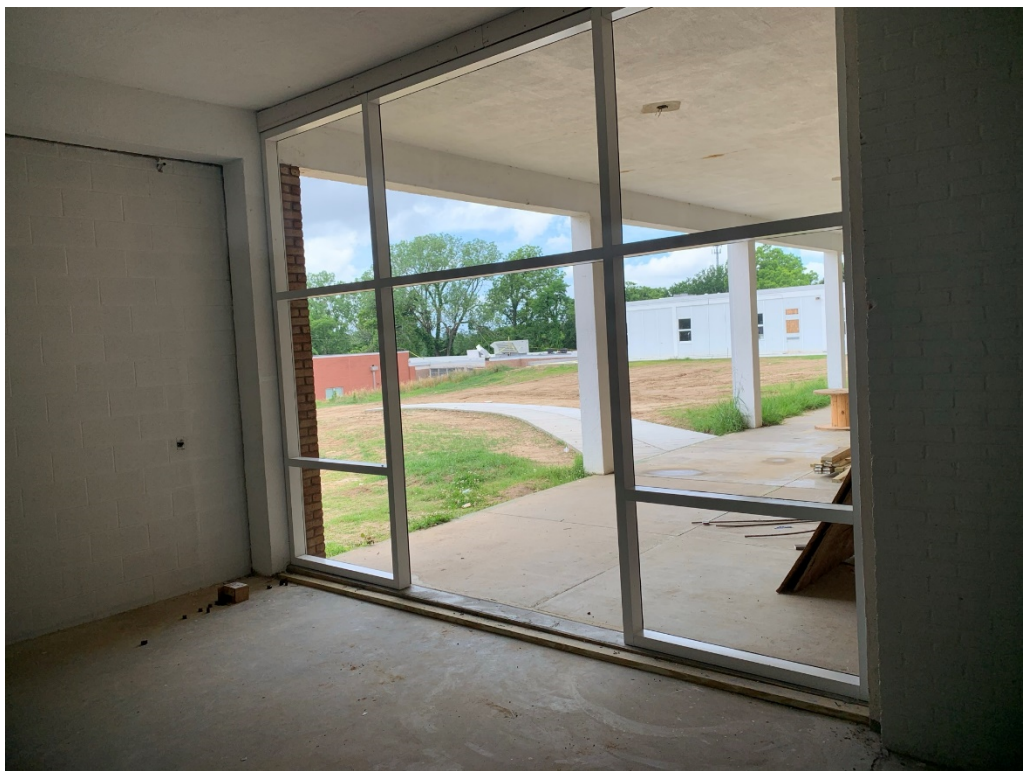
Figure 10 – Storefront; will interior of porch area be raised for final floor level to match threshold?

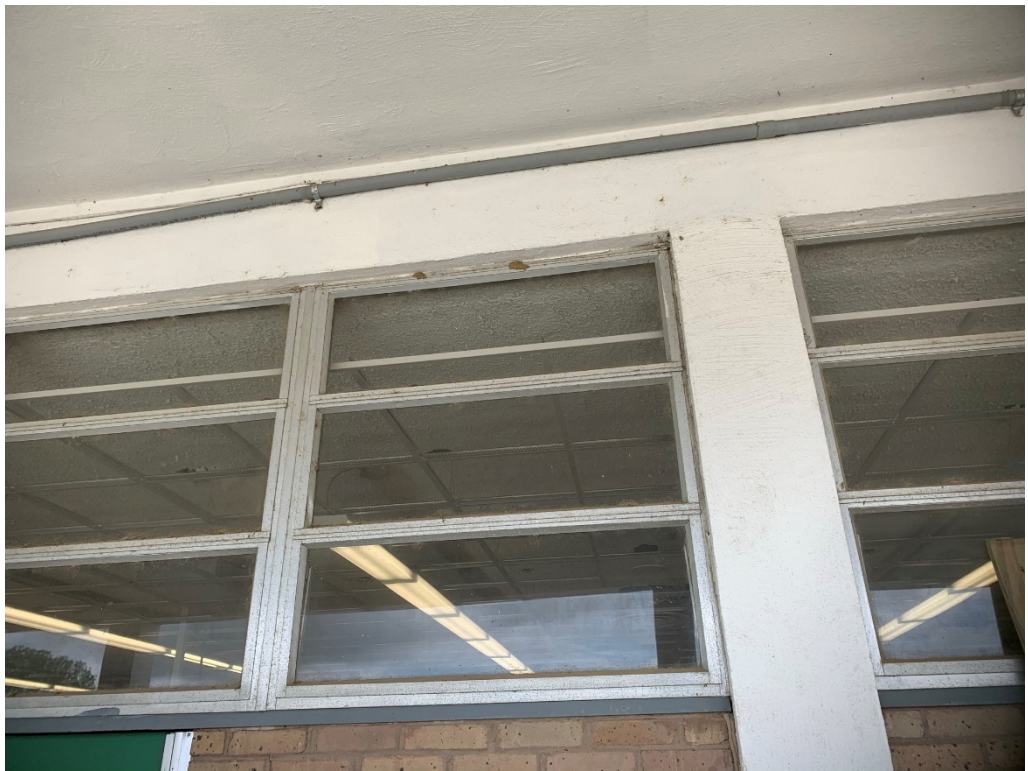
Figure 11 – Library ceiling needs finishing at end where window shows above new ceiling

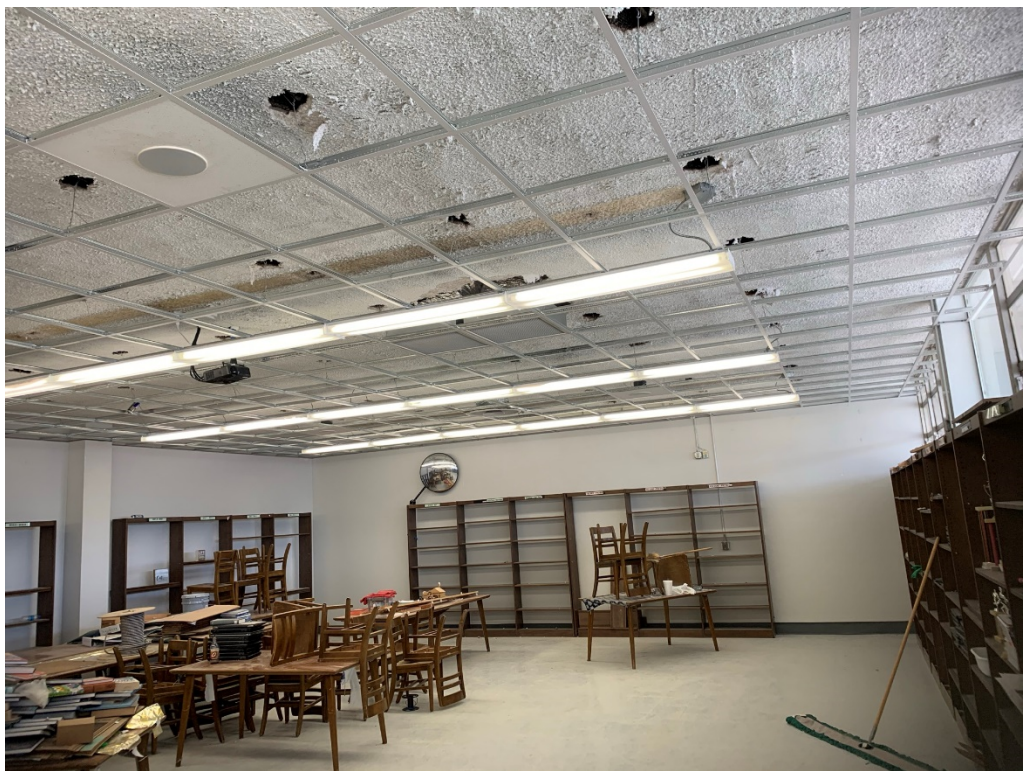
Figure 12 – New Ceiling in Library

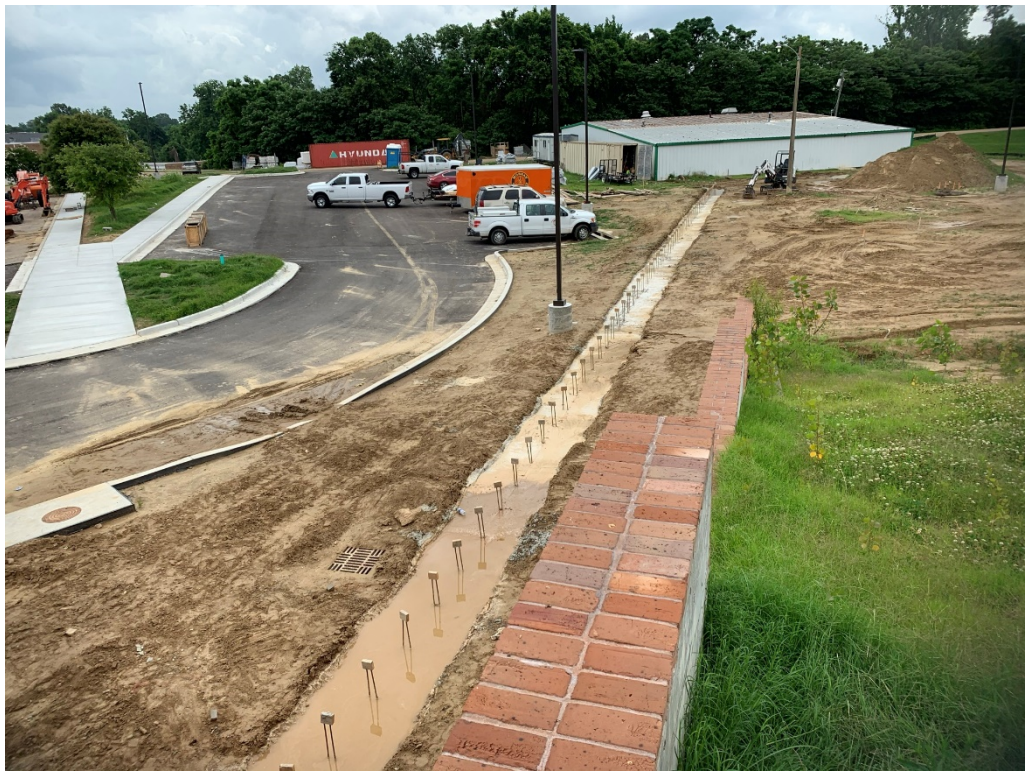
Figure 13 – New Sidewalk Base

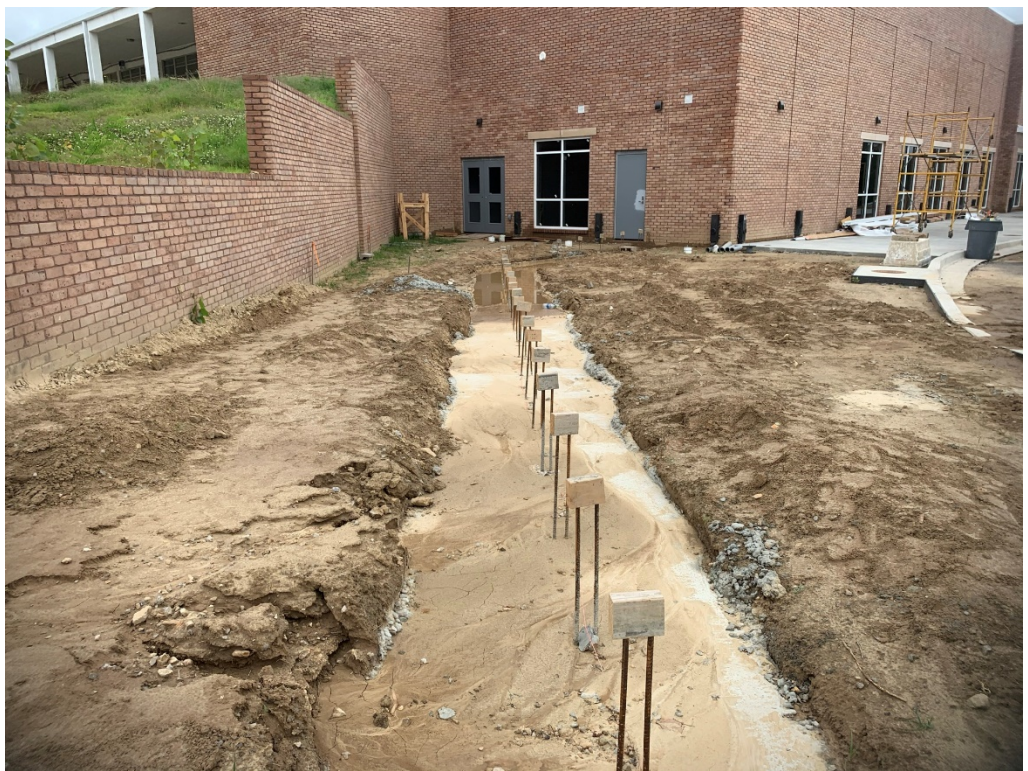
Figure 14 – Sidewalk Base
