Architect's Field Report

16 May 2021

18053-Vicksburg Junior High School / Report Number 034

Contract Paul Jackson & Son
Date / Time 14 June 2021 / 12:45 PM
Weather / Temp Clear / 91 ° F
Est % Complete 75%
Sched Conformance + 00 days
Work in Progress Door Hardware Installation
Window Panel Replacement

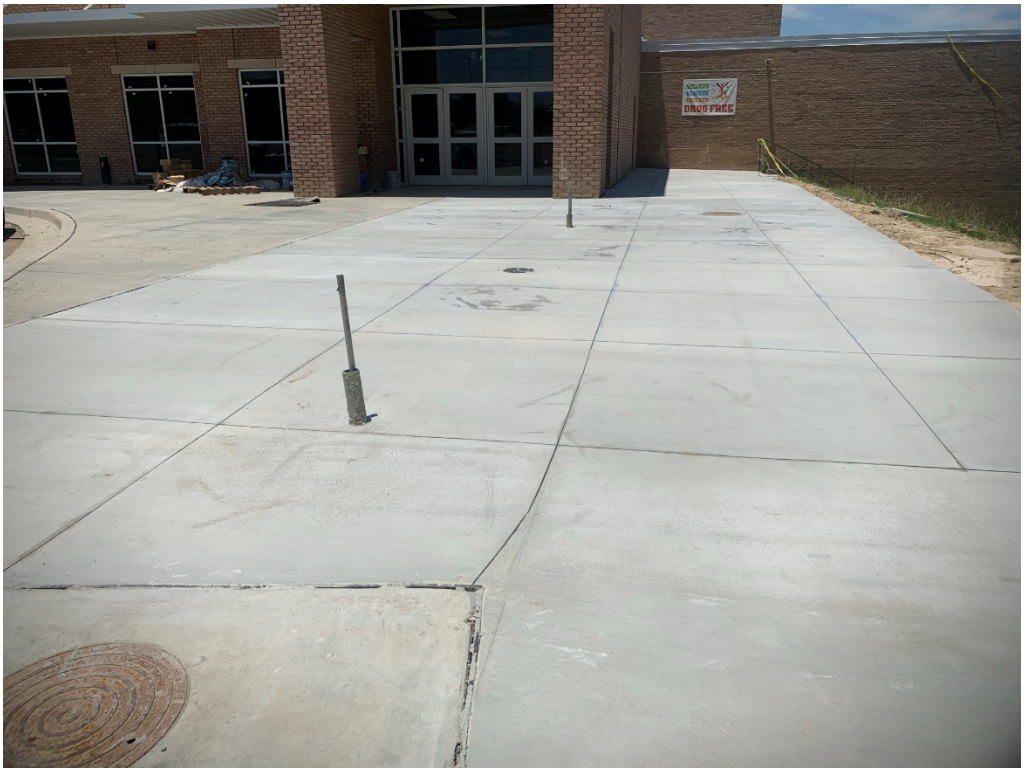
Figure 1 – New Concrete at Entry

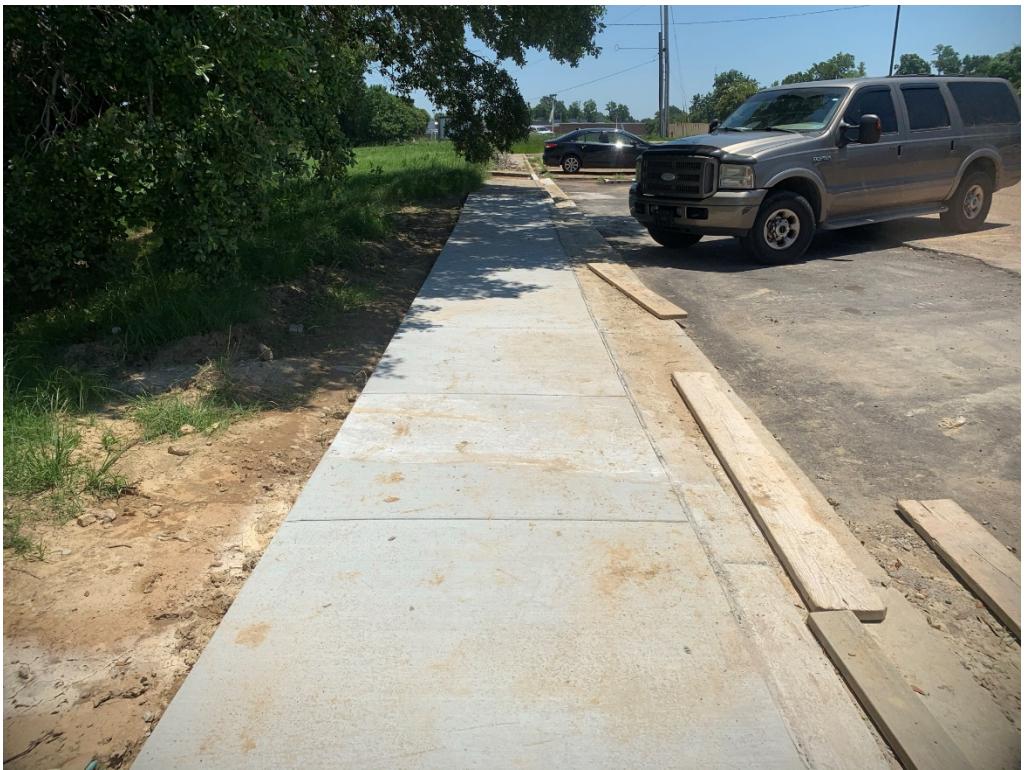
Figure 2 – New Concrete at Sidewalk

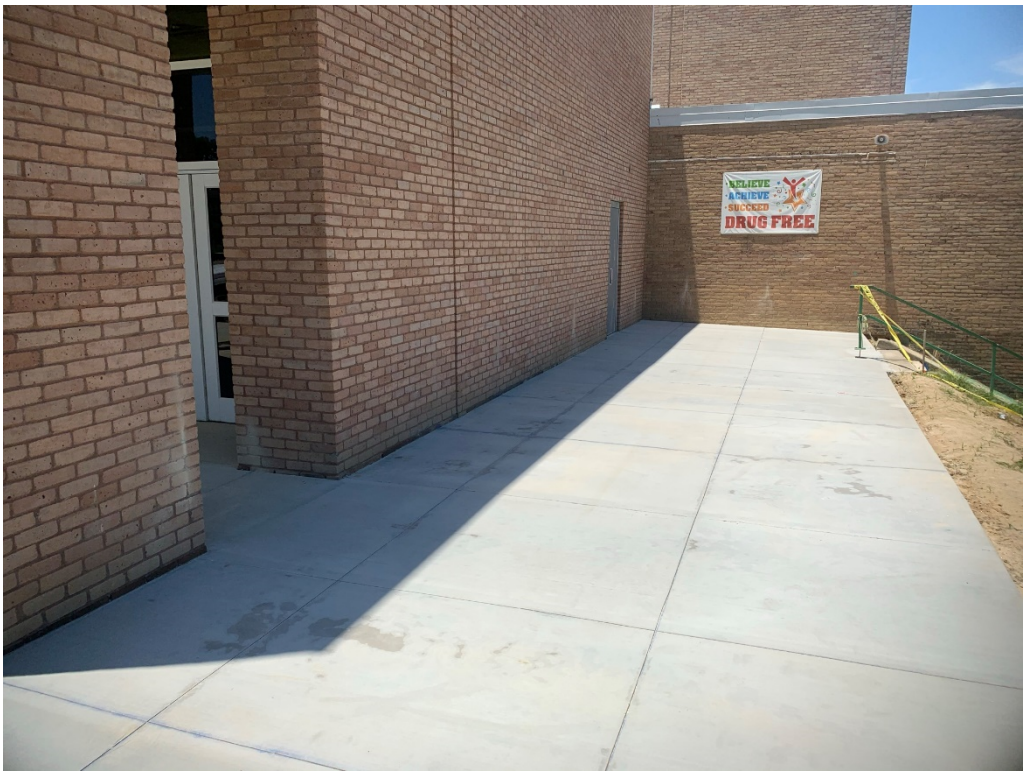
Figure 3 – New Concrete at Entry

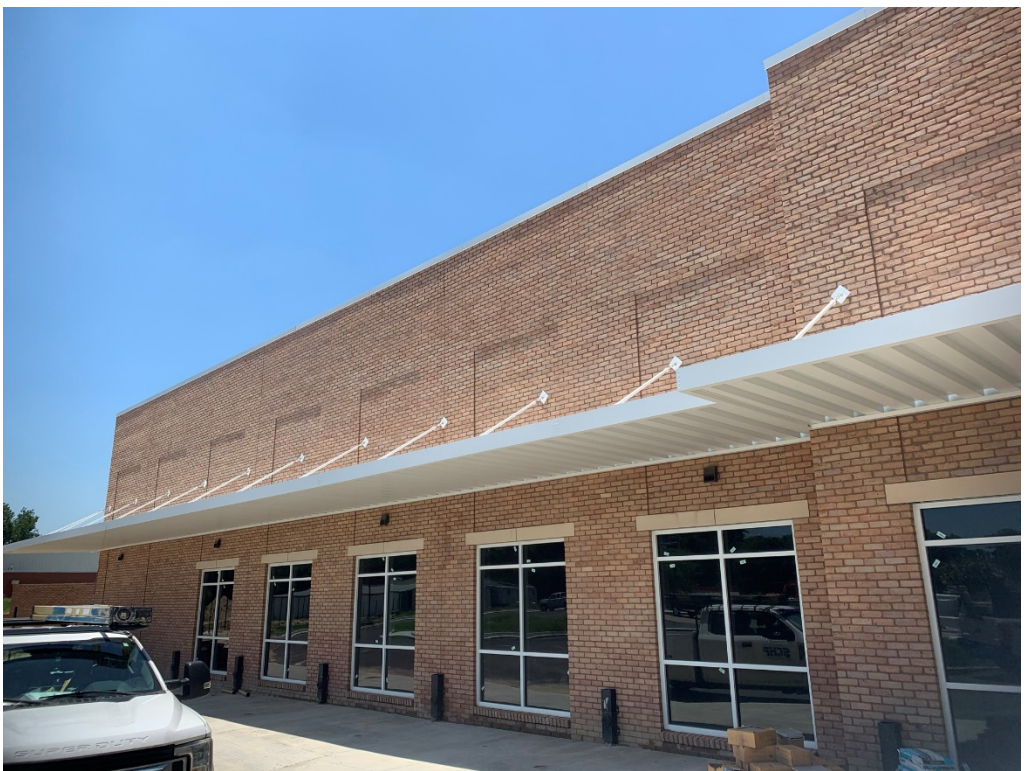
Figure 4 – Majority of Awning has been installed

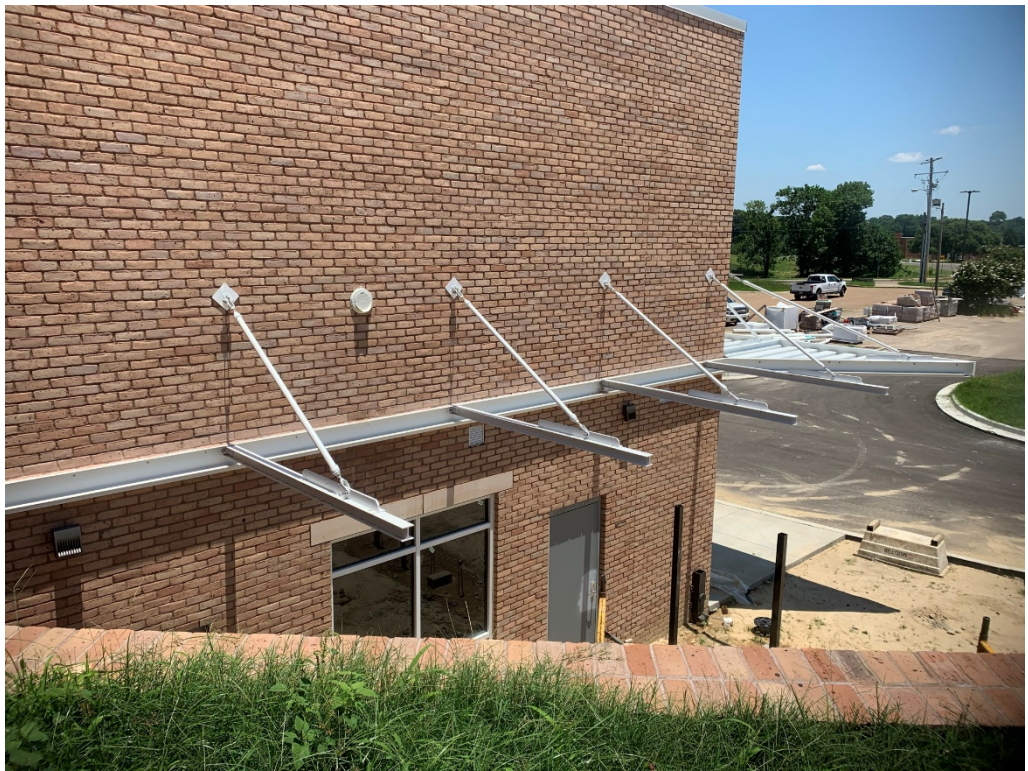
Figure 5 – Awning Install is Ongoing

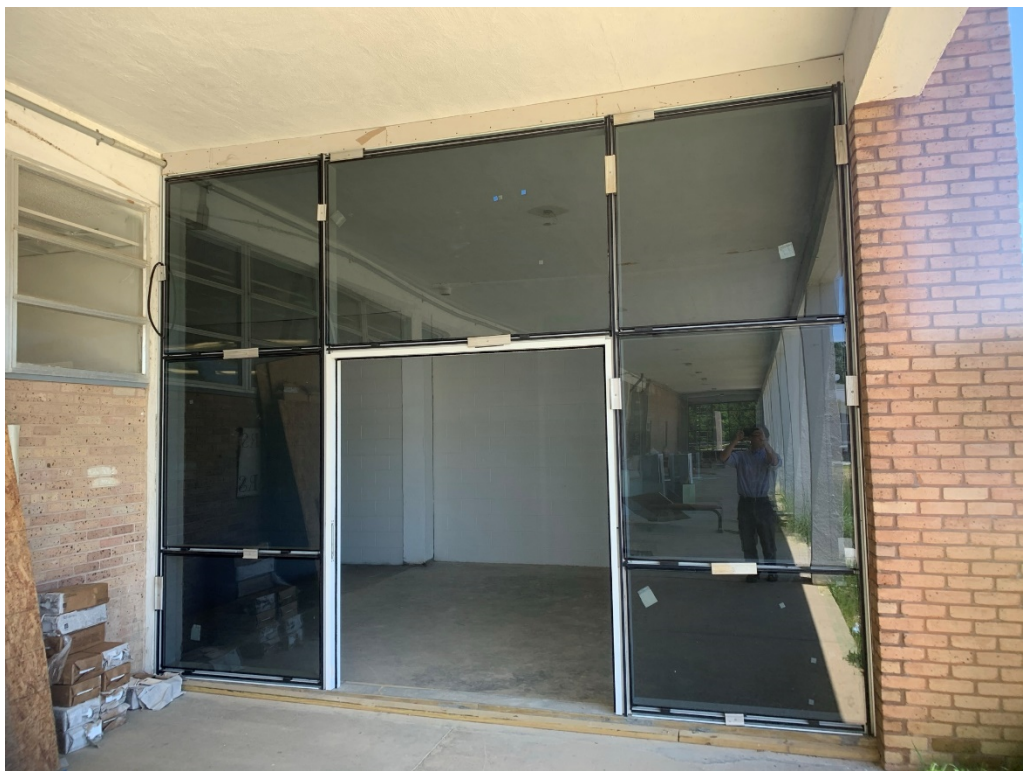
Figure 6 – Curtain Wall Progress at Upper Floor Entry

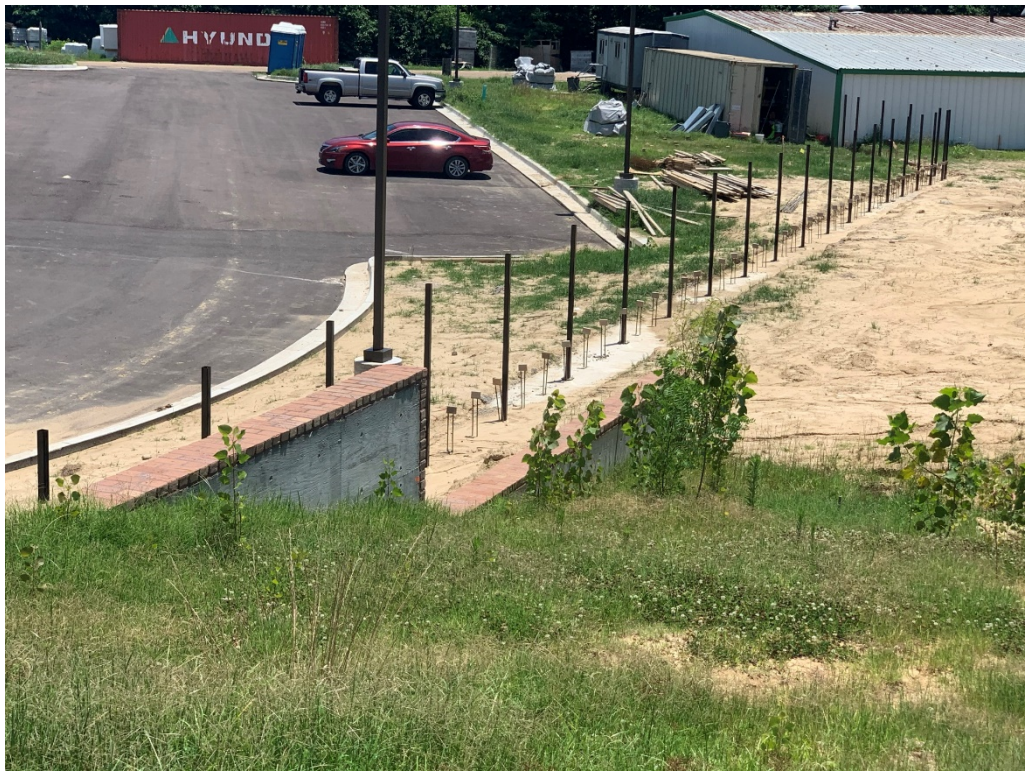
Figure 7 – Fence Posts Installed

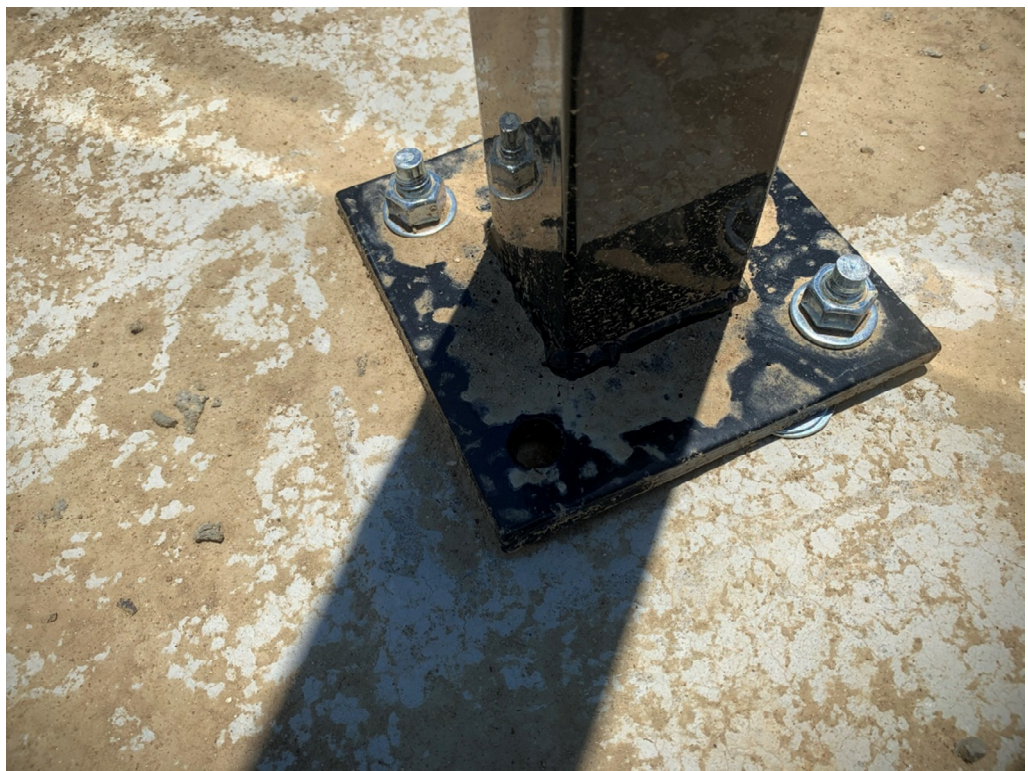
Figure 8 – Missing Concrete Anchors in Some Installed Members

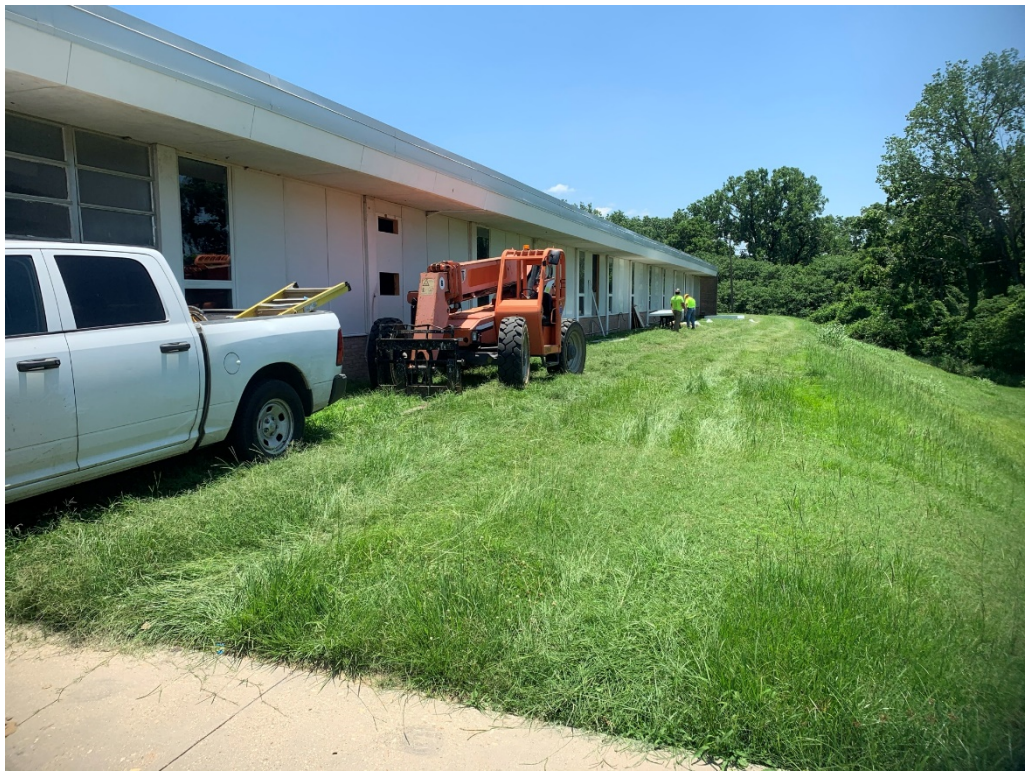
On the west side, workers were installing foam panels. They were cutting panels to fit and had multiple workers demoing HVAC units, cutting panels and finishing out trim around the panels.

Figure 9 – Workers Installing panels

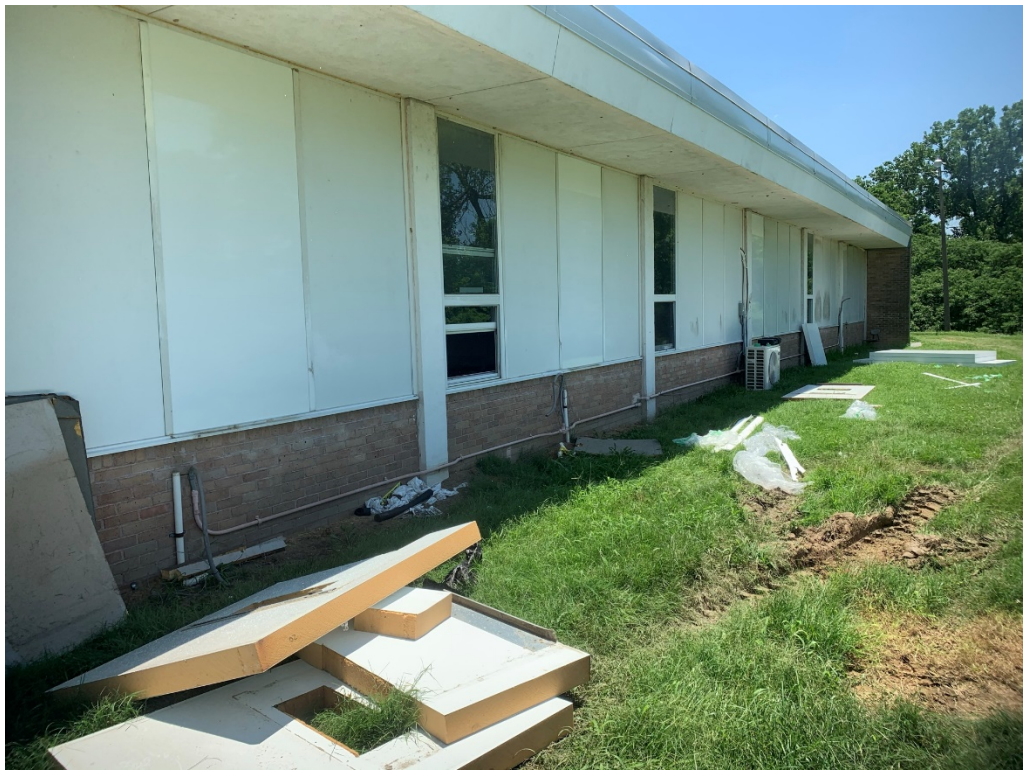
Figure 10 – New Panel Installations

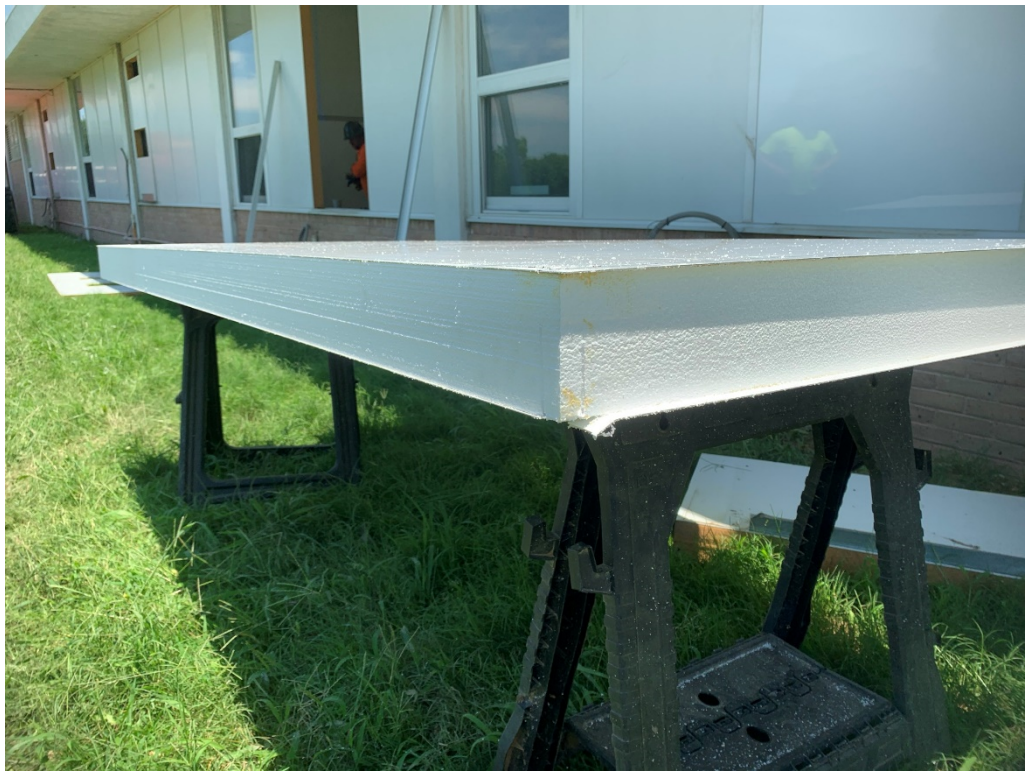
Figure 11 – Foam Panel (cut on site to fit)

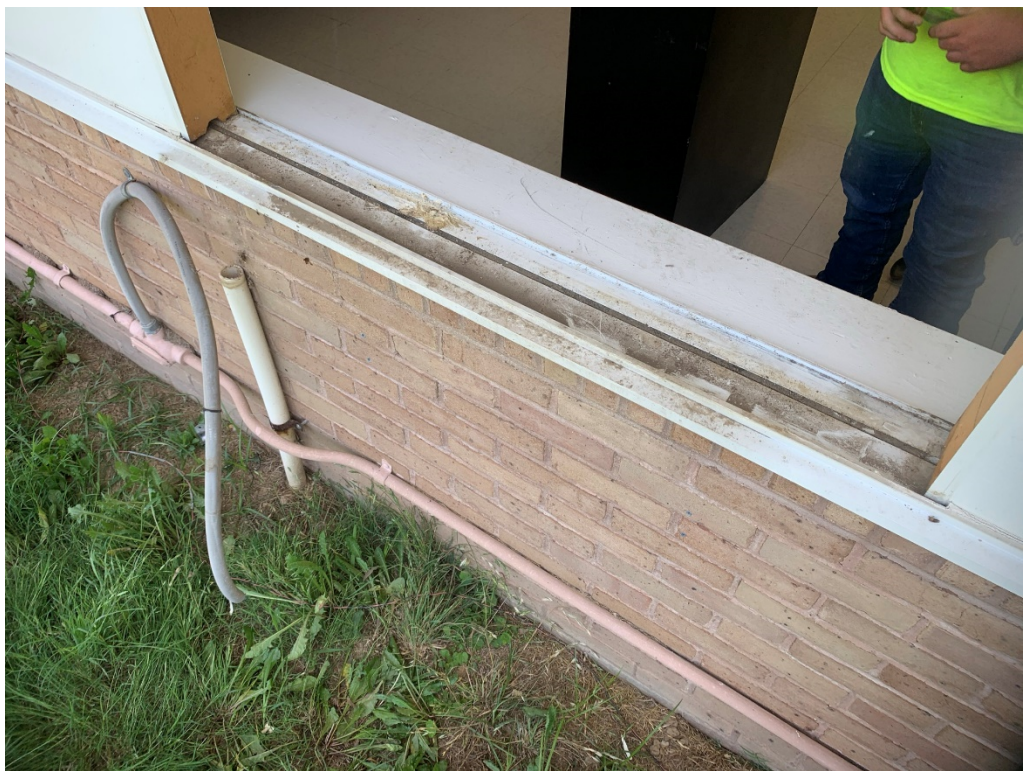
Figure 12 – Bottom of Opening Before Panel Install

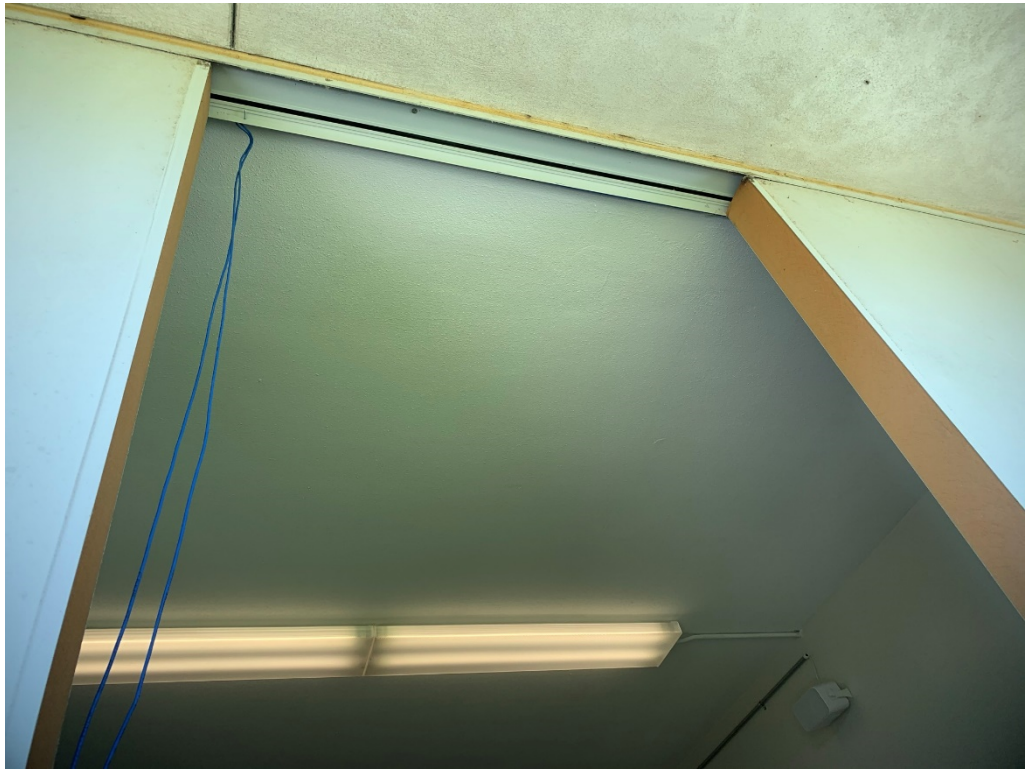
Figure 13 – Top of Opening Before Panel Install

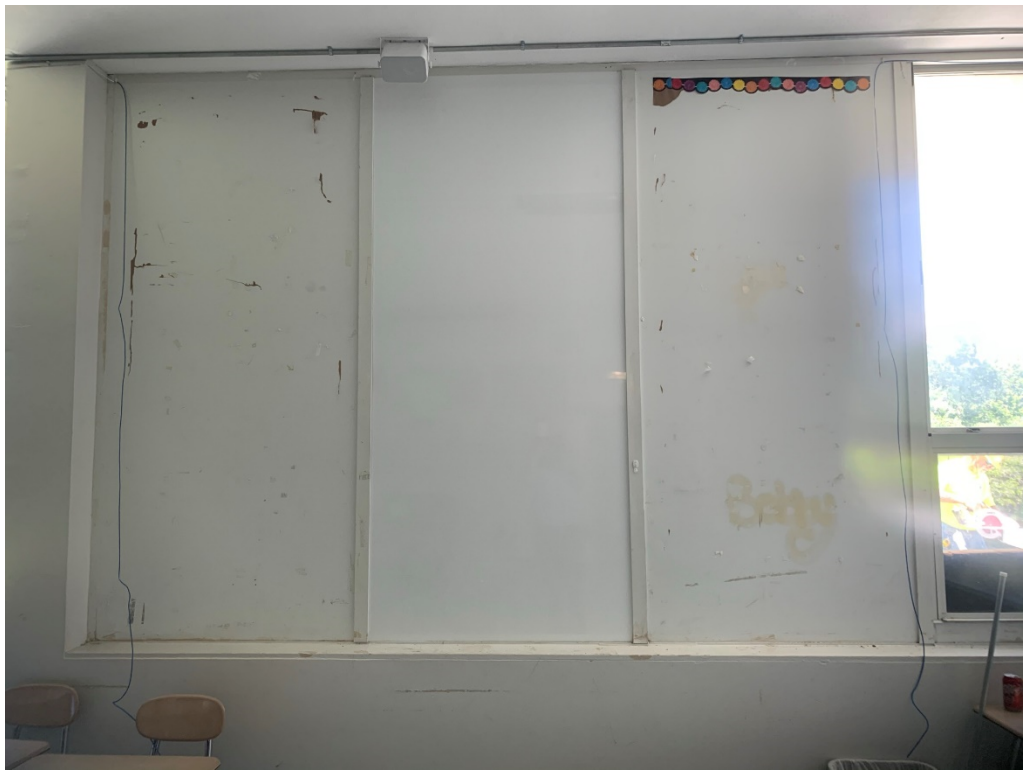
Figure 14 – Typical Installation of New Panels

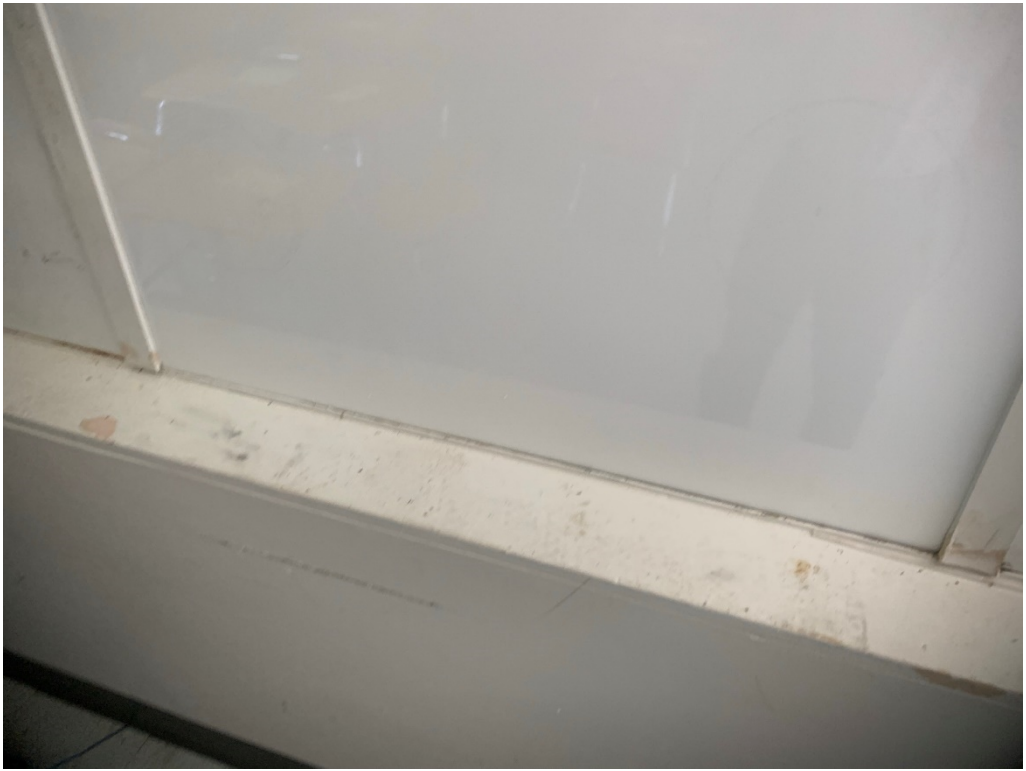
Figure 15 – Bottom of New Panel

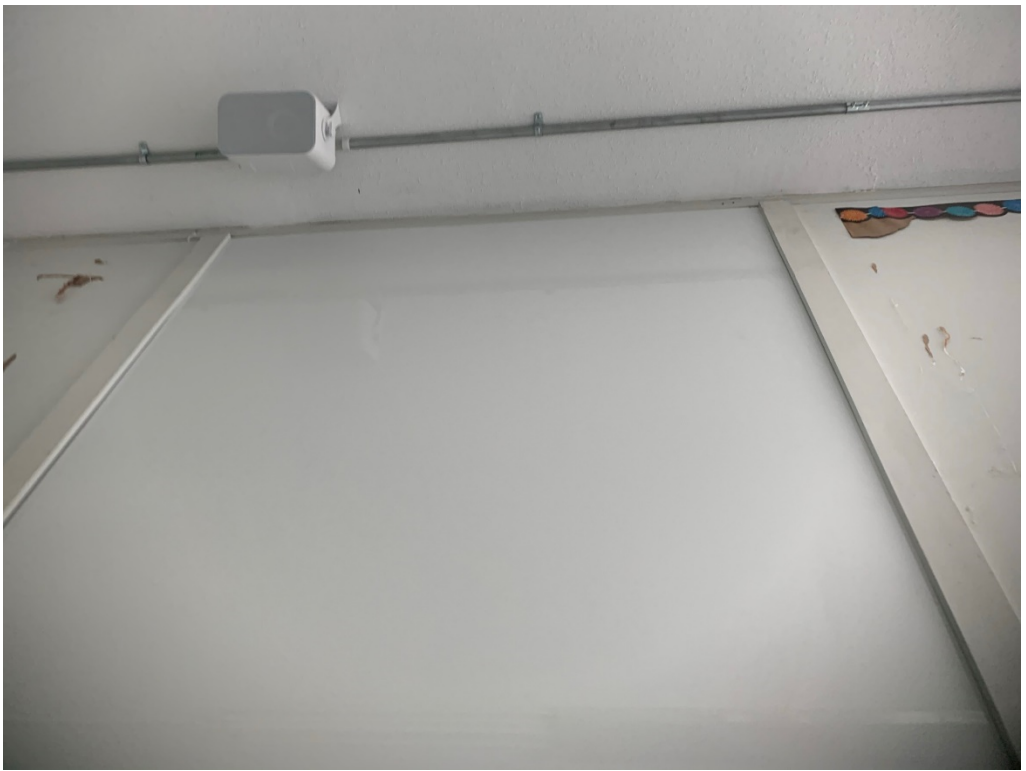
Figure 16 – Top of New panel
