## Architect's Field Report

01 July 2021

18053-Vicksburg Junior High School / Report Number 036

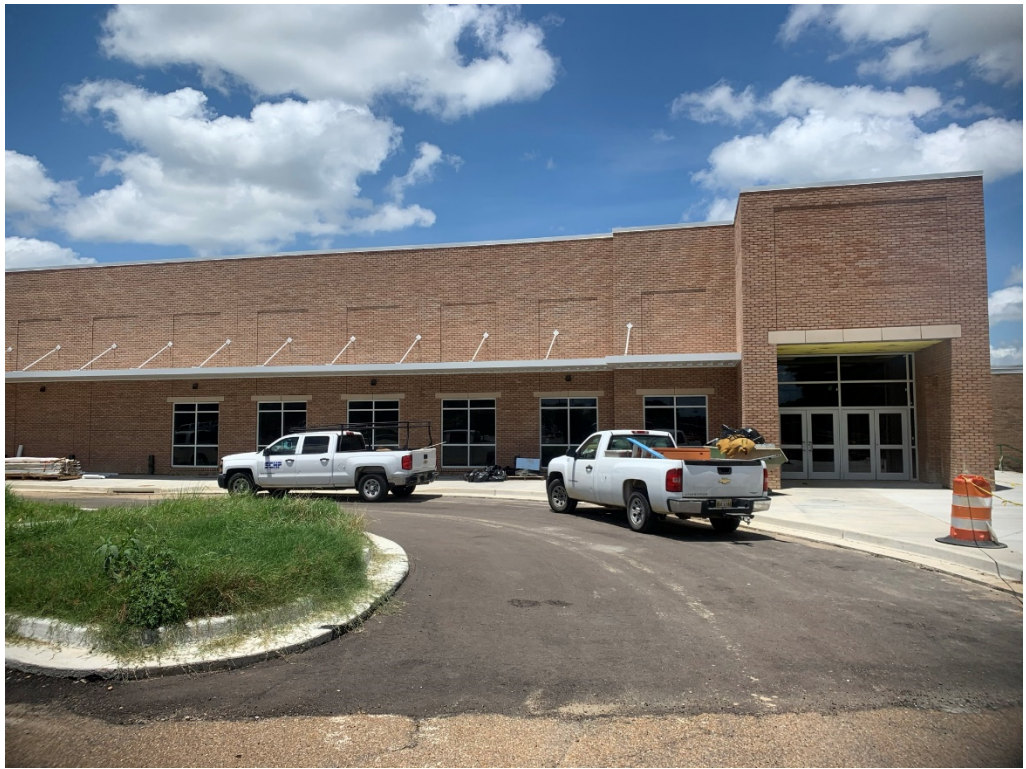
Figure 1 – Front Façade

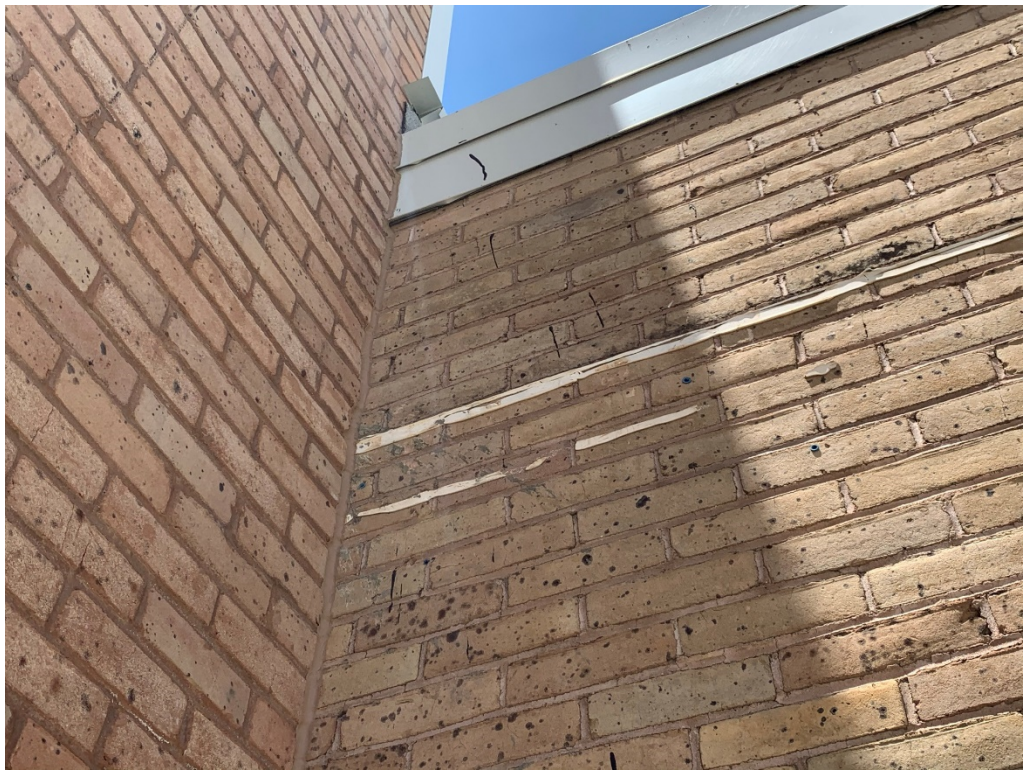
Figure 2 – Asphalt from Roof Work on Brick & Flashing

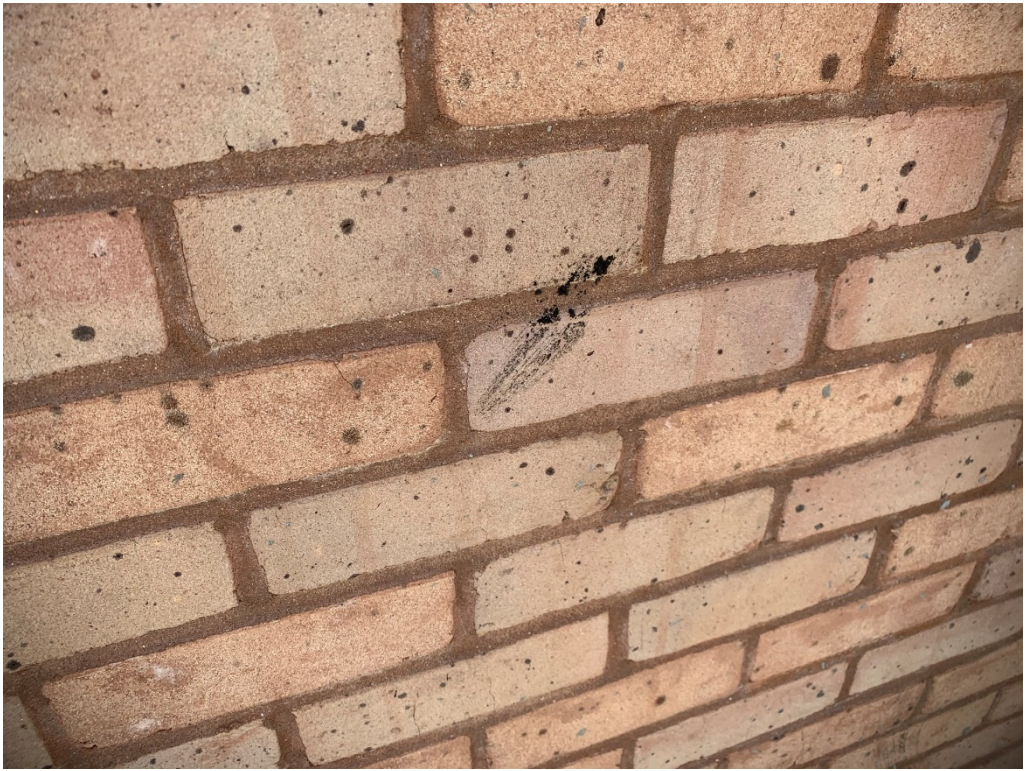
Figure 3 – Asphalt from Roof Work on Brick

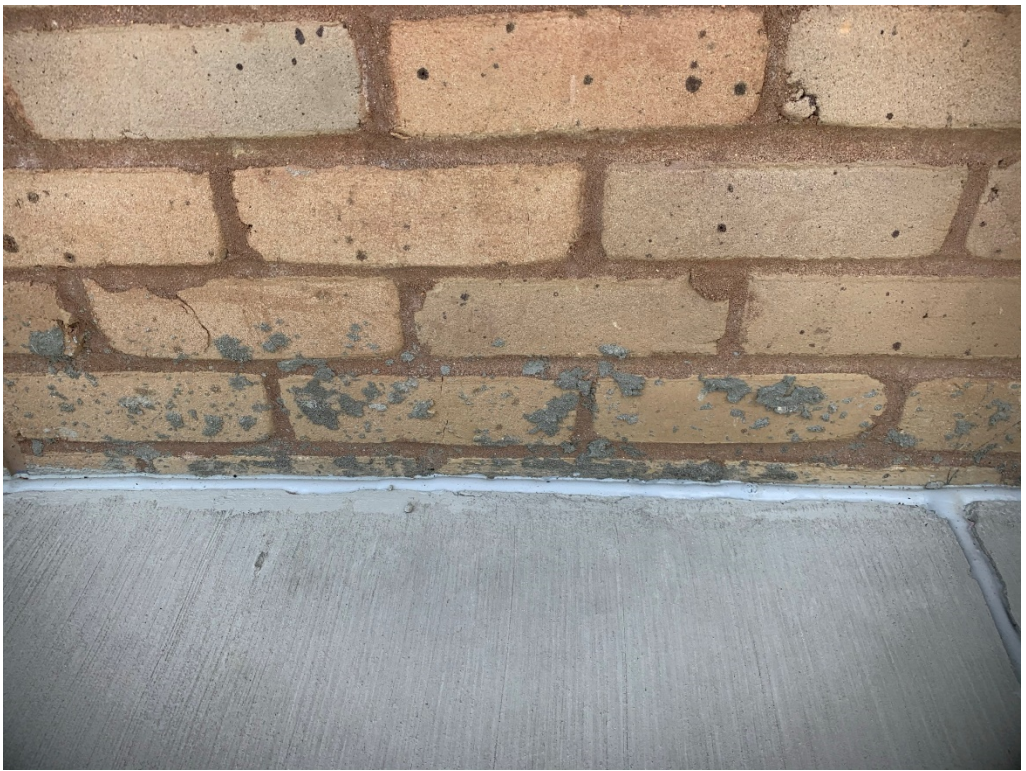
Figure 4 – Concrete Splatter to be Removed

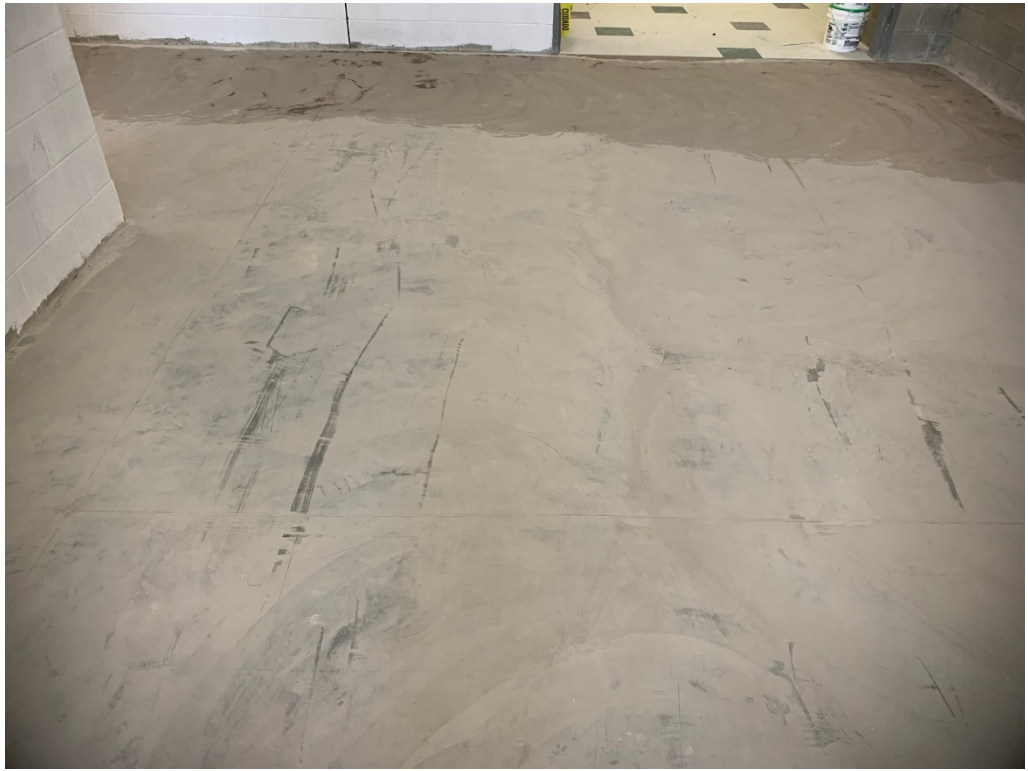
Figure 5 – Floor Prep at Addition

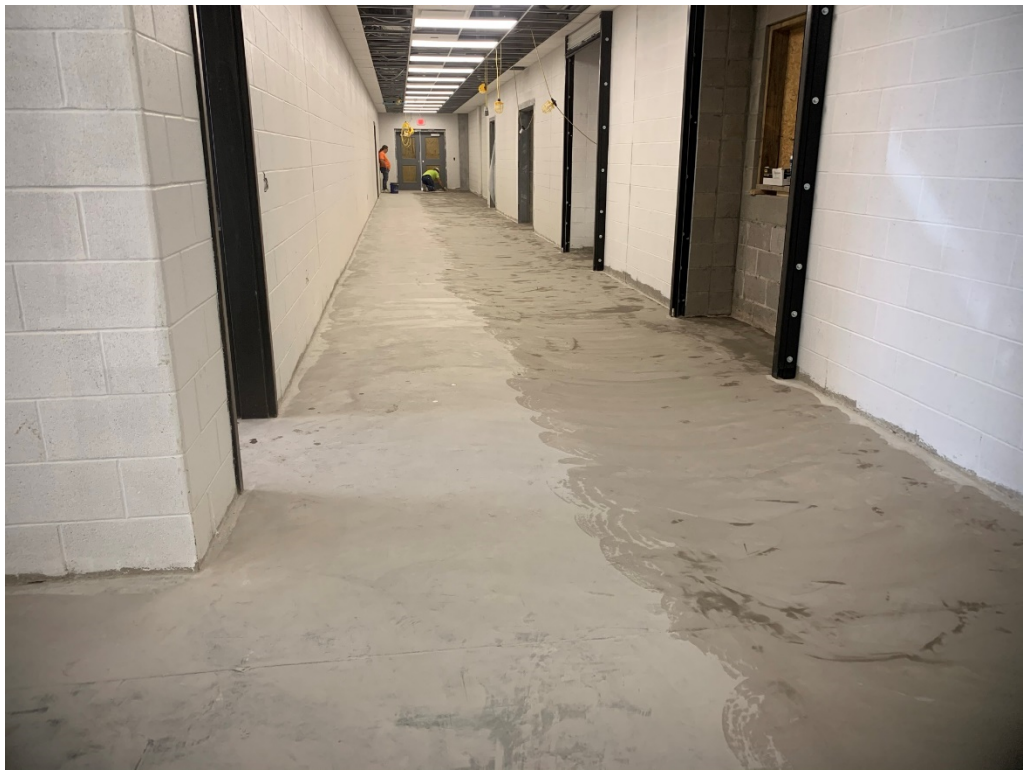
Figure 6 – Floor Prep at Addition

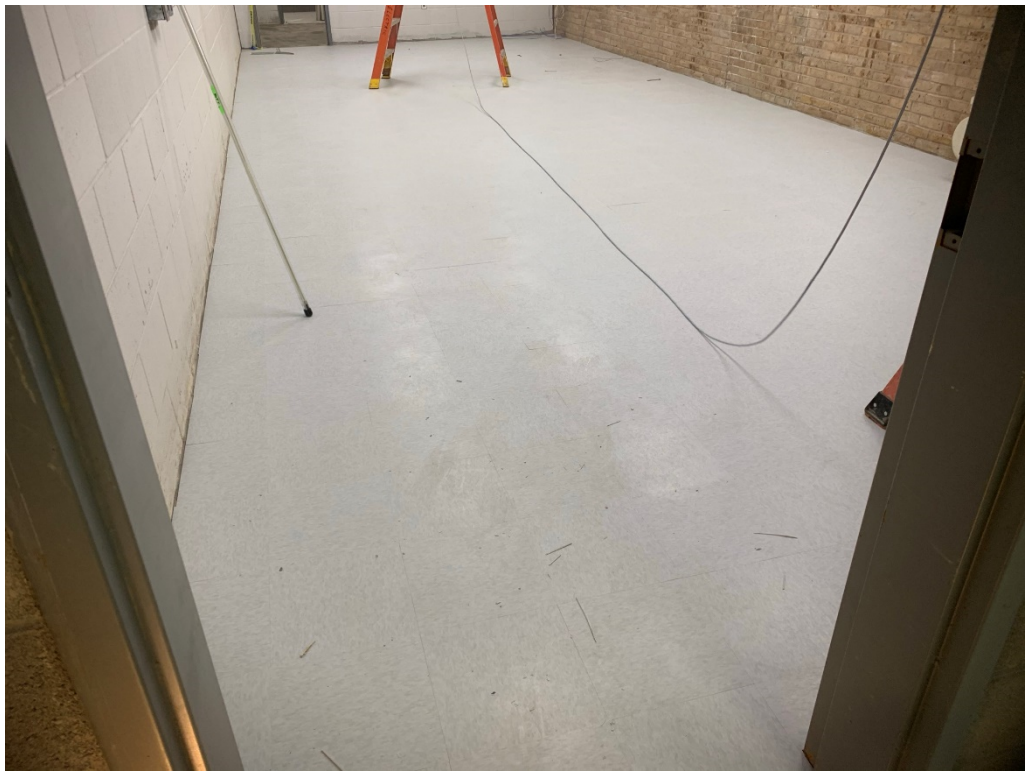
Figure 7 – VCT in Concessions Area

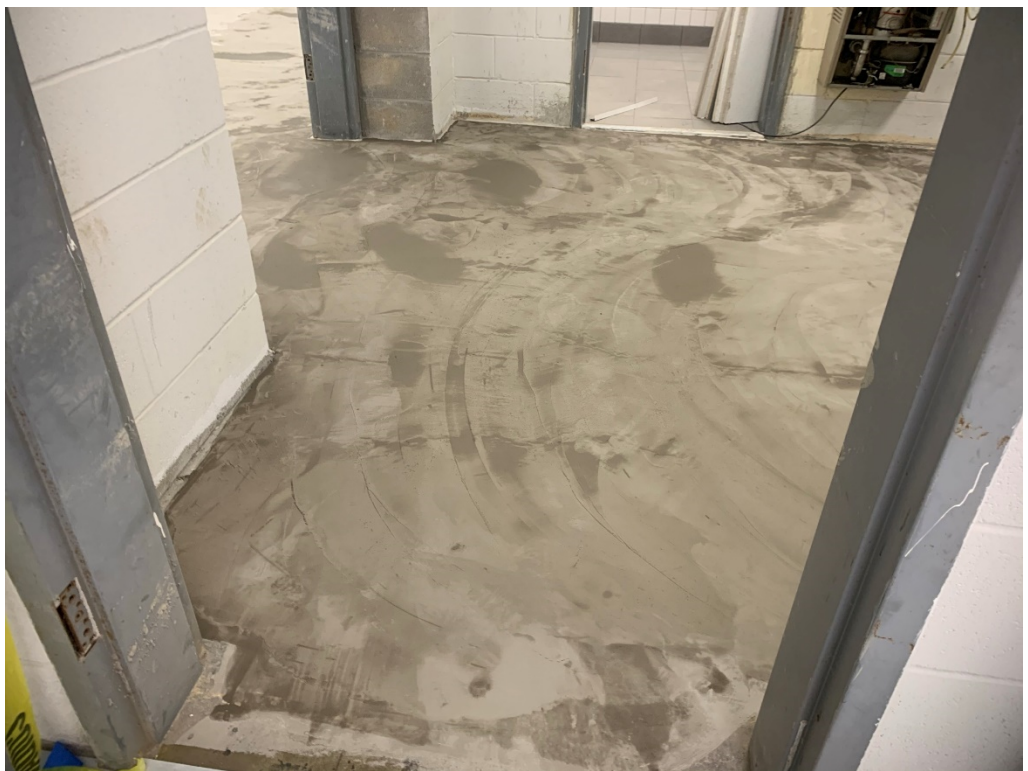
Figure 8 – Flooring Levelled Up and Ready for VCT

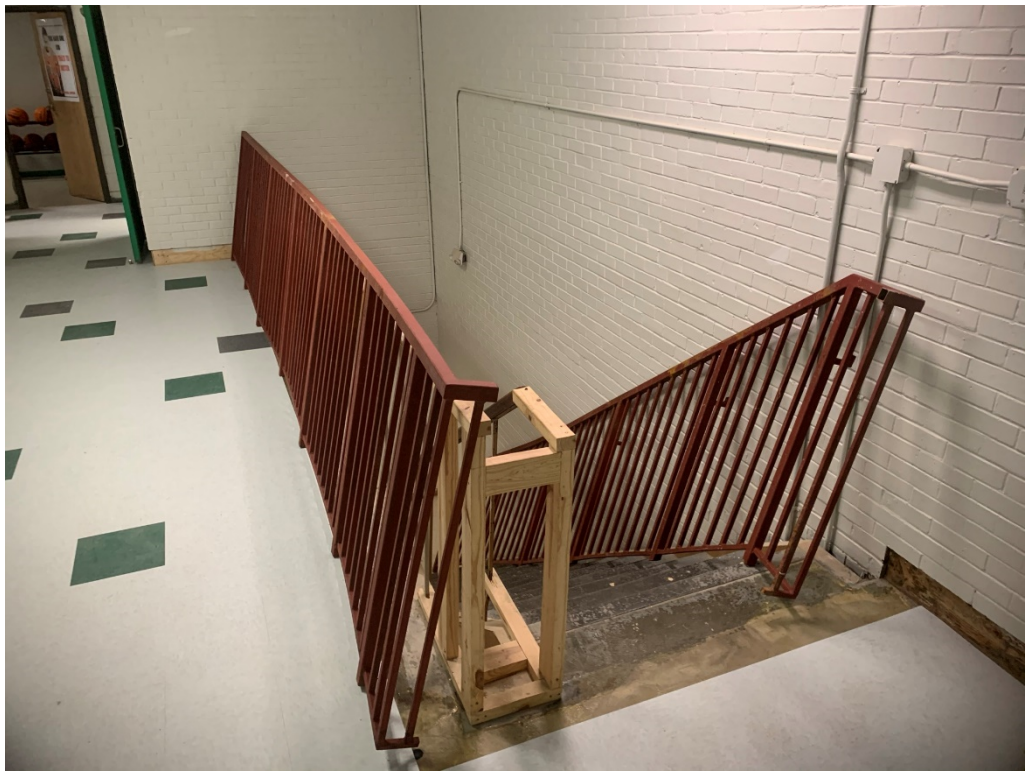
Figure 9 – Metal Railing being fitted

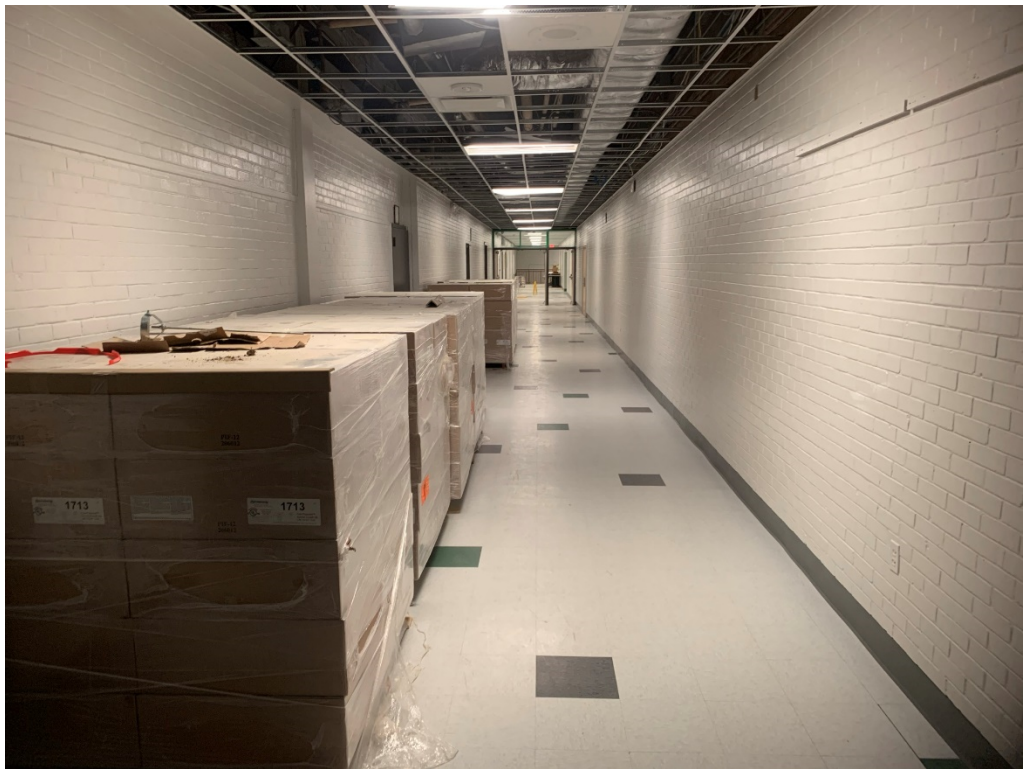
Figure 10 – Ceiling Tile awaiting Installation

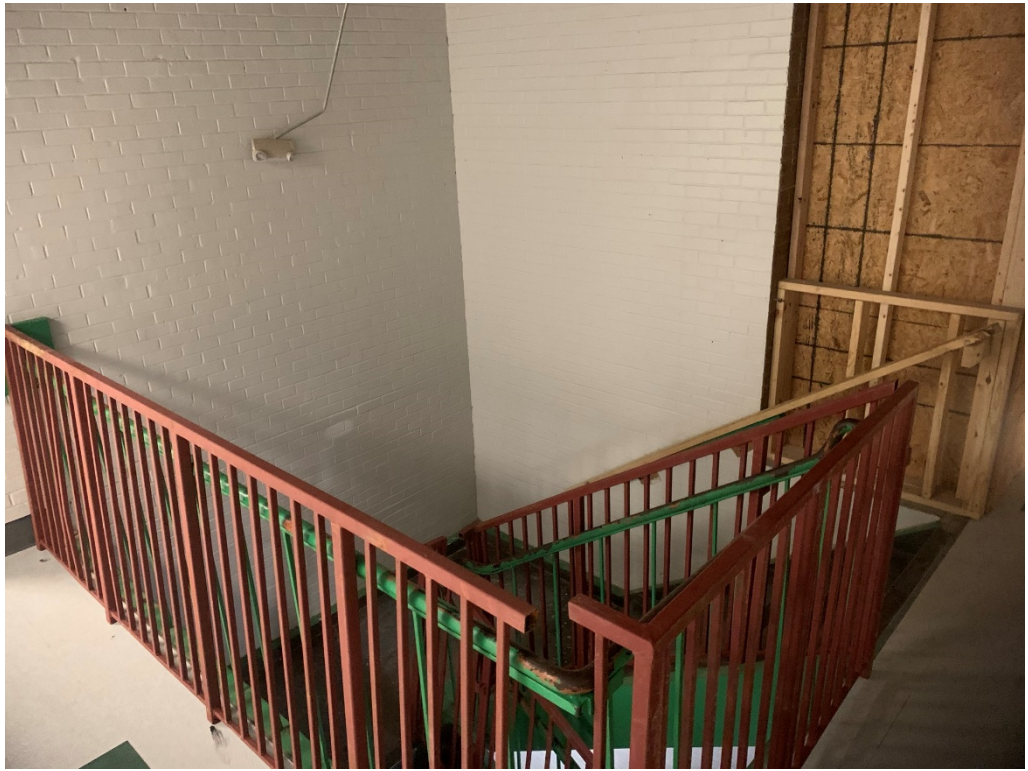
Figure 11 – Metal Railing being fitted

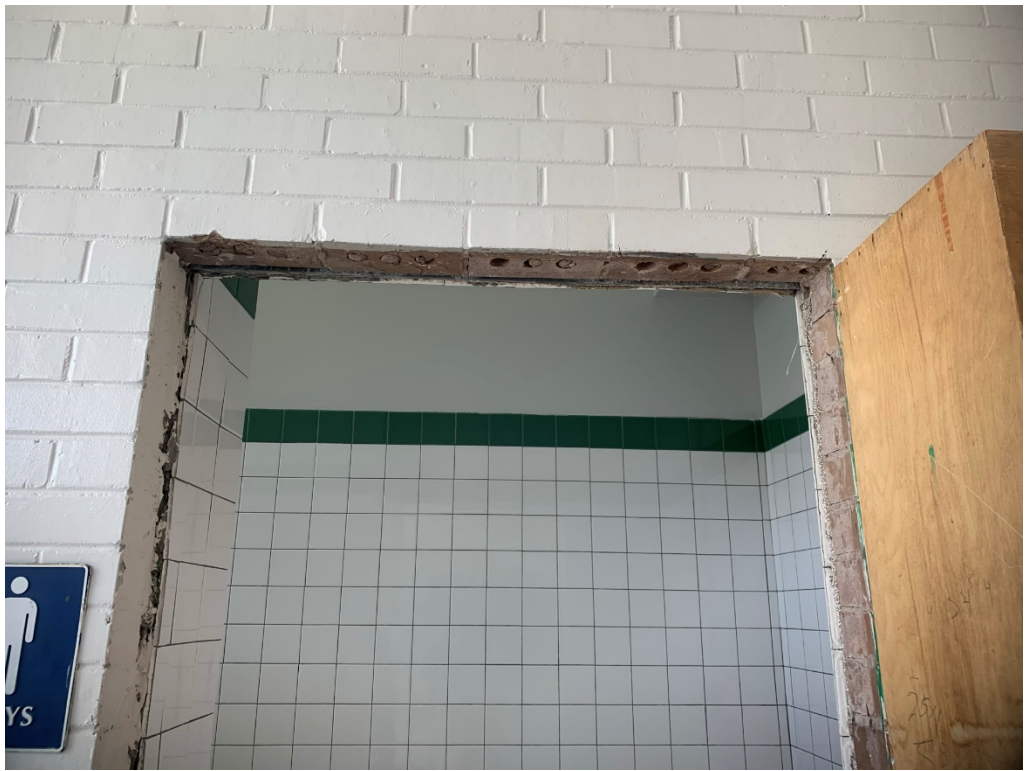
Figure 12 – Jambs Still to be Finished at Bathrooms

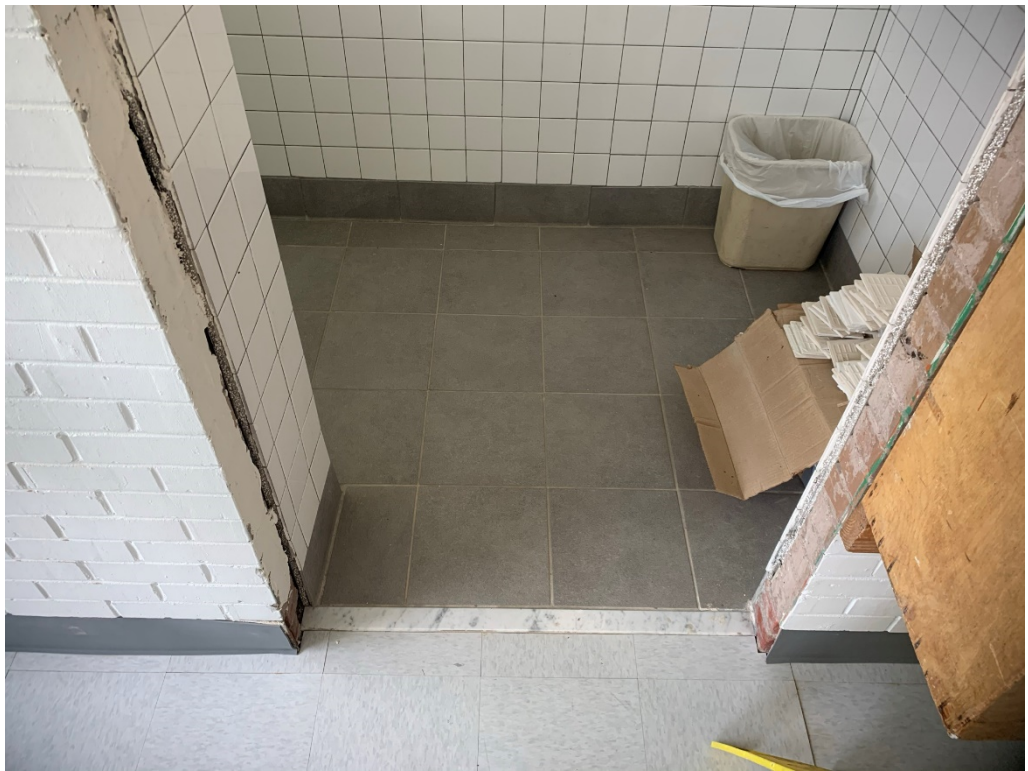
Figure 13 – Jambs Still to be Finished at Bathrooms

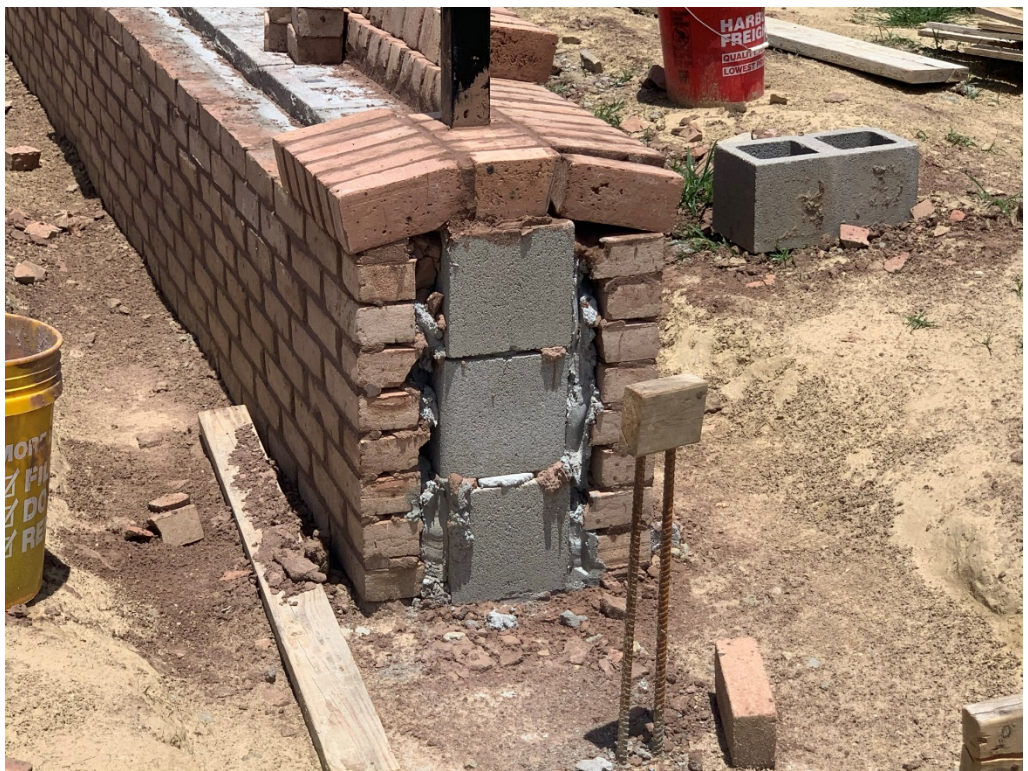
Figure 14 – Masonry Work at Low Fence

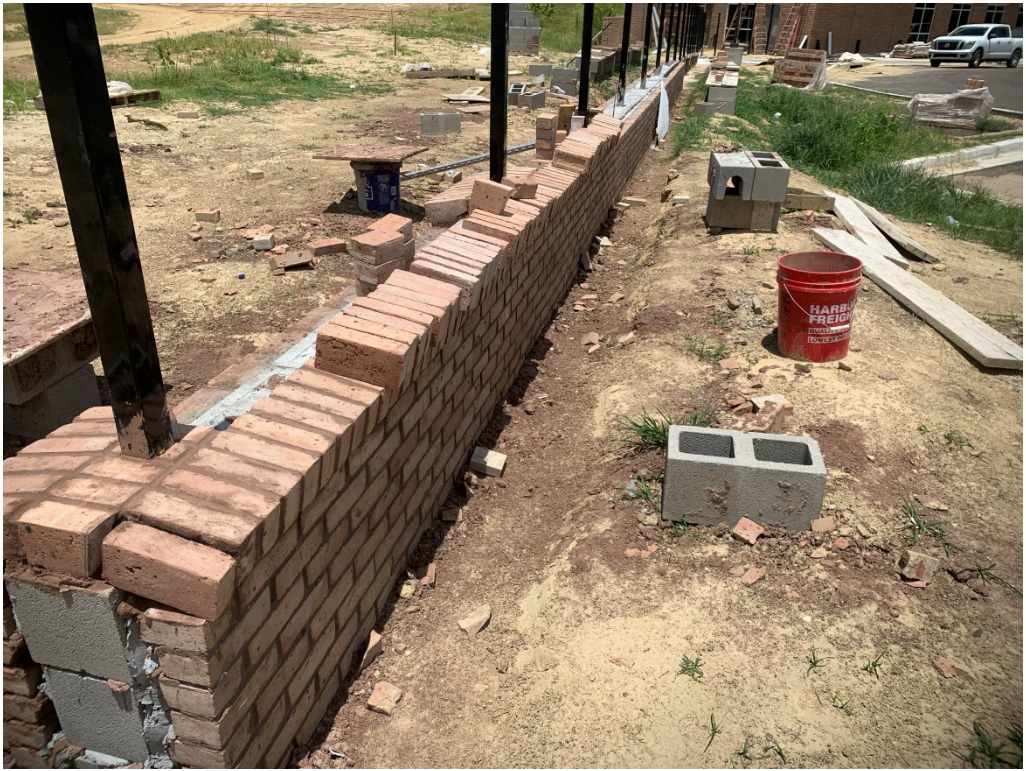
Figure 15 – Masonry Work at Low Fence

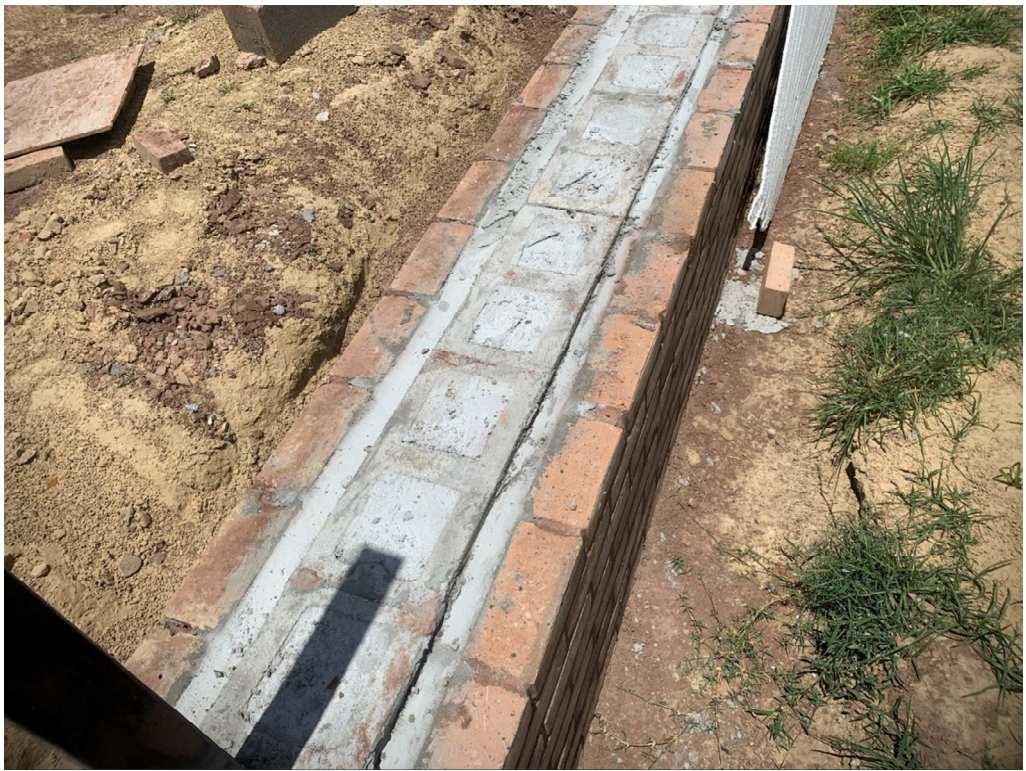
Figure 16 – Filled Block Wall
