Architect's Field Report

18053-Vicksburg Junior High School / Report Number 037

14 July 2021 / 11:30 AM

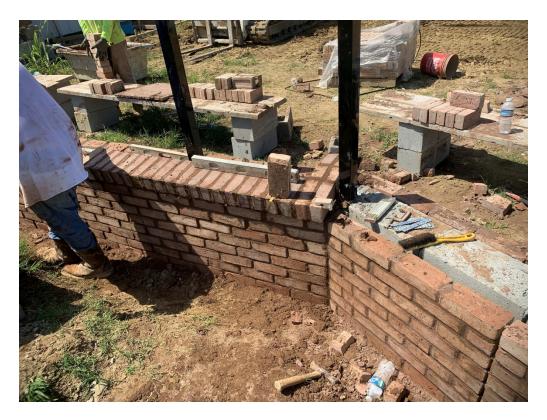
On site, masons were working on our new fence. Installation is ongoing

but workers are slowly making progress.

Figure 1 – Masonry is Ongoing

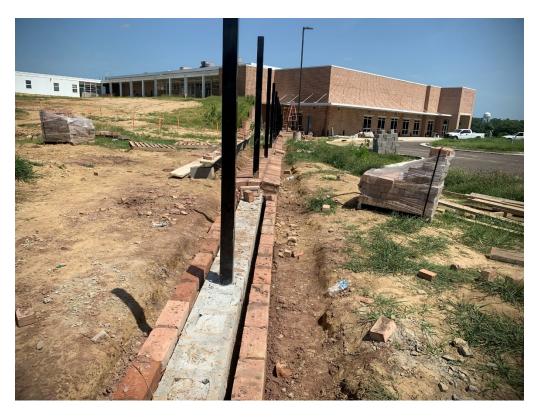
Figure 2 – Masonry is Ongoing

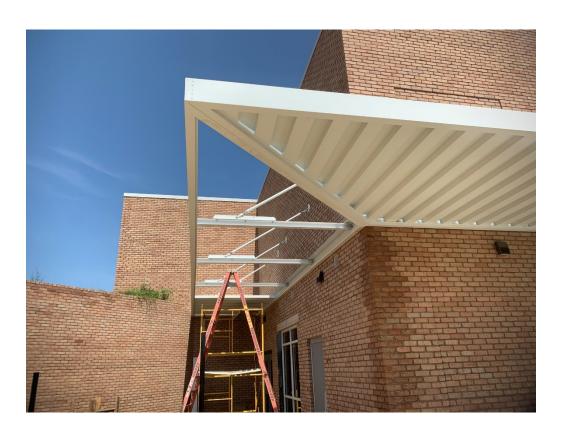
Figure 3 – Awning Installation is Ongoing

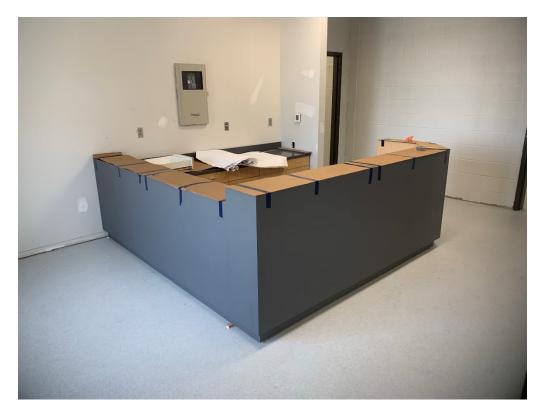
Inside, millwork has been installed. Installation is in progress and some

Figure 4 – New Millwork Installed

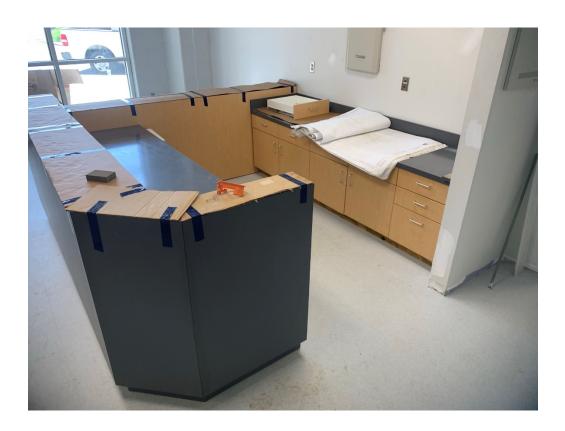
Figure 5 – New Millwork Installed

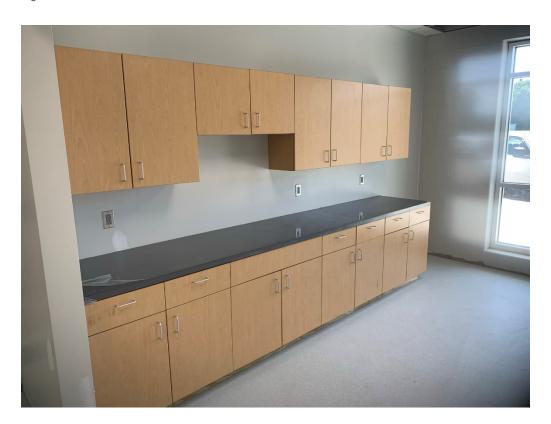
Figure 6 – New Millwork Installed

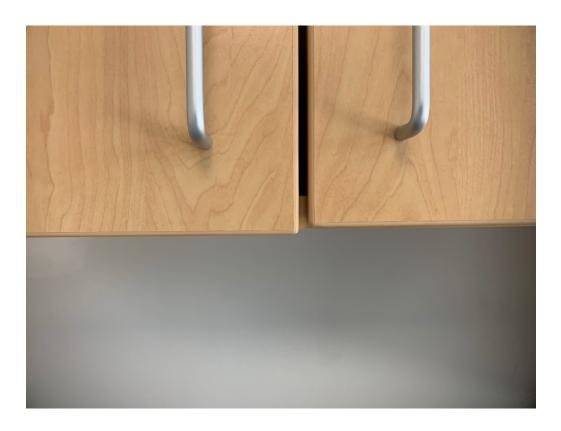
adjustments are still needed.

Figure 7 – Upper Millwork Doors Require Adjustment

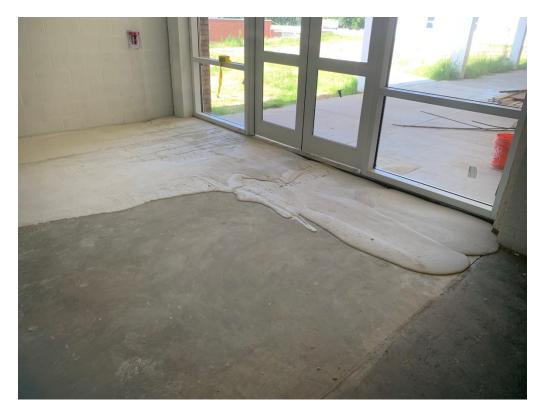
Prep at the storefront entry at the upper floor is ongoing. Some leveling has been performed, but it appears that this is a process that may take several pours. Ceiling work has been completed in the library area

Figure 8 – Leveling at Up Floor in Ongoing for new Storefront Entrance

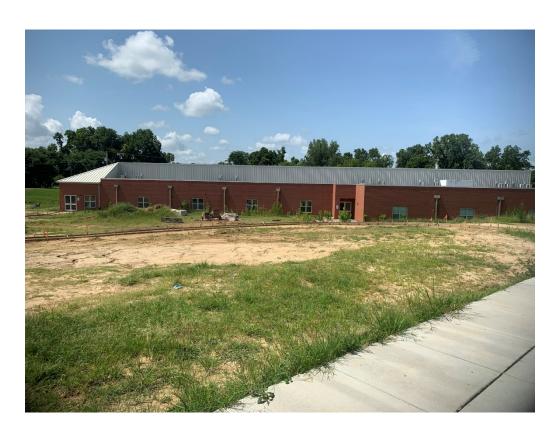
Site work is ongoing. Workers were installing forms for our new

sidewalk.

Figure 9 – Site Work is Ongoing

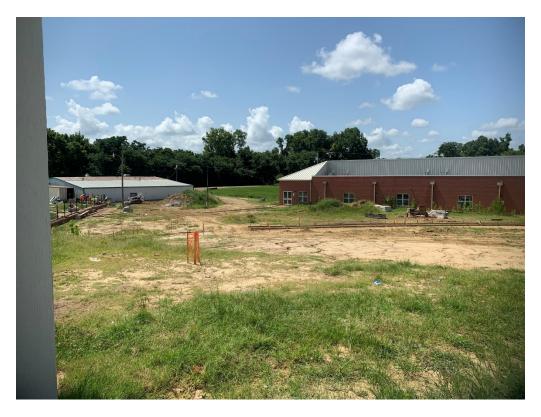
Figure 10 – Site Work is Ongoing

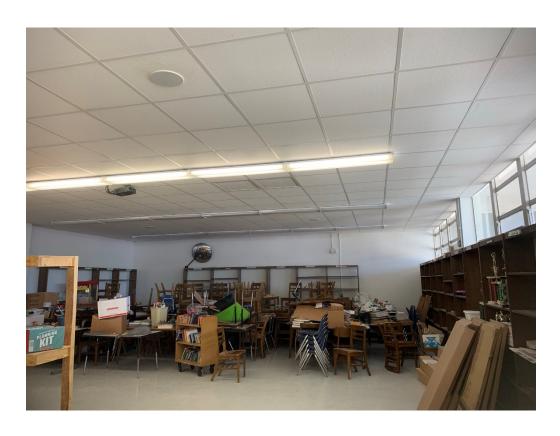
outside of this entrance at the 3rd floor.

Figure 11 – New Ceiling in Library

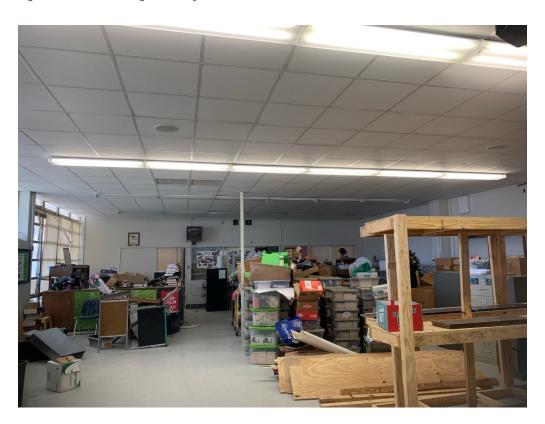
Figure 12 – New Ceiling in Library
