Architect's Field Report

22 October 2021

18053-Vicksburg Junior High School / Report Number 039

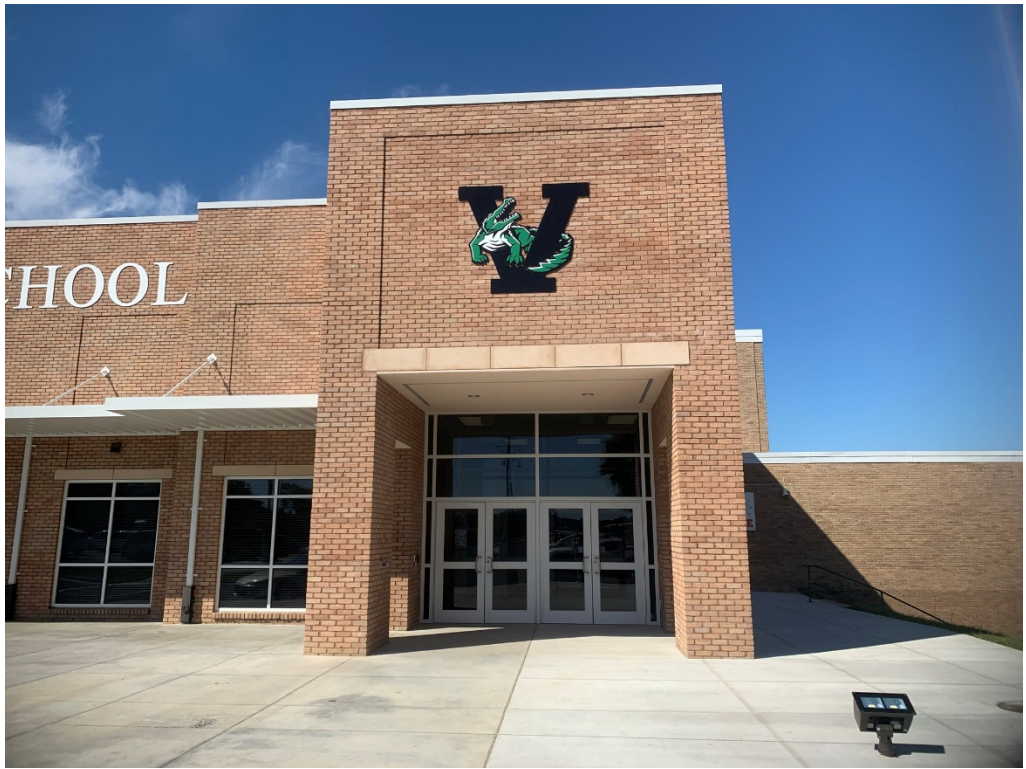
Figure 1 – Entrance Progress

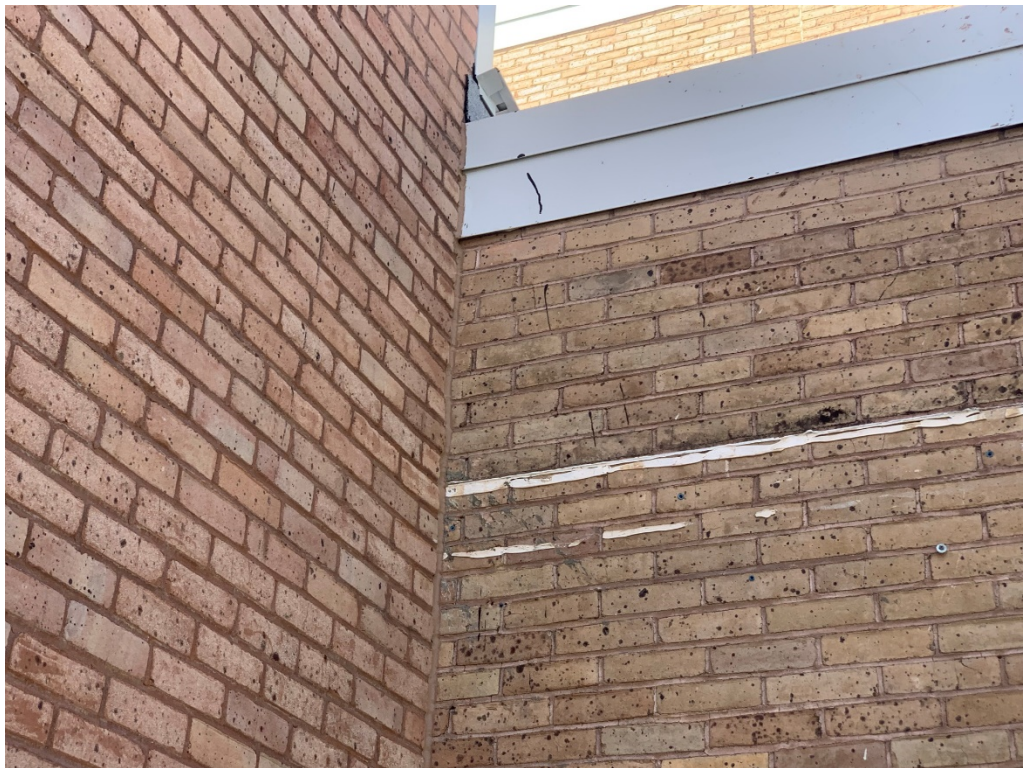
Figure 2 – Roof tar still present from new construction

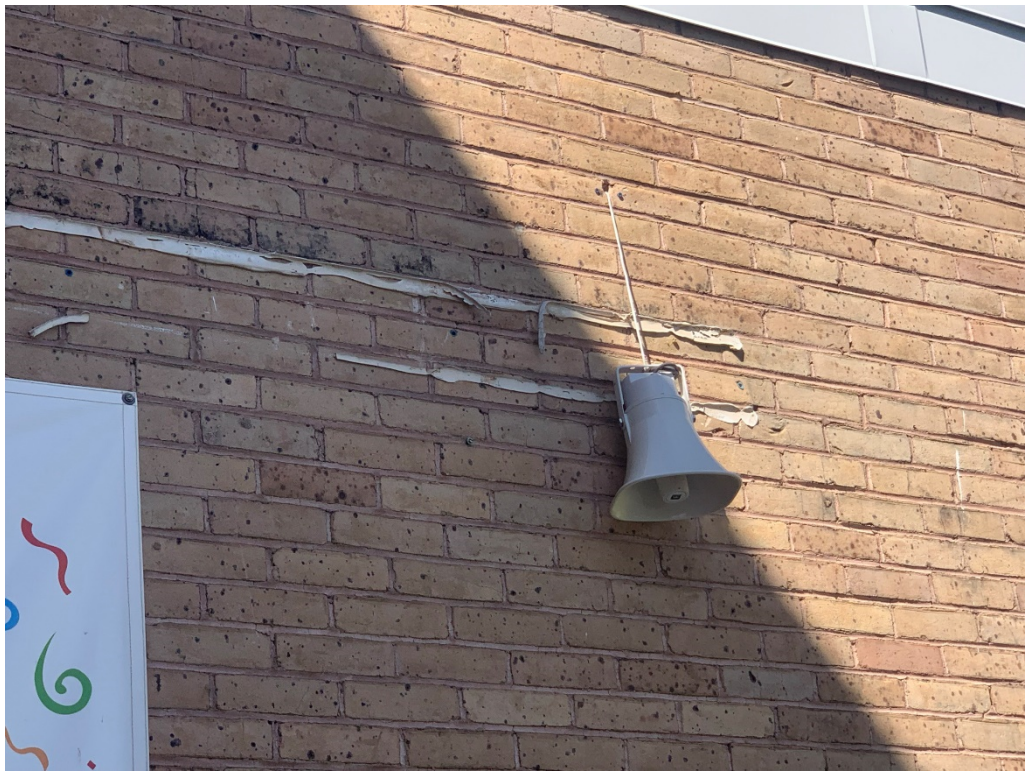
Figure 3 – Caulk still present at demoed awning; anchor mega phone

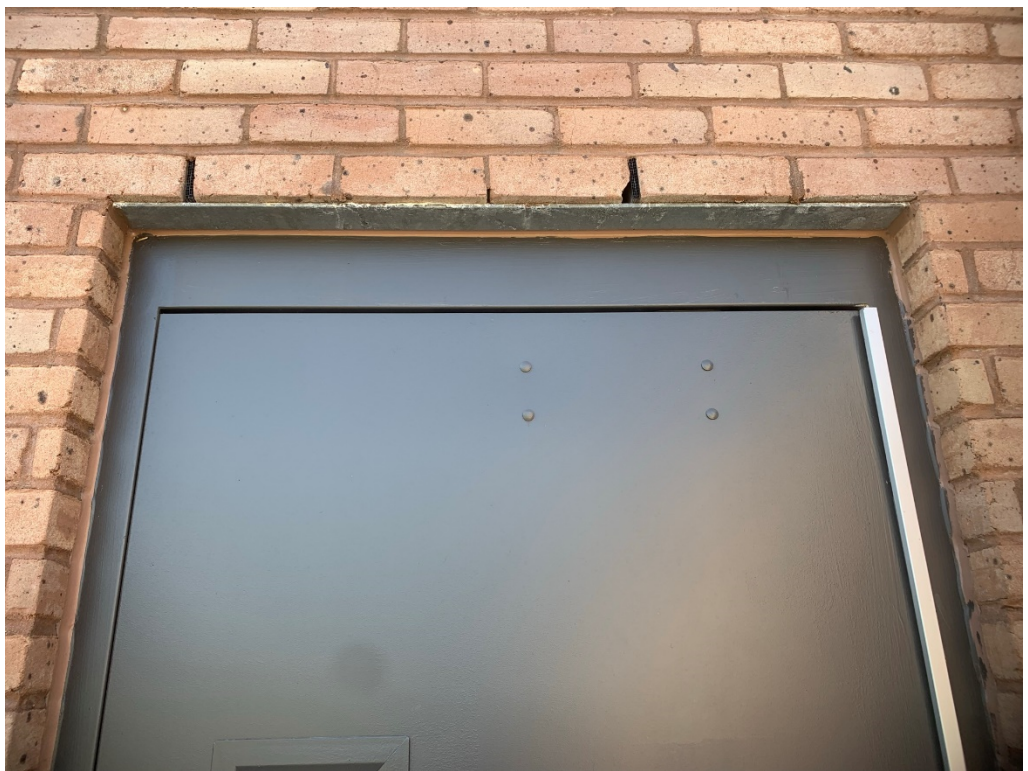
Figure 4 – Upper jamb still showing steaking

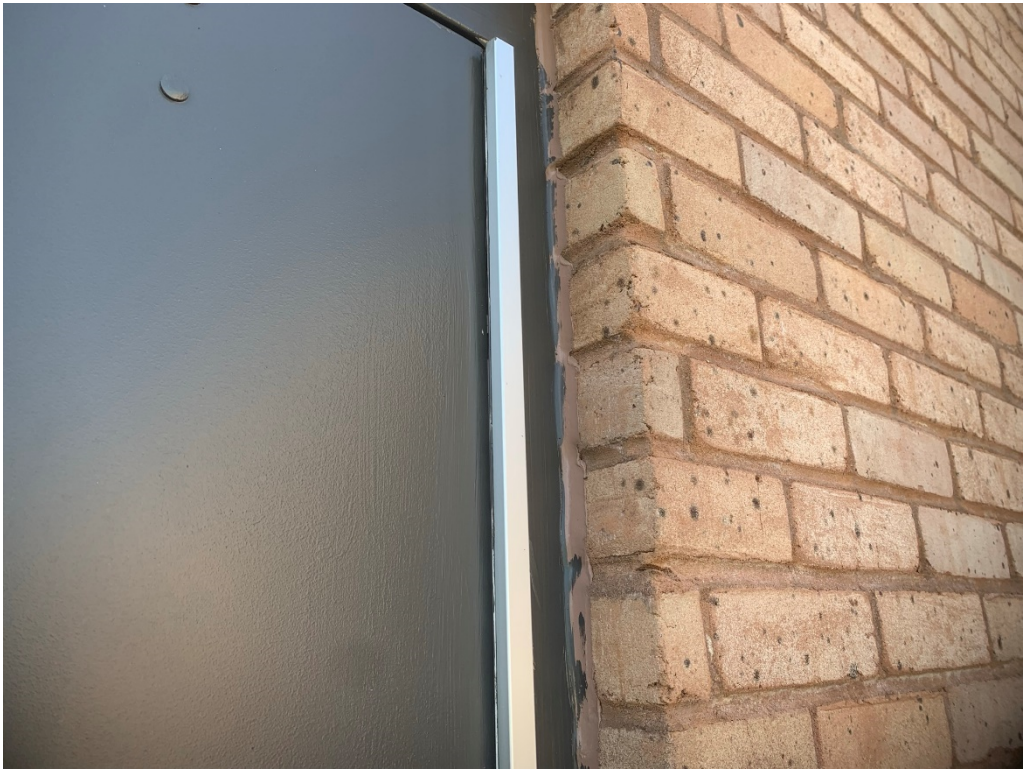
Figure 5 – Cut This line straight

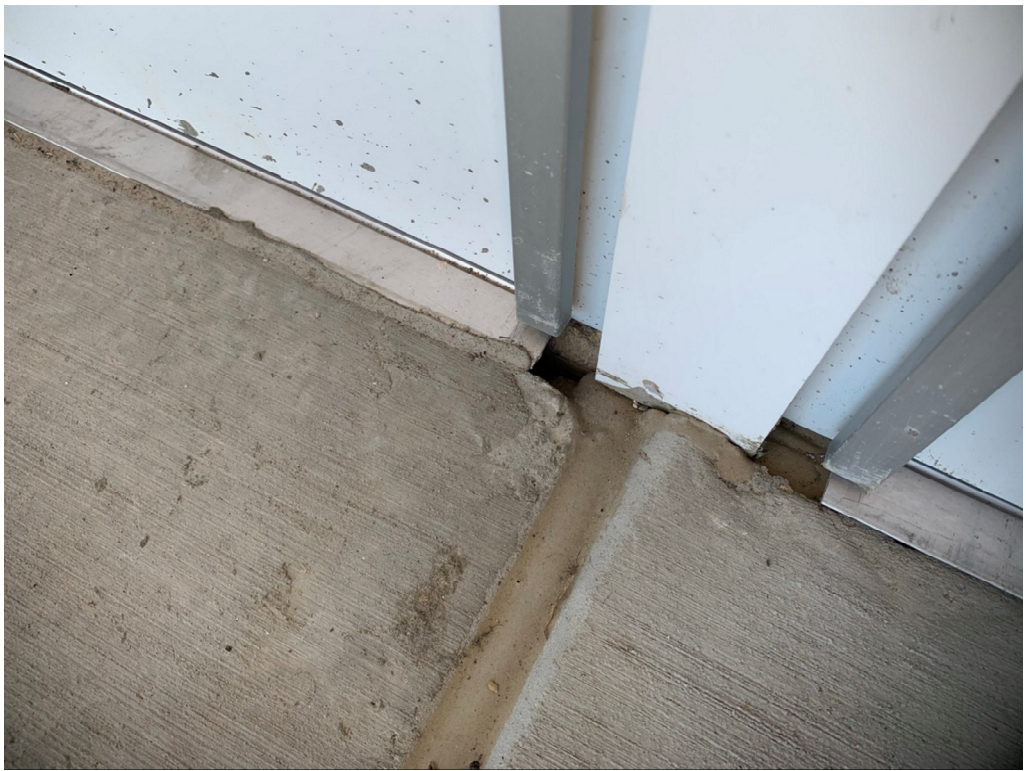
Figure 6 – Fill in gaps between concrete porch and slab at storefront install at entrance

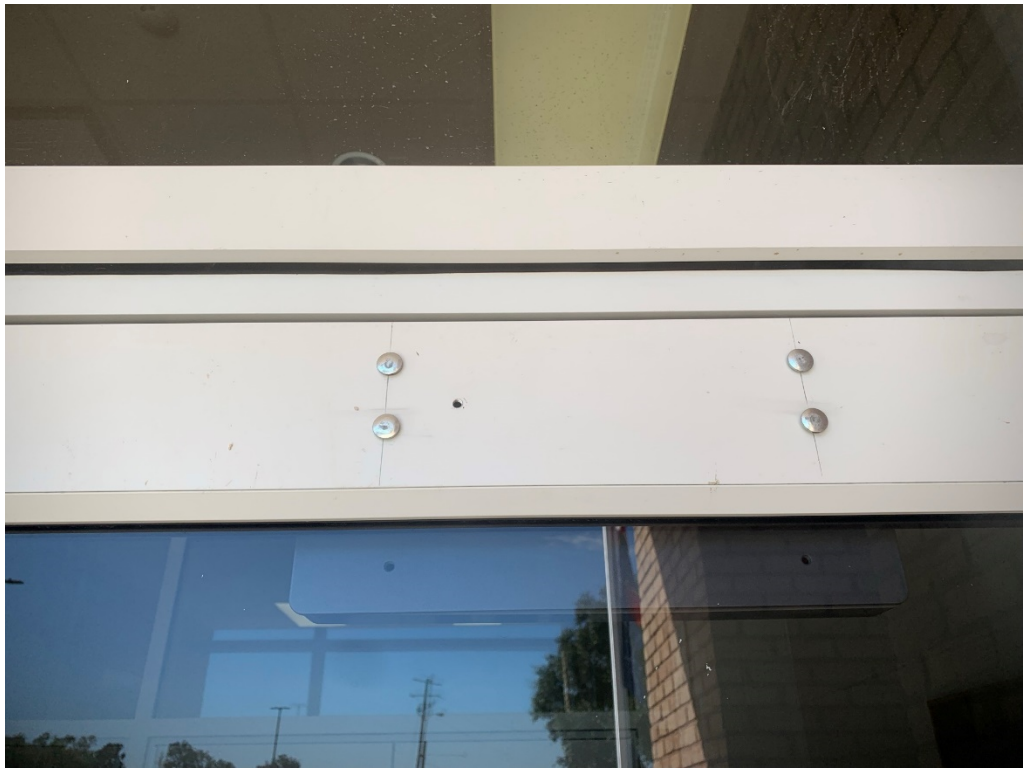
Figure 7 – Construction marks still present at New Doors; fill mis-drilled hole

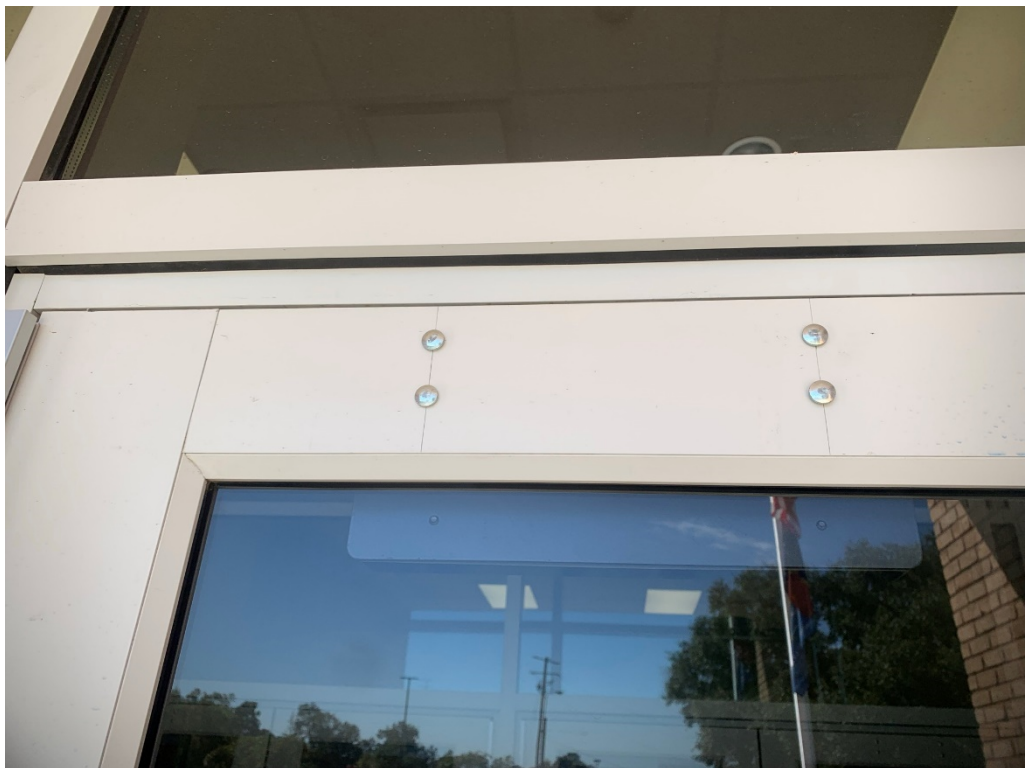
Figure 8 – Construction marks still present at New Doors

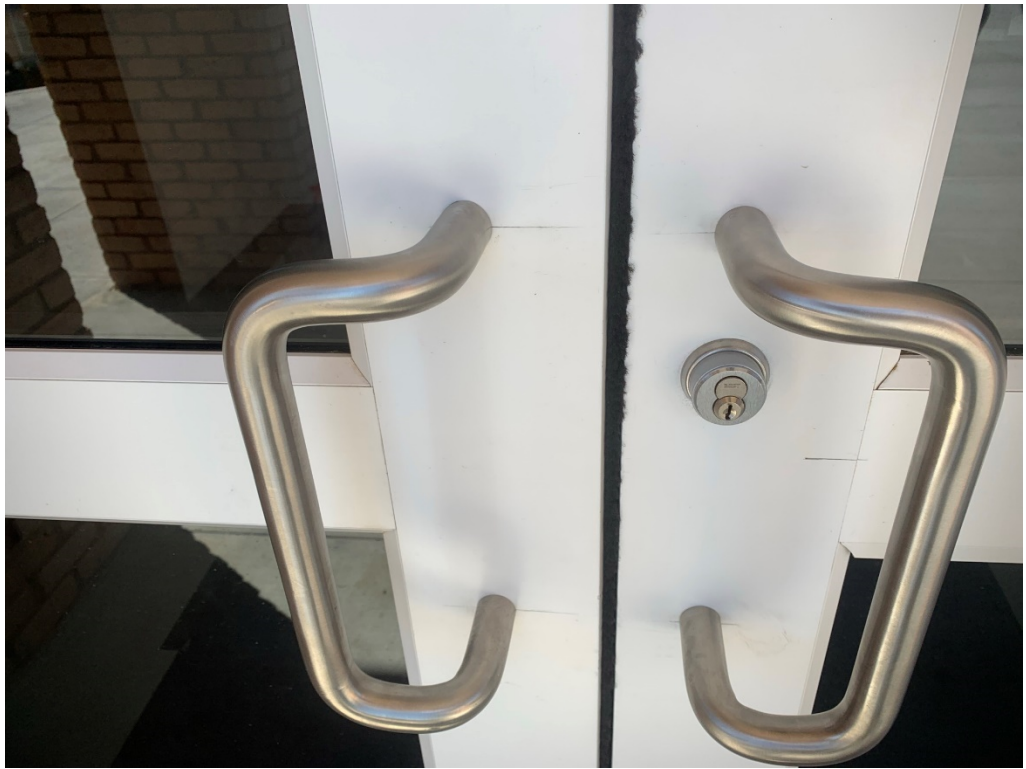
Figure 9 – Construction marks still present at New Doors

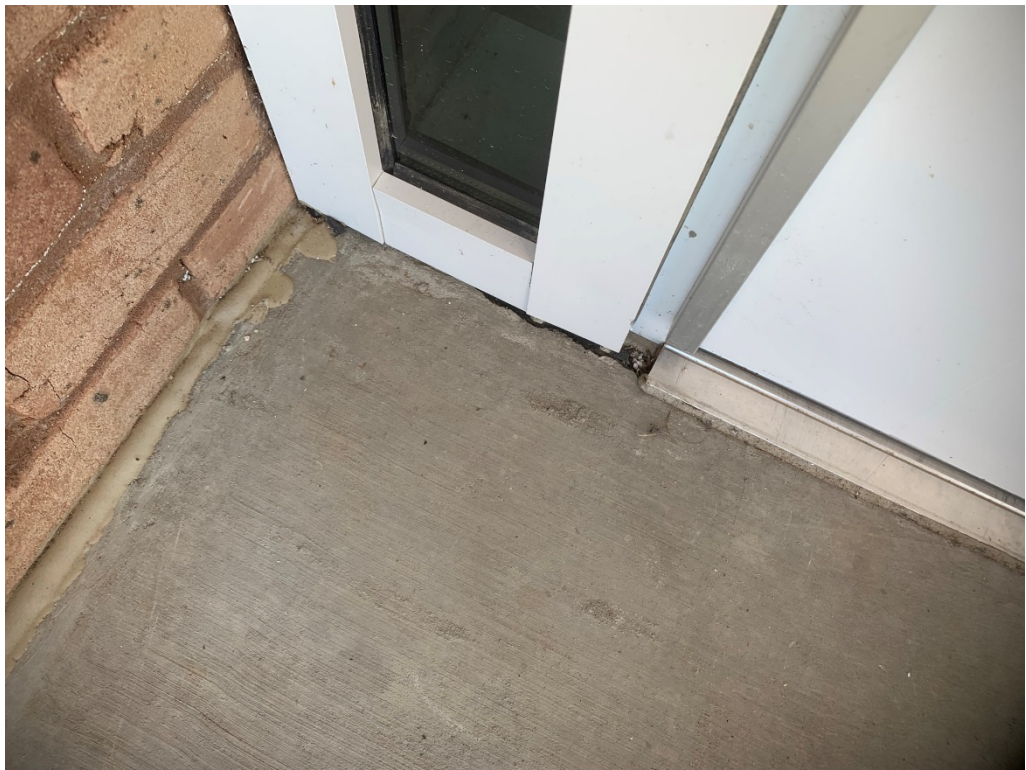
Figure 10 – Fill in gaps between concrete porch and slab at storefront install at entrance

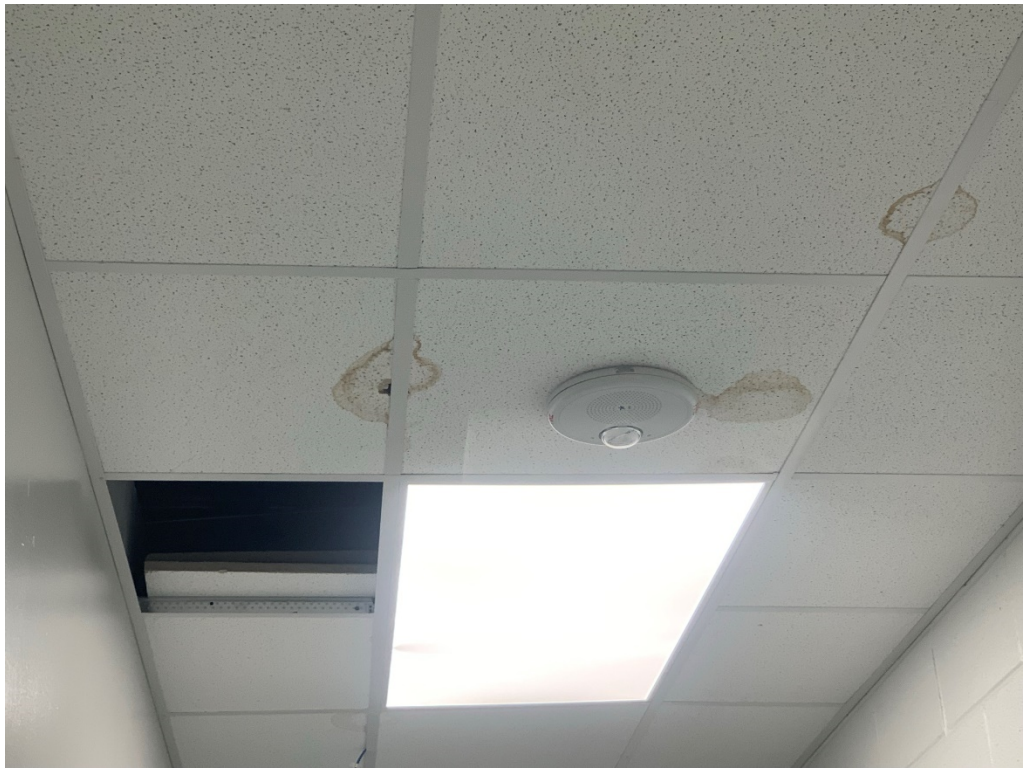
Figure 11 – Leaks still present at A-212

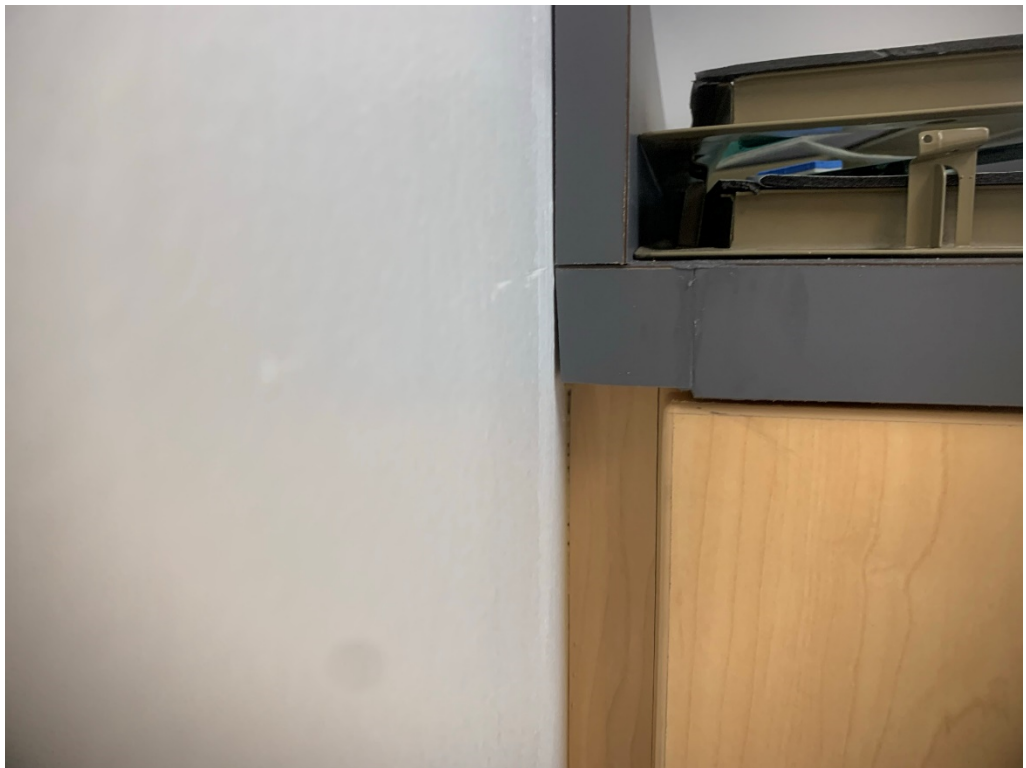
Figure 12 – Laminate counter at A-205 still has non flush laminate piece

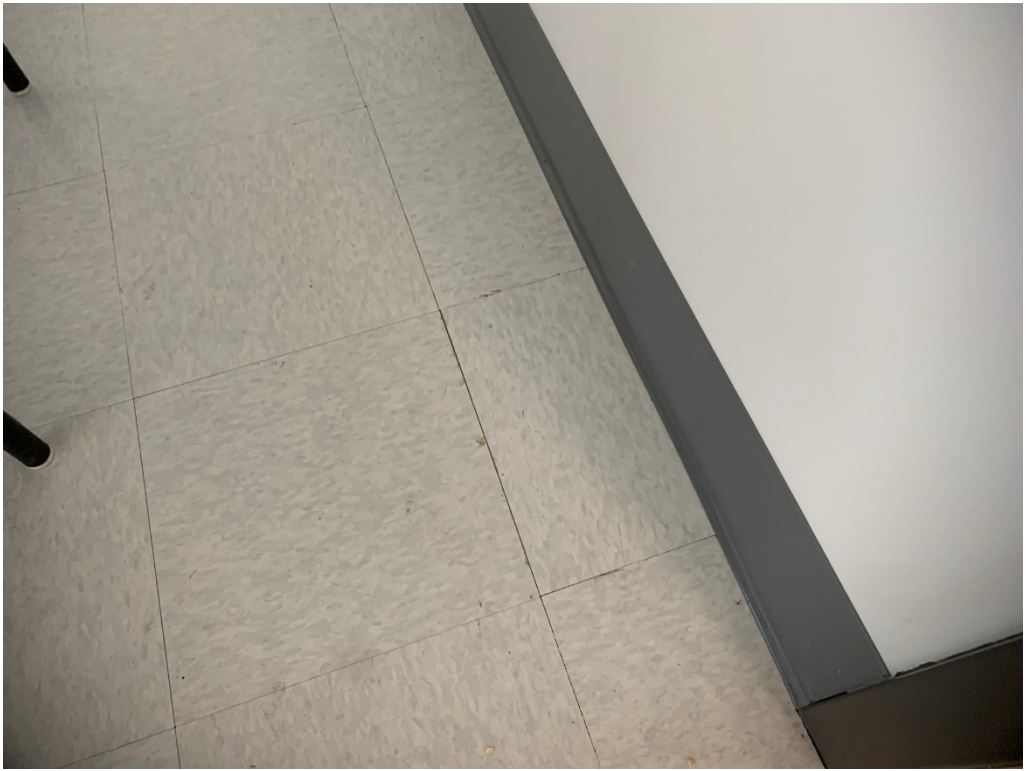
Figure 13 – Conference A-206 Tile Sliding

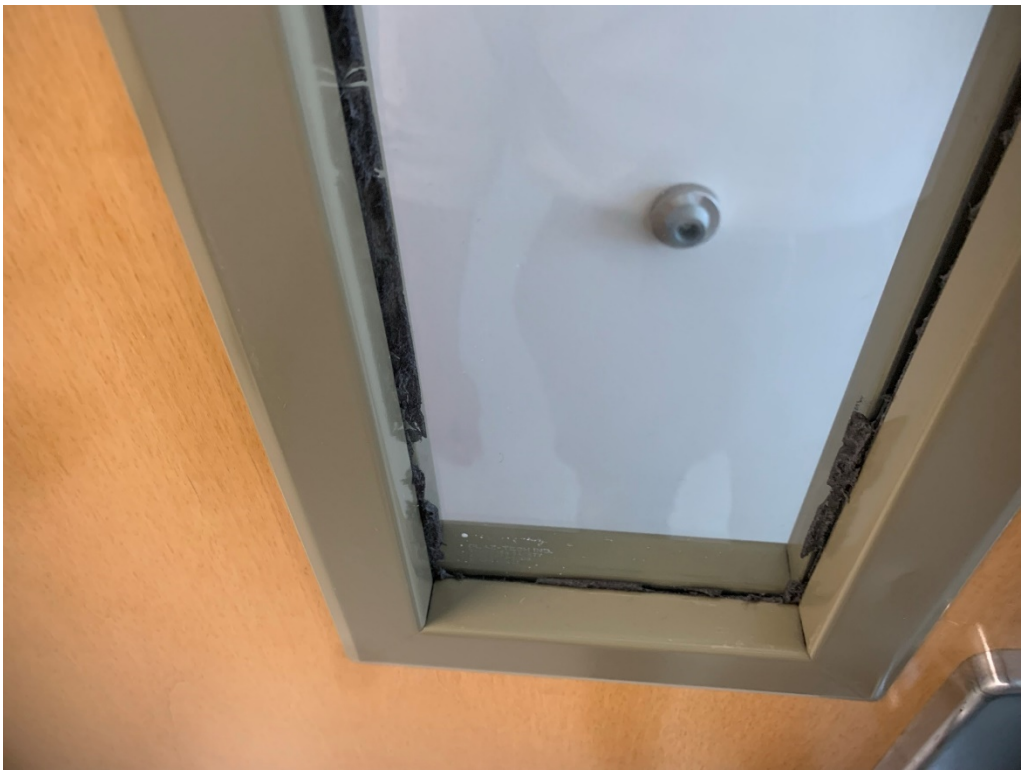
Figure 14 – Clean up edges where foam is tattered at glass installation

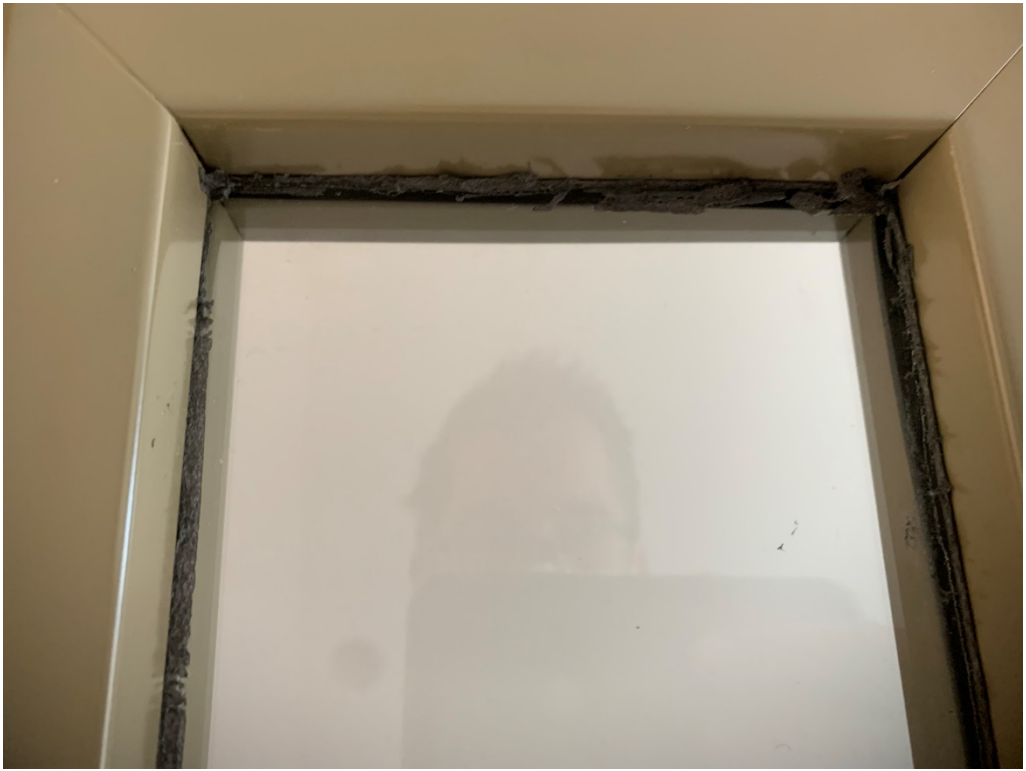
Figure 15 – Clean up edges where foam is tattered at glass installation

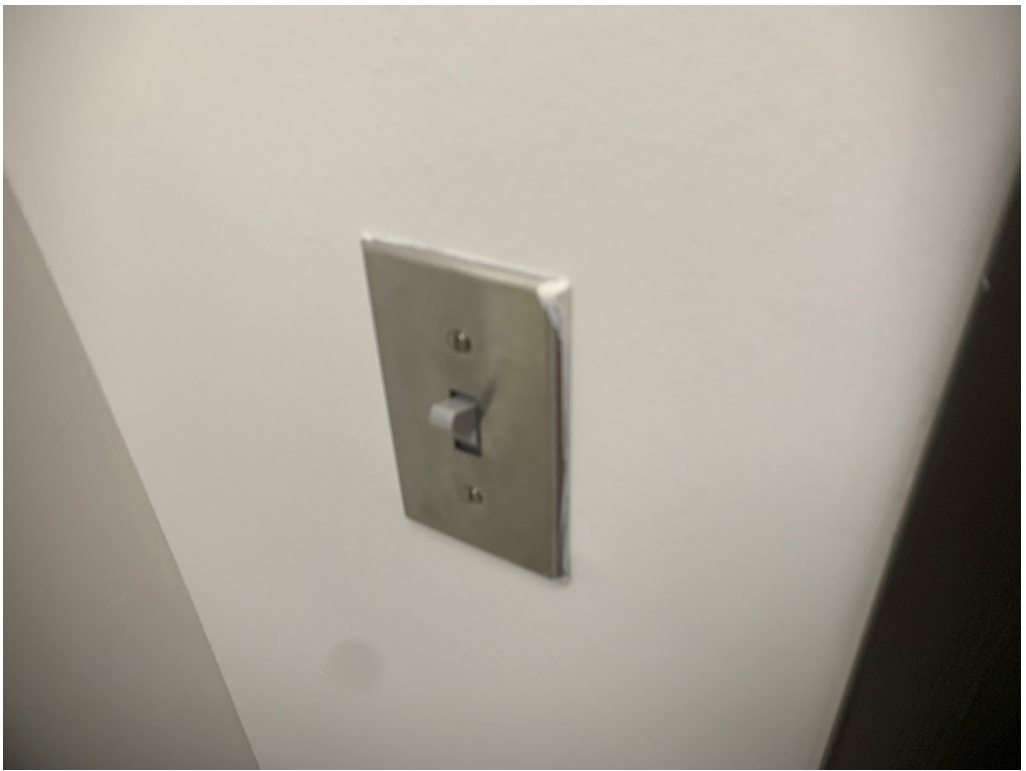
Figure 16 – Clean Plate at A-212

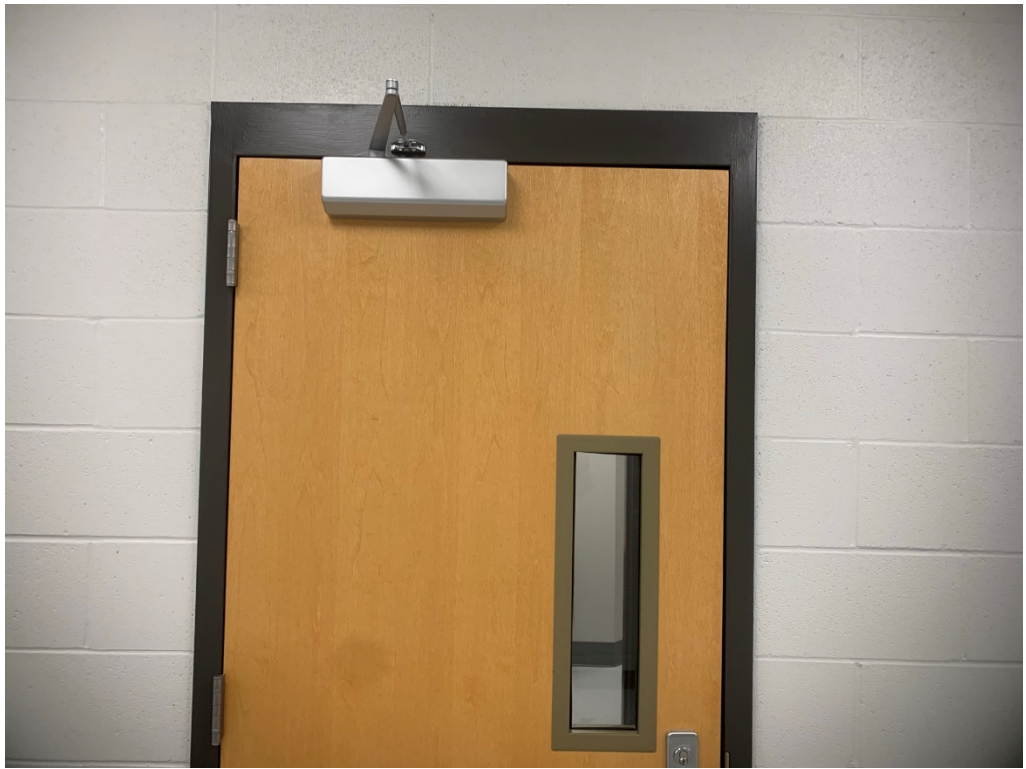
Figure 17 – Door 215 needs to be adjusted (crooked in frame)

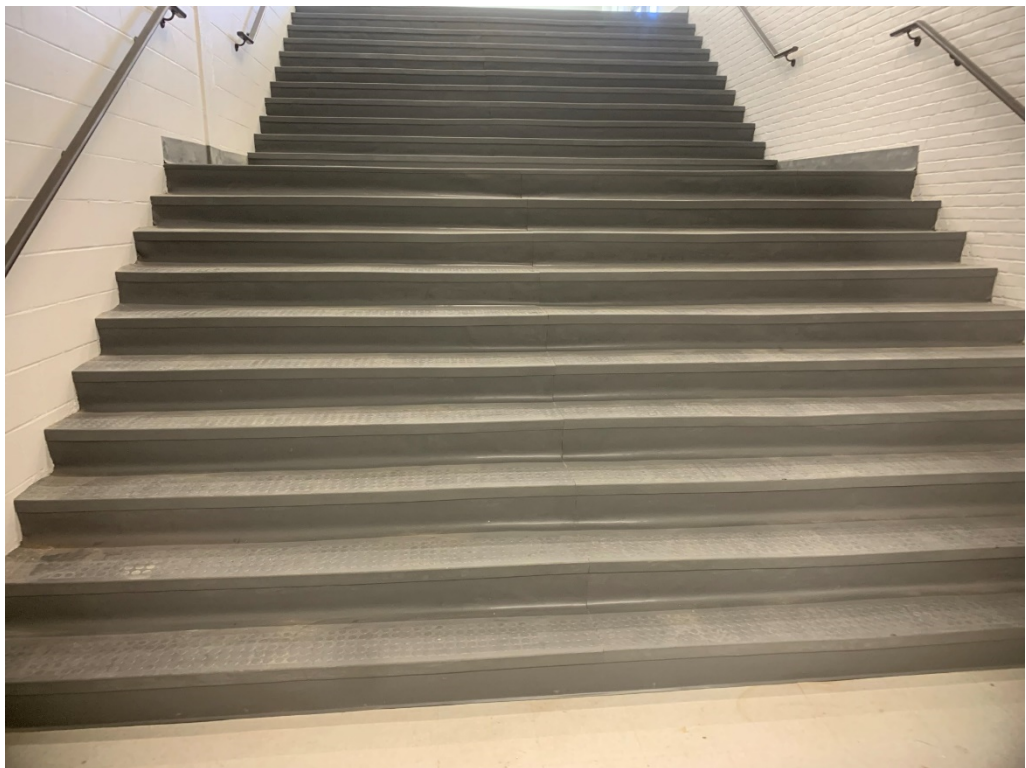
Figure 18 – Floors need cleaning

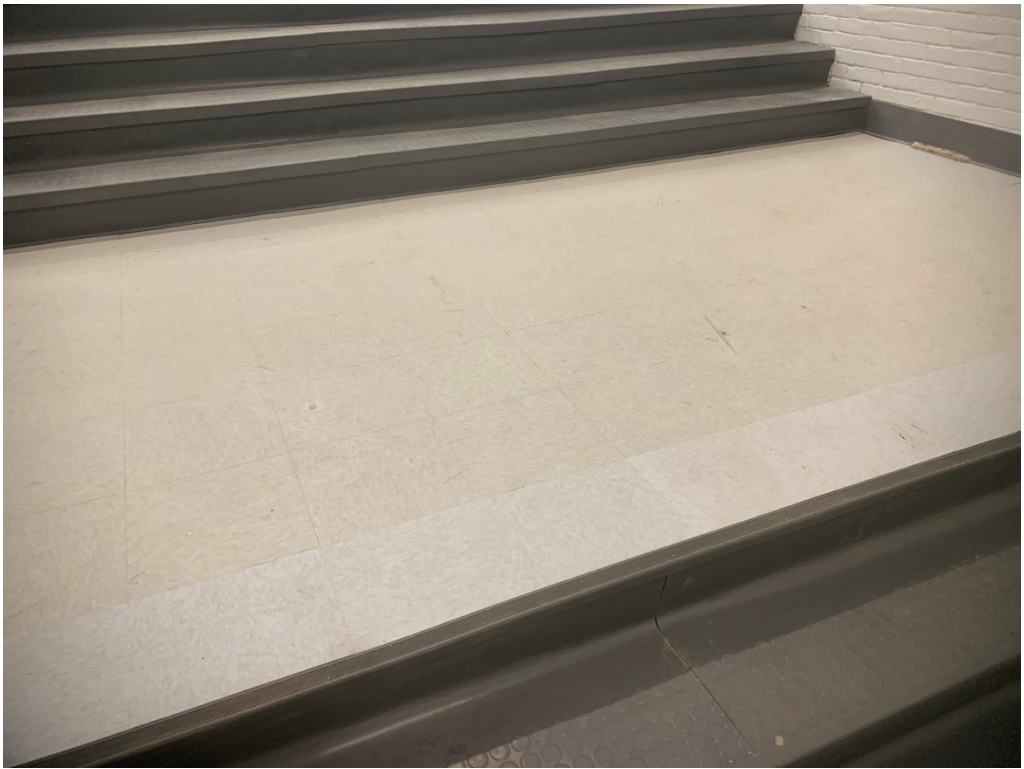
Figure 19 – Floors need cleaning

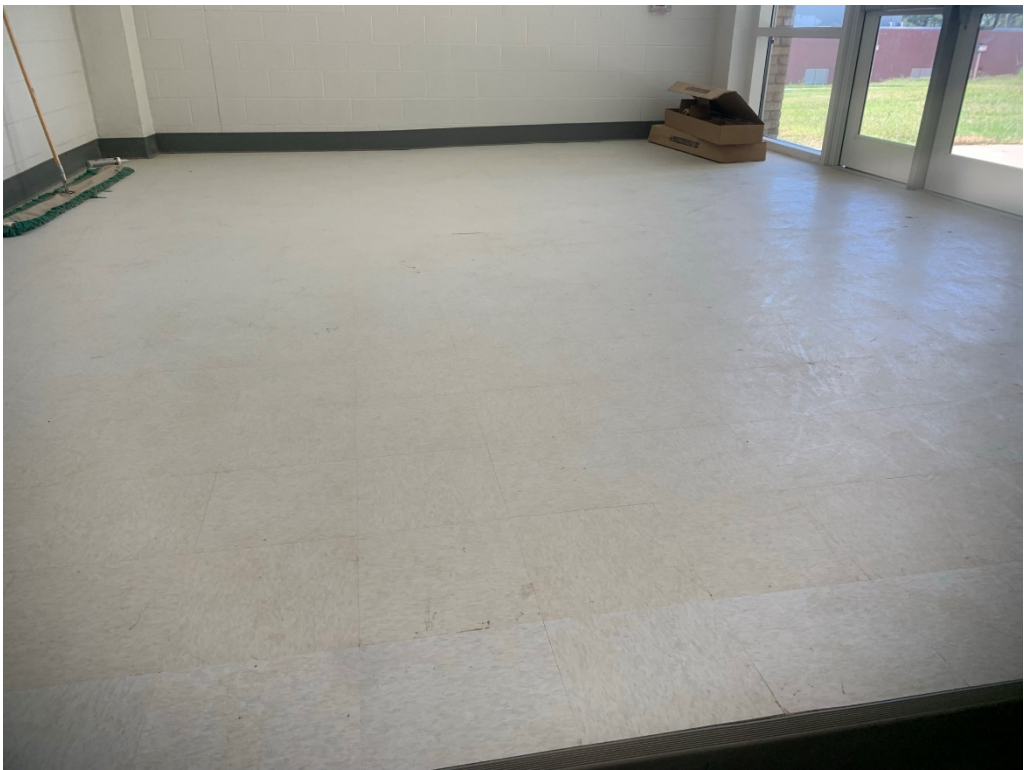
Figure 20 – Floors need cleaning

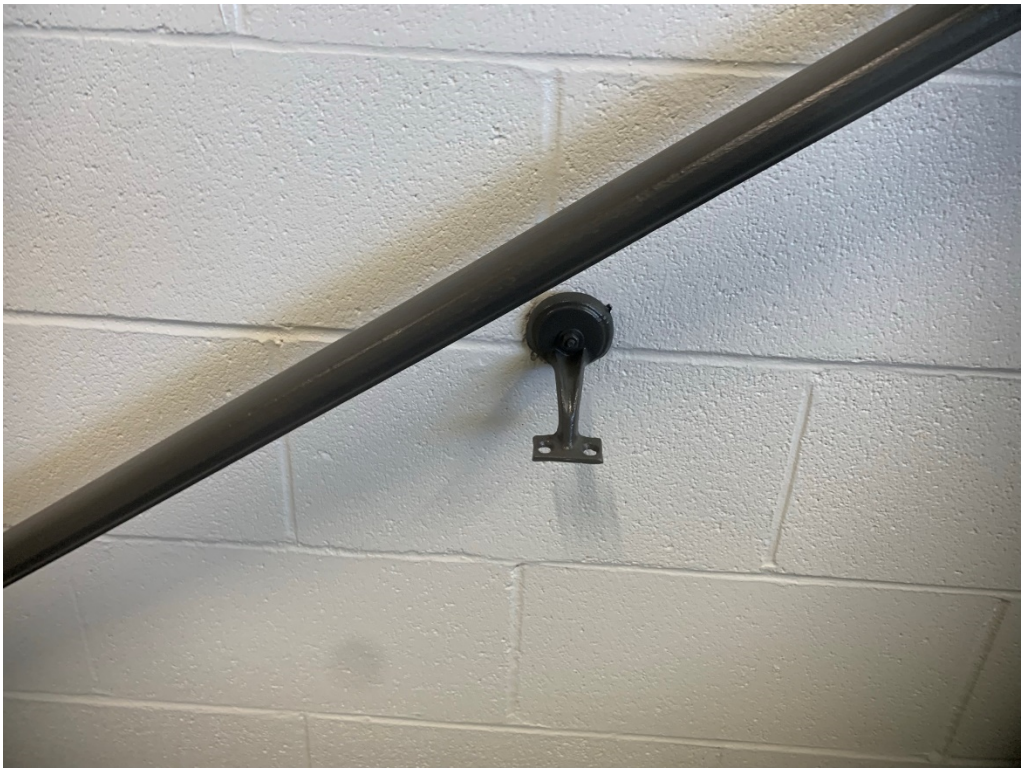
Handrails throughout have major issues. They do not conform to the construction documents in several areas and need to be replaced. Note written general notes on page A-701 as well as drawings for your reference.

Figure 21 – Handrails missing supports

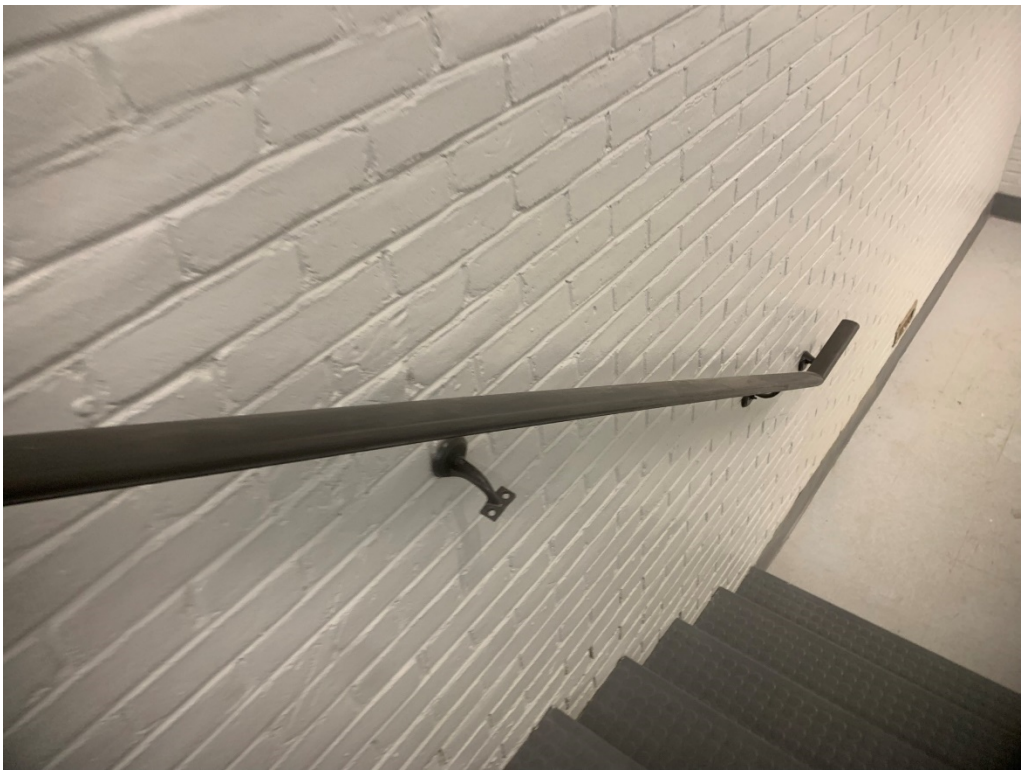
Figure 22 – Handrails missing supports

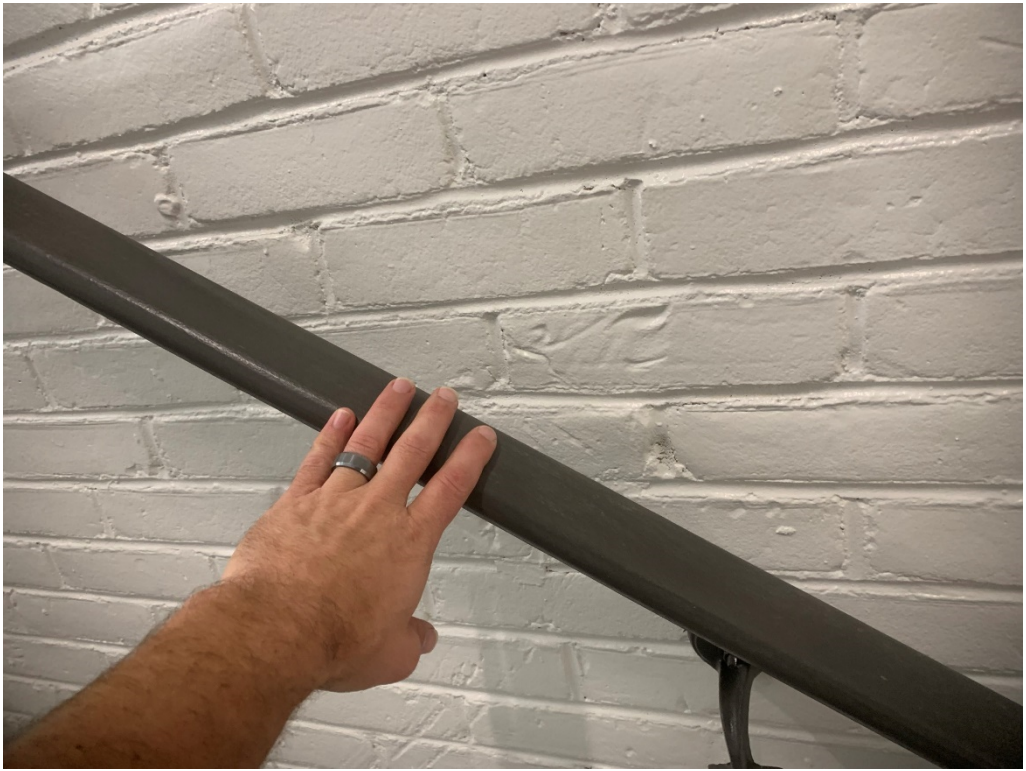
Figure 23 – Handrail is rough in some areas and needs to be sanded and repainted

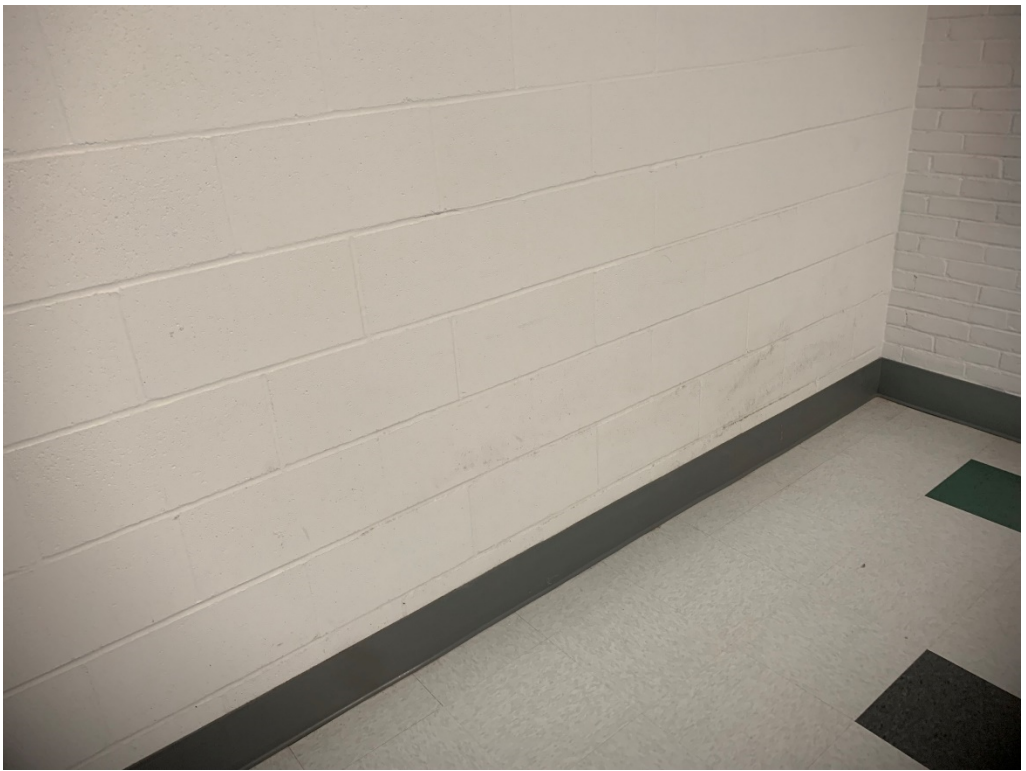
Figure 24 – Clean dirt at wall in E-200 near concessions

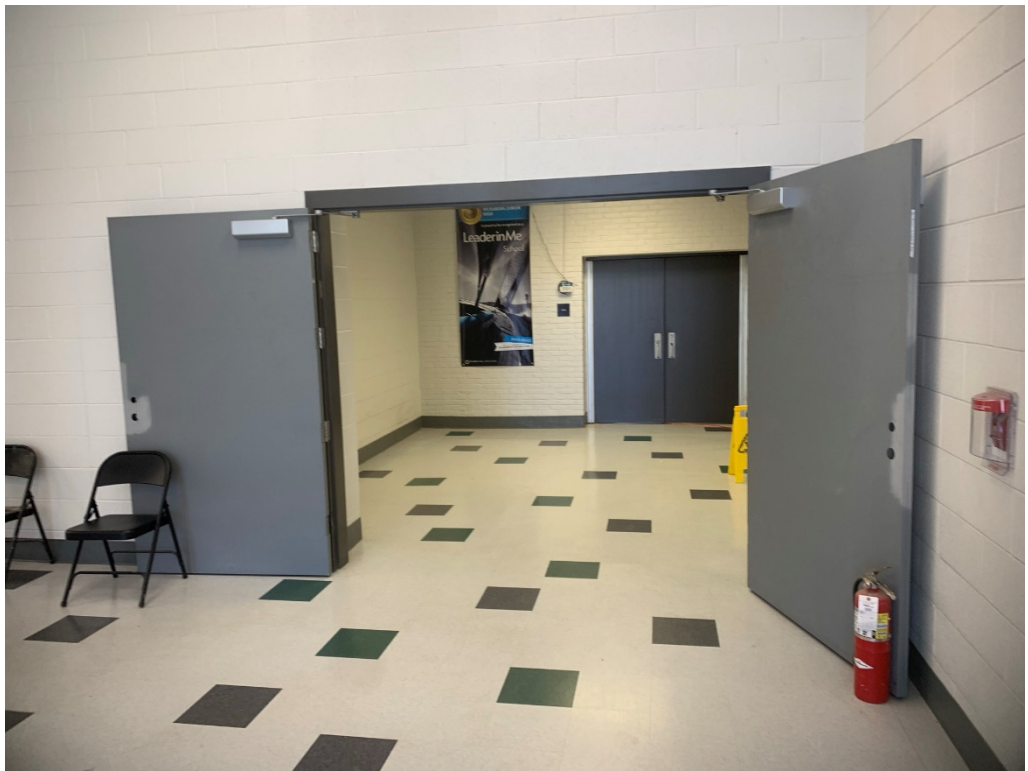
Figure 25 – Unpainted Doors

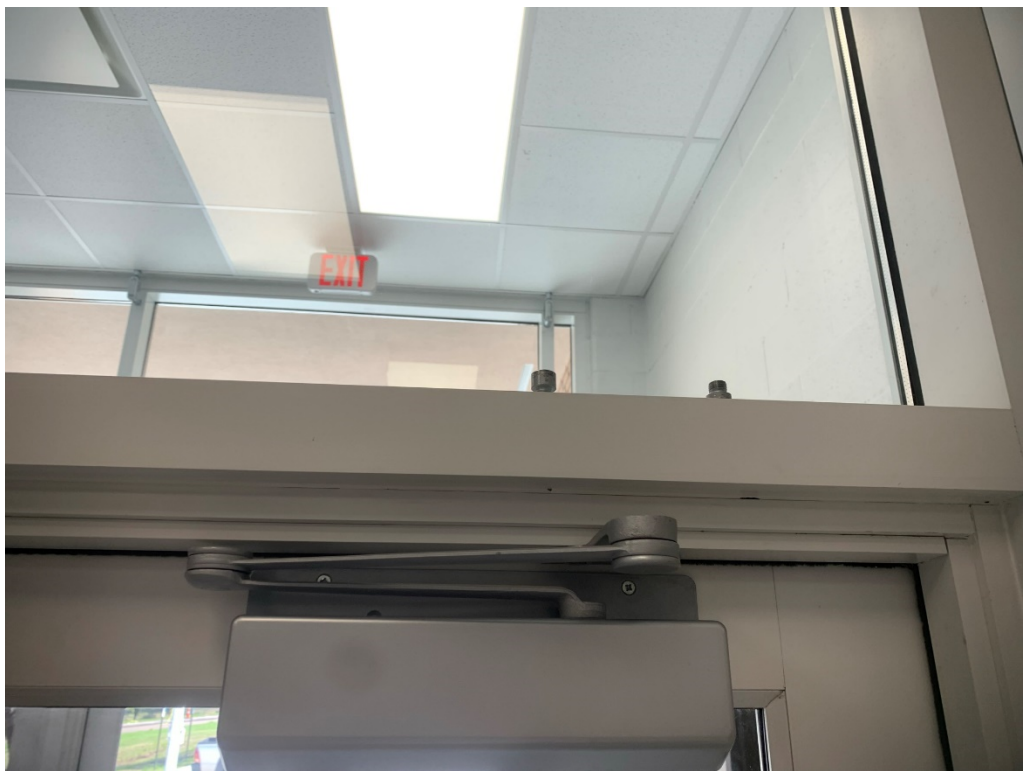
Figure 26 – Remove construction materials

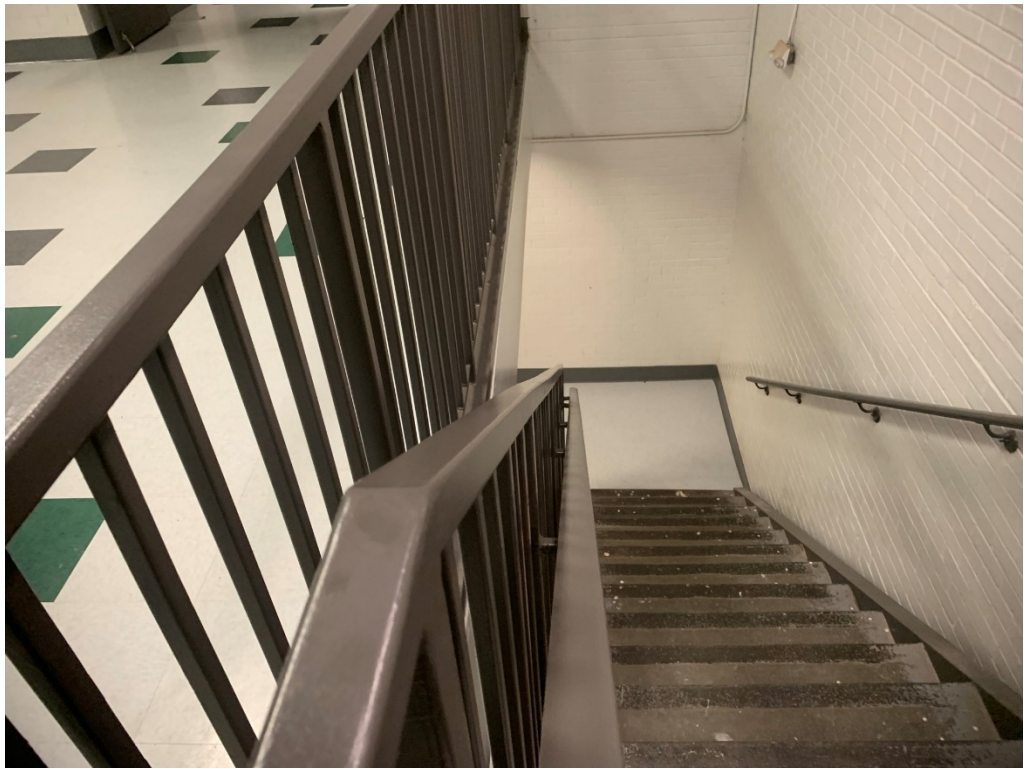
Figure 27 – Guardrail is not straight

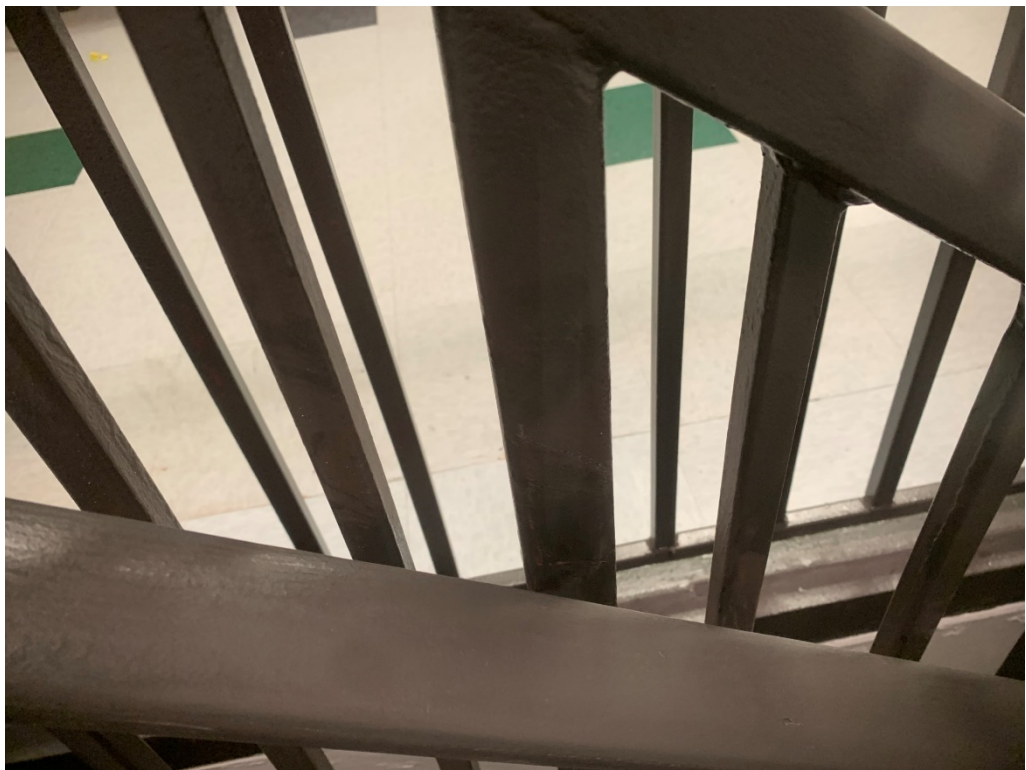
Figure 28 – Clean Guardrails free of construction dust

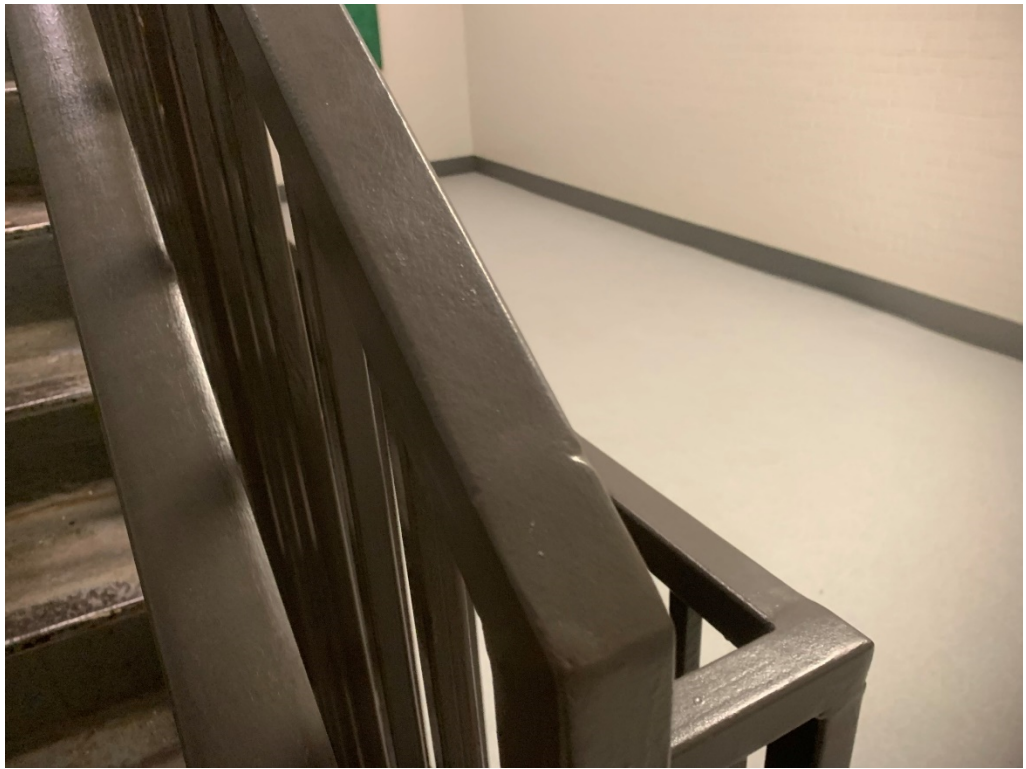
Figure 29 – Guardrails need repair for smooth appearance
