Architect's Field Report

22 October 2021

18053-Vicksburg Junior High School / Report Number 039

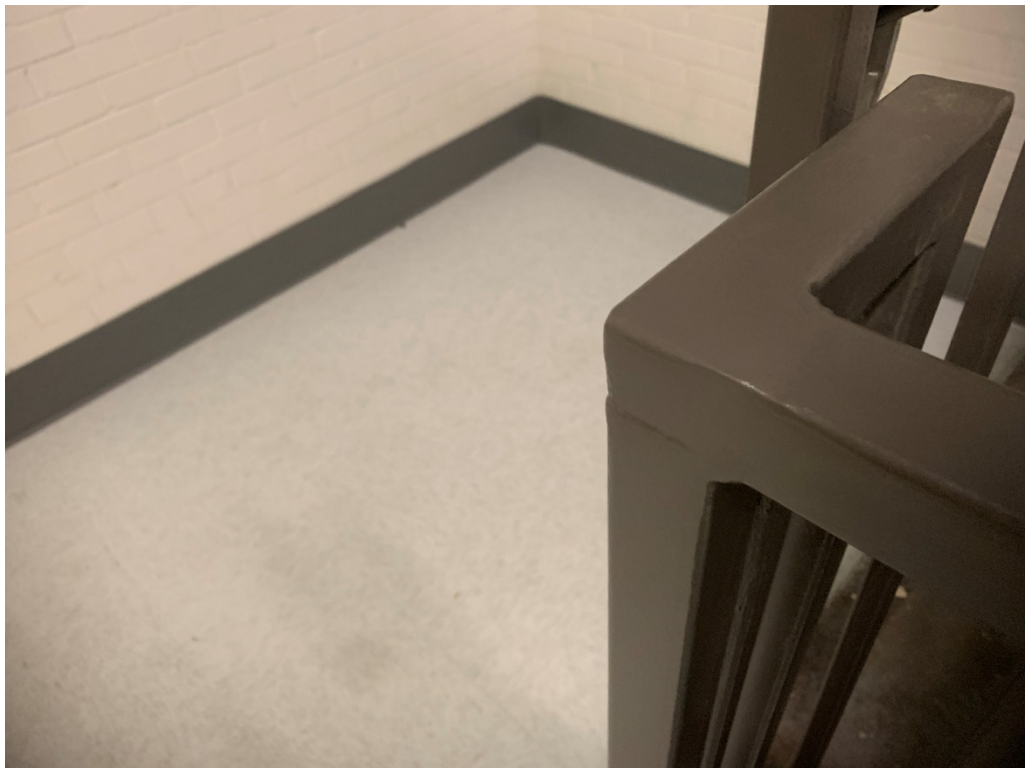
Figure 30 – Guardrails need repair for smooth appearance

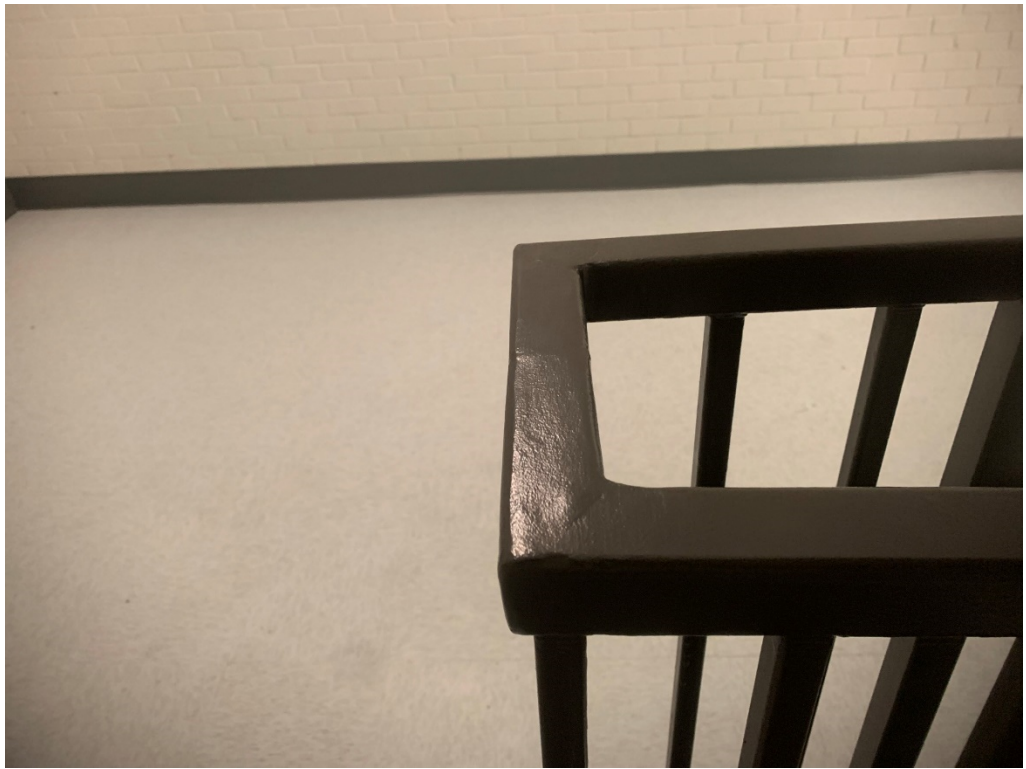
Figure 31 – Guardrails need repair for smooth appearance

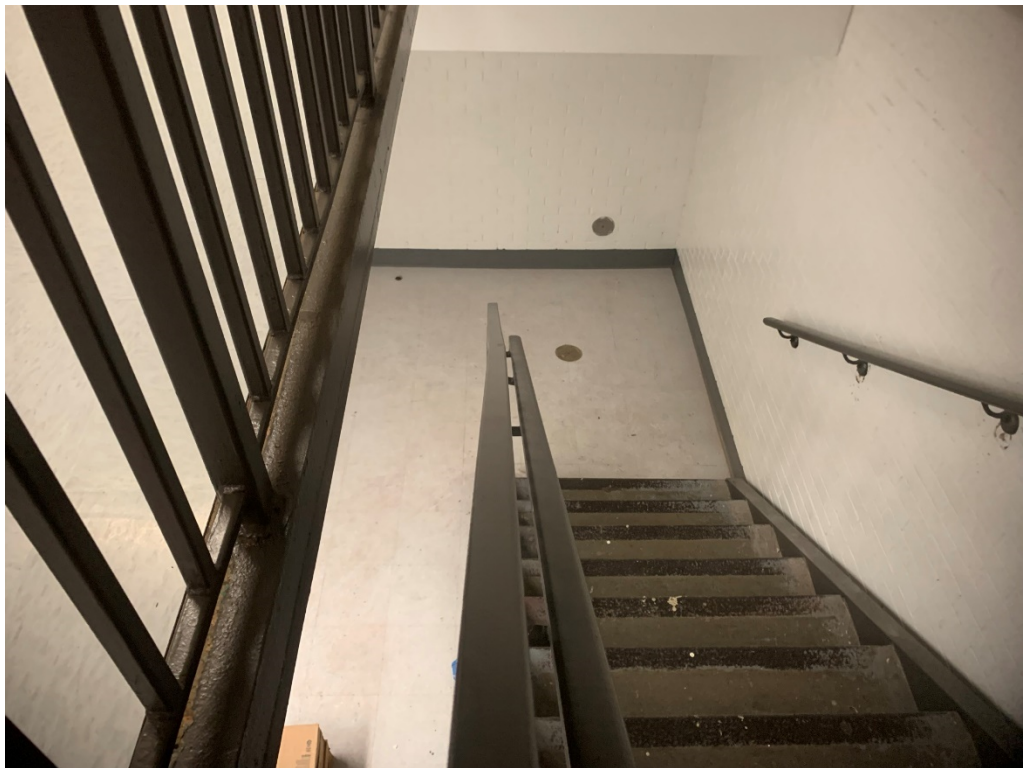
Figure 32 – Guardrail is not straight

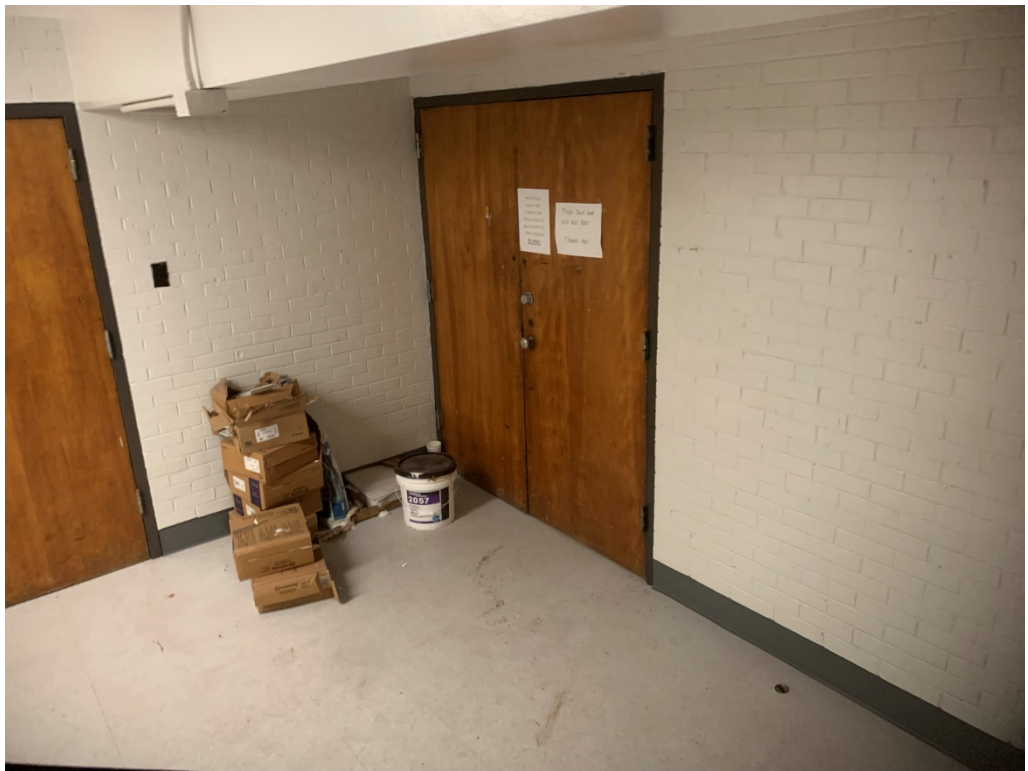
Figure 33 – Clean out flooring materials

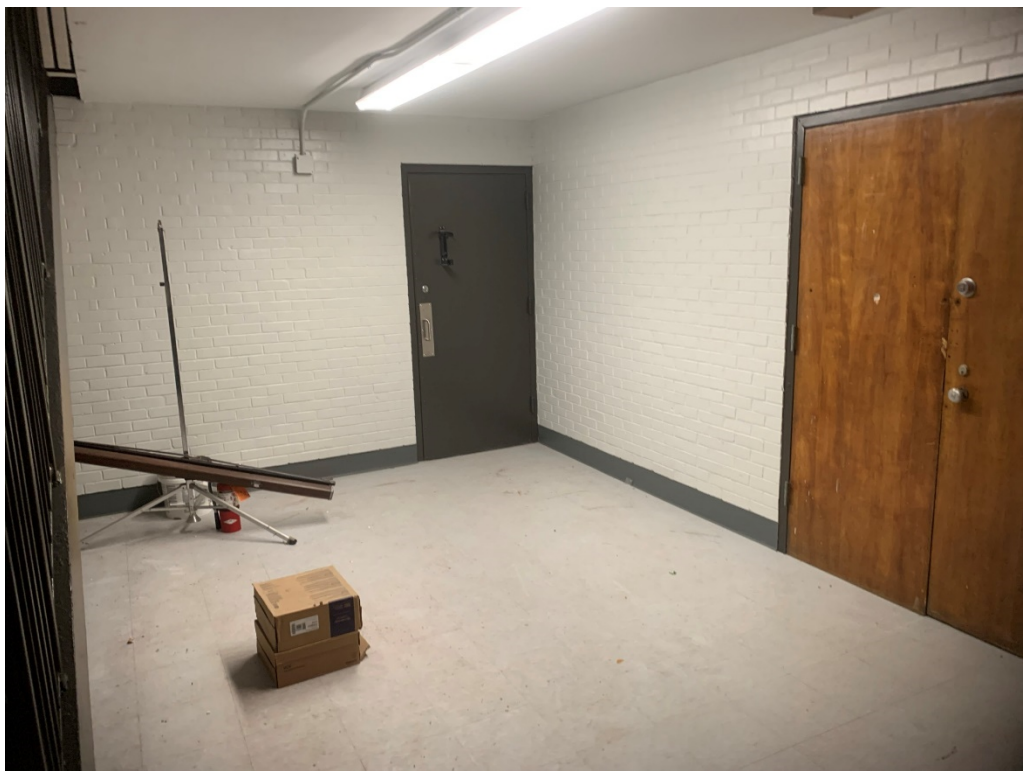
Figure 34 – Clean out flooring materials

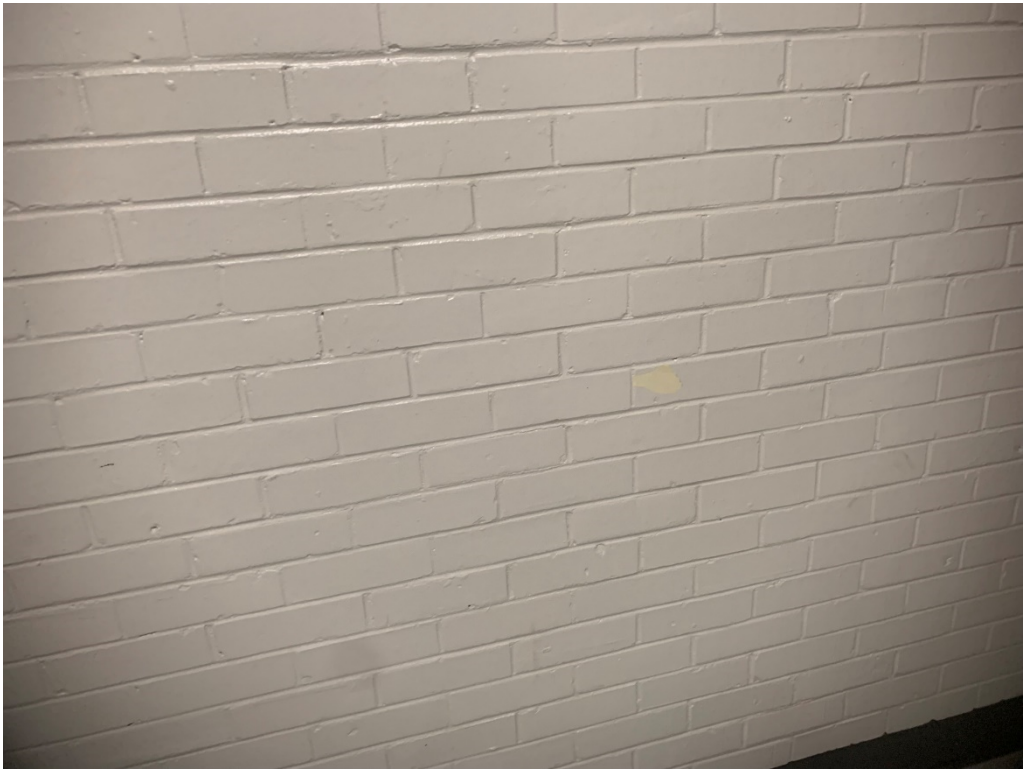
Figure 35 – Paint peeling at walls in cooridor

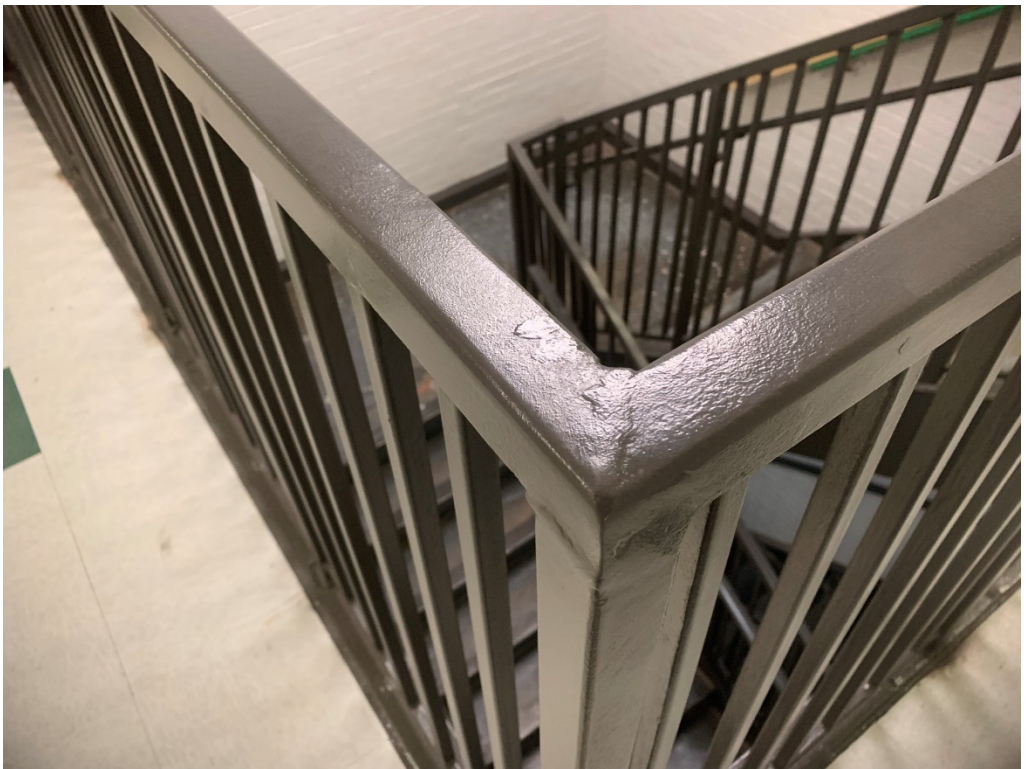
Figure 36 – Guardrails need repair for smooth appearance

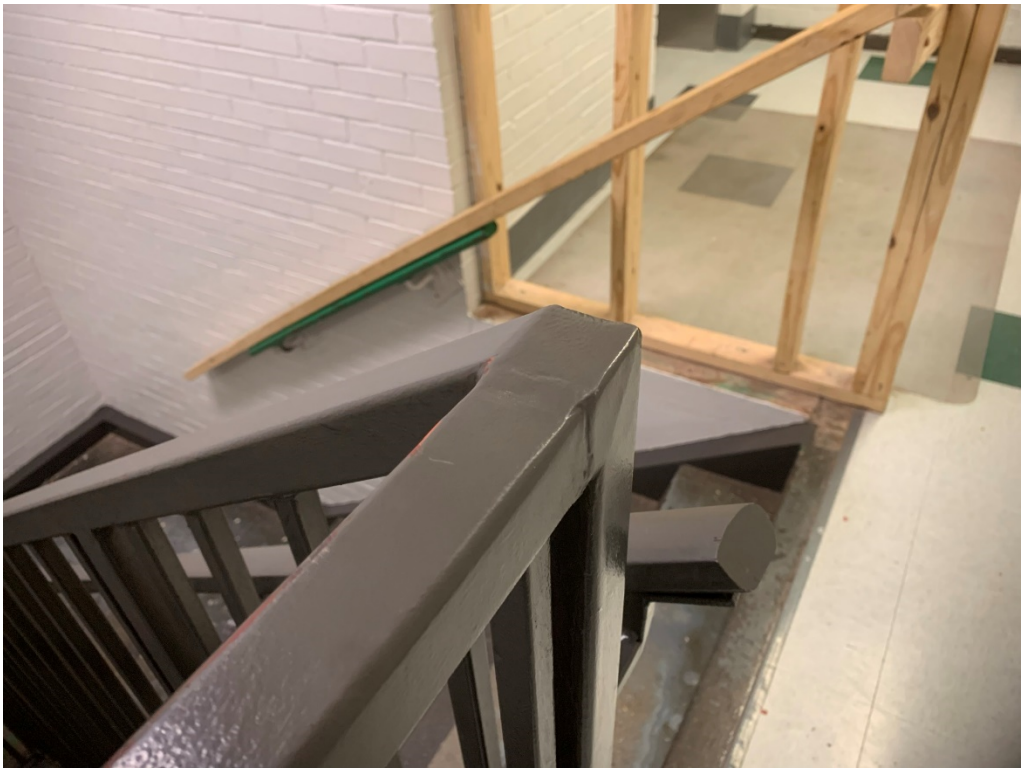
Figure 37 – Guardrails need repair for smooth appearance

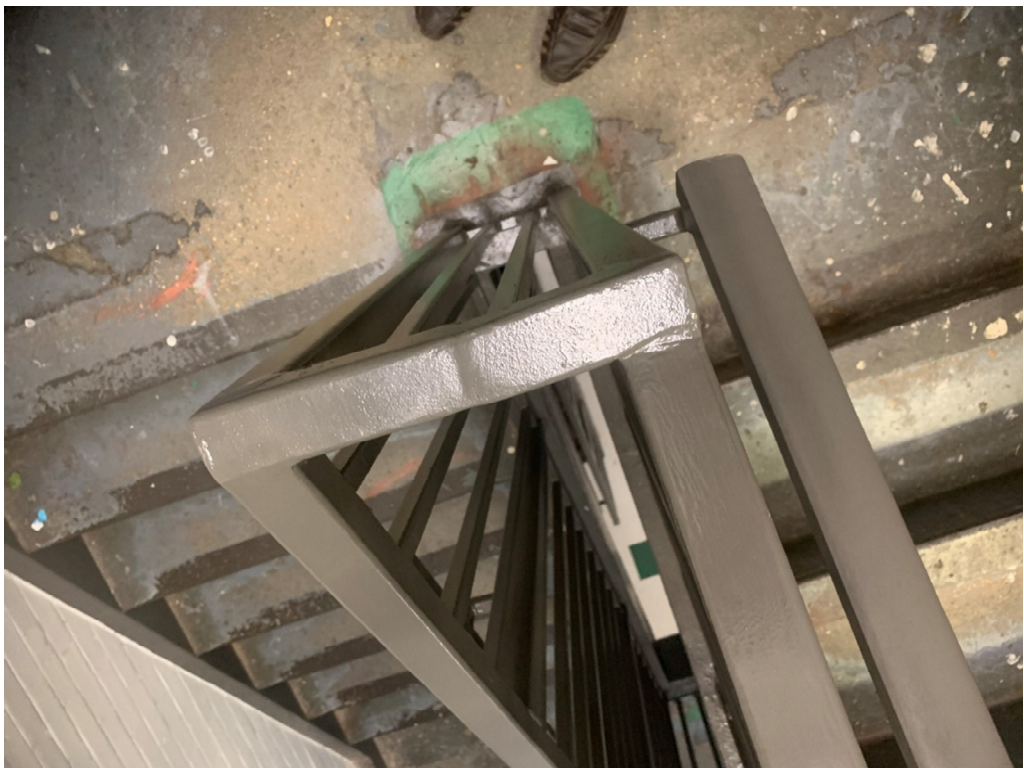
Figure 38 – Guardrails need repair for smooth appearance

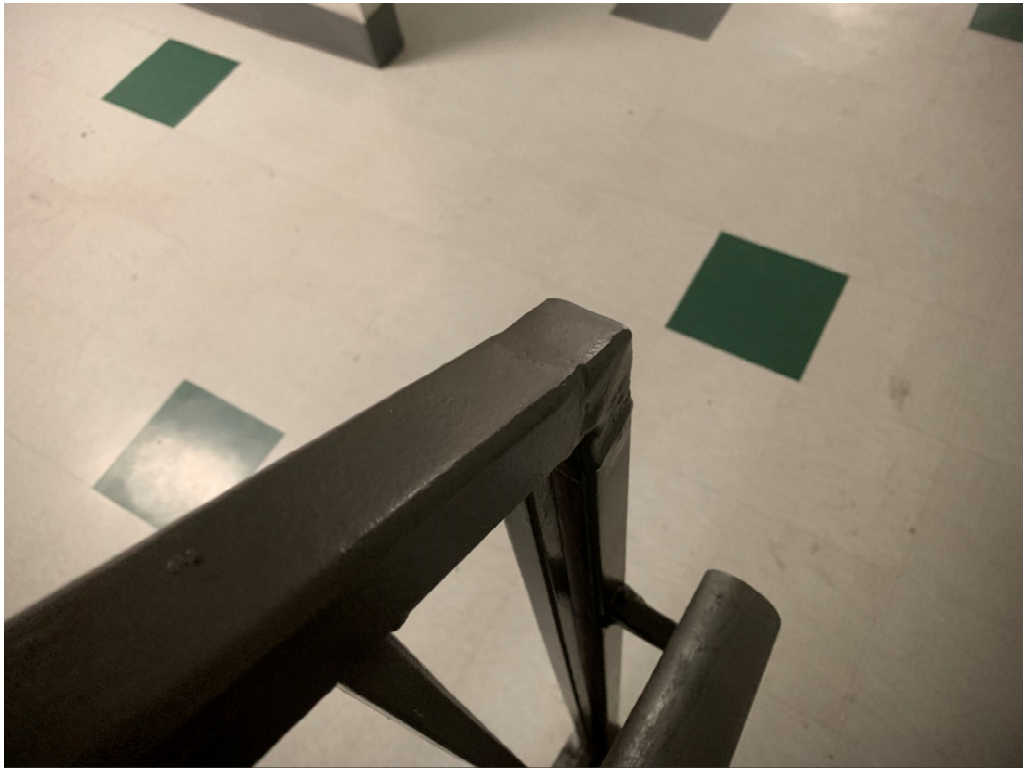
Figure 39 – Guardrails need repair for smooth appearance

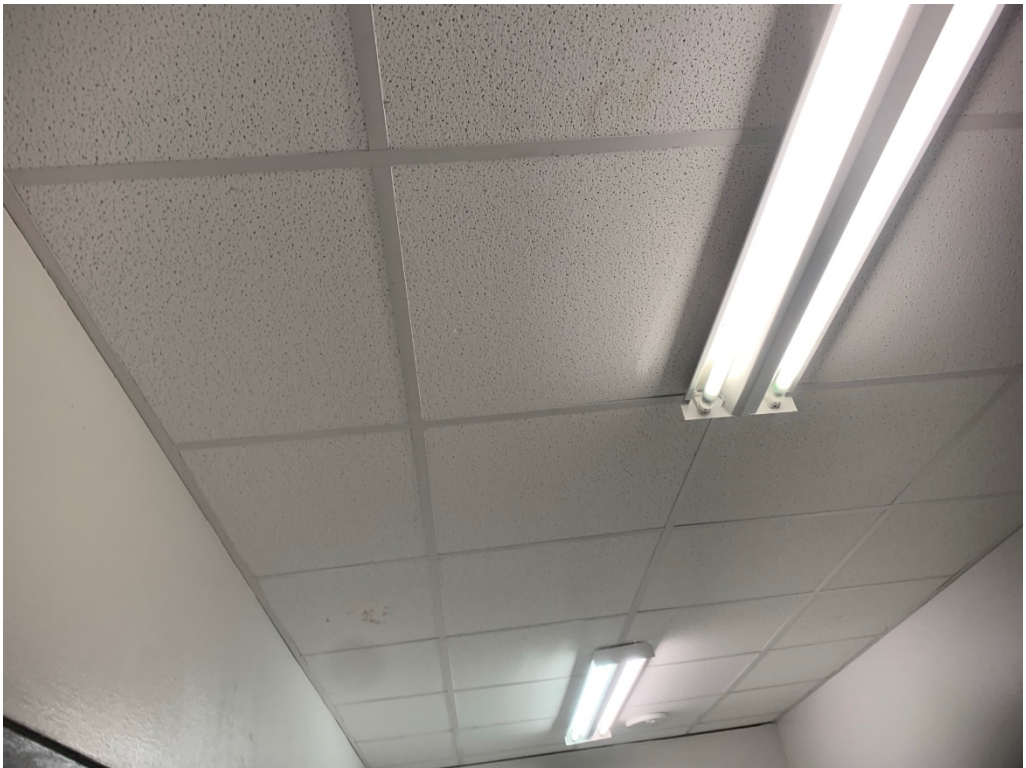
Figure 40 – Clean/replace ceiling tile @ E-111

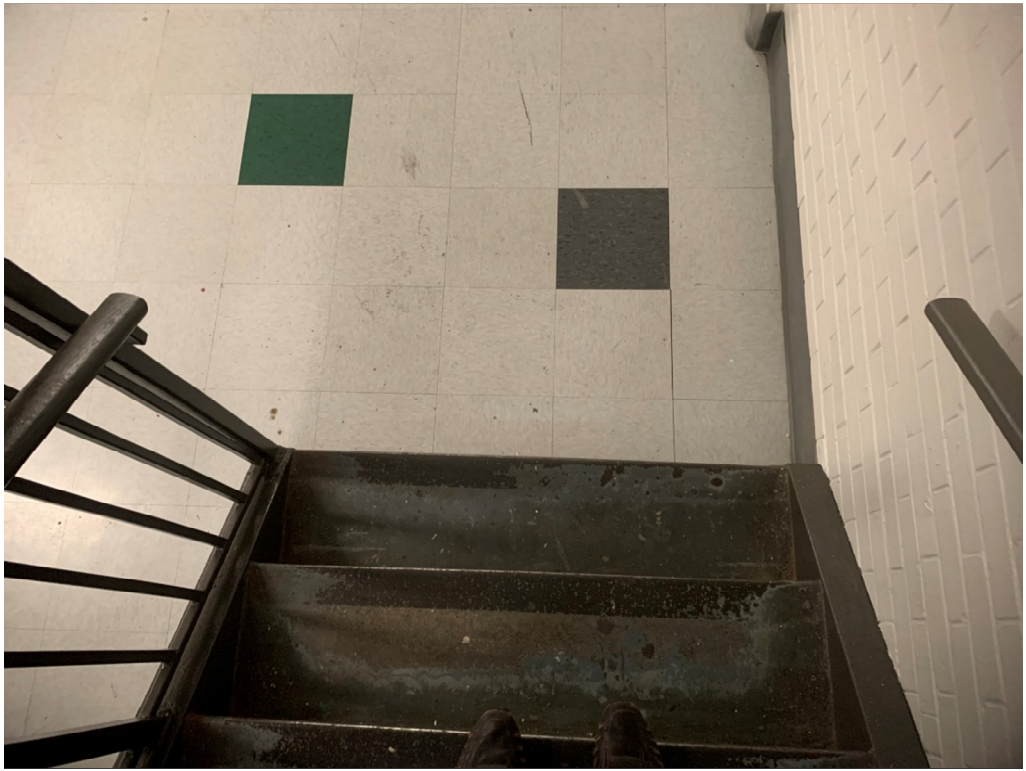
Handrails throughout have major issues. They do not conform to the construction documents in several areas and need to be replaced. Note written general notes on page A-701 as well as drawings for your reference.

Figure 41 – Handrail does not extend 12" past last step

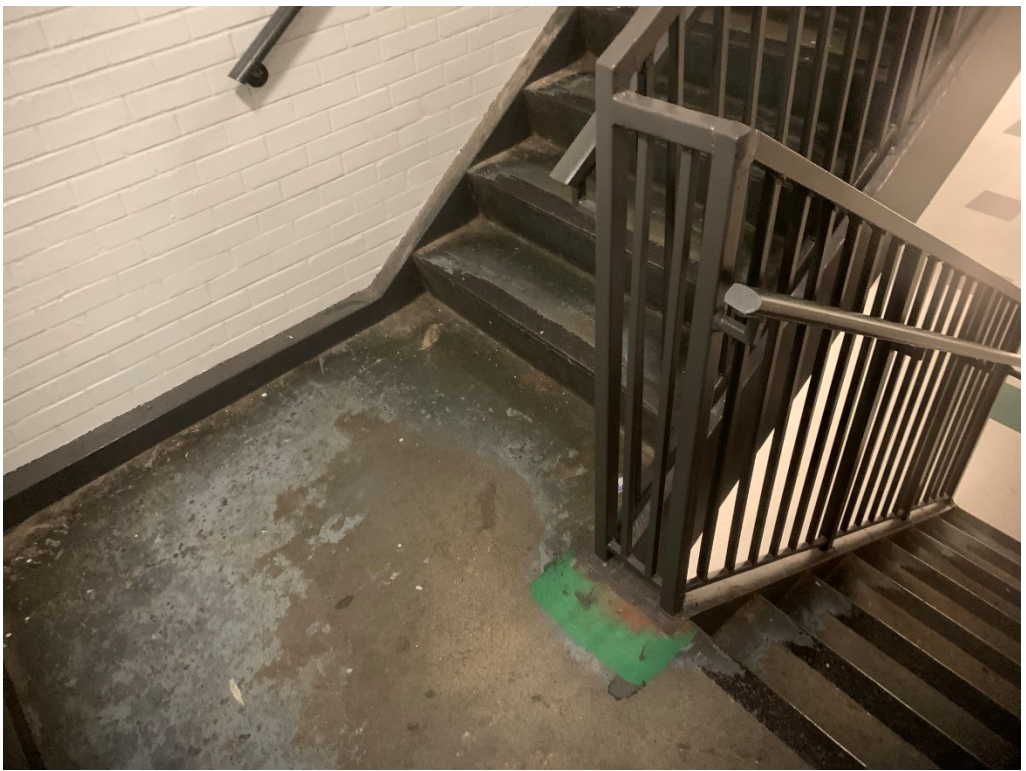
Figure 42 – Handrails do neither return to wall or are continuous per drawings

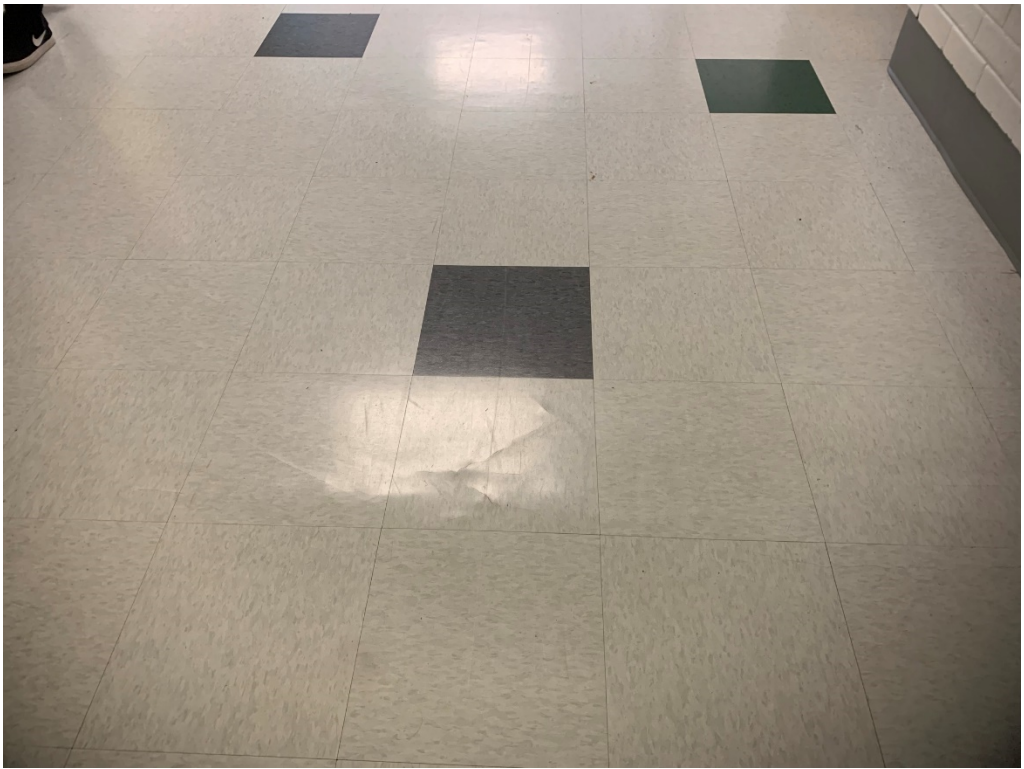
Figure 43 – Floor tile at E-216 near E-212 transmitting through poorly prepped subfloor; replace and prep correctly

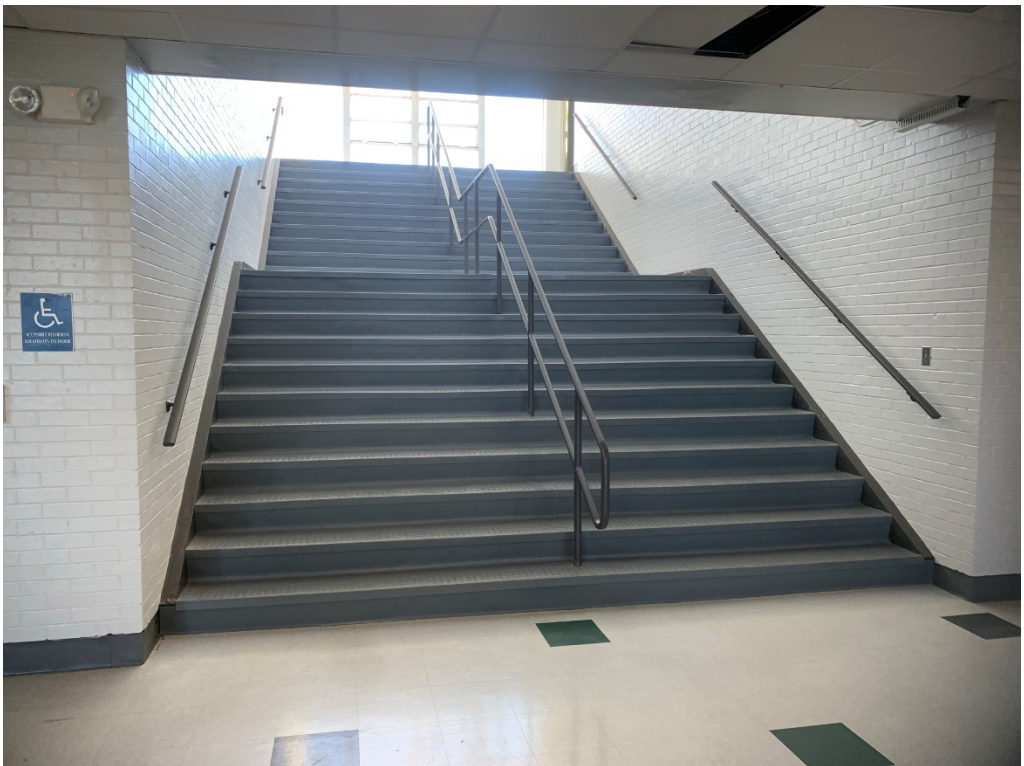
Figure 44 – Treads Installed

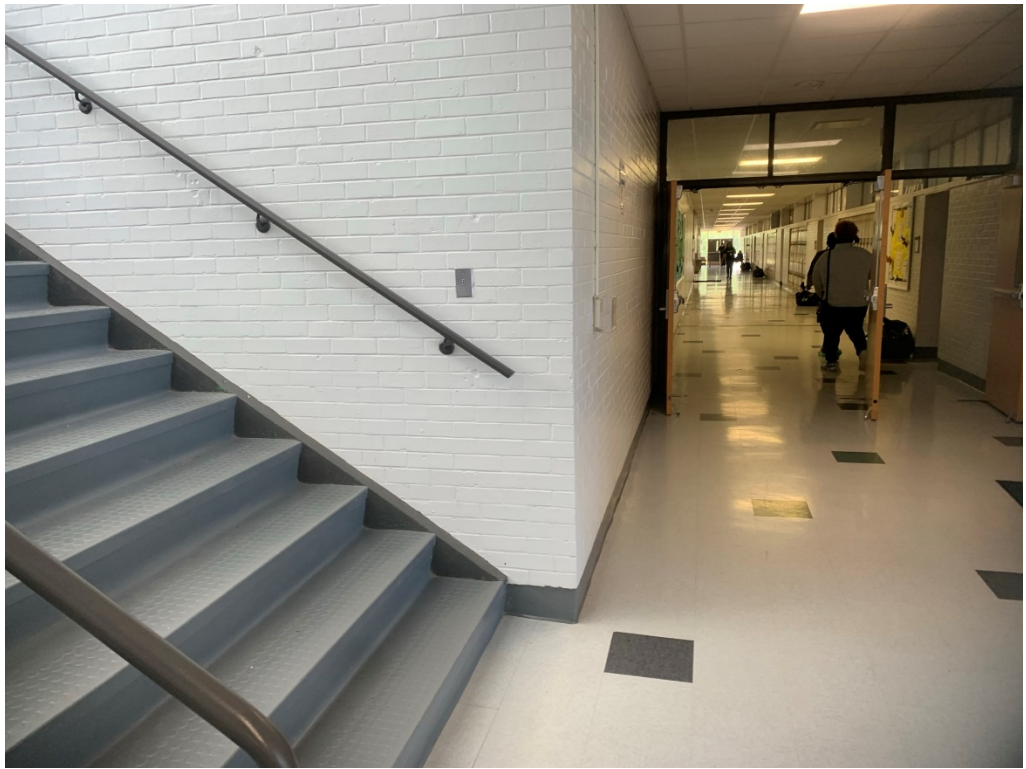
Figure 45 – Handrail does not extend 12" past last step

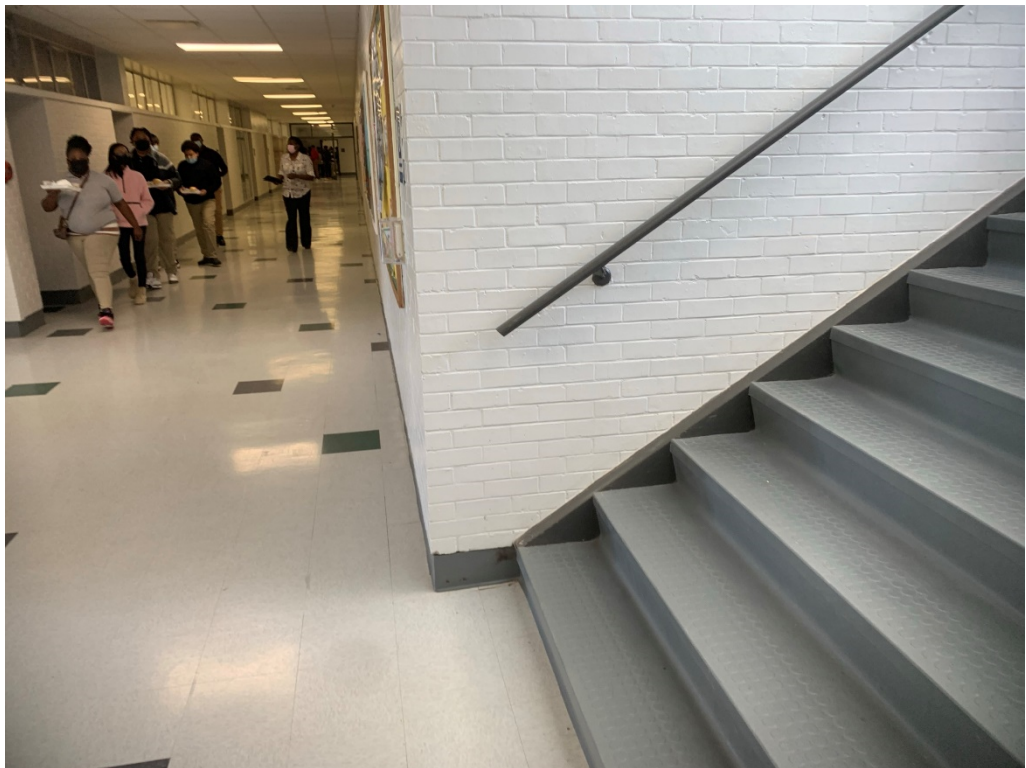
Figure 46 – Handrail does not extend 12" past last step

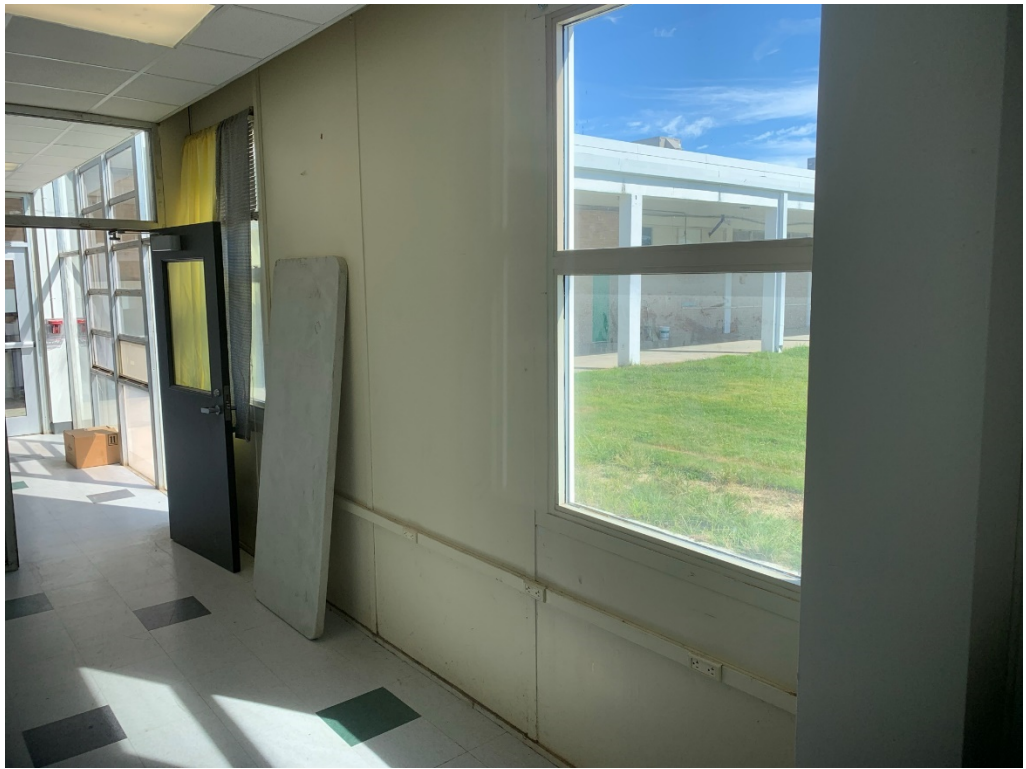
Figure 47 – Wall Missing Paint

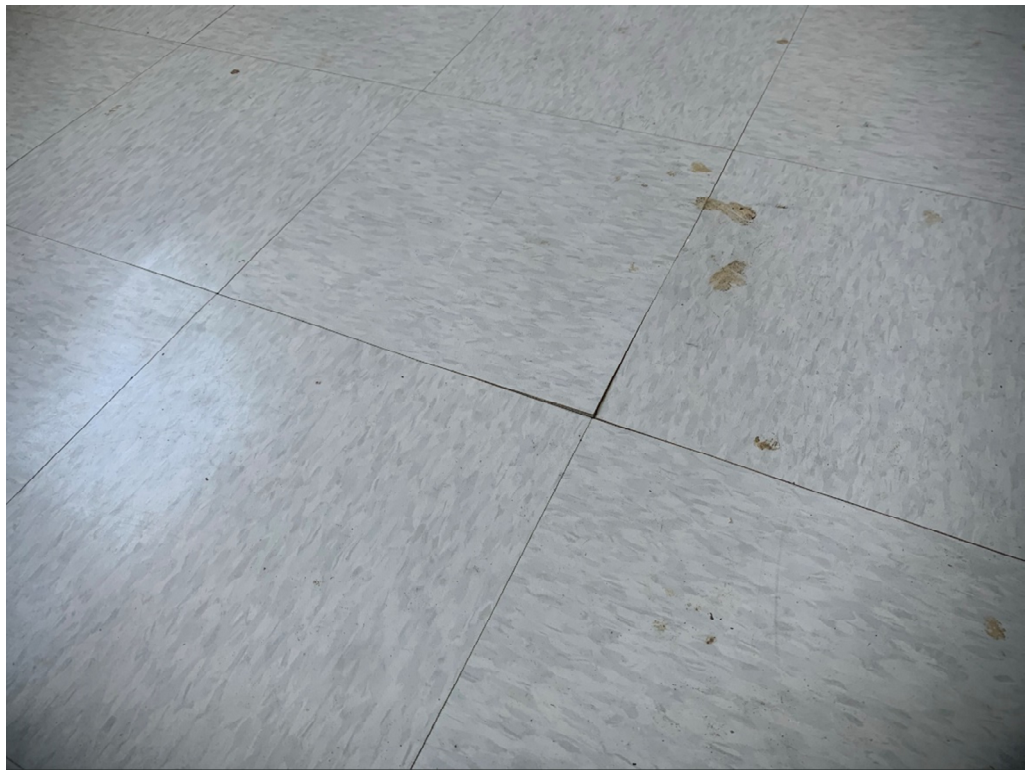
Figure 48 – Floor tile raised in admin area

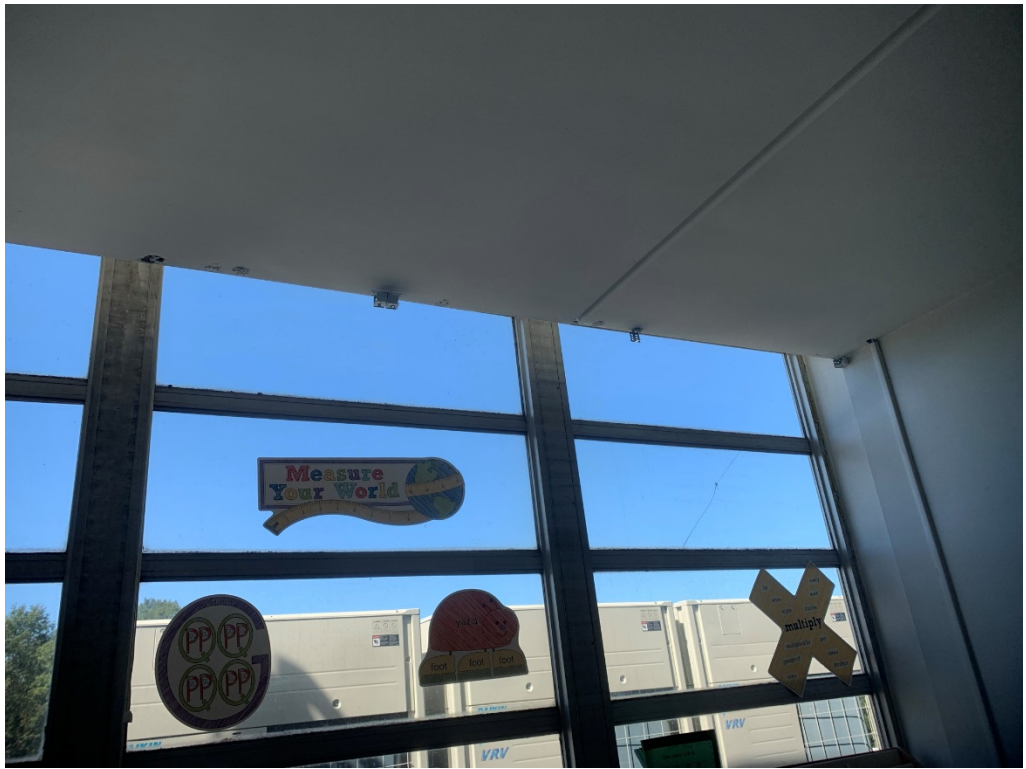
Figure 49 – Blinds still to be installed

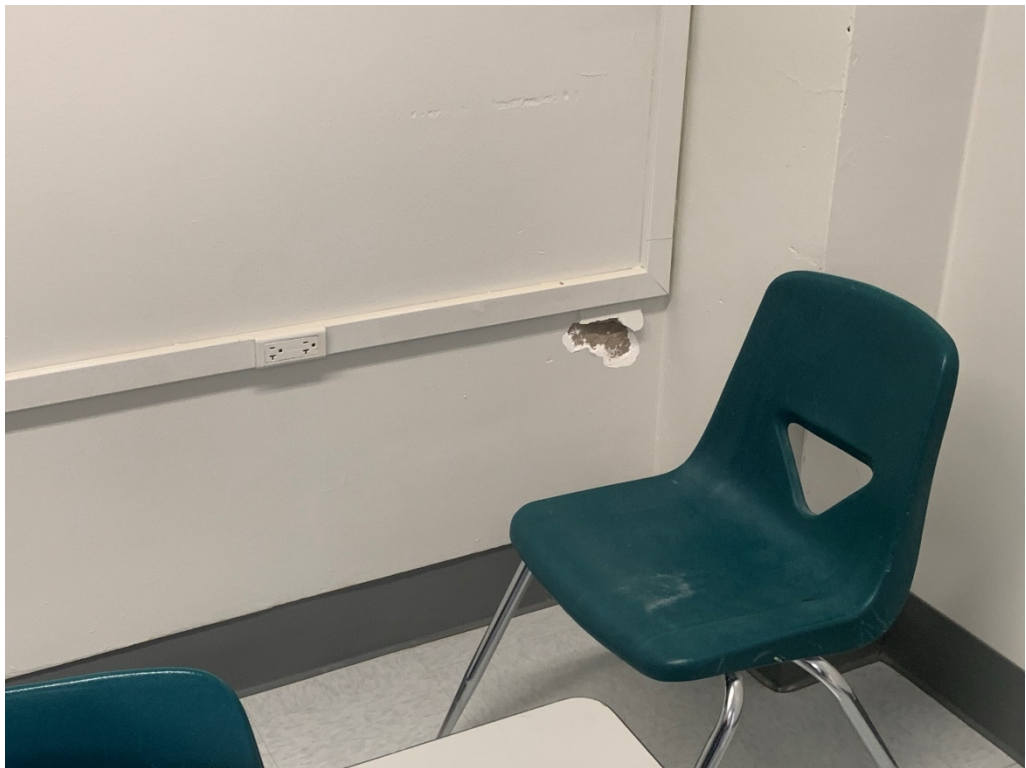
Figure 50 – Patch needed at E-308

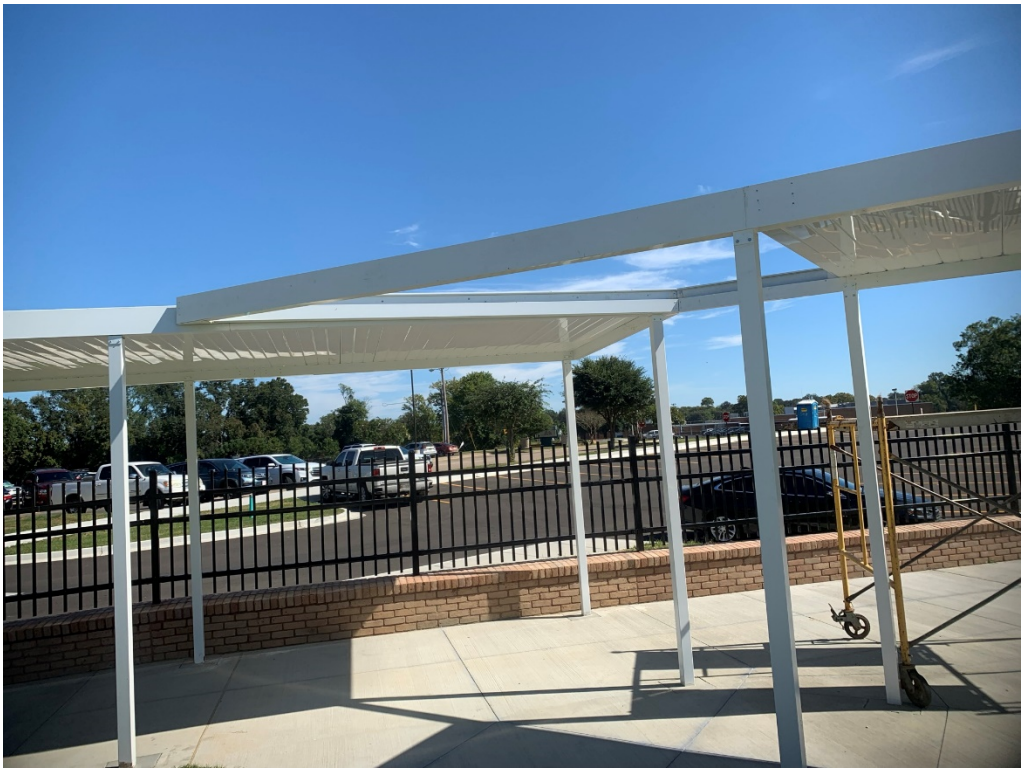
Figure 51 – Finish Awning Install

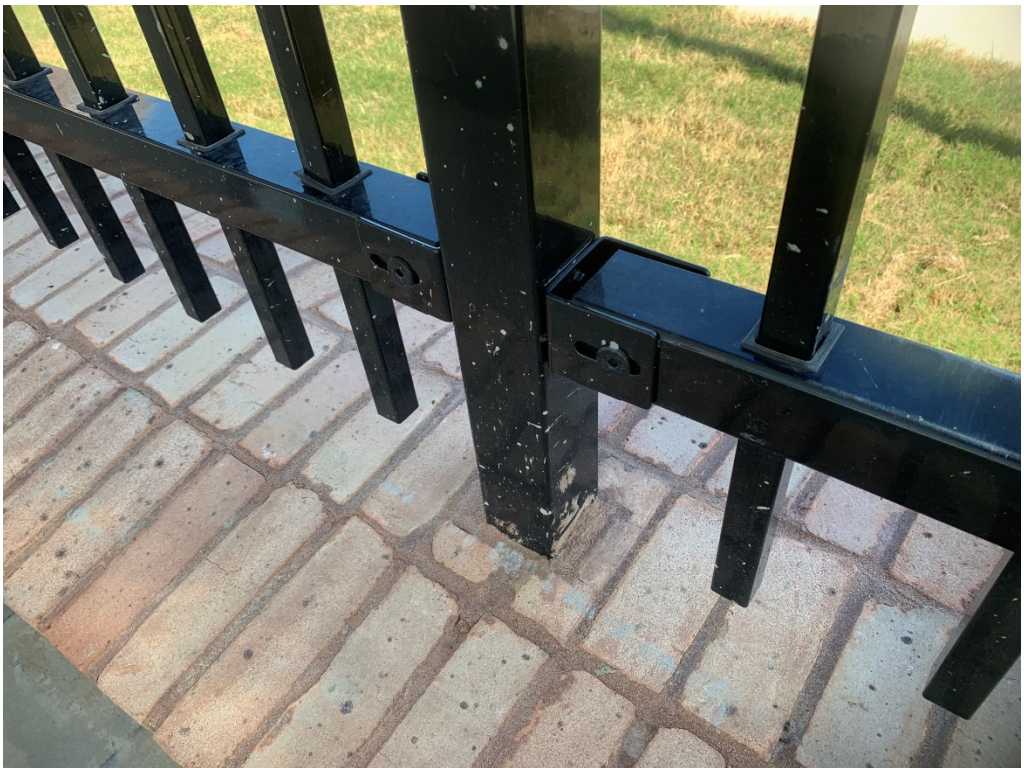
Figure 52 – Clean new fence and paint where scuffed

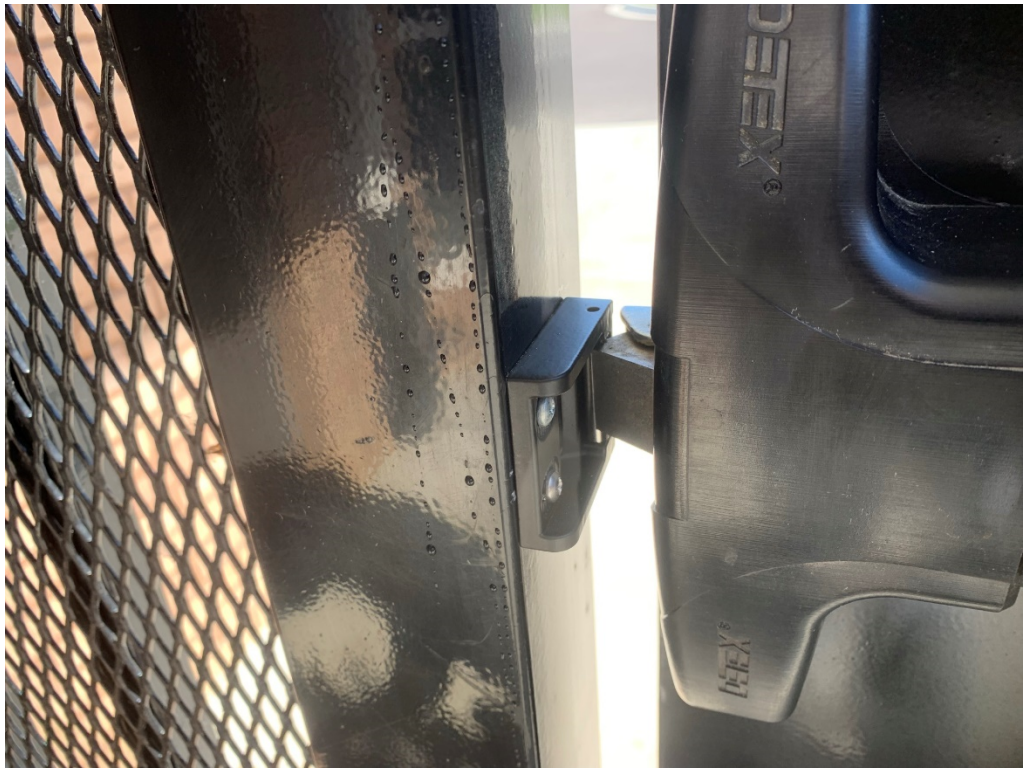
Figure 53 – Adjust Latch so Gate cannot be pulled open

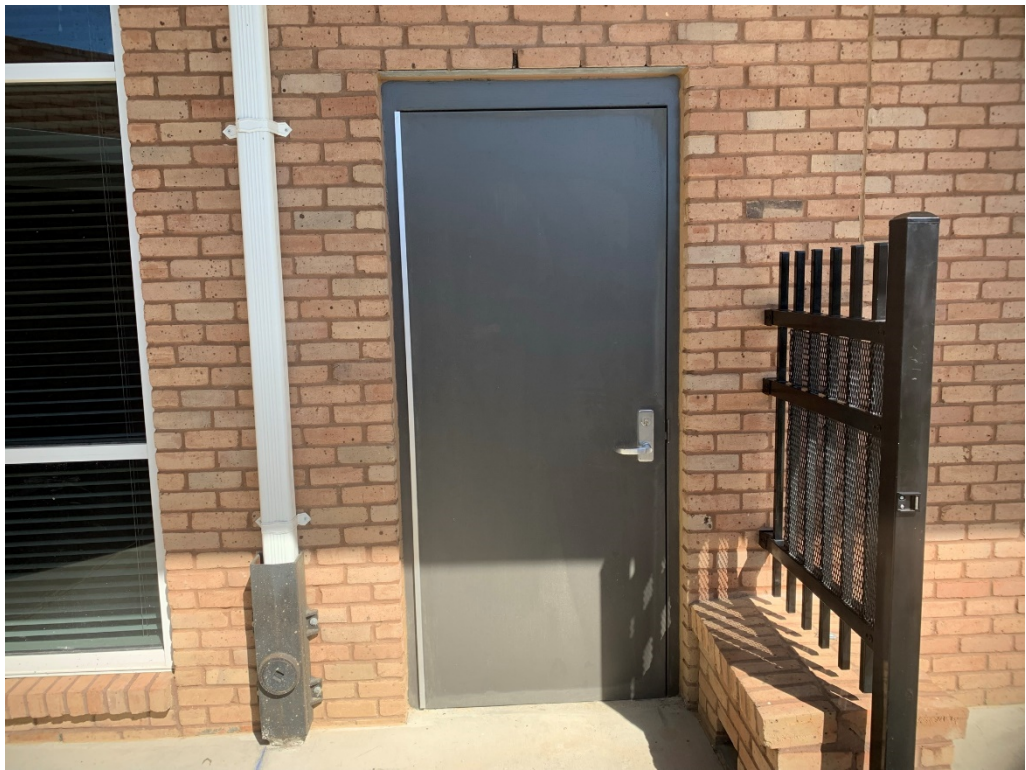
Figure 54 – Finish Painting Door Panel & Jamb
