## Architect's Field Report

07 April 2020

18056-Warren Central Junior High School / Report Number 006

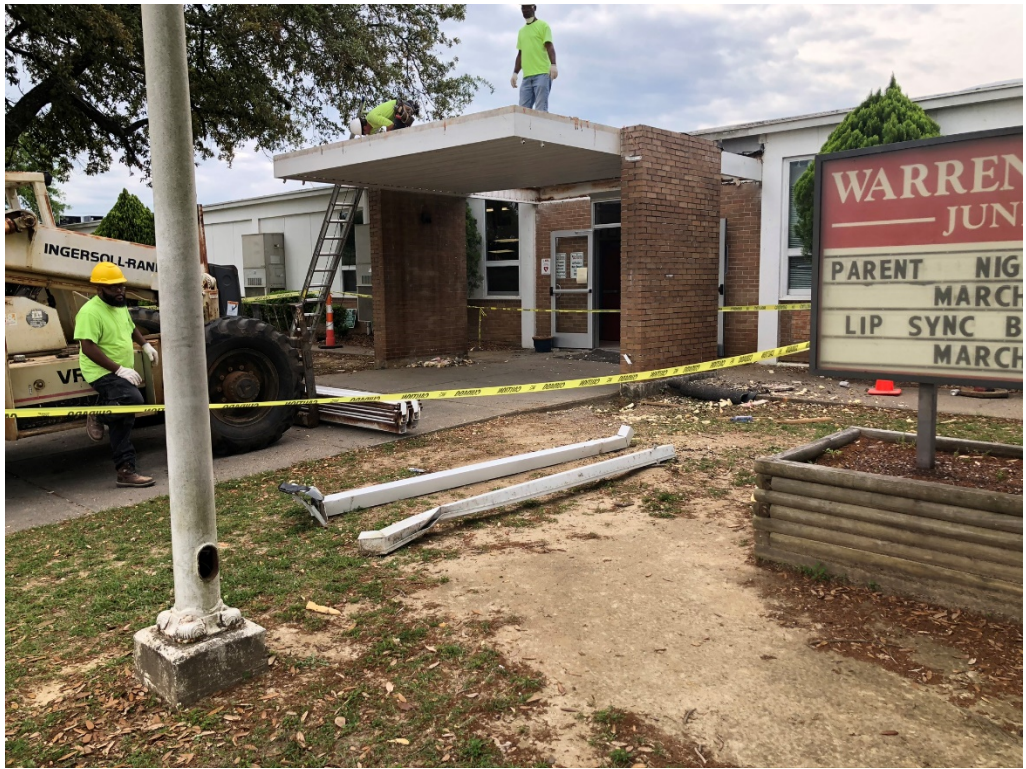
Figure 1 – School Entry Demo Begun

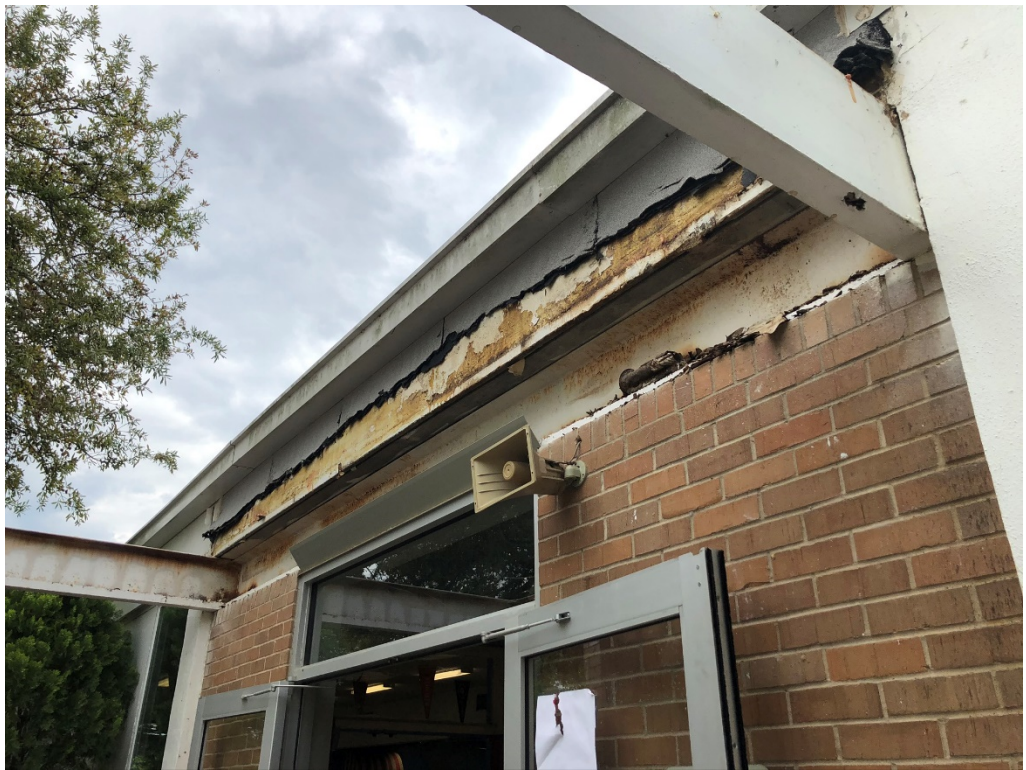
Figure 2 – Connection of Entry Awning to School

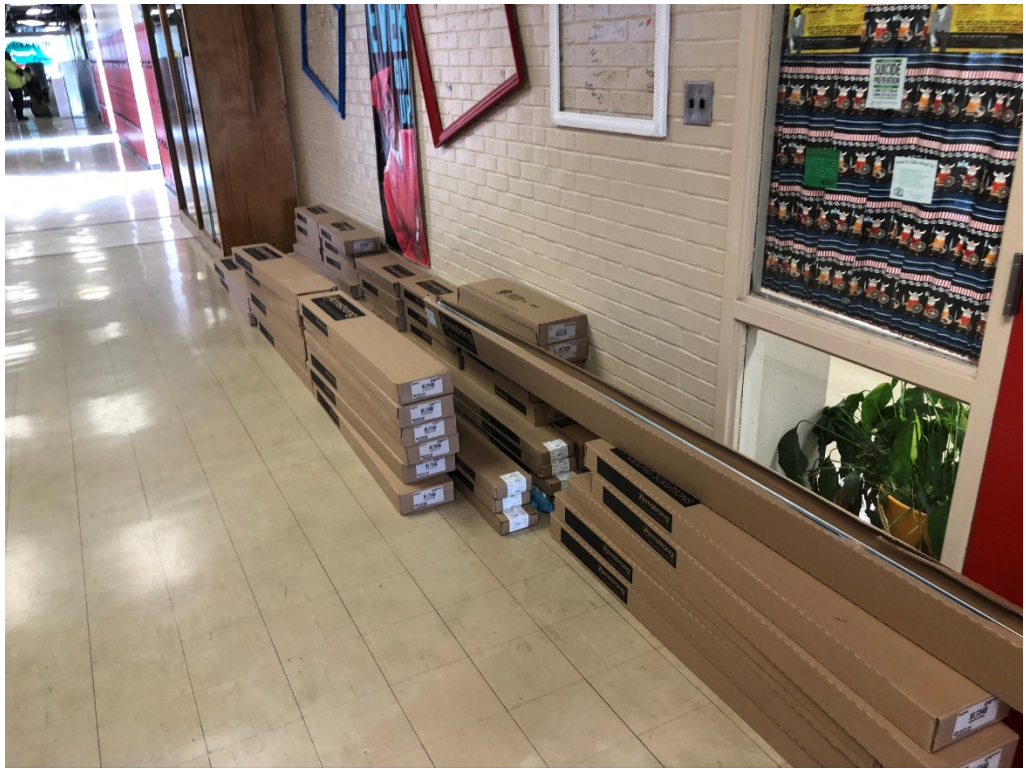
Figure 3 – Ceiling Grid Stored in Hall @ 3<sup>rd</sup> Floor

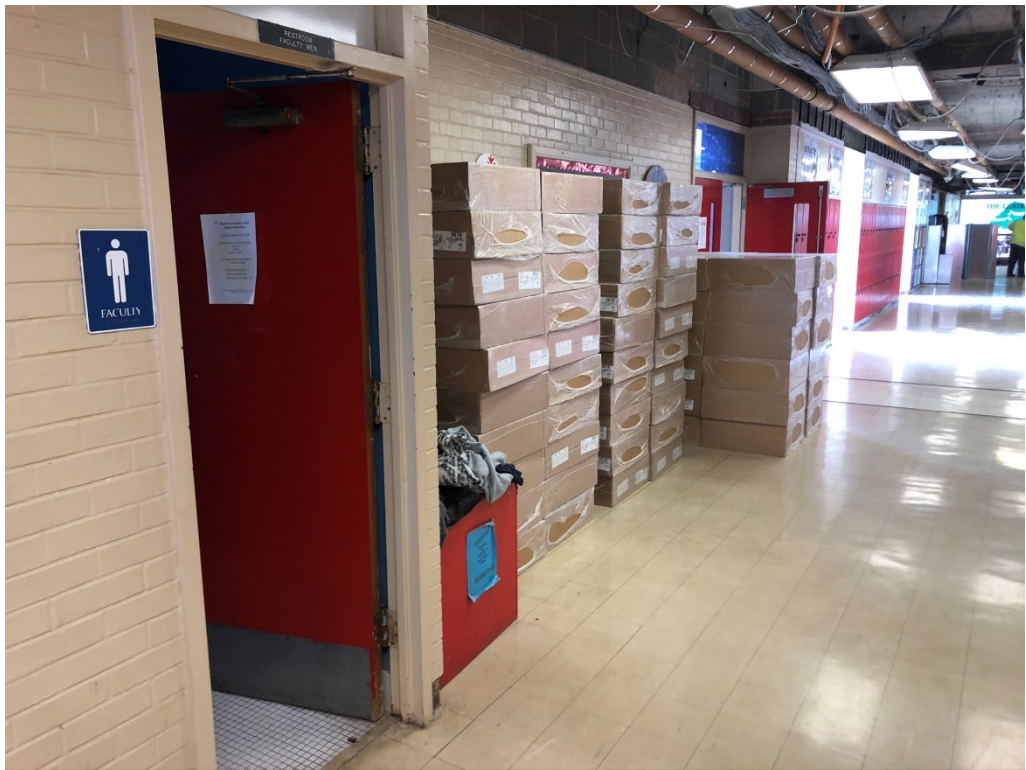
Figure 4 – Ceiling Tile Stored in Hall @ 3<sup>rd</sup> Floor

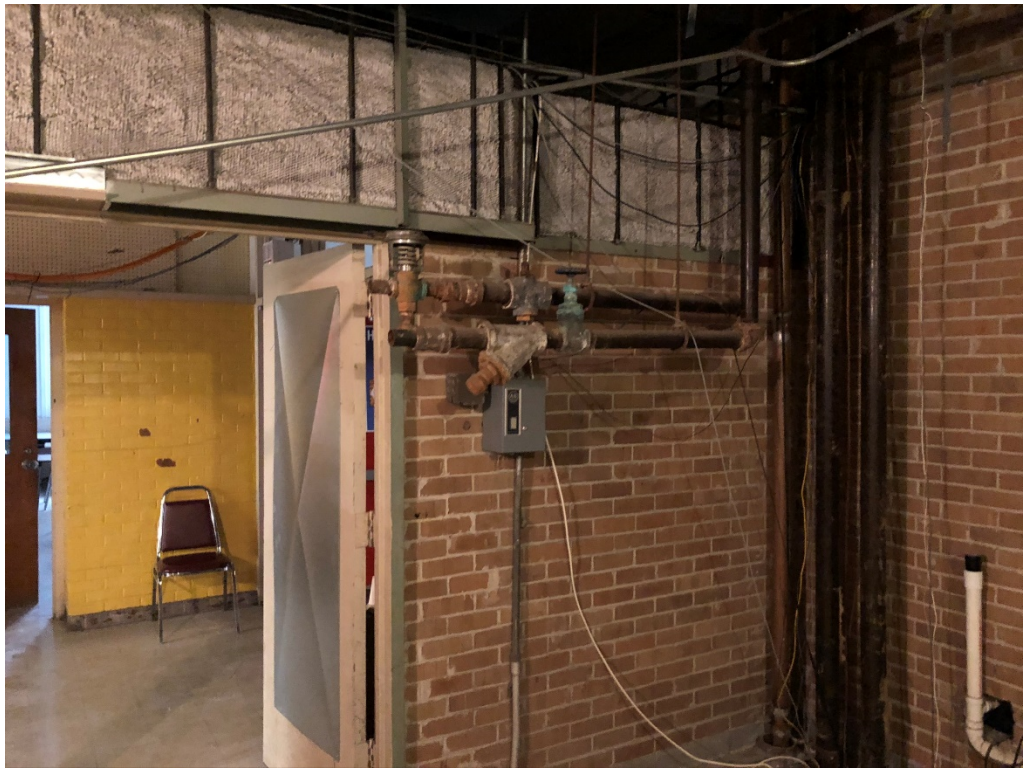
Figure 5 – Similar Condition on 2<sup>nd</sup> Floor Mechanical Room Exists as in E-322

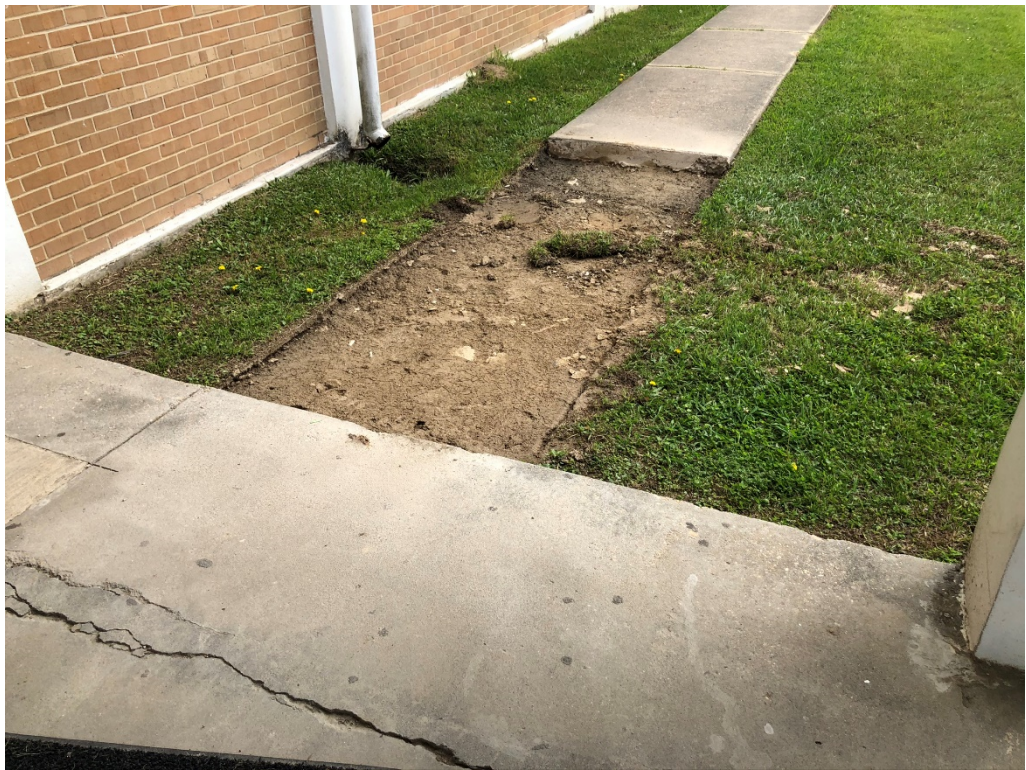
Figure 6 – Concrete cut and removed at 1<sup>st</sup> floor breezeway

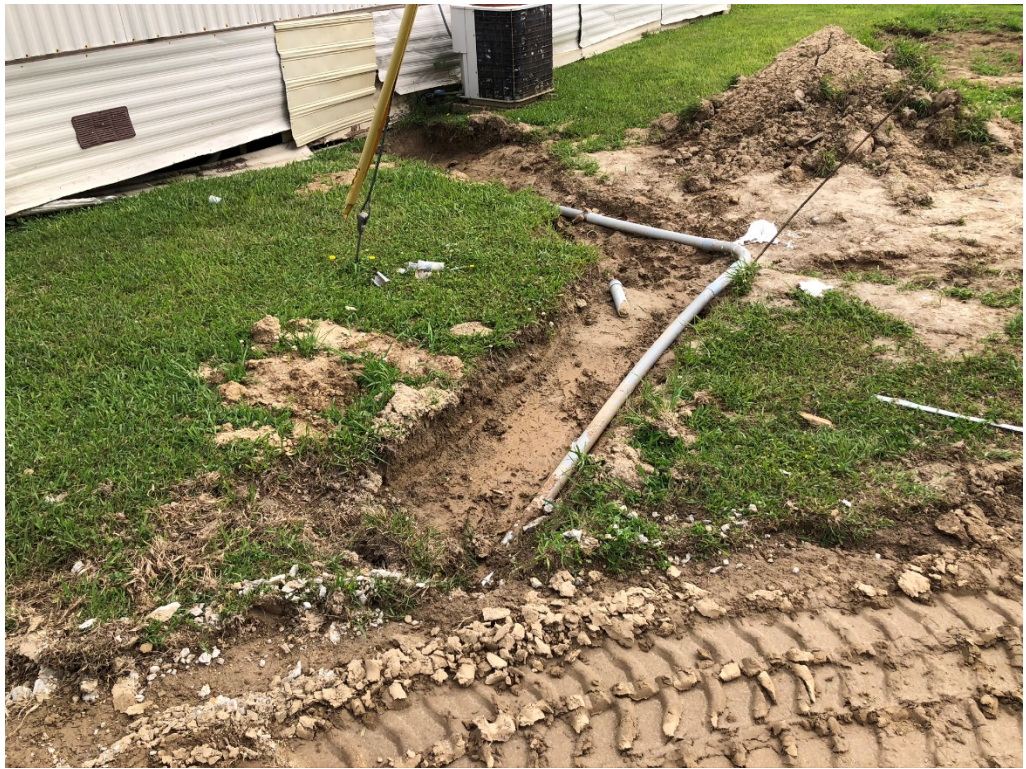
Figure 7 – Underground Electrical Exposed in Shallow Trench

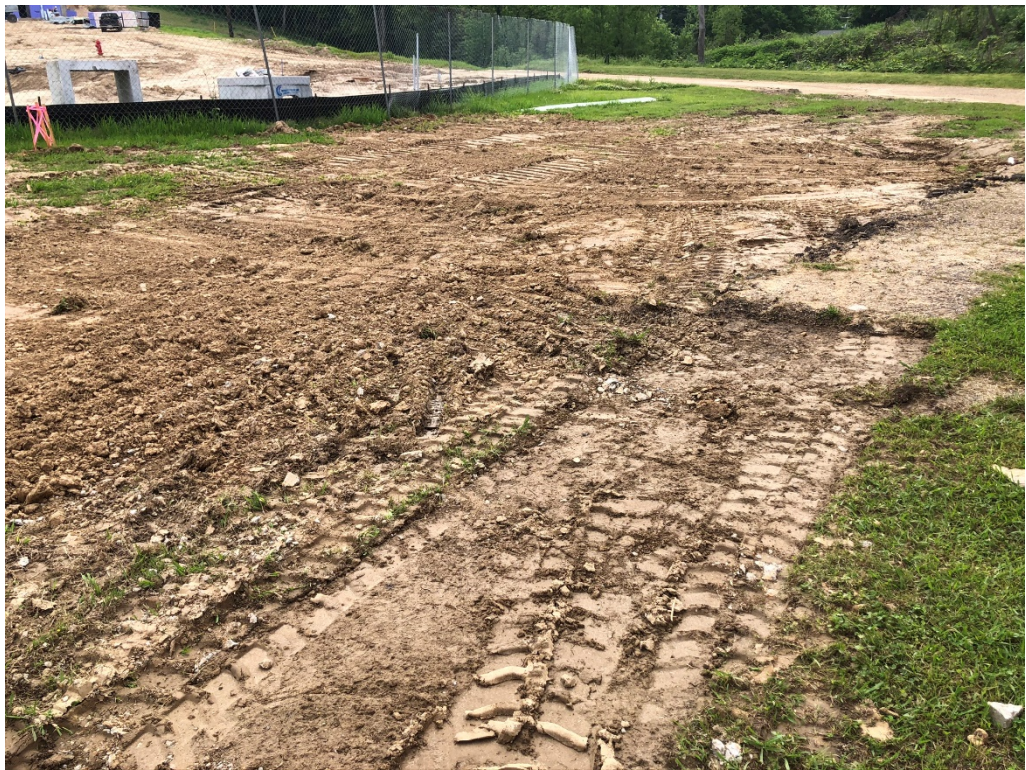
Figure 8 – Storm Sewer Covered

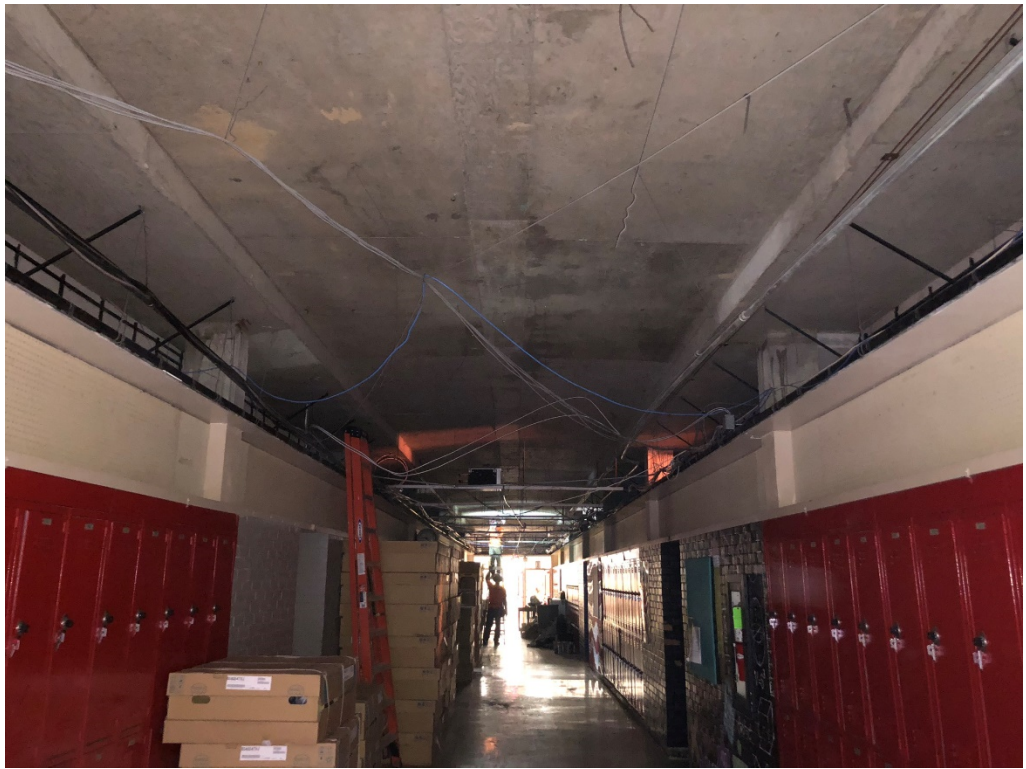
Figure 9 – Ceiling Demo and at East 3<sup>rd</sup> Floor Hall

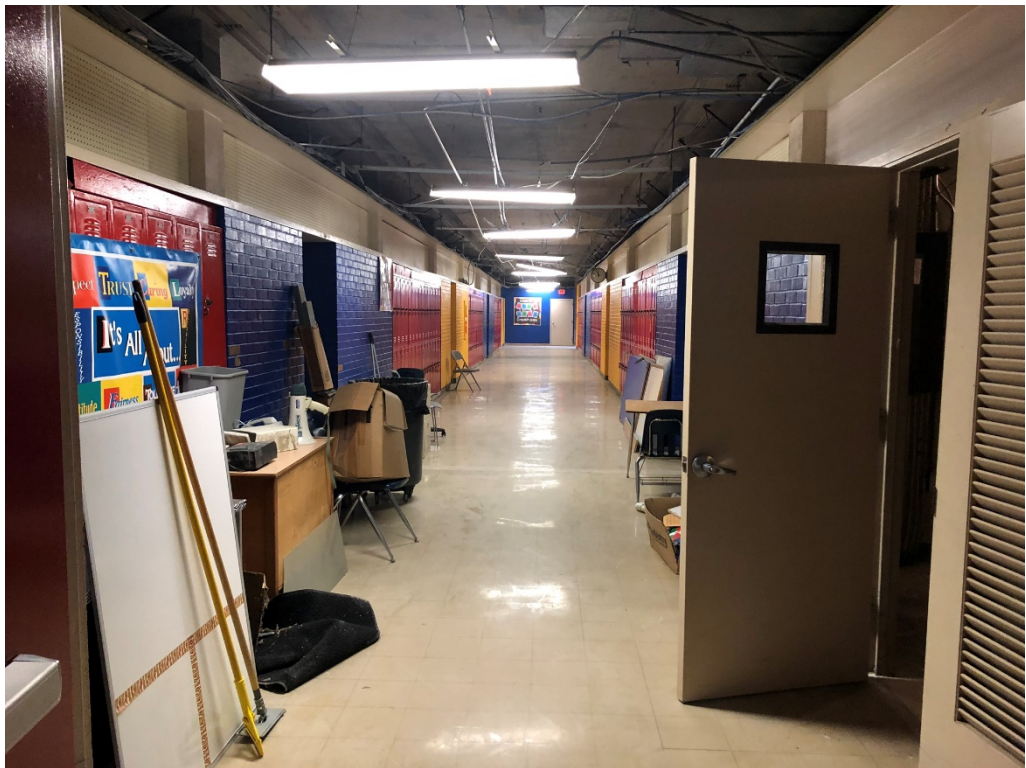
Figure 10 – Ceiling Demo and at West 3<sup>rd</sup> Floor Hall
