Architect's Field Report

24 July 2020

18056-Warren Central Junior High School / Report Number 012

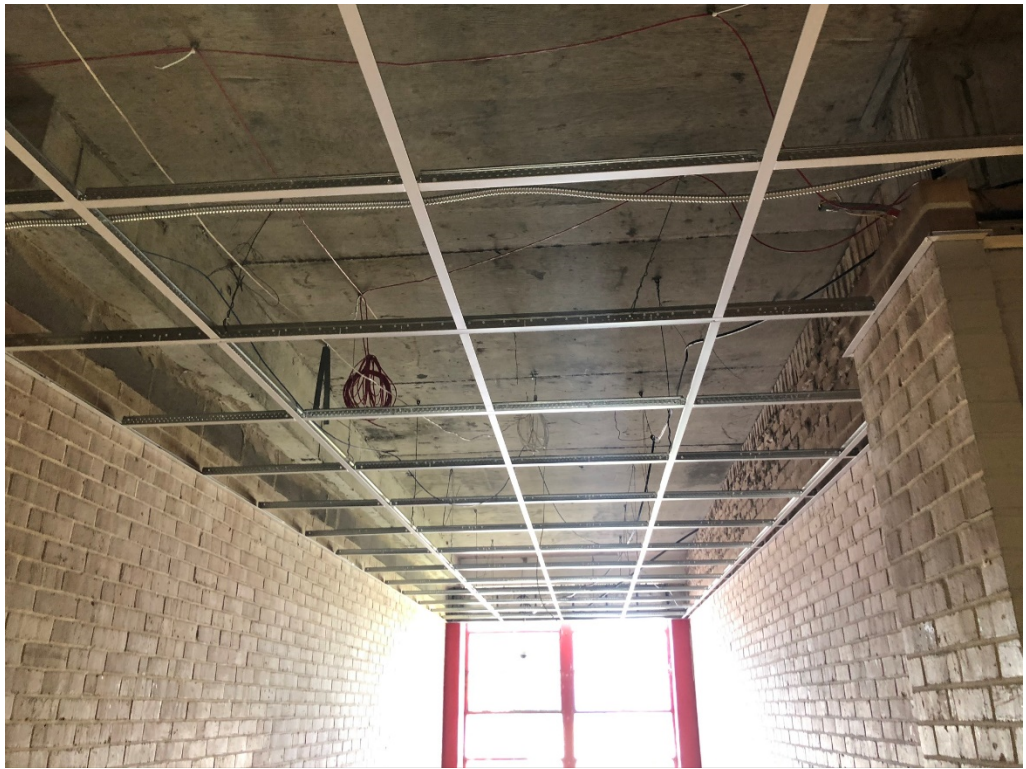
Arriving on site, I entered through the side entrance on the west side of the property. Ceiling Grid has been installed here at the 3rd floor east & west halls. There are some service items still to attend to above the ceiling (ie at least 1 copper connection that is disconnected).

Figure 1 – Ceiling Grid at West hall 3rd Floor

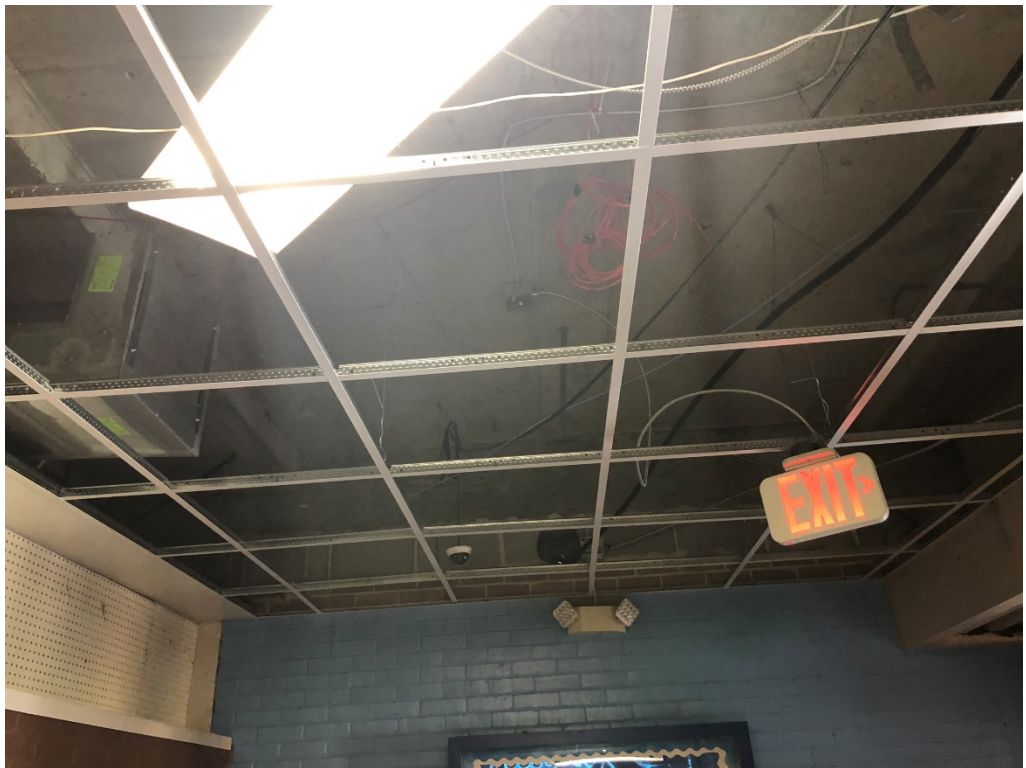
Figure 2 – Ceiling Grid at West hall 3rd Floor

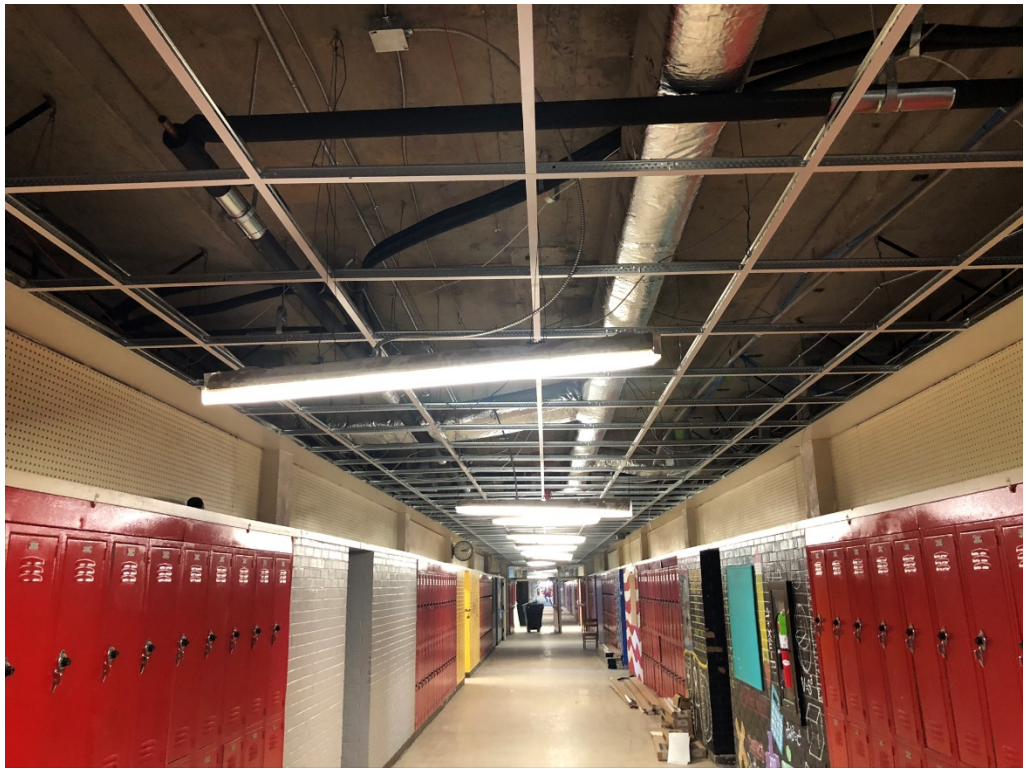
Figure 3 – Ceiling Grid at West hall 3rd Floor

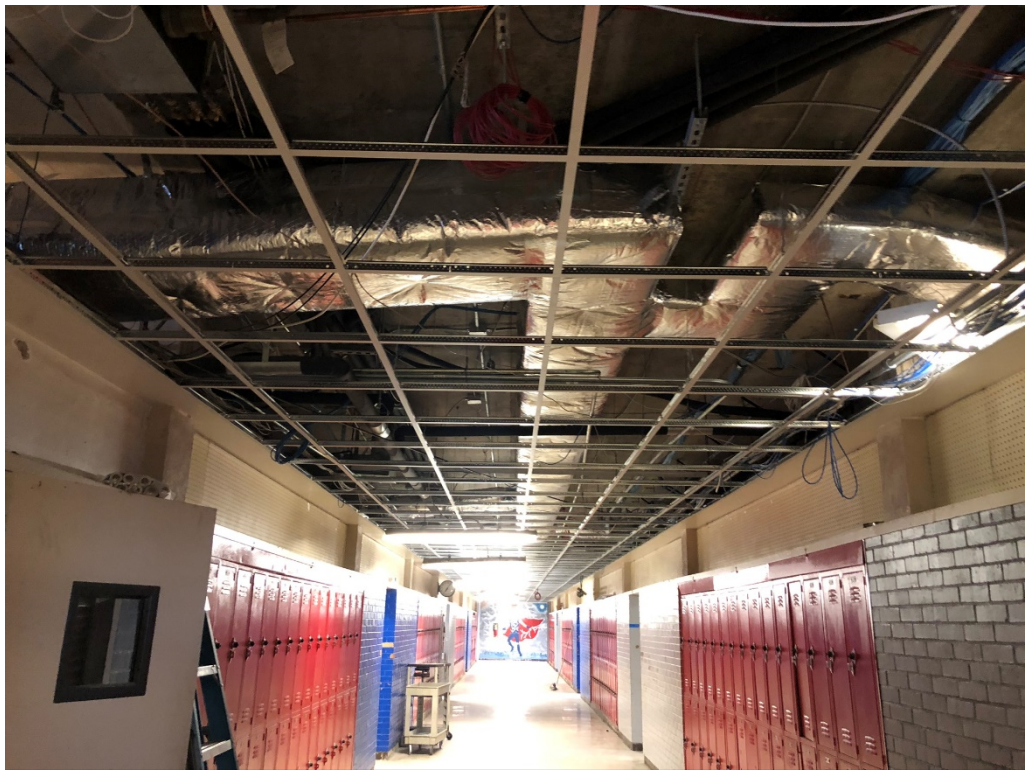
Figure 4 – Ceiling Grid at West hall 3rd Floor

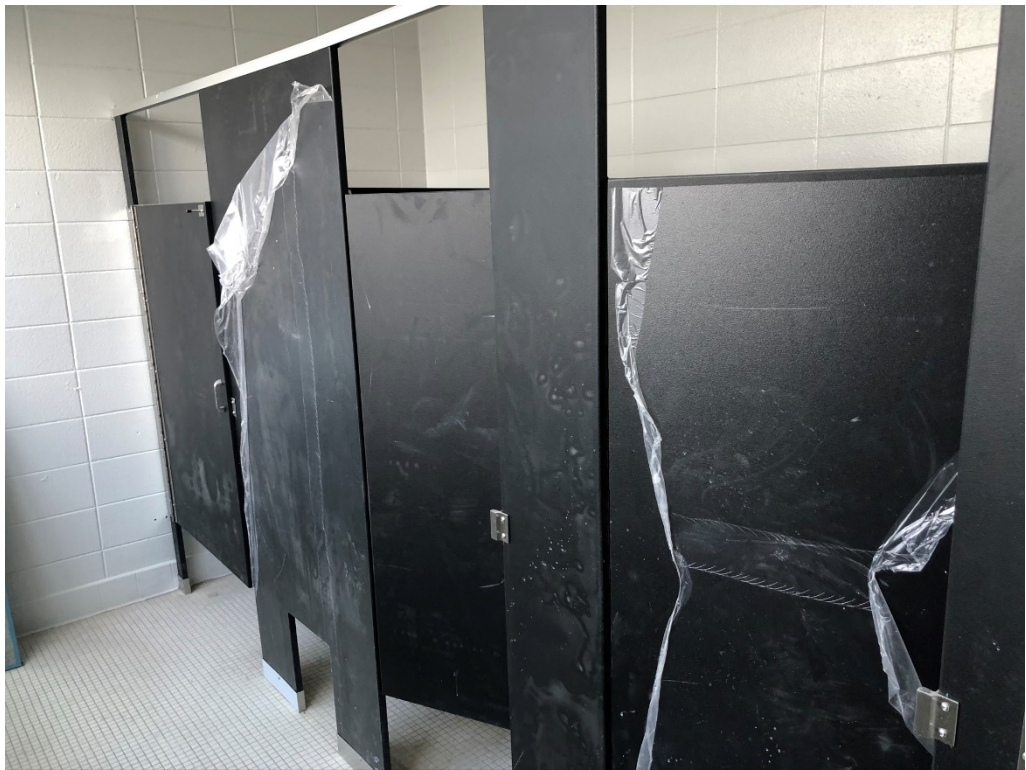
E-319 & E321 have toilet partitions installed. The back side of the new brick wall constructed at the entrances to these 2 rooms have been partially caked with gypsum mud in an effort to level the surface with the existing plaster. This is not acceptable. Plaster should be used in this construction and not gypsum mud as it is incongruous with a masonry material. The installed gypsum mud should be scraped off and a plaster base should be used at the brick to level up with the existing plaster wall.

Figure 6 – E-321 Toilet Partitions

Action Required Remove gypsum mud and install plaster coats at 3rd floor bathroom walls.

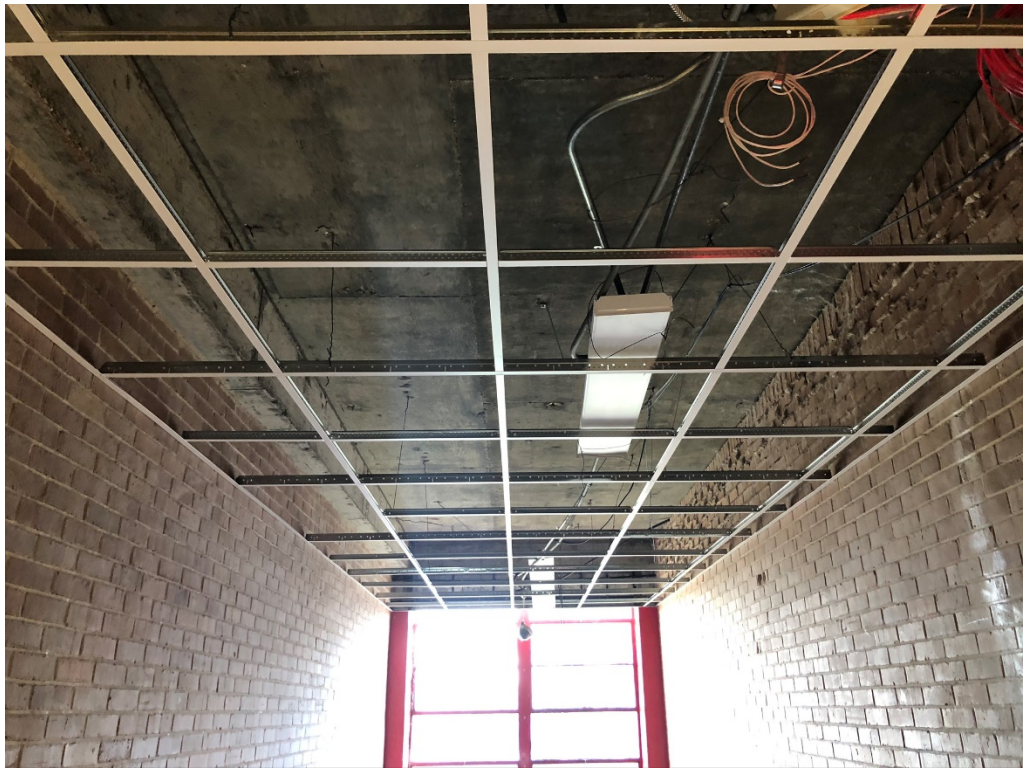
Figure 7 – Ceiling Grid at East hall 3rd Floor

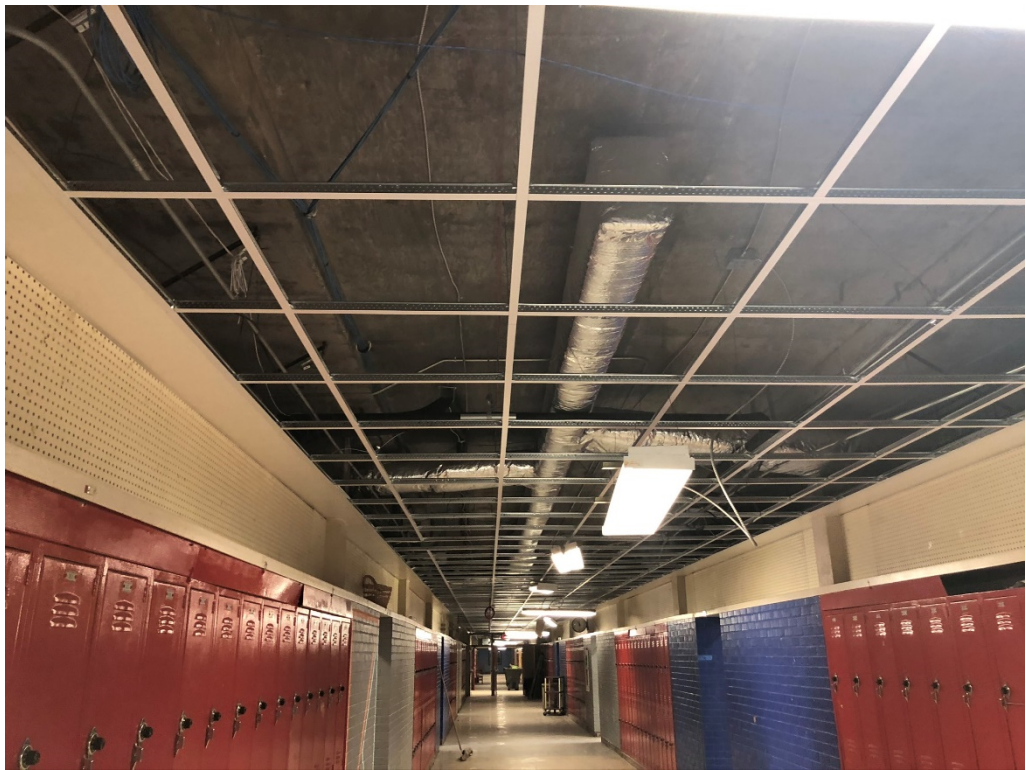
Figure 8 – Ceiling Grid at East hall 3rd Floor

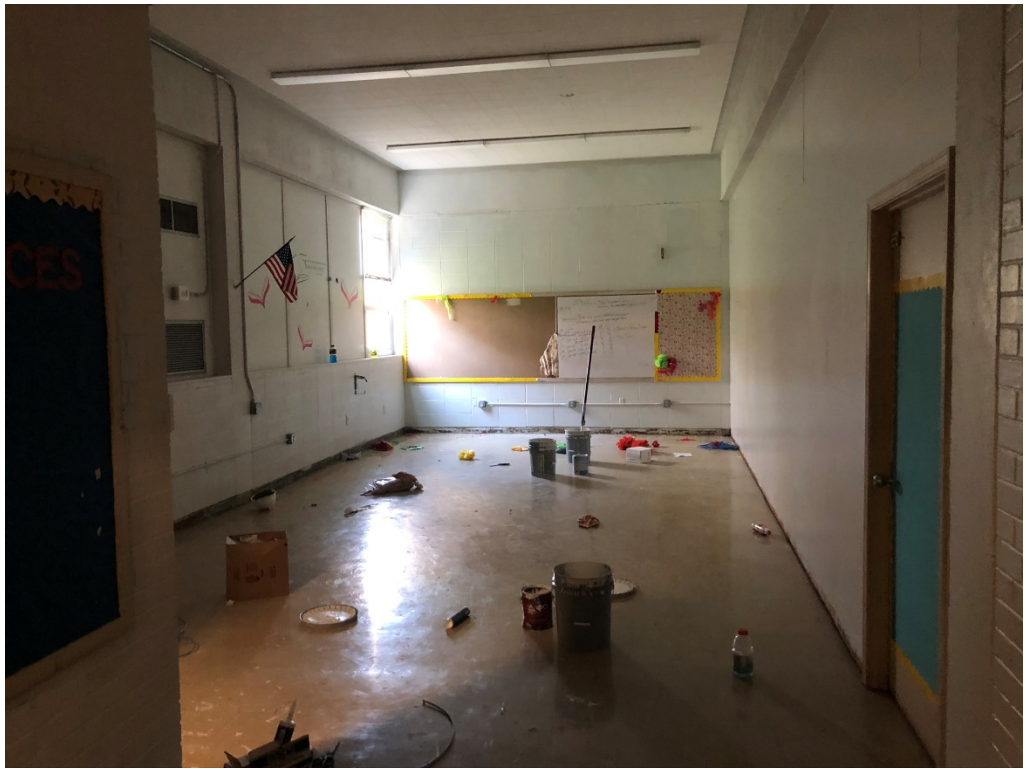
Figure 9 – 1st Floor Paint Work Ongoing

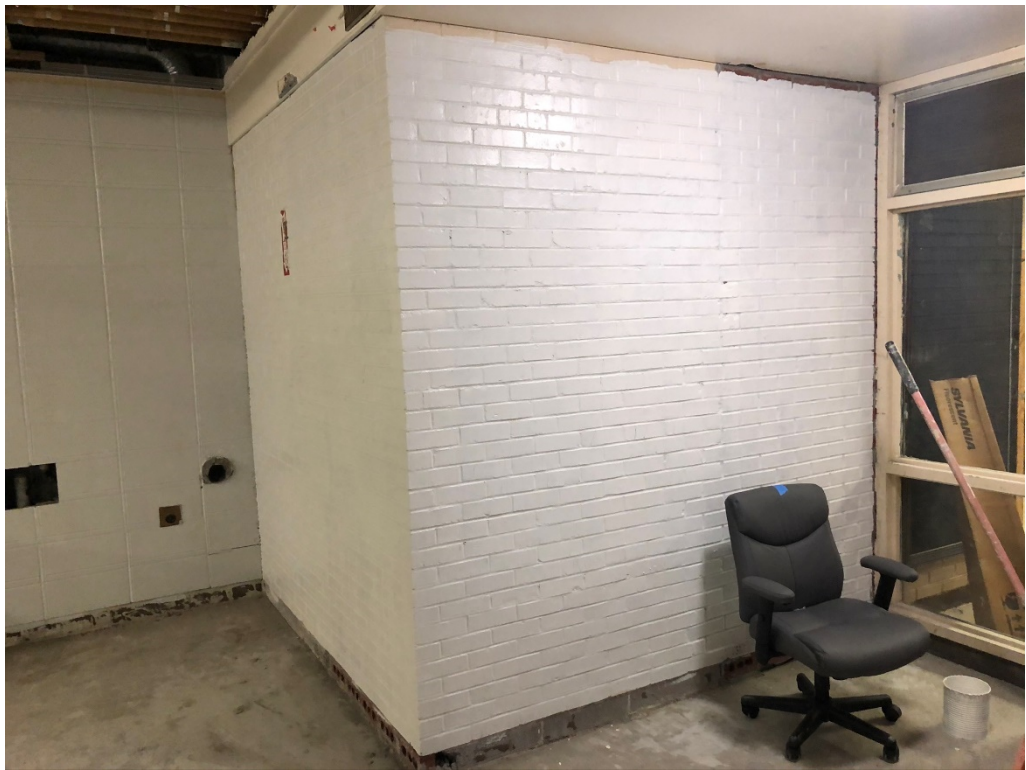
Figure 10 – 1st Floor Bathroom and Painted Brick

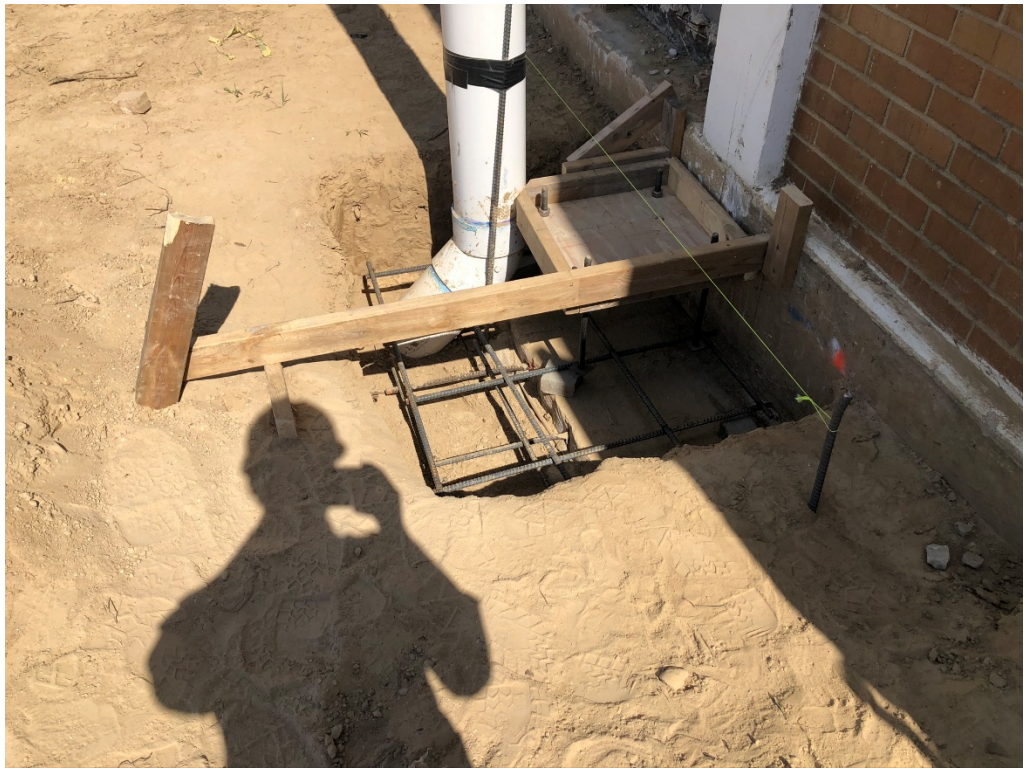
Figure 11 – Formed Spread Footing

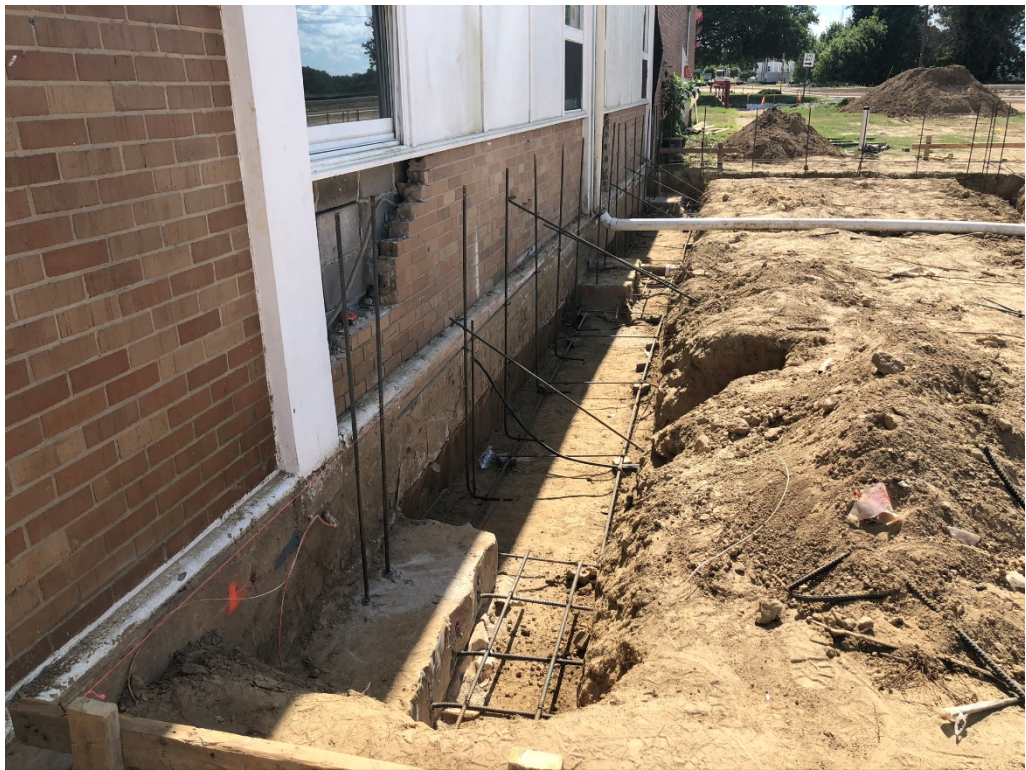
Grade beams at the addition are prepared for concrete which should be occurring today.

Figure 12 – Formed Grade Beam at Addition

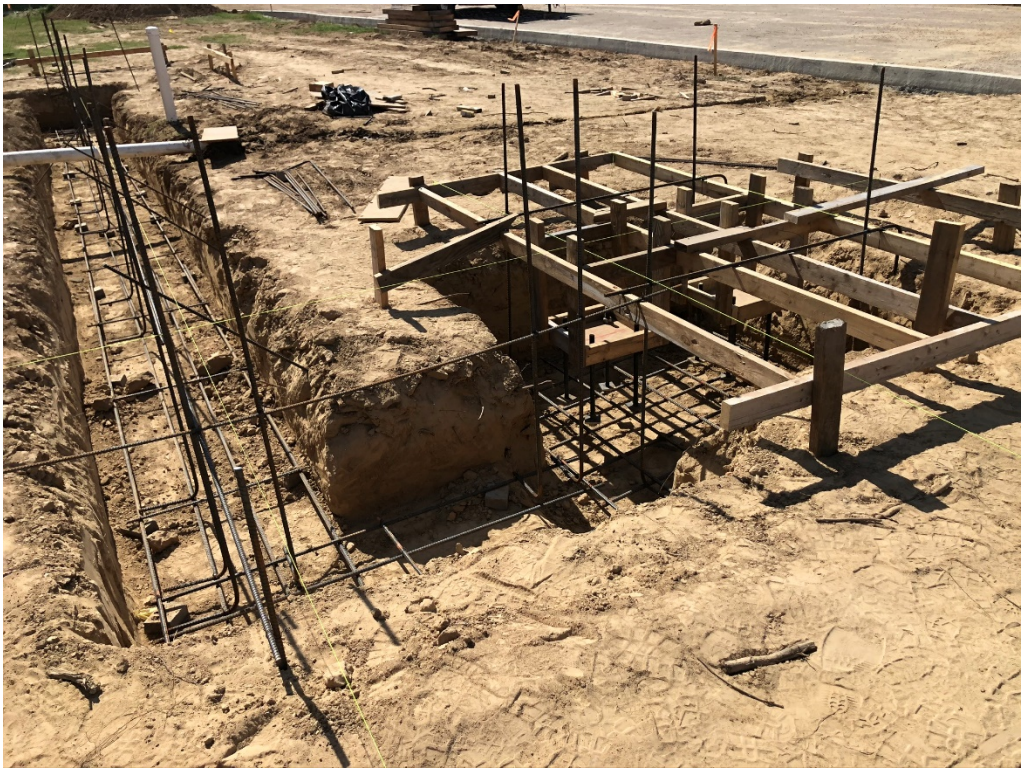
Figure 13 – Formed Grade Beam at Addition

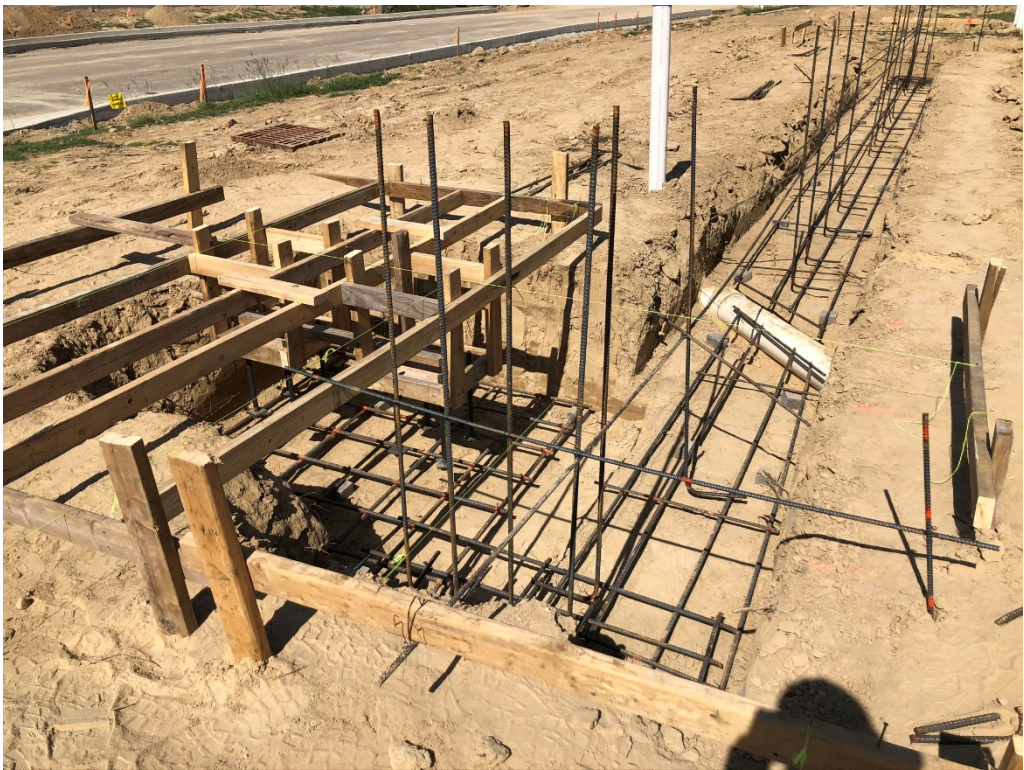
Figure 14 – Formed Grade Beam at Addition
