## Architect's Field Report

31 December 2020

18056-Warren Central Junior High School / Report Number 018

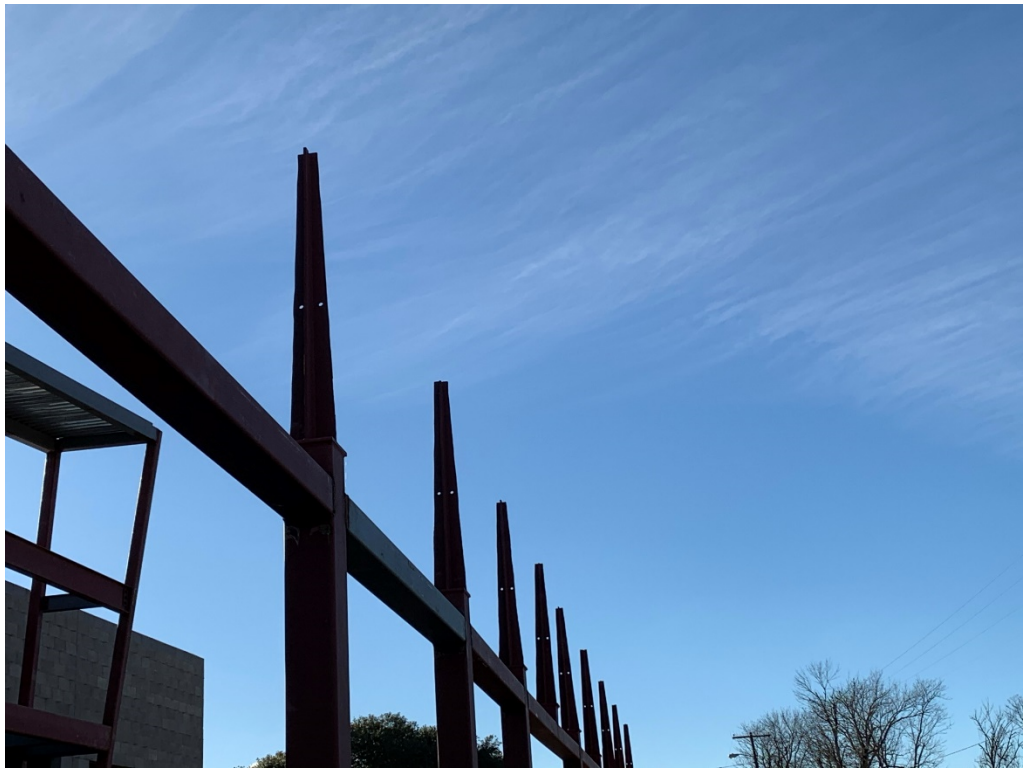
At the exterior, steel work at the entrance has been performed. Spires at the drop off have also been installed, but are not acceptable and require replacement. Cuts at these finished pieces are not straight.

Figure 1 – Steel Spires need to Be Replaced with New spires that are cut Straight

Action Required Replace Spires where cuts are not straight.

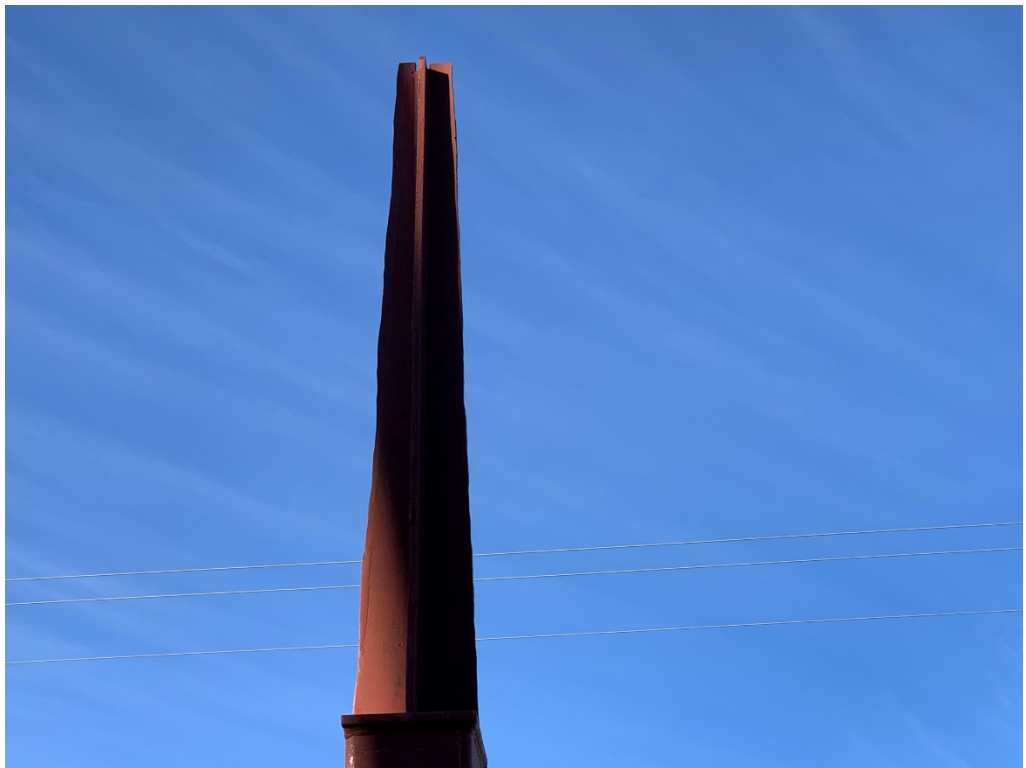
Figure 2 – Steel Spires need to Be Replaced with New spires that are cut Straight

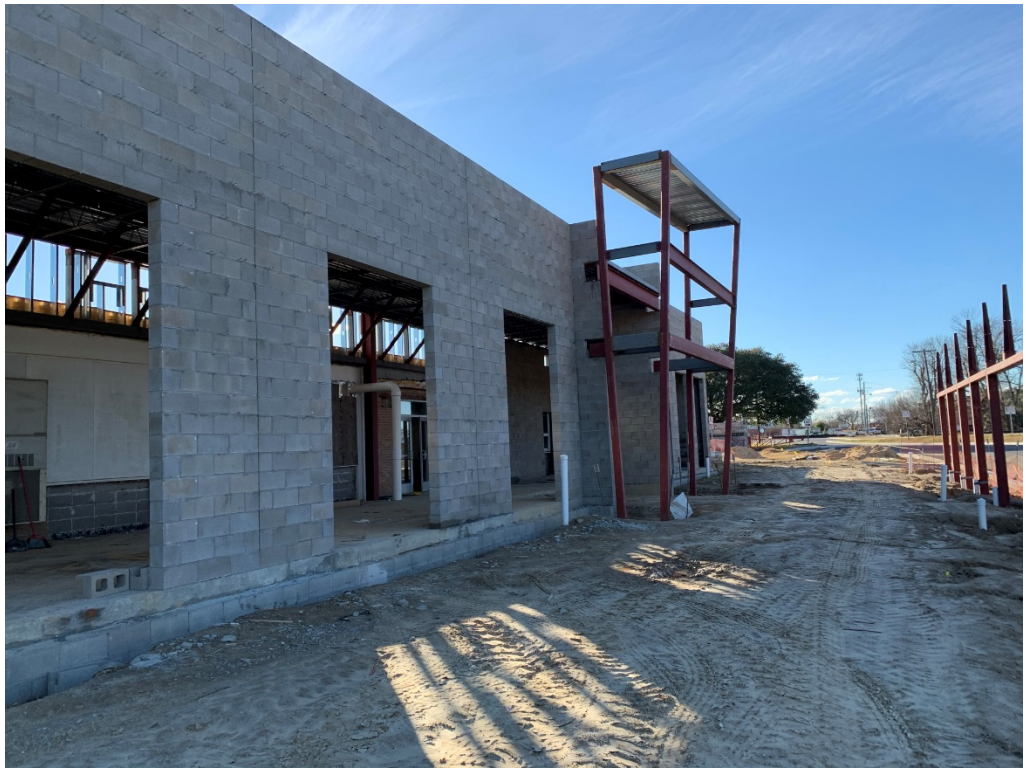
Figure 3 – Steel Entry Work

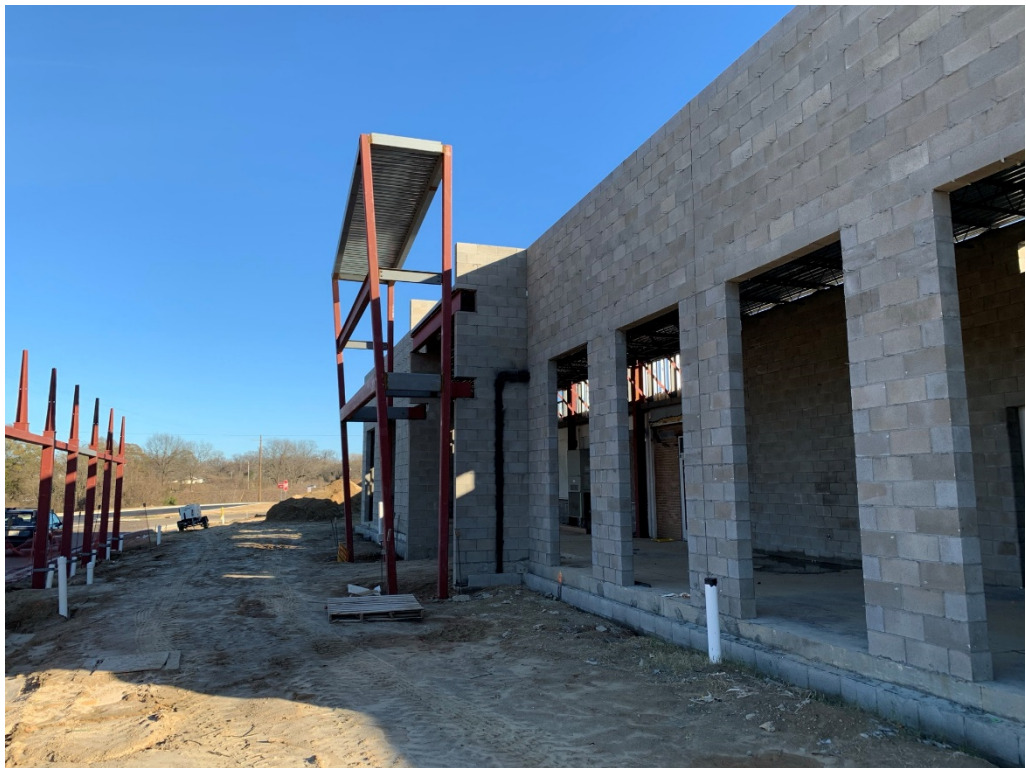
Figure 4 – Steel Entry Work

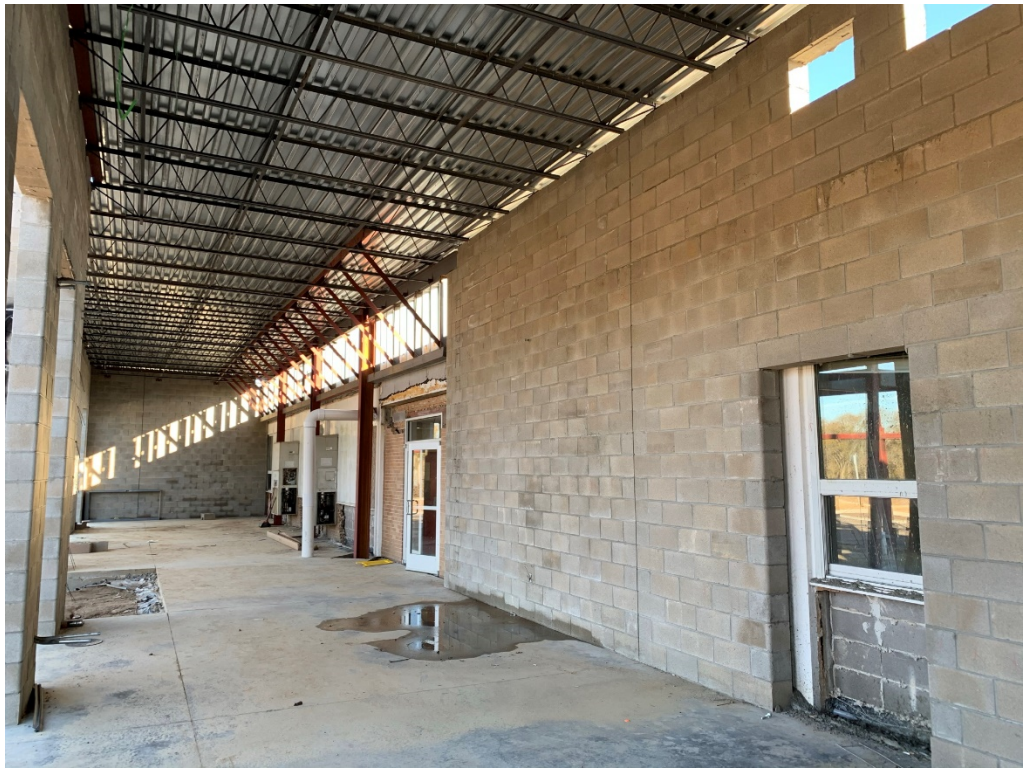
Figure 5 – Interior of New Addition

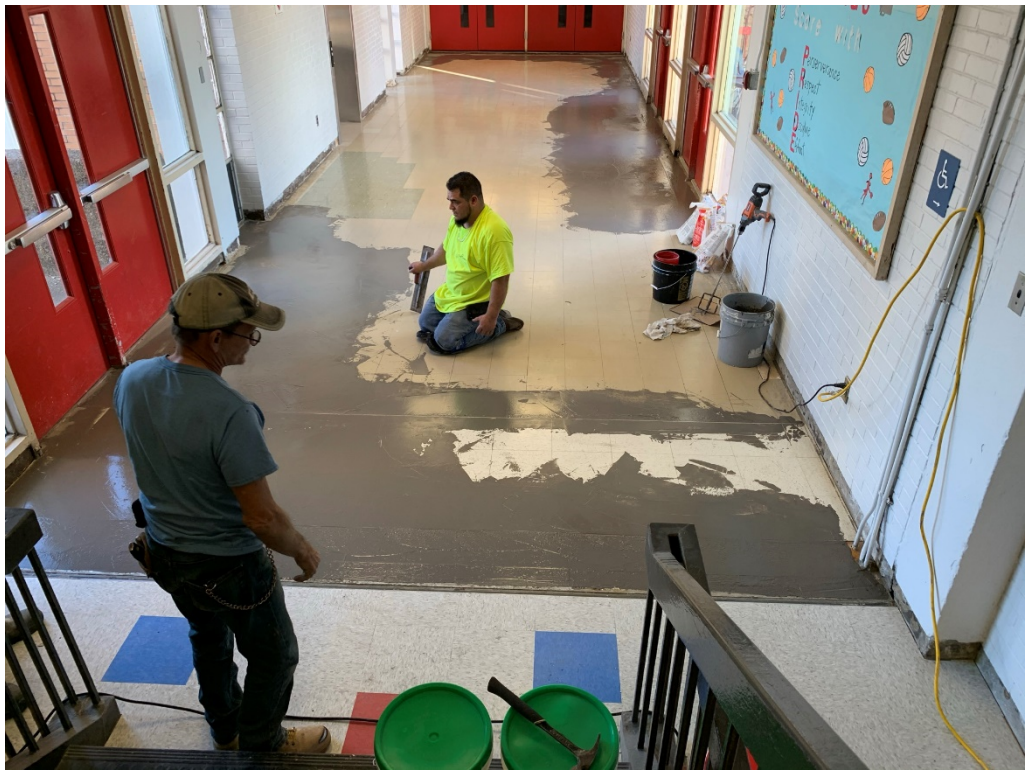
Figure 6 – Floor Work at Second Floor

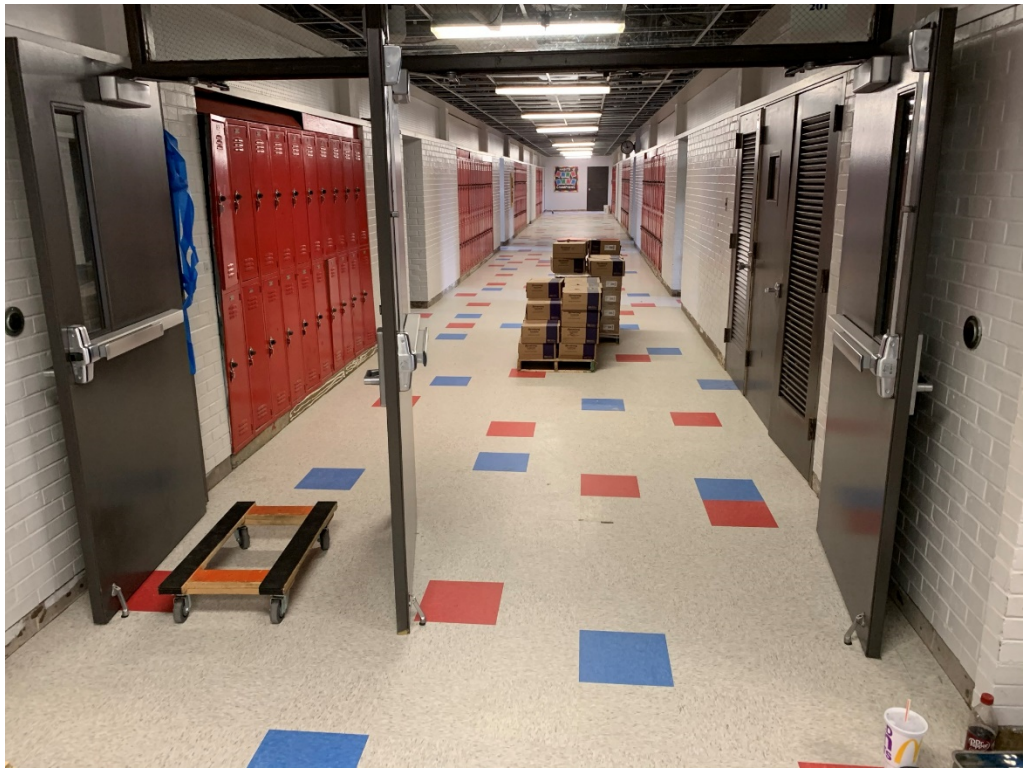
Figure 7 – Floor Work at Second Floor

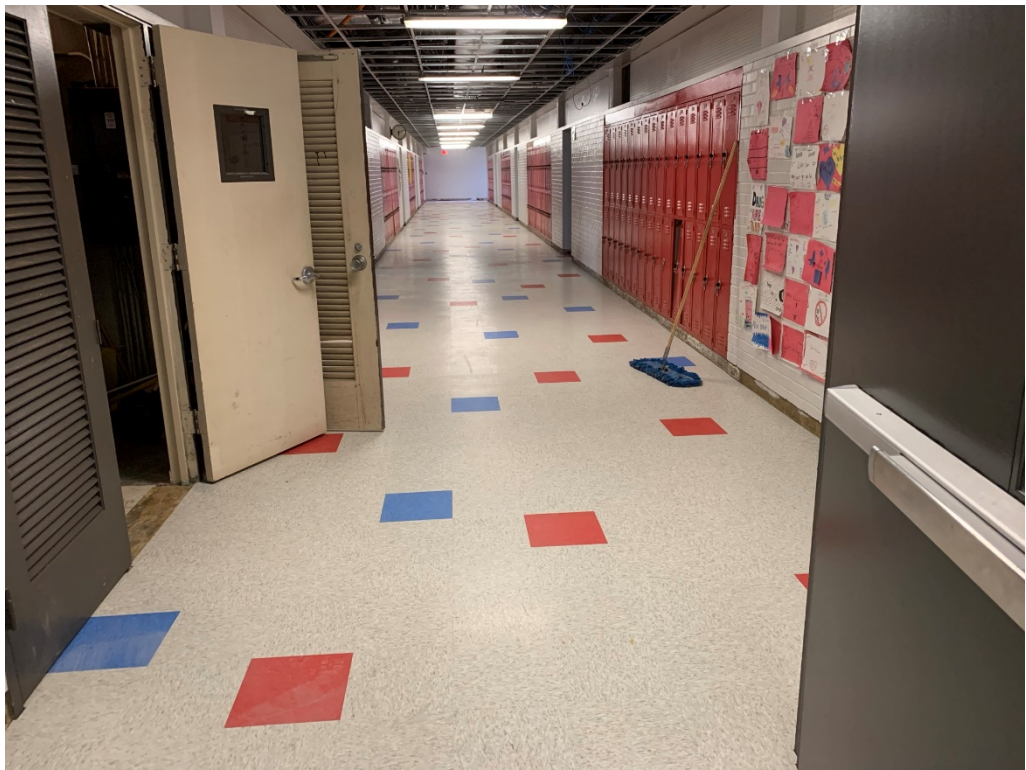
Figure 8 – Floor Work at Second Floor

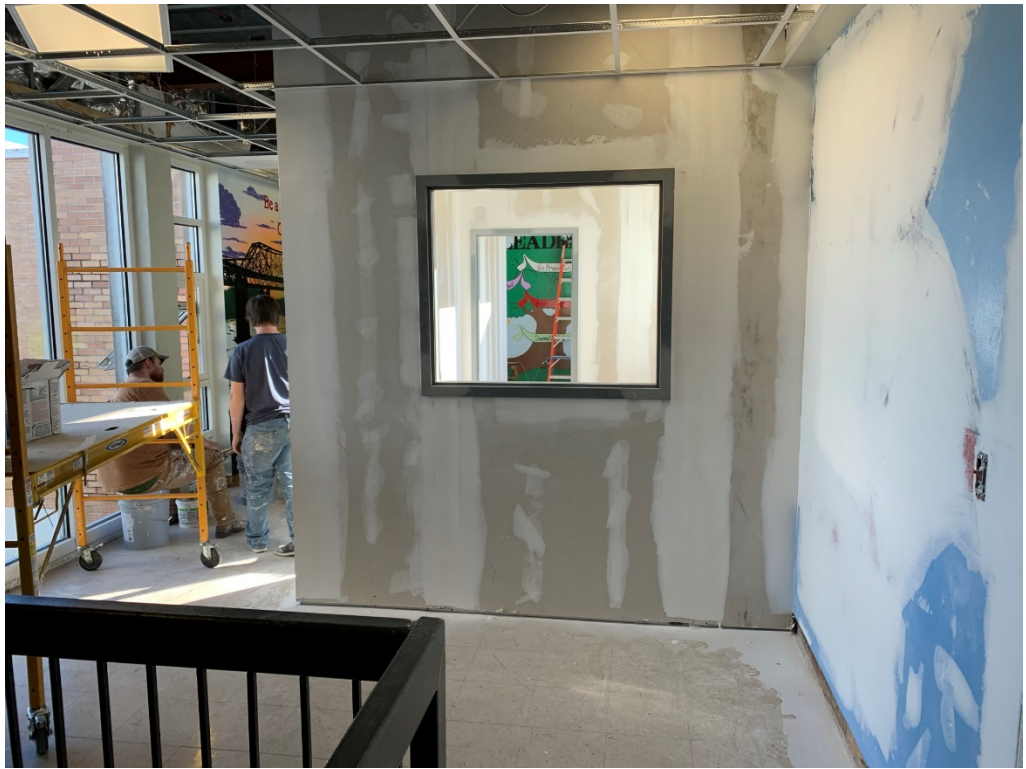
Figure 9 – Paint work is Ongoing

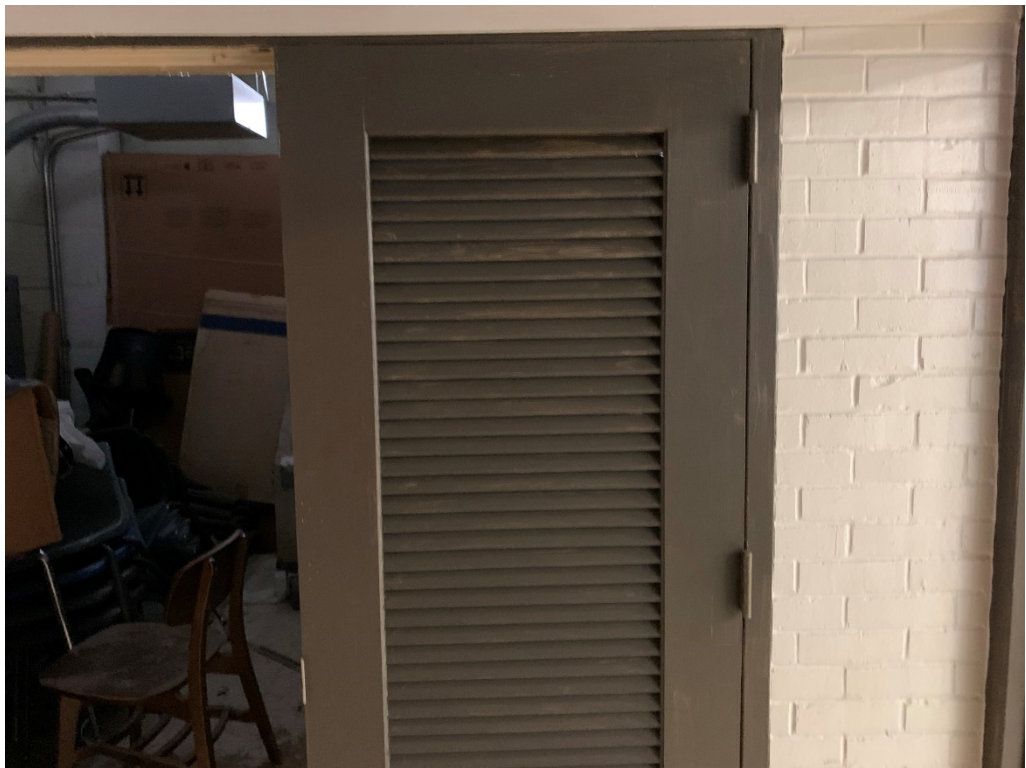
Figure 10 – Paint work is Ongoing
