## Architect's Field Report

31 March 2021

18056-Warren Central Junior High School / Report Number 021

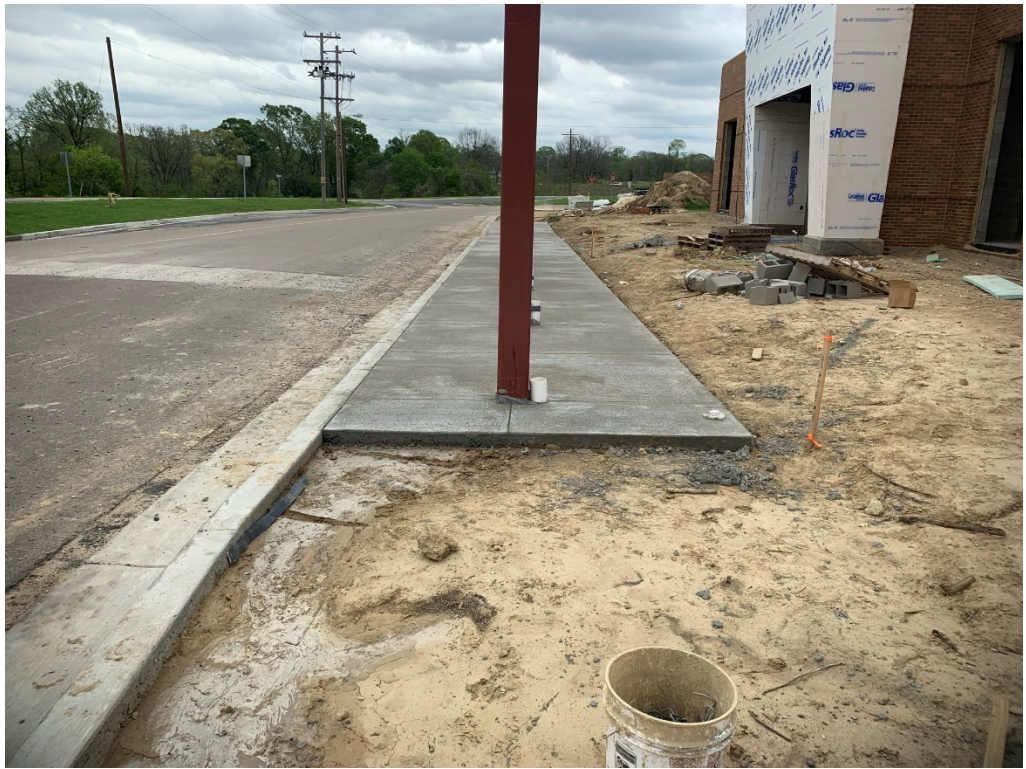
Observations Arriving on site, I note that work has been performed at the drop-off sidewalk location. The ADA ramp looks good at this sidewalk.

Figure 1 – New Sidewalk at Road

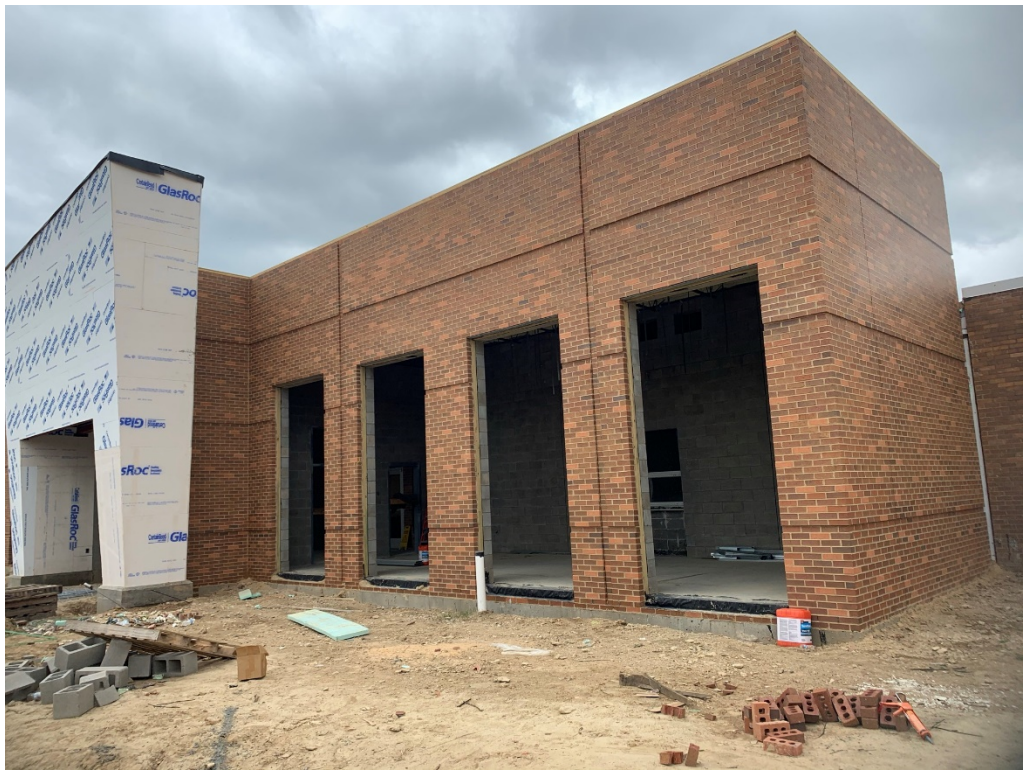
Figure 2 – Addition Progress

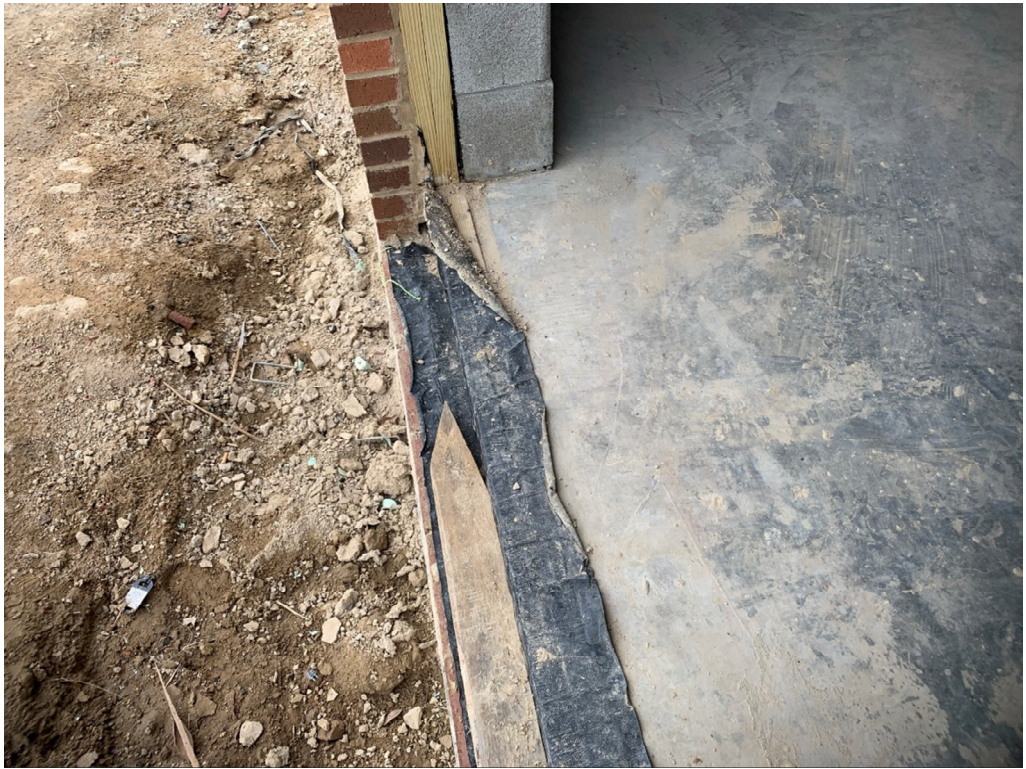
Membrane Flashing at windows will need to be replaced were damaged before window installation.

Figure 3 – Asphalt Flashing will require repair/replacement

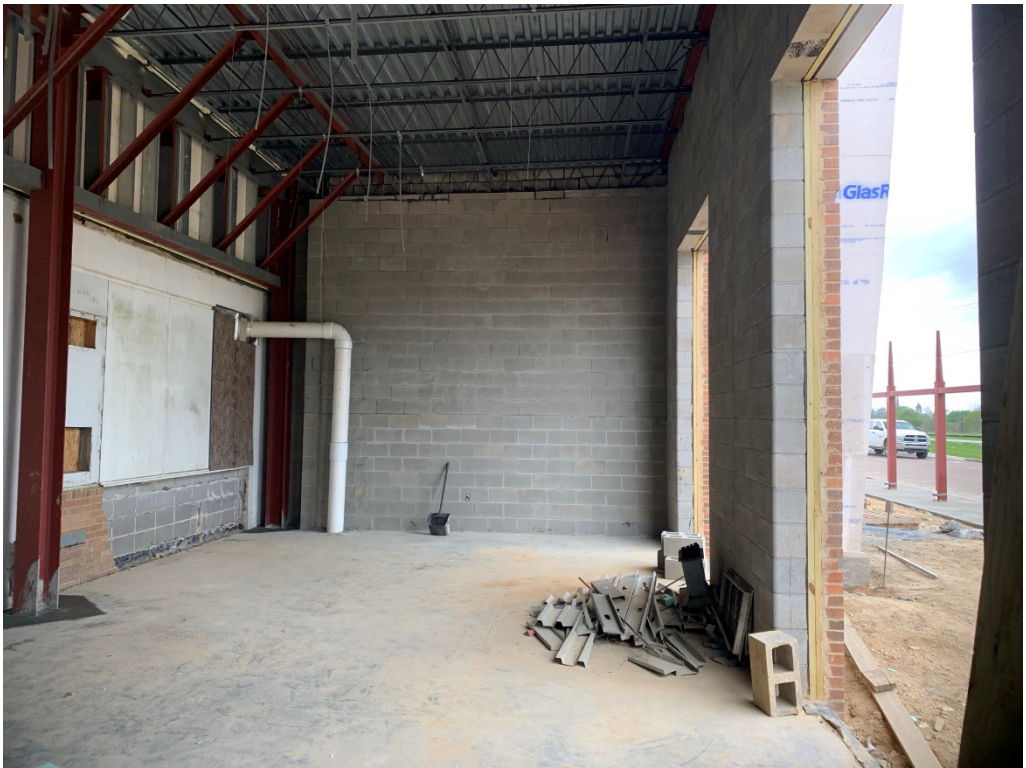
Figure 4 – New CMU Interior Wall

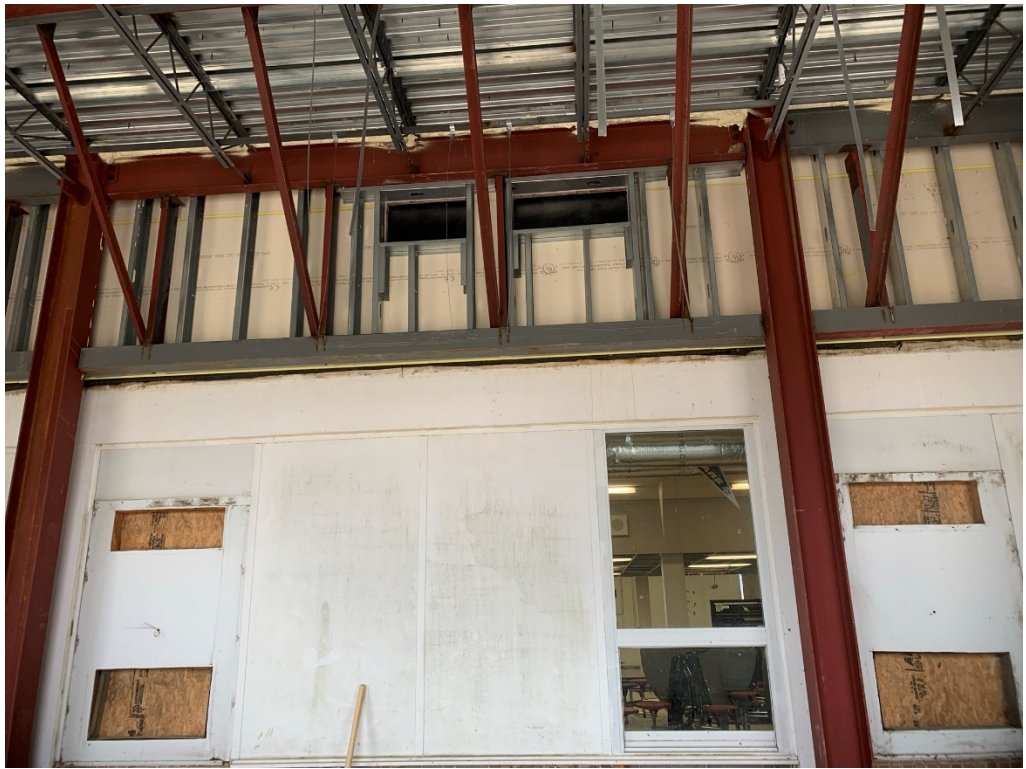
Figure 5 – Ducting Framed In

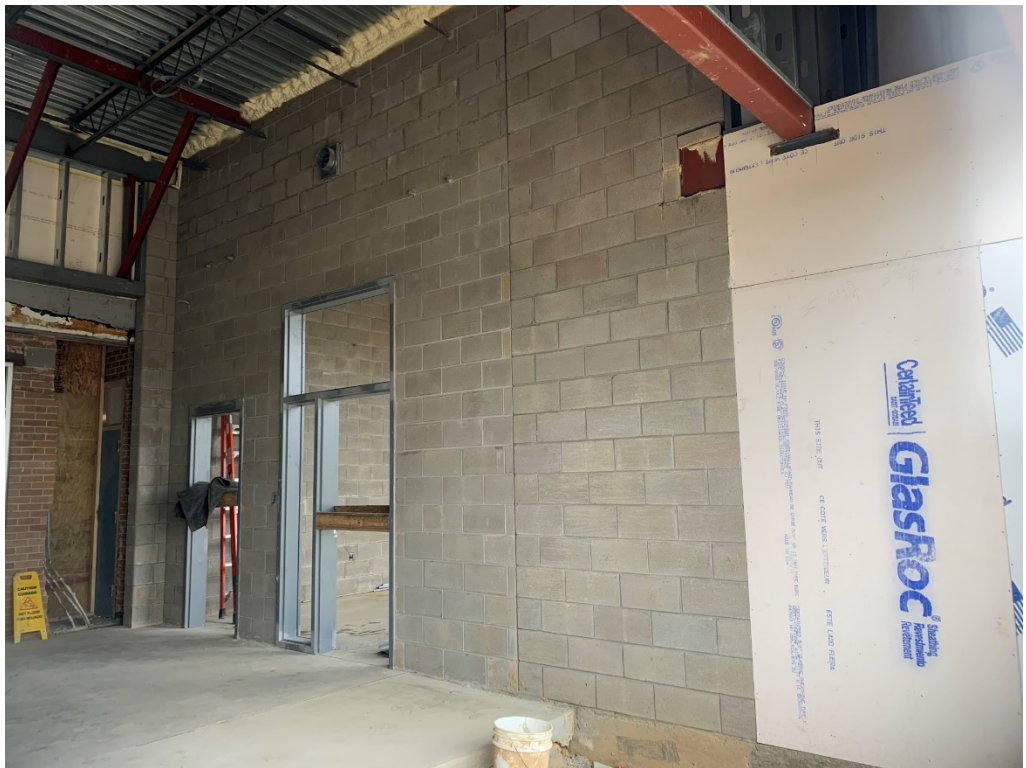
At the interior of the addition, CMU block walls have been installed to roof deck; there is foam at a rated wall here that needs to be removed as this is a fire-rated interior wall. Details concerning foam between block and roof deck apply to exterior walls only. Remove foam and complete block with mortar to deck as is required for Fire-Rating.

Figure 6 – New CMU Interior Wall with Frames; there should be no foam at this rated wall

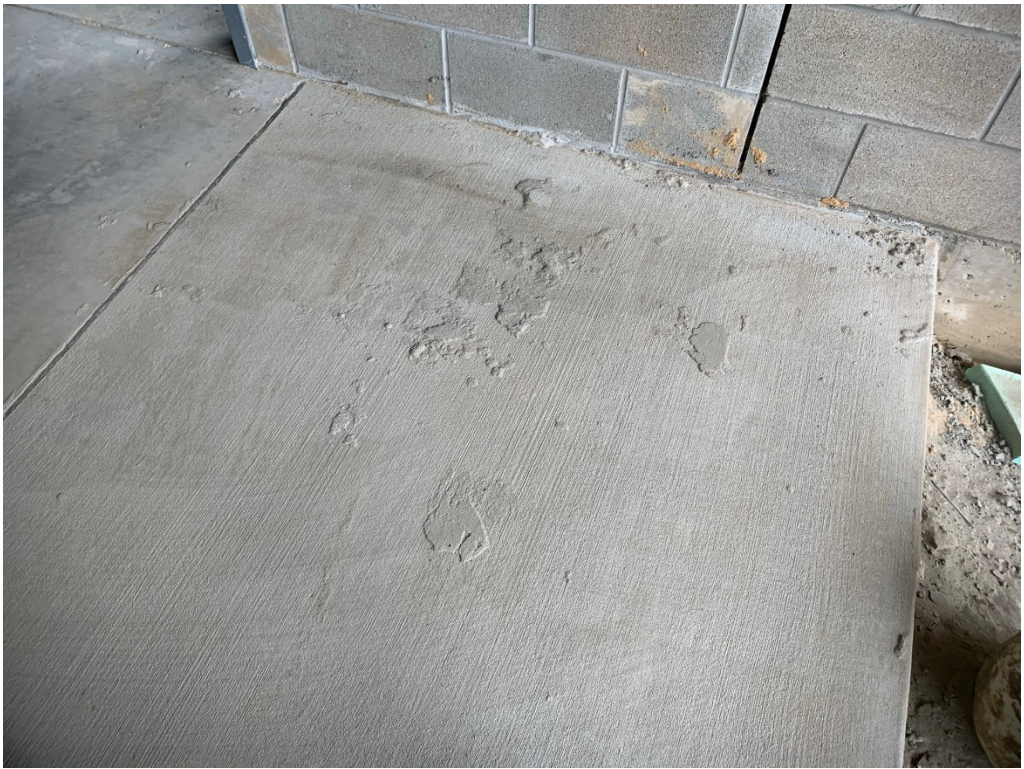
Also, in this area, mortar has been spilled at our new concrete entry platform that needs to be removed without damaging our new concrete brushed finish.

Figure 7 – Mortar Spills on New Concrete

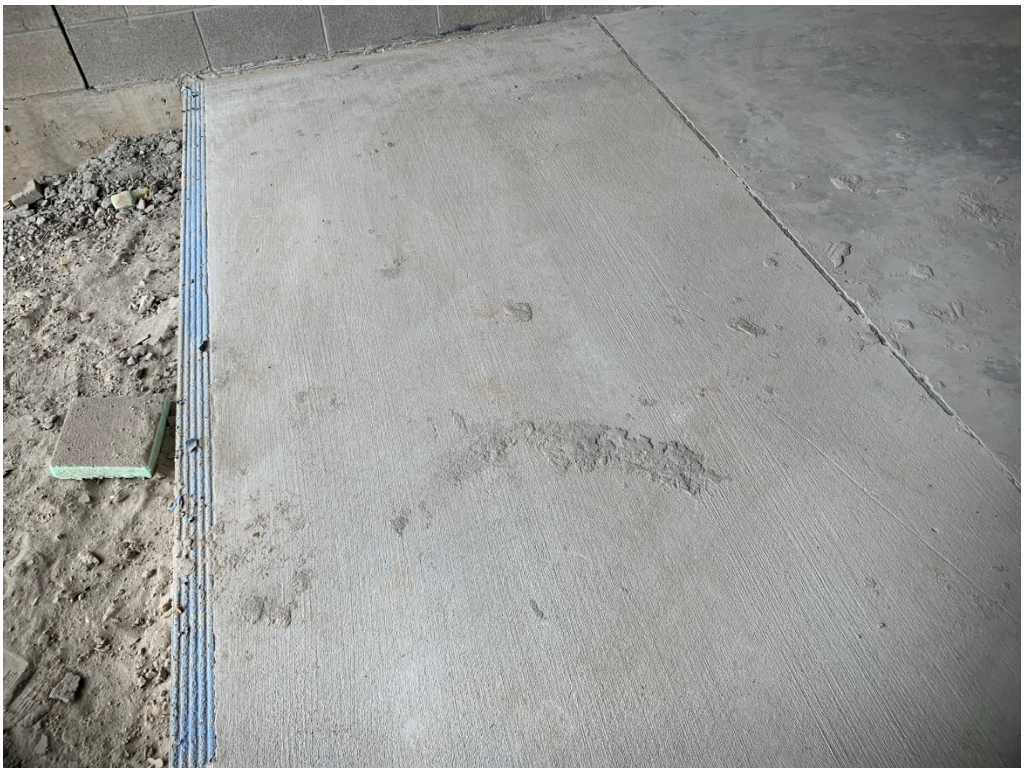
Figure 8 – Mortar Spills on New Concrete

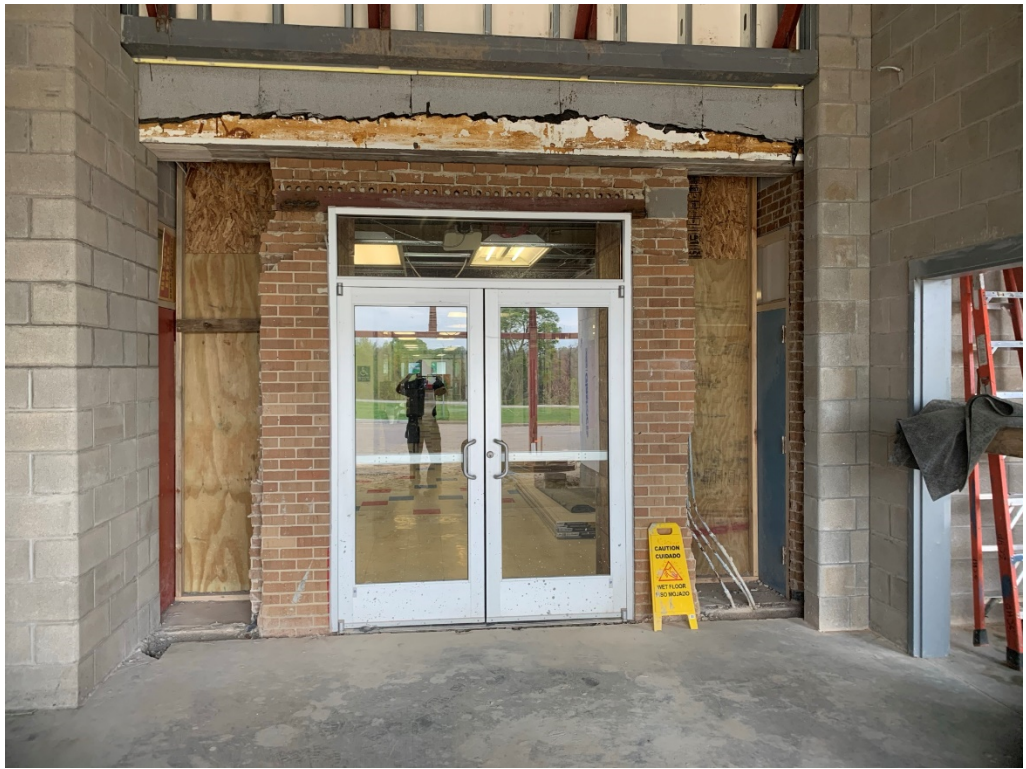
Figure 9 – Partially Demoed Entry

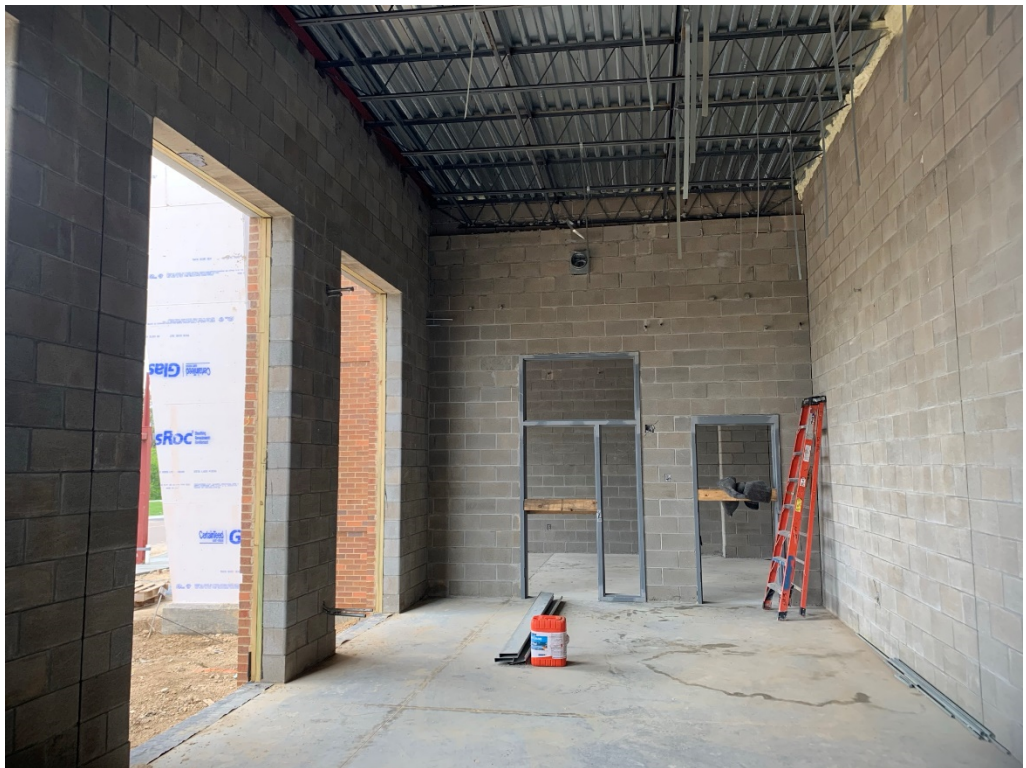
Figure 10 – New CMU Interior Wall with Frames

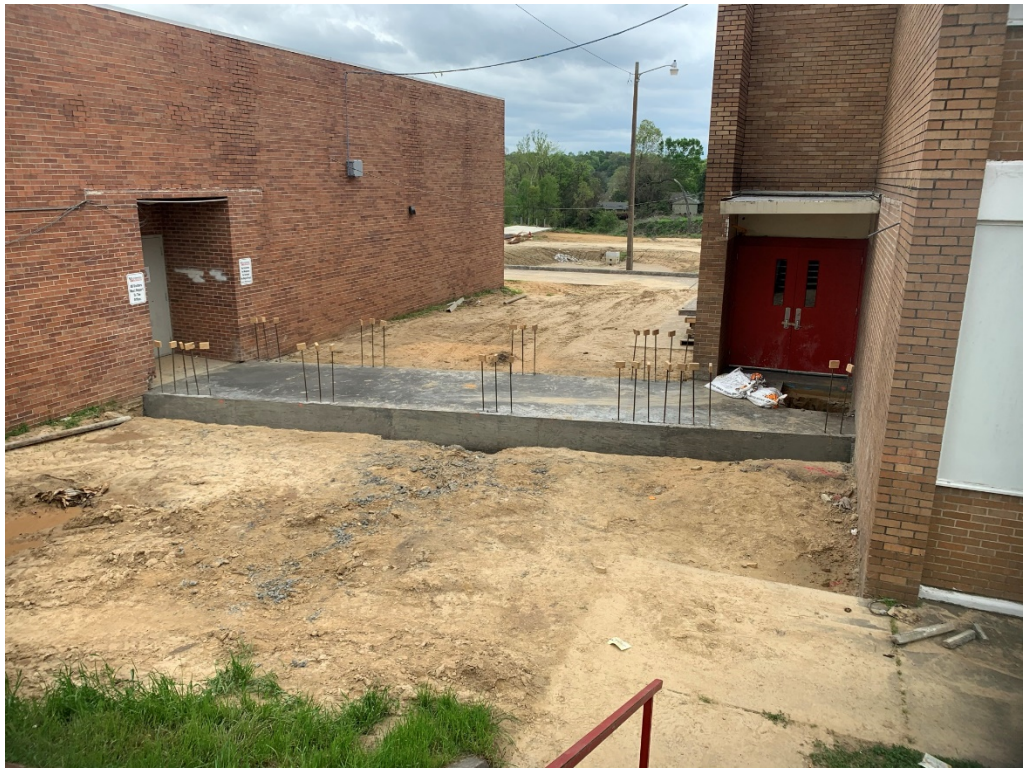
Figure 11 – New Slab @ Connector

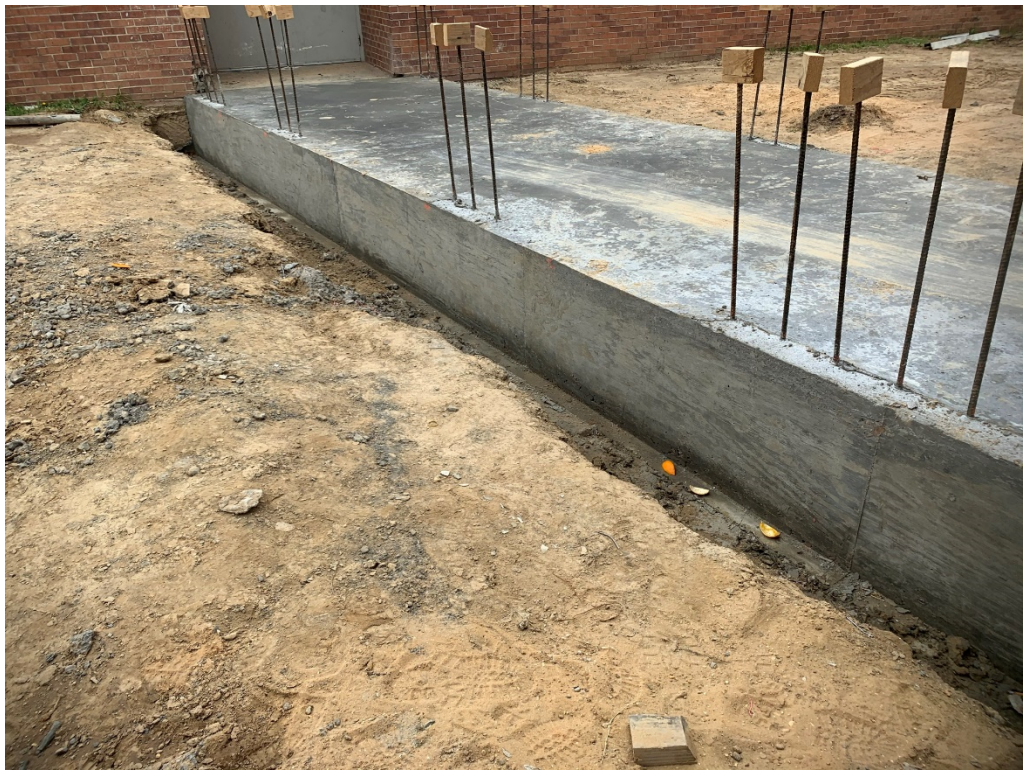
Figure 12 – New Slab @ Connector

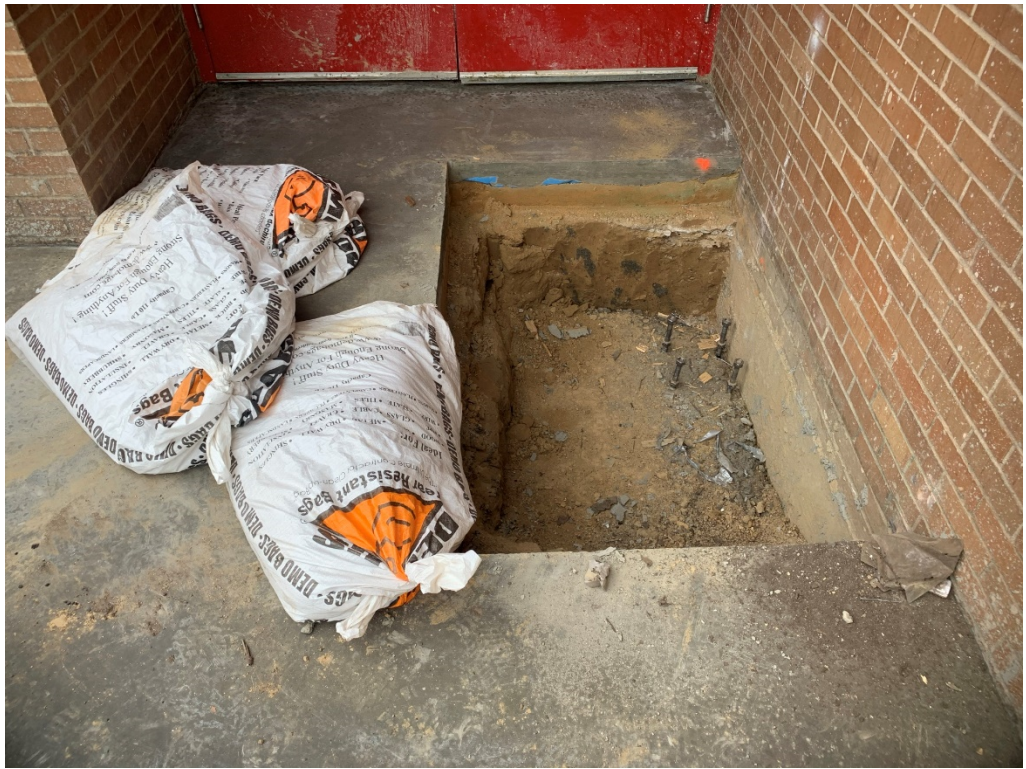
At the connection between buildings, concrete work looks good; there is an open excavation that has no warning barriers around it and could be a hazard to anyone wandering onto the site.

Figure 13 – Inadequate Protection at Excavation

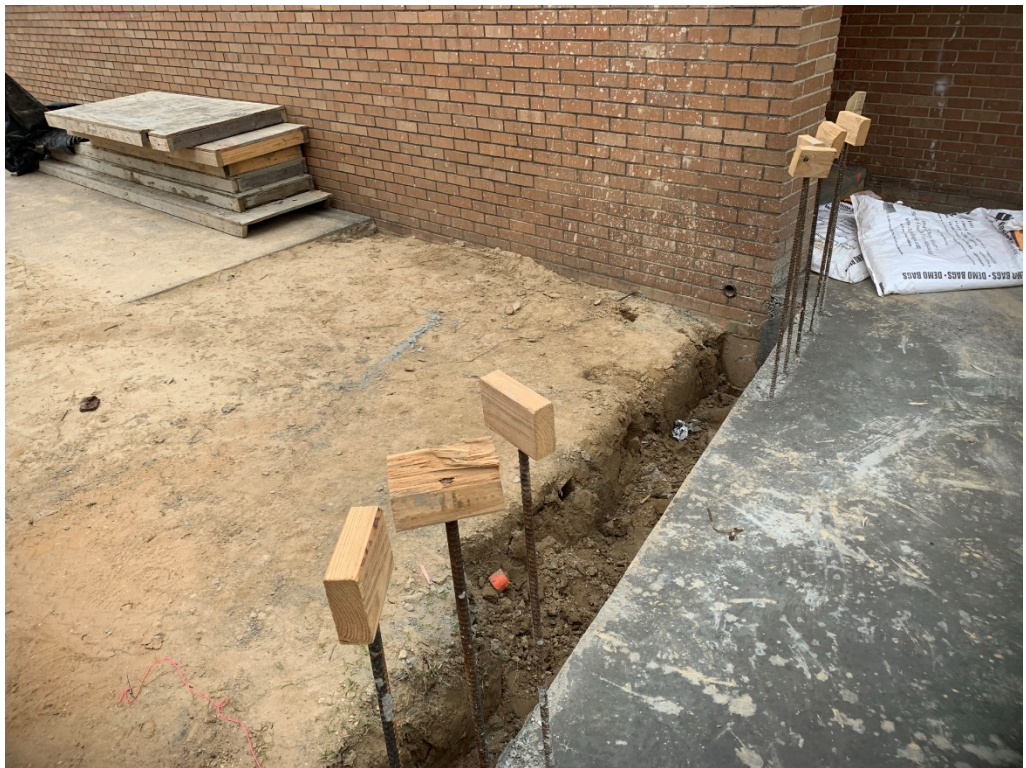
The new concrete foundation appears to be around 3-4" taller than the nearest sidewalk. Be sure to maintain a slope no greater than the 1:12 required in the contract documents.

Figure 14 – Difference Between New Slab & Sidewalk appears to require at least 36' of ramp to maintain 1:12 slope min but preferably should be 1:20 (60')
