## Architect's Field Report

23 April 2021

18056-Warren Central Junior High School / Report Number 022

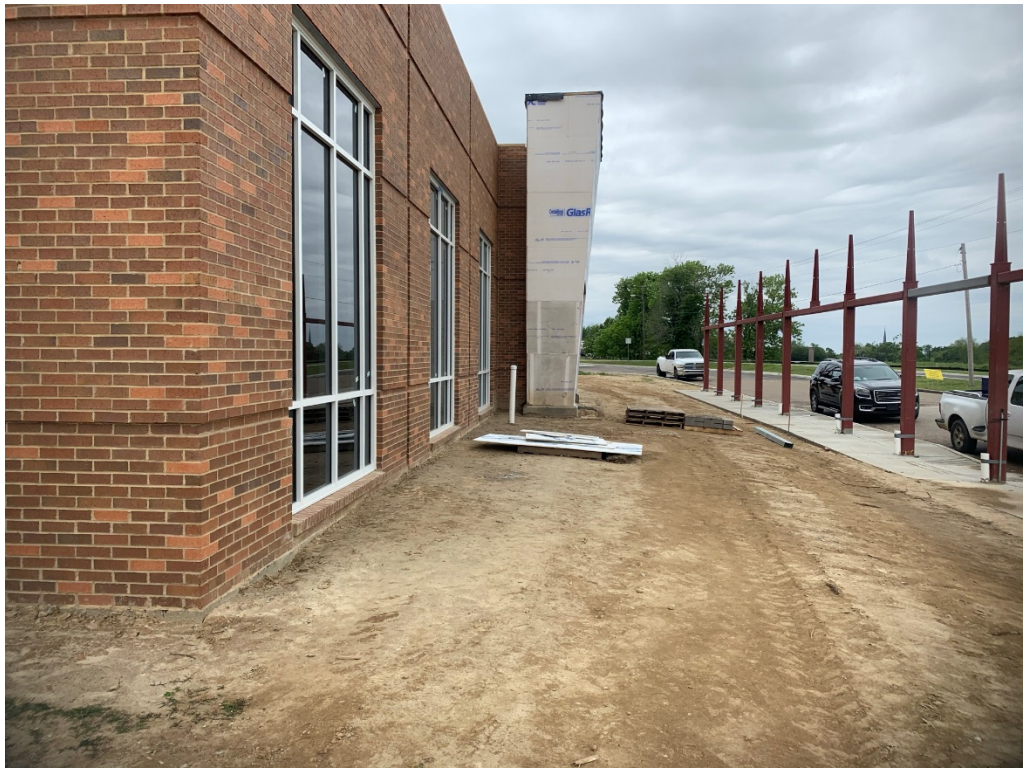
Figure 1 – Curtain Wall Installed at addition

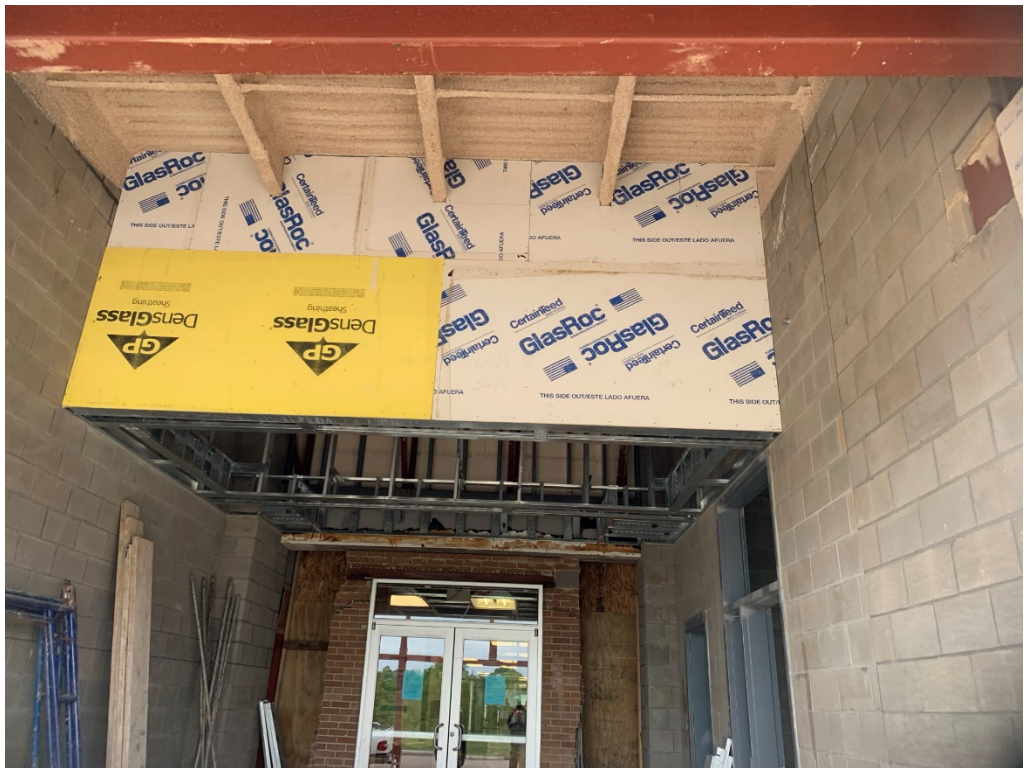
Figure 2 – Progress at main entry

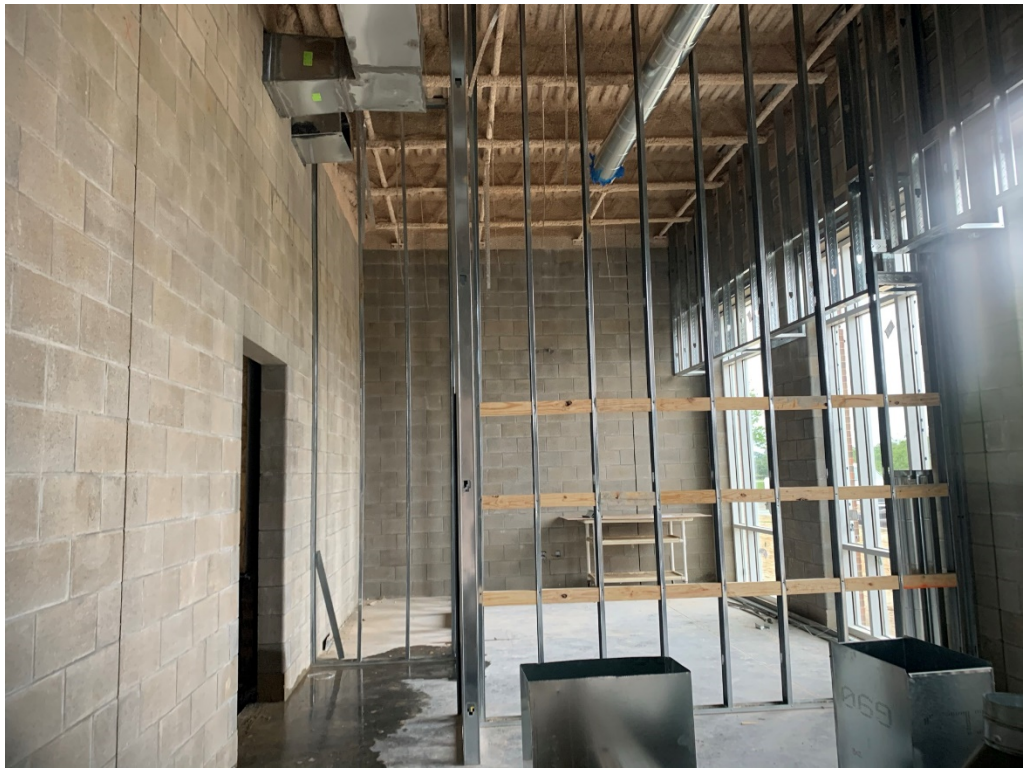
Figure 3 – Admin Area Framing (water from recently cut opening for ducting; to be sealed)

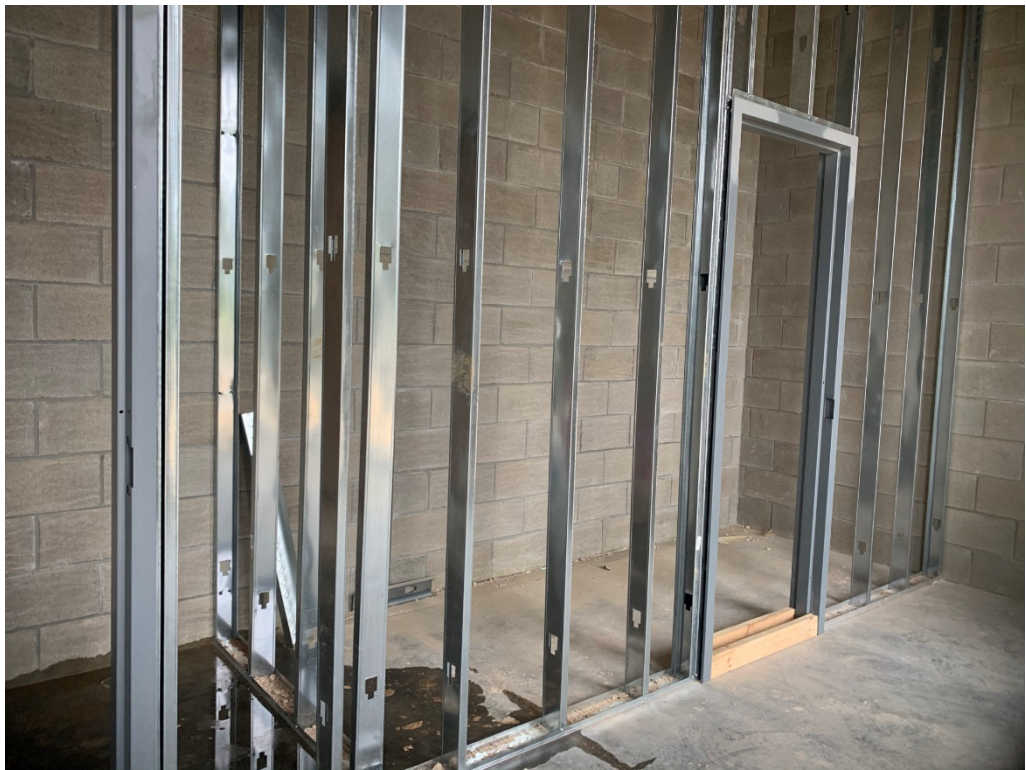
Figure 4 – Admin Area Framing (water from recently cut opening for ducting; to be sealed)

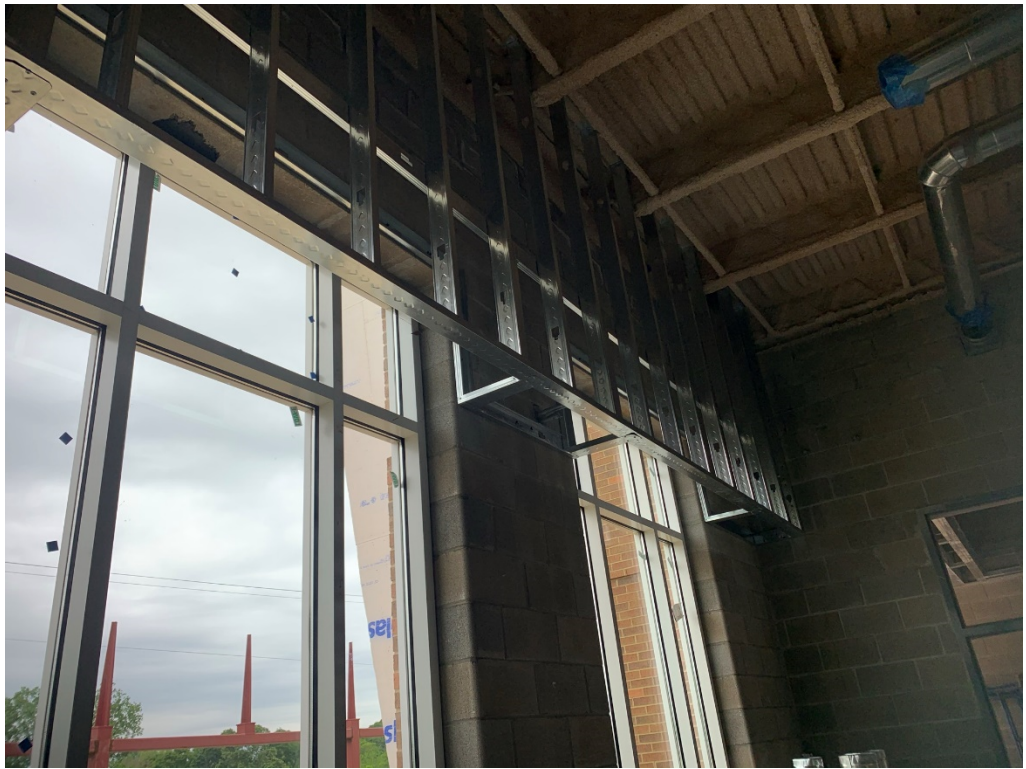
Figure 5 – Admin Area; furr down

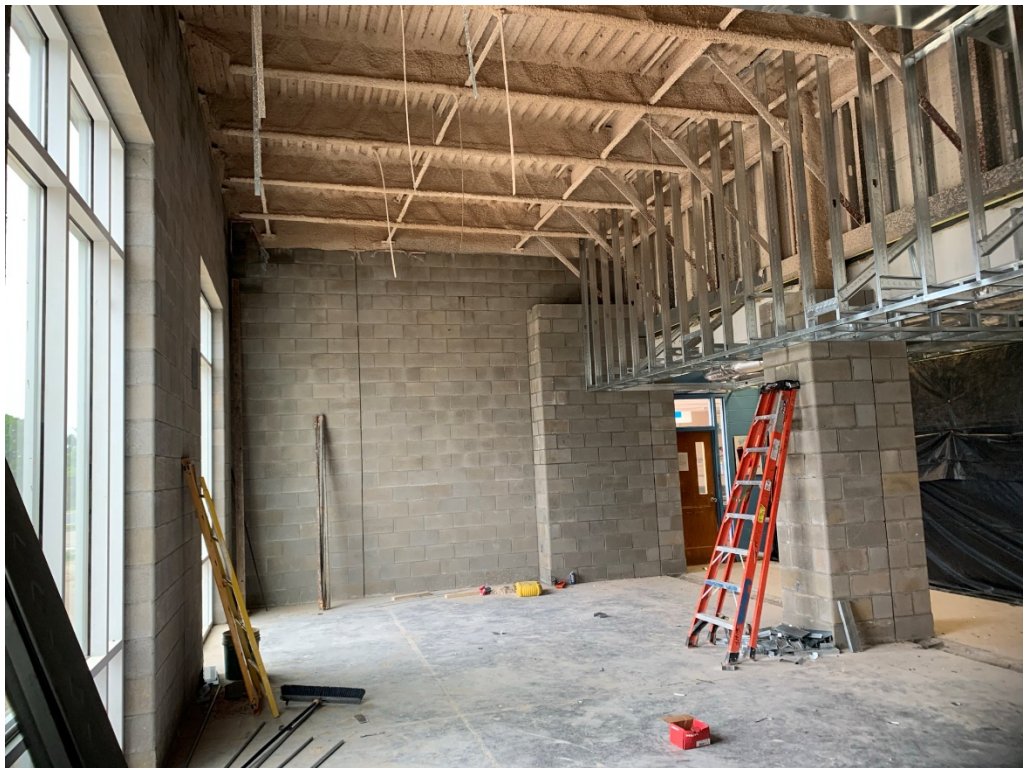
Figure 6 – Cafeteria Addition Space

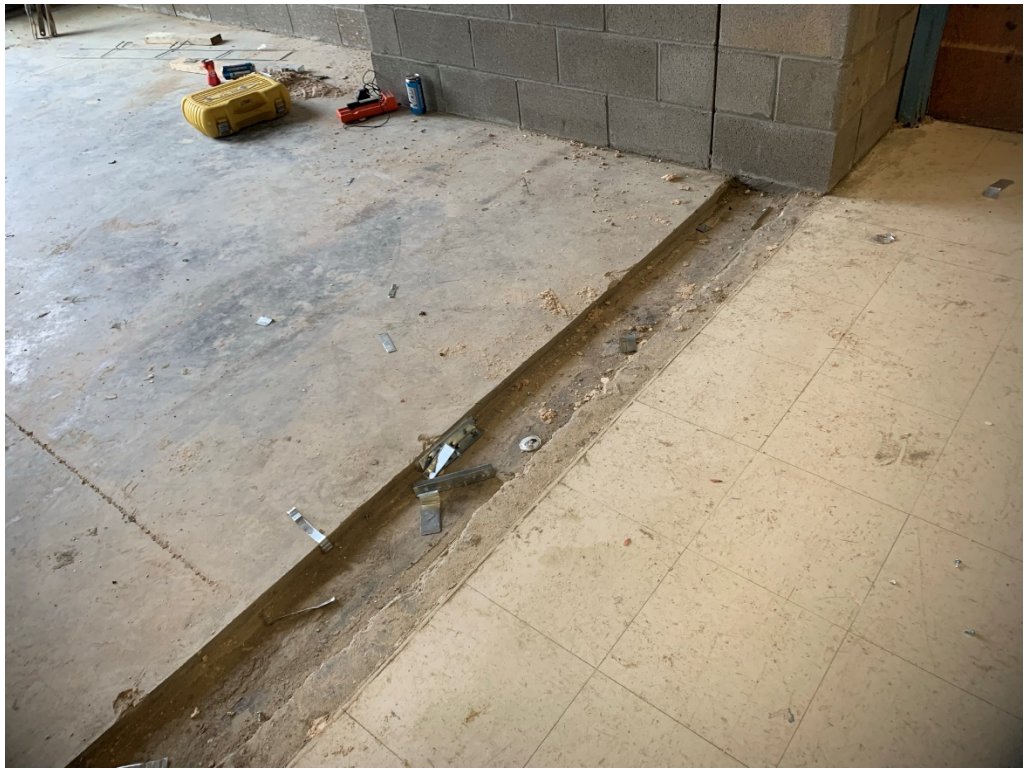
Figure 7 – Floors align well; great job

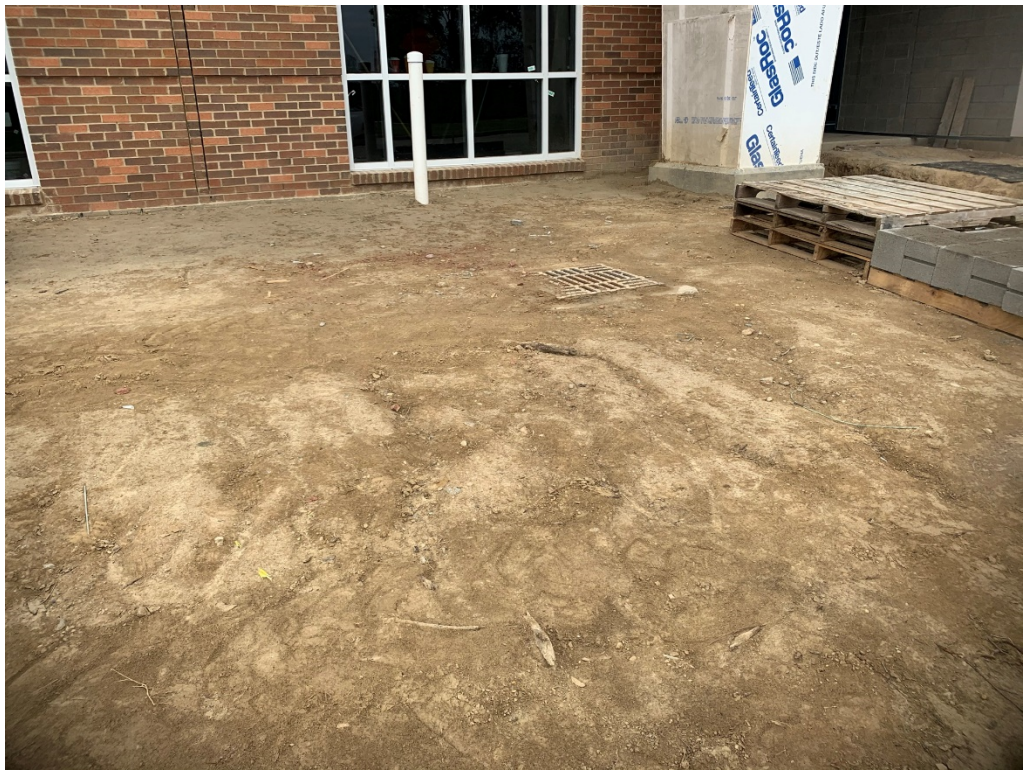
Figure 8 – Is this inlet too high? it does not appear to have a collection area

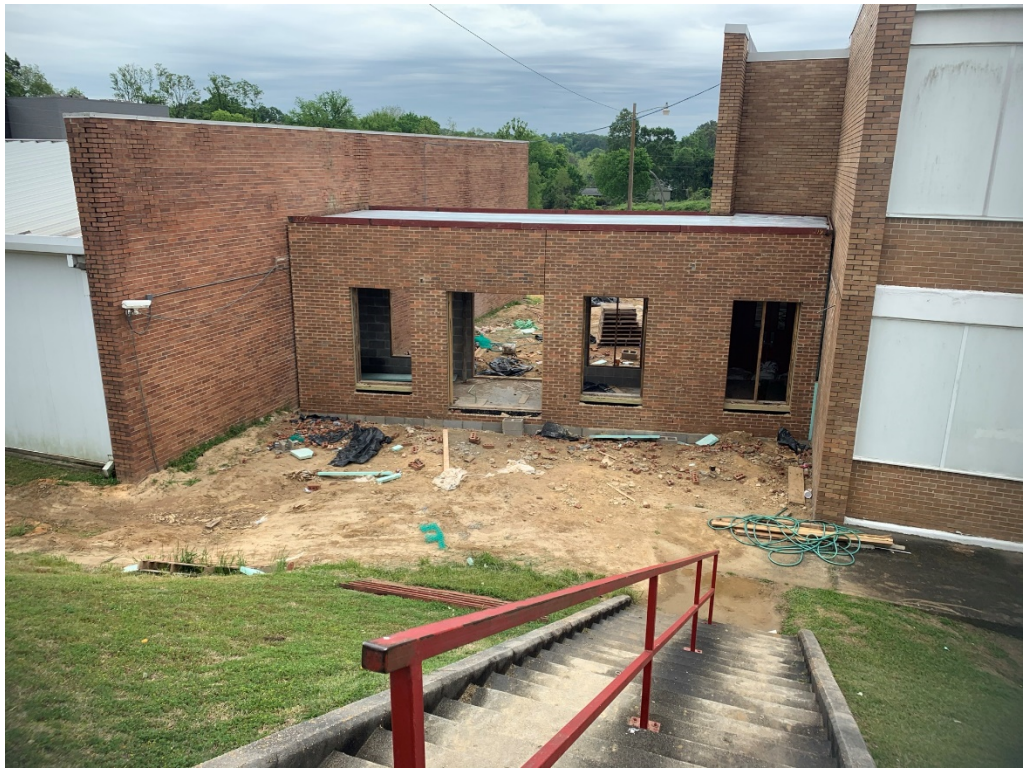
Figure 9 – Built Connector

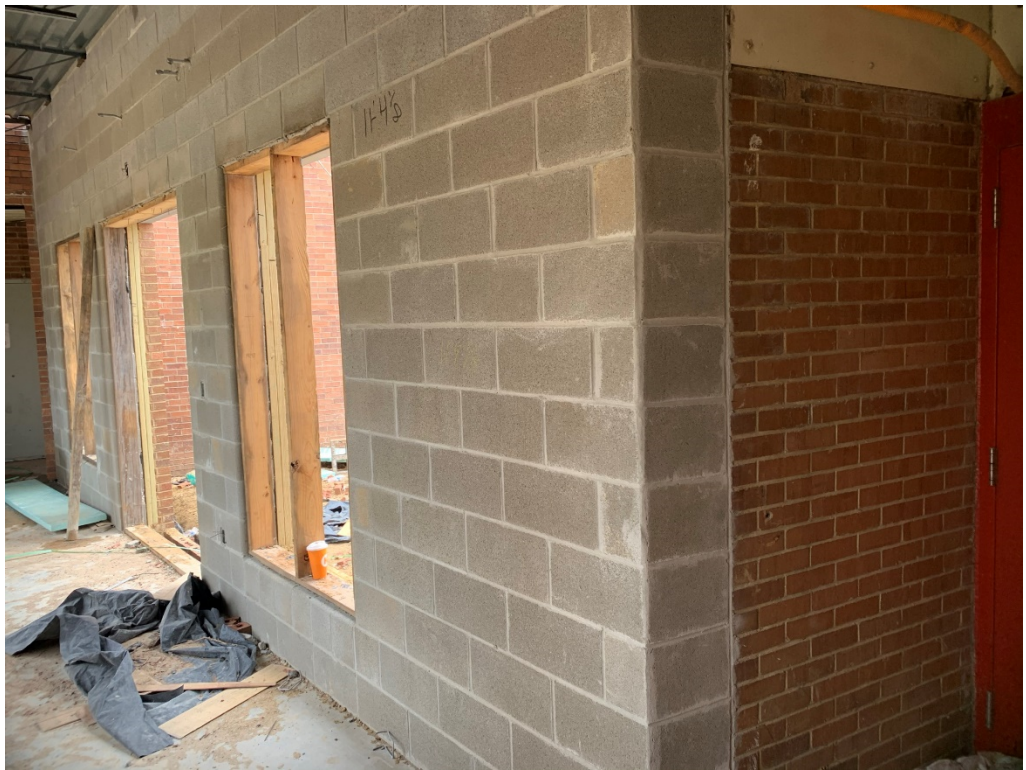
Figure 10 – Corner Condition at 2<sup>nd</sup> floor connector

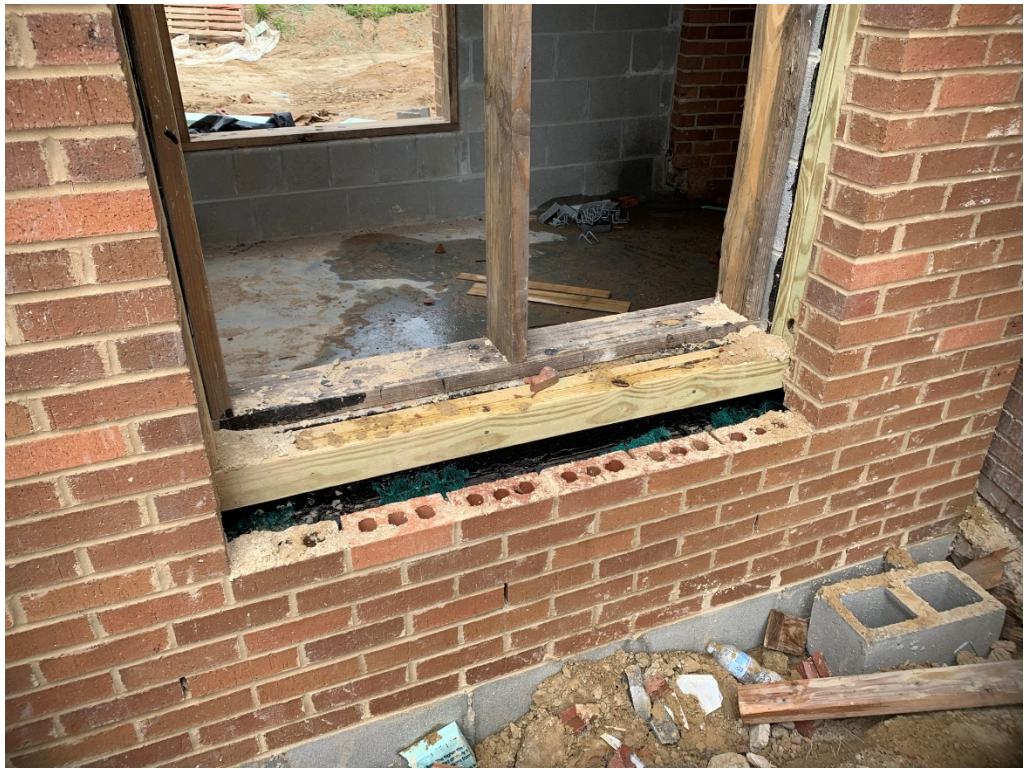
Figure 11 – Window Construction at 2<sup>nd</sup> floor connector

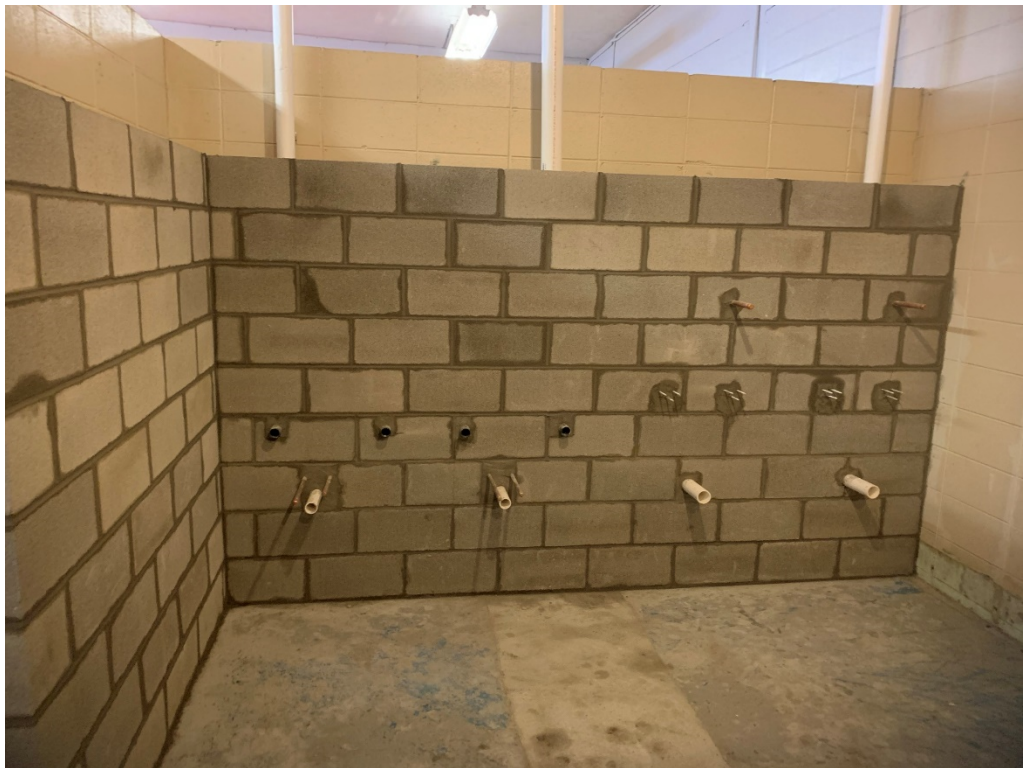
Figure 12 – Masonry Work at Field House Bathroom

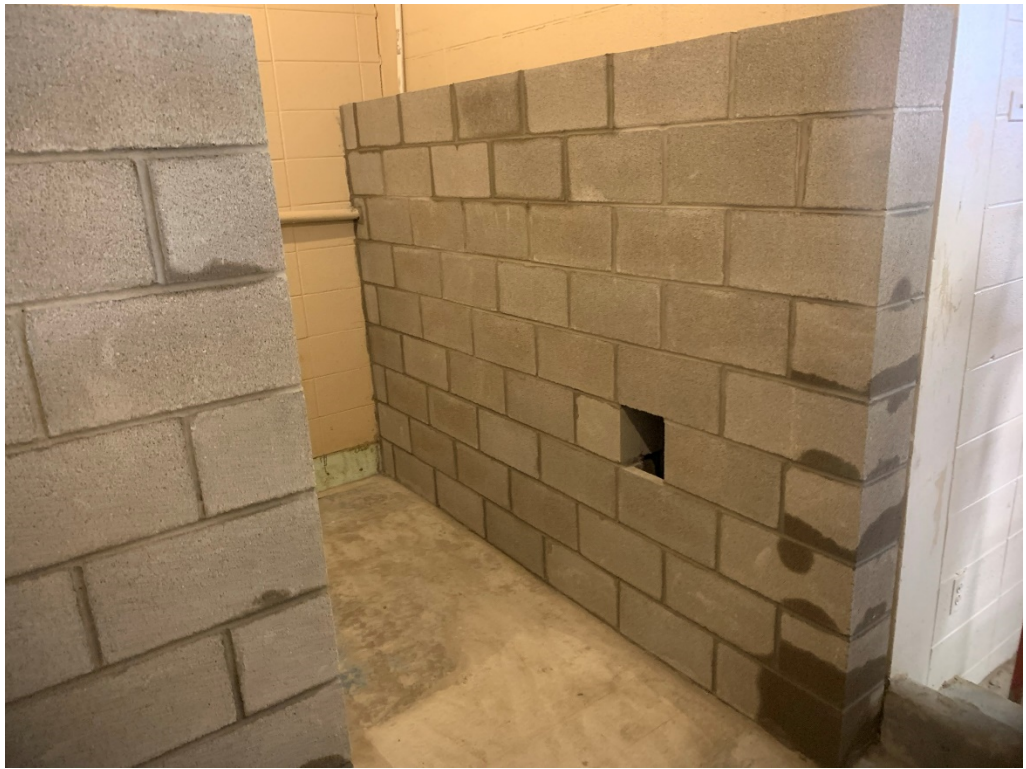
Figure 13 – Masonry Work at Field House Bathroom

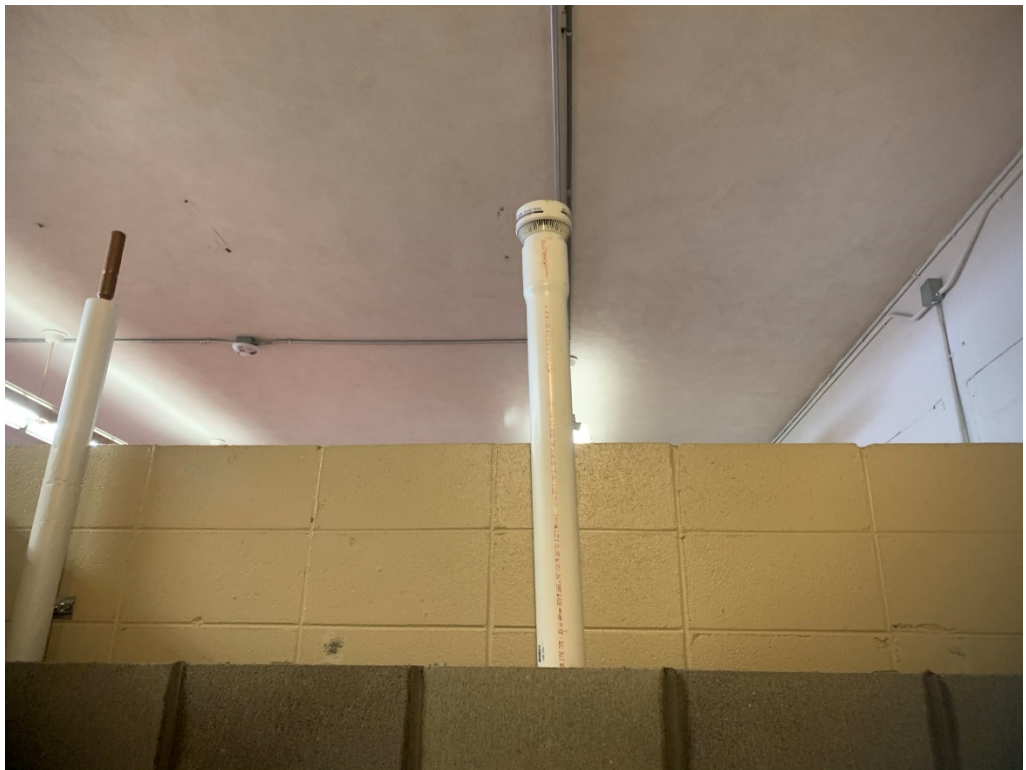
Figure 14 – In wall plumbing

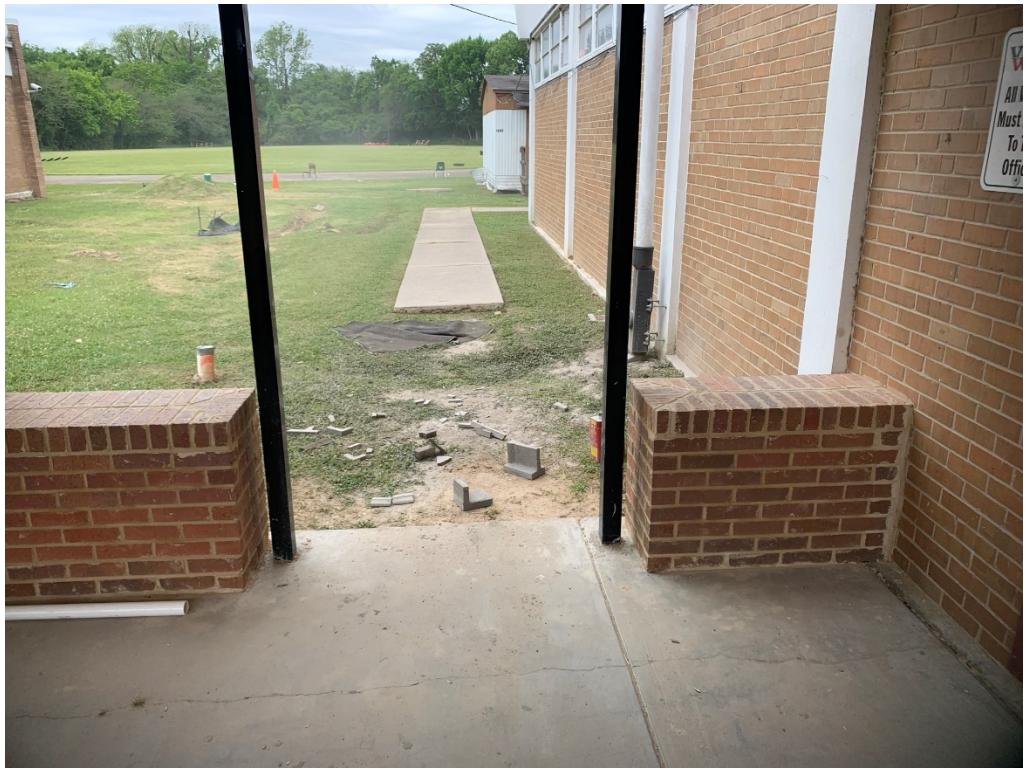
Figure 15 – Brick work at first floor connector

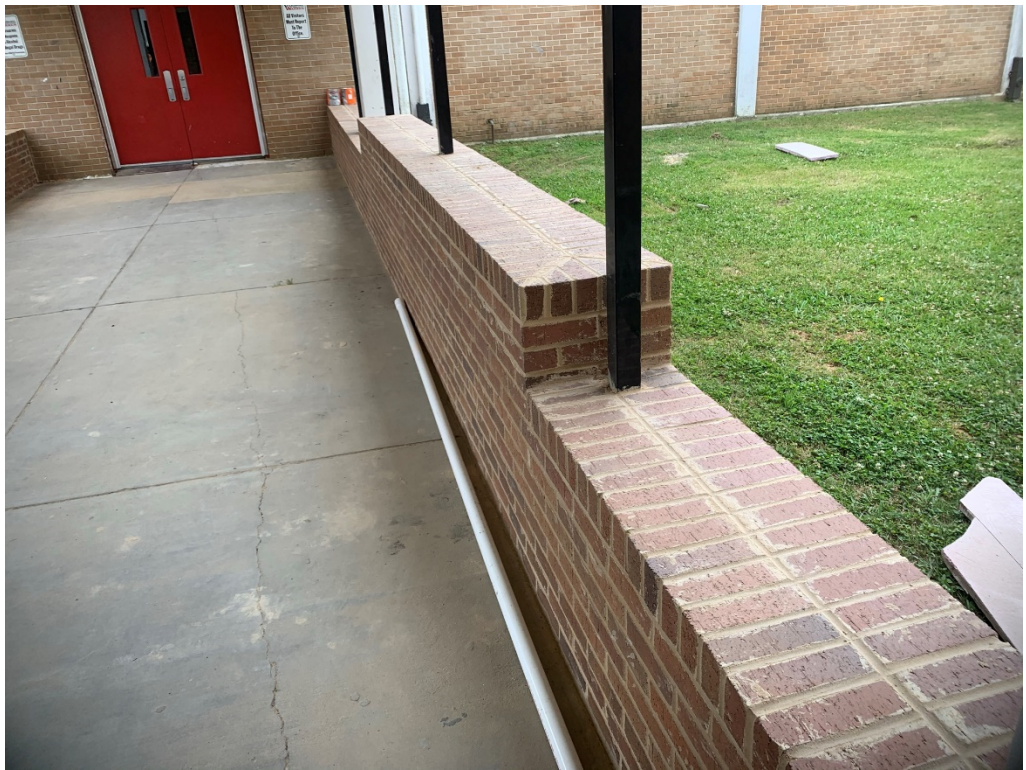
Figure 16 – Brick work at first floor connector

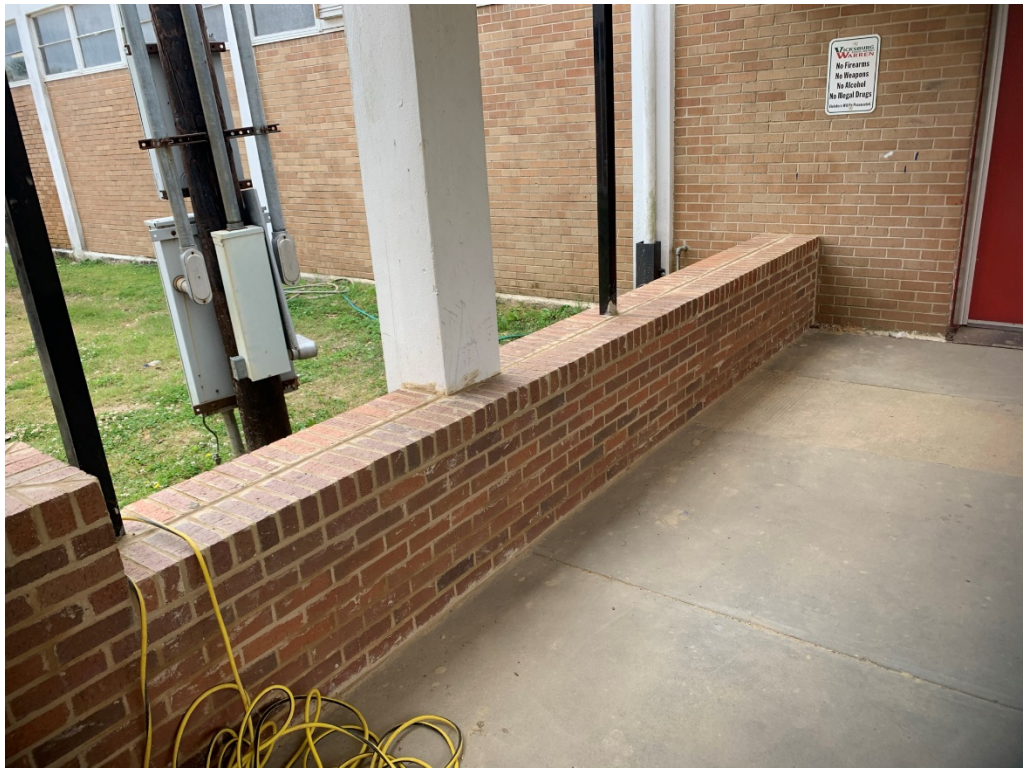
Figure 17 – Brick work at first floor connector

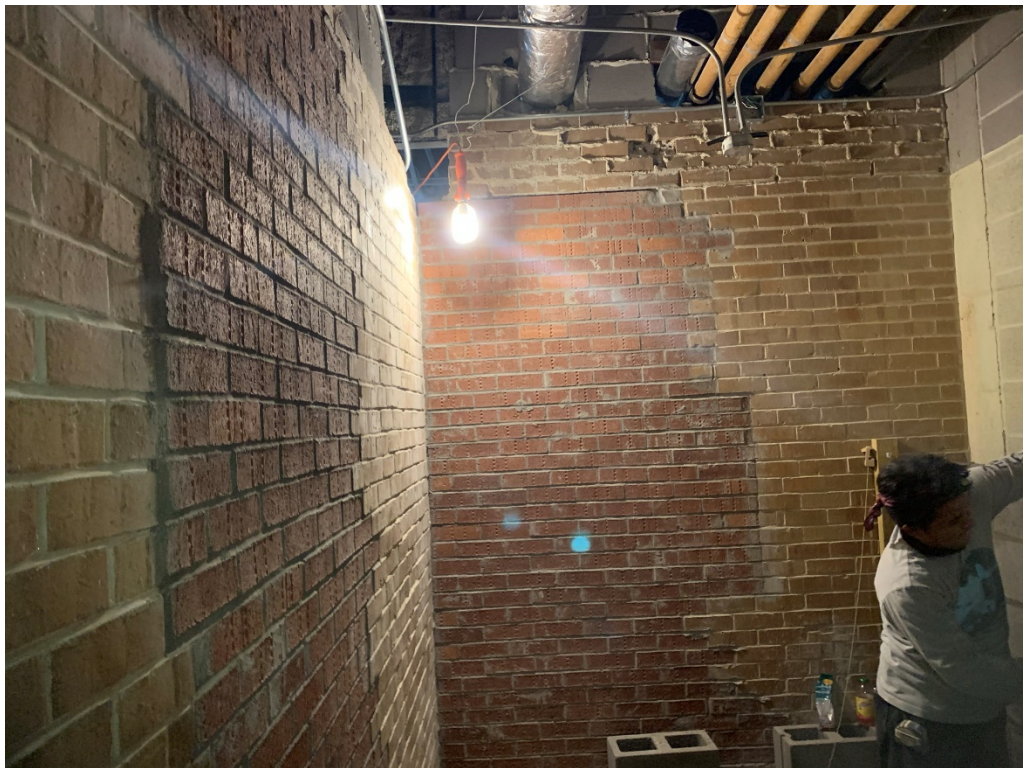
Figure 18 – Masonry Work in lowest floor bathroom
