Architect's Field Report

18056-Warren Central Junior High School / Report Number 025

10030-Warren central Julior High School / Report Number 025	
Contract	Paul Jackson & Son
Date / Time	22 June 2021 / 2:00 PM
Weather / Temp	Sunny / 91 ° F
Est % Complete	80%
Sched Conformance	+ 00 days
Work in Progress	Awning Install
Present at Site	Paul Purser, DBA
Observations	Awning work is ongoing and nearing completion at the front entry. The awning appears straight and in good order.
	Inside, there is a leak at the cafeteria east wall. Is the roof fully flashed at this point?
Items to Verify	None
Action Required	None
Report By:

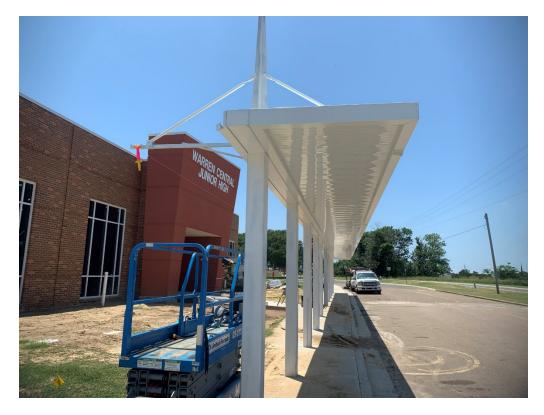
Figure 1 – Awning Installation

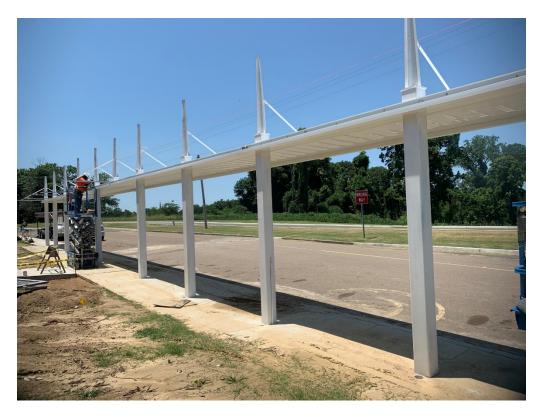
Figure 2 – Awning Installation

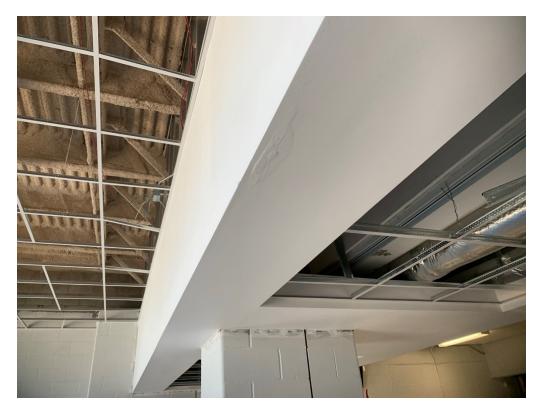
Figure 3 – damaged mud-work due to moisture

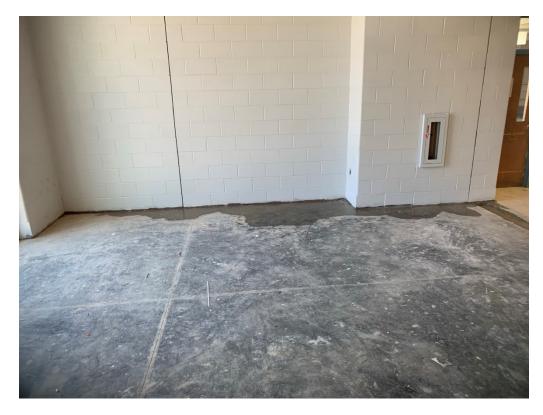
Figure 4 – A leak is apparent here; is there a solution yet?

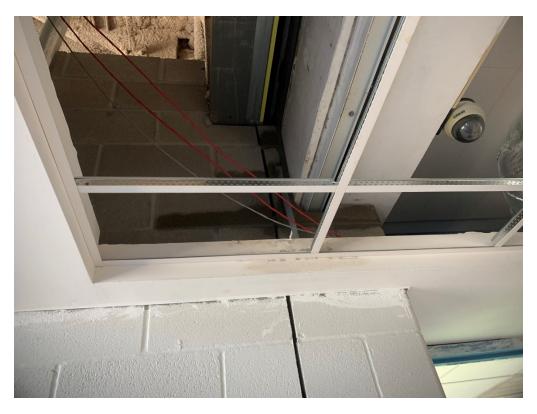
Figure 5 – A leak is apparent here; is there a solution yet?

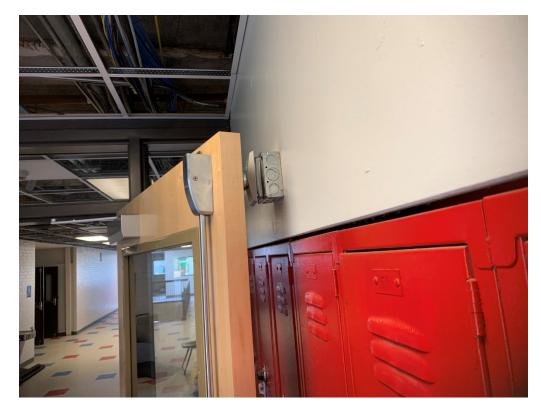
Figure 6 – Electronic Holds Installed and Operational
