Architect's Field Report

01 July 2021

18056-Warren Central Junior High School / Report Number 026

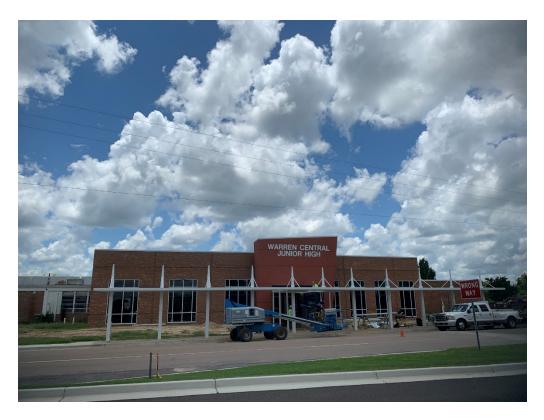
Figure 1 – North Building Facade

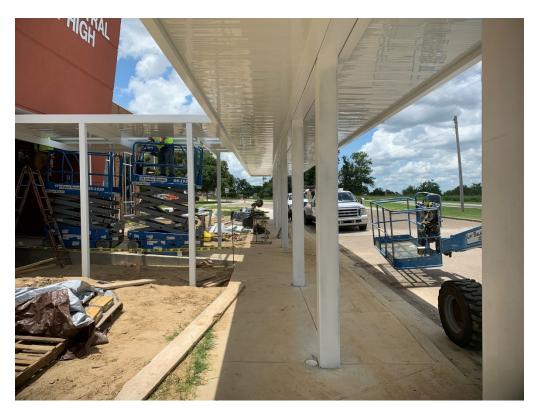
Arriving on site, I entered through the front entry. Awning work here is

nearing completion. Stucco, here, is complete as well.

Figure 2 – Awning Installation; paint at steel work is ongoing and requires more coverage

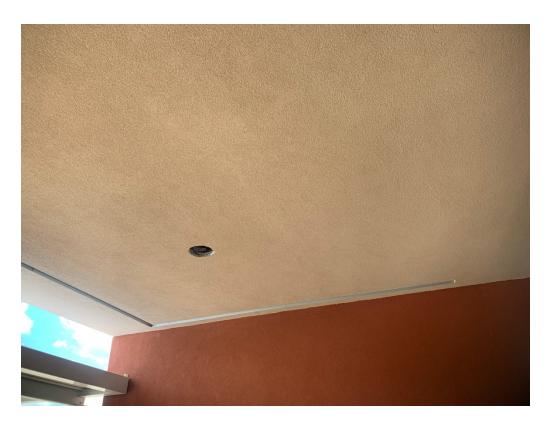
Figure 3 – Stucco Work at Entry Complete

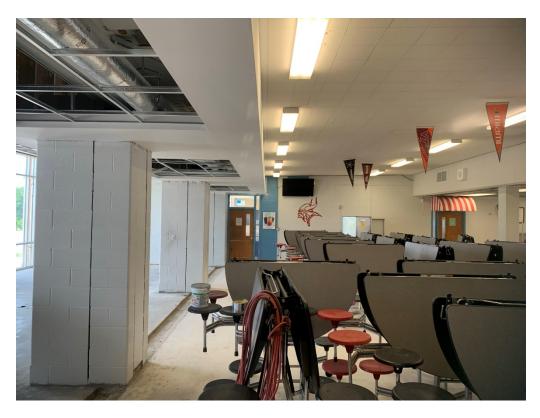
At the interior, the temporary wall between cafeteria sections has been

removed. Work in this area is ongoing.

Figure 4 – Temporary Divider Removed at Cafeteria

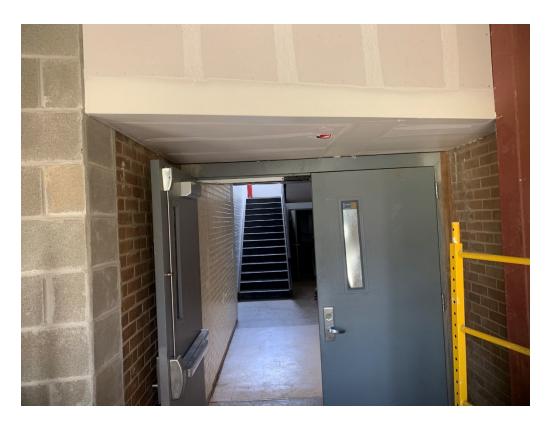
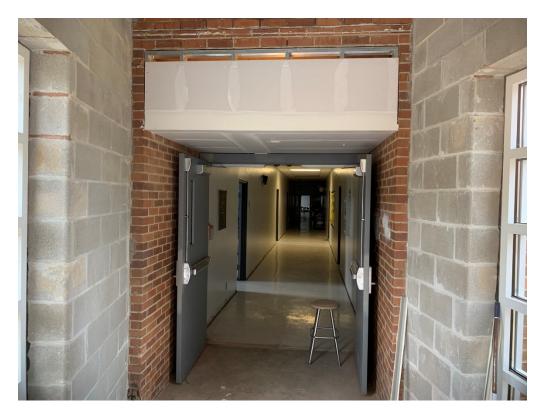
Finish work at the 2nd floor corridor is being performed. The connector has been opened and temporary walls have been removed. Ensure security on site at this connector and that doors here are lockable and

Figure 5 – Corridor Addition Opened Up

Figure 6 – Corridor Addition Opened Up

being locked overnight.

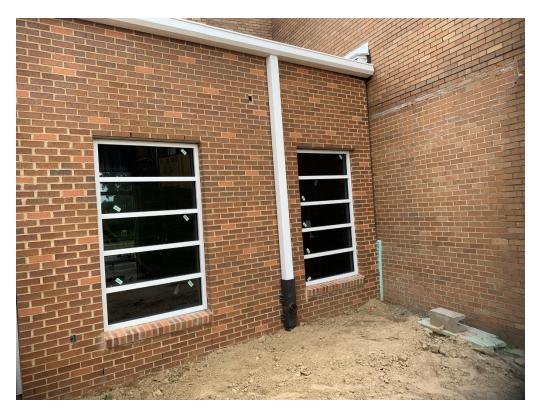
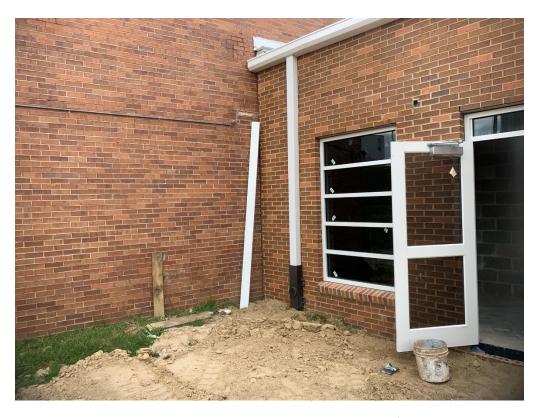
Figure 7 – Gutters Tied into Drainage at North Façade of Corridor at $2^{\rm nd}$ Floor

Figure 8 – Gutters Tied into Drainage at North Façade of Corridor at 2nd Floor
