Architect's Field Report

22 October 2021

18056-Warren Central Junior High School / Report Number 028

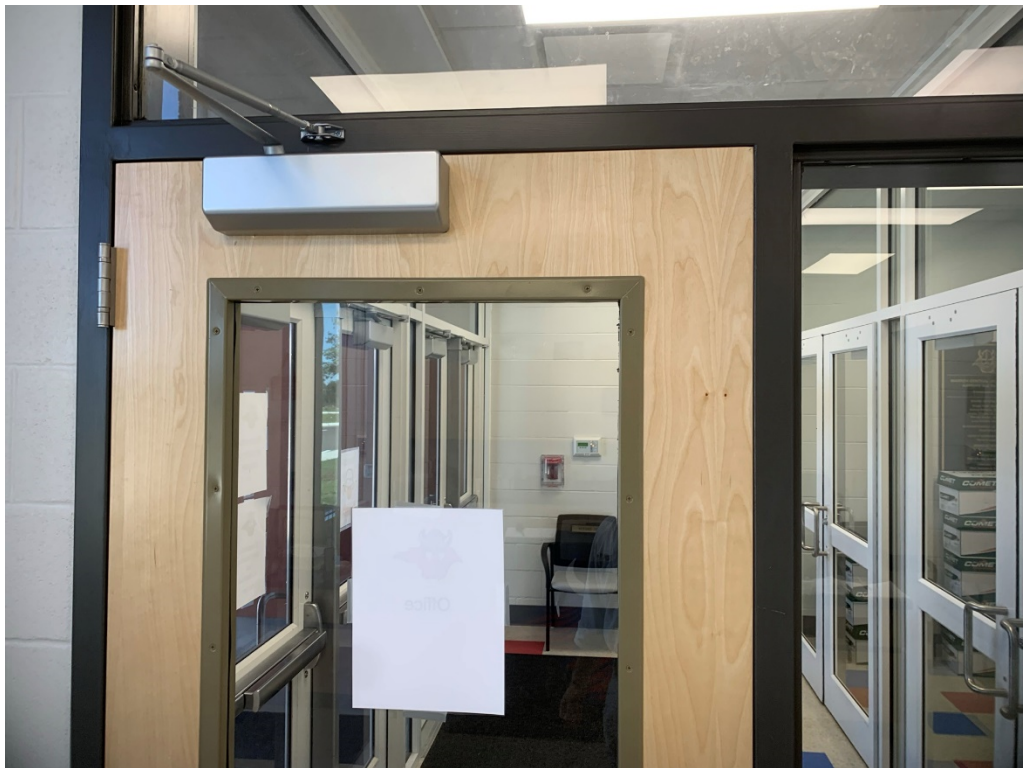
Figure 2 – Door needs adjustment; it's crooked in frame and drags at the top

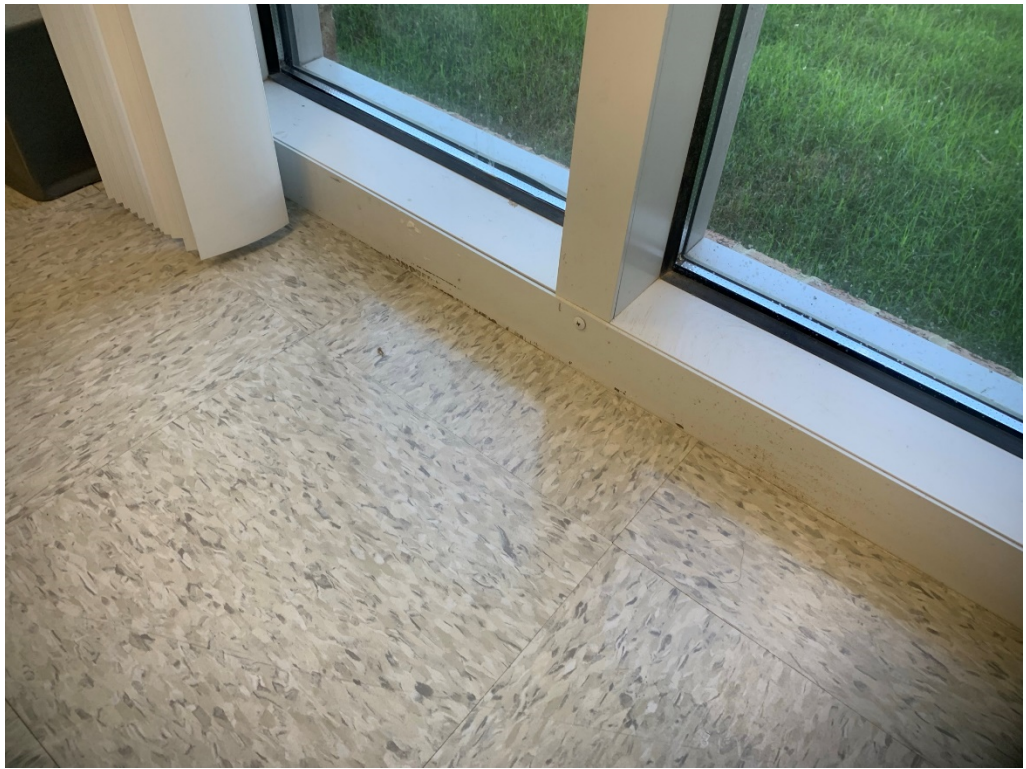
Figure 3 – New storefront to be cleaned/refinished at A-305

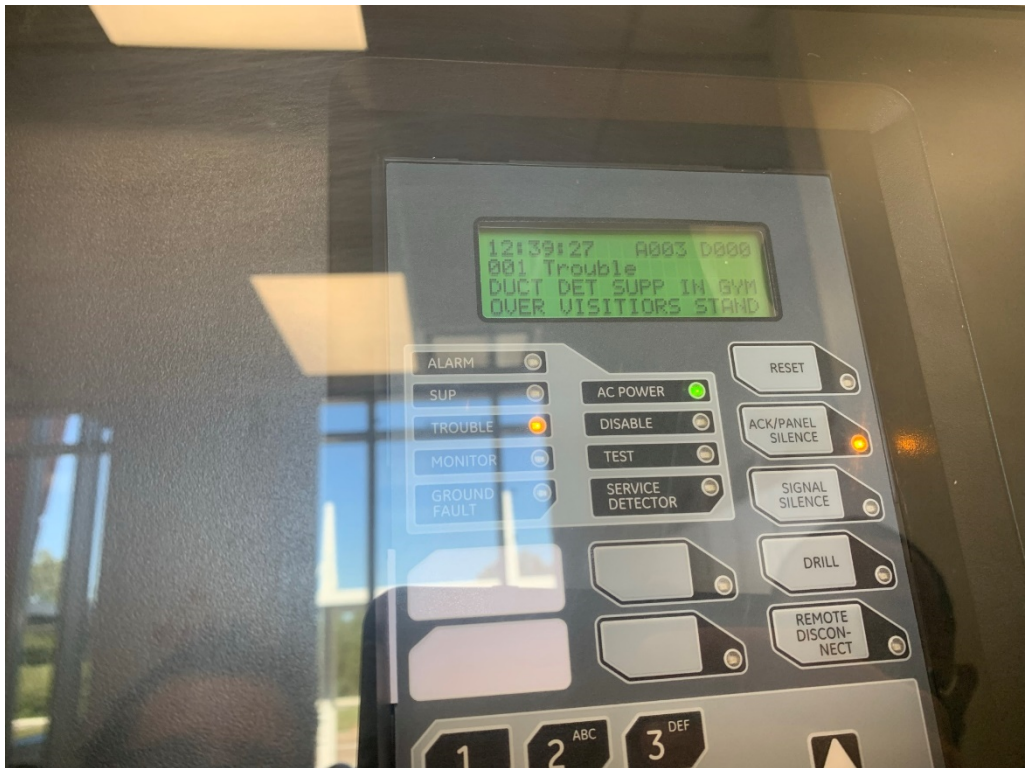
There is an ongoing alarm that is set off at the panel that I discussed with the principal. Figure 4 shows its error. Please make this a priority to repair.

Figure 4 – Continual error message at alarm panel to be corrected

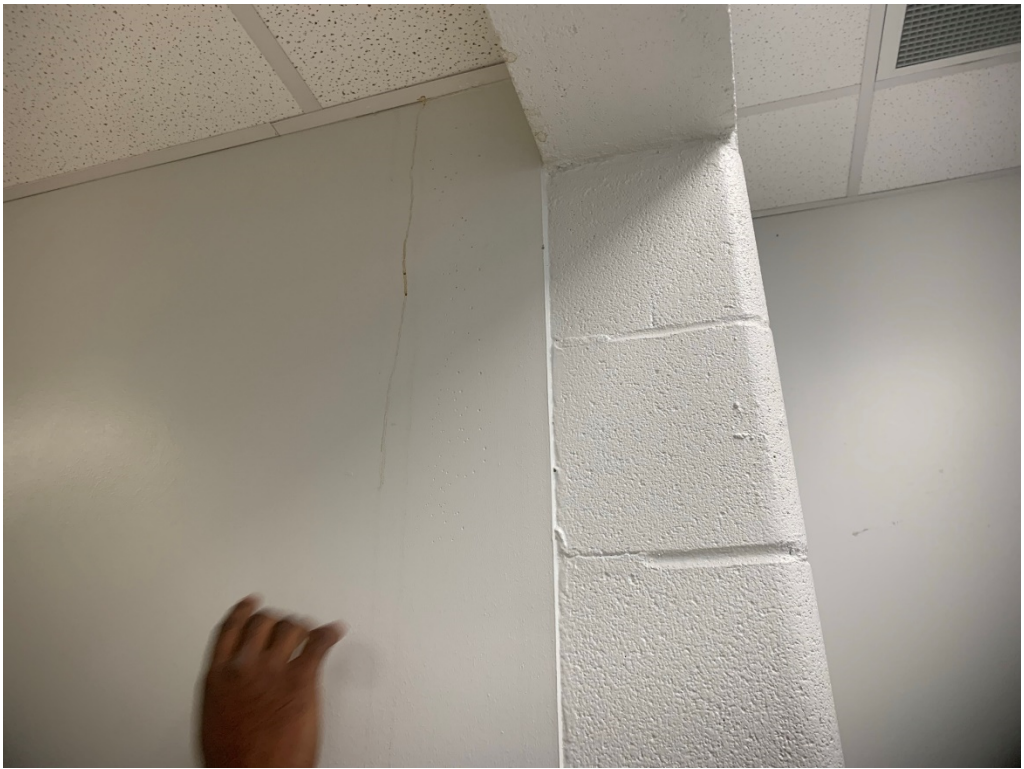
Figure 5 – Roof leak still present at A-305

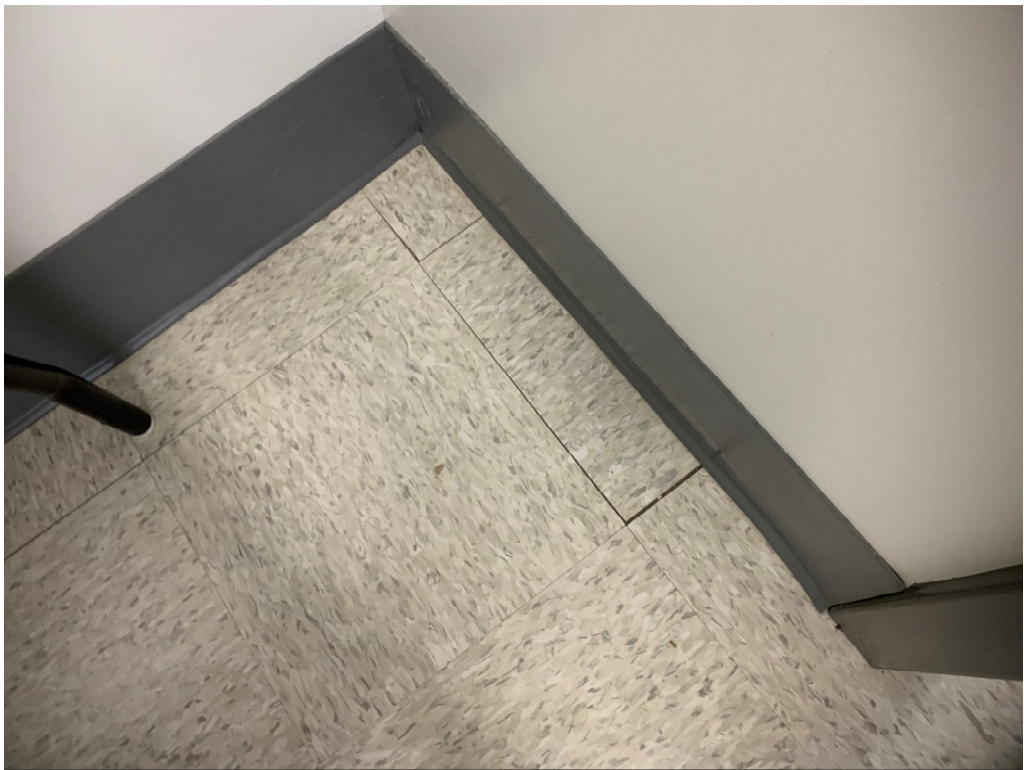
Figure 6 – Tile to be resecured in place at A-305

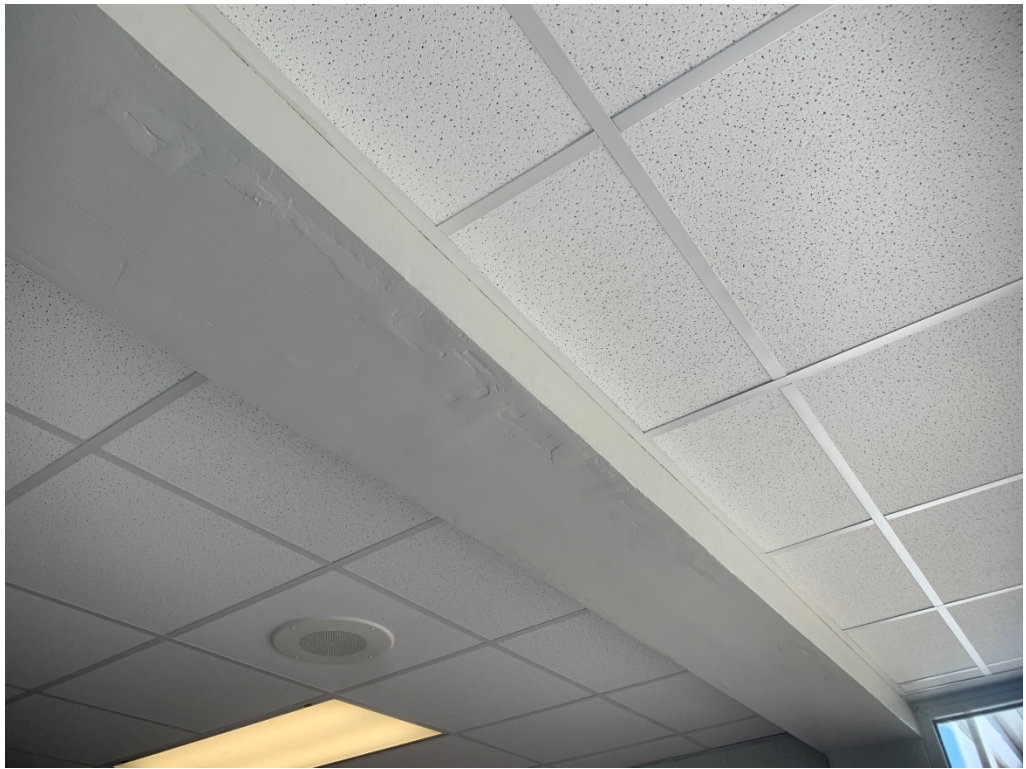
Figure 7 – Mottled finish at south end of E-320 to be smoothed and repainted

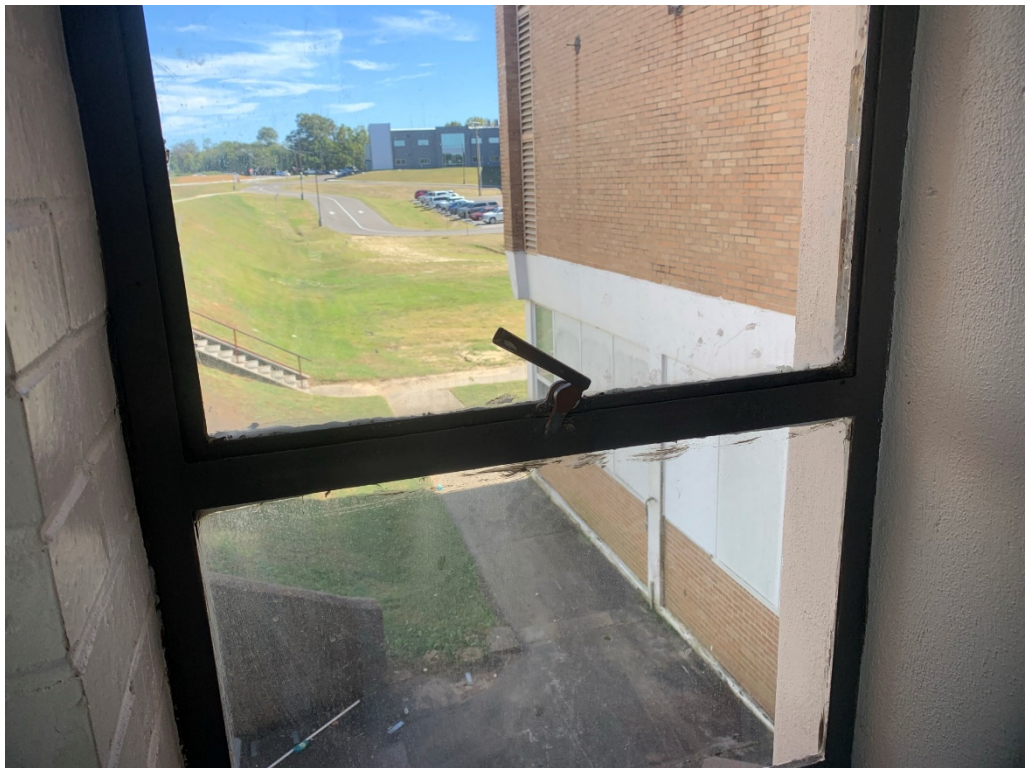
Figure 8 – Paint at window glazing to be removed

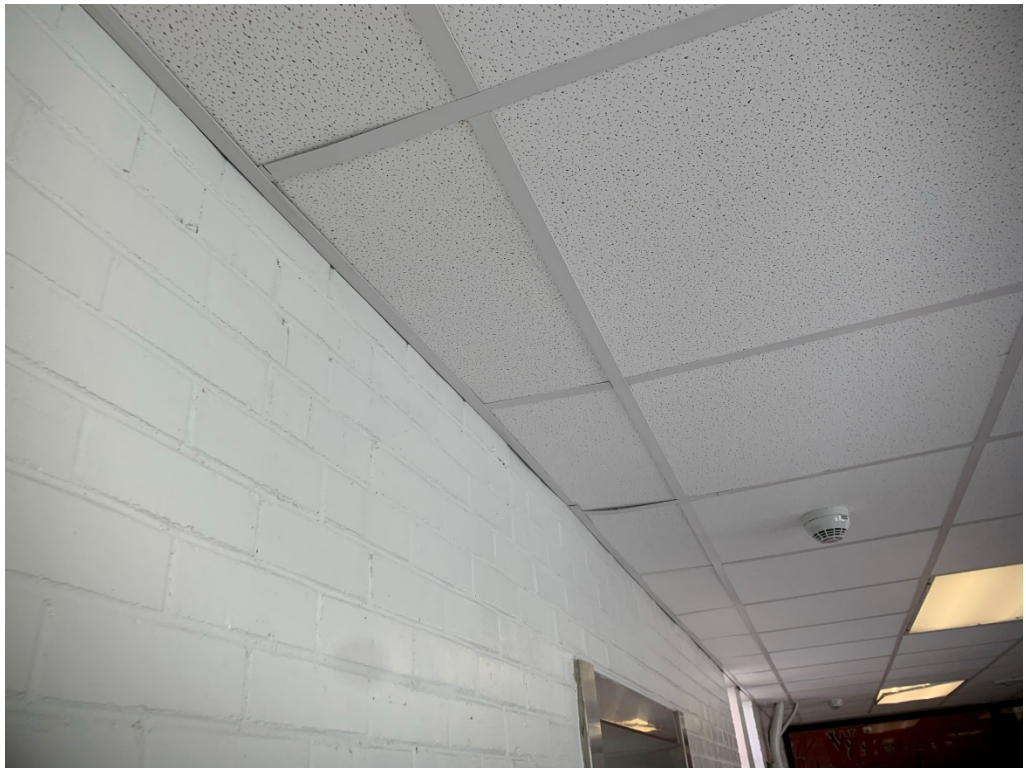
Figure 9 – Ceiling is still sagging at south end of E-220

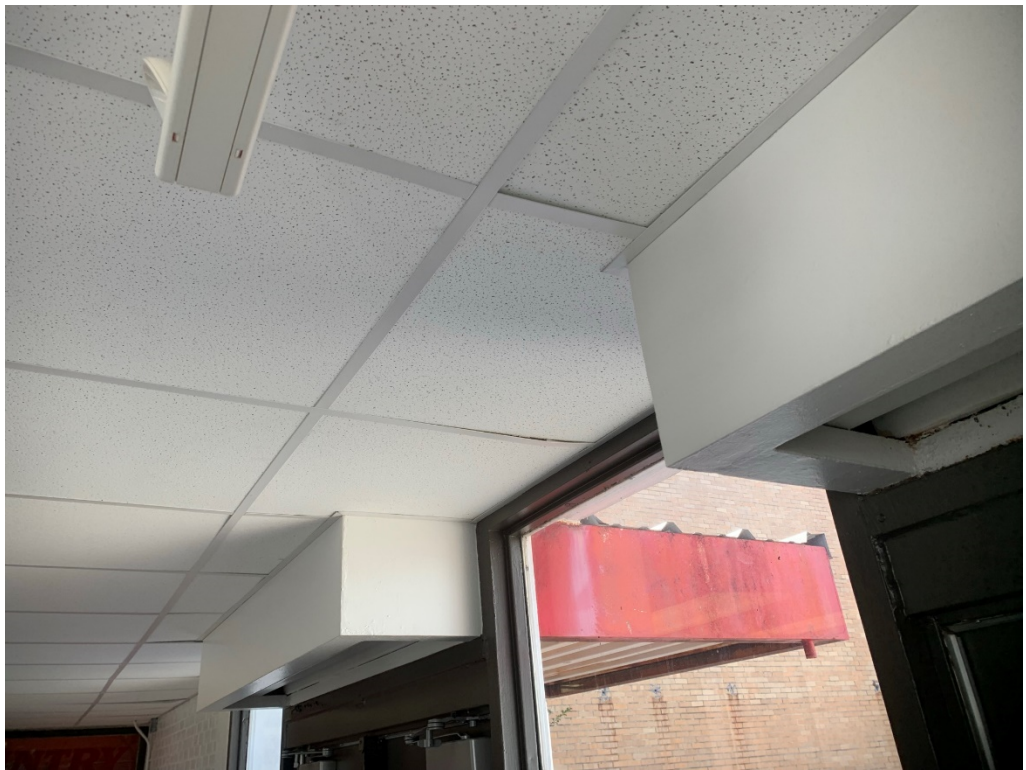
Figure 10 – Ceiling is still sagging at south end of E-220

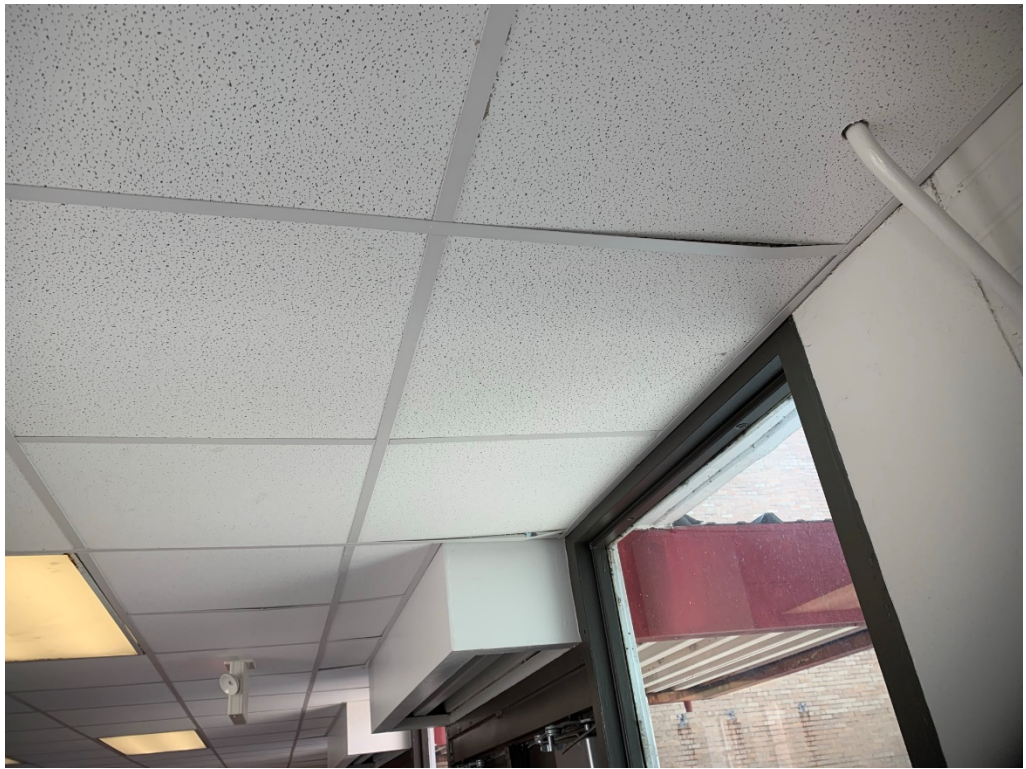
Figure 11 – Ceiling is still sagging at south end of E-220

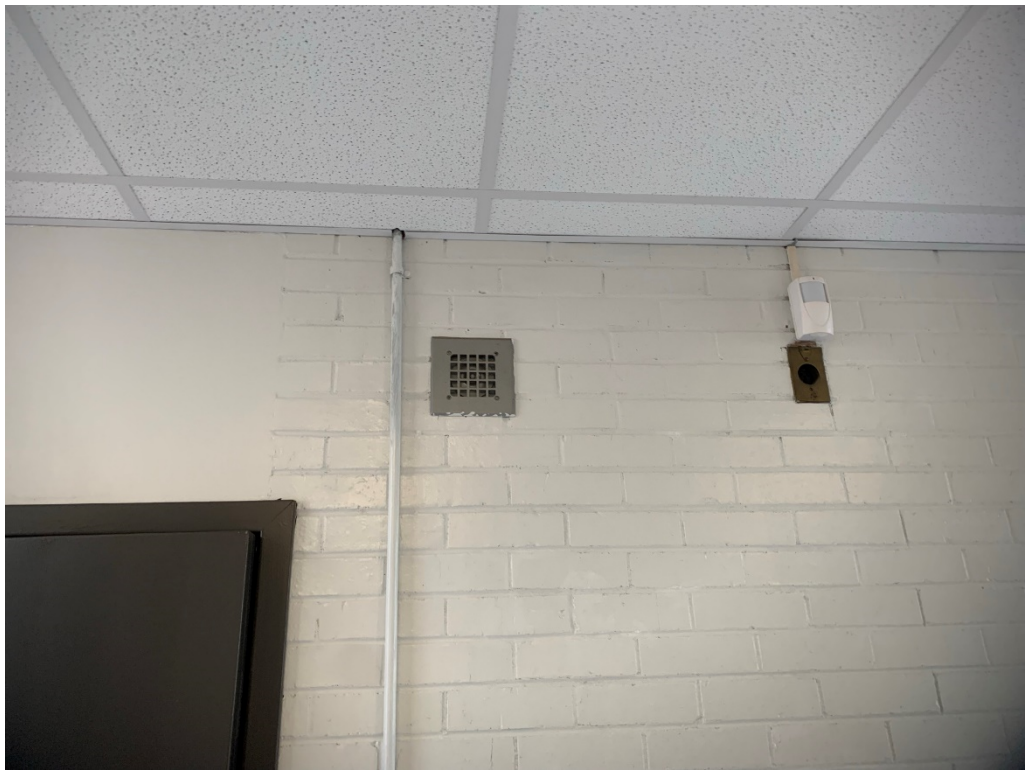
Figure 12 – Paint conduit fully

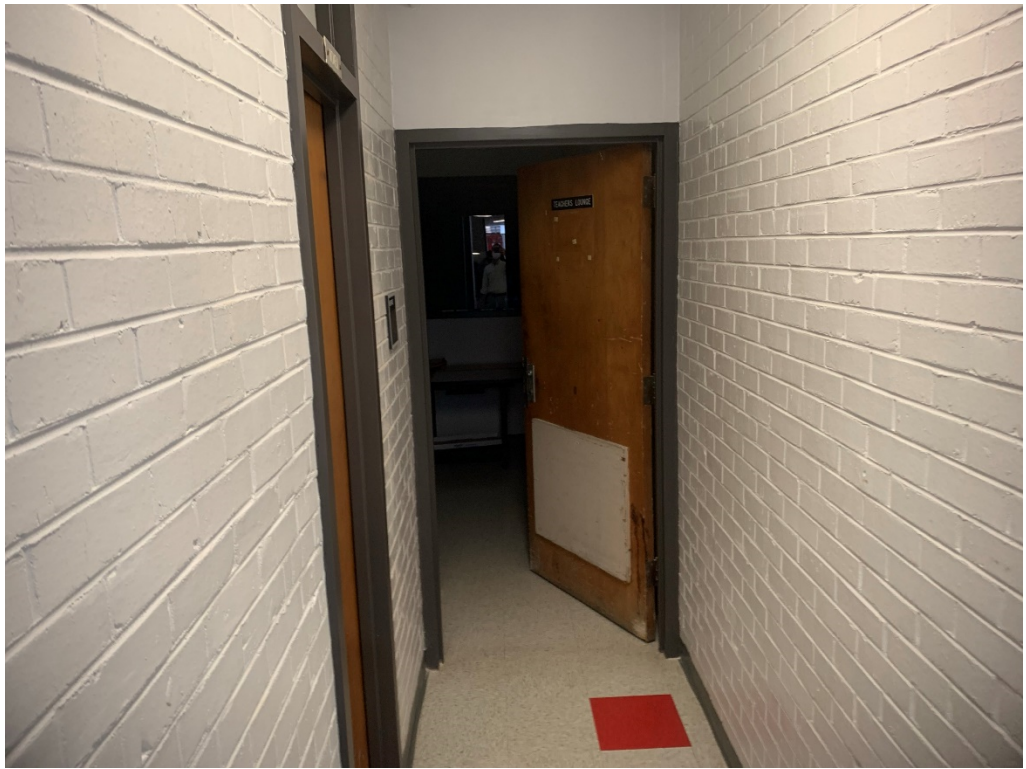
Figure 13 – Door to be removed per Construction Documents

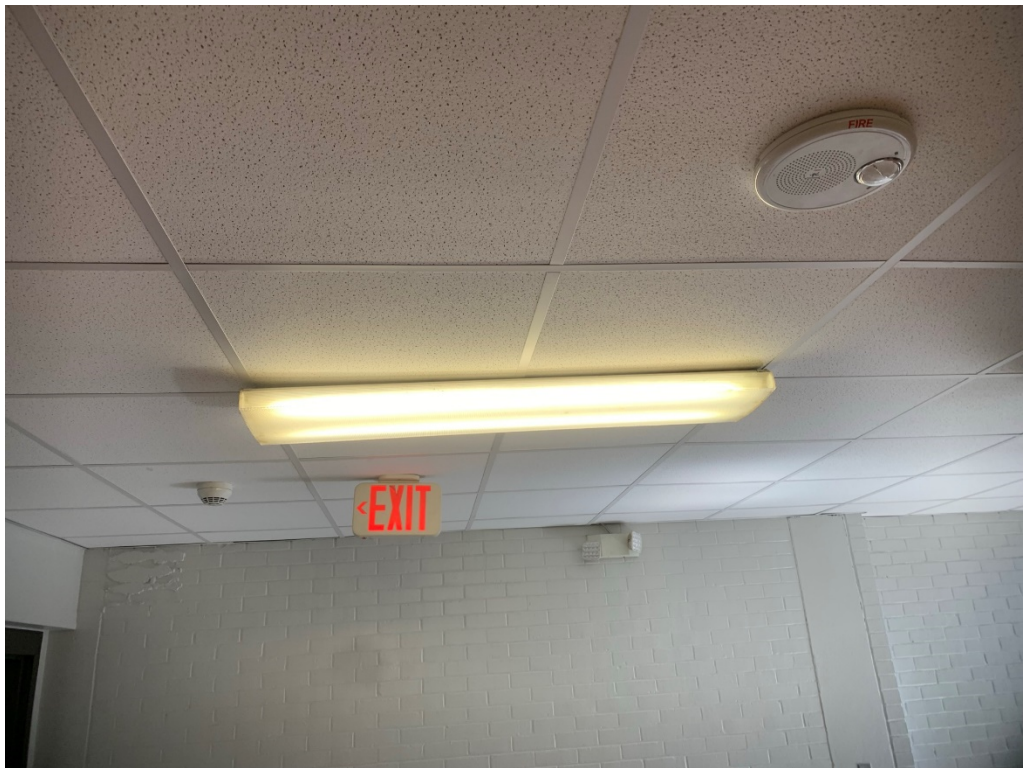
Figure 14 – Light crooked at end of E-226

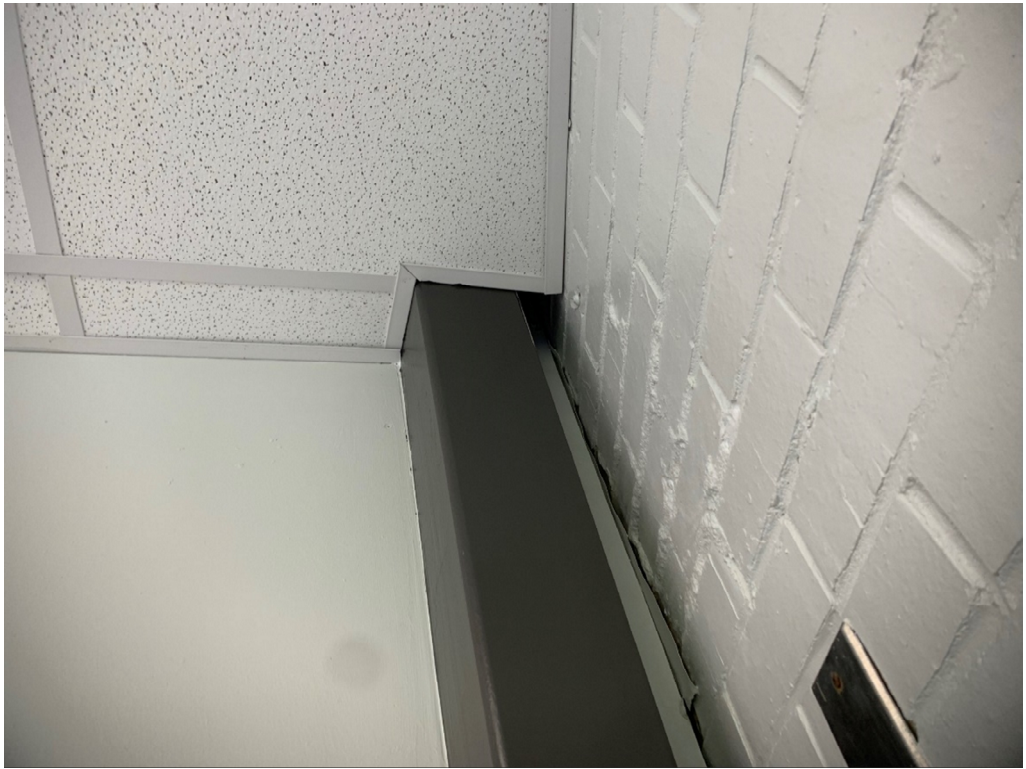
Figure 15 – Fill gap with matching trim

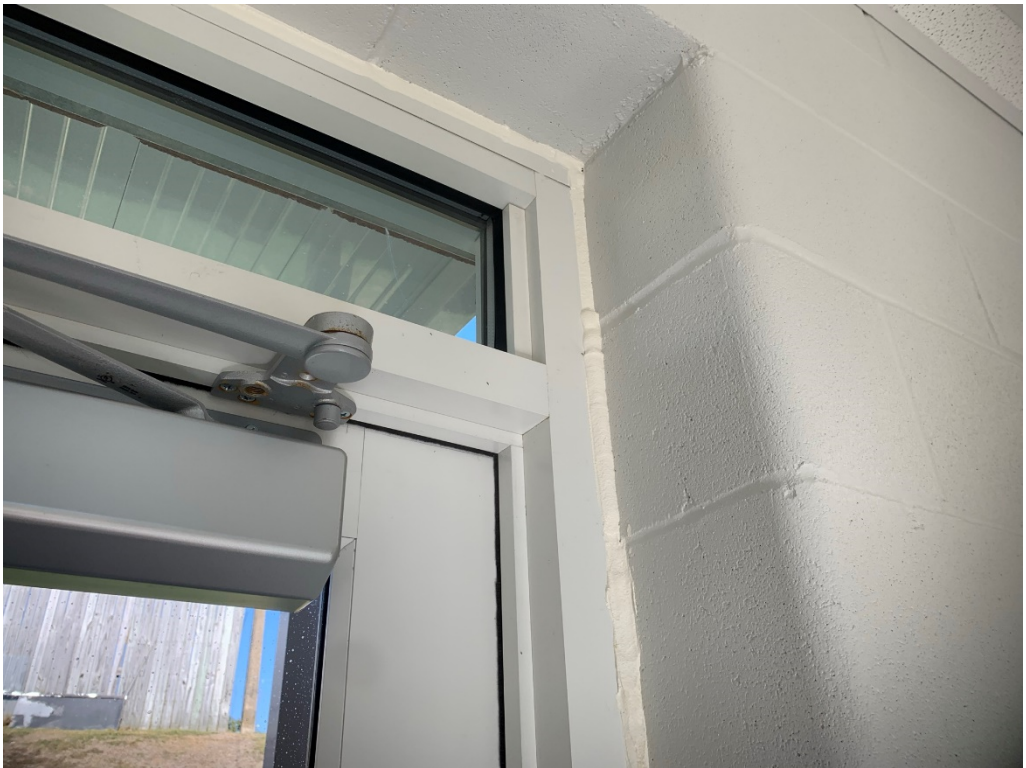
Figure 16 – Caulking still lumpy at new; smooth

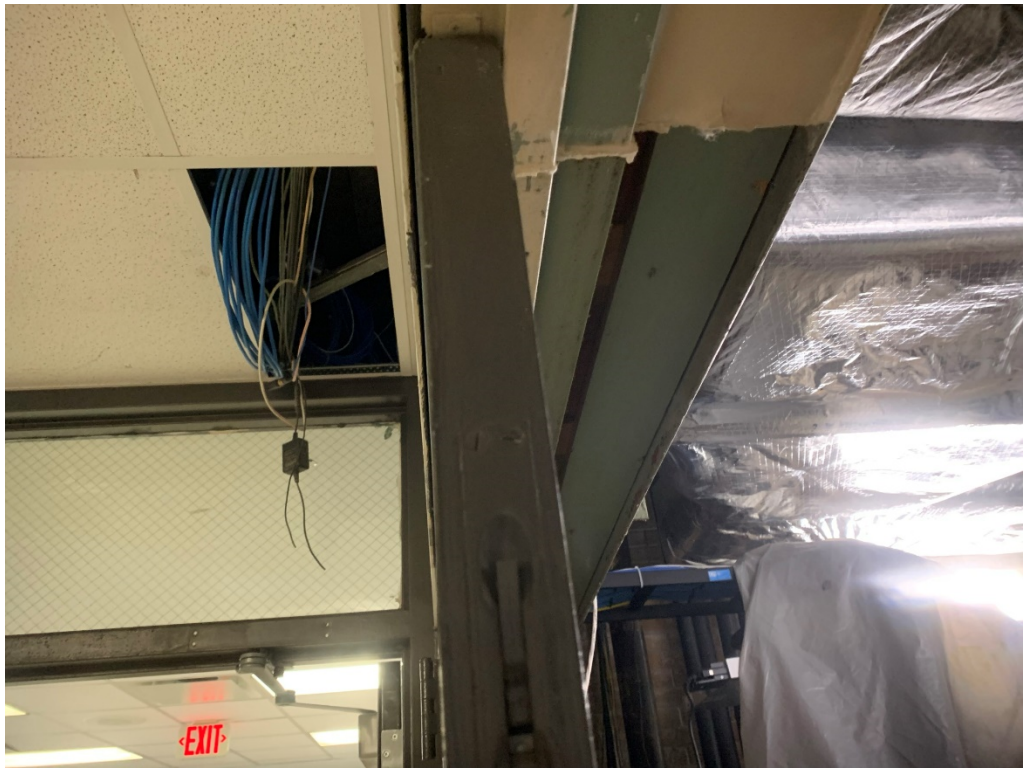
Figure 17 – Hardware has been painted, making it inoperable; return to working order

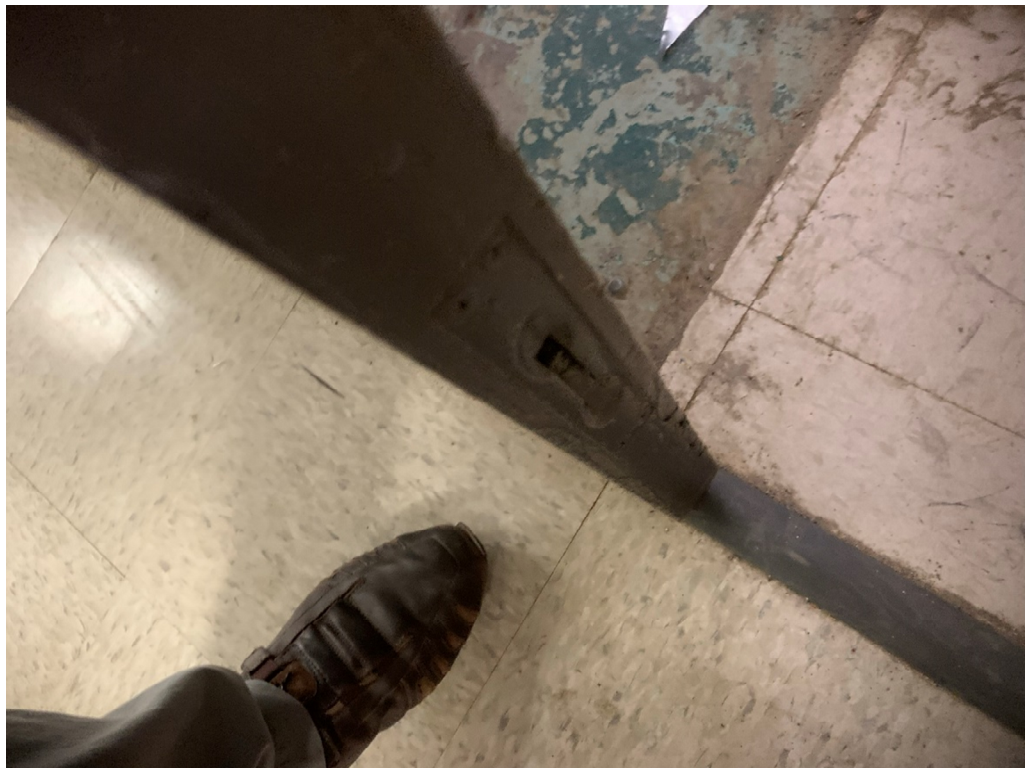
Figure 18 – Hardware has been painted, making it inoperable; return to working order

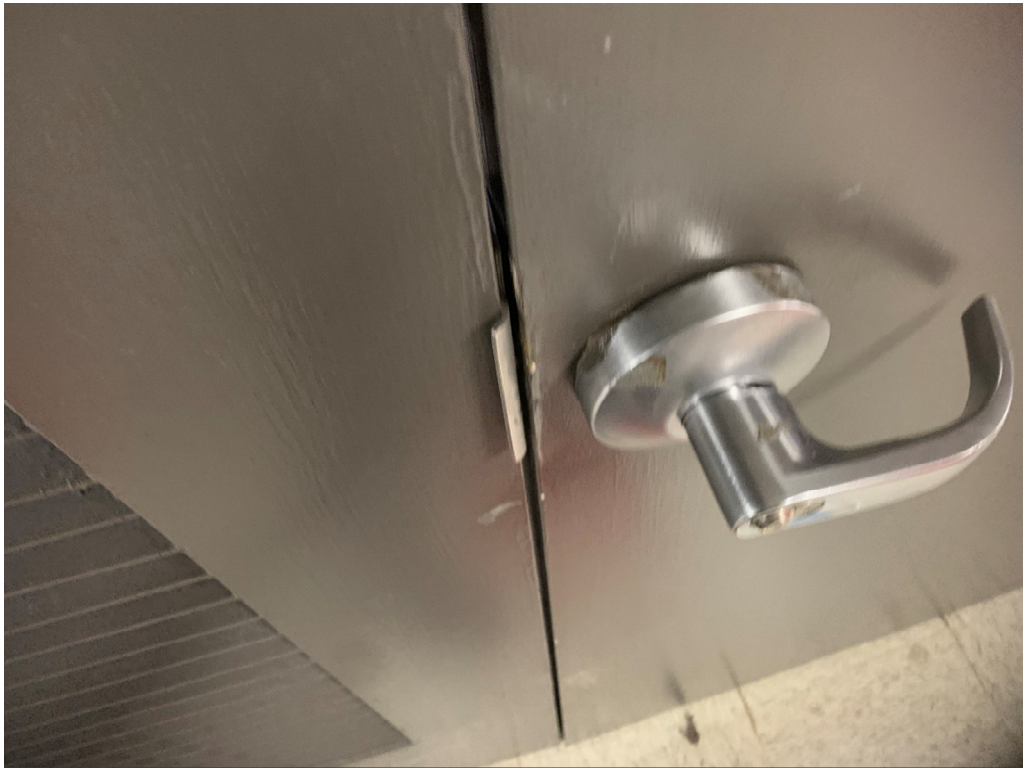
Figure 19 – Remove paint at hardware

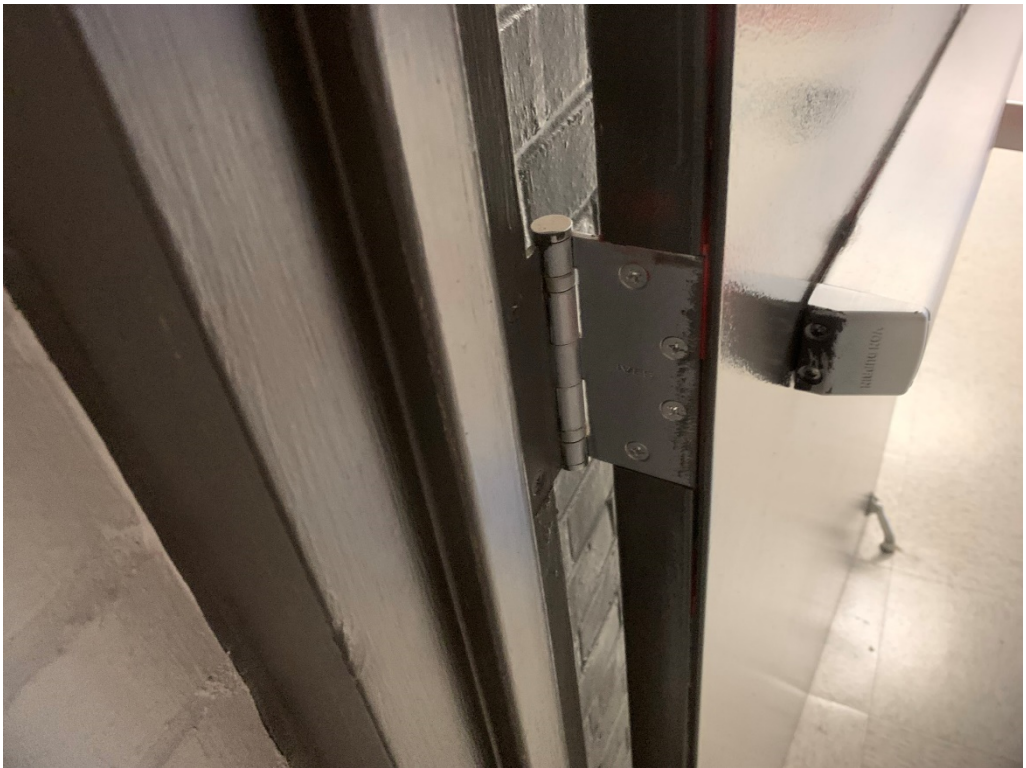
Figure 20 – Remove paint at hardware

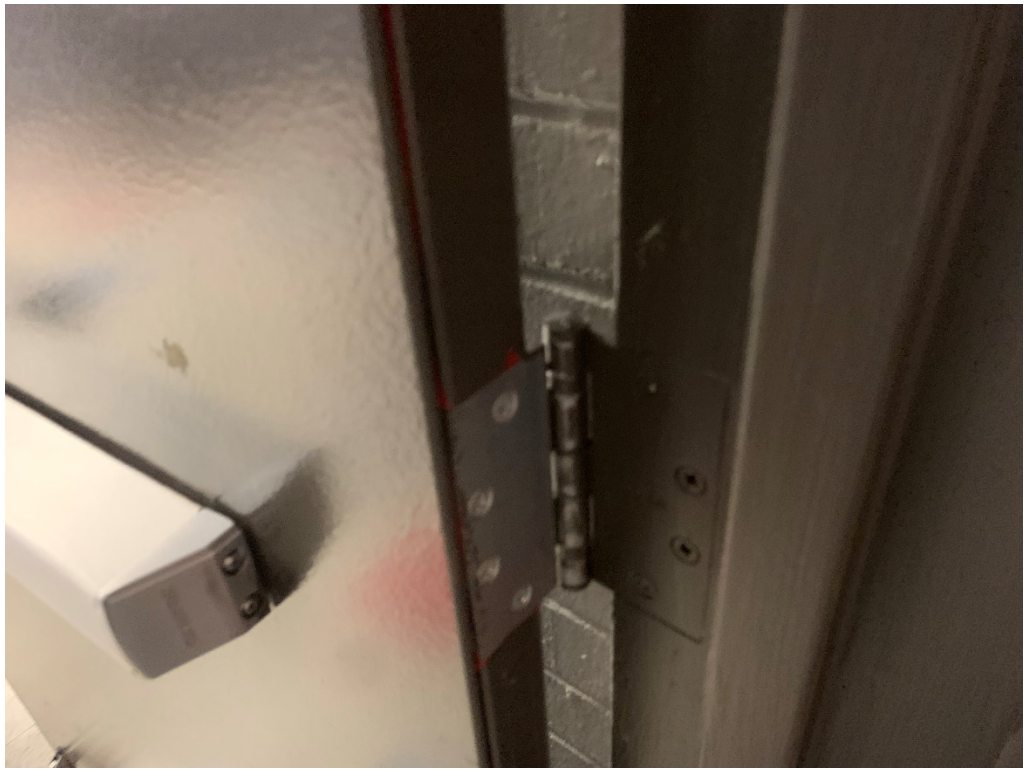
Figure 21 – Remove paint at hardware

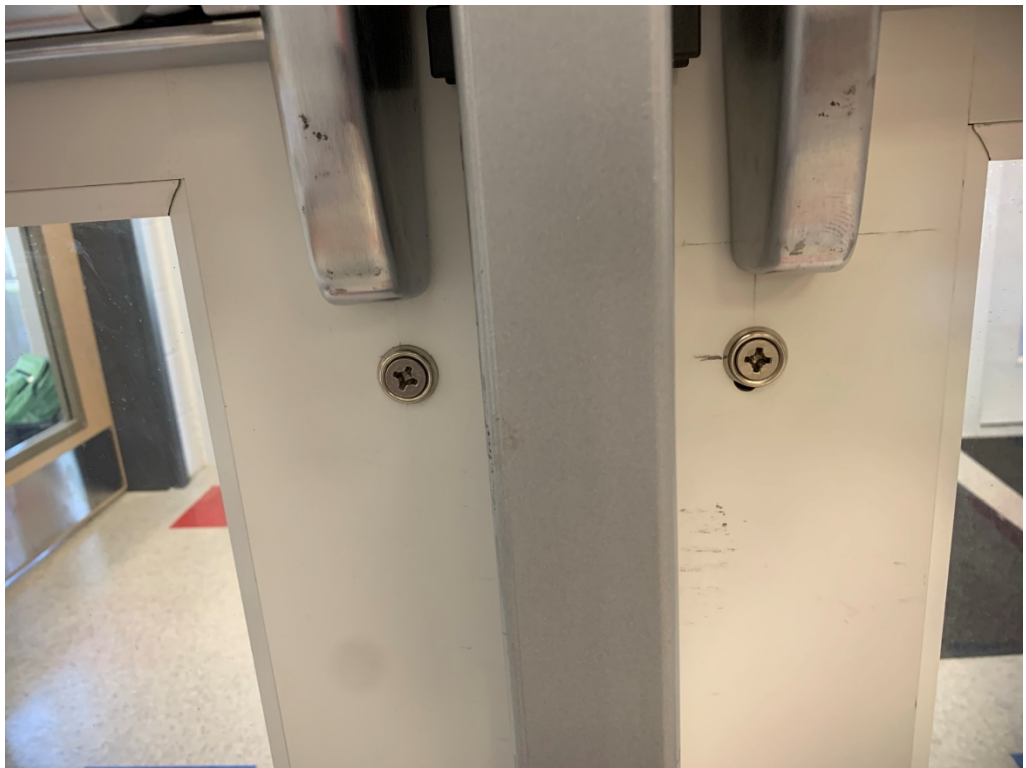
Figure 22 – Construction marks still present at storefront; remove

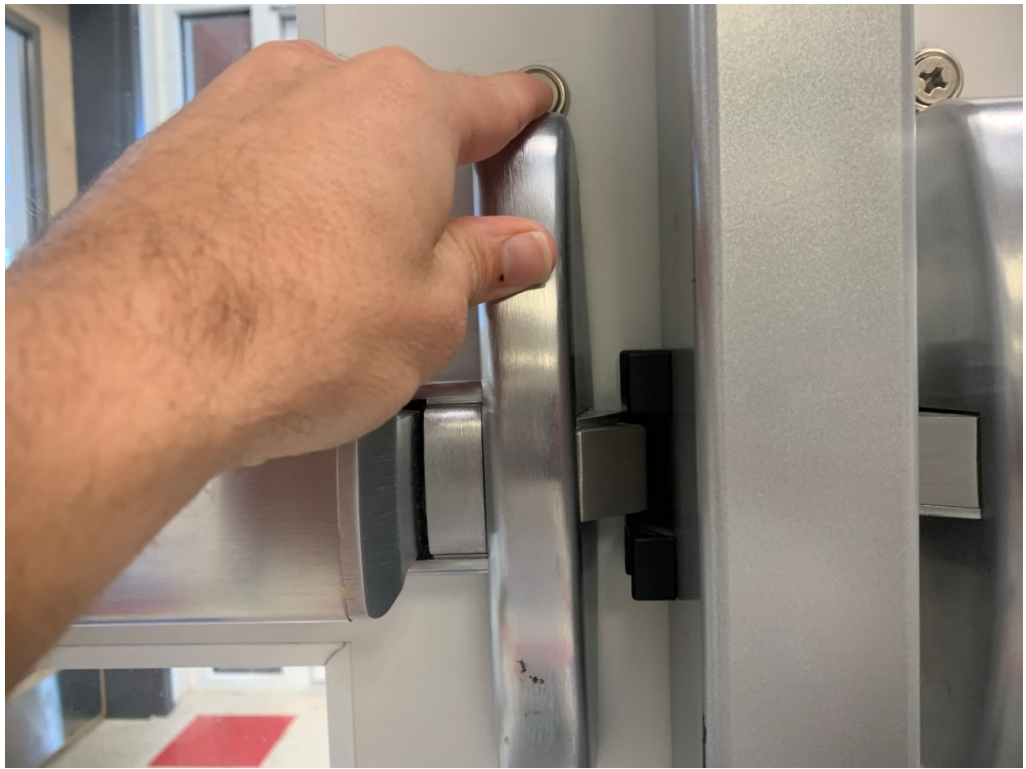
Figure 23 – Secondary latch not engaged @ catch; adjust catch to receive both parts of latch

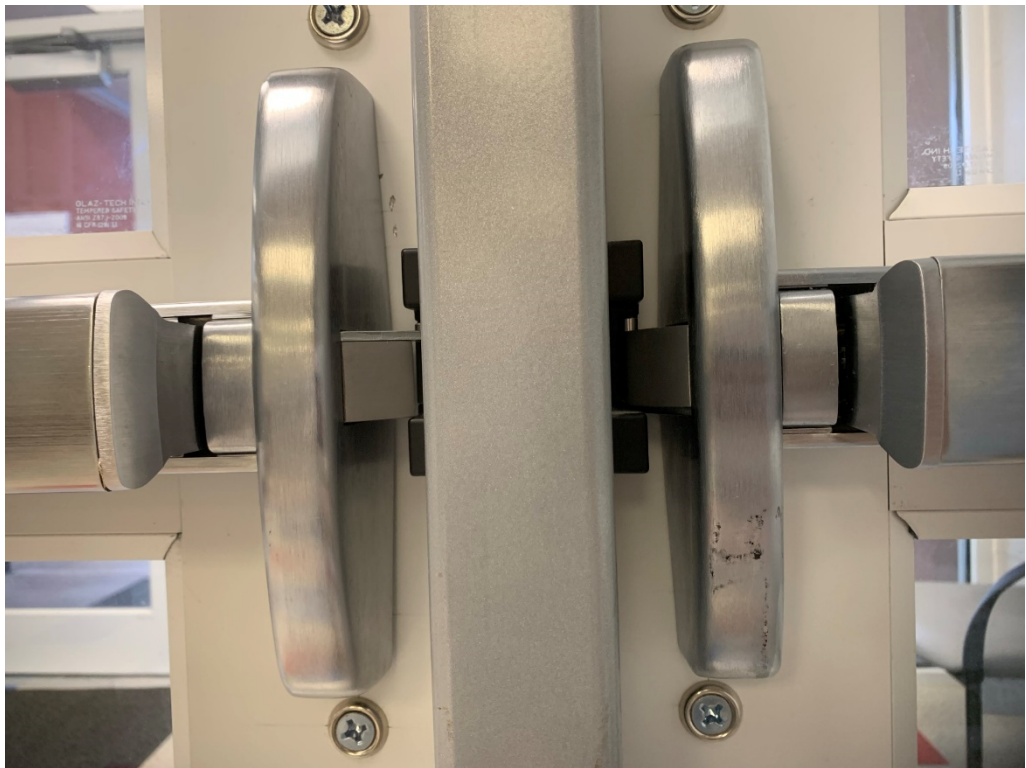
Figure 24 – Secondary latch not engaged @ catch; adjust catch to receive both parts of latch

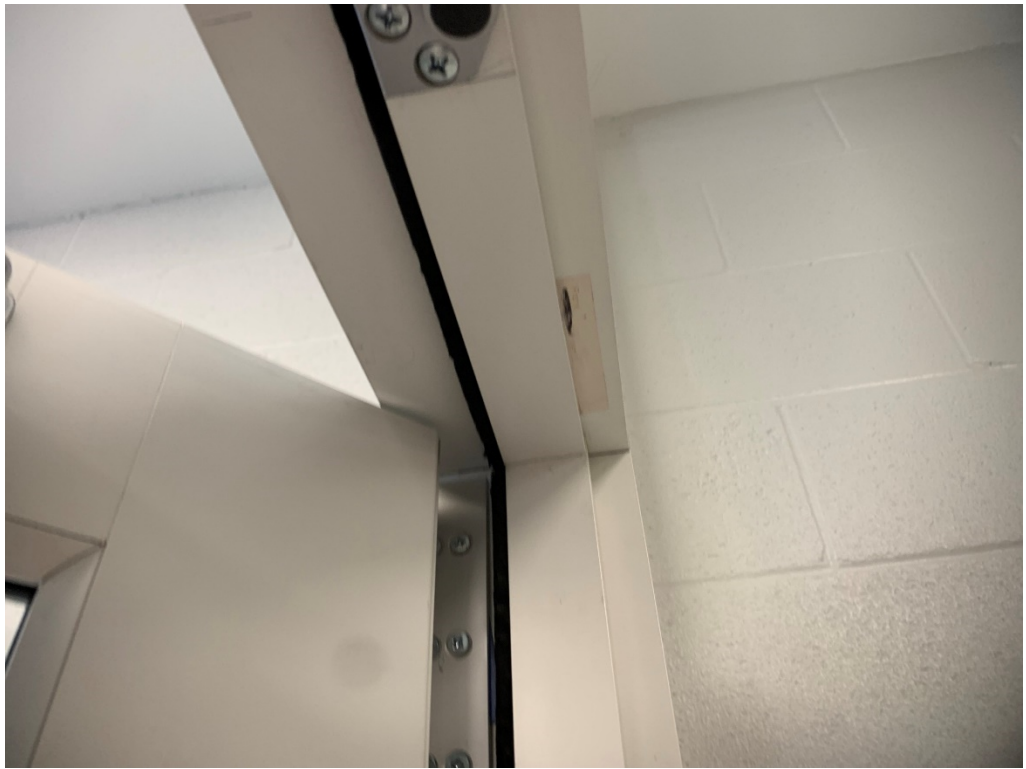
Figure 25 – Remove sticker at Storefront
