Architect's Field Report – Warranty Walk

18 October 2022

18056-Warren Central Junior High School / Warranty Walk

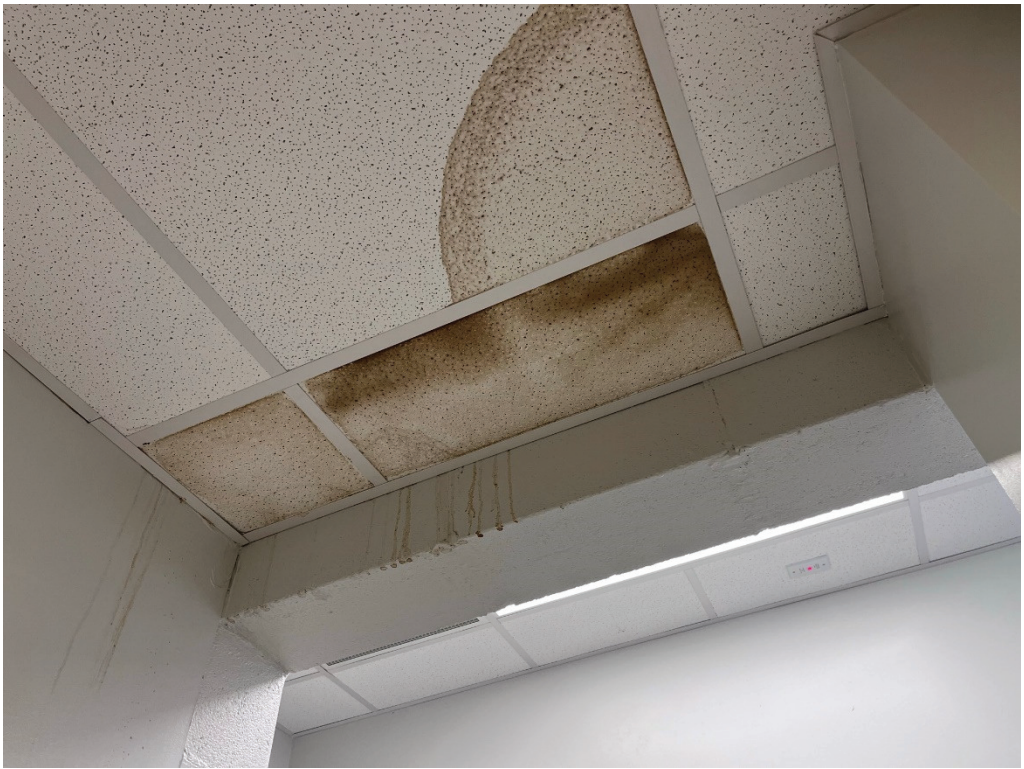
The connection between the addition and the existing school have had several leaks. These were noted during construction and were repaired, but have since opened up again. Throughout the connection on the east and west ends, water is infiltrating the space through the roof. This should be repaired by the contractor through their basic warranty.

Figure 1 – Leak at W end of Addition

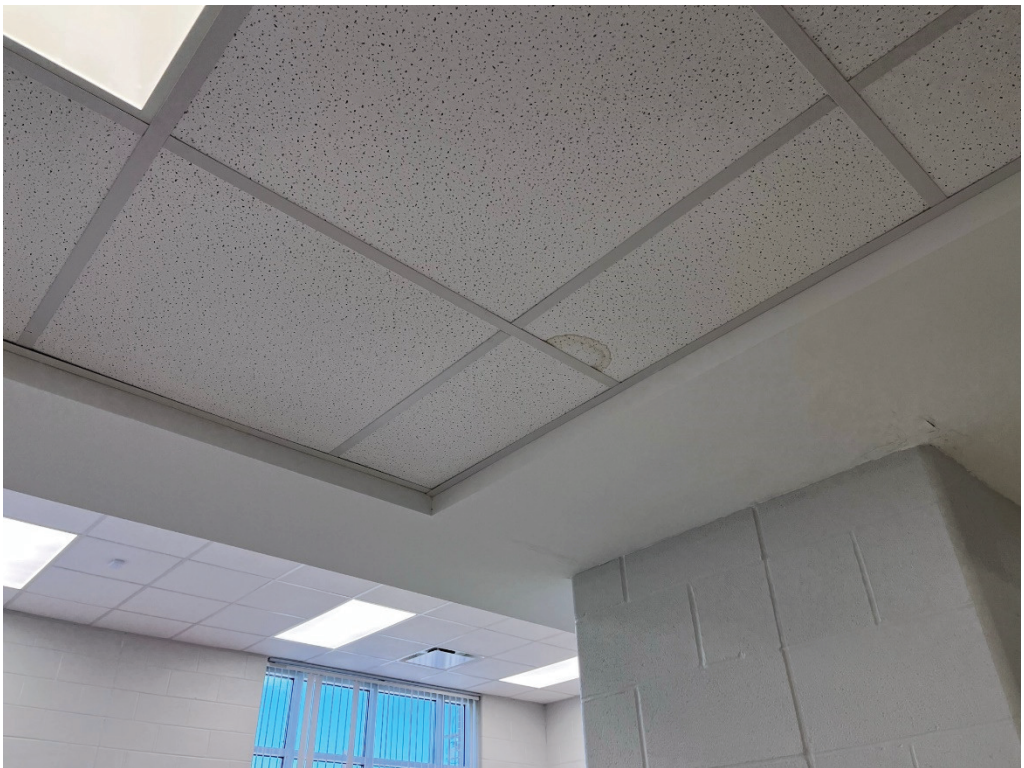
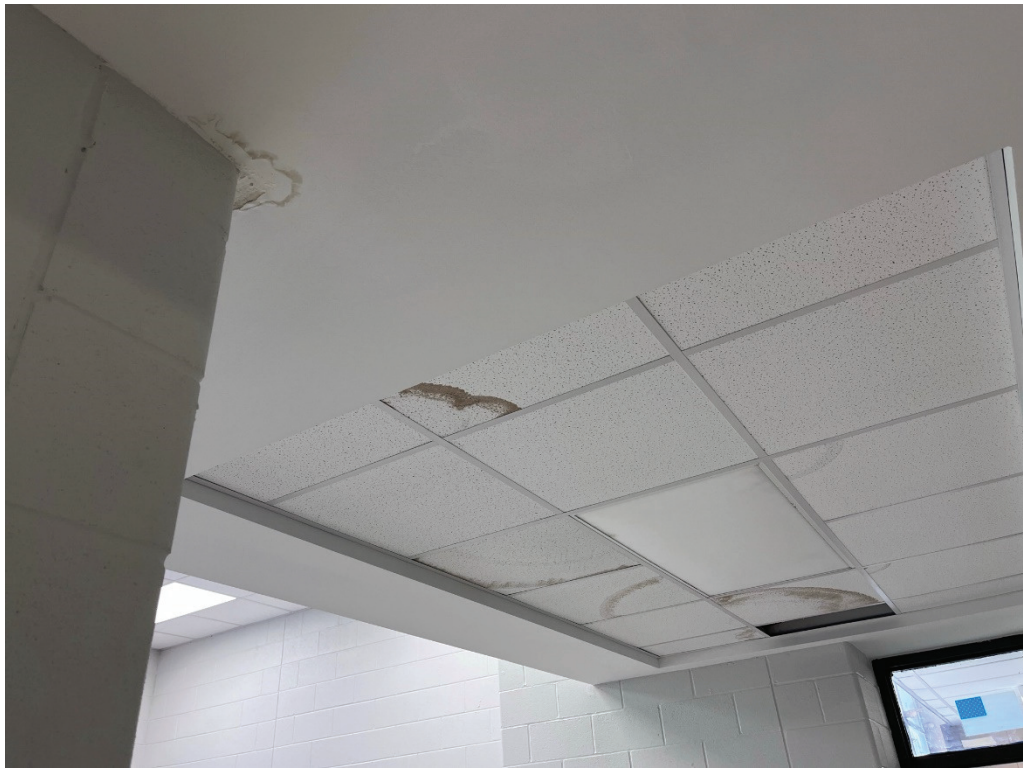
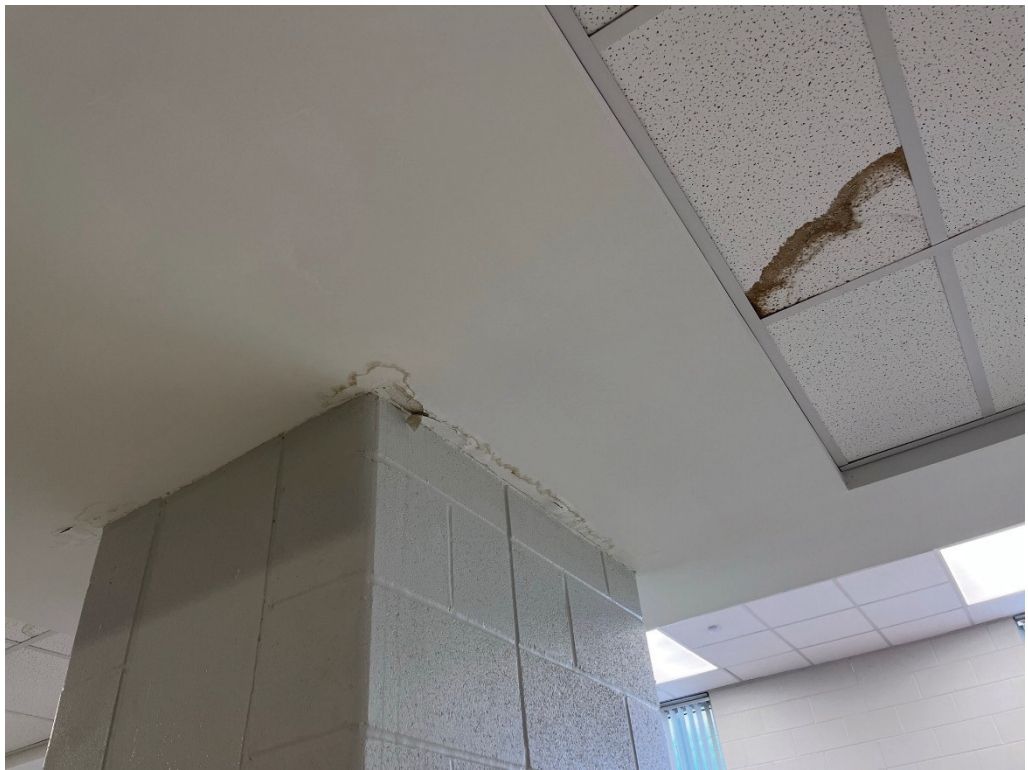
Figure 2 – Leak at E end of Addition

Figure 3 – Leak at E end of Addition

Figure 4 – Leak at E end of Addition

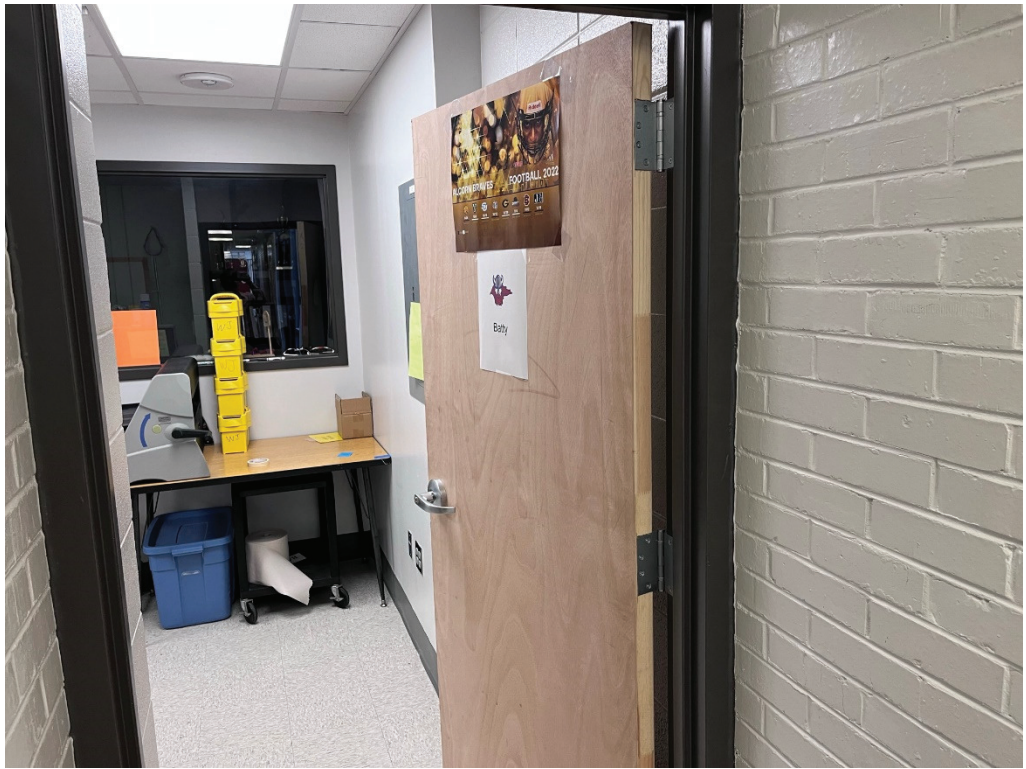
There was door installed in the 2nd floor administrative area that was never finished. It is bare wood. This should be finished.

Figure 5 – Door Installed with Bare Wood

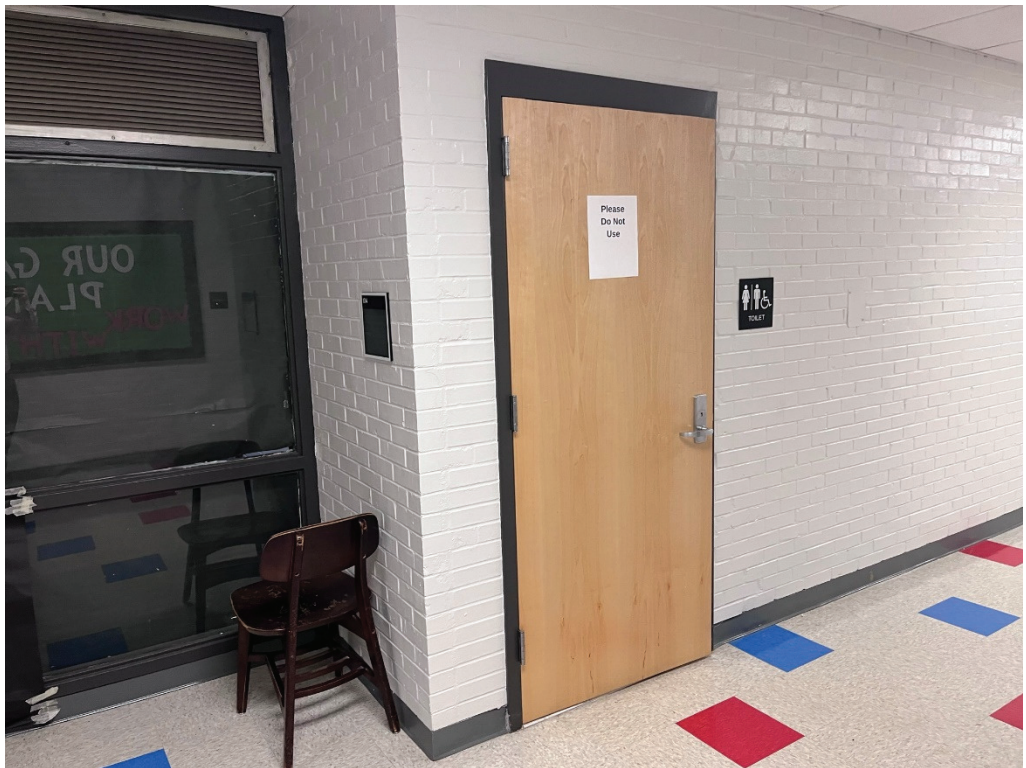
There is a door closer at the lower level that appears to never have been complete (at the newly installed single toilet room); a secondary screw is missing at the arm's attachment to the steel frame; there does not appear to be a hole drilled for the screw here which tells me that the screw was never present and should be installed properly by the contractor.

Figure 6 – Door with door closer not installed completely

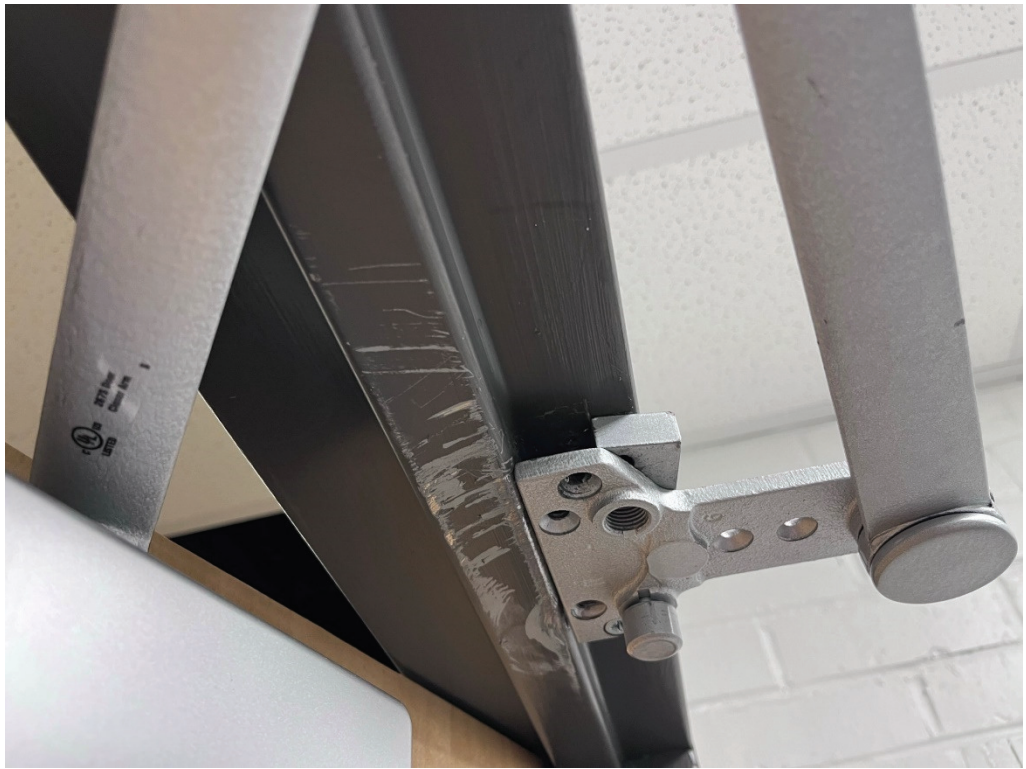
Figure 7 – No Predrilled hole is apparent

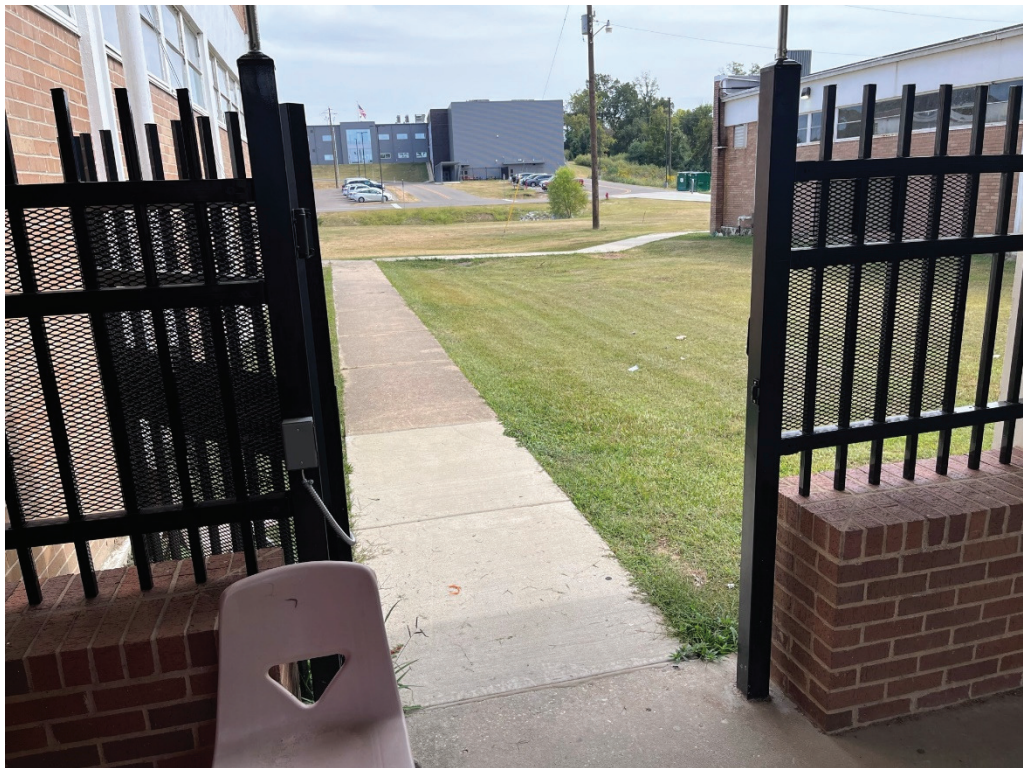
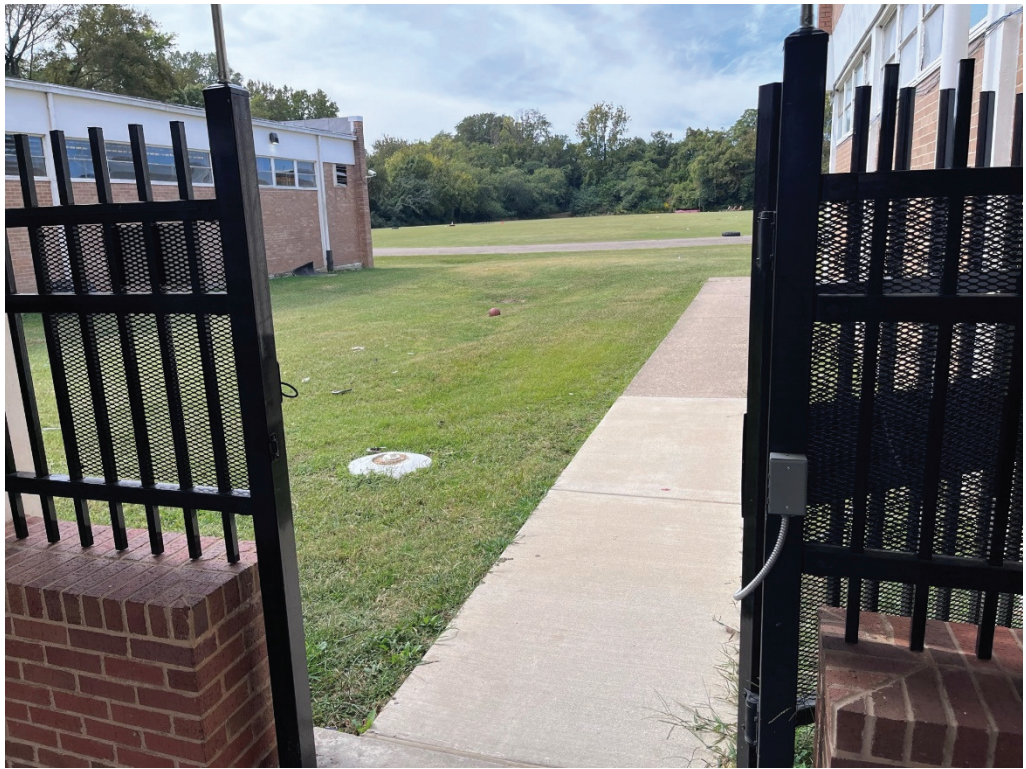
Lastly, there are 2 gates at the lowest level open air breezeway; Mr. Leflore mentioned that he thought these never latched properly, but Mr. Sanderford believes that they were working and that students had damaged them. They were currently under repair by the school. I do not believe this would be a warranty issue if damaged by the students.

Figure 8 – Gates Disputed as to completeness

Figure 9 – Gates Disputed as to completeness

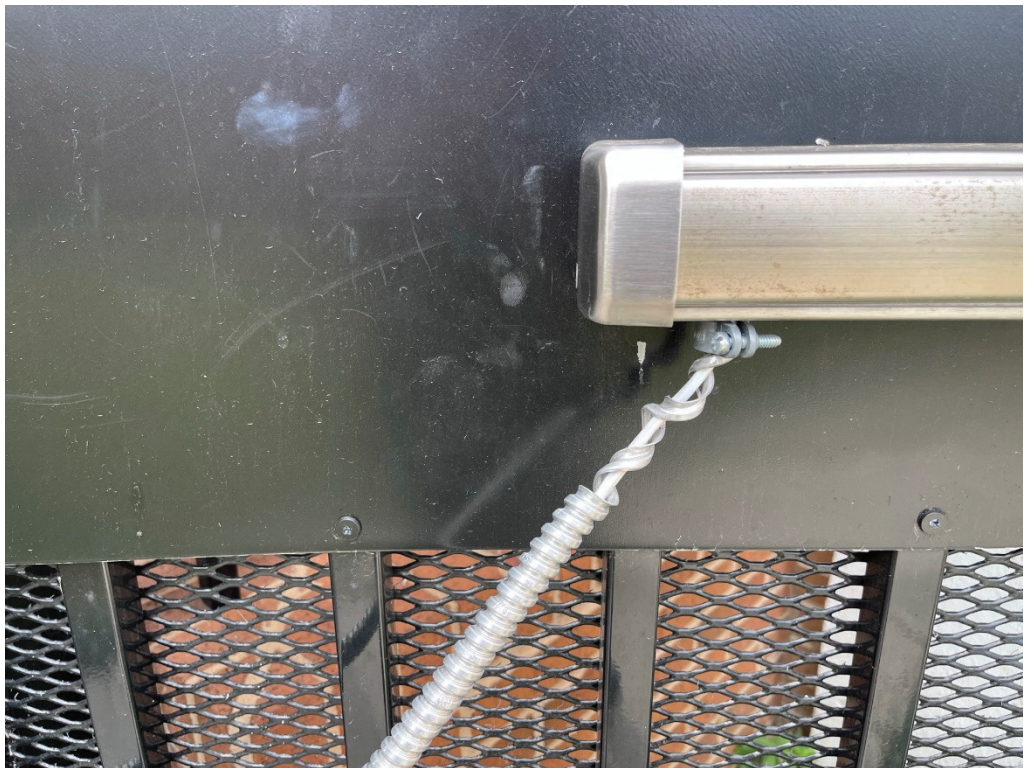
Figure 10 – Unraveling Conduit

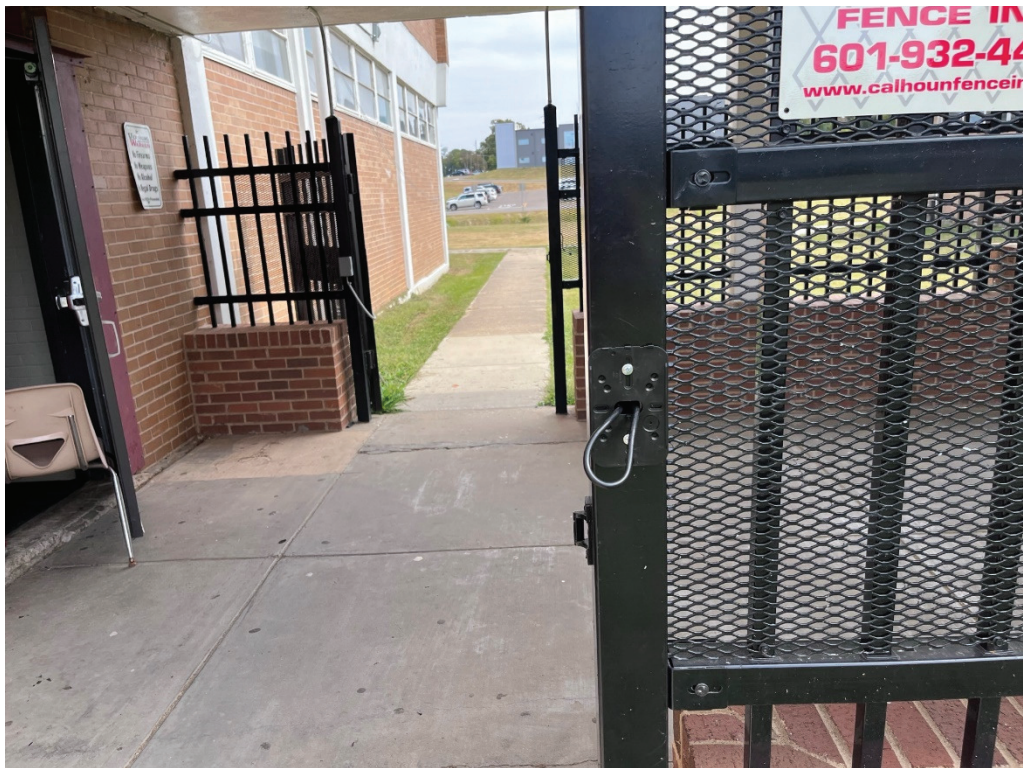
Figure 11 – School Replacing Keypads

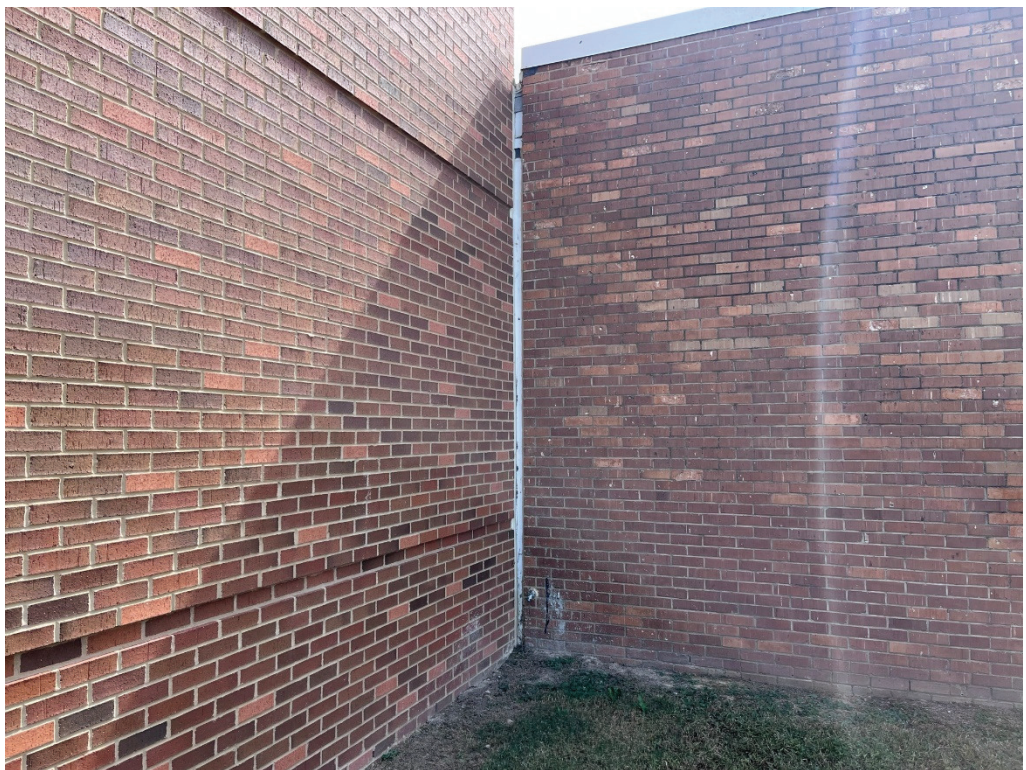
A Cover Expansion plate was supposed to be installed at the exterior junction between the addition and the existing building. We were told it would be installed. It is still not installed.

Figure 12 – Missing Expansion Cover
