Architect's Field Report

28 May 2020

18057-Warrenton Elementary / Report Number 001

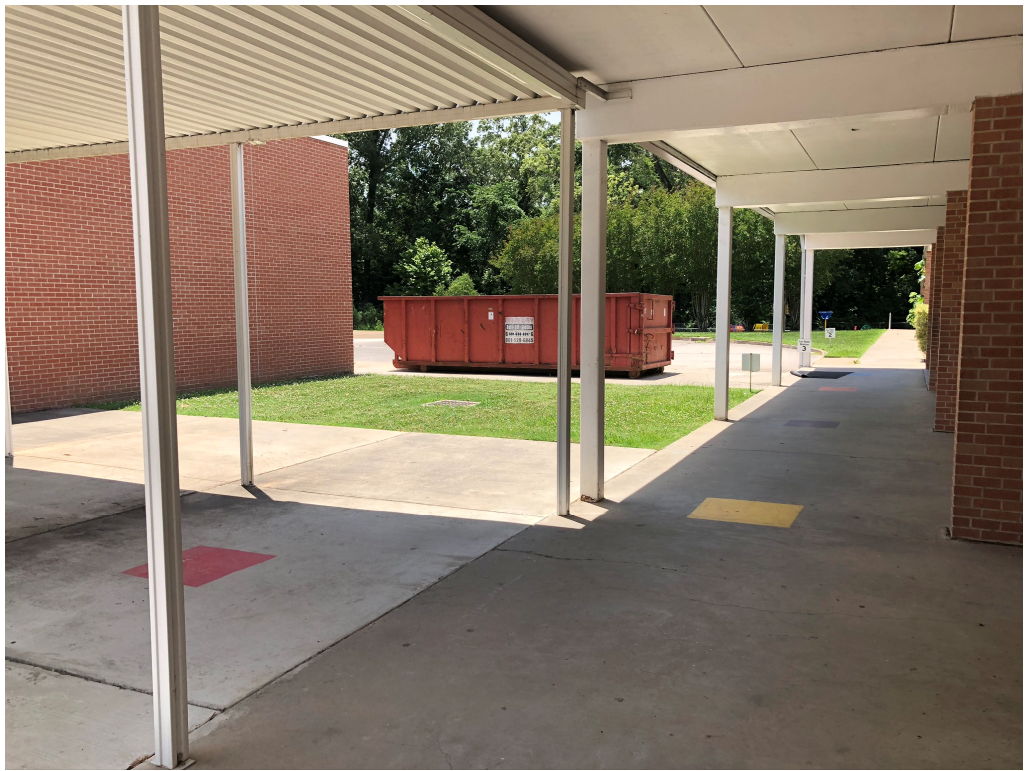
Figure 1 – Dumpster On Site

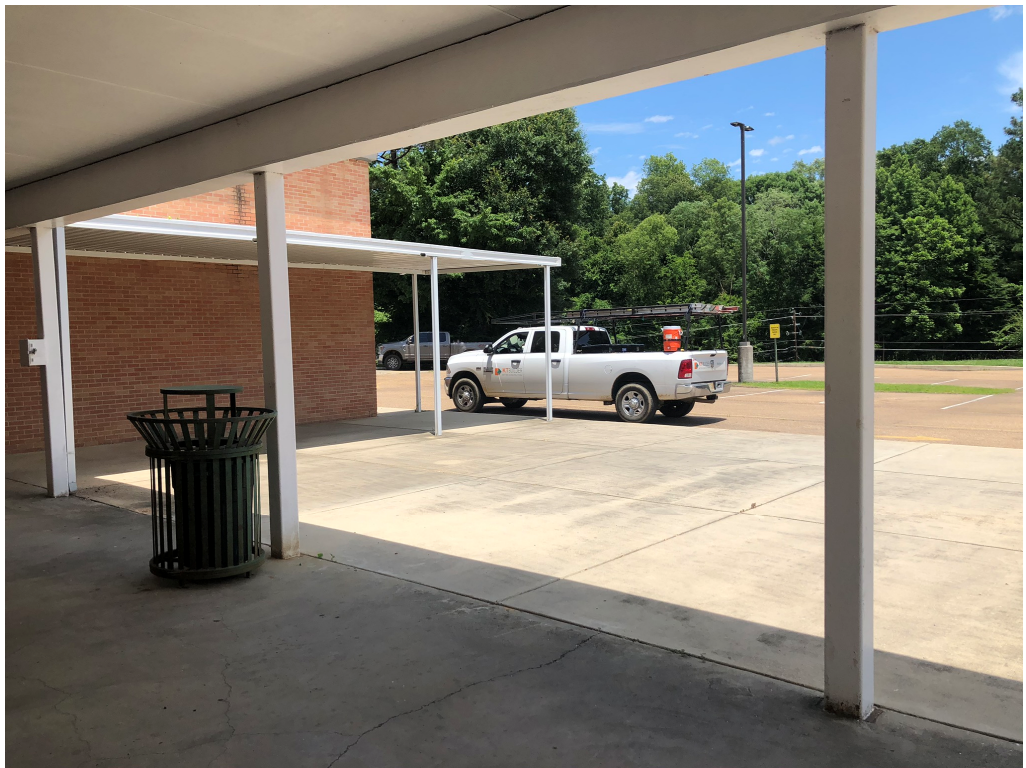
Figure 2 – Contractor On Site (First Day)

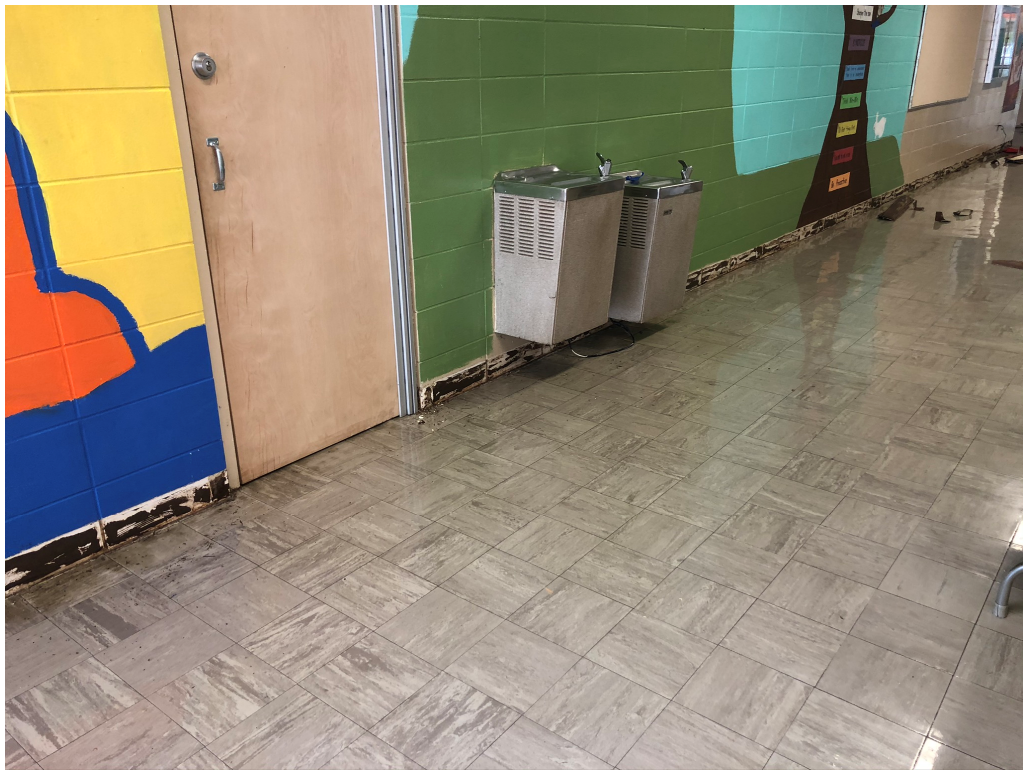
Figure 3 – Floor Base Removal Ongoing

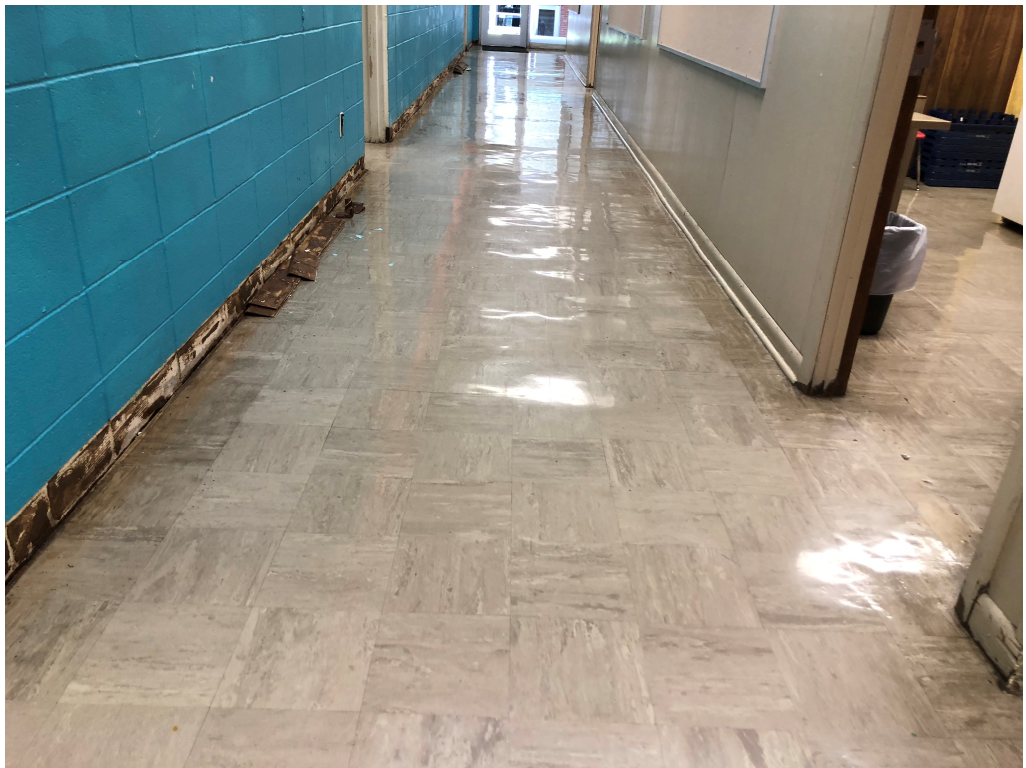
Figure 4 – Floor Base Removal Ongoing

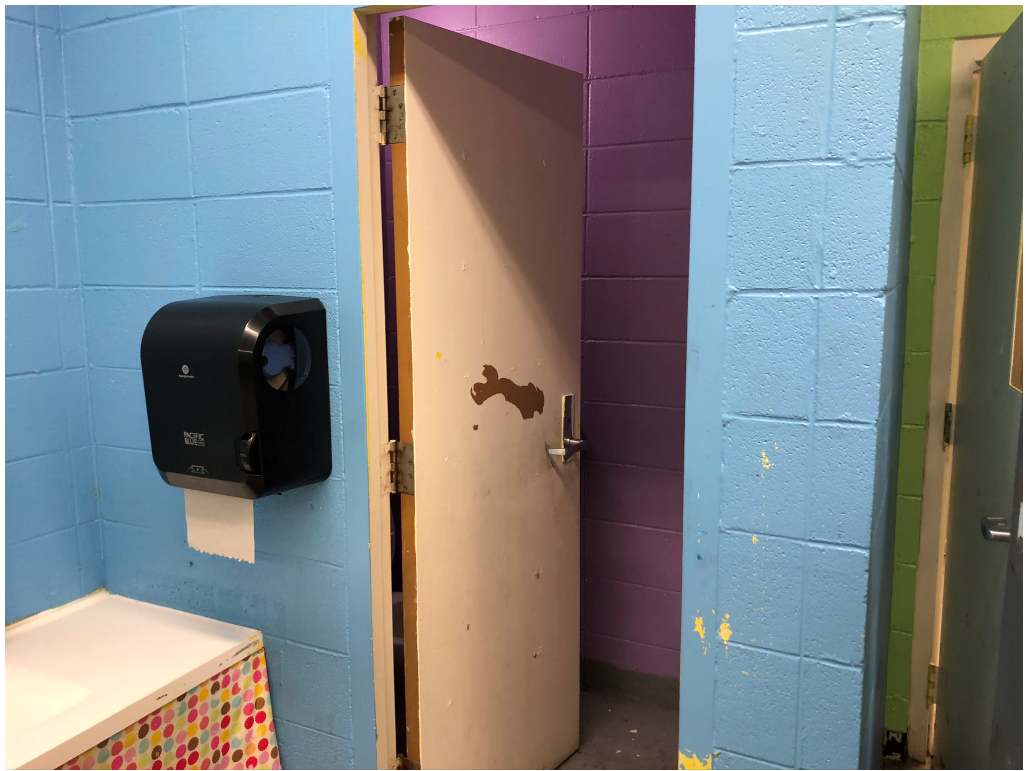
Figure 5 – Doors in Rooms Requested to Forego Painting Show Much Damage

Observations Arriving on site, I met Hunter McNeer, KT, in the main hallway. We discussed some painting changes requested by the client which removes painting from a large portion on the 300 wing. We reviewed the wing and would like to recommend at least painting the doors in the rooms that are marked for no painting.

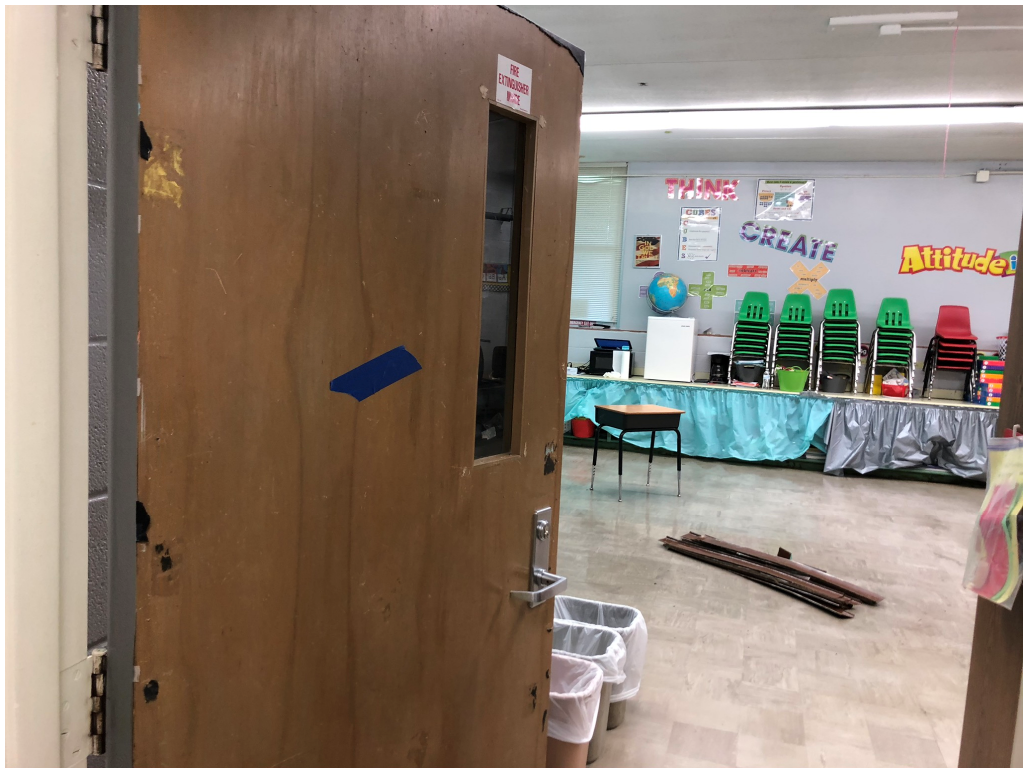
Figure 6 – Blue Tape on door to indicate No Paint in Room (typical in 300 wing)

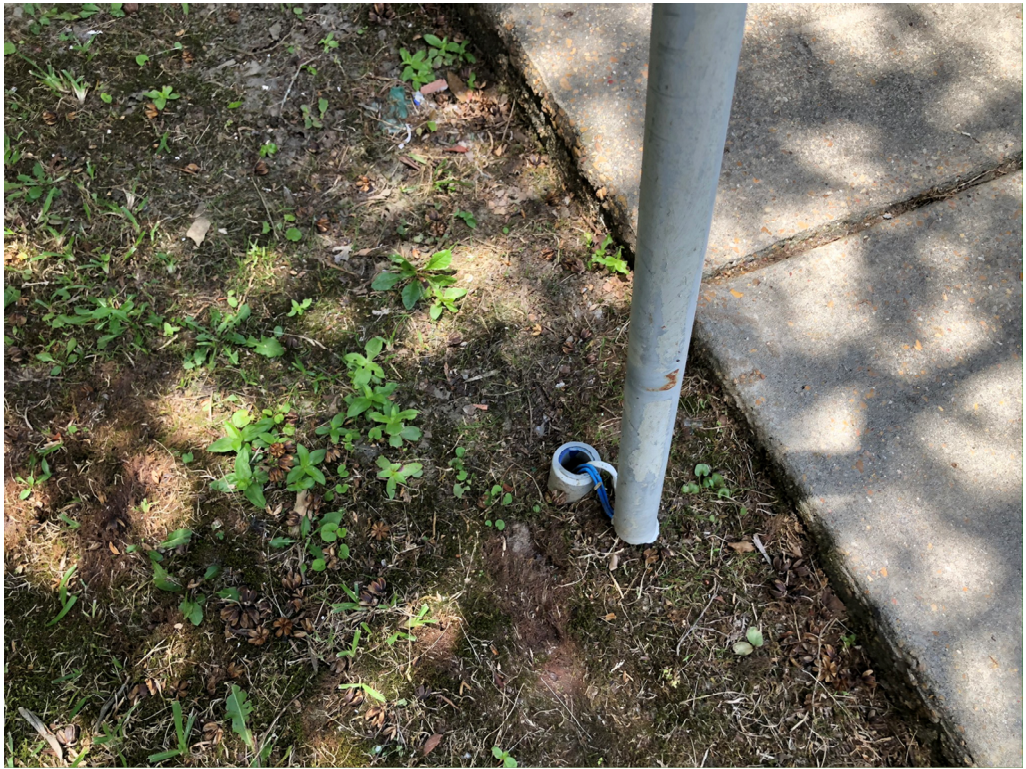
Figure 7 – Conduit inside of footprint of new ADA Ramp; should re route be overhead?

We also reviewed the location for the new ADA ramp to the outside classroom between the 300 and 200 buildings. There is not 7'-0" as required for the ramp between exterior columns and the outside building. I suggested that if the contractor had to build the ramp and notch around a column, that it would be fine as long as we have 32" between column and inner handrail. This would keep that ramp at 7'-0" in width but move it onto the existing concrete walk.

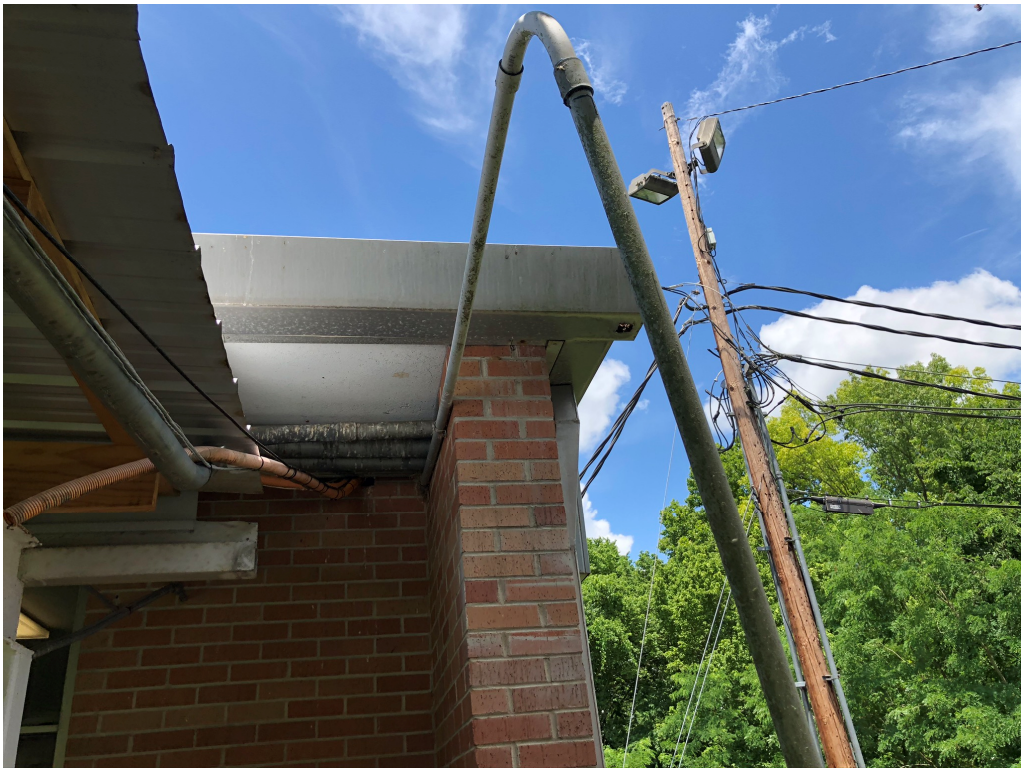
Figure 8 – Conduit inside of footprint of new ADA Ramp; should re route be overhead?
