Architect's Field Report

18 June 2020

18057-Warrenton Elementary / Report Number 002

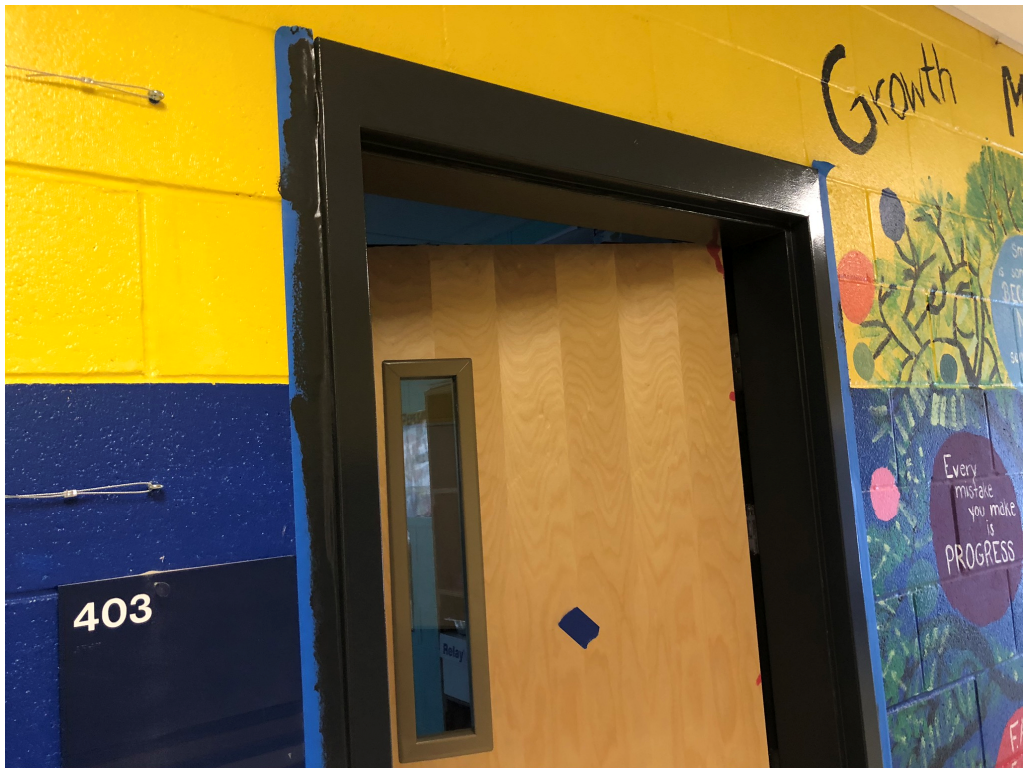
Observations I arrived on site, entering at building D. I noted paint work at door Jambs here.

Figure 1 – Interior Paint Work @ Building D

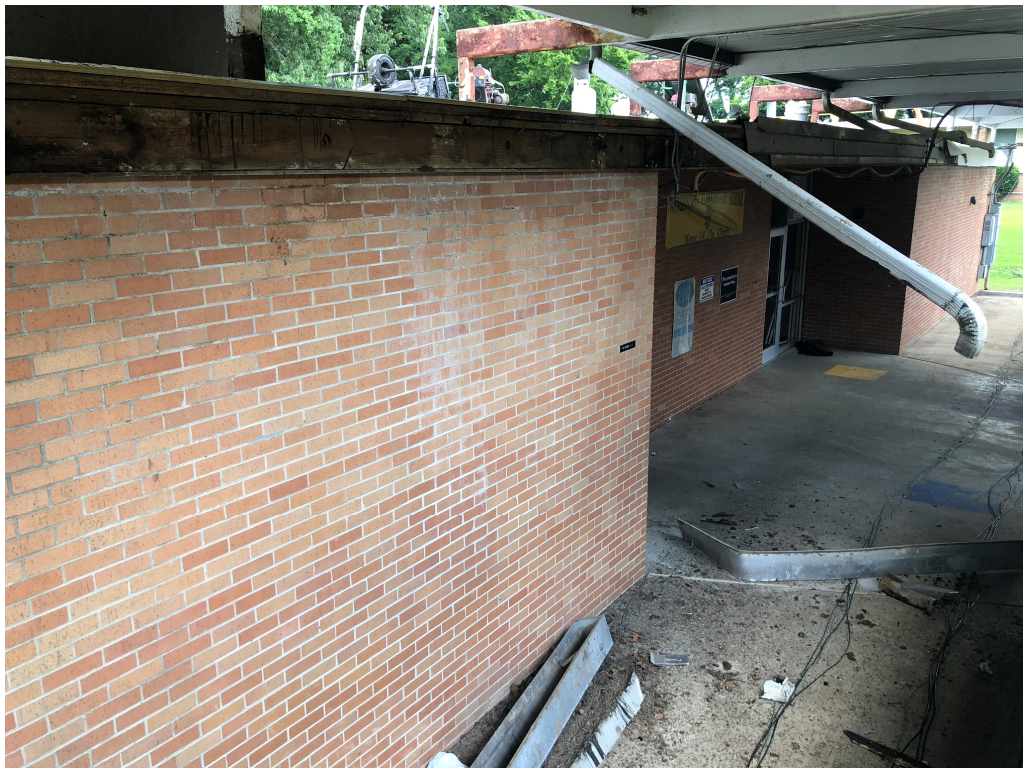
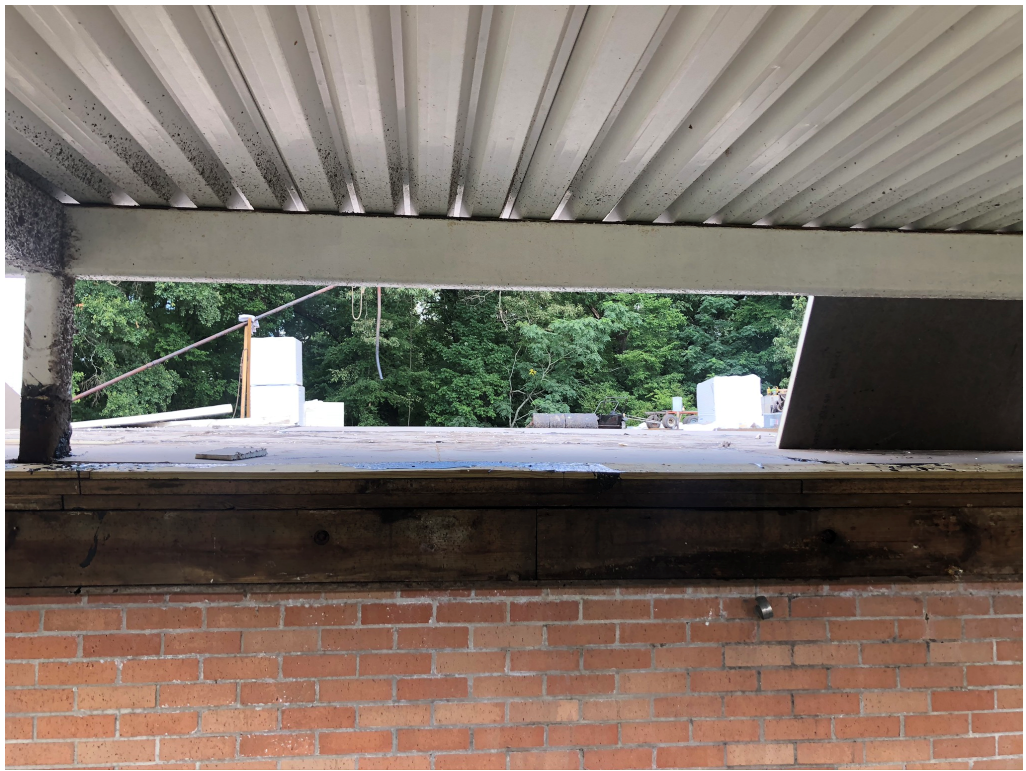
Walking around to the back of the property, I noted roofers at work on Building B. Roofing demo was ongoing.

Figure 2 – Roofing Work @ Building B

Figure 3 – Roofing Work @ Building B

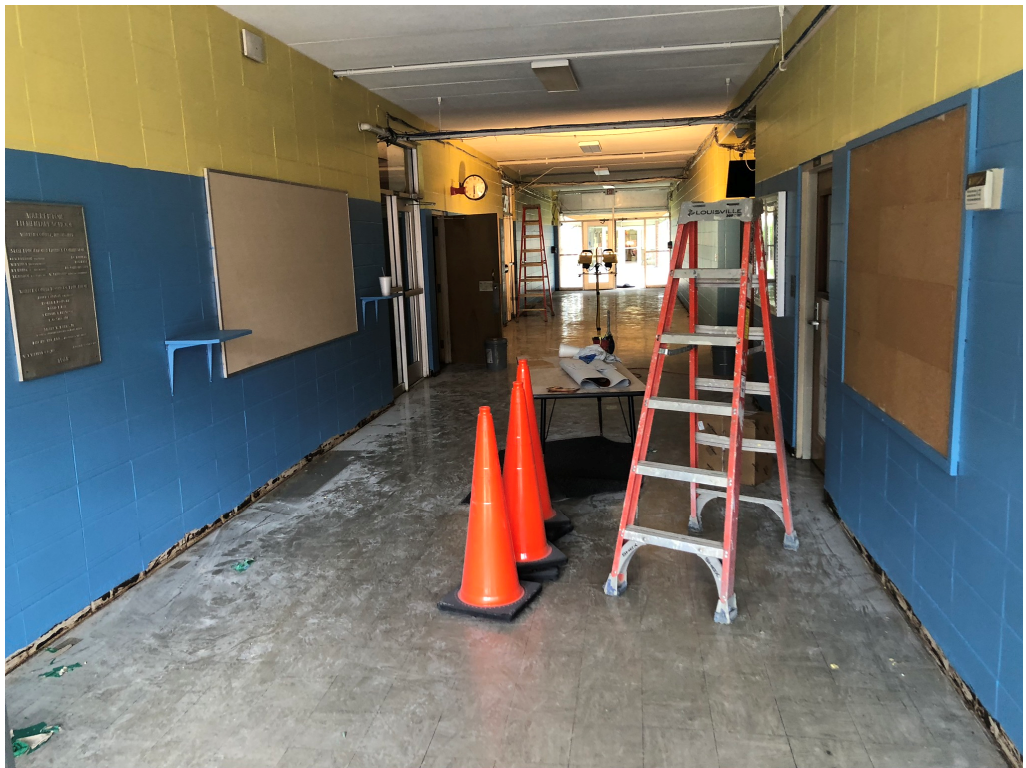
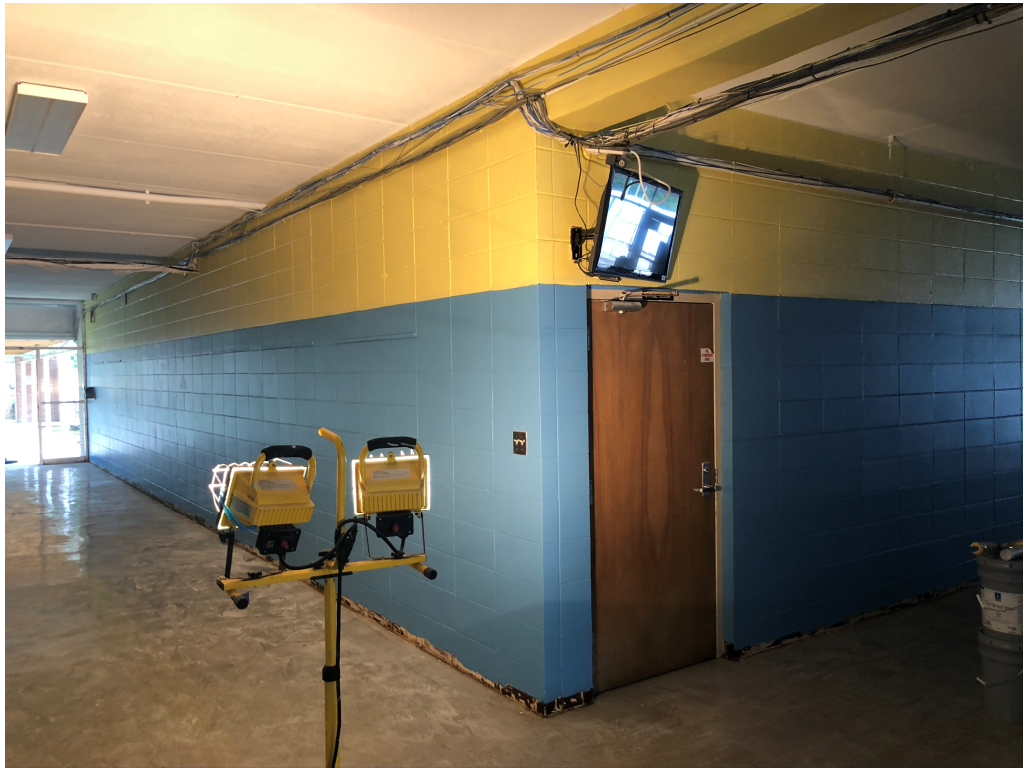
I entered Building A where I saw that paint work has been performed at hallway walls. Gas heaters in this area have also been removed.

Figure 4 – Interior Paint Work @ Building A

Figure 5 – Interior Paint Work @ Building A

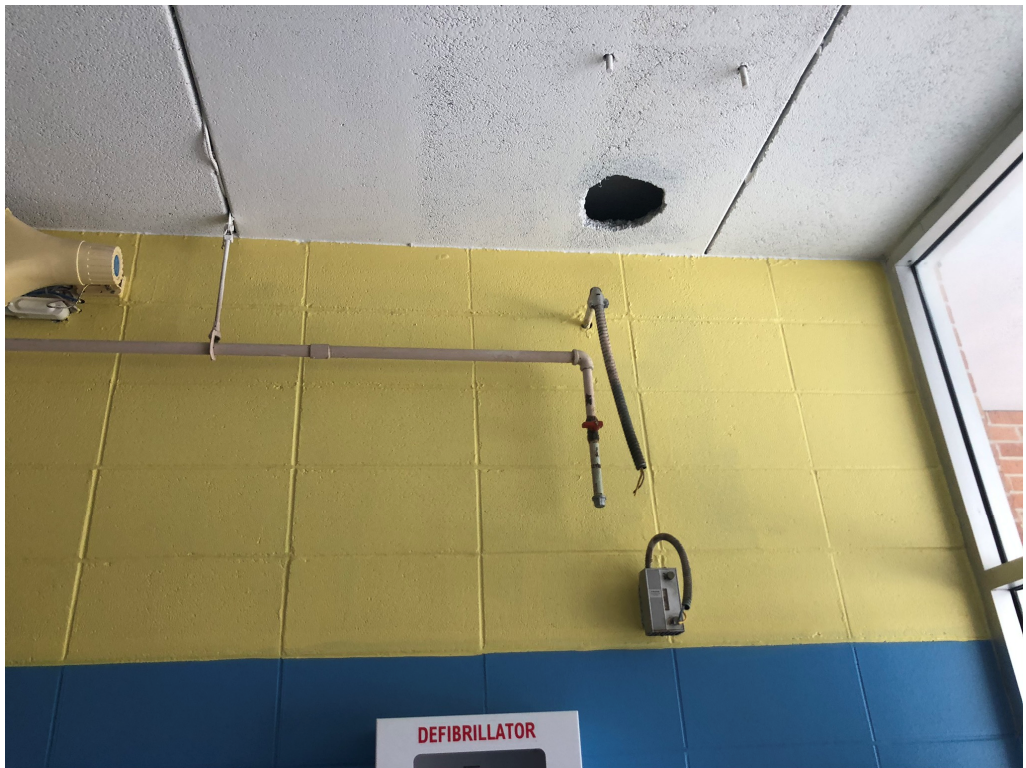
Figure 6 – Heater Removed @ Building A

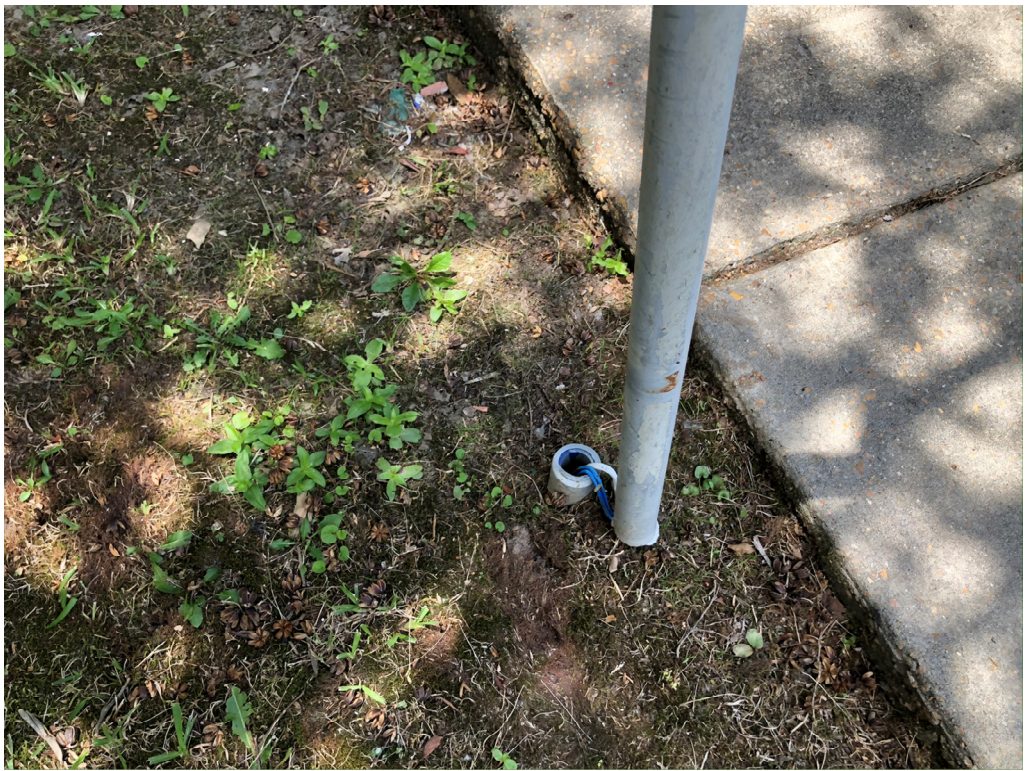
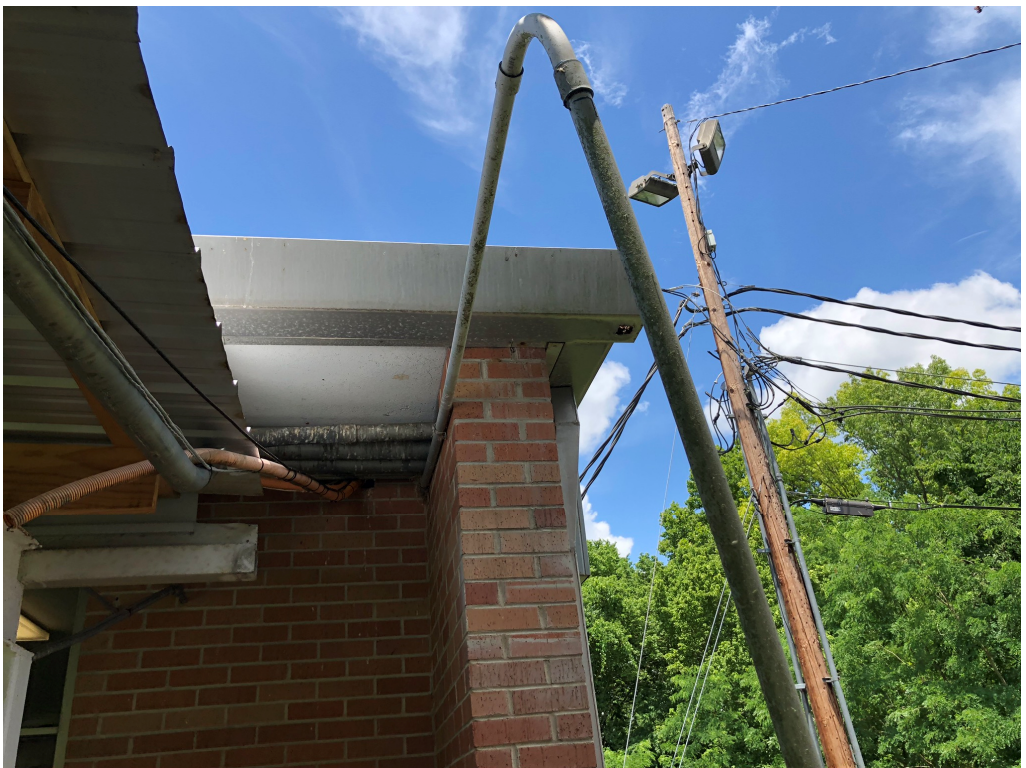
Figure 7 – Conduit inside of footprint of new ADA Ramp; should re route be overhead?

Figure 8 – Conduit inside of footprint of new ADA Ramp; should re route be overhead?
