Architect's Field Report

18057-Warrenton Elementary / Report Number 003

24 June 2020 / 1:00 PM

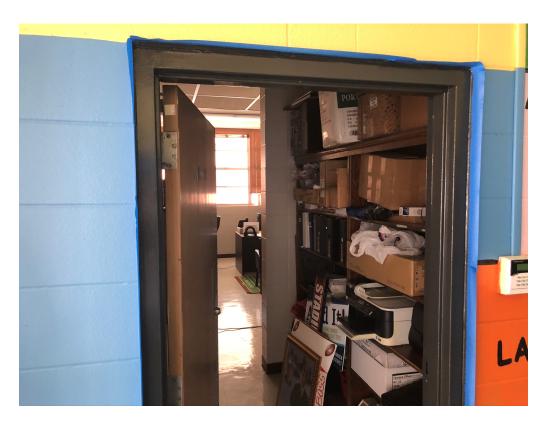
A. Paint work in ongoing in this area.

Figure 1 – Interior Paint Work @ Building A

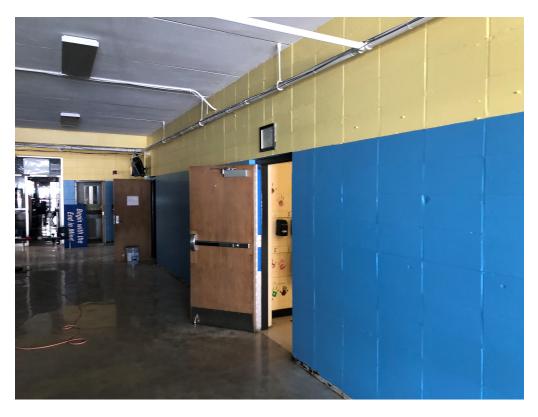
Figure 2 – Interior Paint Work @ Building A

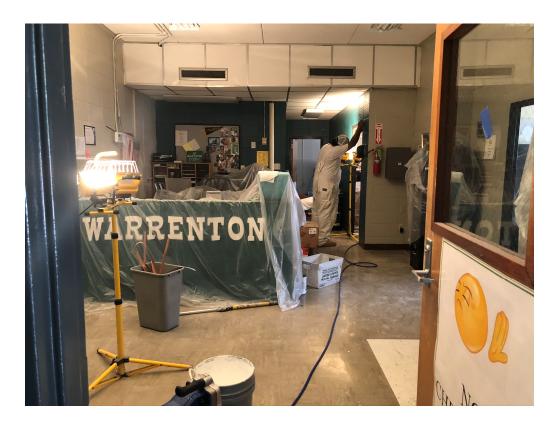
Figure 3 – Interior Paint Work @ Building A

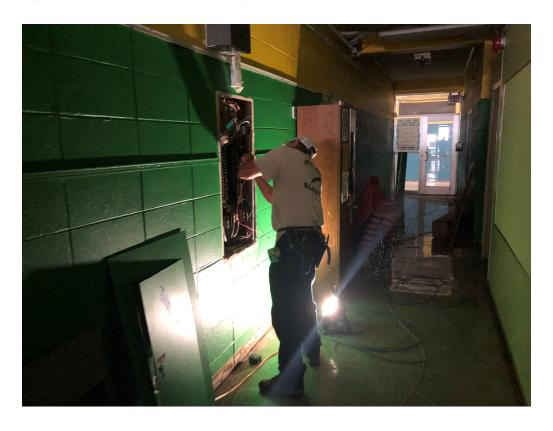
I walked to the rear section of building A and met an electrician who was reworking an interior panel. Upon inquiry, I found out that he is actually working directly for the school and is repairing an issue that arose during the re-roofing process whereby electrical conduit was removed from above the roof slab in order to install new roofing. I was told that Mr. Bill Sanderford had directed the removal of the conduit as it was in disrepair and reworking it above the roof could potentially cause water damage due to the length of time it would take to rework the services

Figure 4 – Electrical Work @ Building A

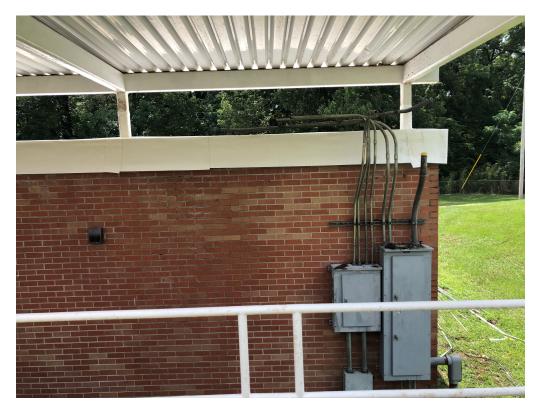
properly.

Figure 5 – Cut Power Conduit @ Building B

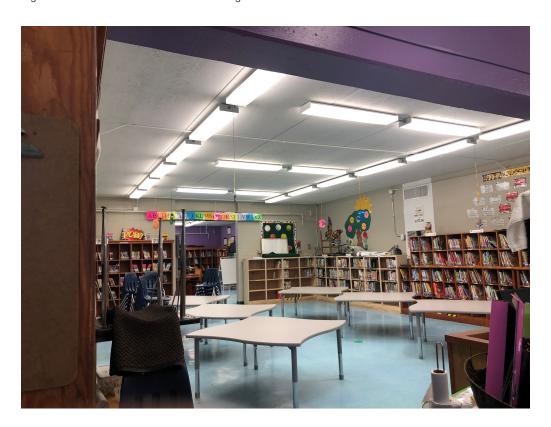
Figure 6 – Building C is in Similar Situation with Conduit Above; From Below it is impossible to know whether or no the conduit is embedded in the above roof deck or not
