Architect's Field Report

03 July 2020

18057-Warrenton Elementary / Report Number 004

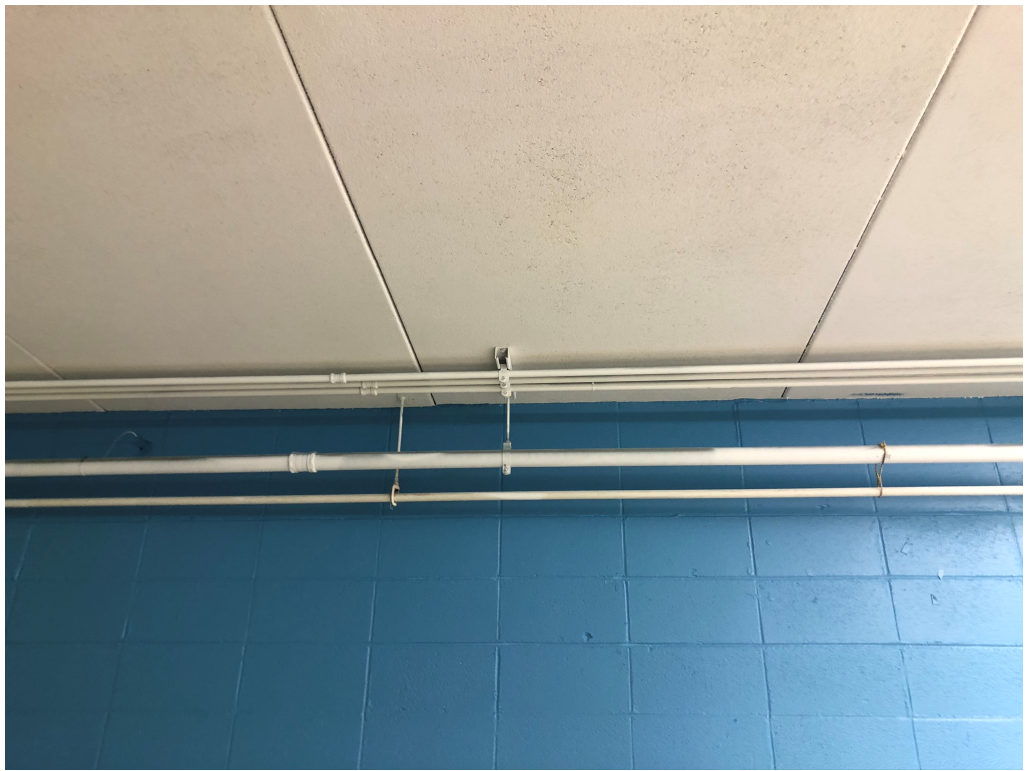
Figure 1 – Ceiling paint Work; Pipes should be fully painted if attached to ceiling.

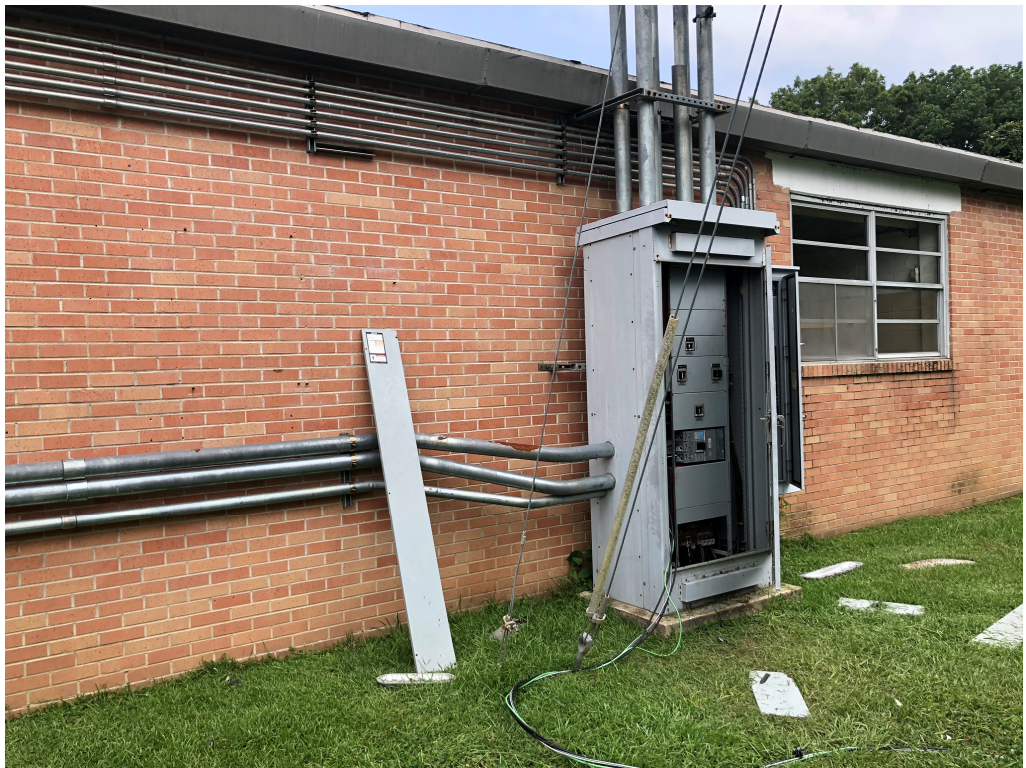
There is a temporary power wire that connects an open panel on the interior of this back space from the main exterior distribution panel. This needs to have some kind of temporary protection around it to prevent accidental electrocution. At the exterior main distribution panel, the same needs to be put into place. These are required to be connected temporarily due to the issues concerning roofing work that has been previously discussed at Tuesday's (6/30) meeting.

Figure 2 – Temporary Power Run from Main Panel (temporary protection or caution tape needed around open panel if left open continually throughout the day)
