Architect's Field Report

01 October 2019

18059-AOI Academy of Innovation / Report Number 002

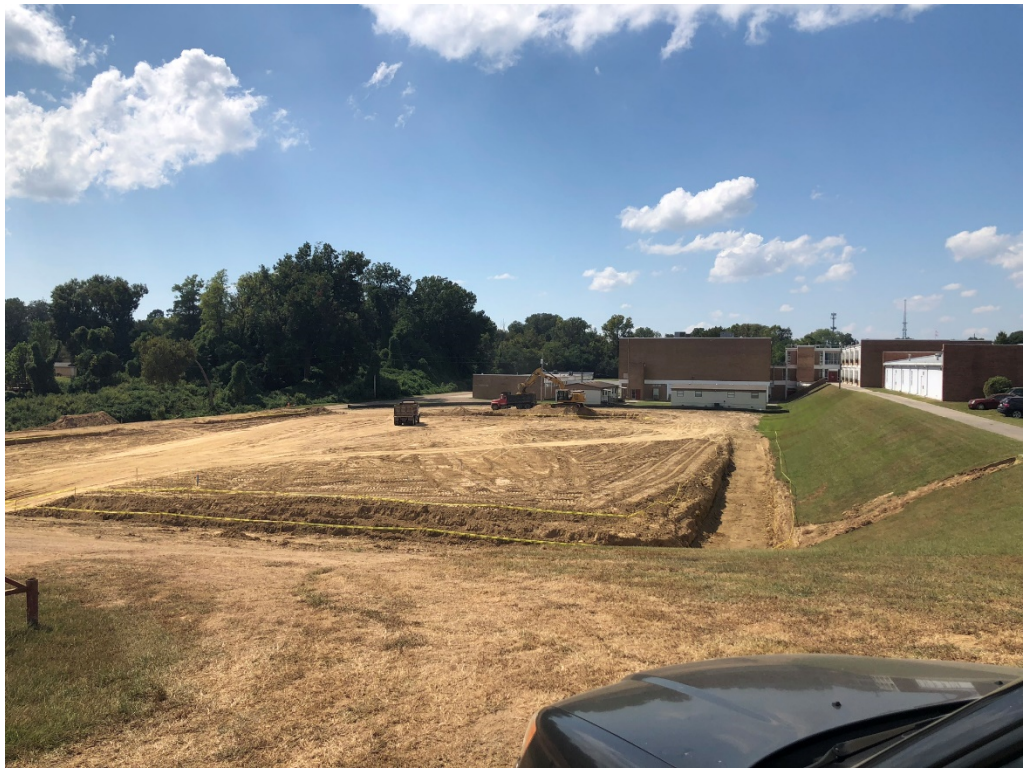
Figure 1 – Lower Pad Developing (N Entrance Looking SW)

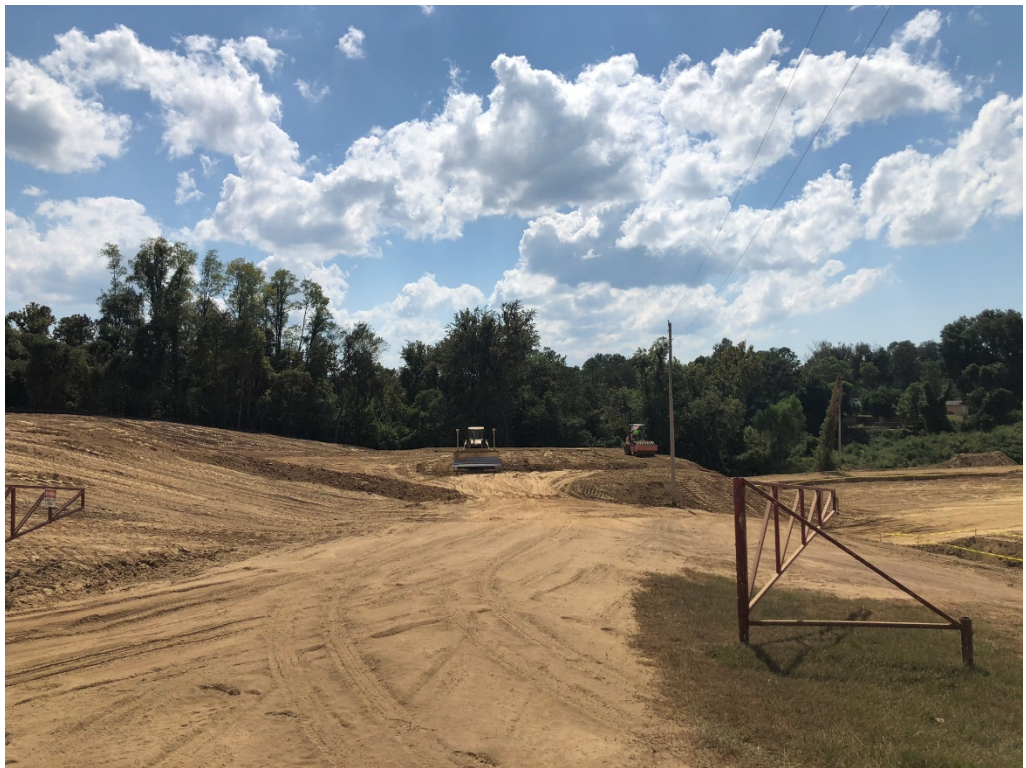
Figure 2 – Lockable Gate Entrance (N Entrance Looking S)

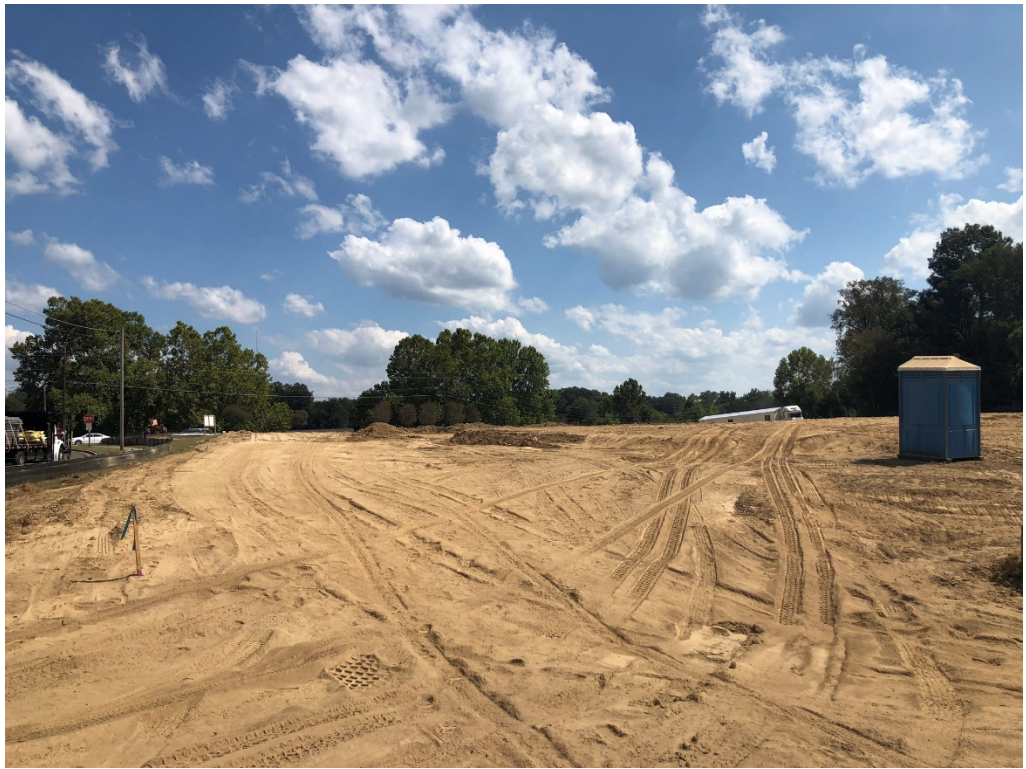
Figure 3 - Upper Pad Work (N Entrance Looking SE)

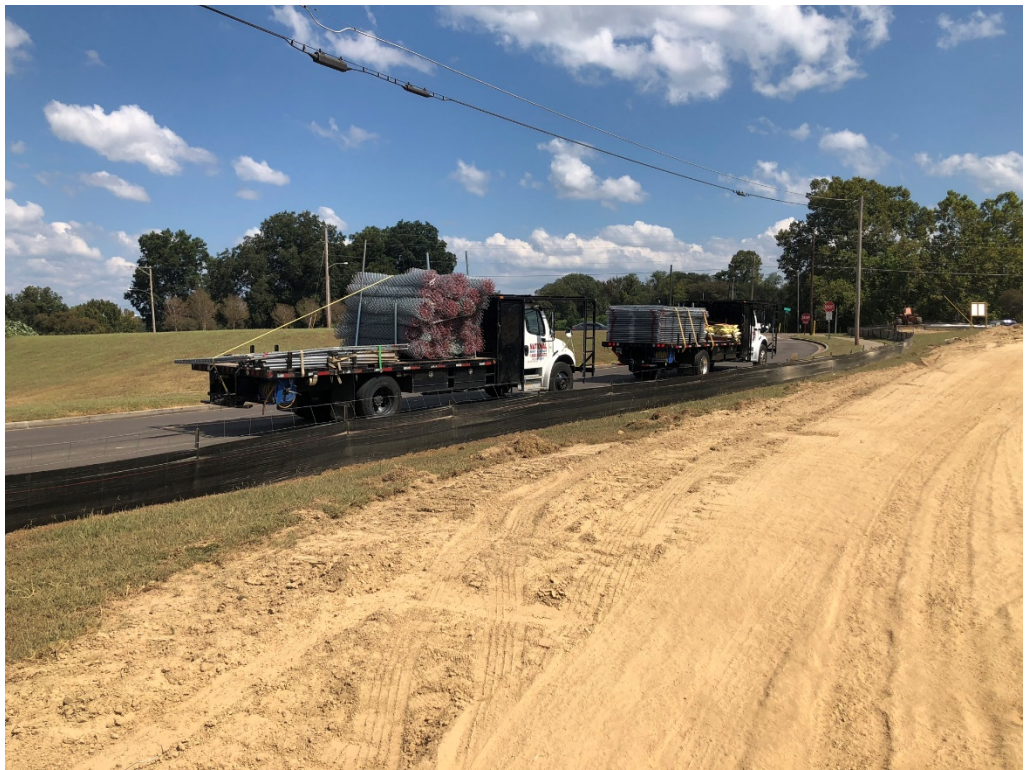
Rental Fencing being delivered is by National.

Figure 4 – Temporary Fencing being Delivered

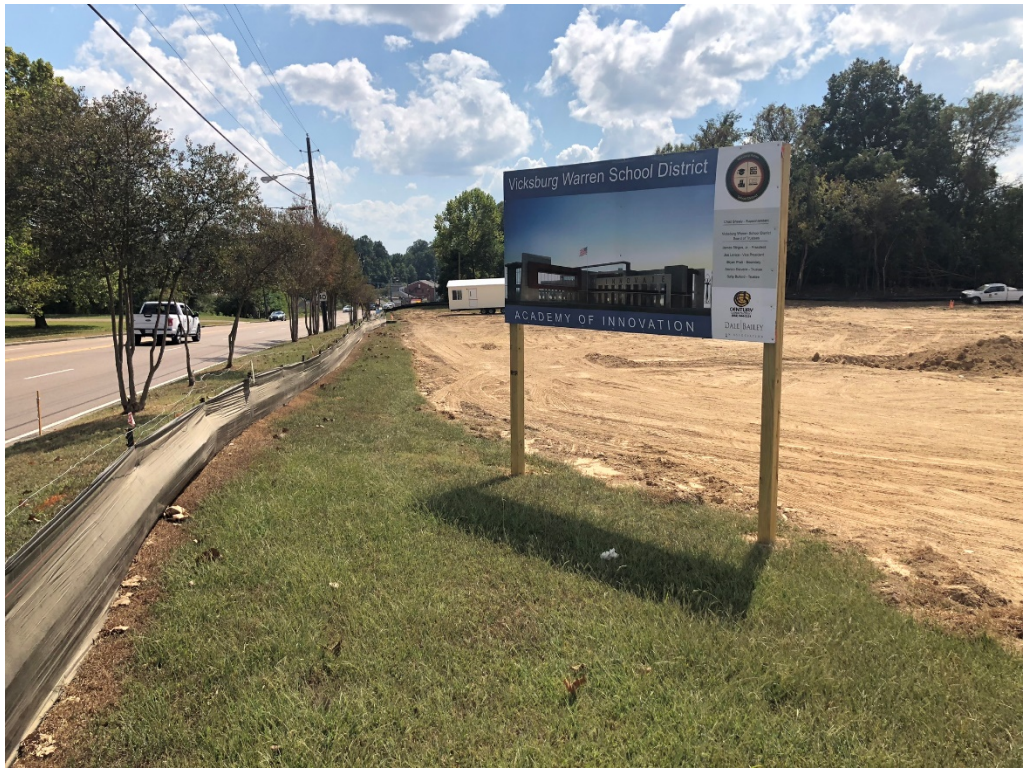
Figure 5 – Street Front Signage for Project

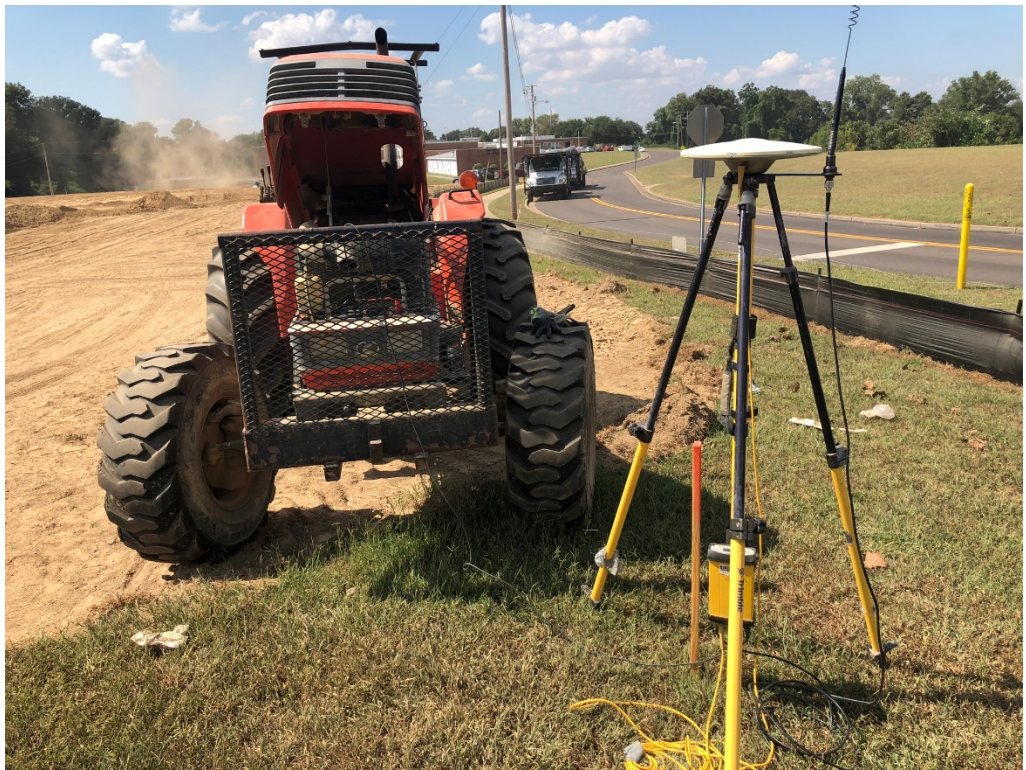
GPS surveying equipment was in use for laying out the building.

Figure 6 – GPS Locating Equipment Connected to Tractor Power

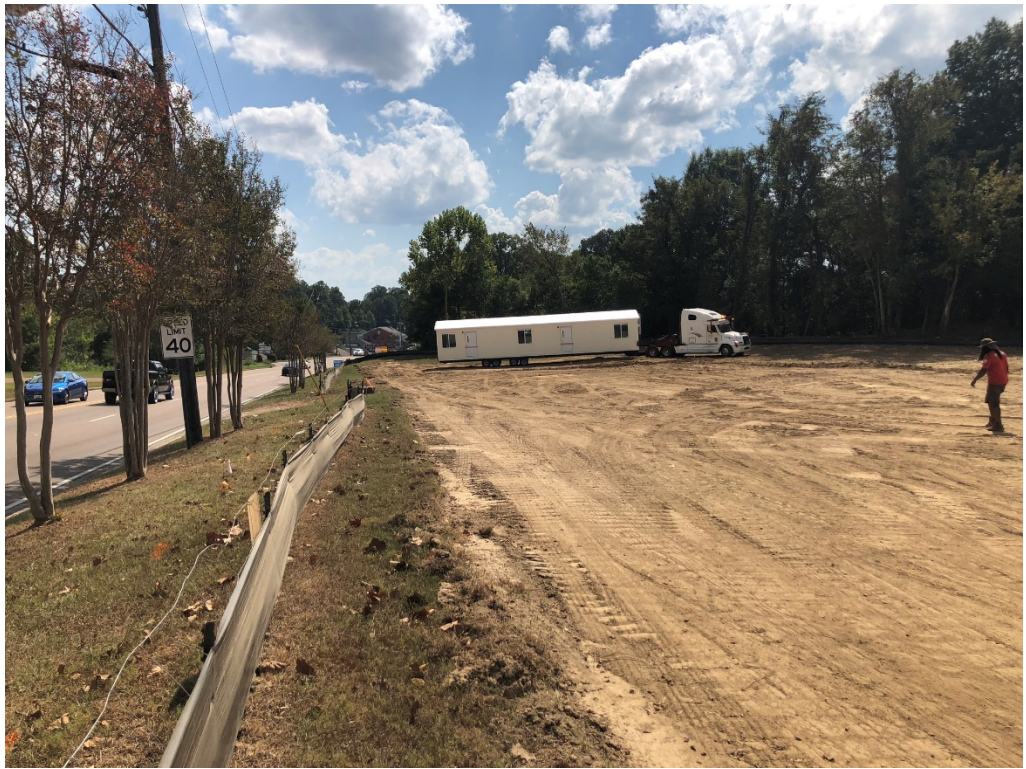
After walking site Perimeter while documenting, I spoke with Joey Moore. He was setting Job site Trailer in place as it was just delivered. He implied that bottom and middle slabs were nearly to grade.

Figure 7 – Job Site Trailer Set on SE Corner of Project Site

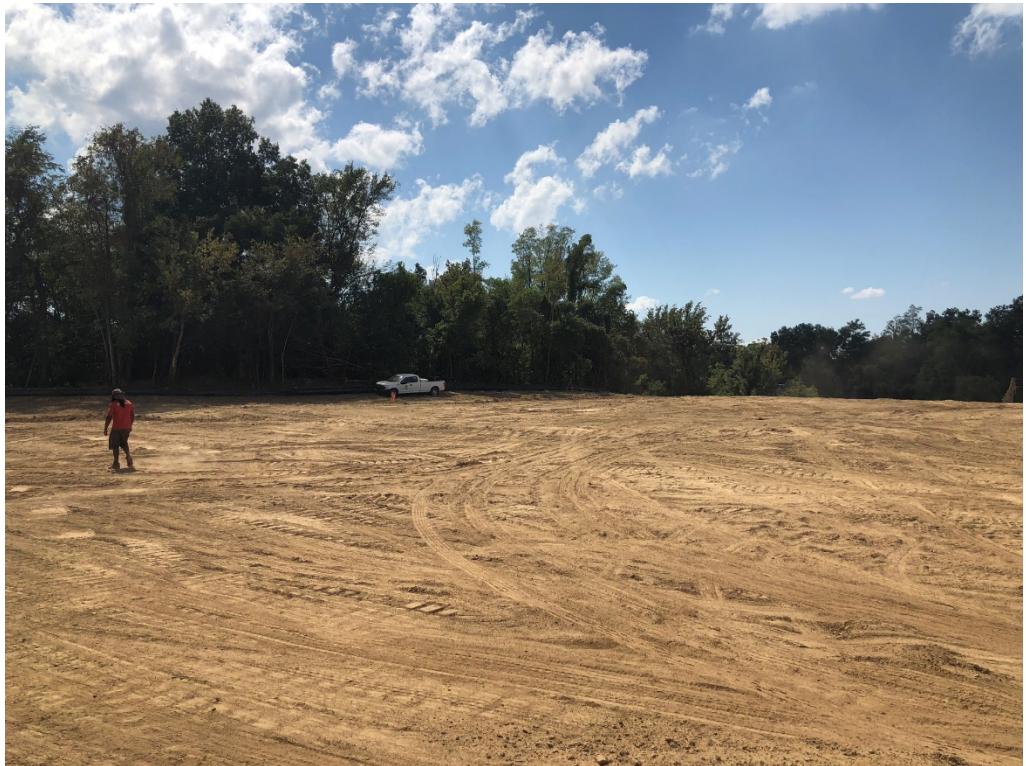
Figure 8 – Upper Pad (No Grade Work Yet)

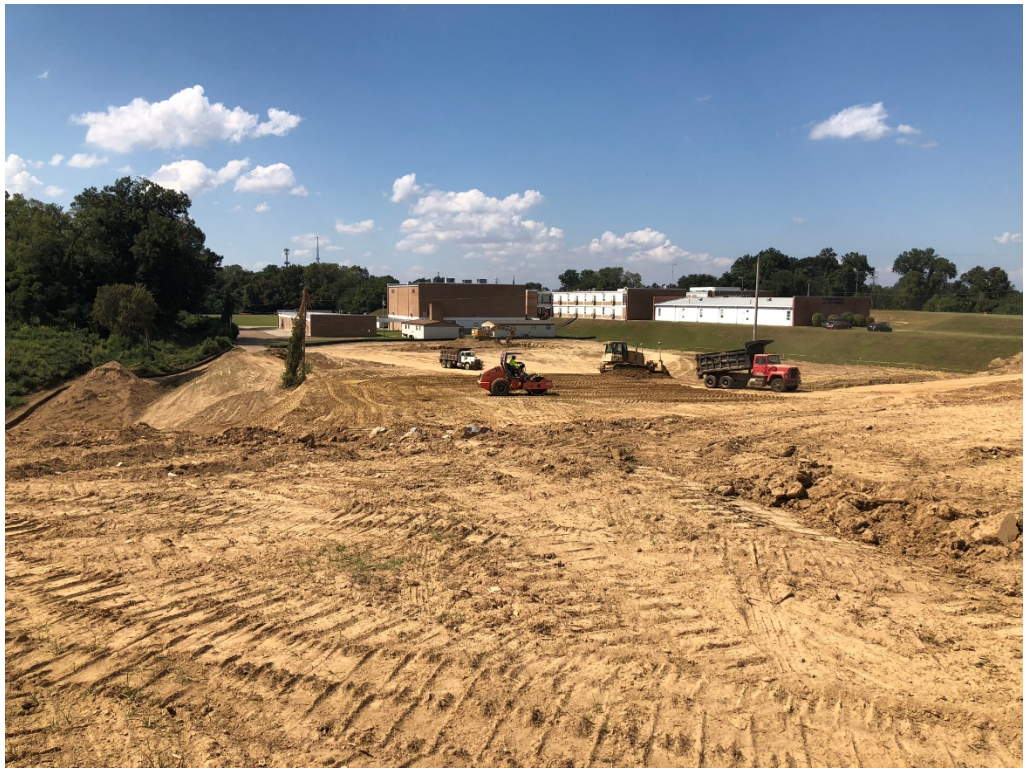
Figure 9 – South Side Slightly East of Center Looking NW

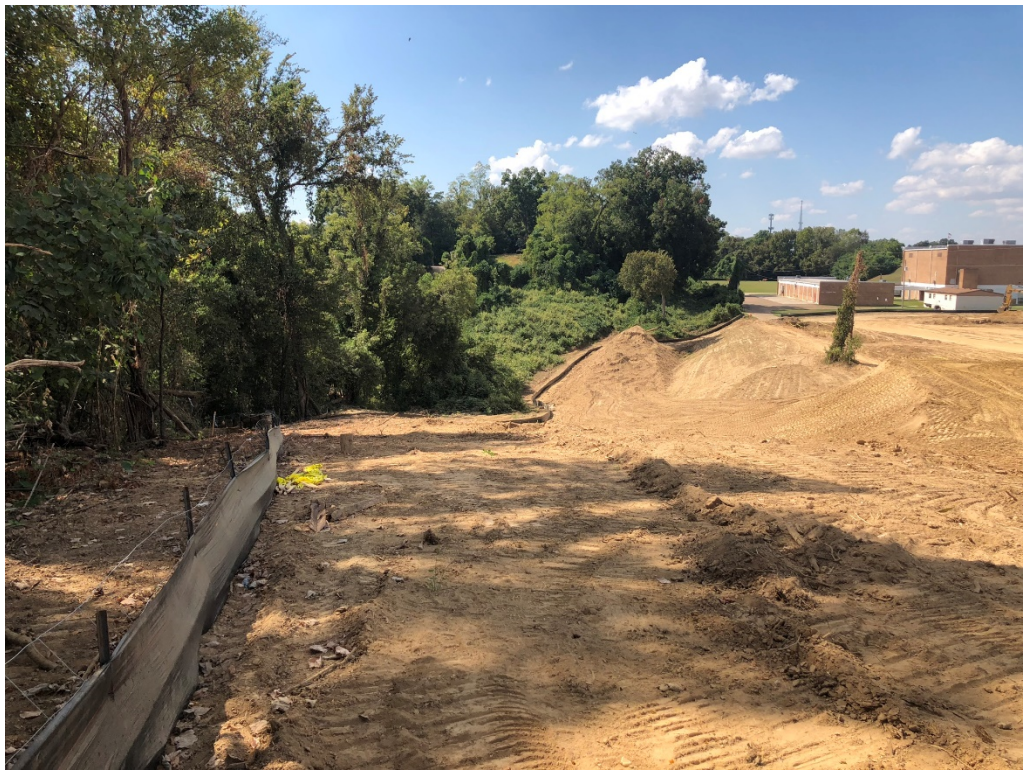
Figure 10 - South Side Slightly East of Center Looking W

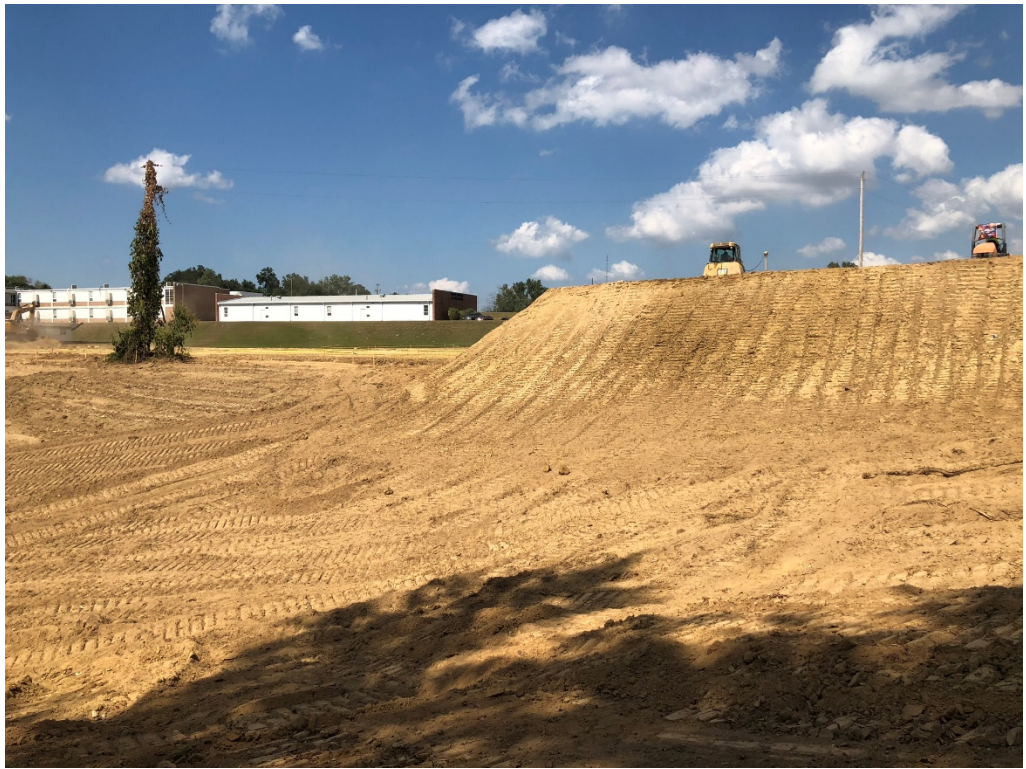
Figure 11 – South Side Center Looking NNW (Steep Grade @ Middle Pad)

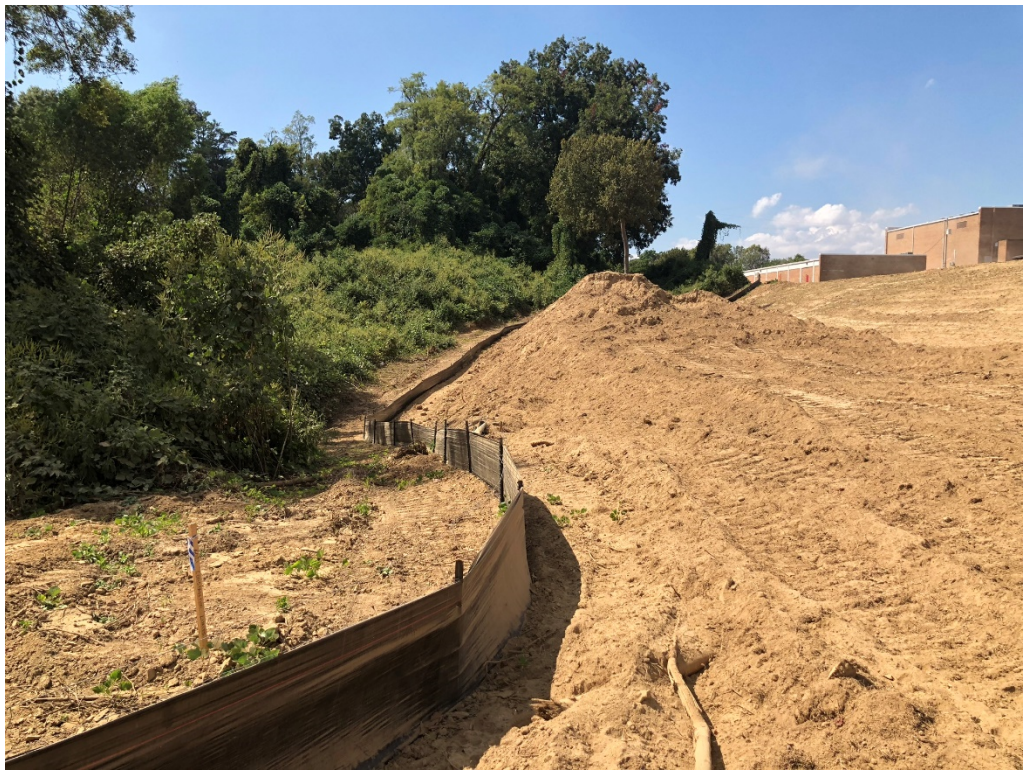
Figure 12 – South Side Center Looking W

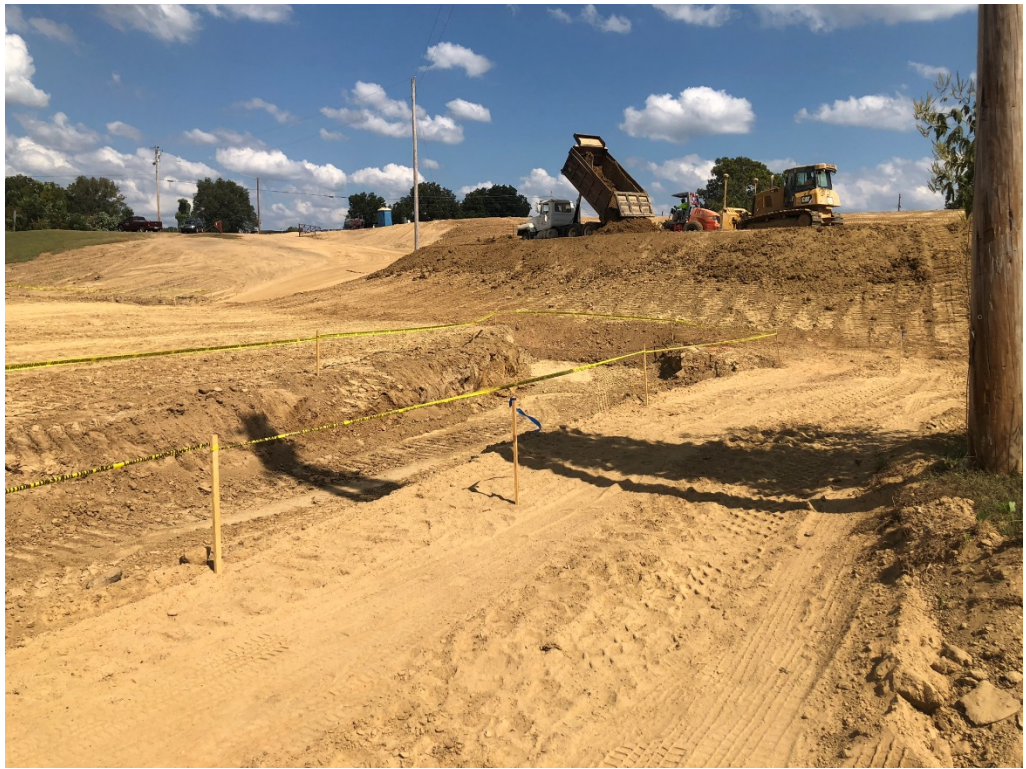
Figure 13 – South Side West of Center Looking NE

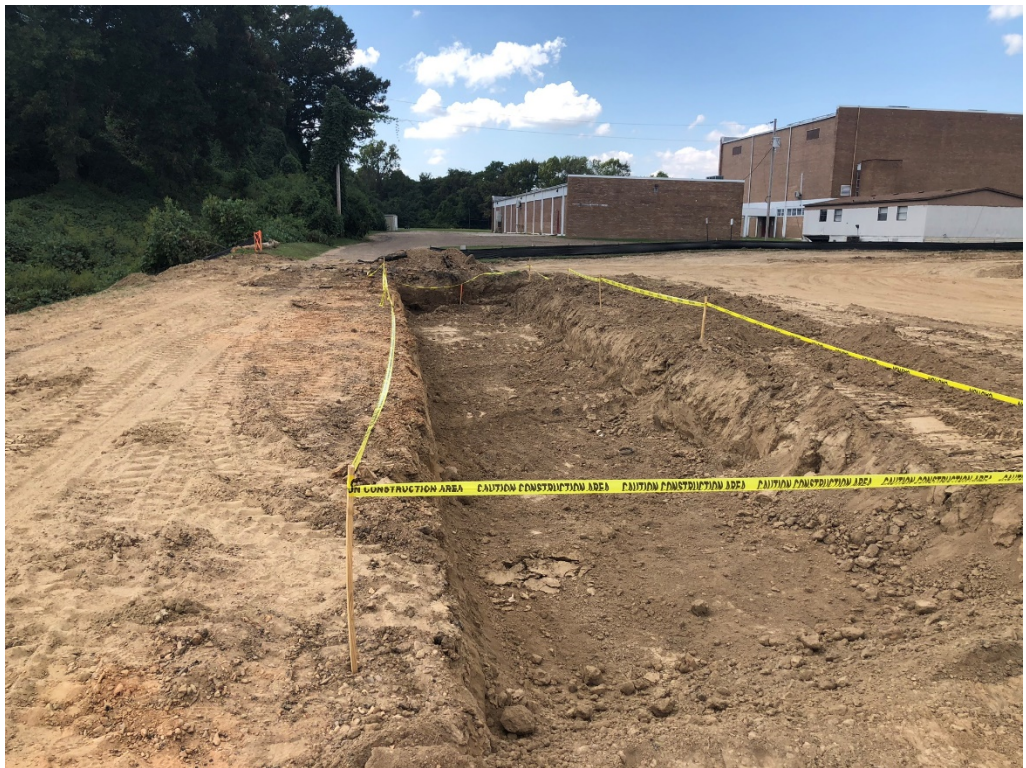
Figure 14 – Trench Dug in Parking Area

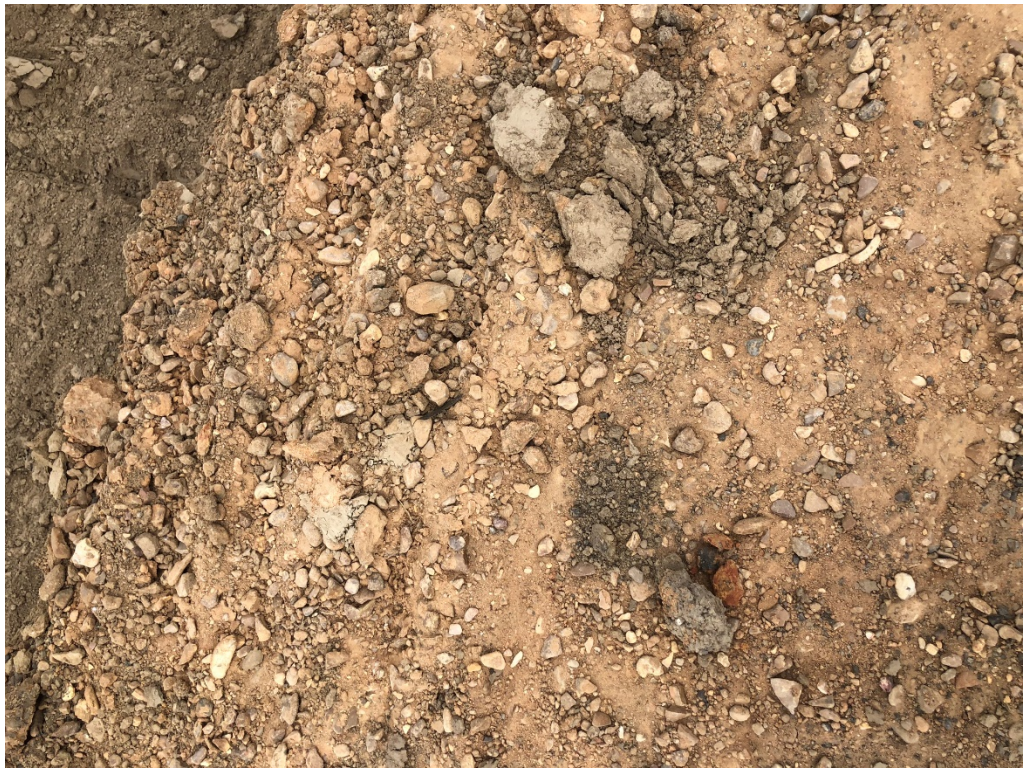
Figure 15 – Aggregate Change NOT Typical @ South Side of Project (road bed)

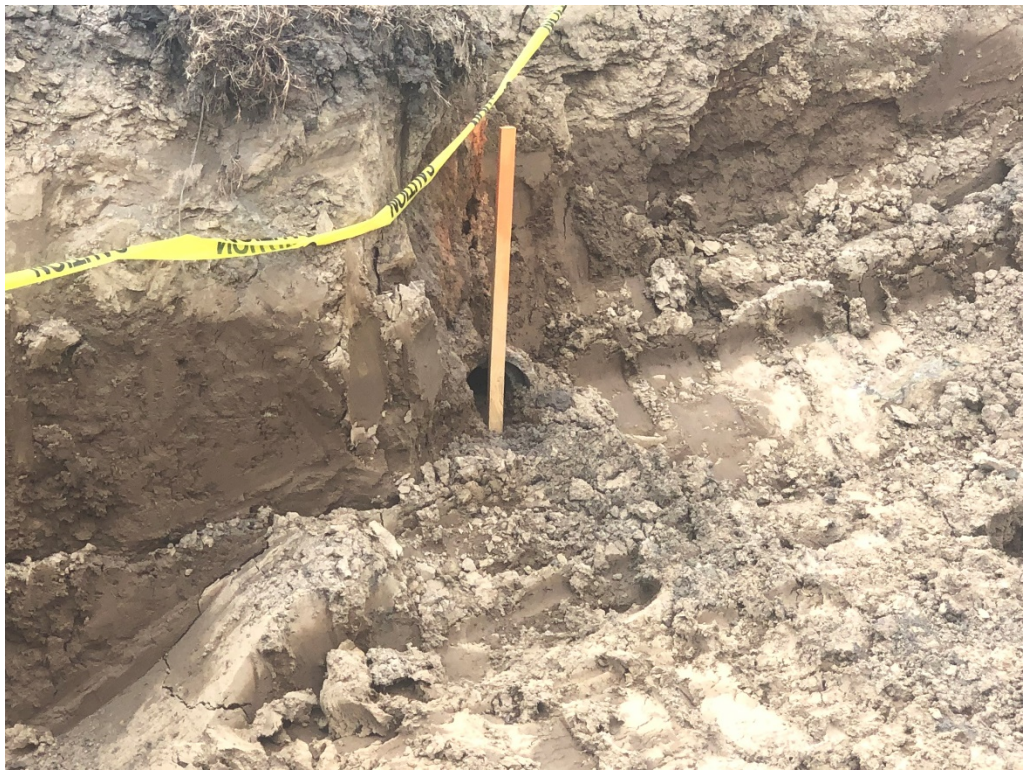
Figure 16 – Hydrant Connection (Removed for Construction)

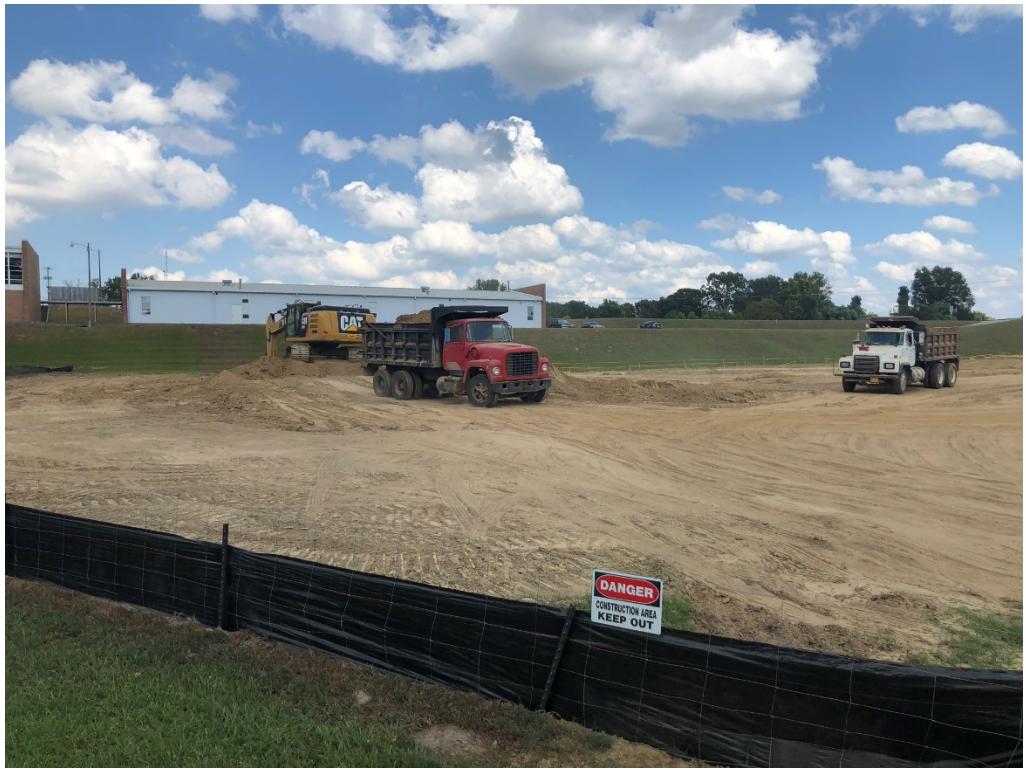
The dig crew was leveling off the middle slab section and digging from western portion of site (to be parking) for fill dirt.

Figure 17 – Fill Dirt Transported to Middle Slab Pad

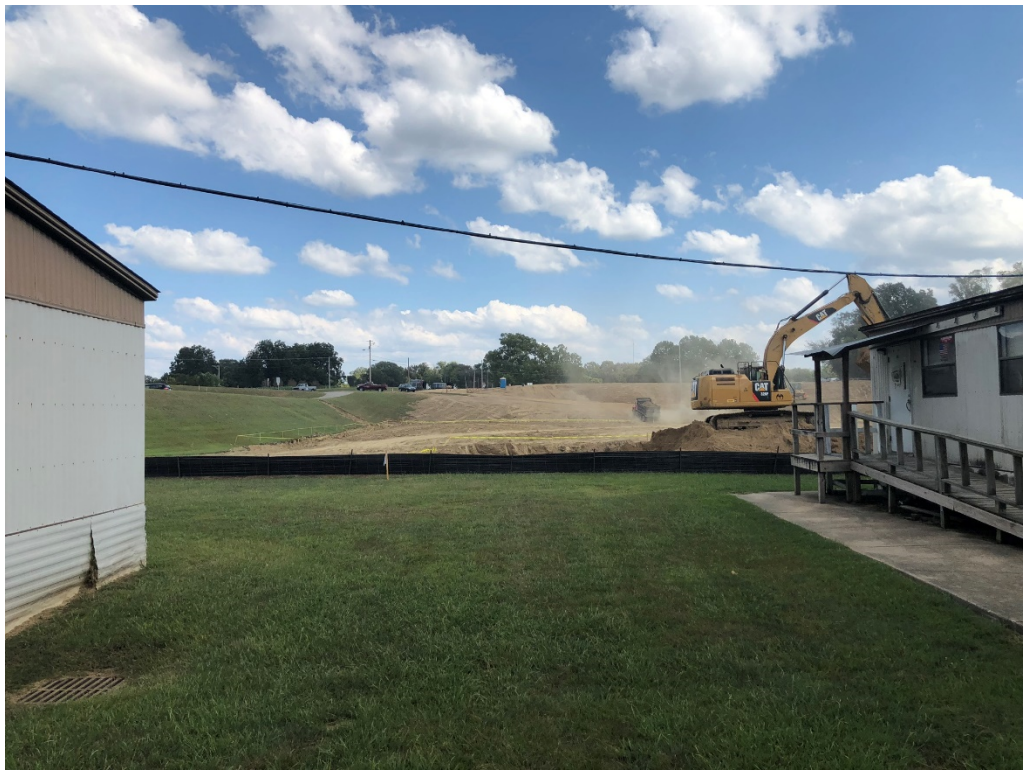
Figure 18 – West Side of Project Looking E

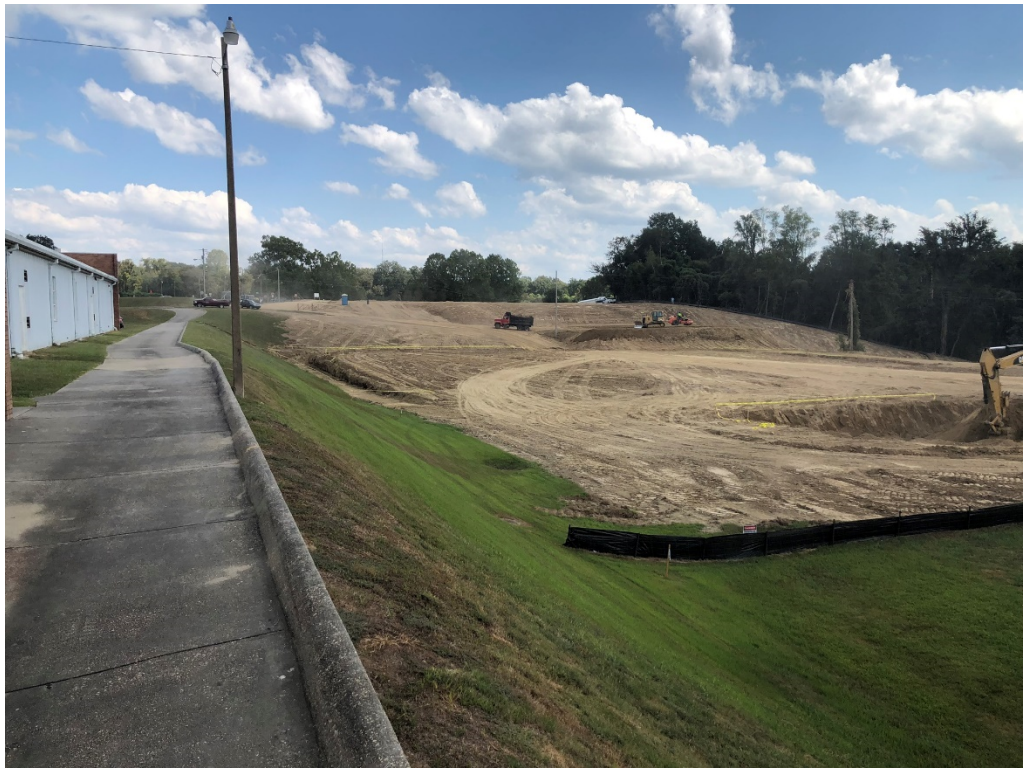
Figure 19 – North West Looking ESE

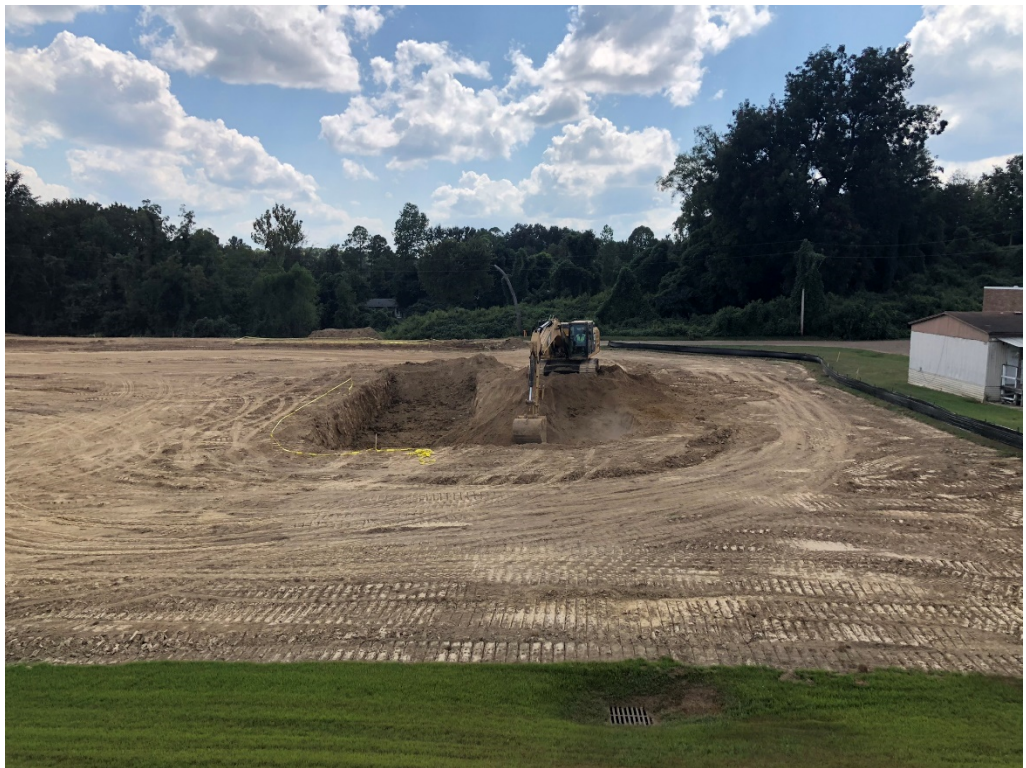
Figure 20 – Fill Dirt Excavated for Middle Slab Pad

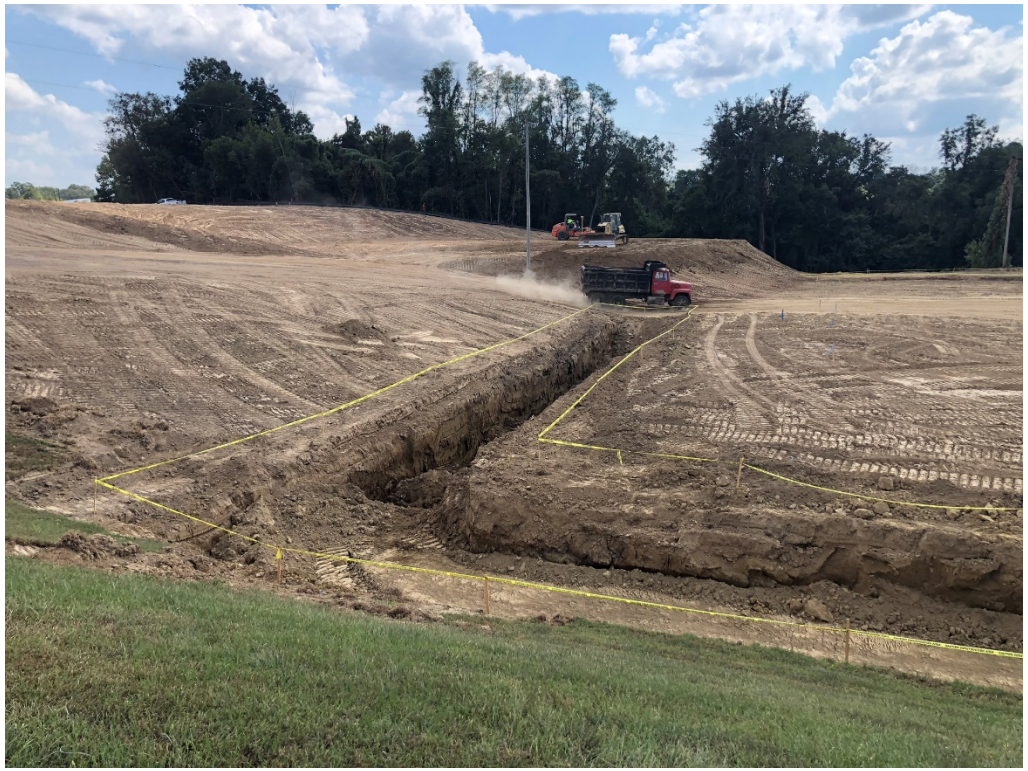
Figure 21 – Trench Dug @ North Side of Property
