Architect's Field Report

08 October 2019

18059-AOI Academy of Innovation / Report Number 003

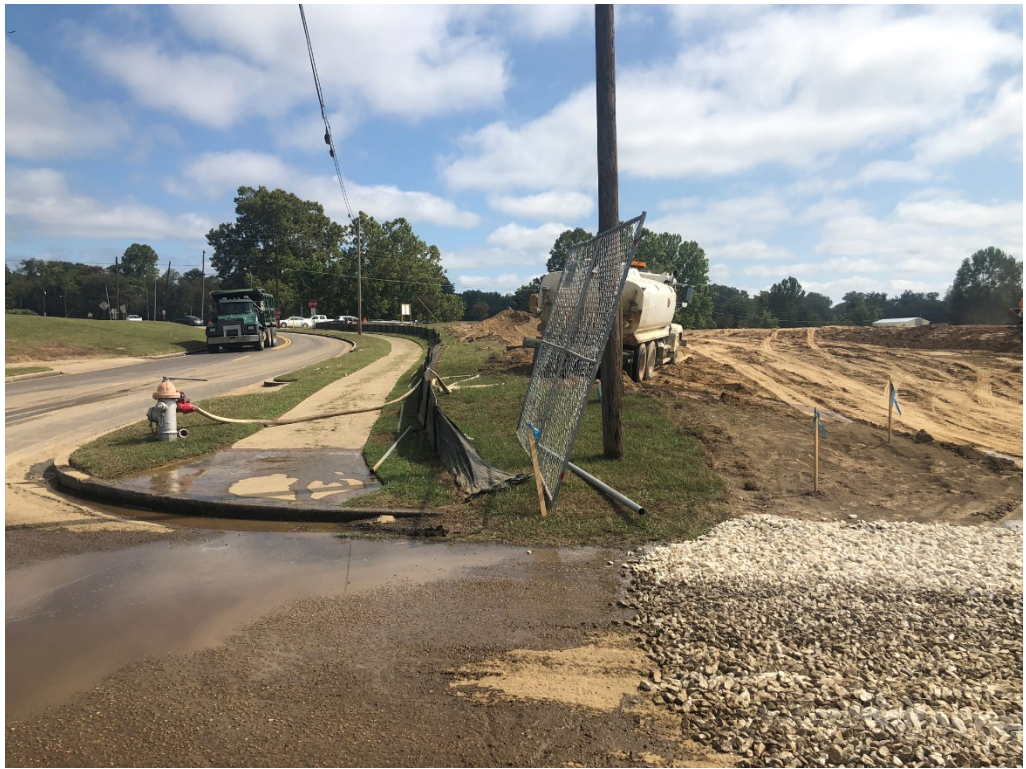
Figure 1 – Potable Water In Use for Watering Slab

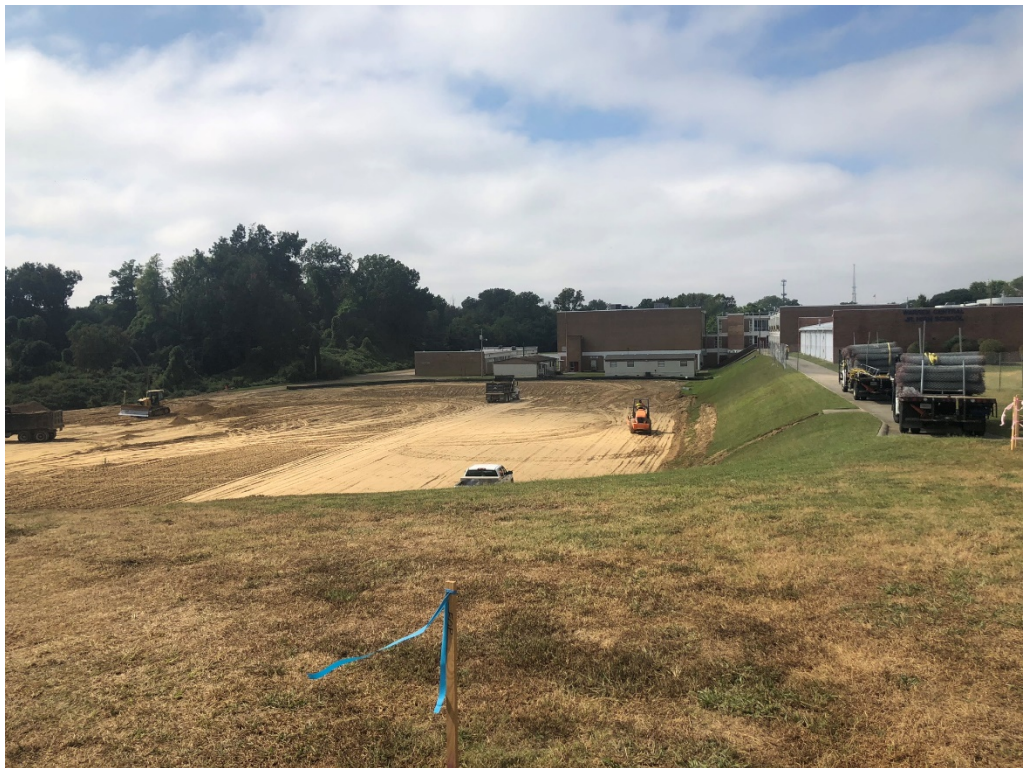
Figure 2 – Lockable Gate Entrance (N Entrance Looking WSW)

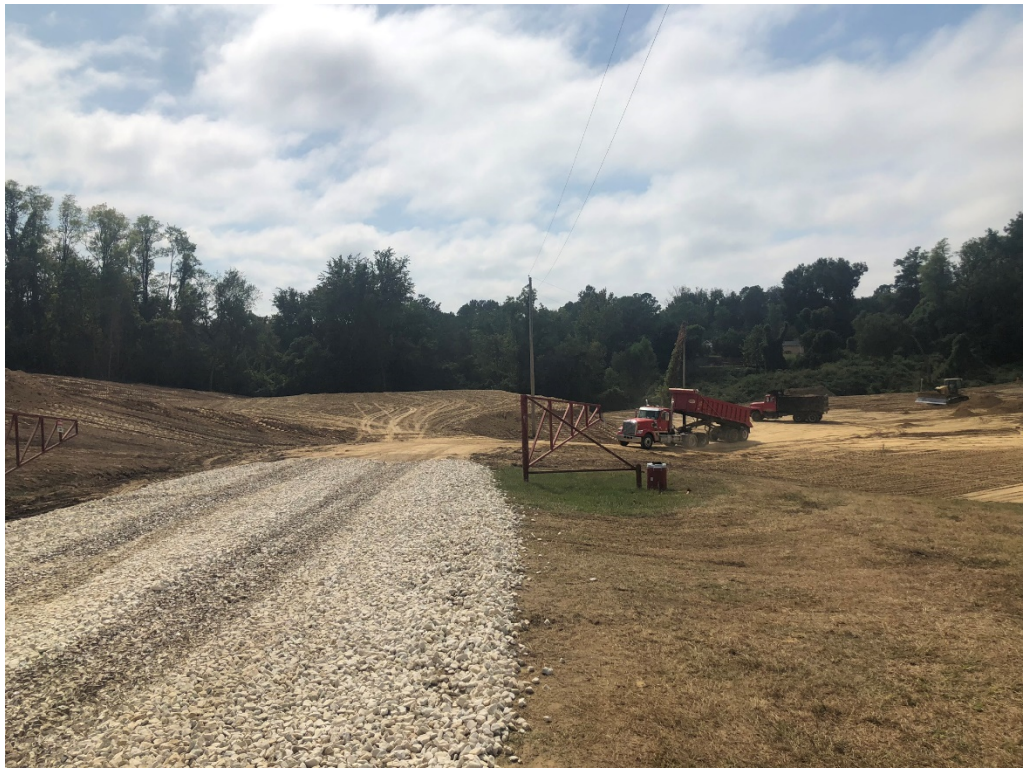
Figure 3 - Lockable Gate Entrance (N Entrance Looking S)

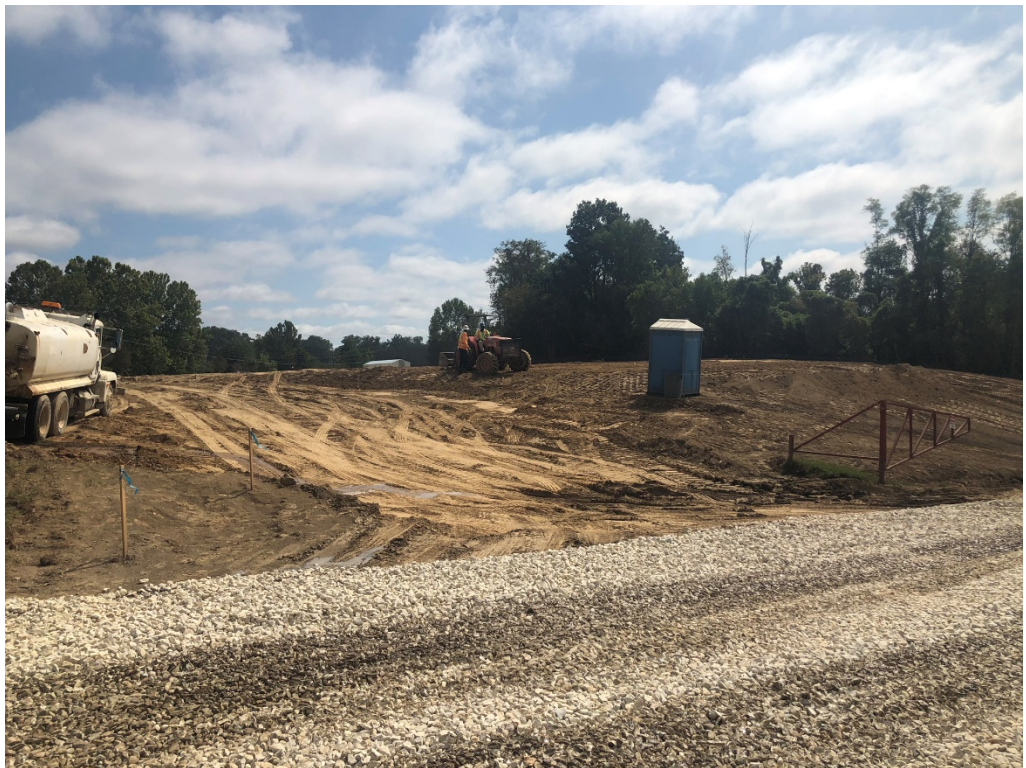
Figure 4 – Upper Pad Work (N Entrance Looking SE)

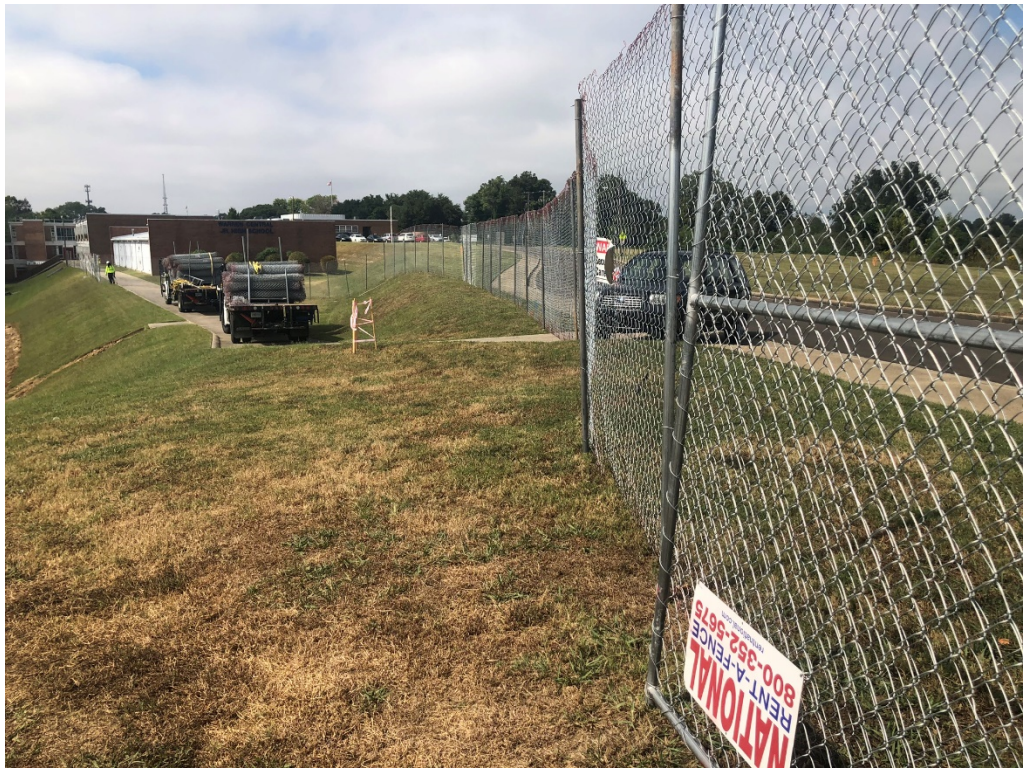
Figure 5 – Temporary Fence Being Installed

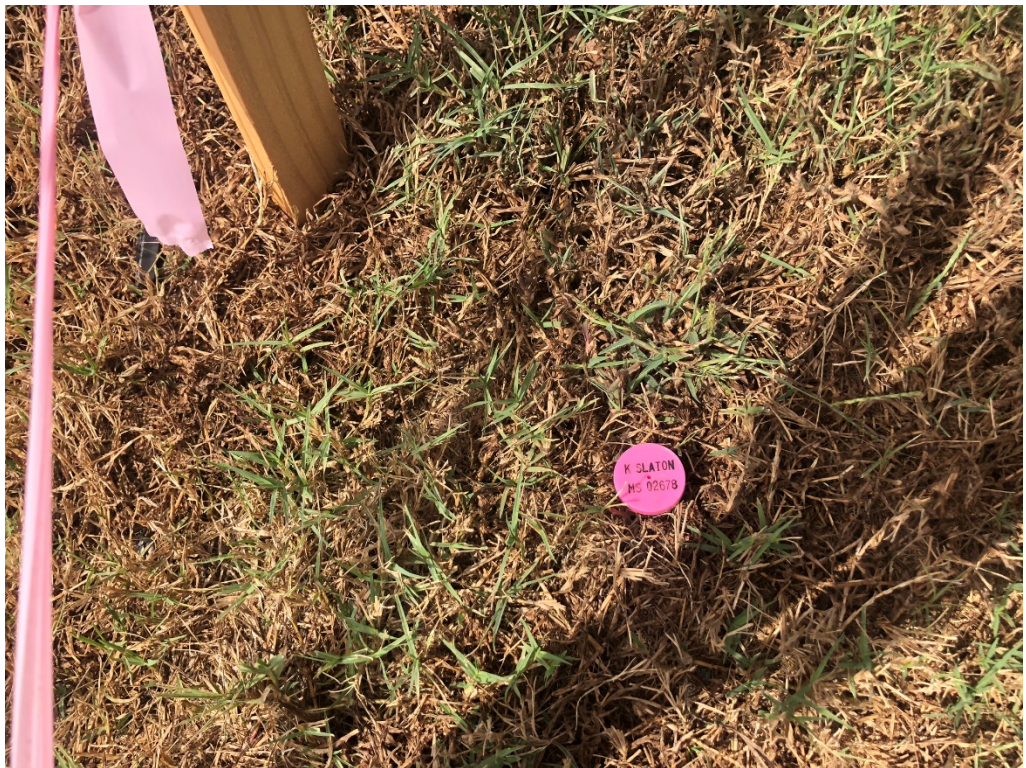
Figure 6 – Surveyor Marker

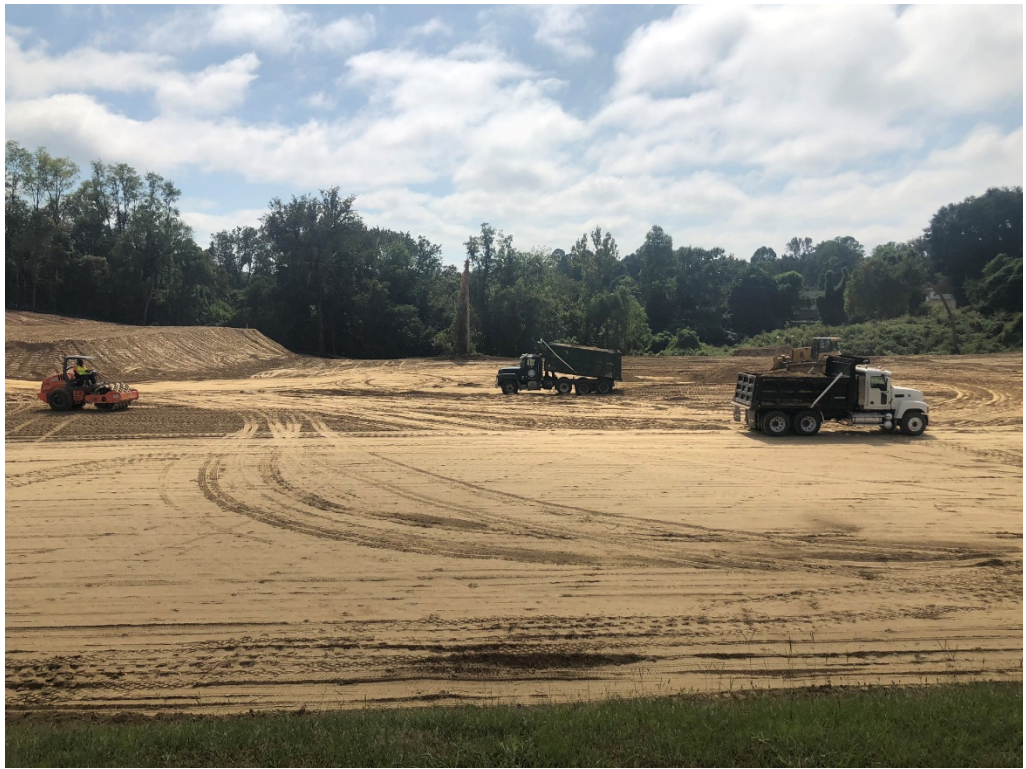
Figure 7 – North West of Center Looking South at Lower Slab/Parking

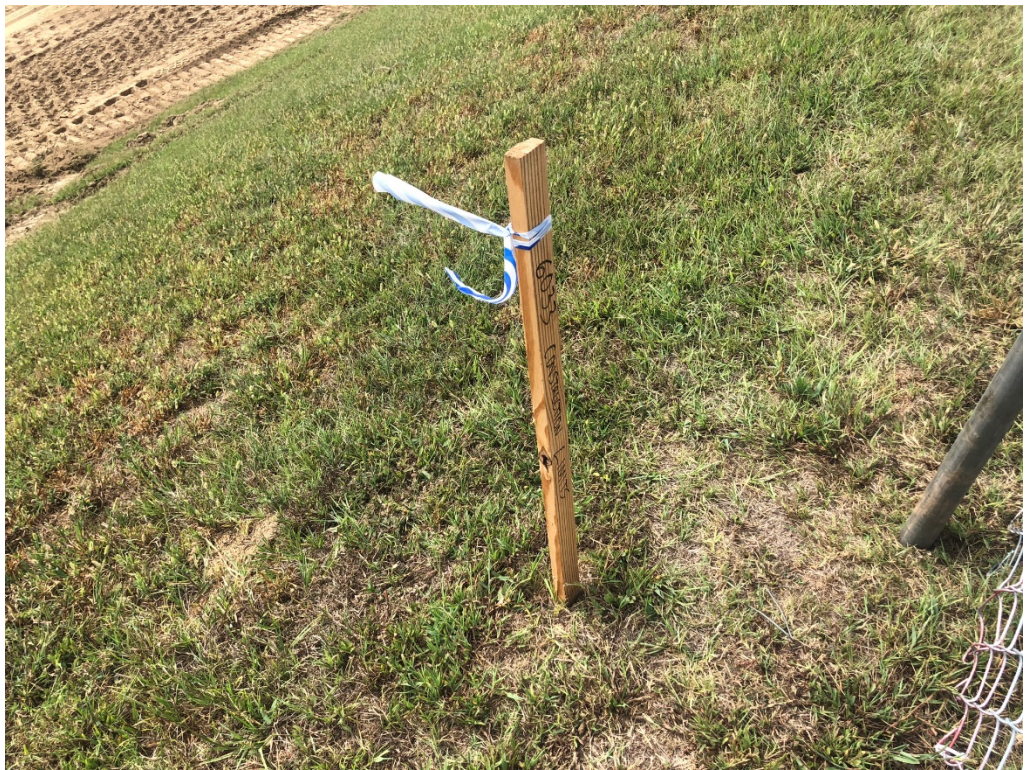
Figure 8 – Example of Site Marking Stake

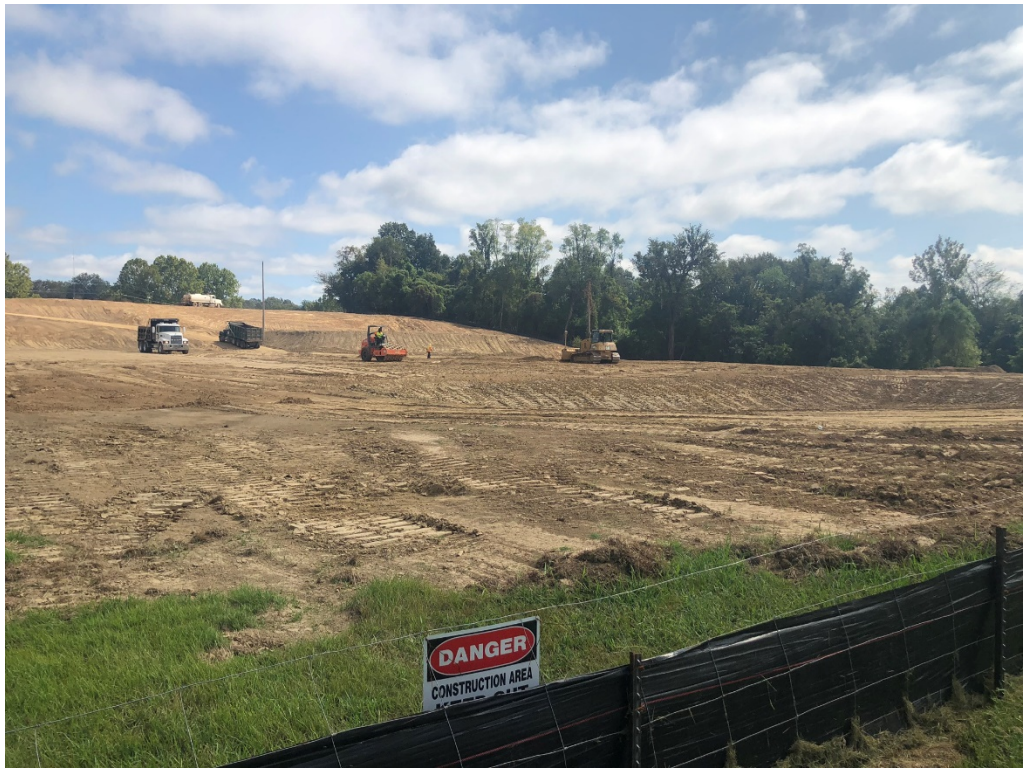
Figure 9 – North West Corner Looking SE (Parking Area)

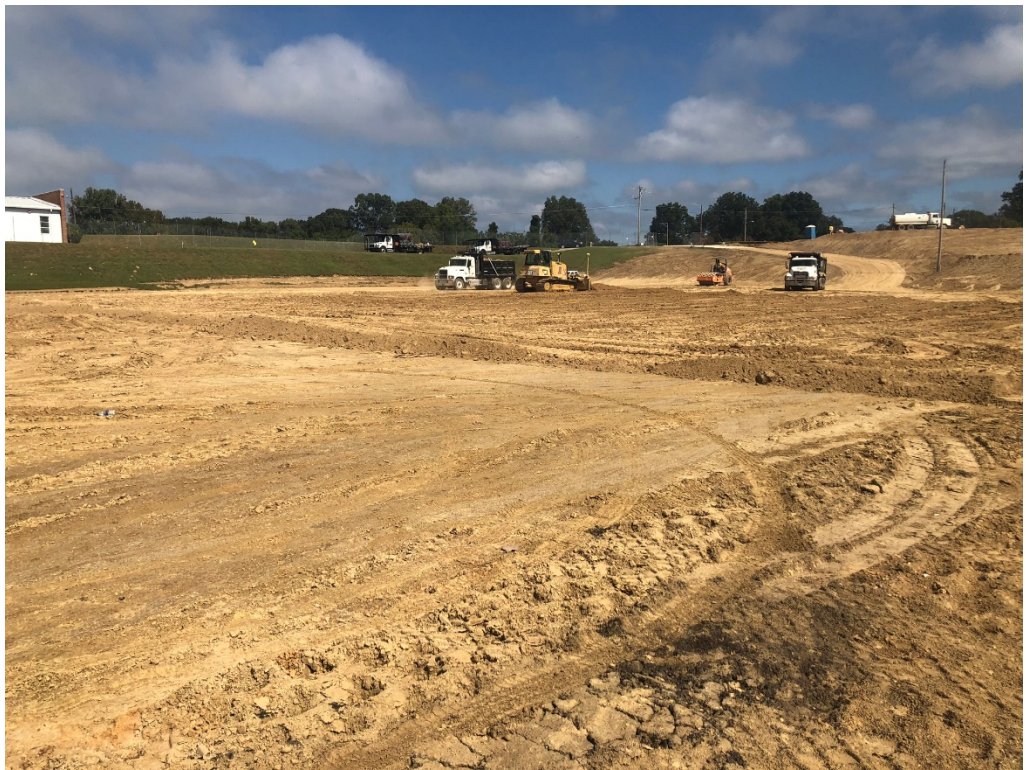
Figure 10 – South West Corner Looking NE

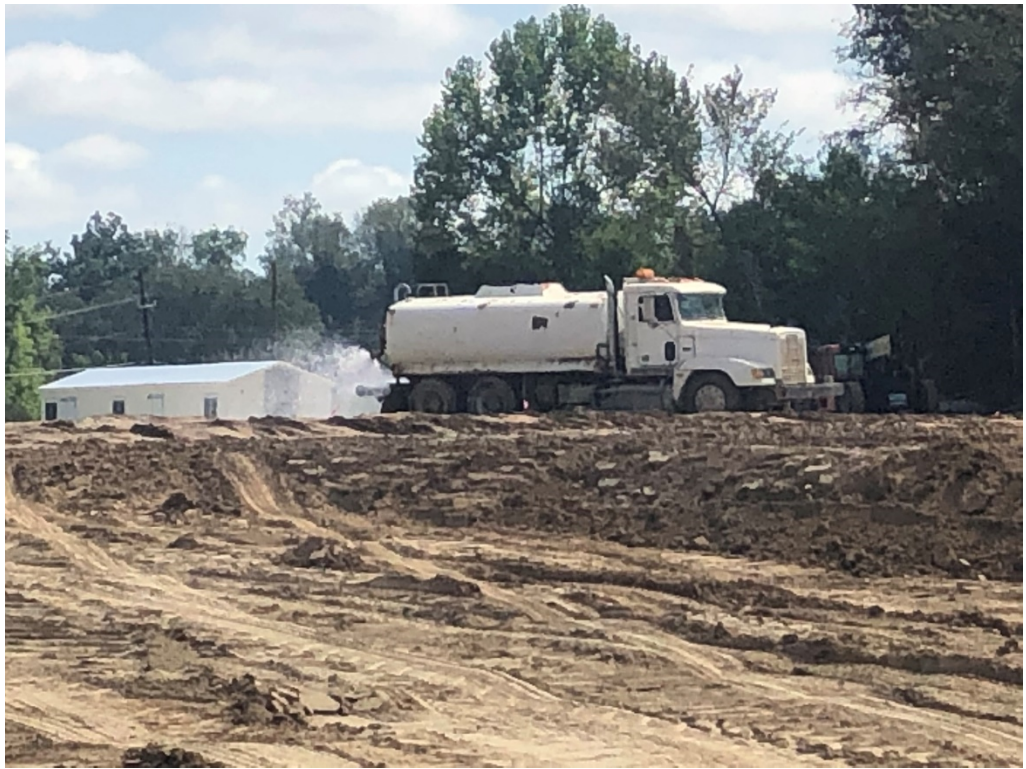
Figure 11 – Watering Truck In Use for Dirt Work

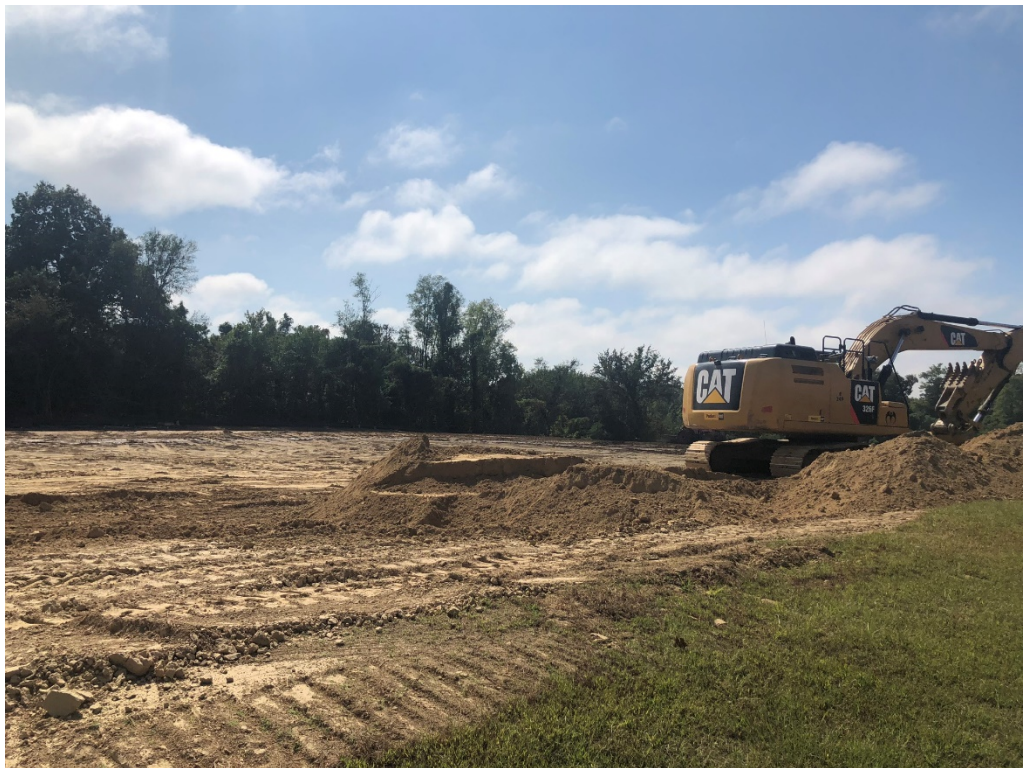
Figure 12 – North East Corner of Site Looking SW (Upper Pad)

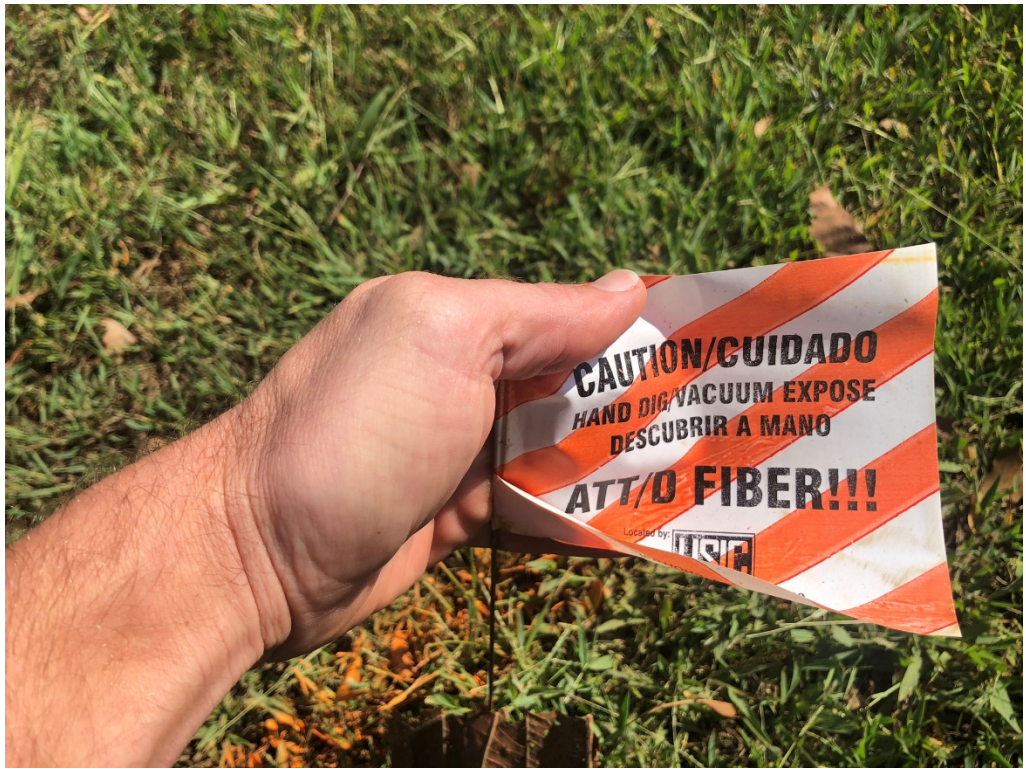
Figure 13 – Orange Marking ATT Fiber at East Side of Site

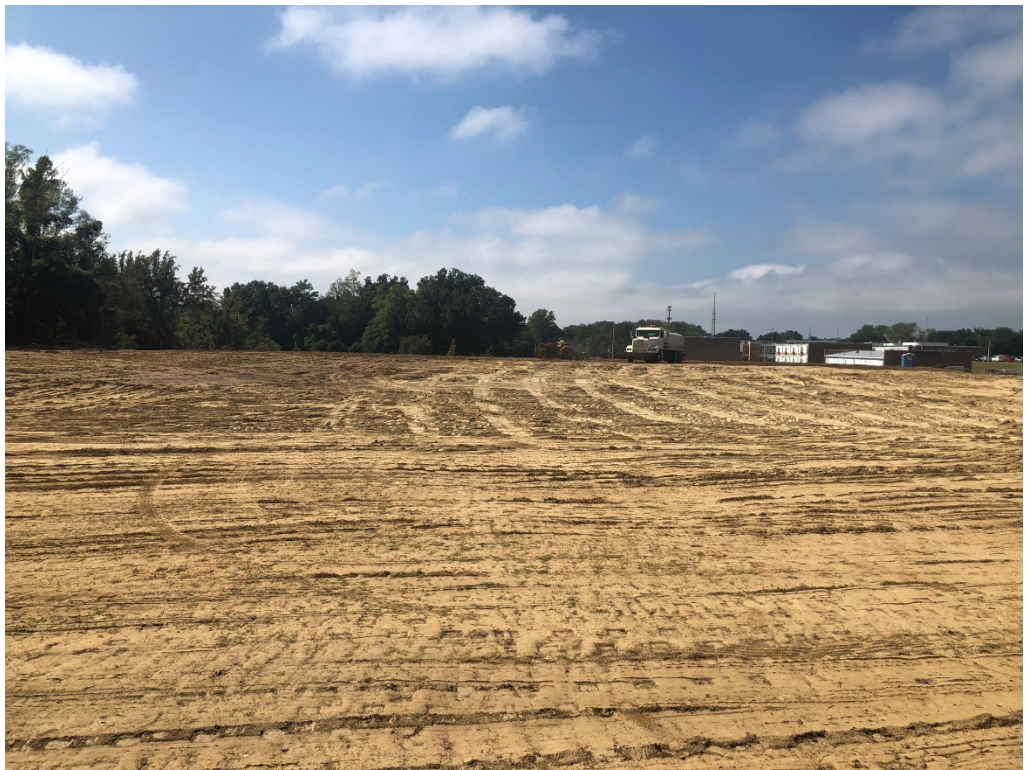
Figure 14 – East of Site Looking West

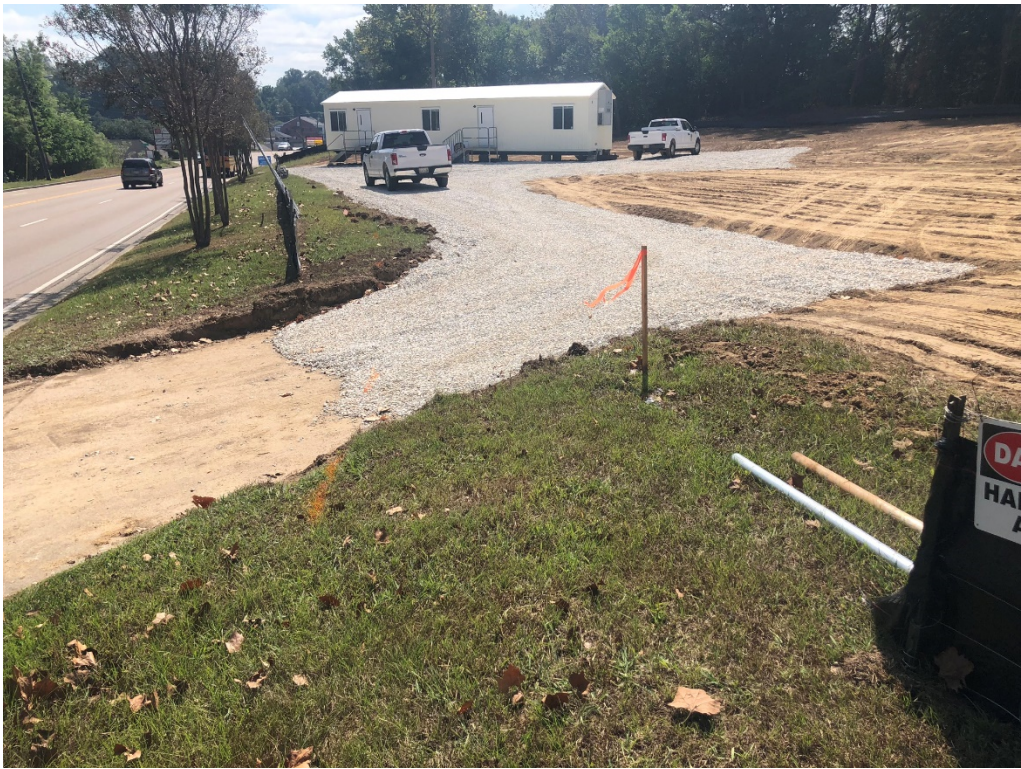
Figure 15 – East Entrance Parking Area

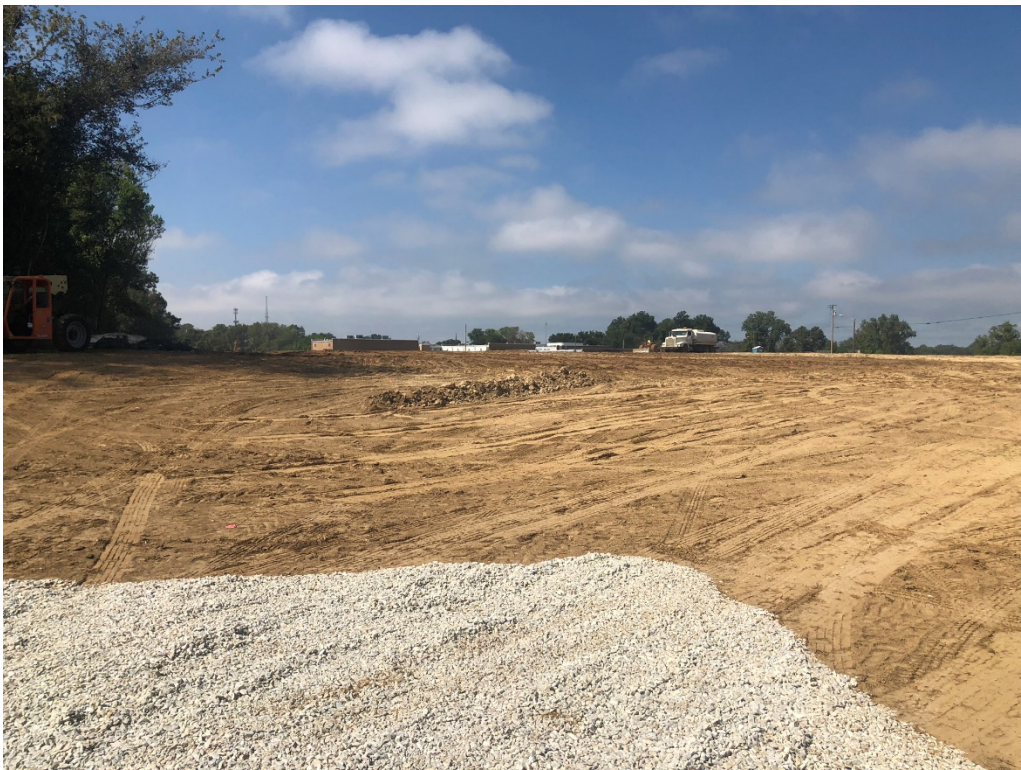
Figure 16 – South East Corner Looking WNW (Upper Slab)

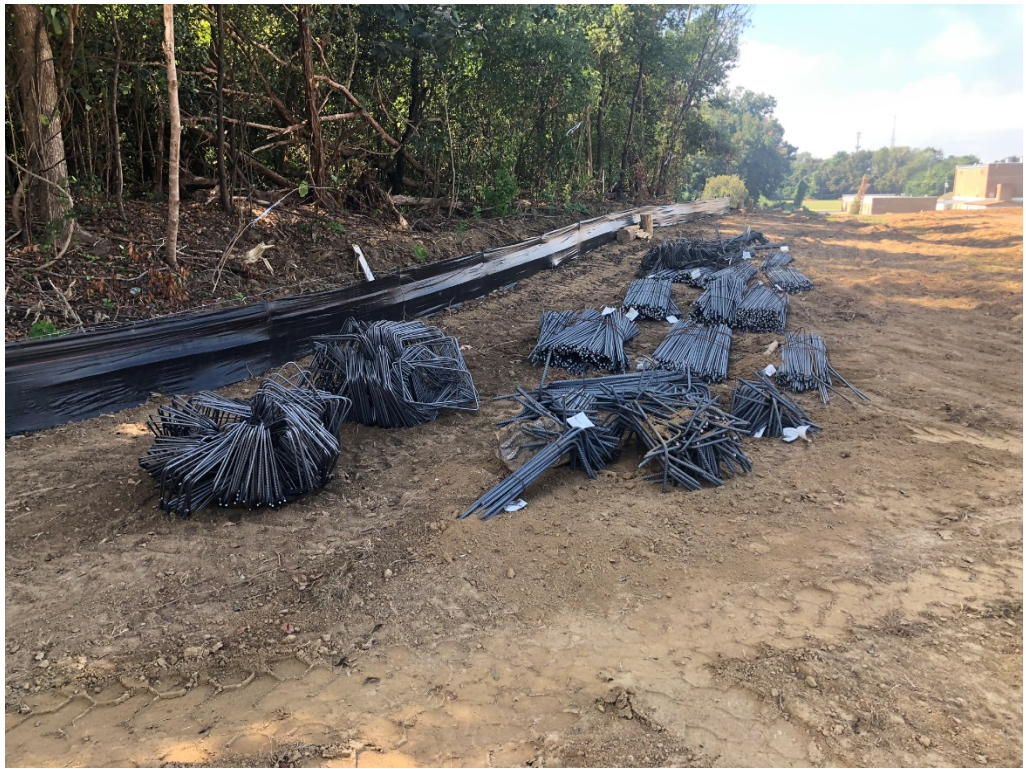
Figure 17 – Some Rebar Bends On Site Stored at South Upper Pad

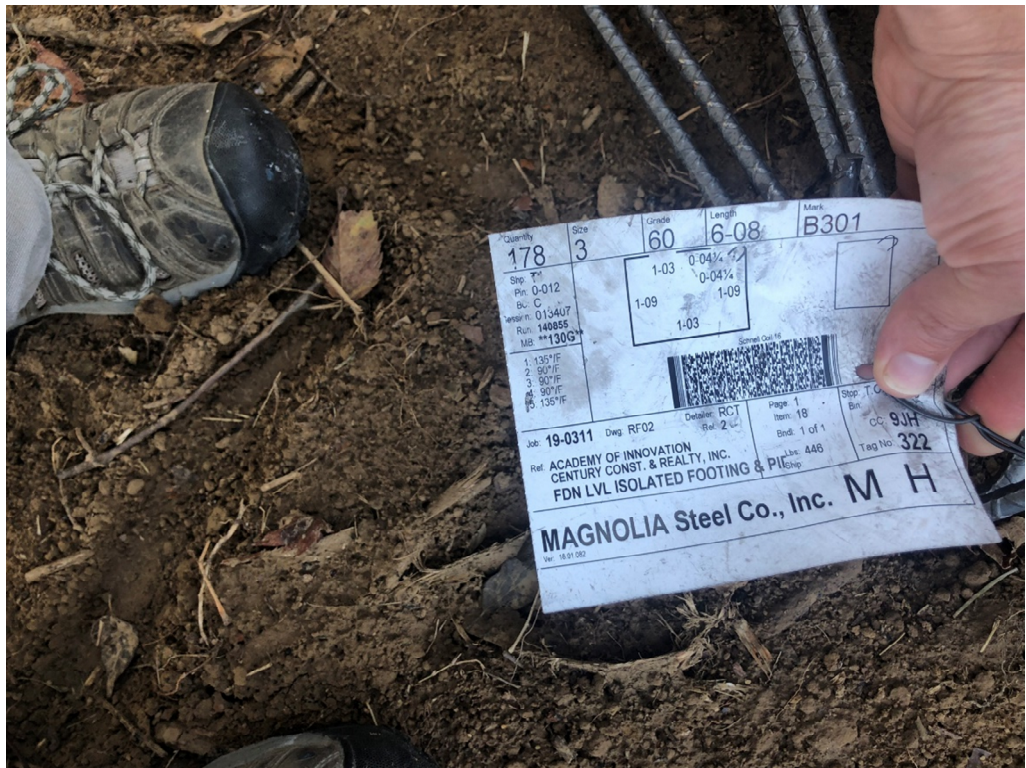
Figure 18 – Manufacturer's Tag on Rebar Bundle

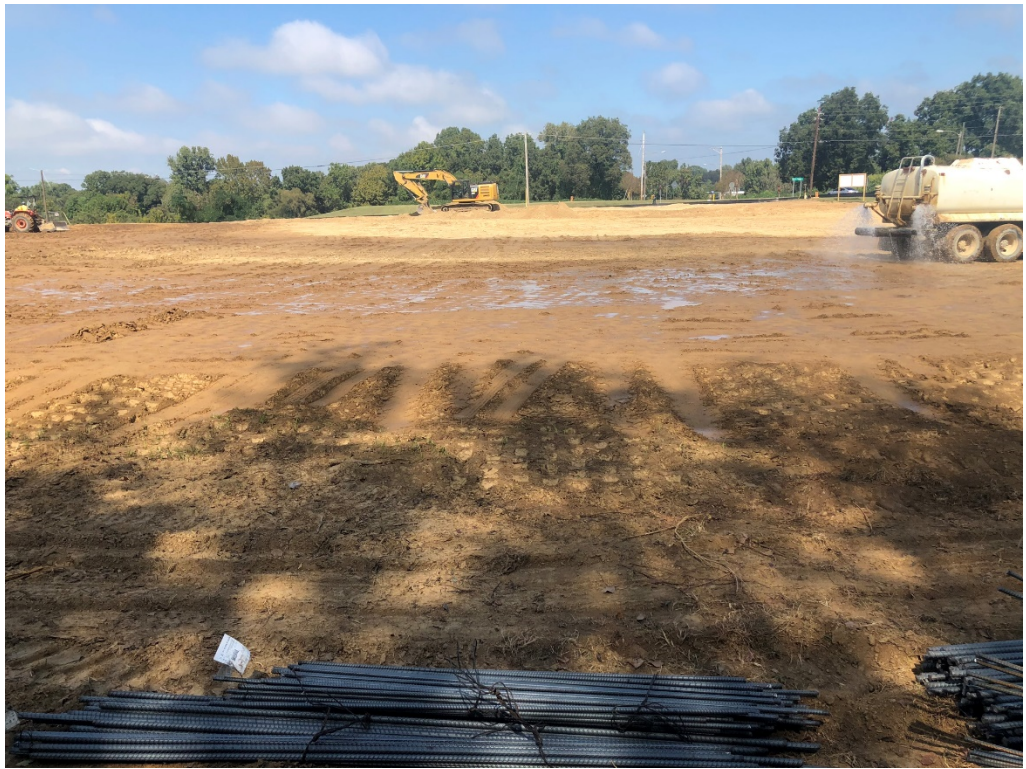
Figure 19 – South East of Center Looking North (Upper Pad)

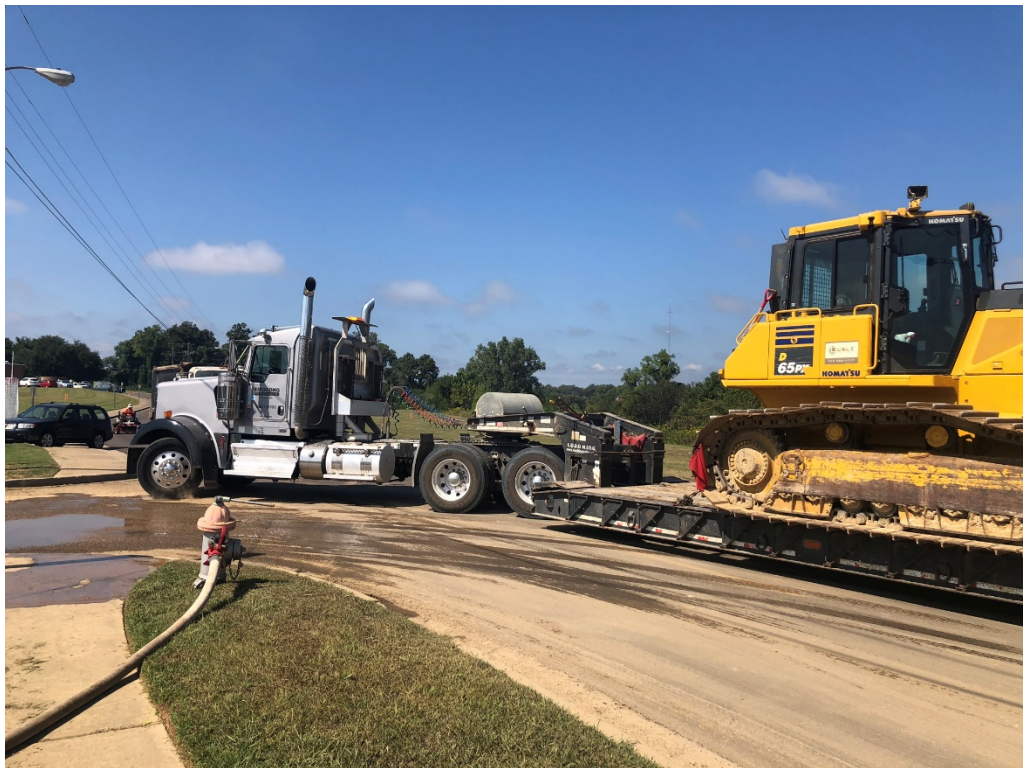
Figure 20 – Birdsong Delivering Equipment

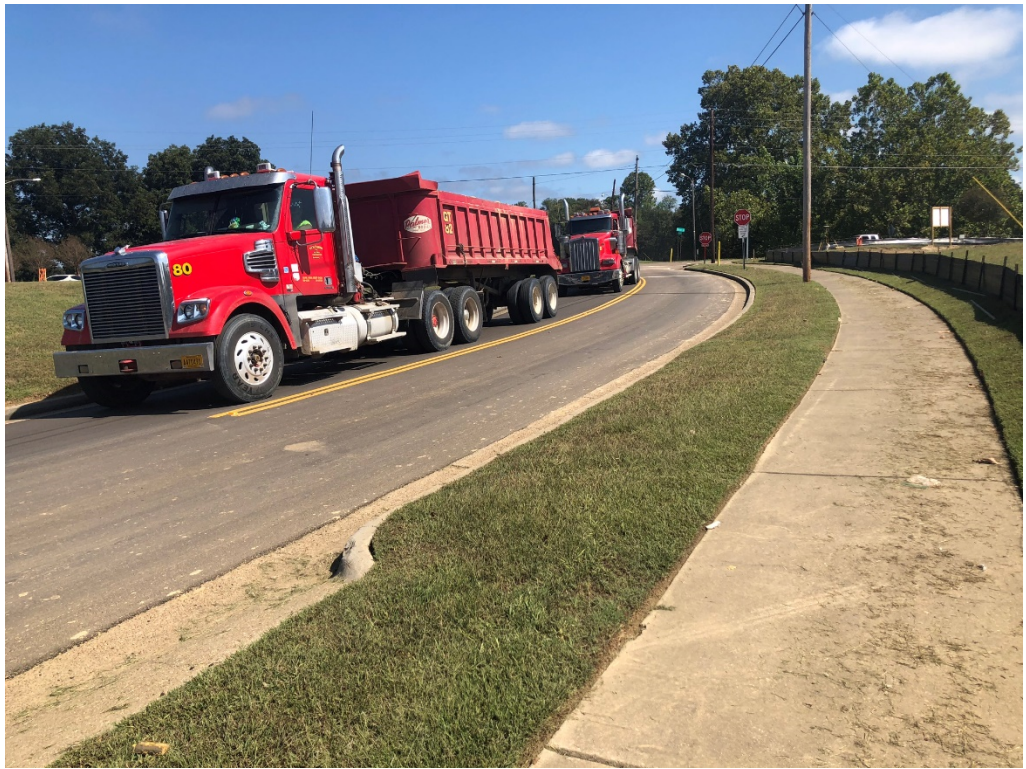
Figure 21 – Dirt Being Delivered
