## Architect's Field Report

16 October 2019

18059-AOI Academy of Innovation / Report Number 004

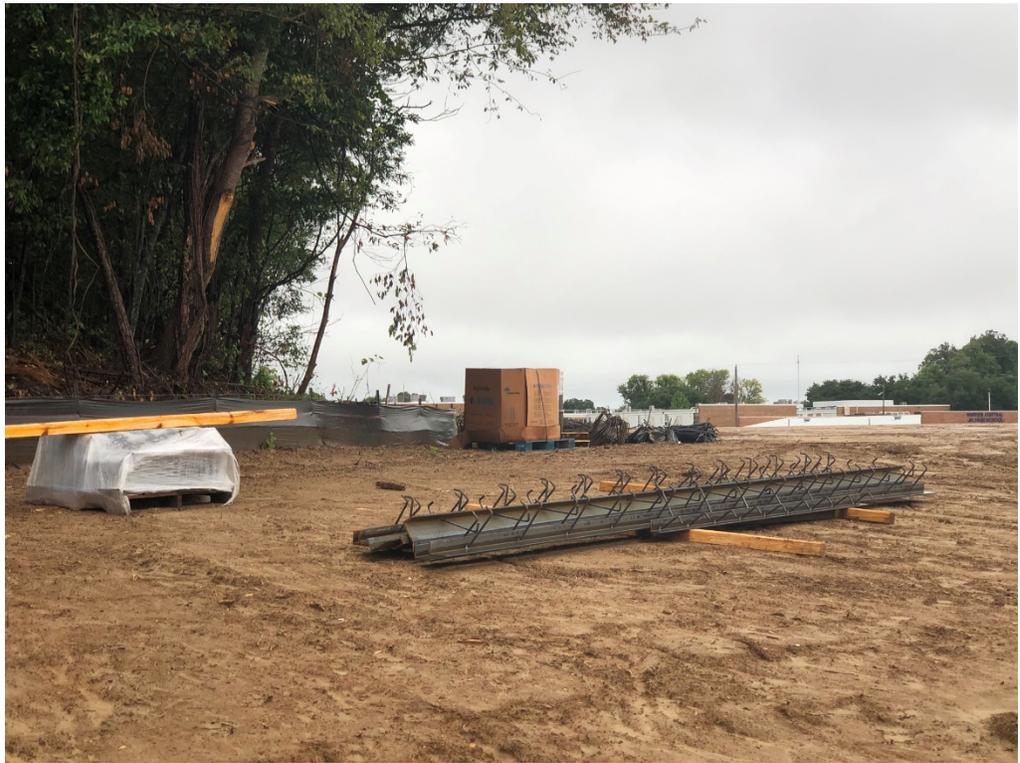
Figure 1 – New Materials stored on Site

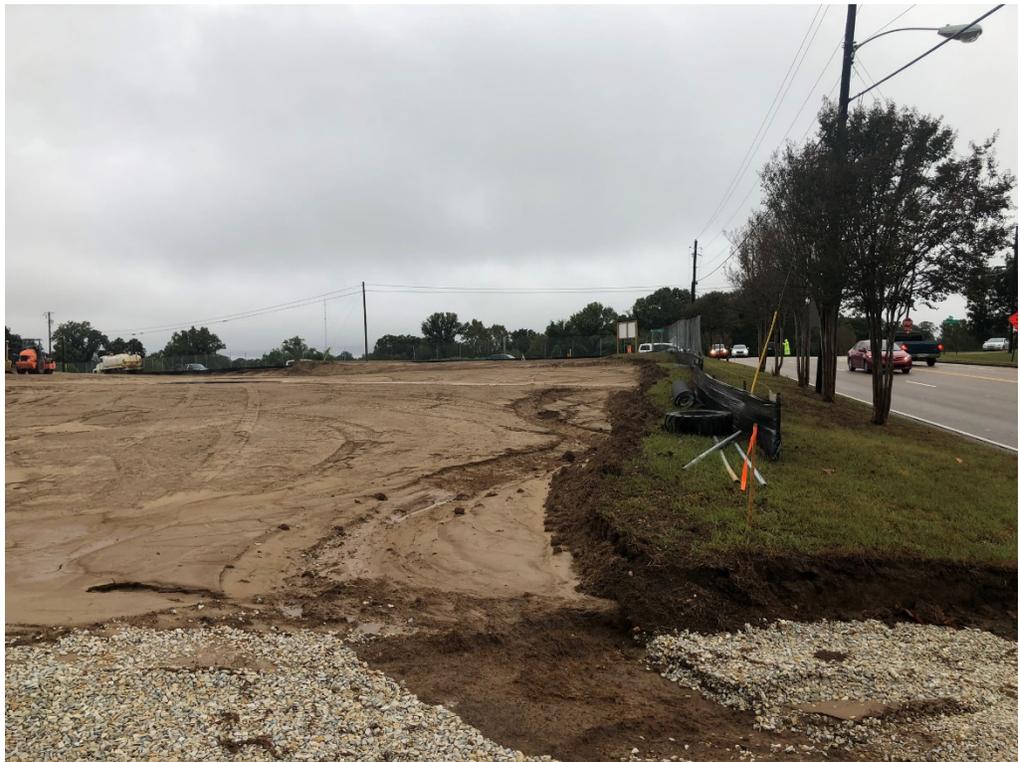
Observations I arrived and it had just cleared up from a hard rain. No one was on site. Entry Gates were open. Some wash out has occurred at the job site trailer entry.

Figure 2 – Wash out at Job Site Trailer Entry

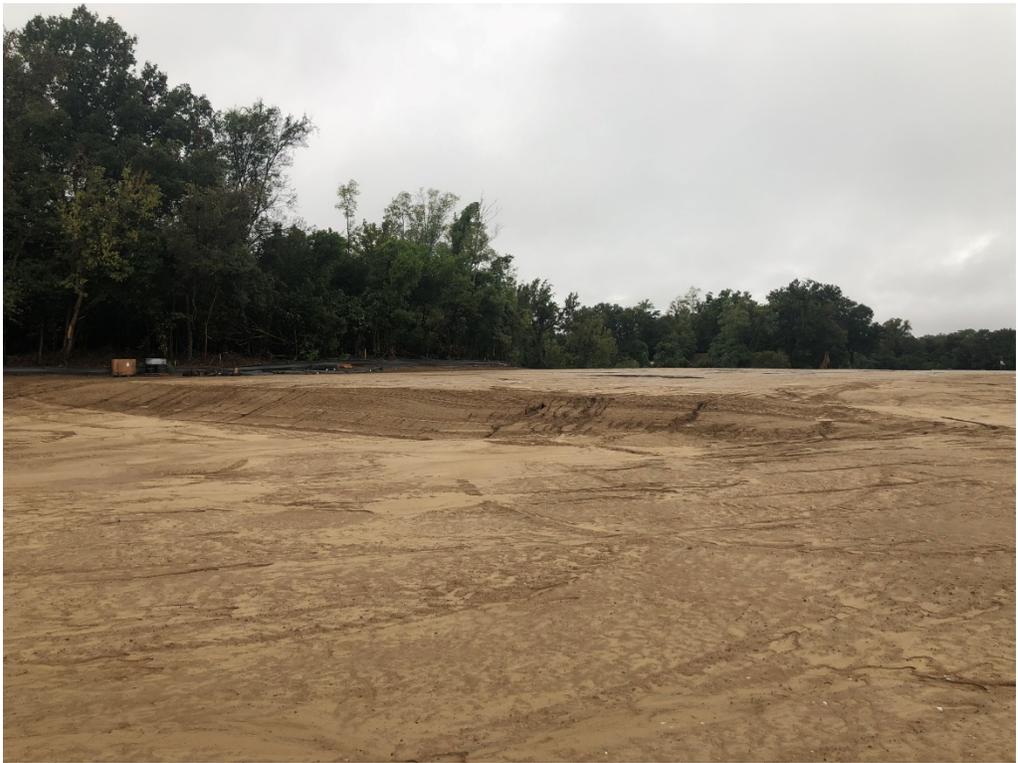
I walked the site. Pad work has been performed at the upper slab section since our last visit. New fencing up at NE Corner of project.

Figure 3 – Pad Development at Upper Slab

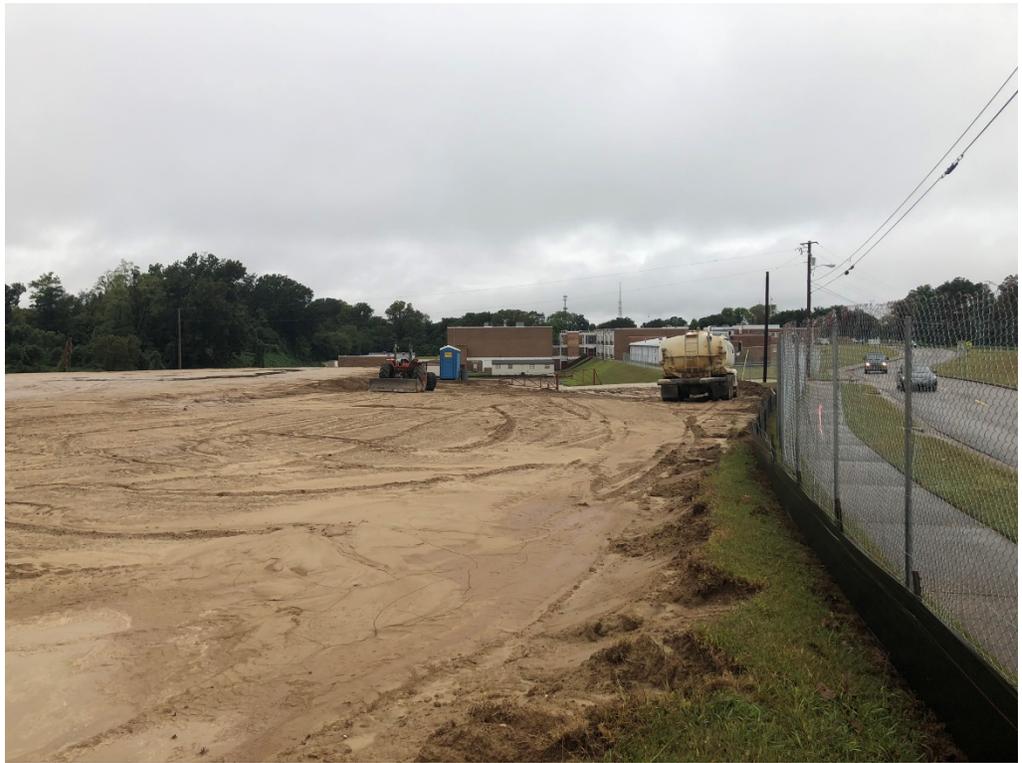
Figure 5 – New Fence at NE Corner

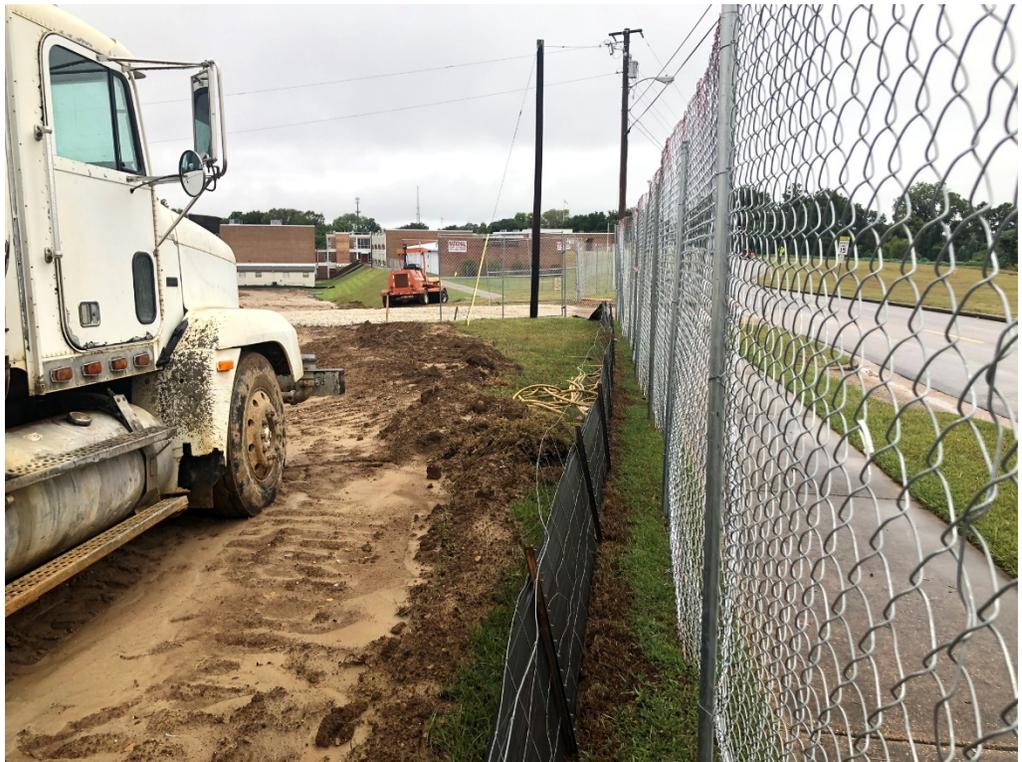
Figure 6 – New Fence

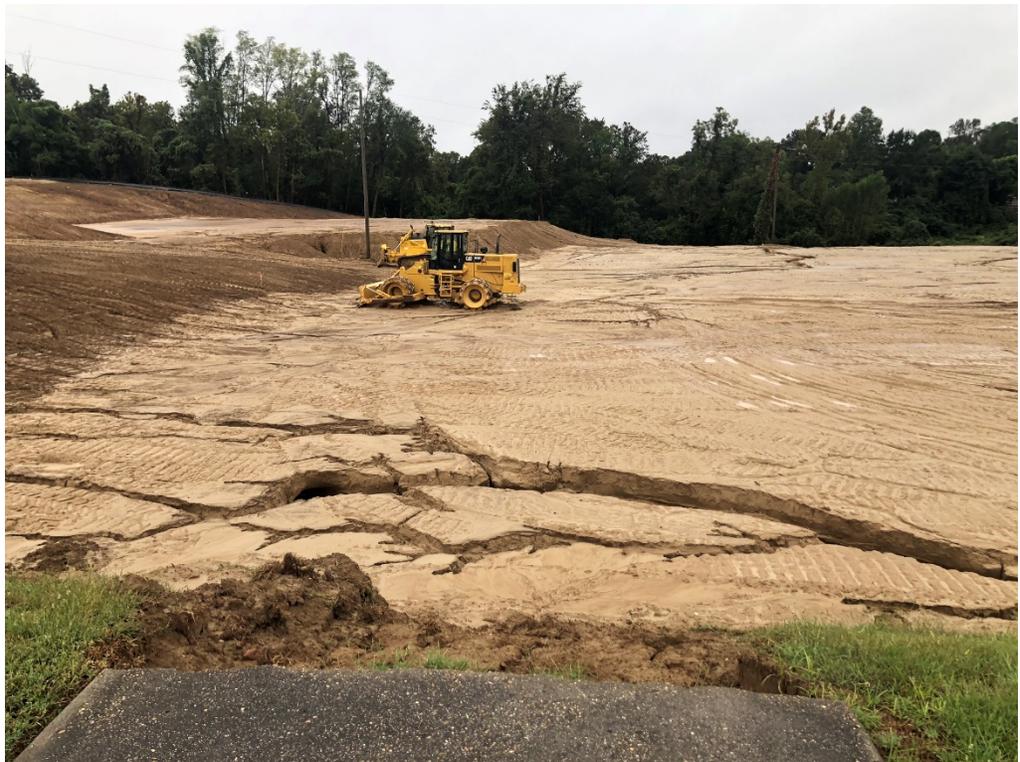
Figure 10 – North West of Center Looking S (Note Wash Out)

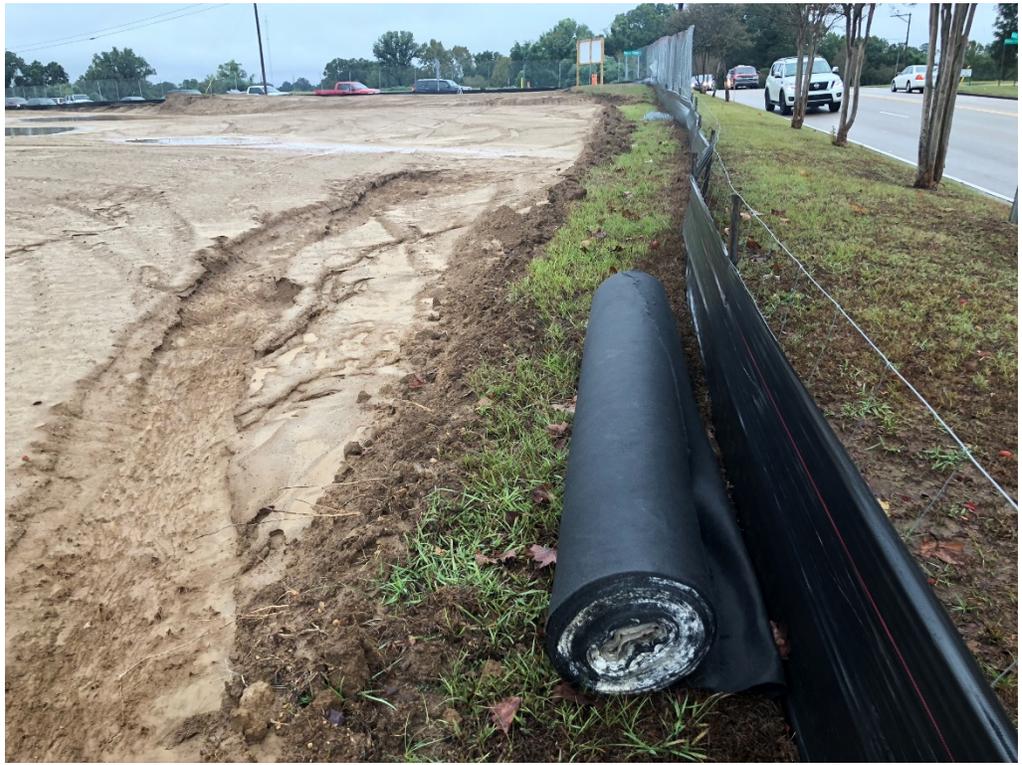
Figure 19 – Stored Material
