Architect's Field Report

25 October 2019

18059-AOI Academy of Innovation / Report Number 005

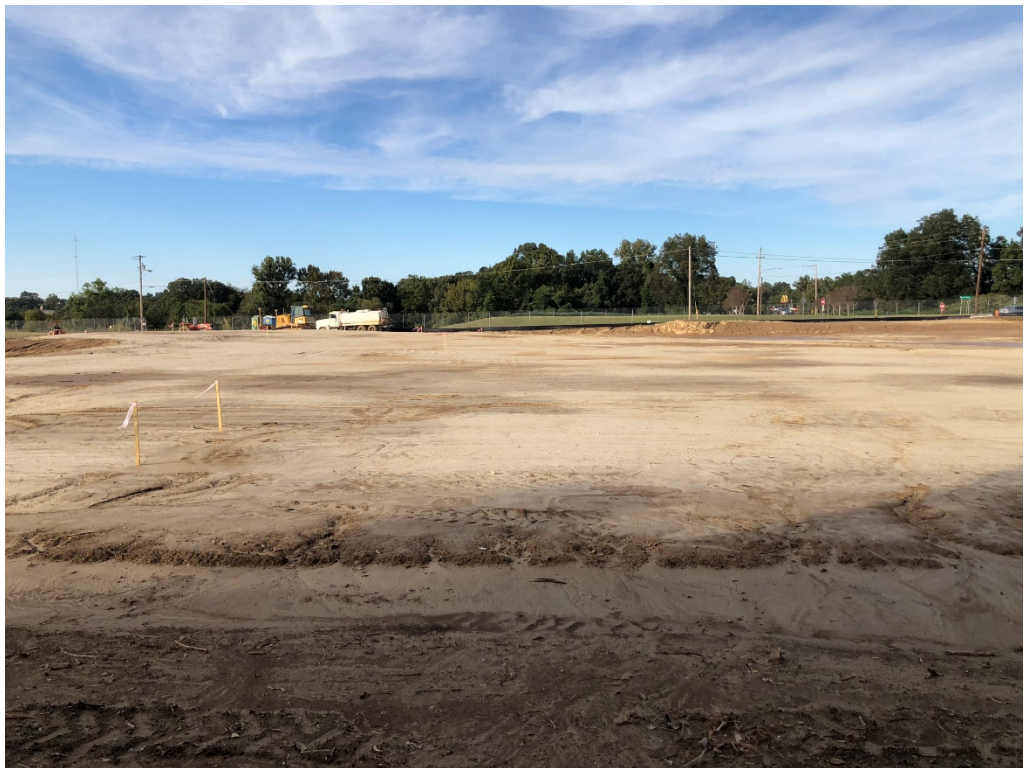
Observations Arriving on site, I noted new work performed at the upper slab; additional dirt work has built up the lower slab section as well.

Figure 2 – South Upper Slab Looking North

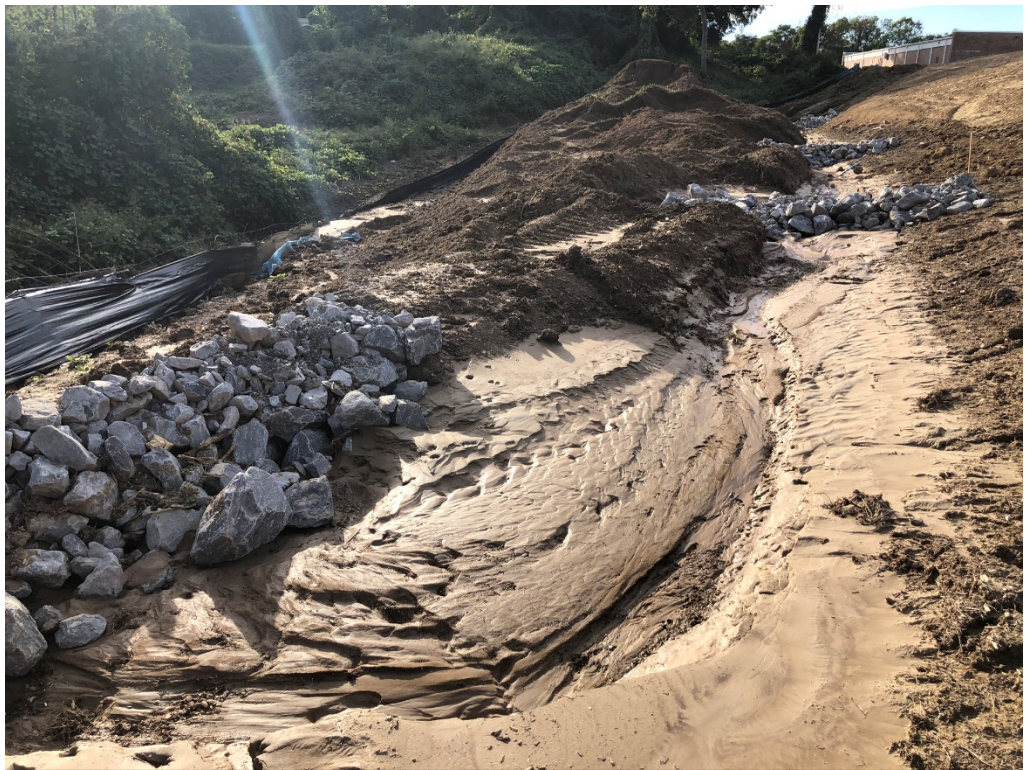
The southern most silt fencing barrier has dirt built up to and within 6" of it's top. There has been an effort to step the drainage in this area with newly installed riprap.

Figure 4 – Riprap Used in Detention (silt fencing in background potentially overwhelmed)

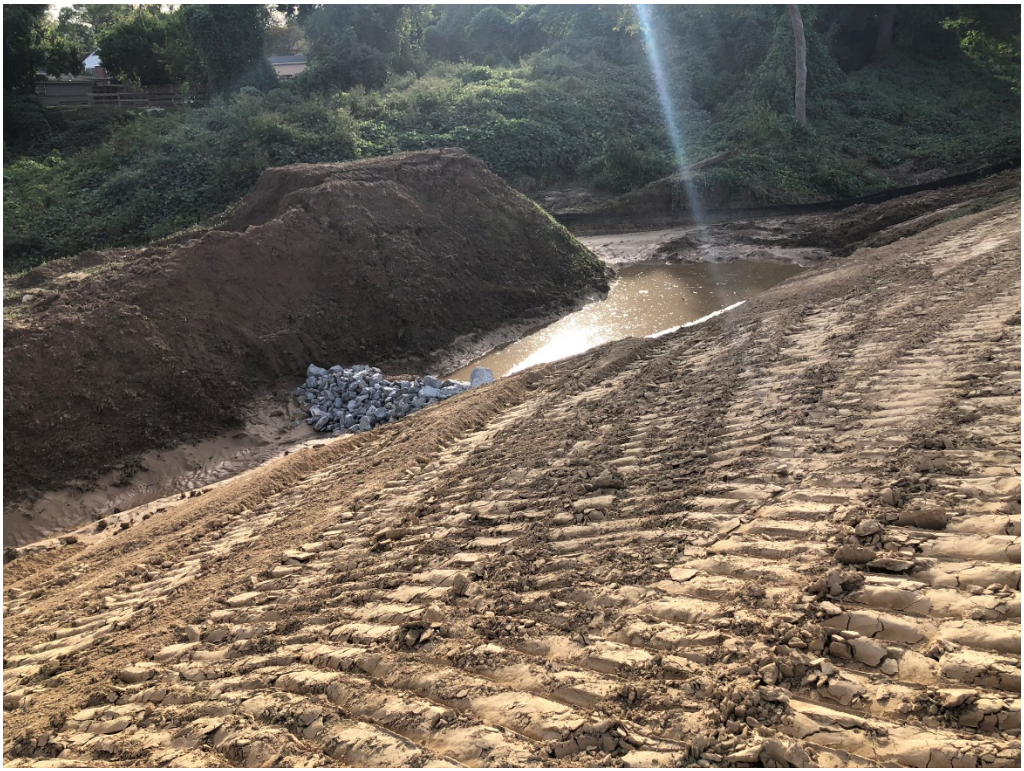
Figure 5 – Water still in Detention

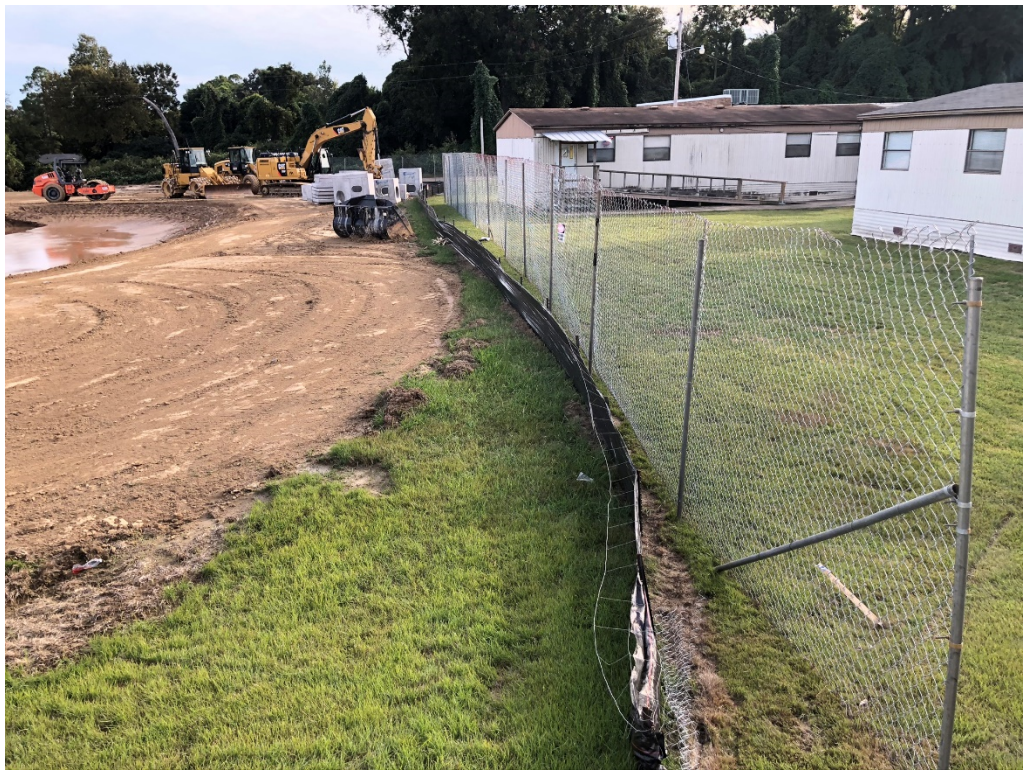
Figure 8 – Temp Fence (gap @ steep slope)

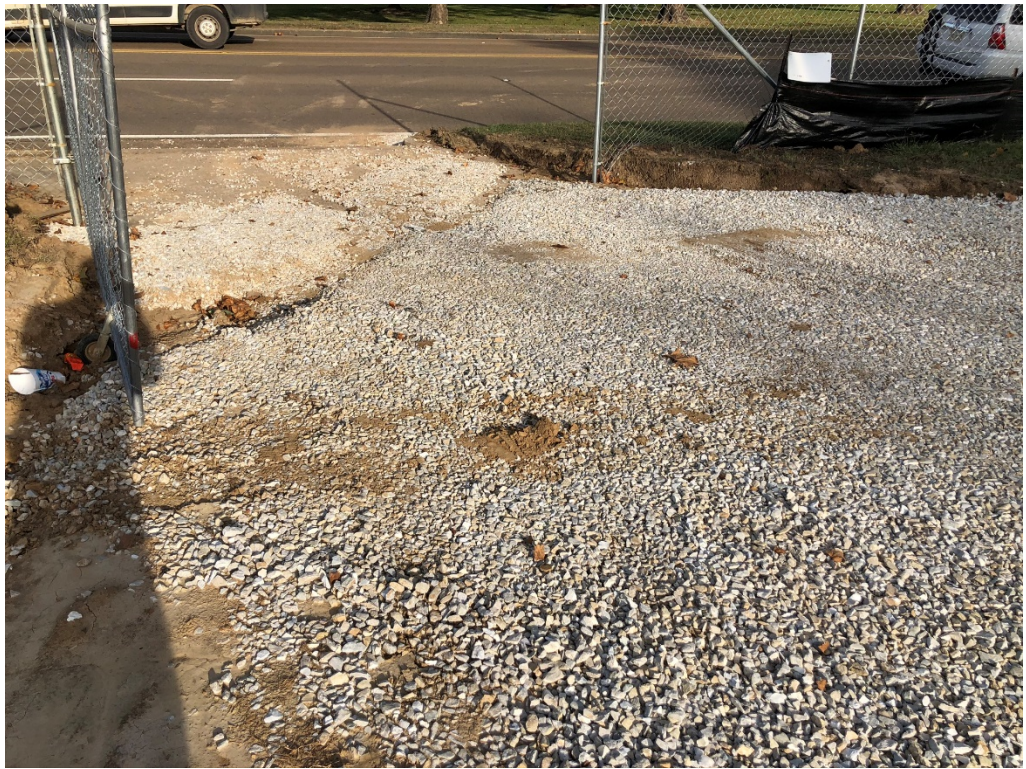
Figure 15 – Natural Drainage Across Temp Drive @ East Entry
