Architect's Field Report

06 November 2019

18059-AOI Academy of Innovation / Report Number 007

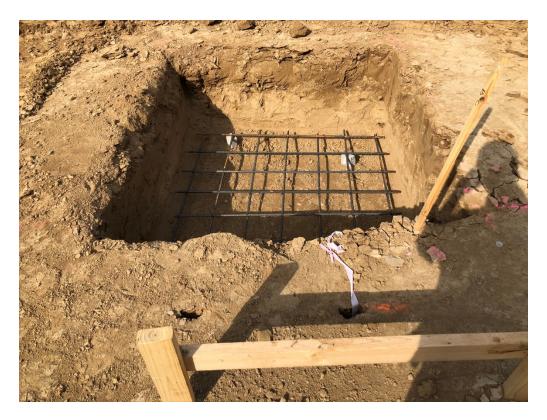
Figure 1 – Isolation Footing (typical)

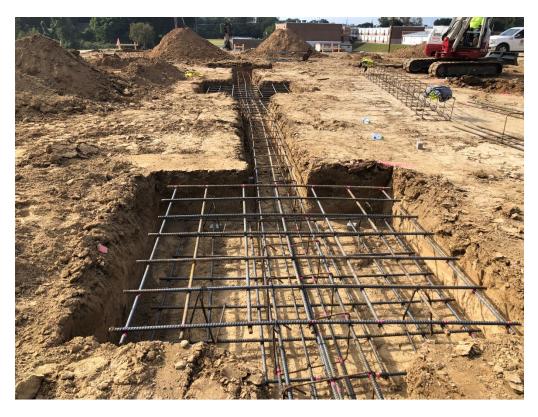
Figure 2 – Isolation footing with Beam (confirm concrete coverage of rebar per Section 032000.3.01/D/5 is adequate)

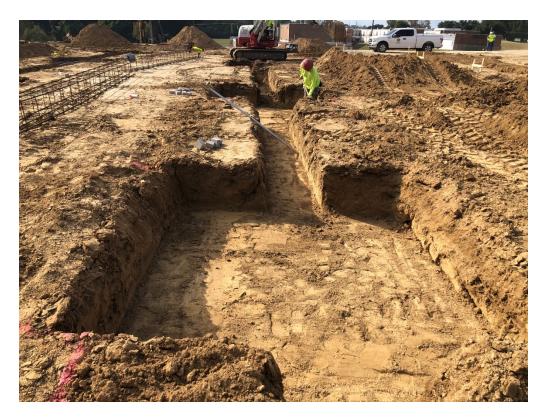
Figure 3 – Excavated Footing

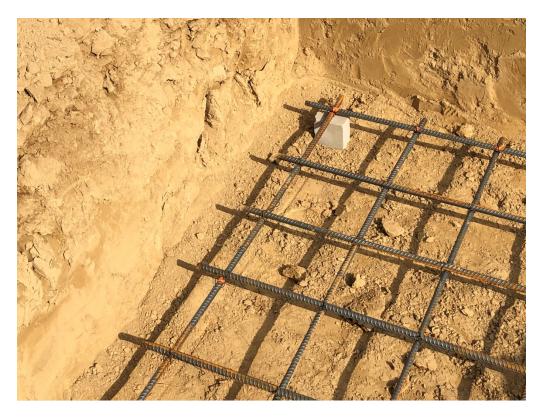
Figure 4 – Confirm Concrete Coverage between rebar and Earth

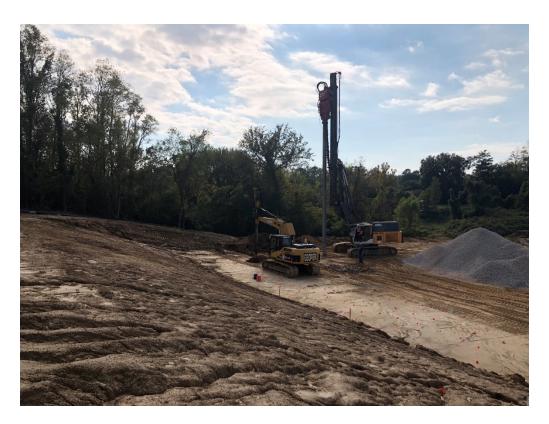
Figure 5 – Geo Pier Drill out and Install

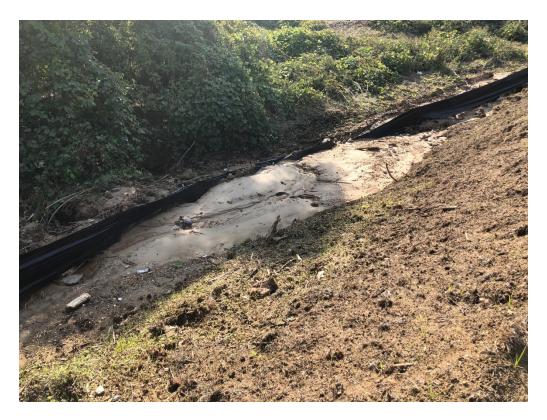
Figure 9 – Low Point in Silt Fencing

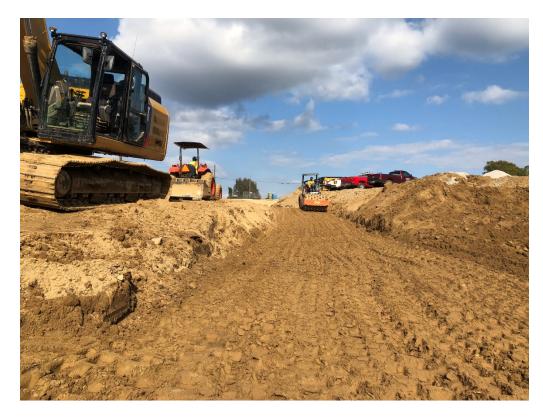
Figure 10 – Dirt Compaction on South Parking Area
