Architect's Field Report

14 November 2019

18059-AOI Academy of Innovation / Report Number 008

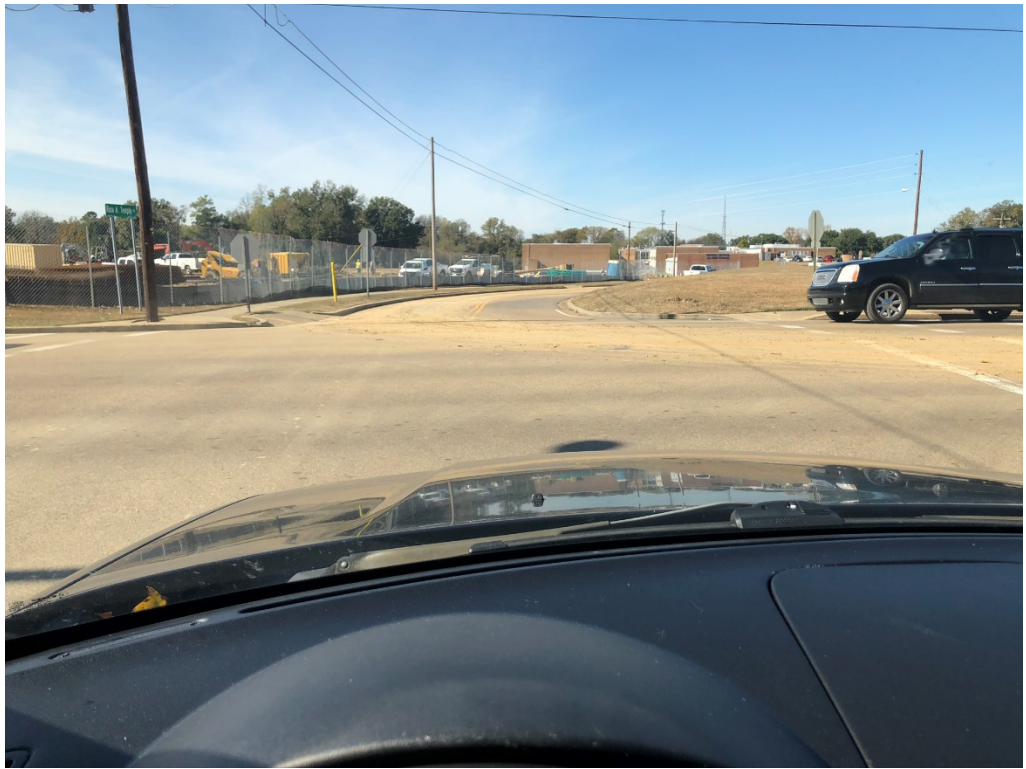
Figure 1 – Dirt Tracked out to Intersection from Work

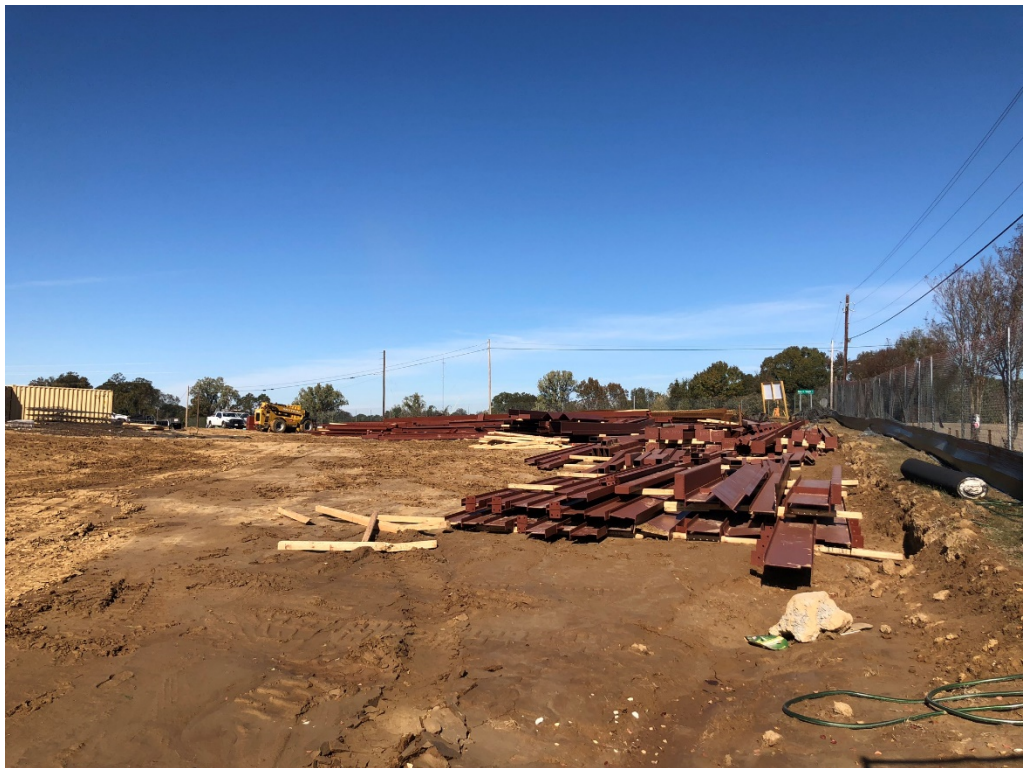
Figure 2 – Red Steel Stored on Site

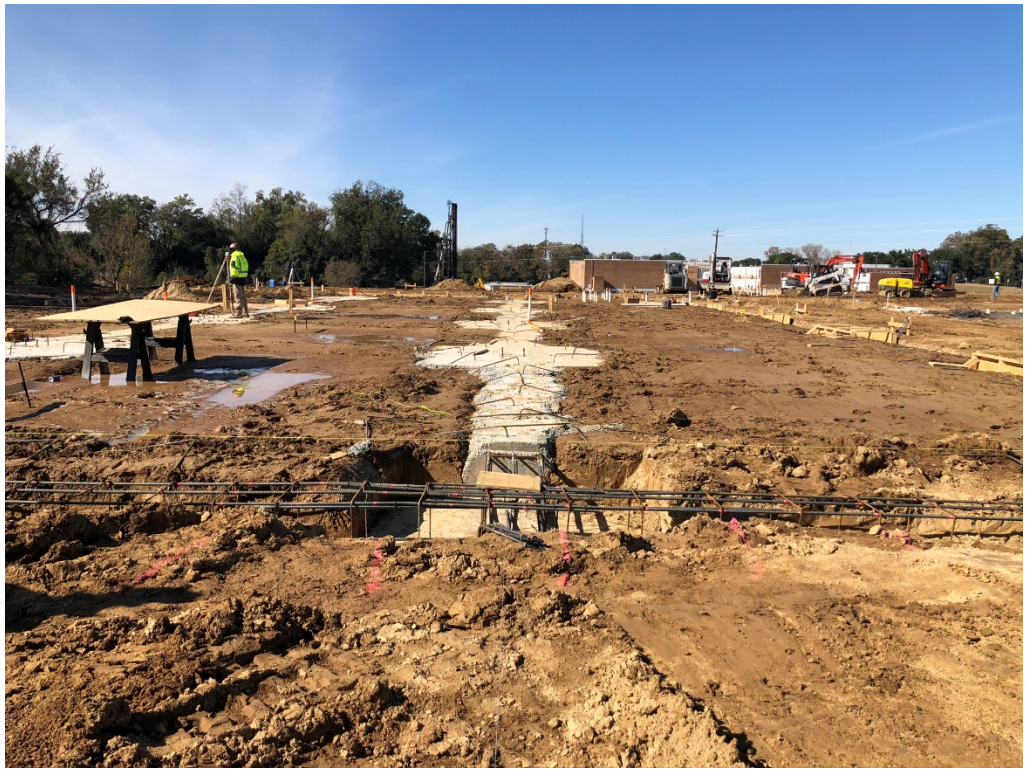
Figure 3 – Foundation Beam

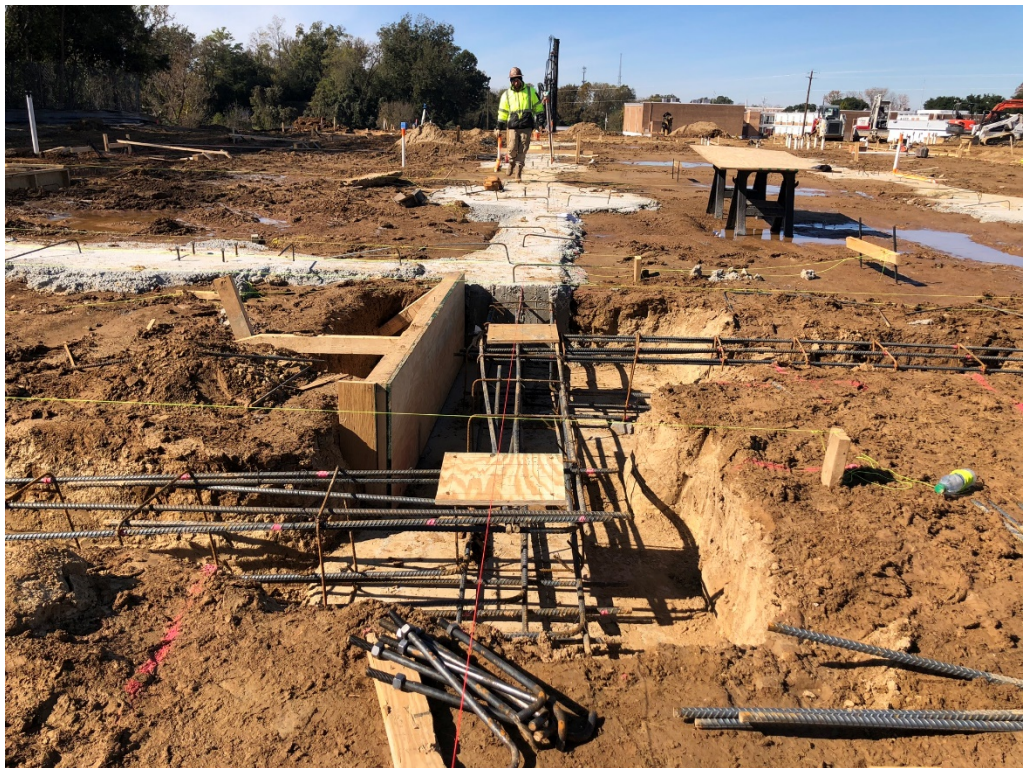
Figure 4 – Reinforcement @ Beams

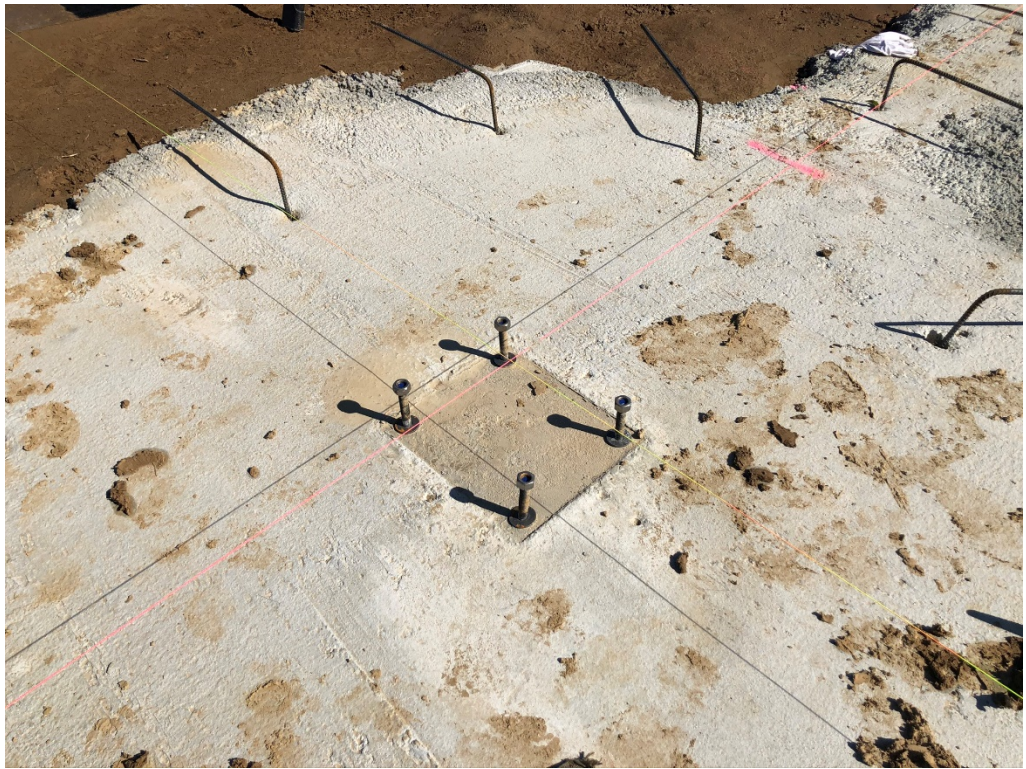
Figure 5 – Typical Bolt Layout @ Isolation Footing

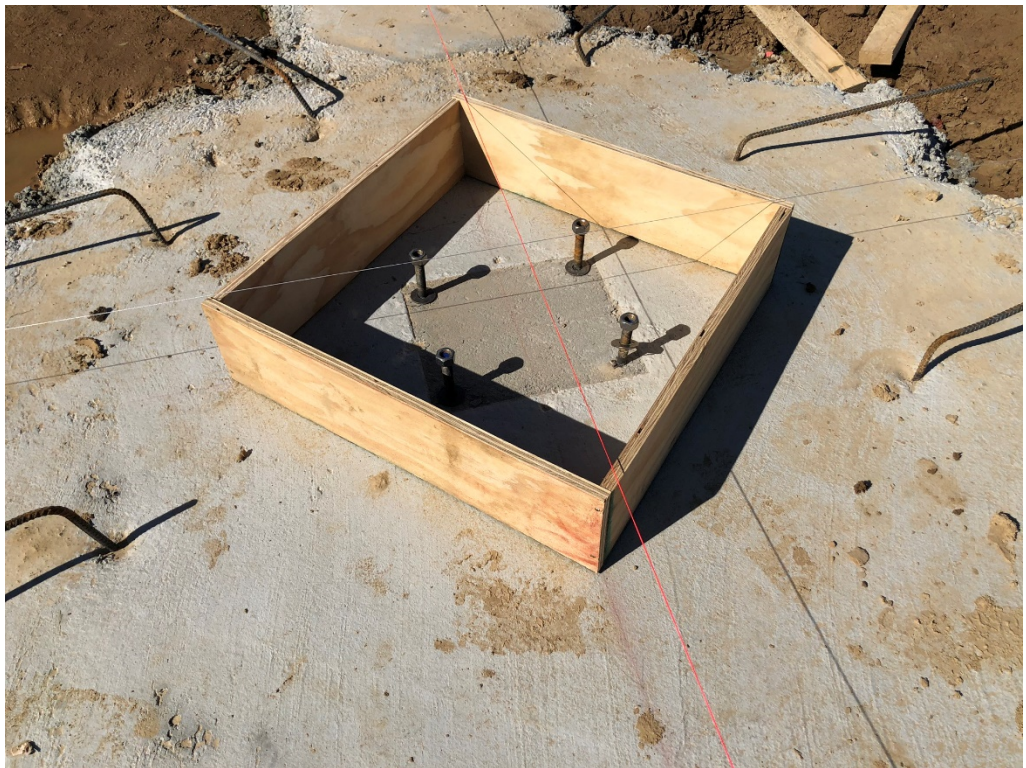
Figure 6 – Lines Laying out Beams

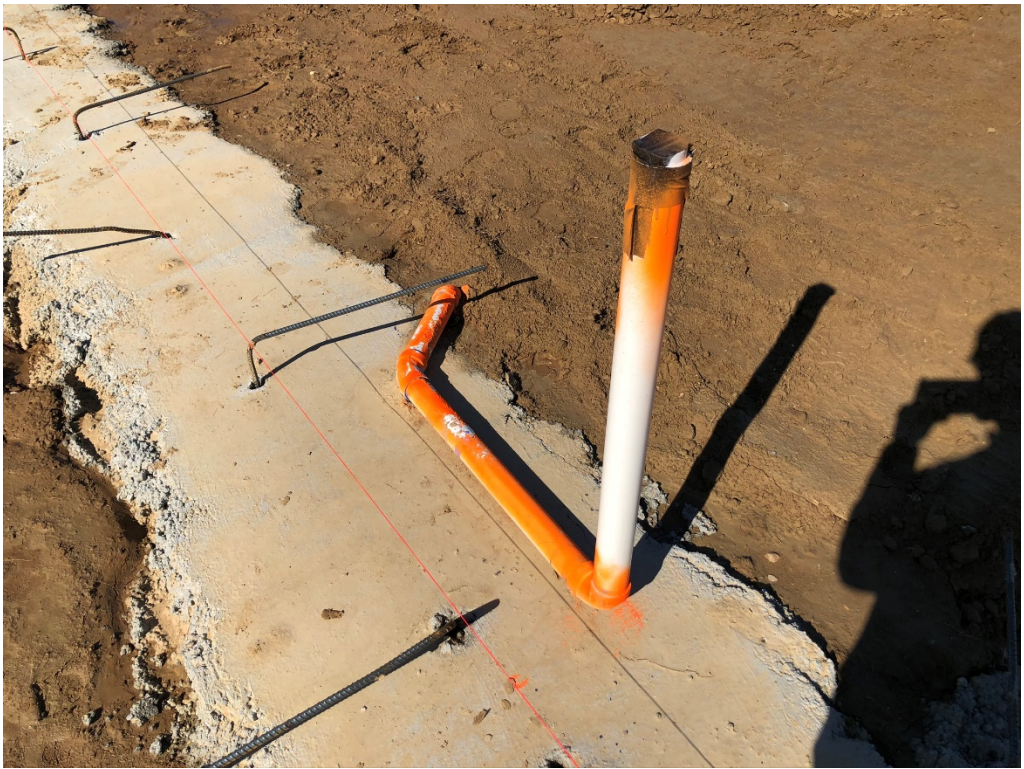
Figure 7 – Stubbed up Plumbing (Confirm to be Encased in Slab Horizontally?)

Items to Verify Confirm Plumbing Horizontal runs are ok to encase in Concrete

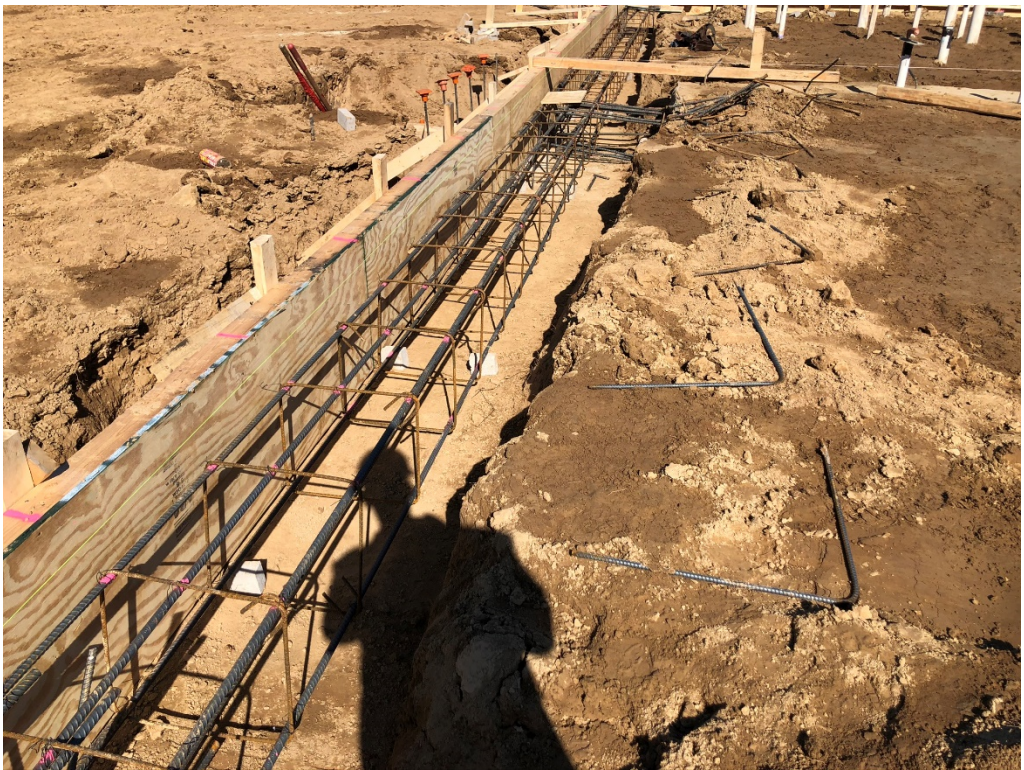
Figure 8 – Plywood @ Excavation for Form

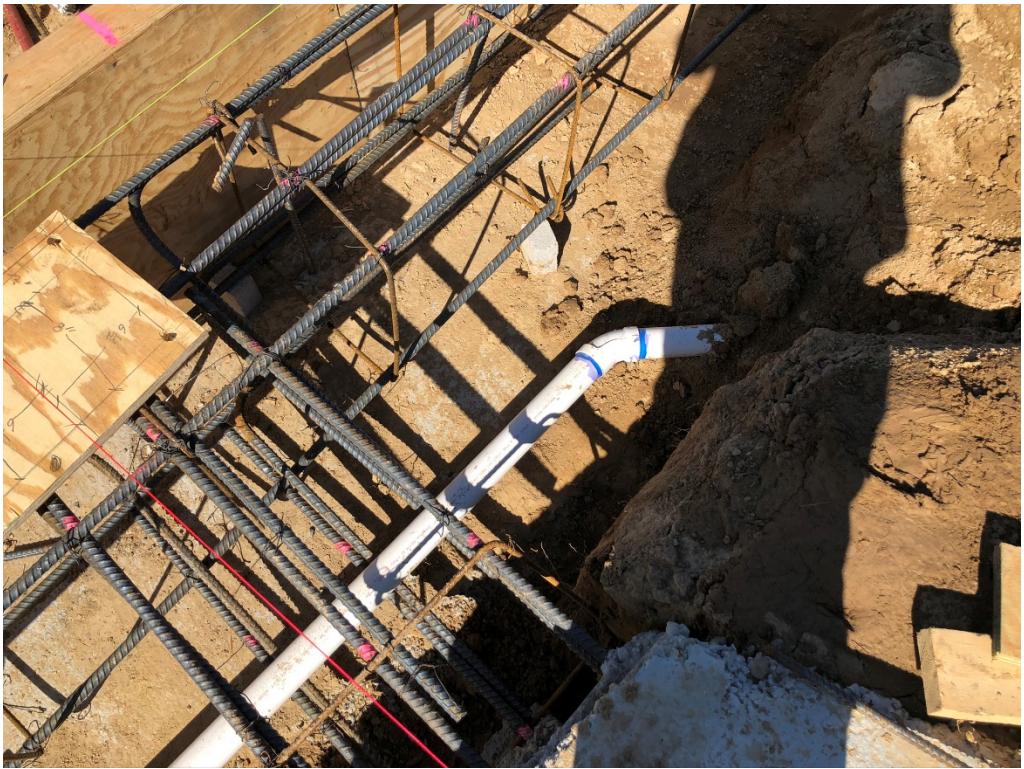
Figure 9 – Horizontal Run of Pipe to be Encased in Footing

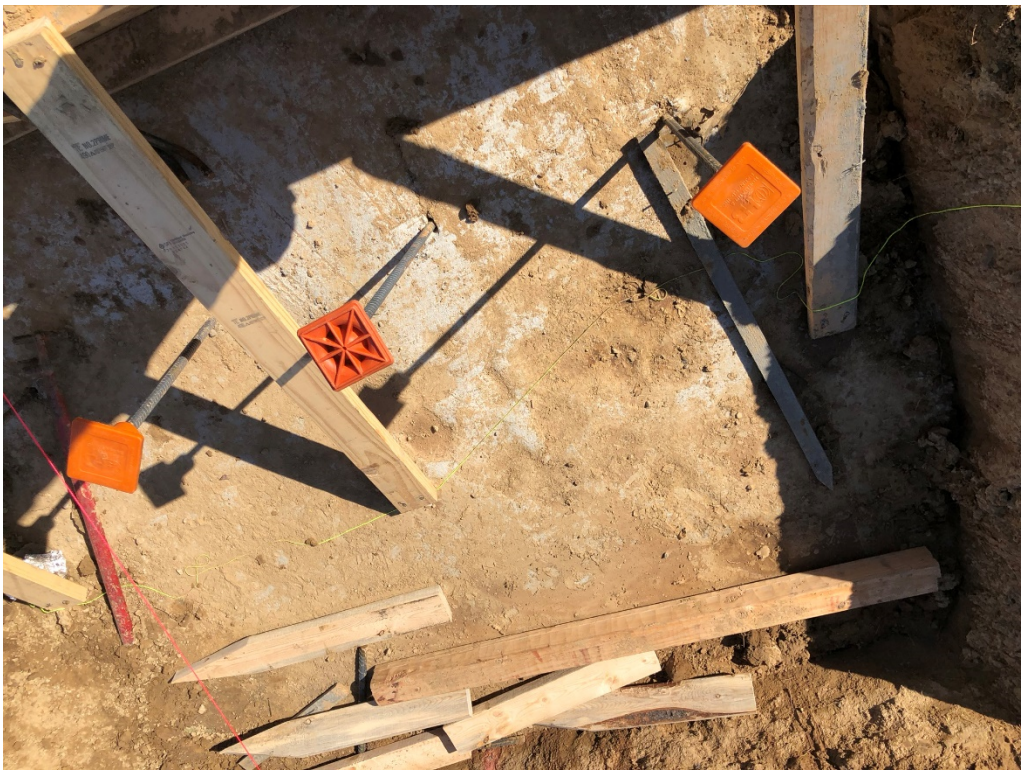
Figure 10 – Safety Caps in use @ Vertical Rebar

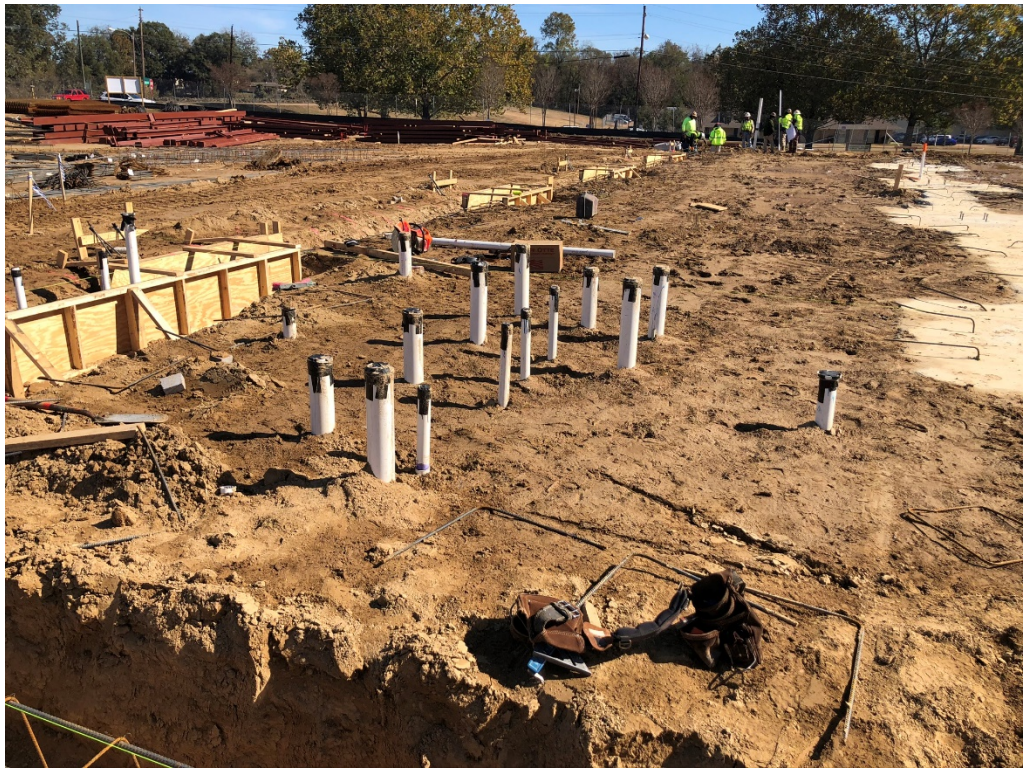
Figure 11 – Plumbing Stubbed Up

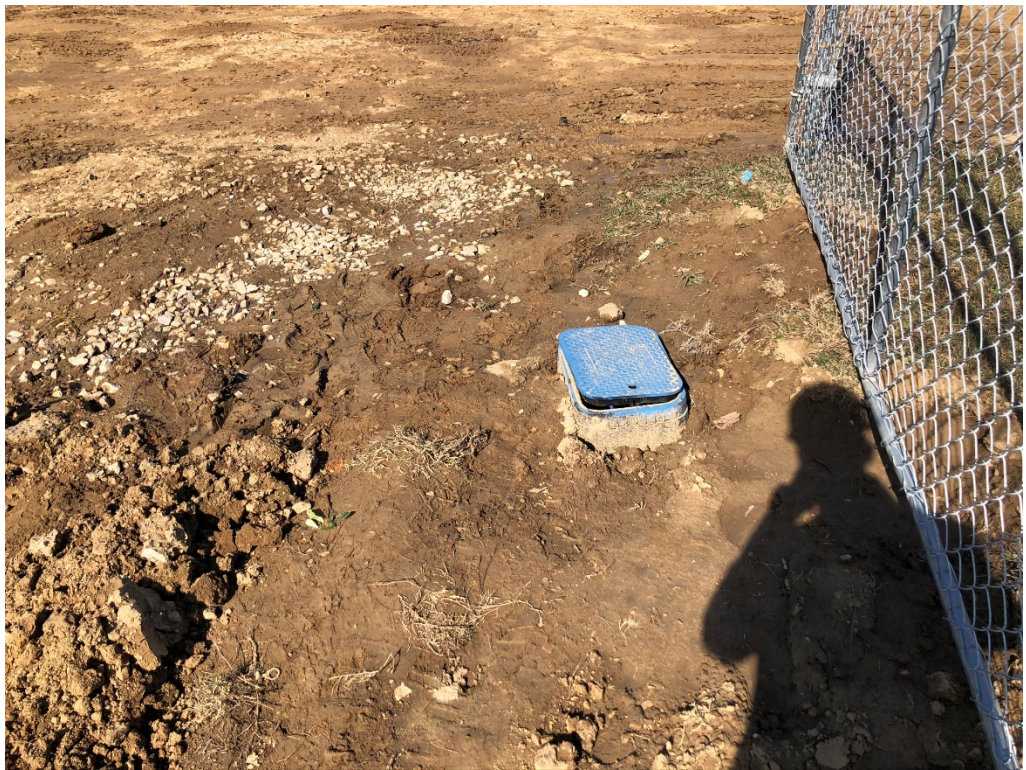
Figure 12 – City Water Tap @ North Entry

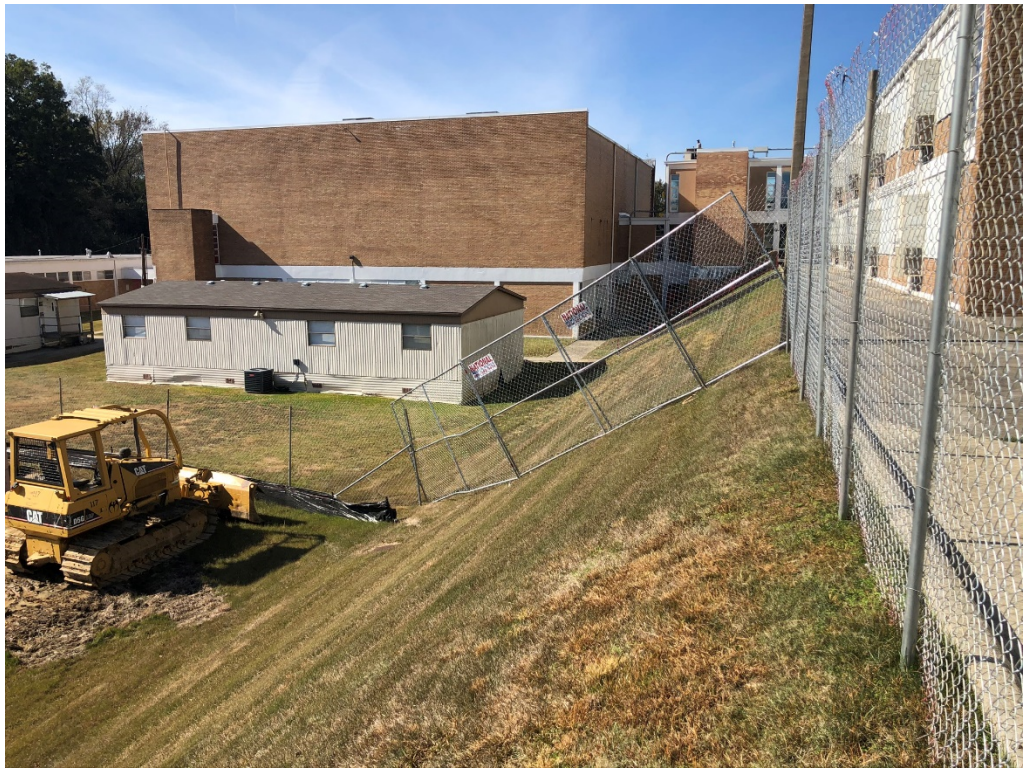
Figure 17 – National Fence Closed Gap in Fencing

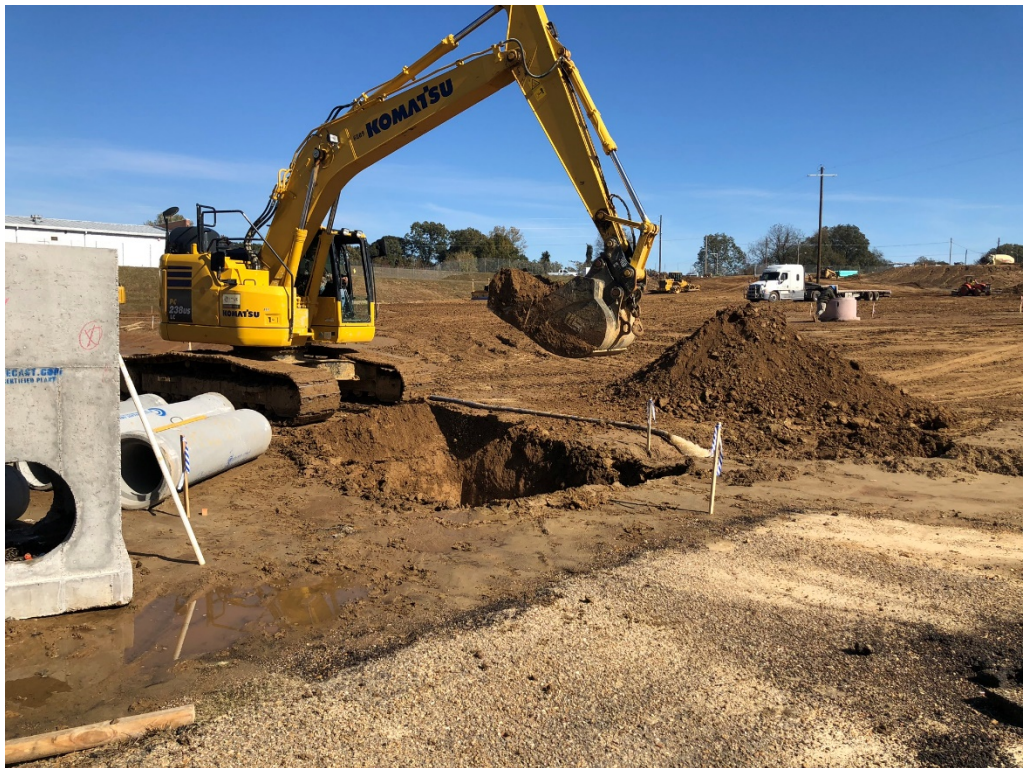
Figure 18 – Storm Sewer Excavation

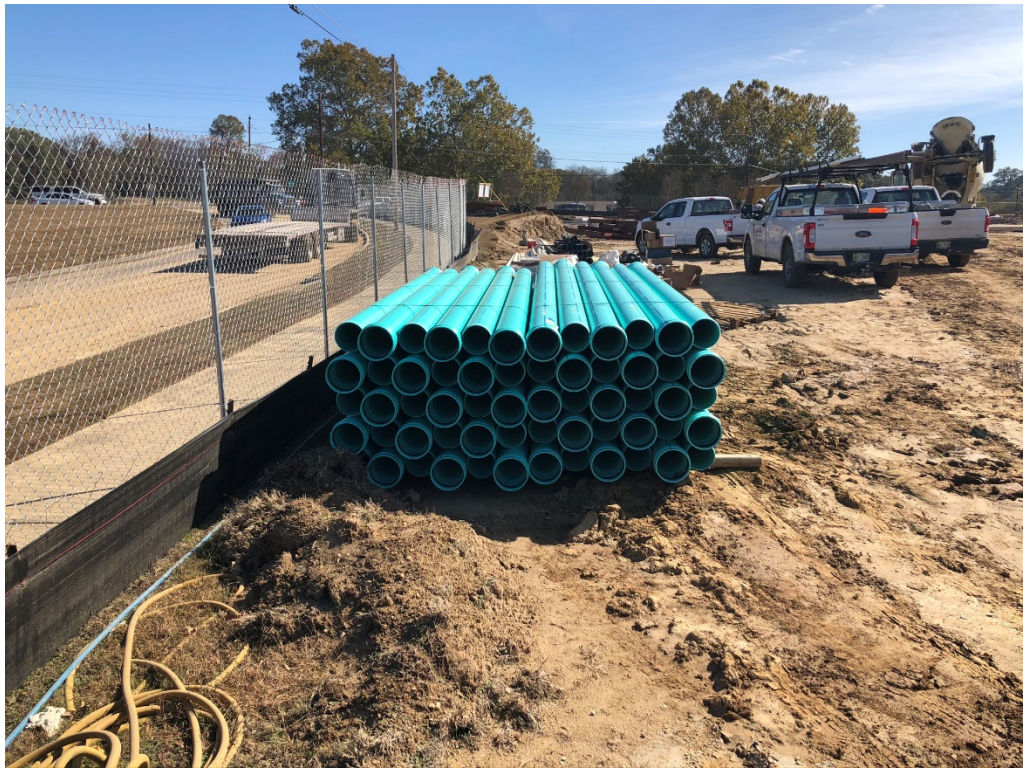
Figure 19 – Pipe Stored on Site

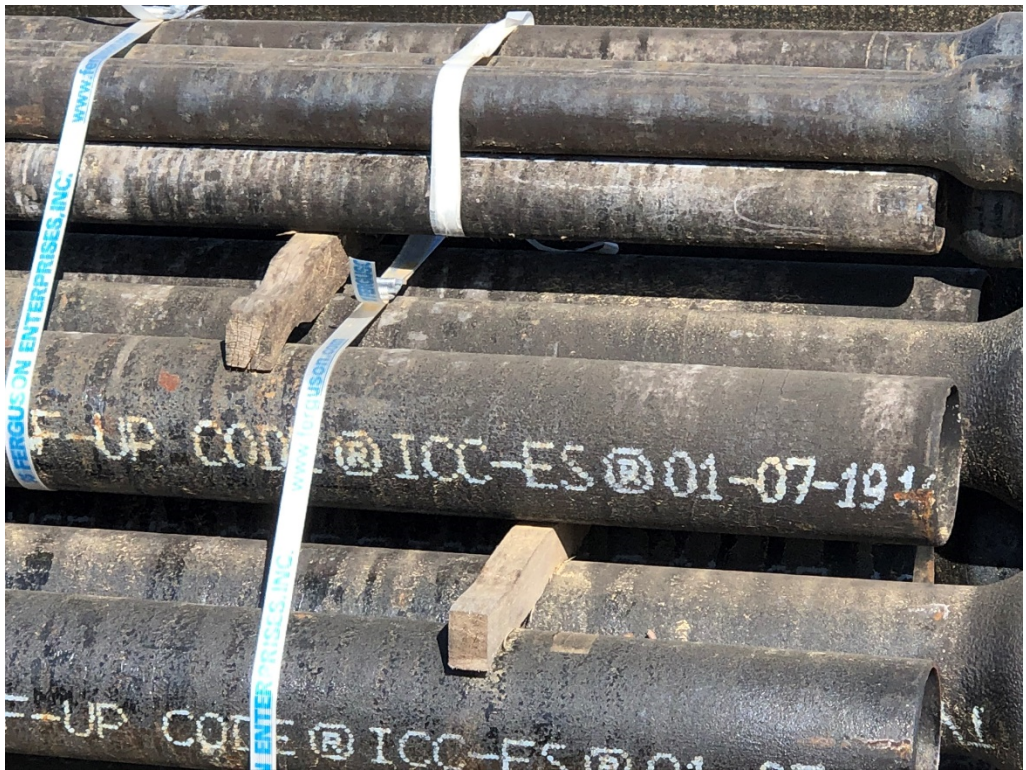
Figure 20 – Pipe Stored on Site

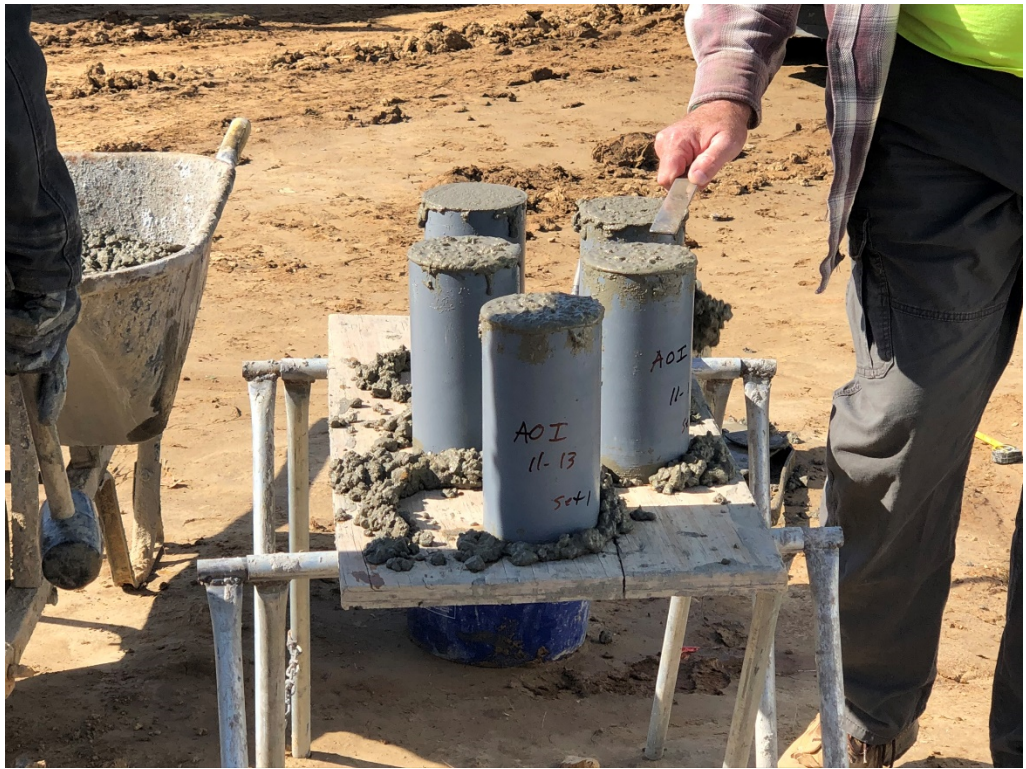
Figure 21 – Concrete Test Cores

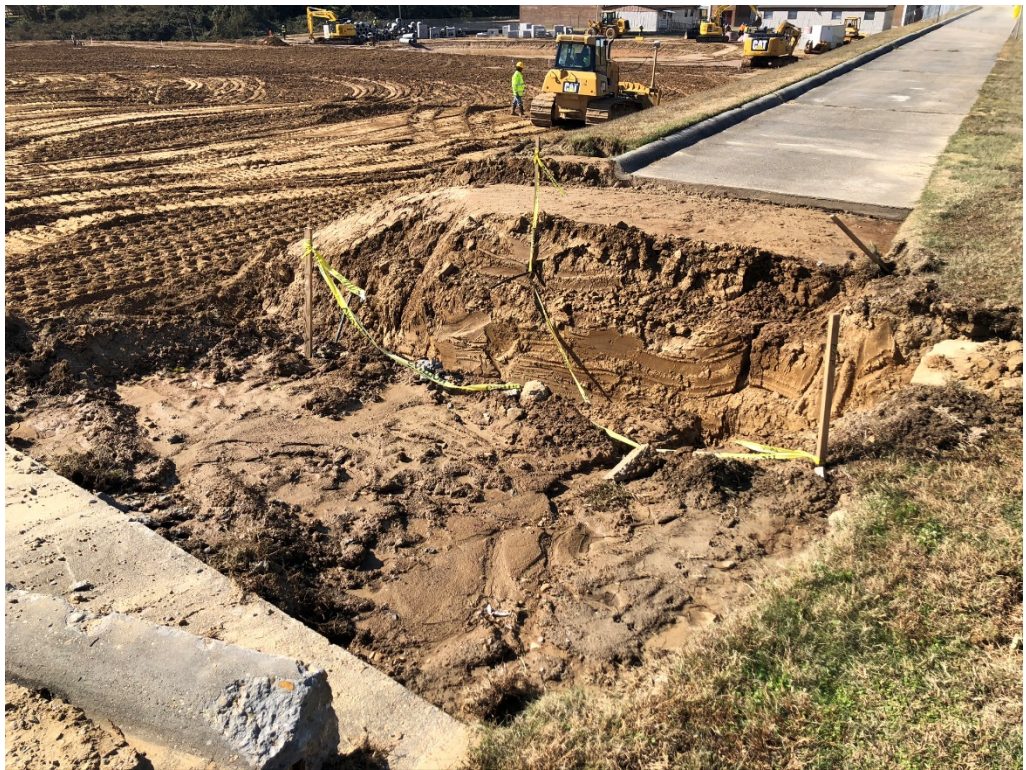
Figure 22 – Drive Removed for work on Storm Sewer Connection
