Architect's Field Report

20 November 2019

18059-AOI Academy of Innovation / Report Number 008

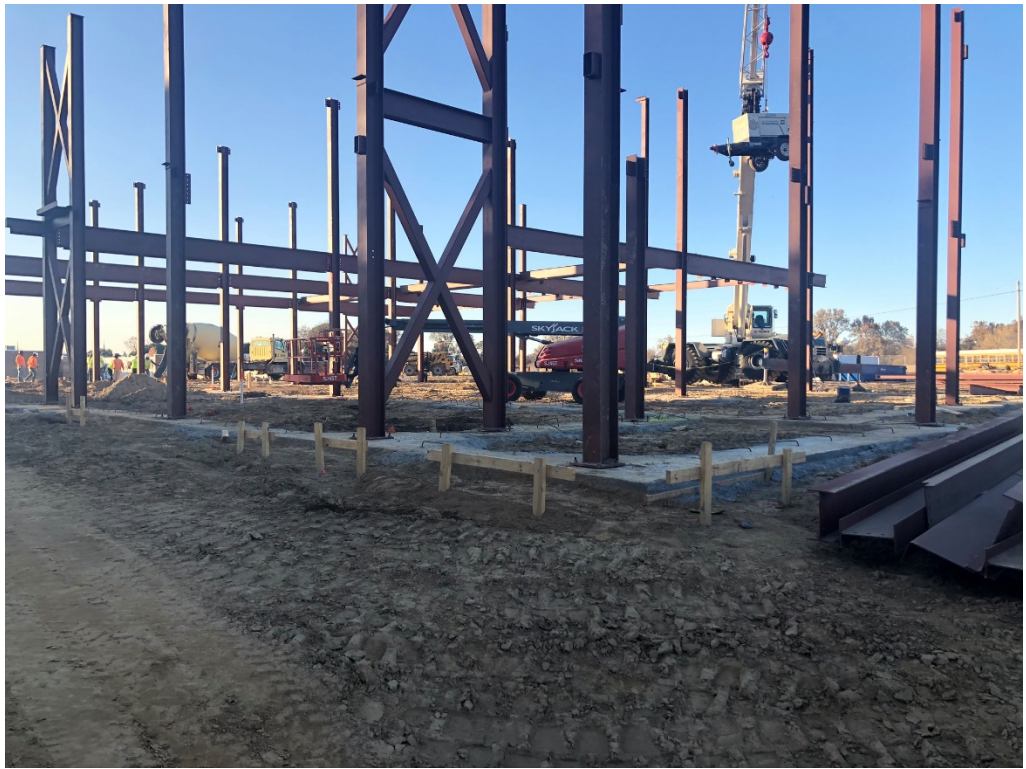
Figure 1 – Red Steel Erected

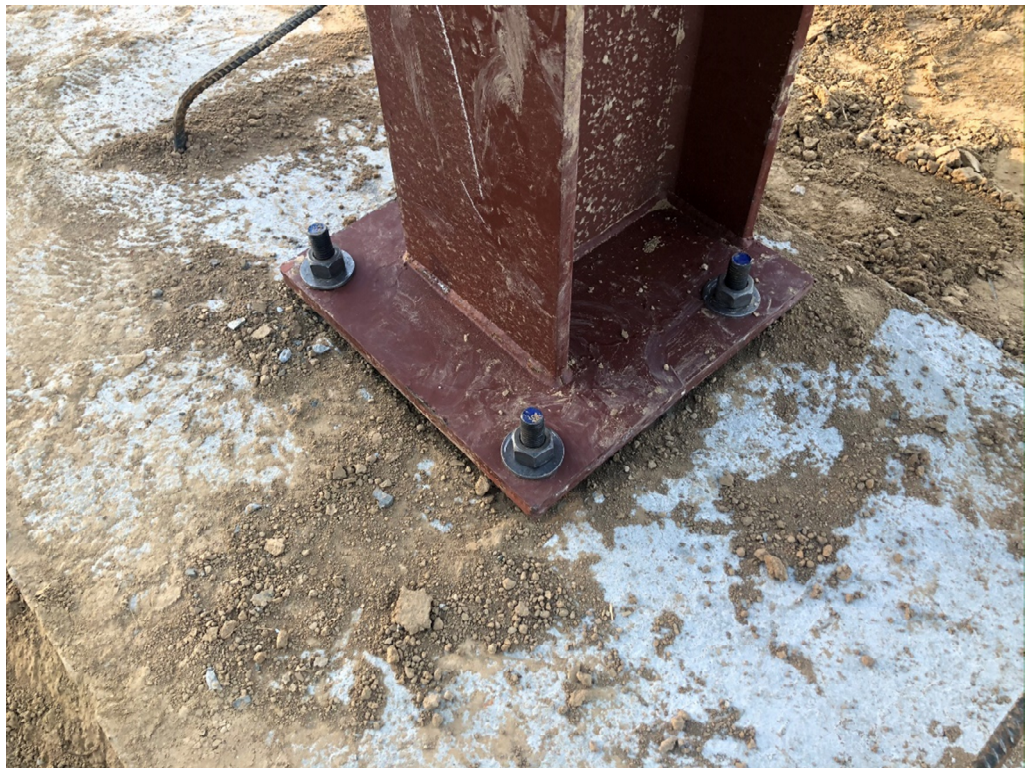
Figure 2 – Typical Connection to Footing

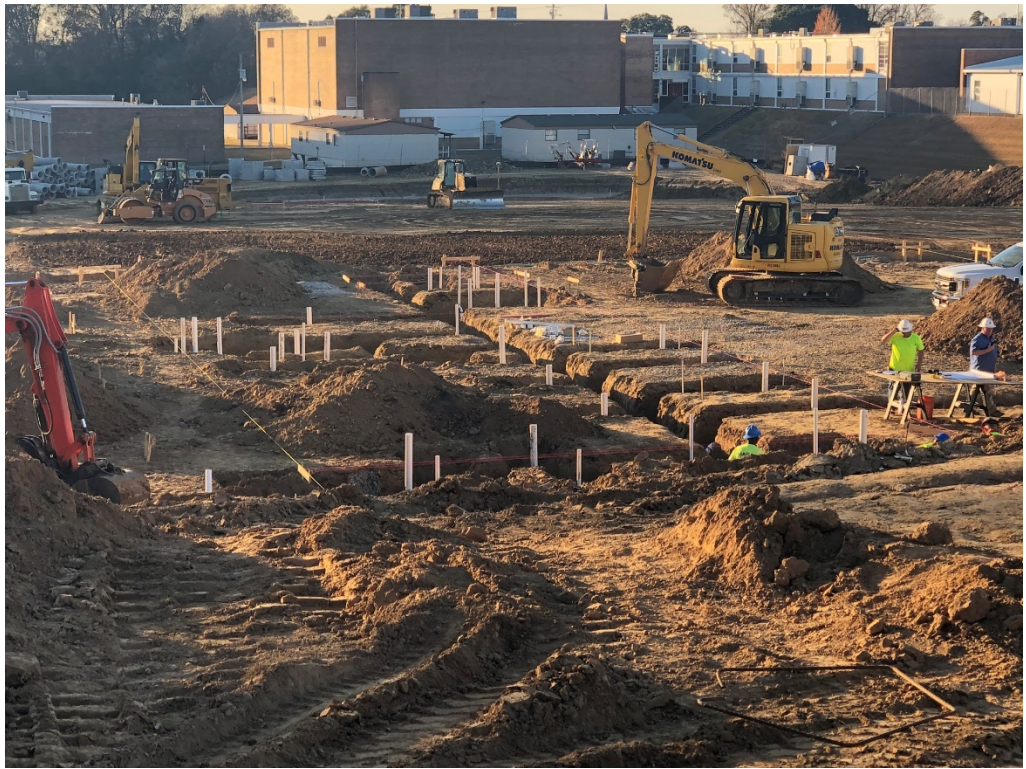
Figure 3 – Plumbing Rough-In at Lower Slab

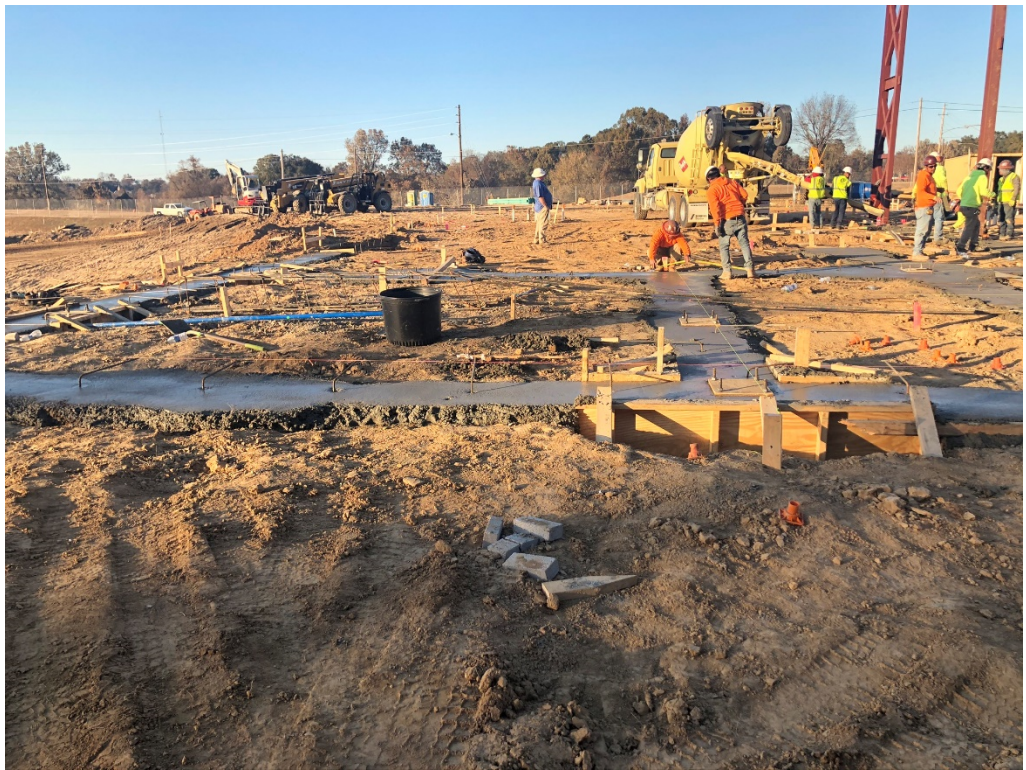
Figure 4 – Foundation Work Cont. at Upper Slab

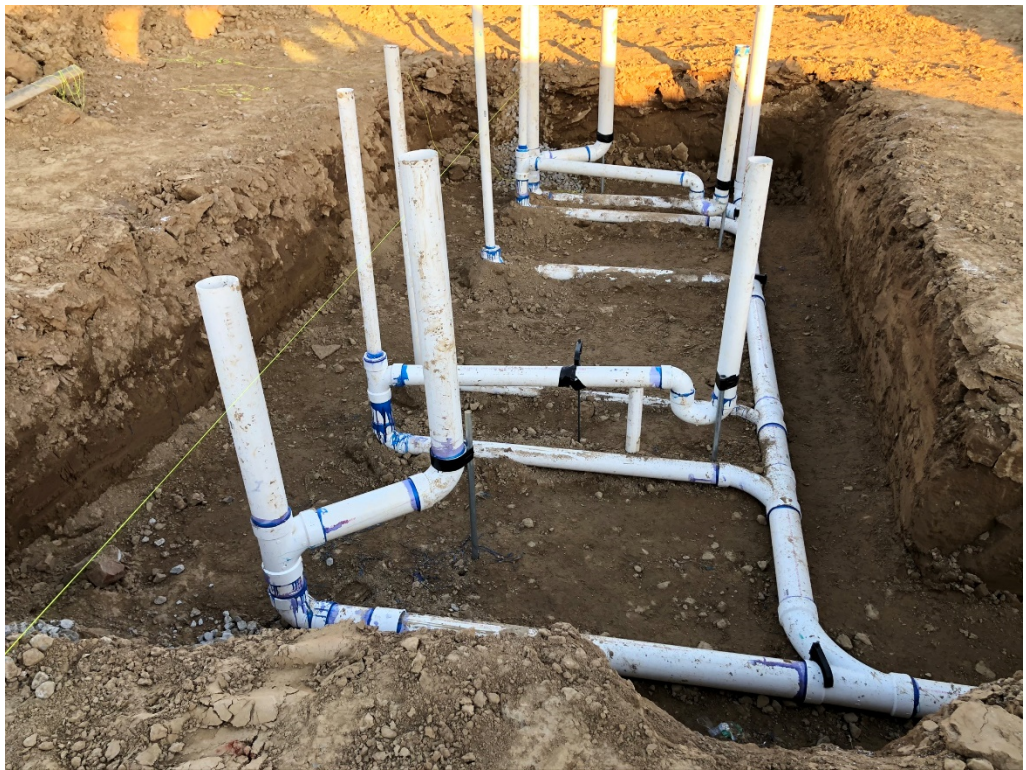
Figure 8 – Rough Plumbing at Lower Slab

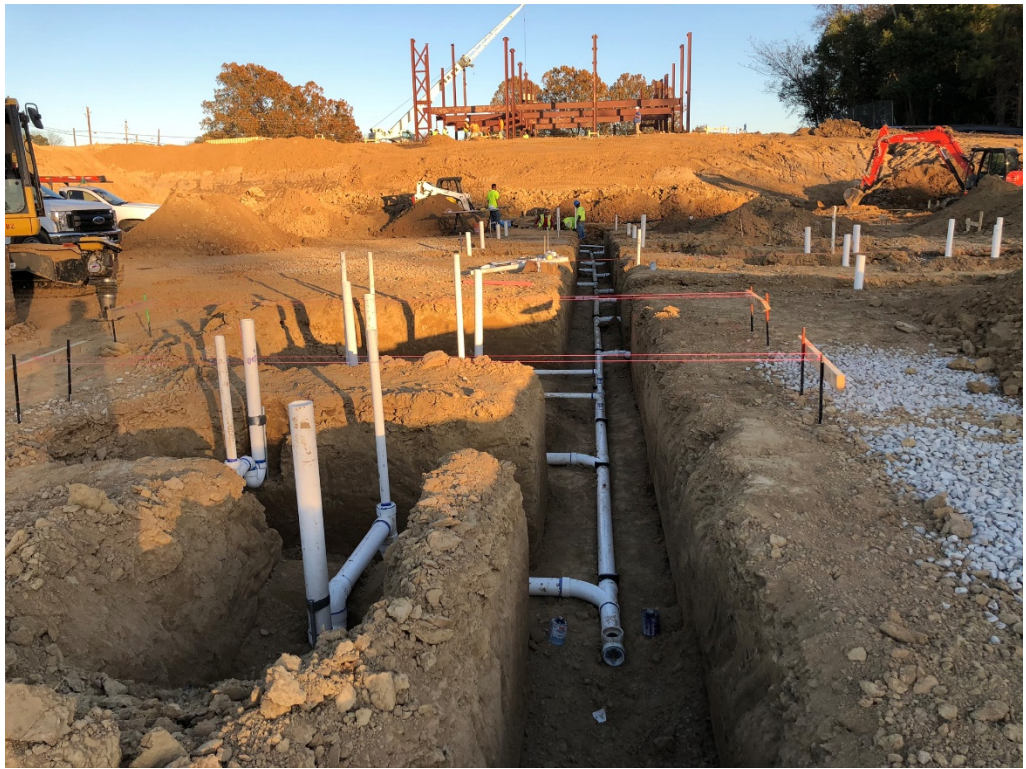
Figure 9 – Rough Plumbing at Lower Slab

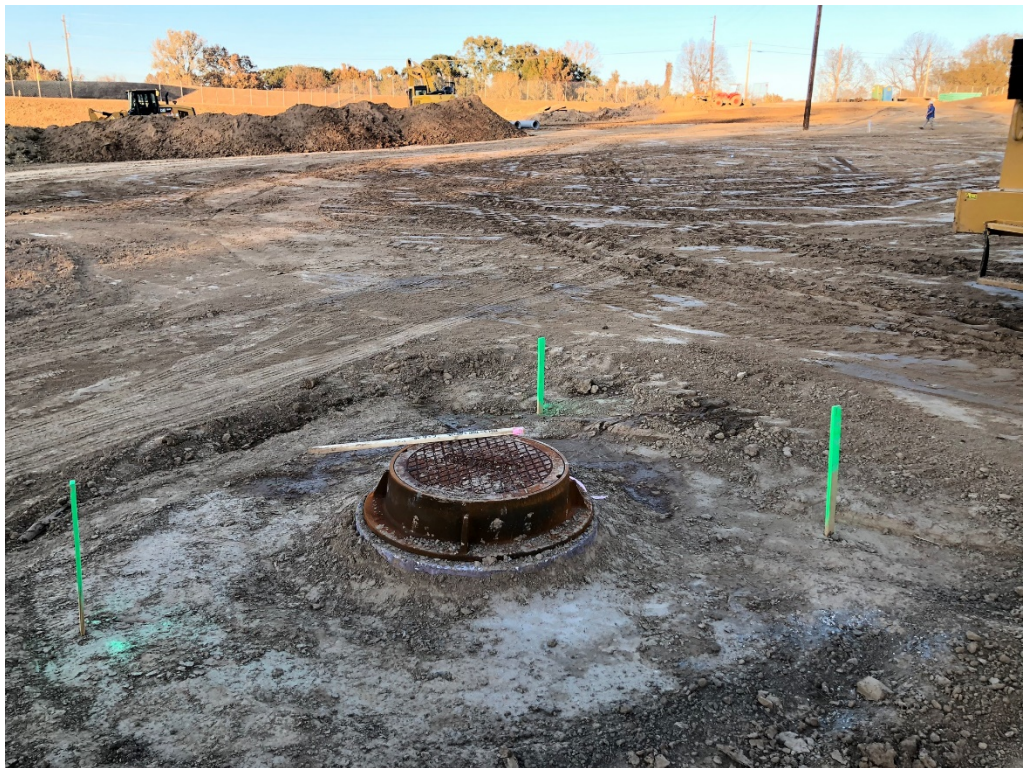
Storm sewer work has also been moving along. About 50-60% of pipe and culverts have been installed and they are working there way back to the drainage outlet at the road on the North end today.

Figure 10 – Storm Sewer Installed in Parking Area

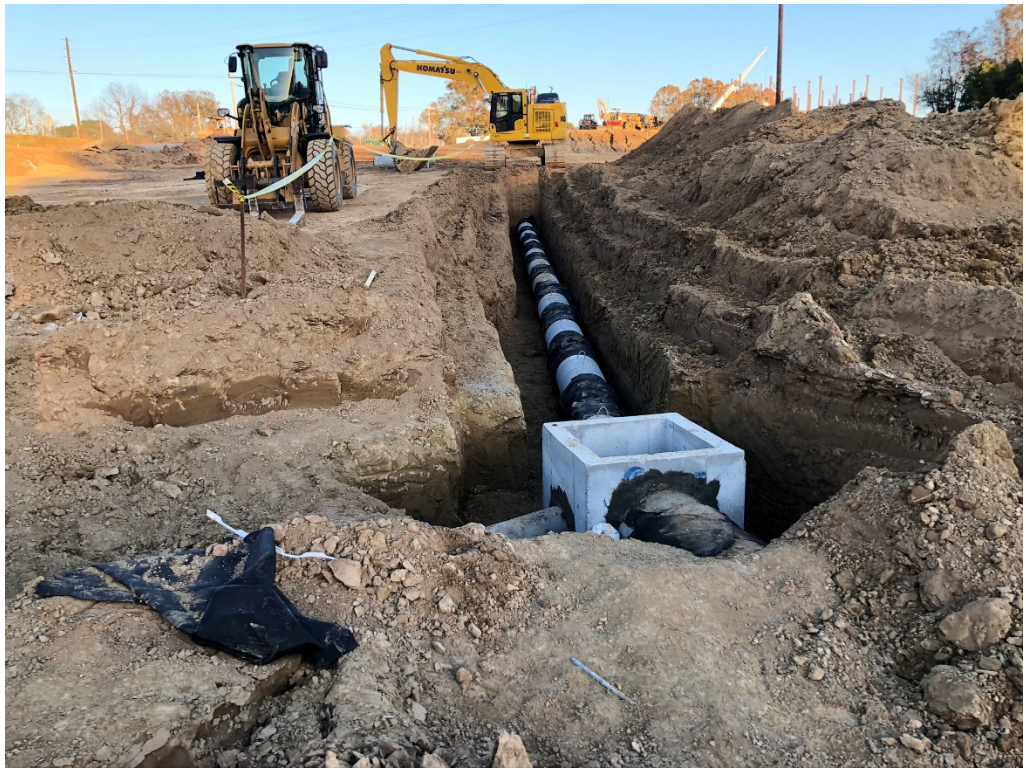
Figure 11 – Storm Sewer Work @ North Side of Parking
