## Architect's Field Report

27 November 2019

18059-AOI Academy of Innovation / Report Number 010

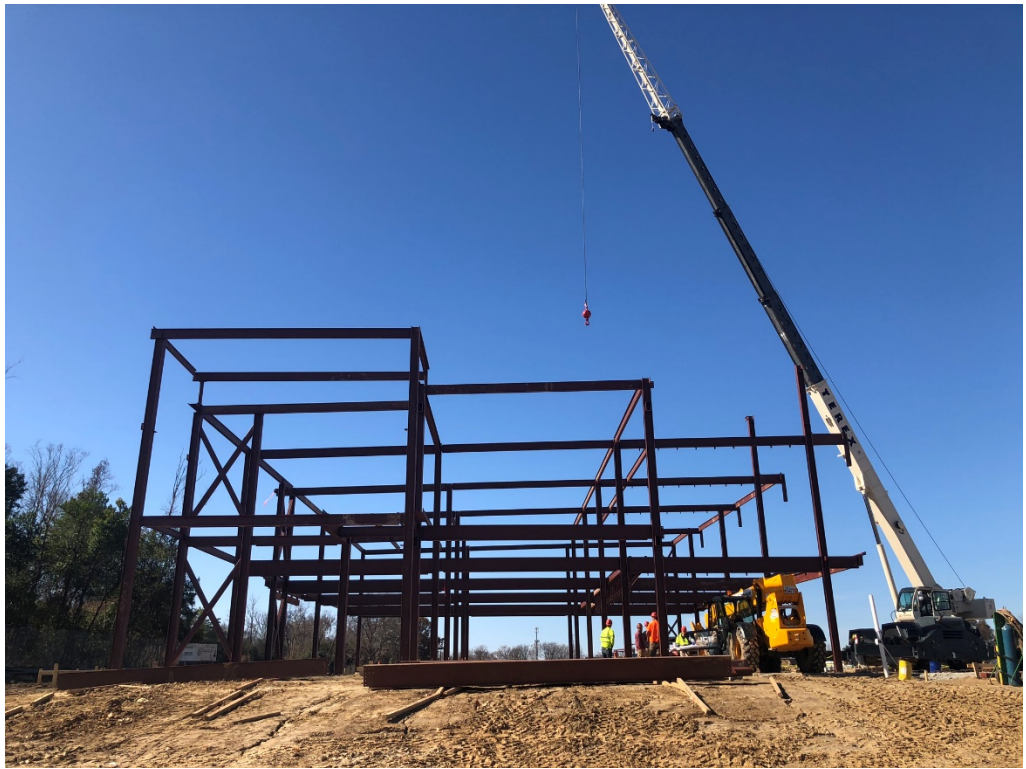
Figure 1 – Red Steel Erected

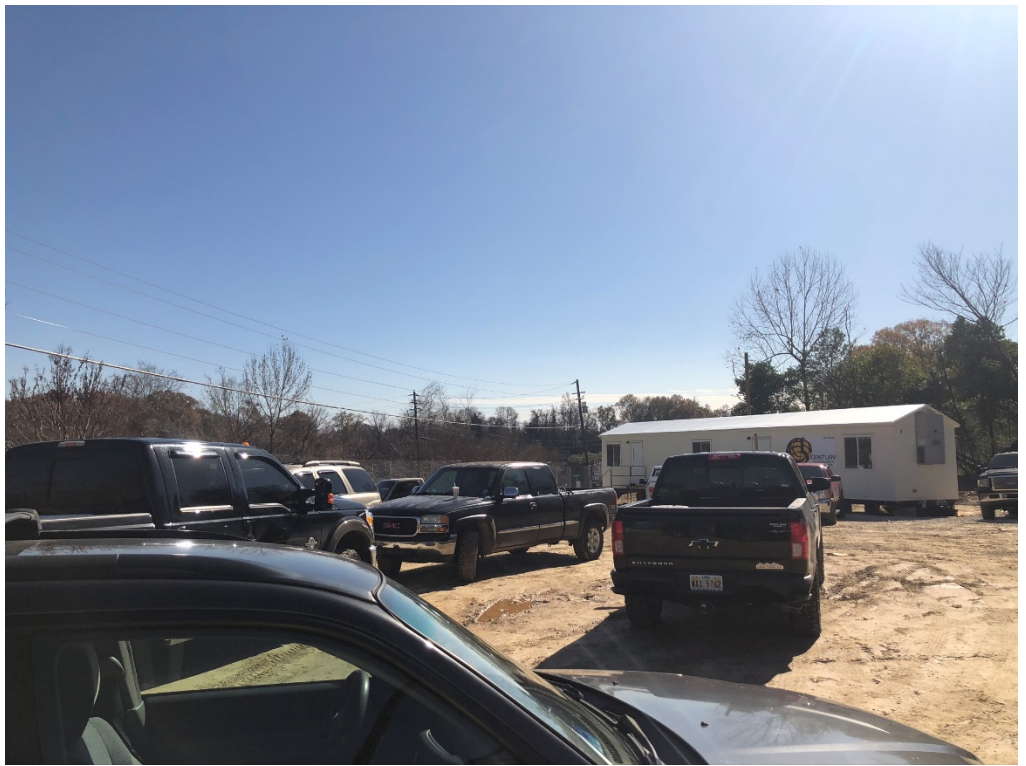
Figure 2 – Parking at Job Site Trailer

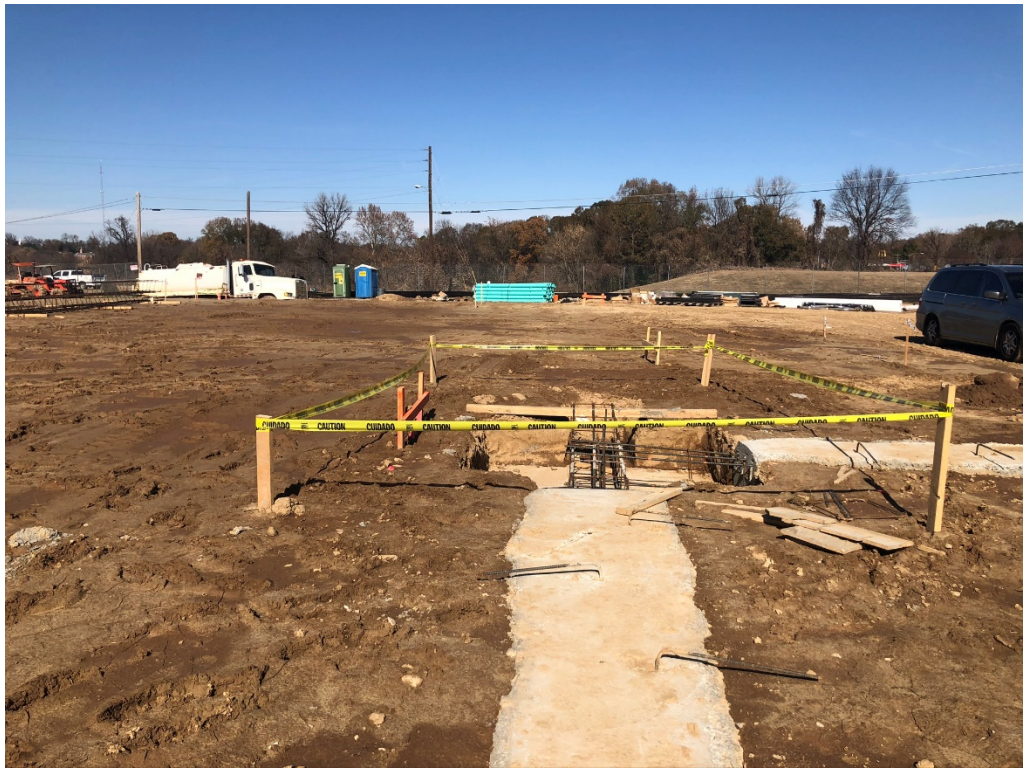
Figure 3 – Warning Tape at Excavation (Typical)

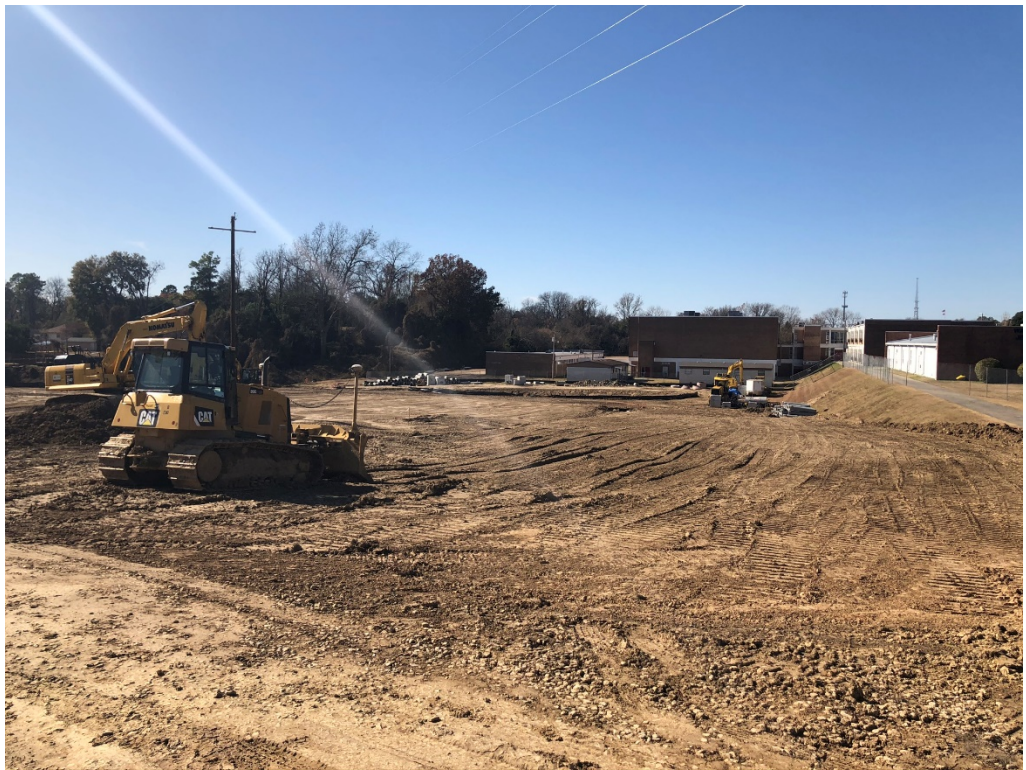
Figure 4 – North Entry Looking WSW

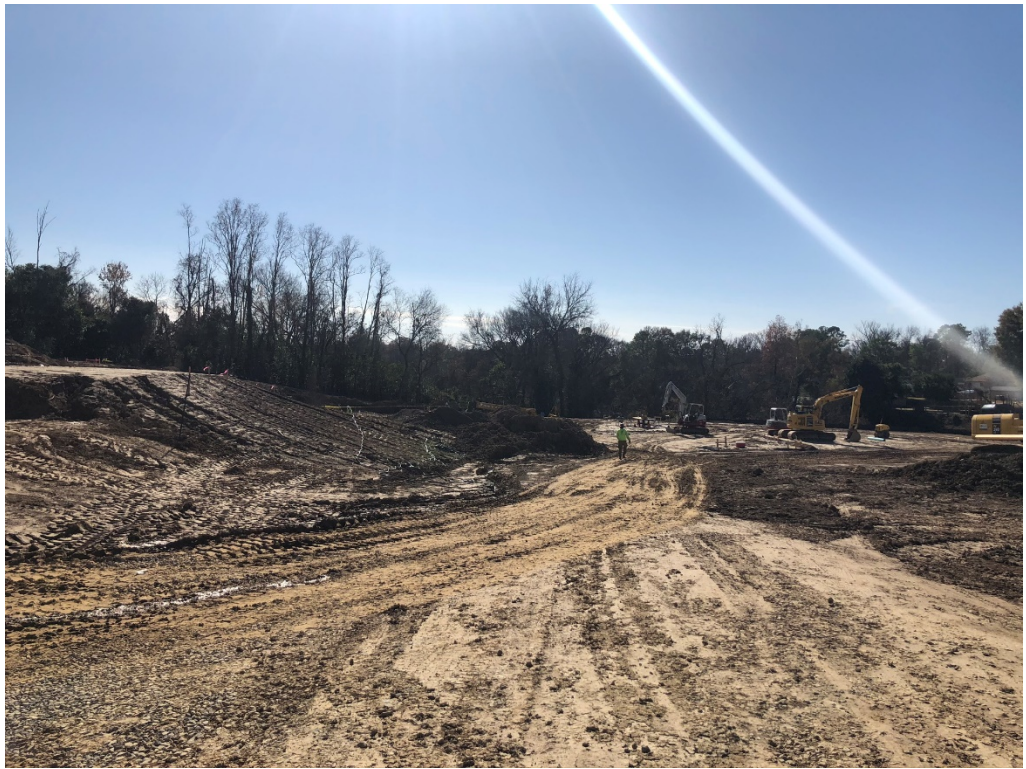
Figure 5 – North Entry Looking S

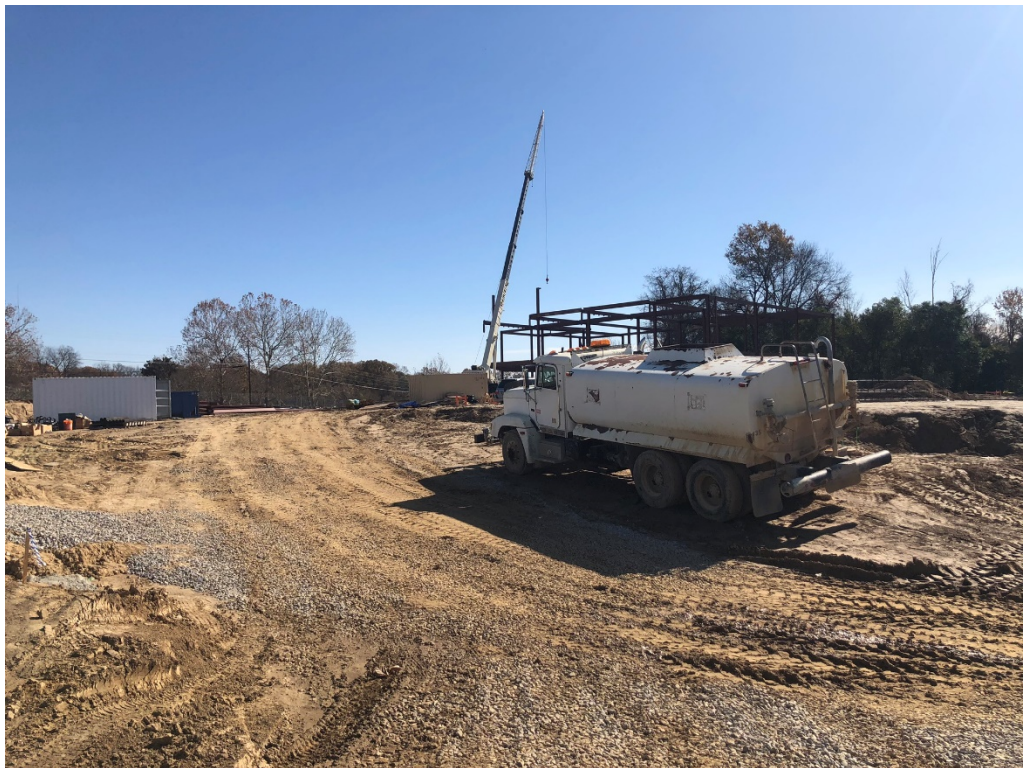
Figure 6 – North Entry Looking ESE

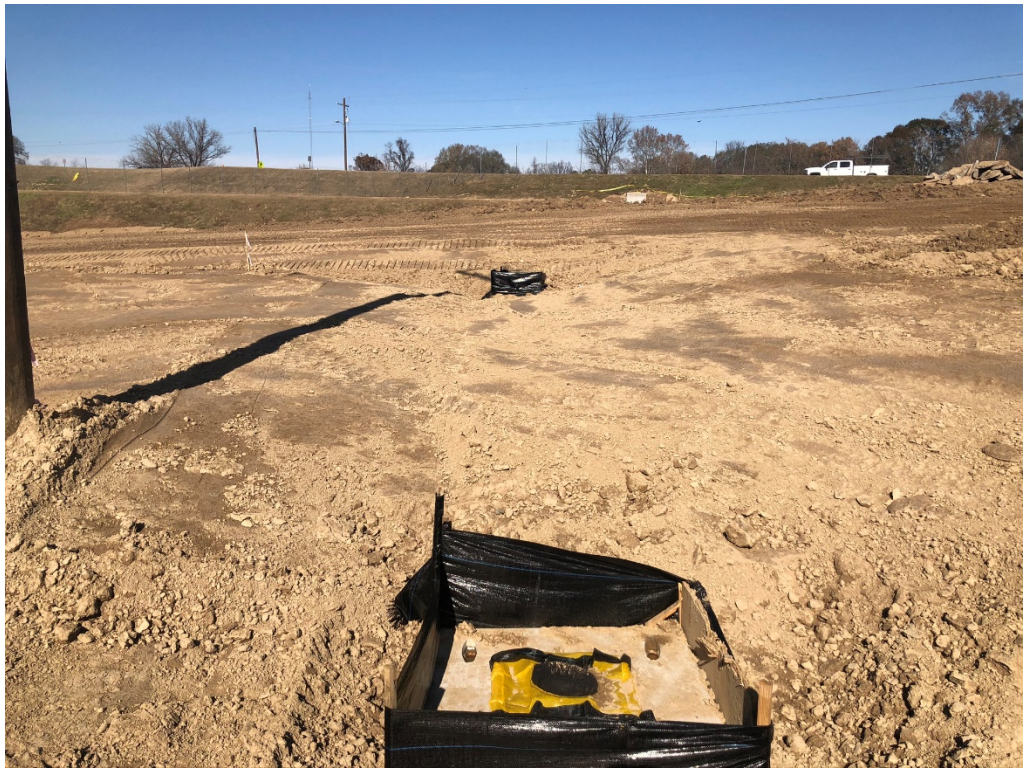
Figure 7 – Storm Sewer Connected (Inlet #8 Looking North)

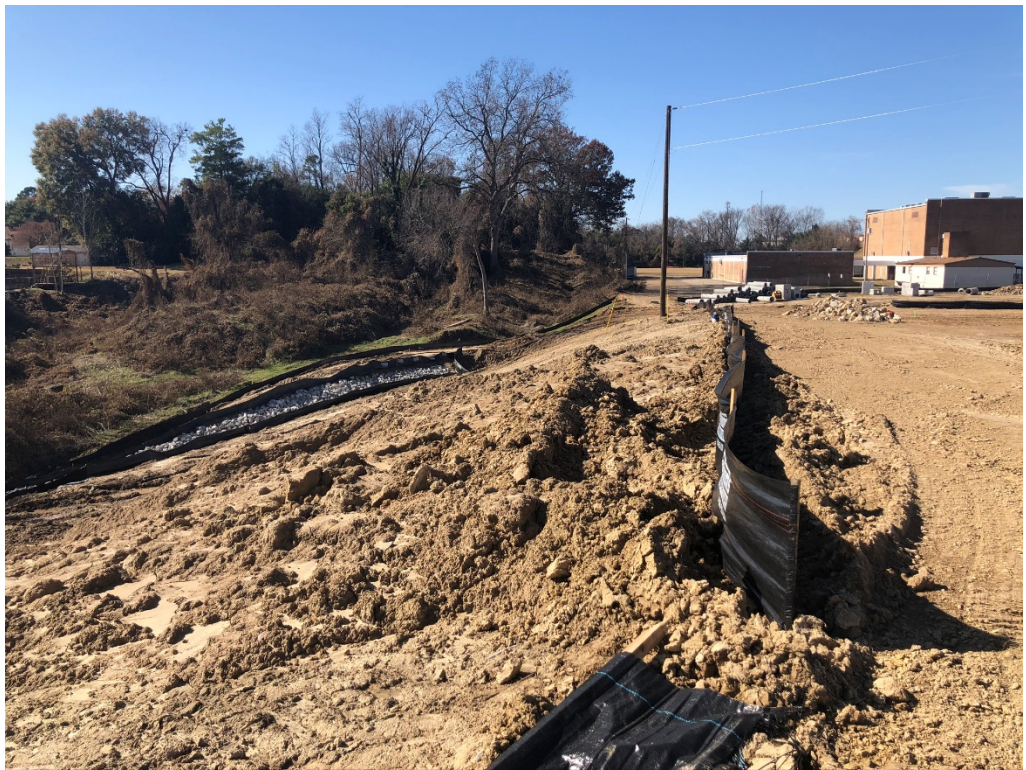
Figure 8 – New Silt Fence at South Edge Of Parking (Also Note New Rip Rap at lower Section)

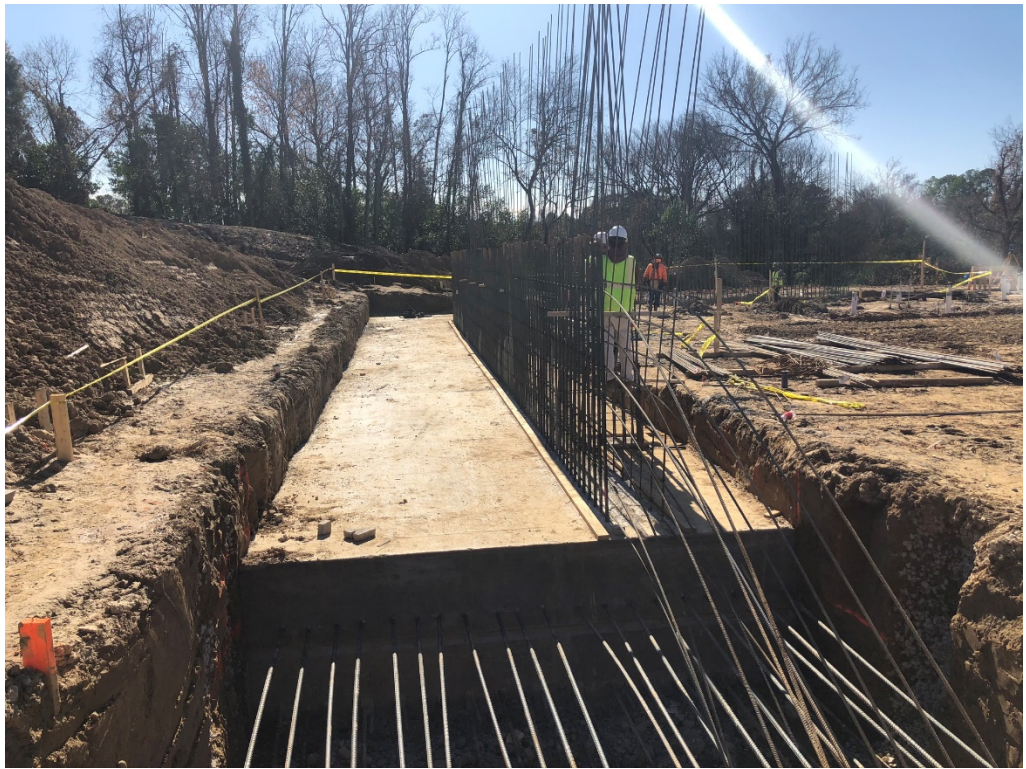
Figure 9 – Foundation Footing at Lower Level

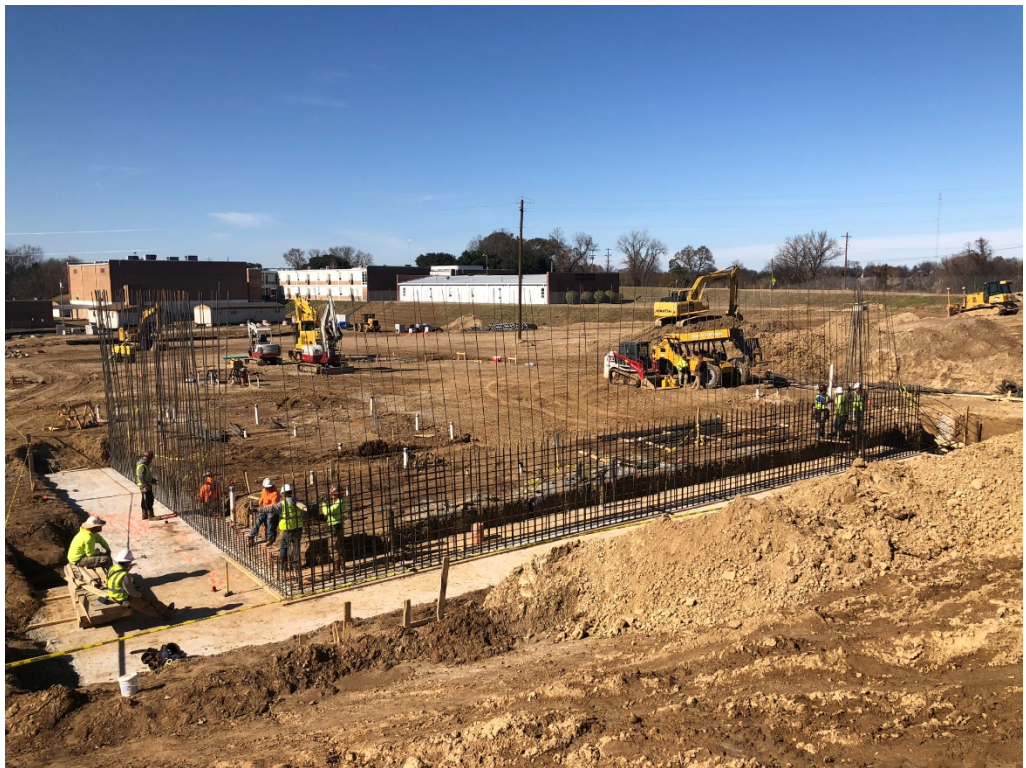
Figure 10 – Foundation Footing at Lower Level

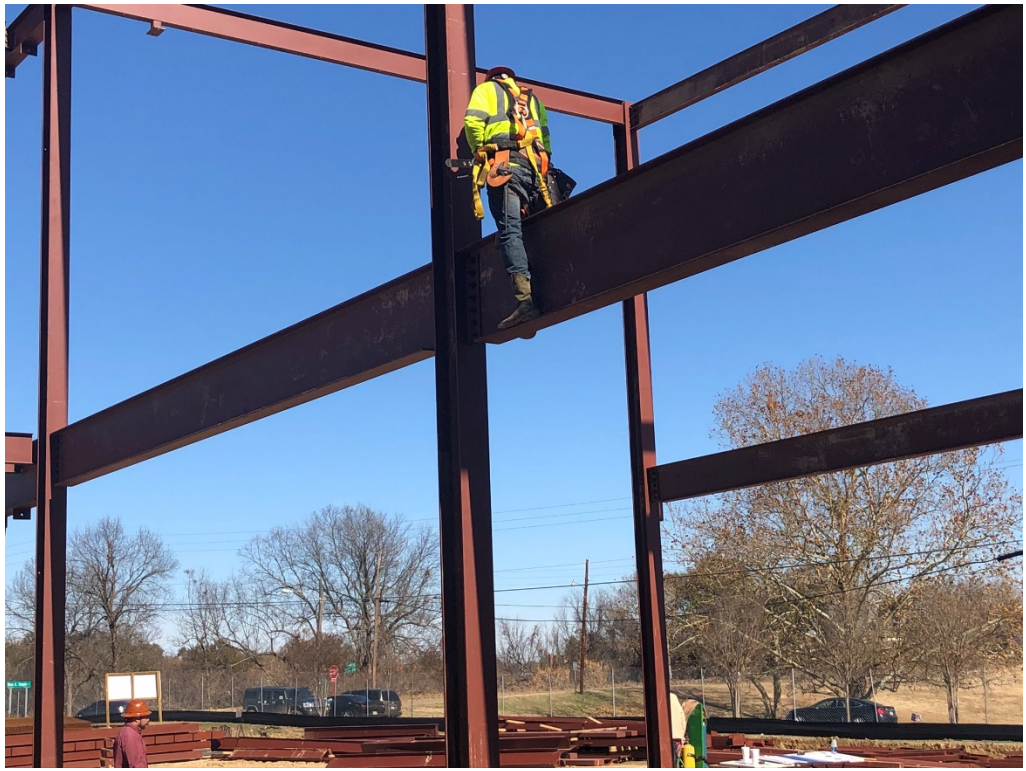
Figure 11 – Steel Erector Bolting Iron Together (Security Device Not in Use)
