Architect's Field Report

06 December 2019

18059-AOI Academy of Innovation / Report Number 011

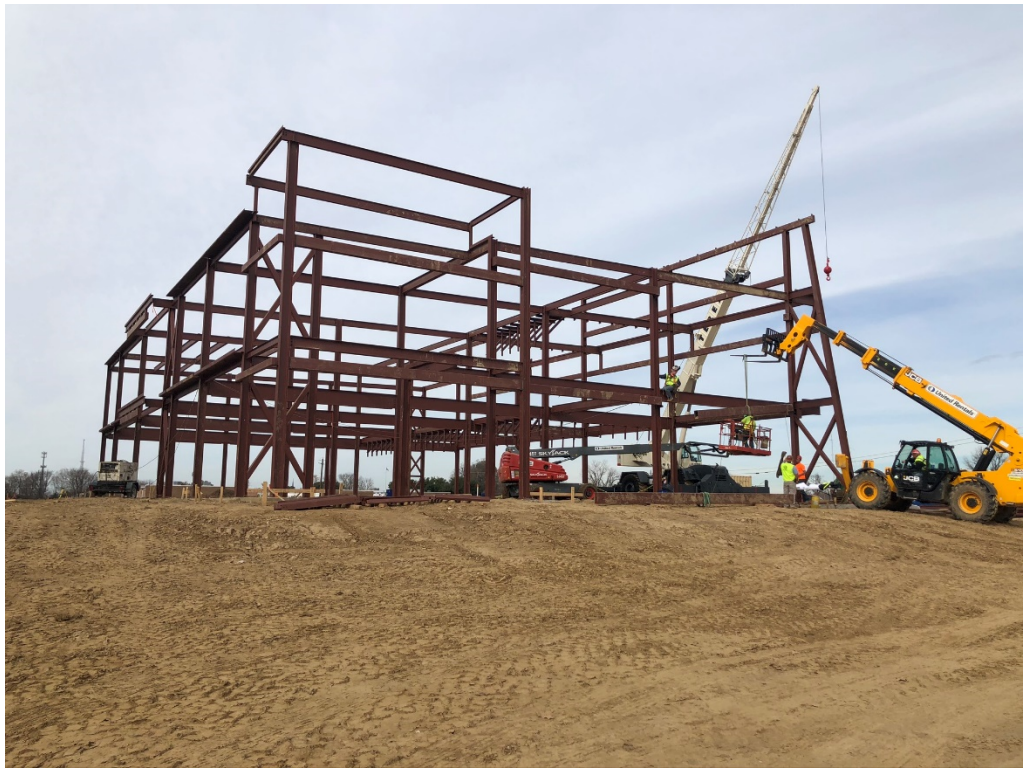
Figure 1 – Red Steel Erected

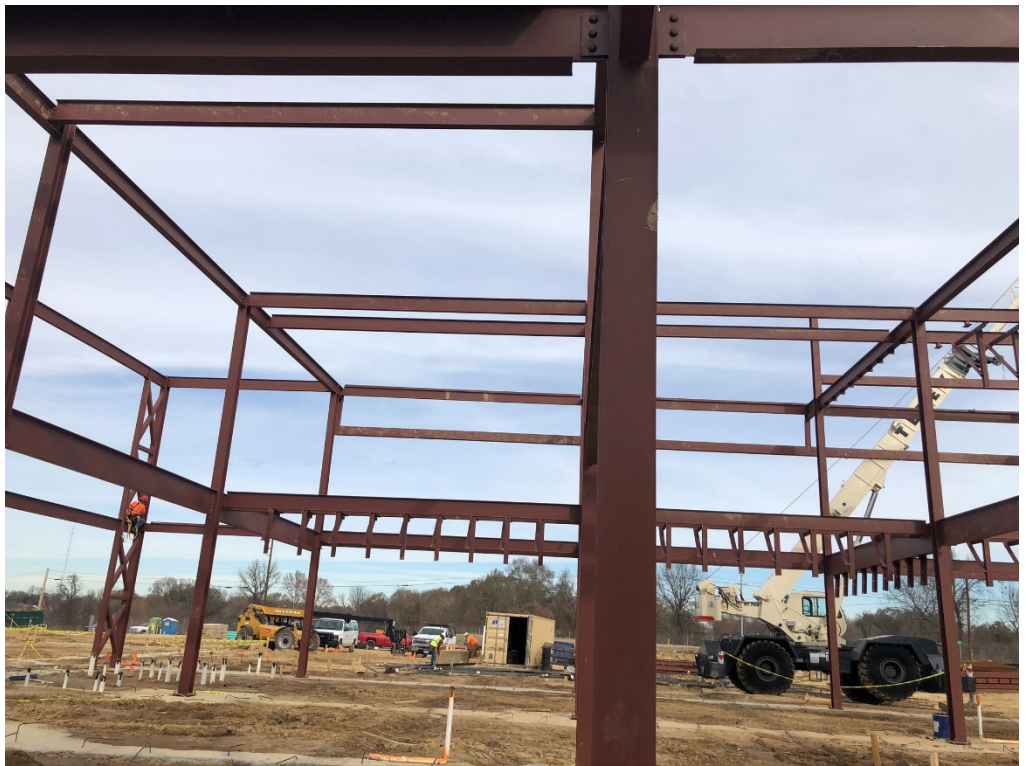
Figure 2 – Steel at Second level slightly out of Plumb (atypical)

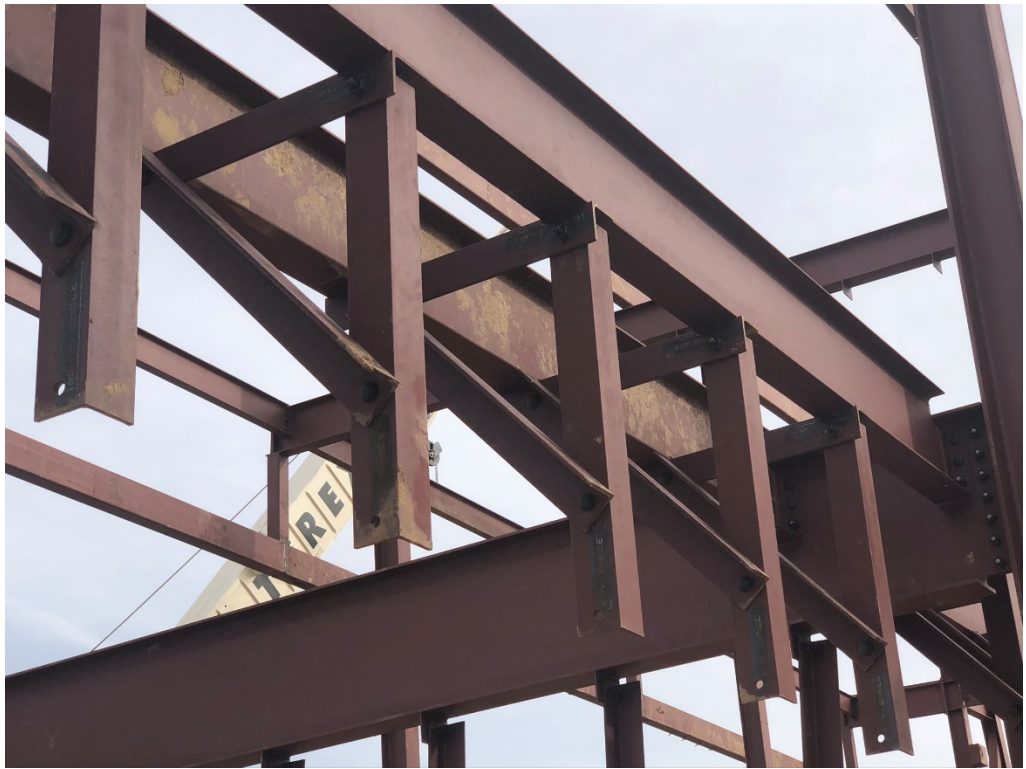
Figure 3 – Bolted Furr Down

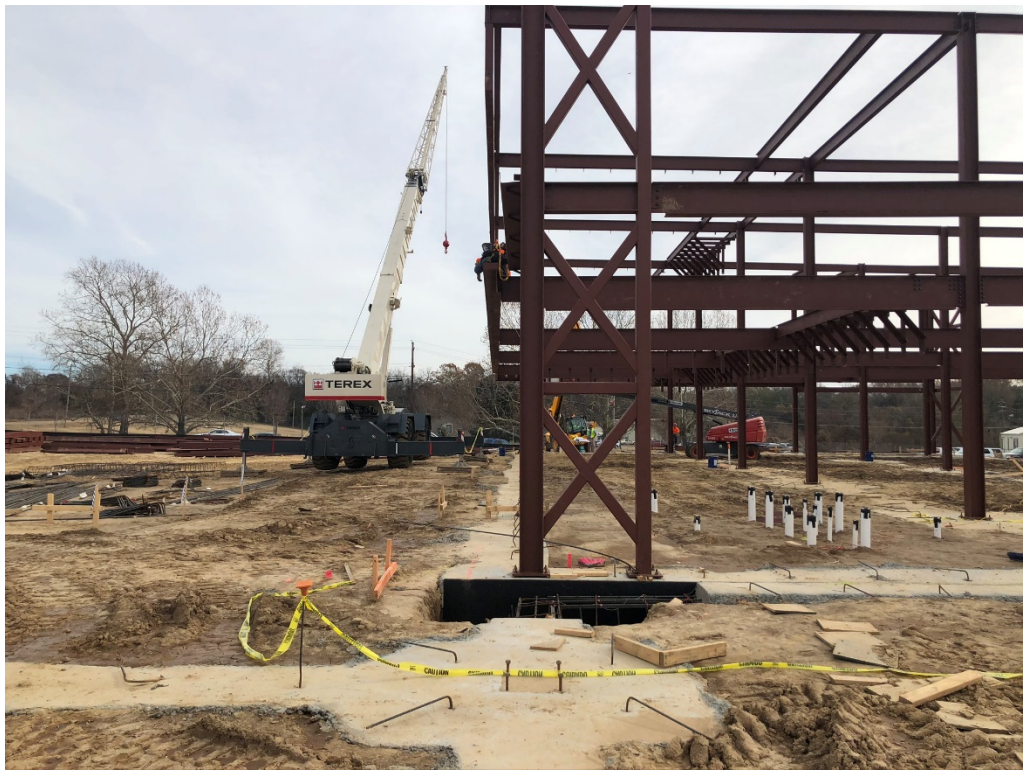
Figure 4 – Steel at Northwest Corner at Upper East Building

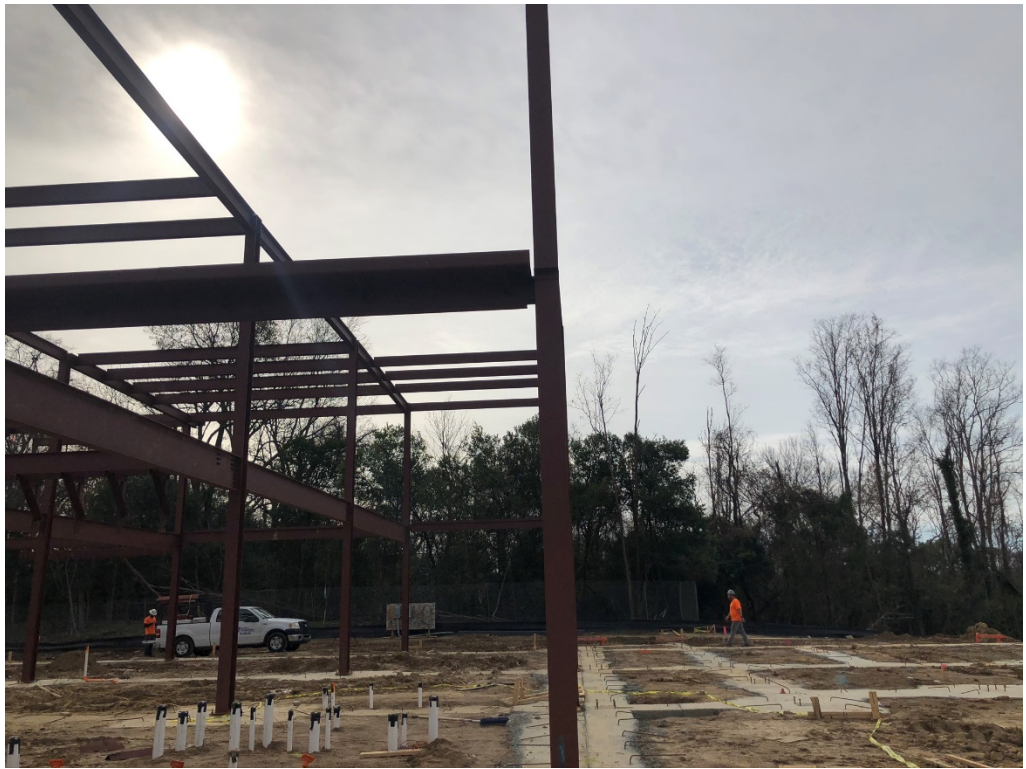
Figure 5 – Steel Plumb (typical)

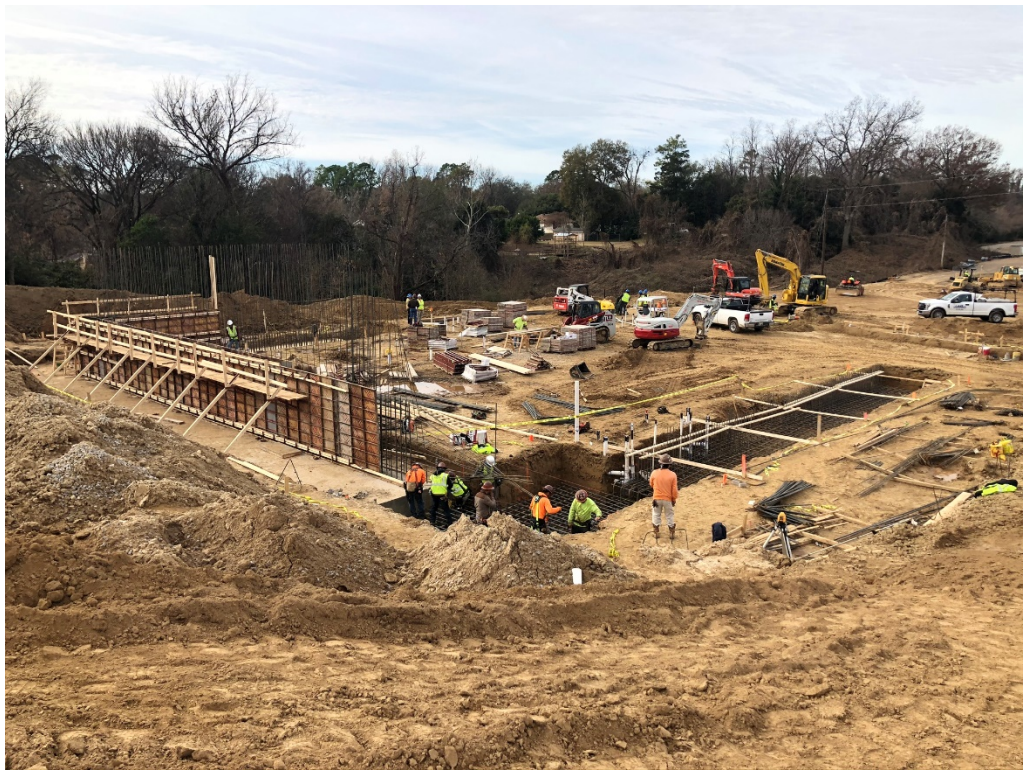
Figure 6 – Lower Level Foundation Work

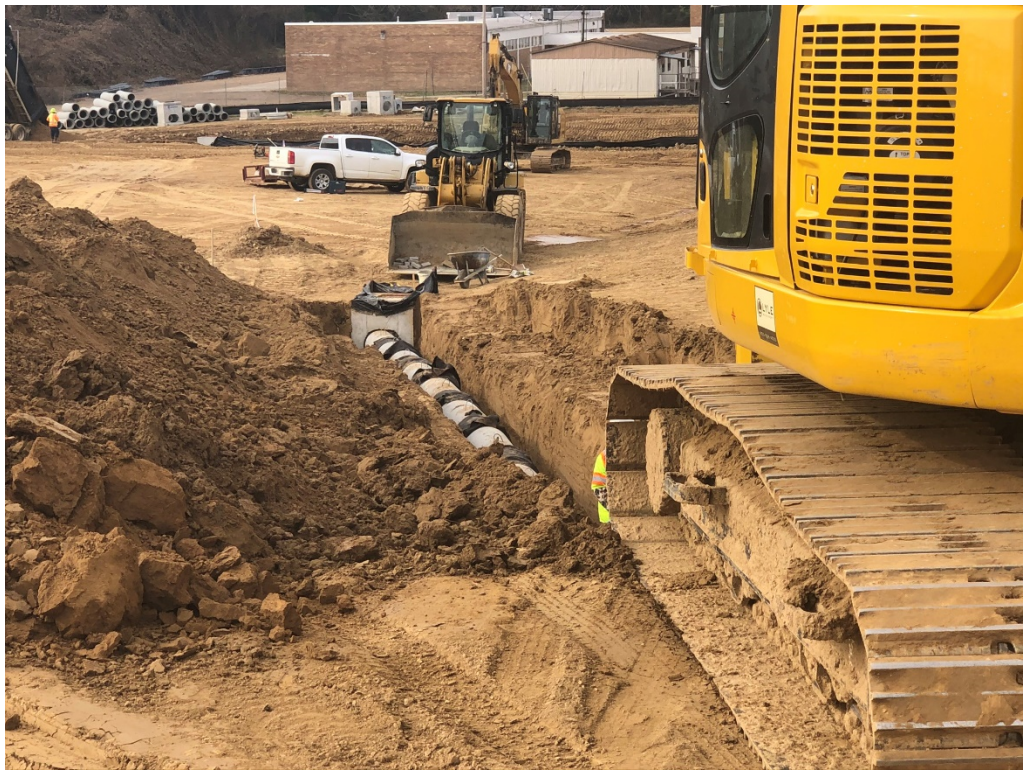
Figure 10 – Storm Sewer Work

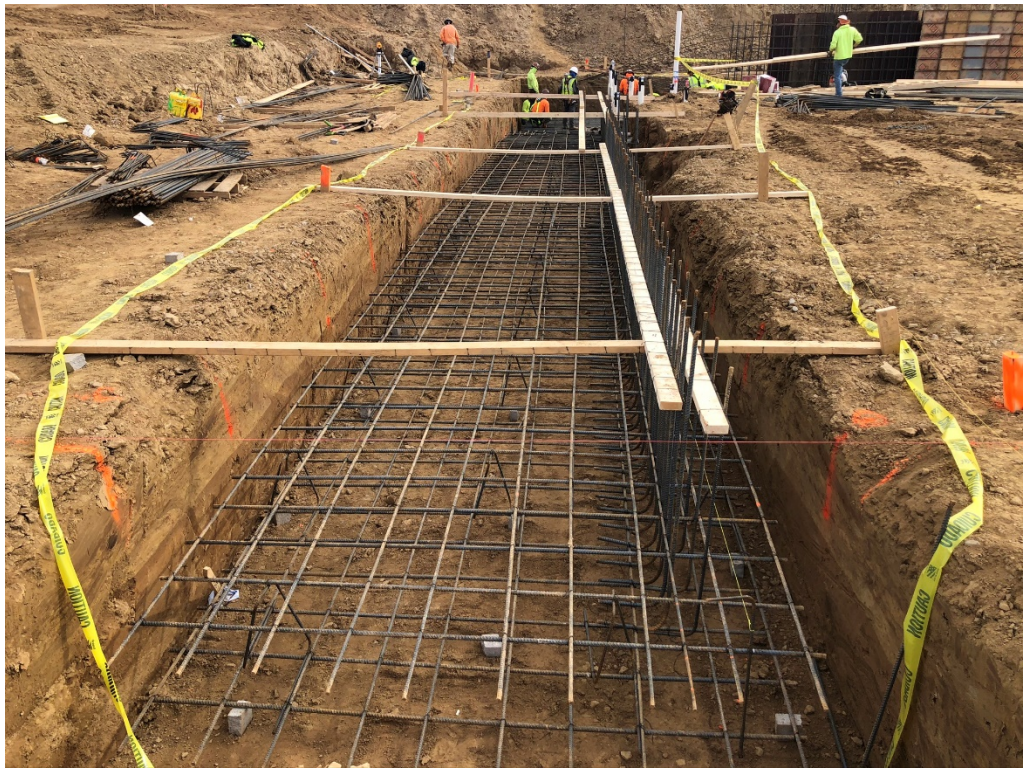
Figure 11 – North Footing on Lower Level

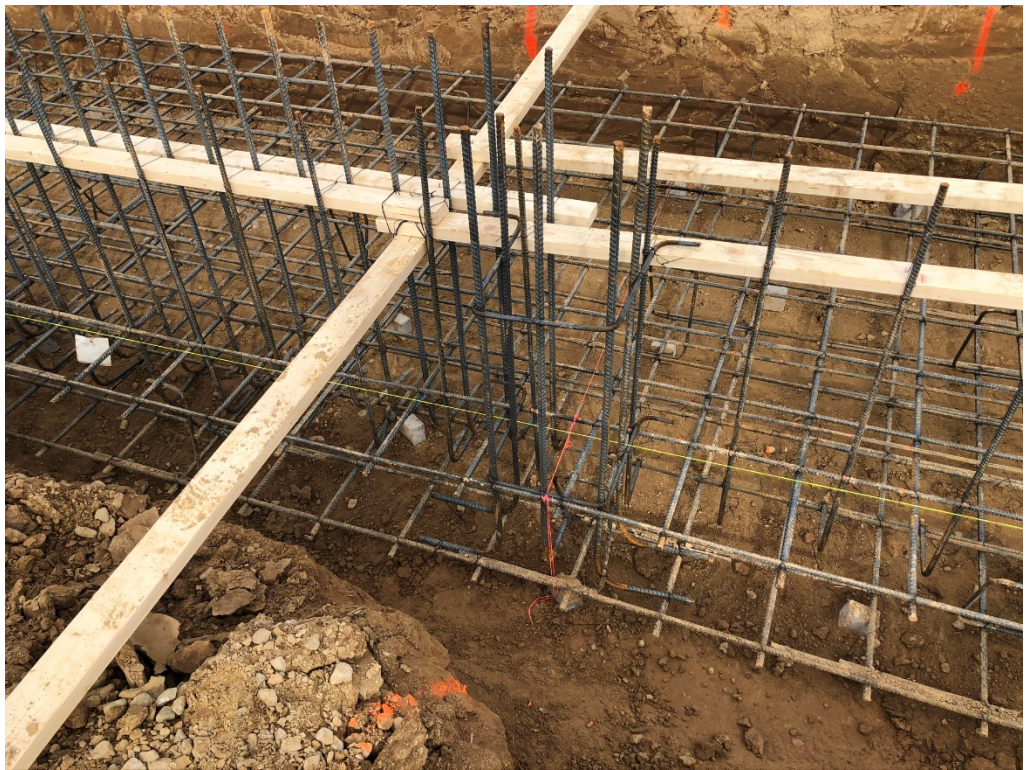
Figure 12 – Tie in Rebar at Pilaster

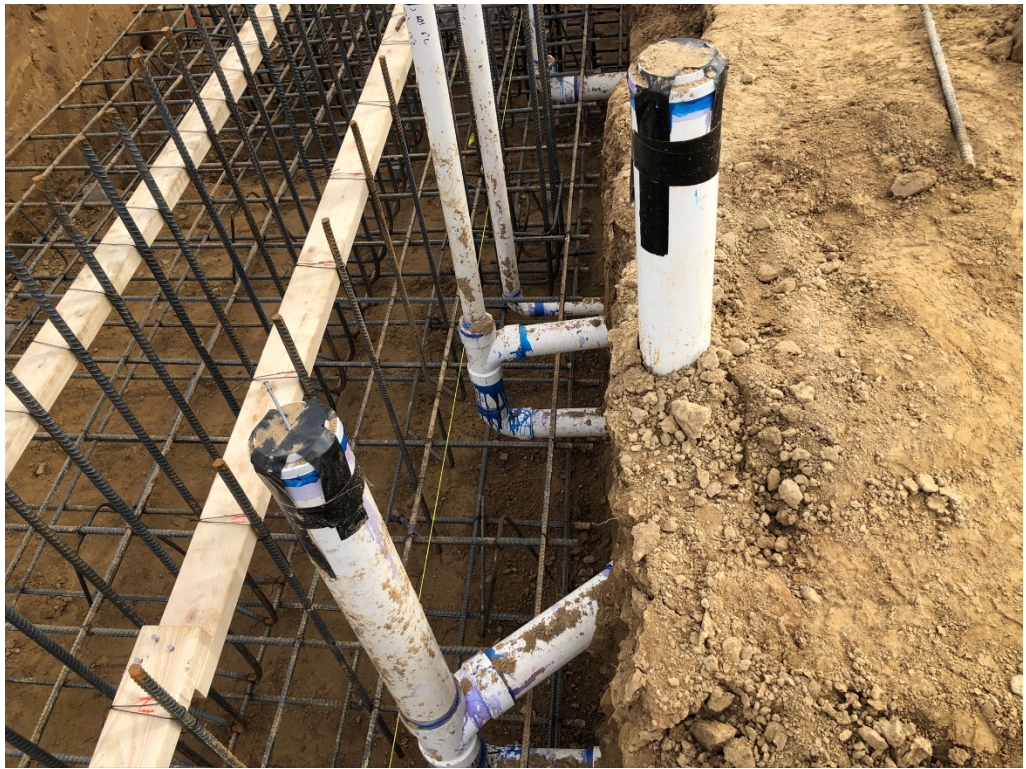
Figure 13 – Plumbing in Footing Pour

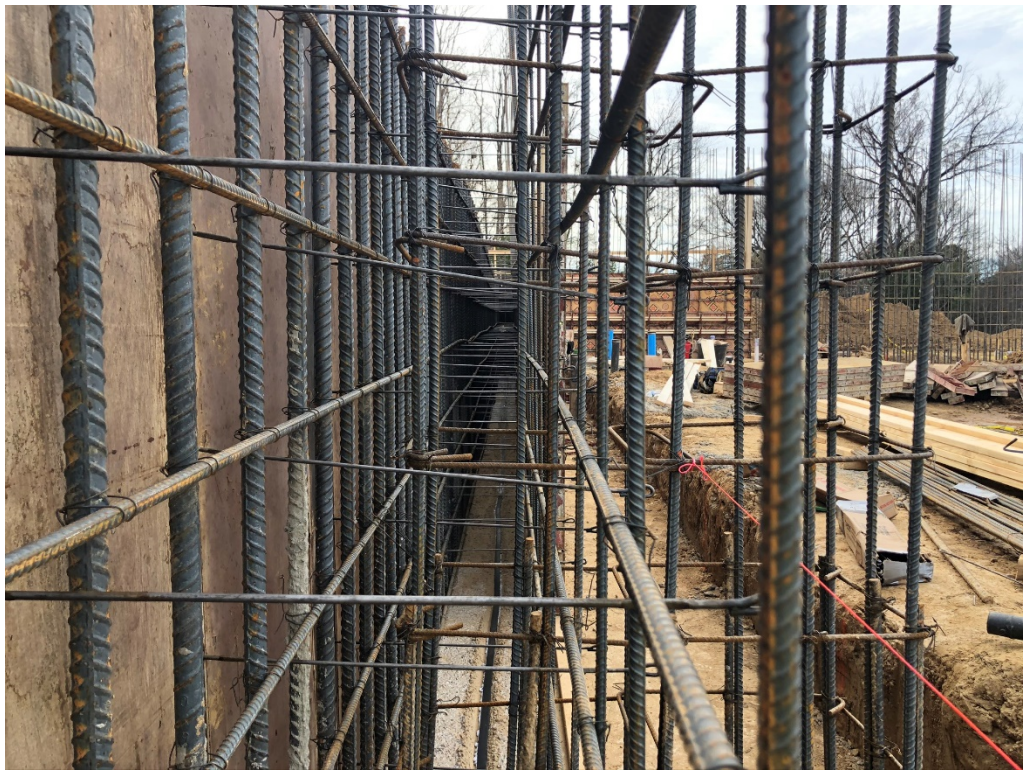
Figure 14 – Retaining Wall Rebar

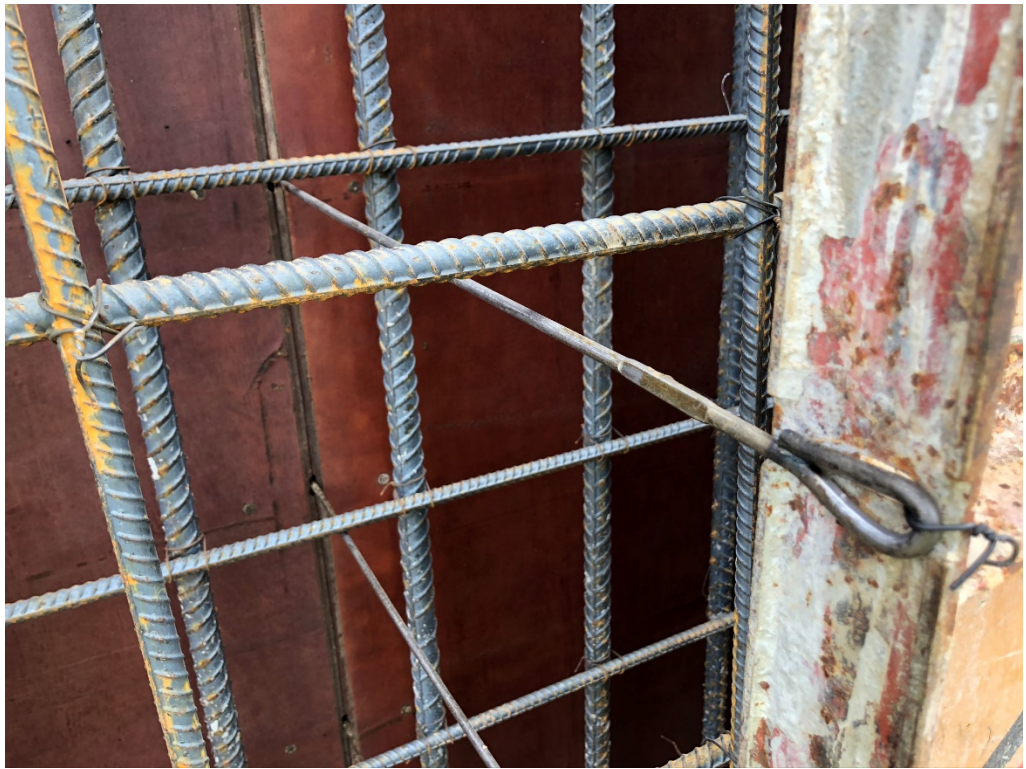
Figure 15 – Tie Bars in Use (typical)

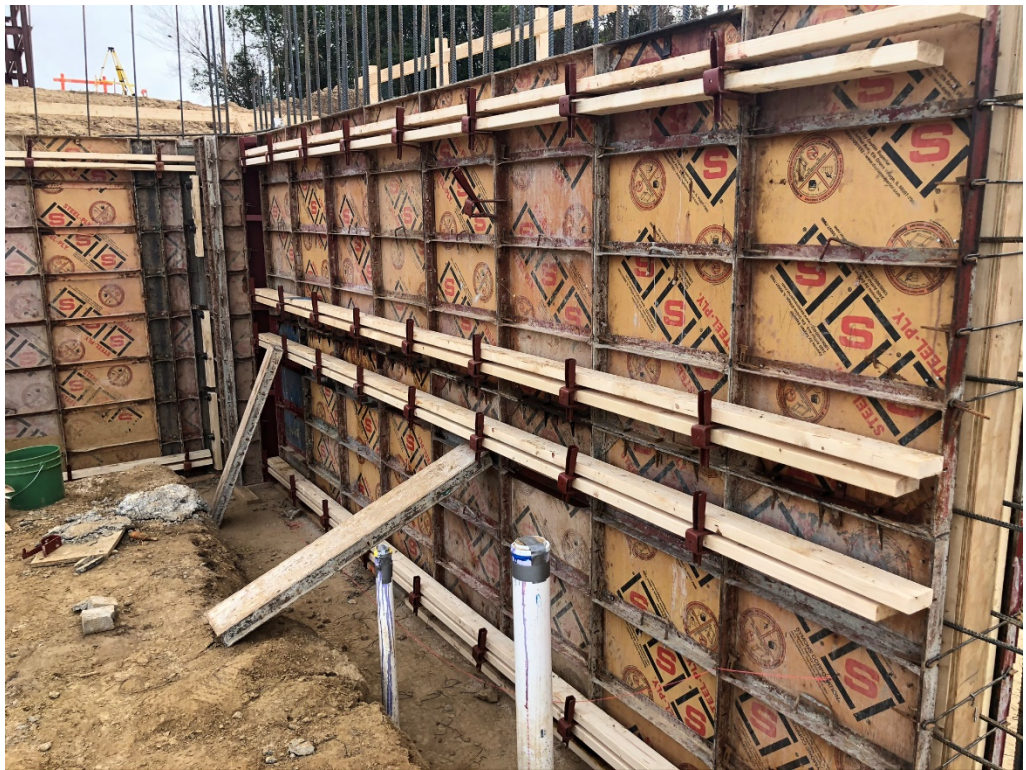
Figure 16 – Braced Retaining Wall

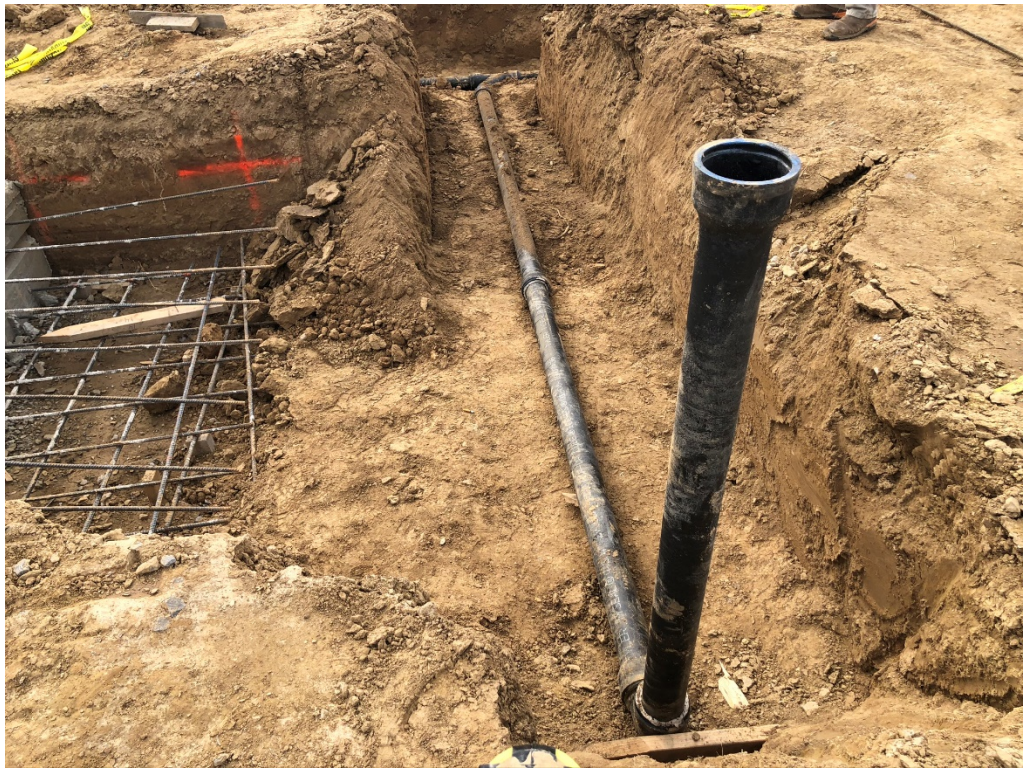
Figure 17 – Sewer Pipe for Head Test

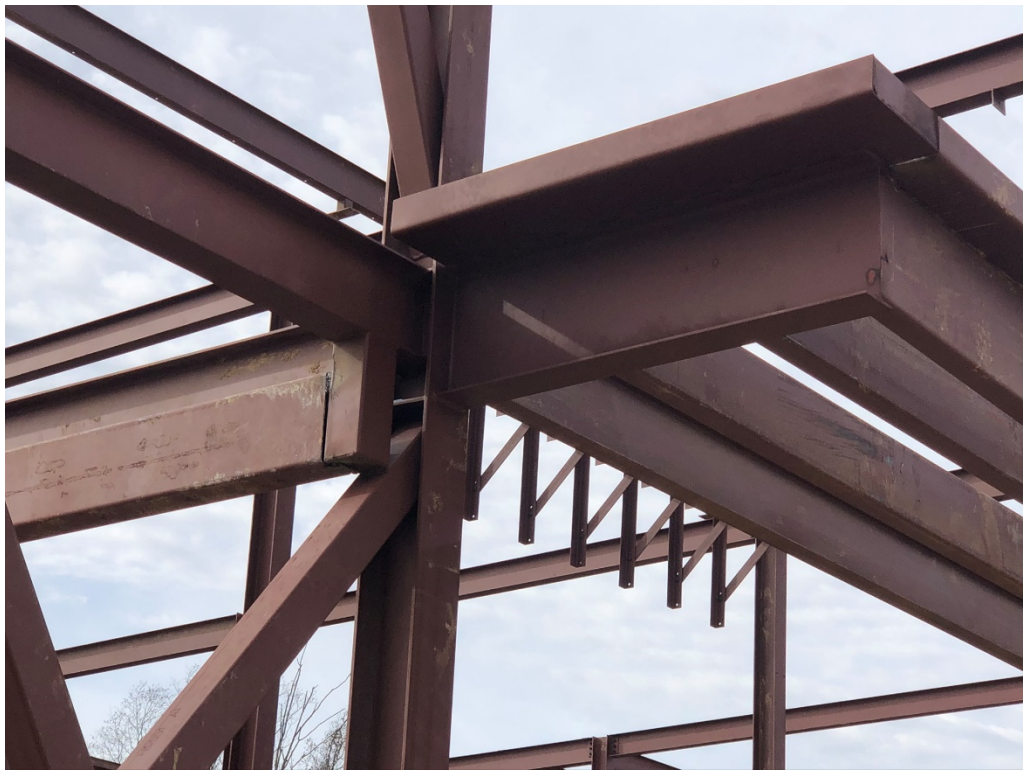
Figure 18 – North East Corner Overhang

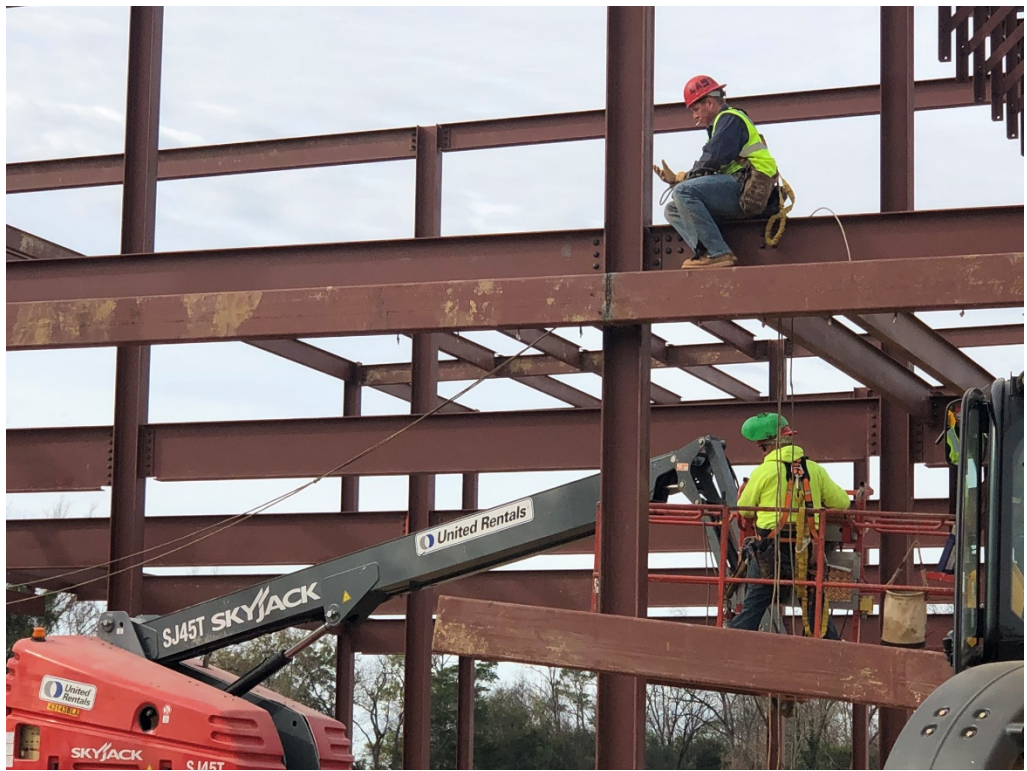
Figure 19 – East Welding Work and Erection
