Architect's Field Report

13 December 2019

18059-AOI Academy of Innovation / Report Number 012

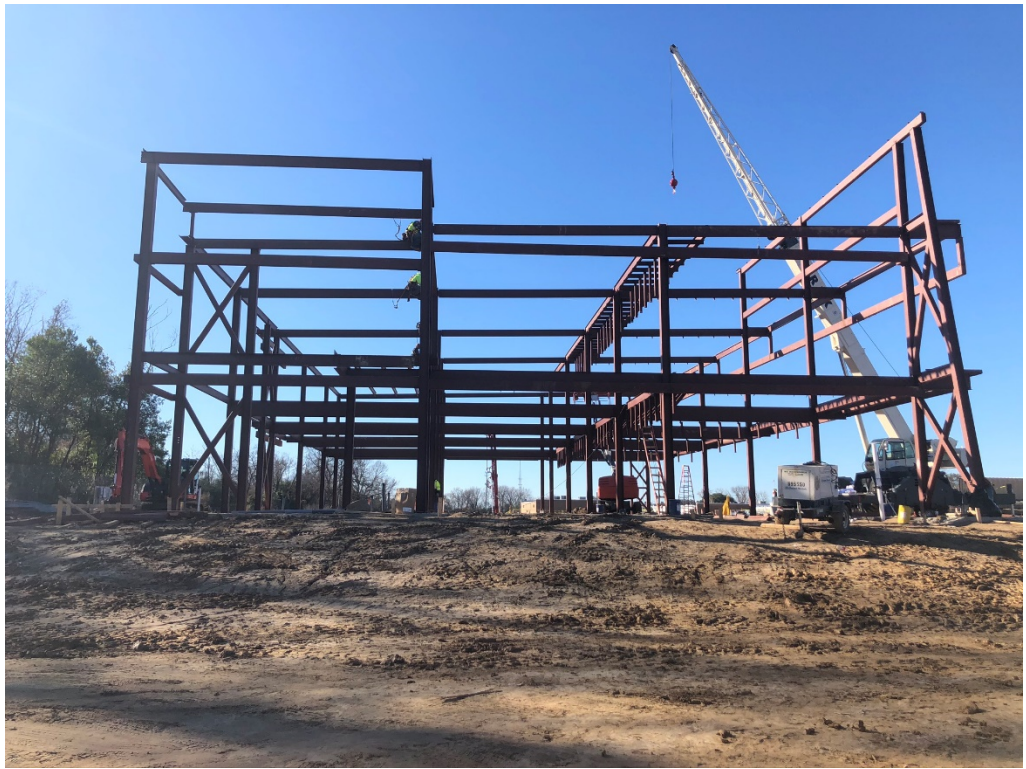
Work on the east section of building continued with erecting Red Steel. Workers were on roof deck installing girders. A crane was in use and workers were actively bolting structure together. Safety devices were in use.

Figure 1 – Red Steel Erected

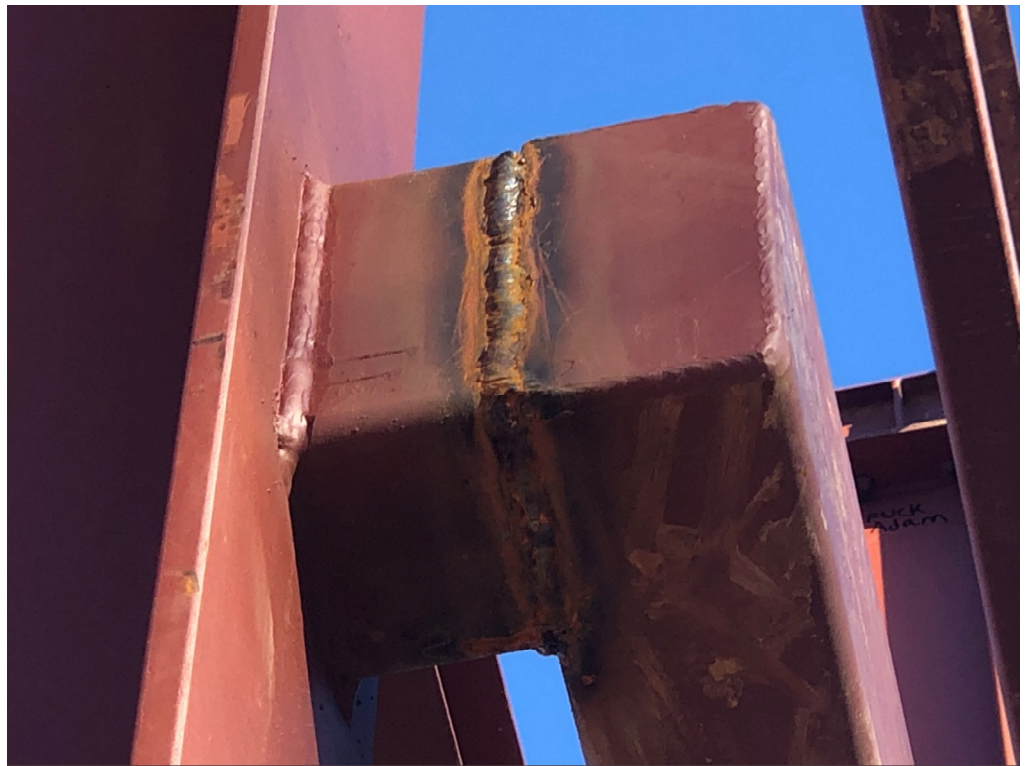
Figure 2 – Field Weld (typical)

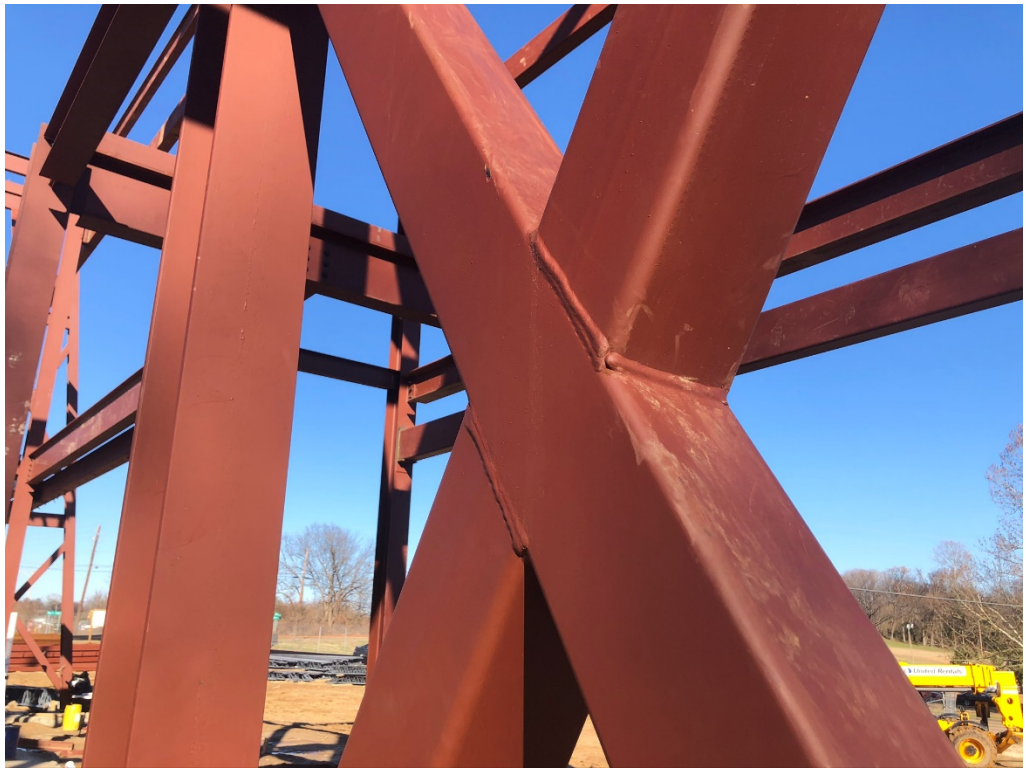
Figure 3 – Manufacturer Weld (typical)

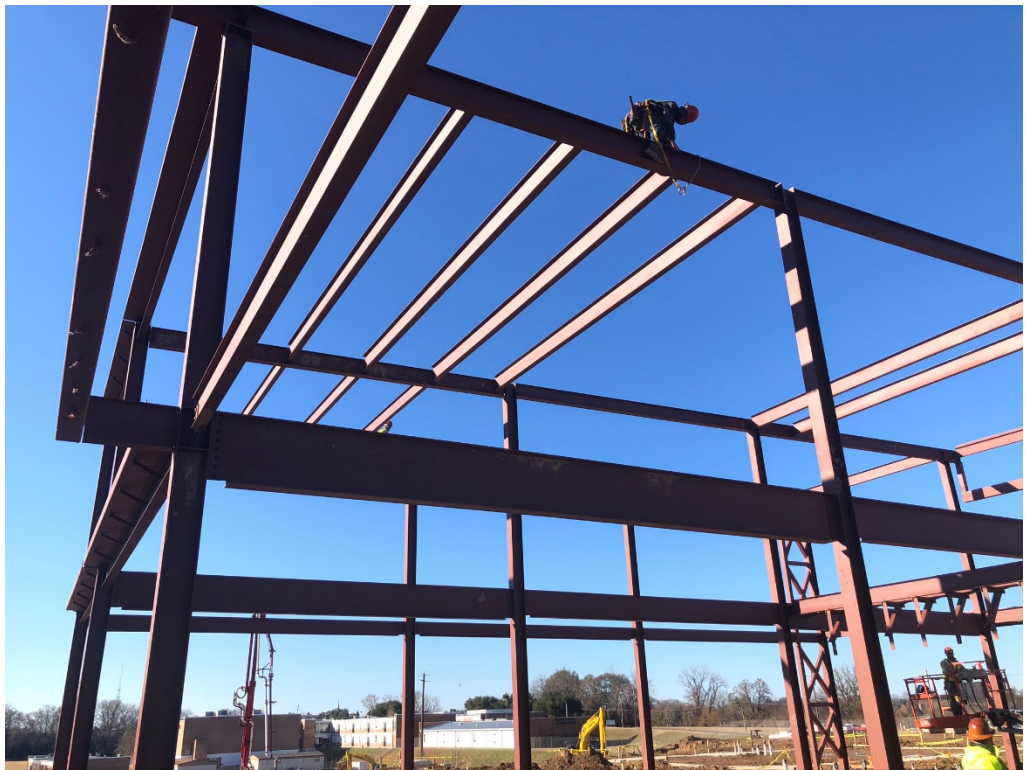
Figure 4 – Roof Girders being Set

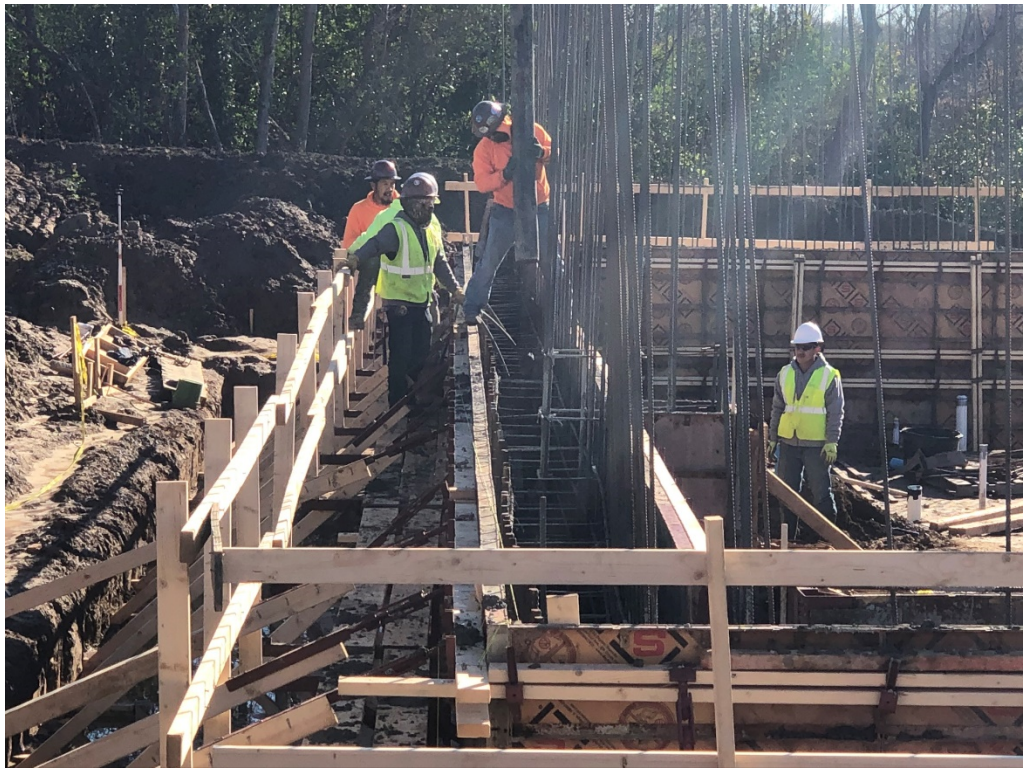
On the west section of building, concrete was being poured into foundation wall using an overhead pump.

Figure 5 – Concrete work @ Foundation Wall

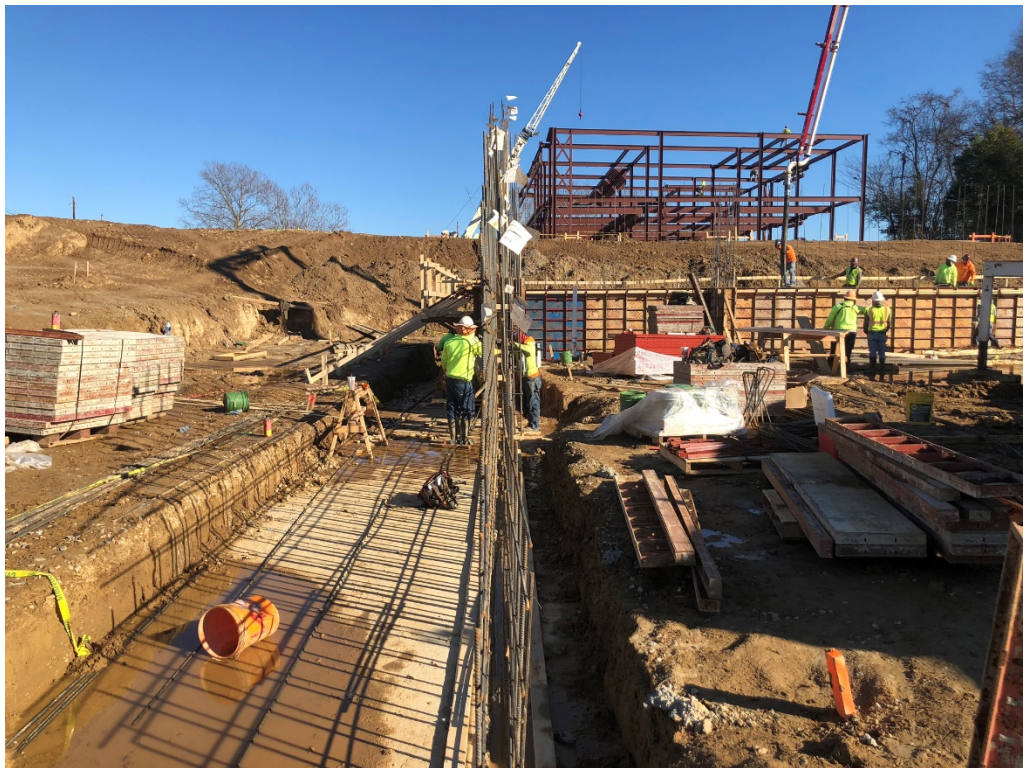
Figure 6 – Foundation Wall (rebar only)

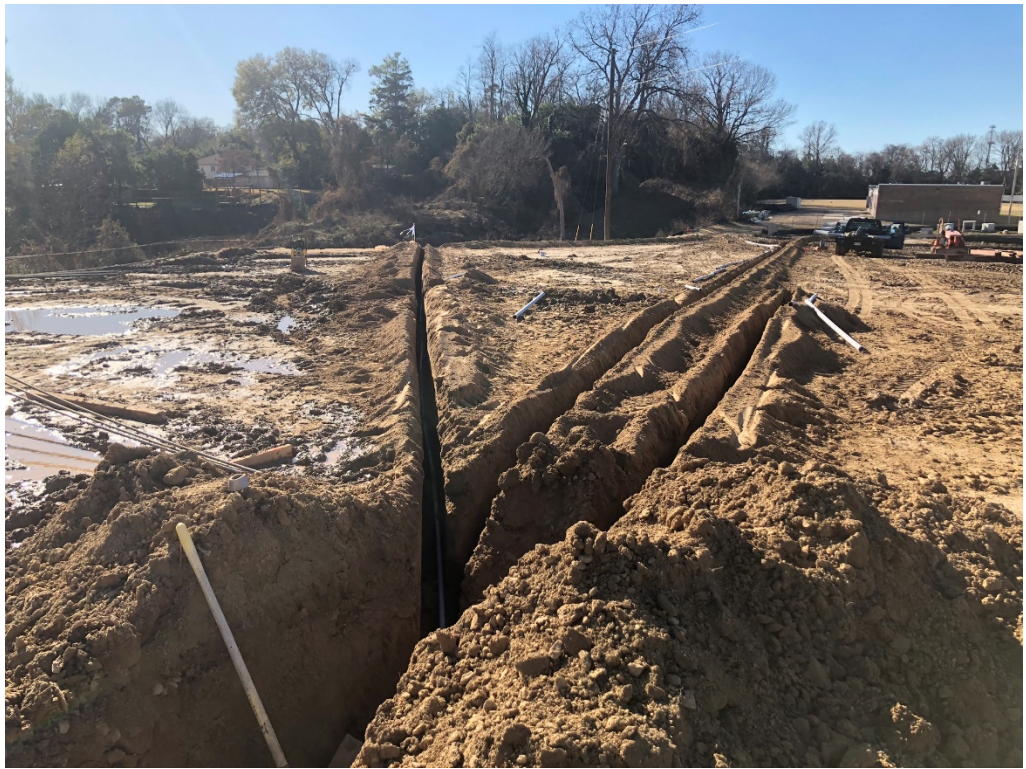
Electrical conduit was being installed to the west of the building in parking areas.

Figure 7 – Underground Conduit

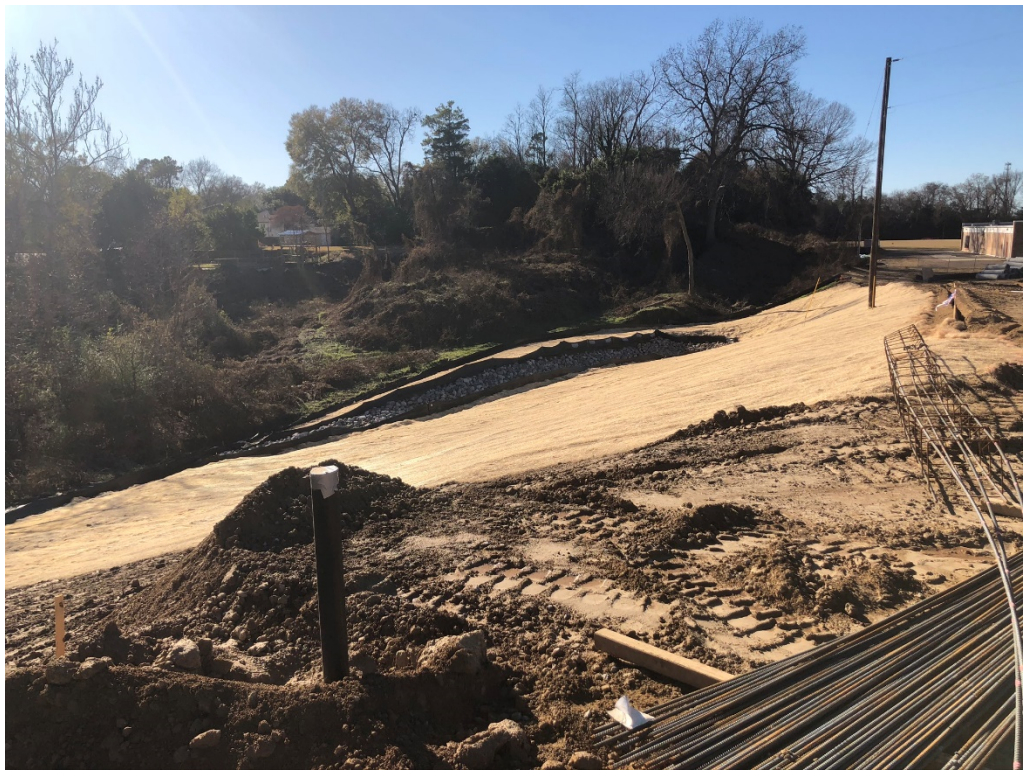
Figure 8 – Erosion Control Installed at Slope

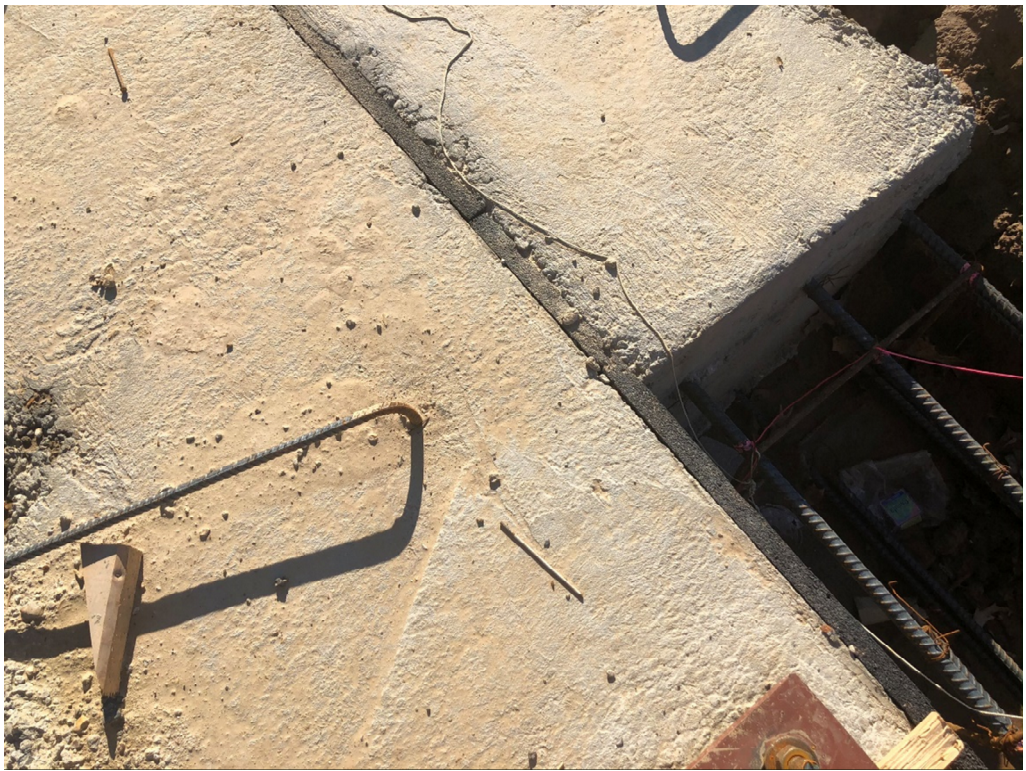
Figure 9 – Expansion joint between east and west upper building sections

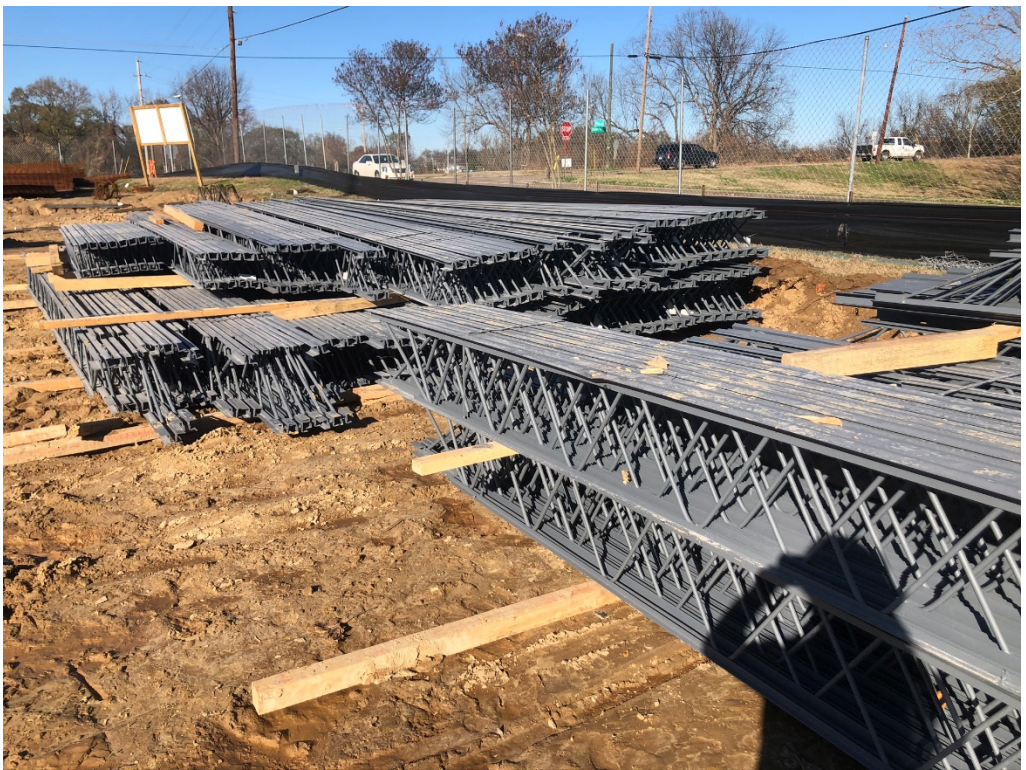
Figure 10 – Steel Trusses on Site
