## Architect's Field Report

201 Park Court, Suite B Ridgeland, MS 39157 P 601.790.9432 F 888.281.0547	18 December 2019
One Jackson Place, Suite 250 188 East Capitol Street Jackson, MS 39201-2100 P 601.352.5411 F 601.352.5362	18059-AOI Academy of Innovation / Report Number 013
161 Lameuse Street, Suite 201 Biloxi, MS 39530 P 228.374.1409 F 228.374.1414	Contract Century Construction Date / Time 17 December 2019 / 3:50 PM Weather / Temp Clear / 39 ° F Est % Complete 24% Sched Conformance +/- 00 days Work in Progress Foundation Work – Formwork Sewer Lining Present at Site Joey Moore, Century Construction Foundation Crew Paul Purser, DBA Observations I spoke with Joey Moore initially and reviewed plans for the next weeks' schedule. He said everything was moving along just fine.  I noted steel deck has been installed and Mr. Moore mentioned that this was so that erectors could hang steel below deck but that concrete would not be poured until the first of the year.  Retaining walk on the lower level continued with removing forms and installing new forms at next level.  Items to Verify None Action Required None Report By:

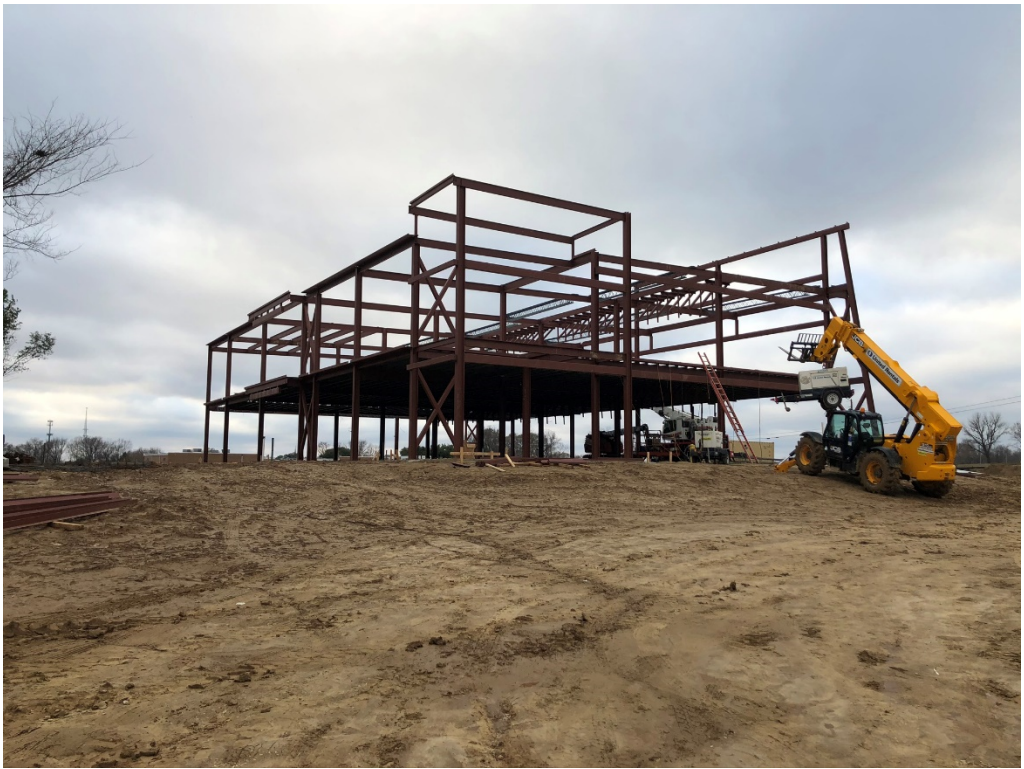
Figure 1 – Red Steel Erected

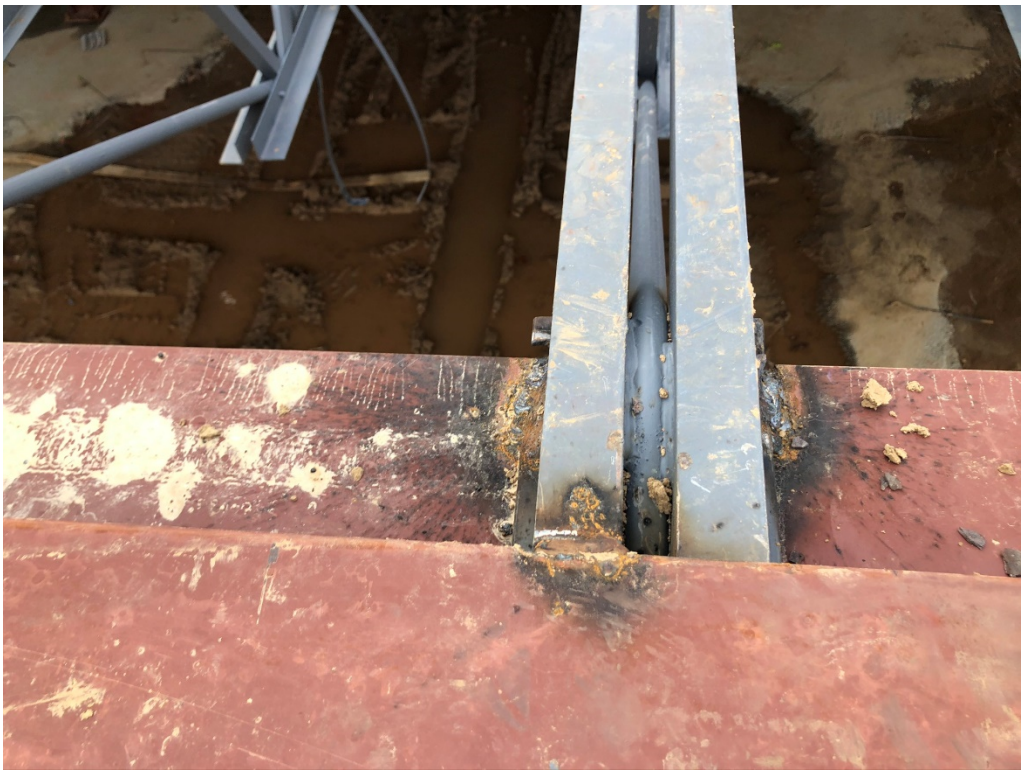
Figure 2 – Field Weld (typical)

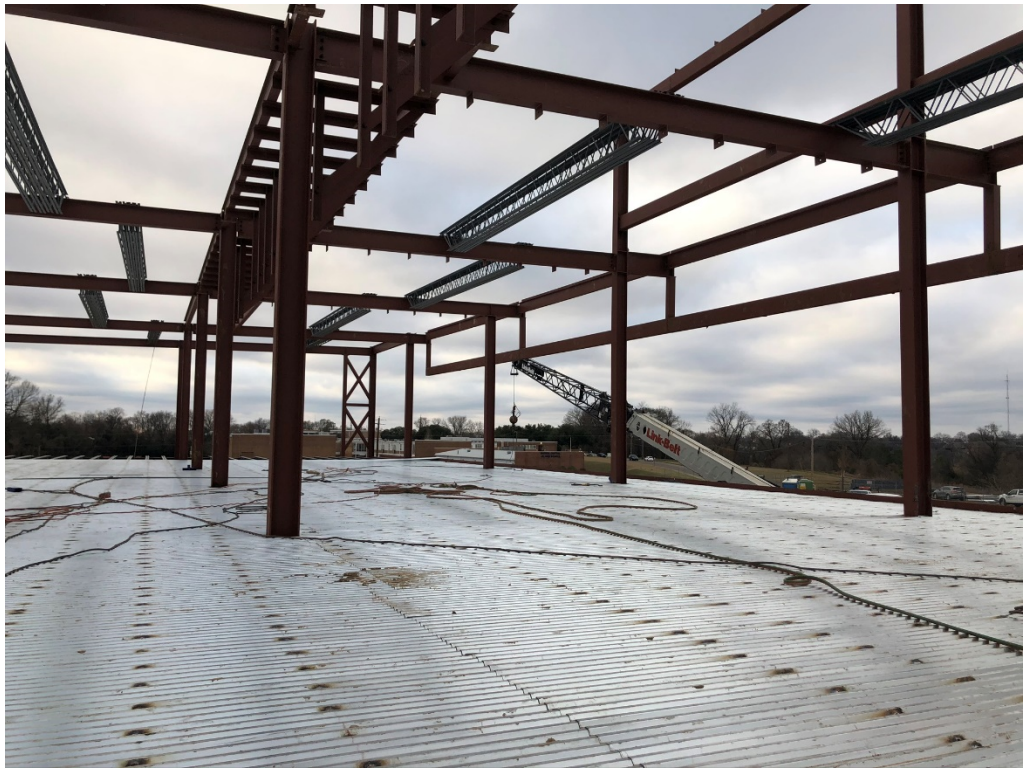
Figure 3 – Steel Deck Installed at Upper Level

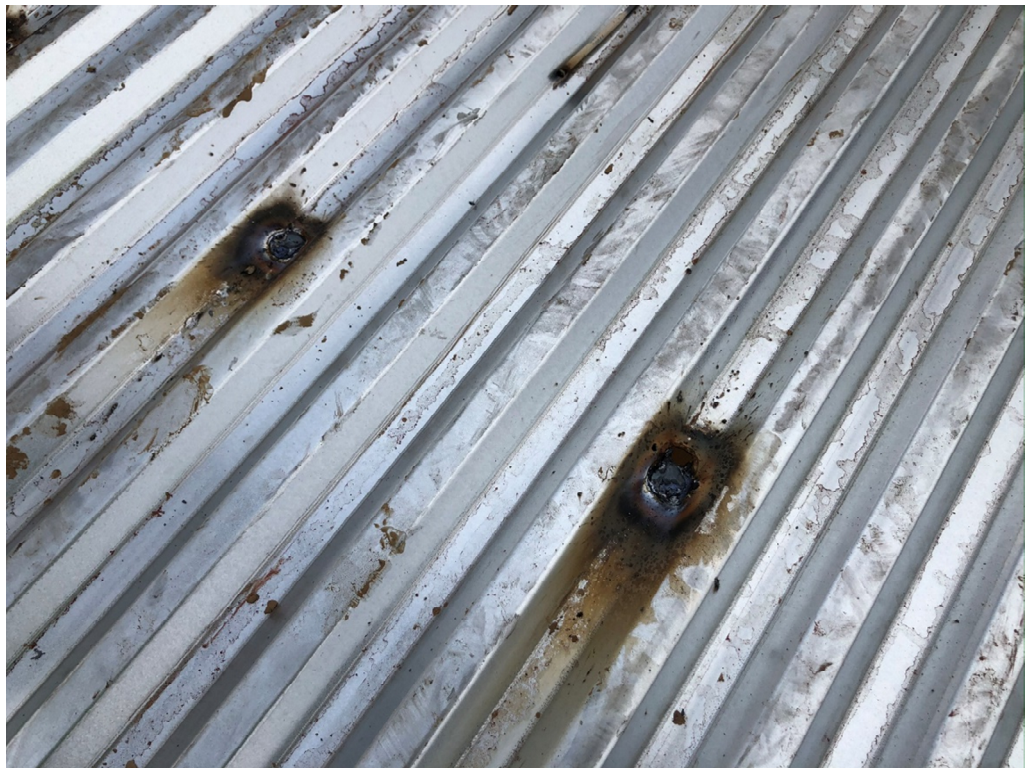
Figure 4 – Spot Welds through Decking (typical)

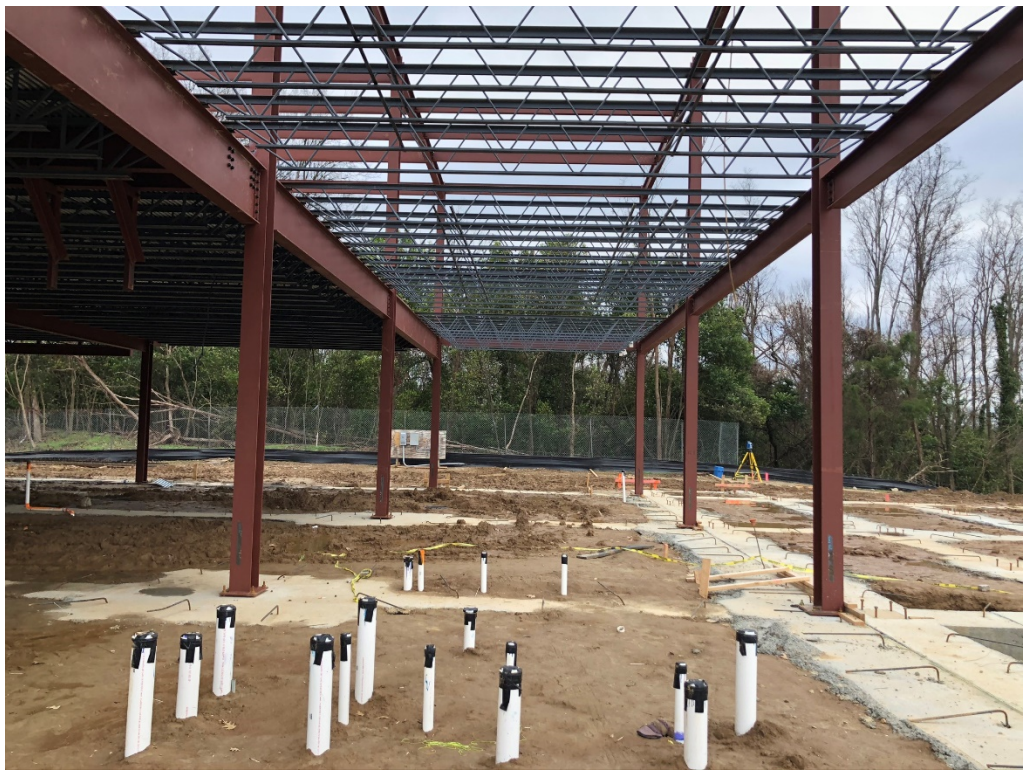
Figure 5 – Steel Joists Laid out and ready for Deck

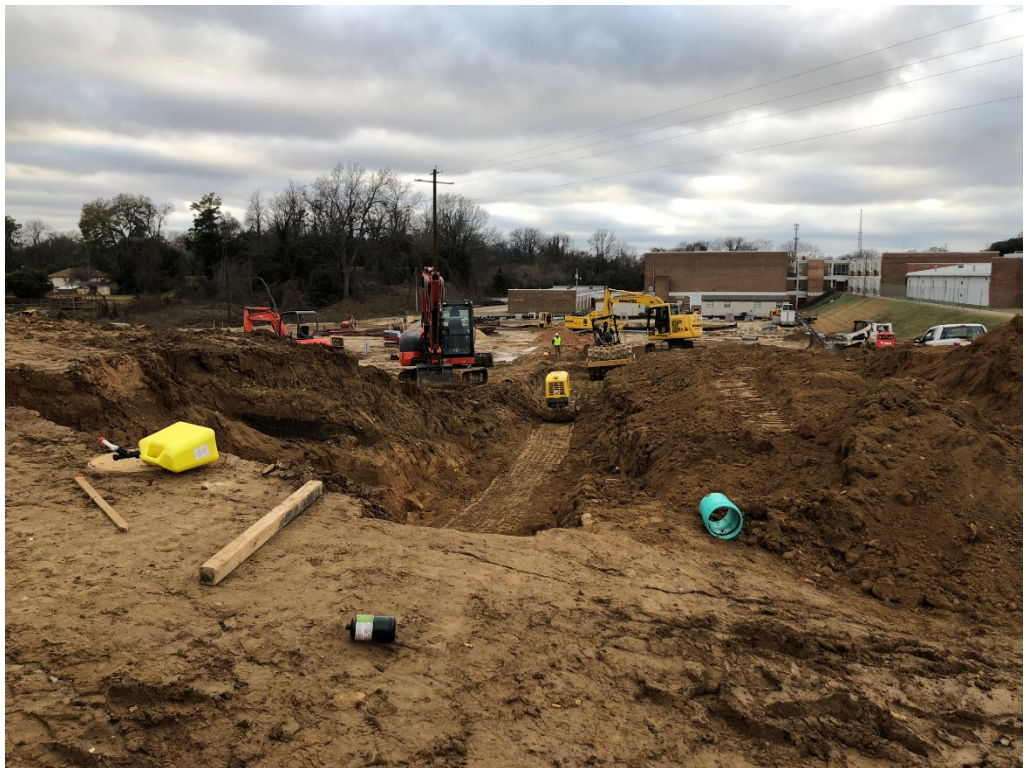
Figure 6 – Sewer Line Trenching

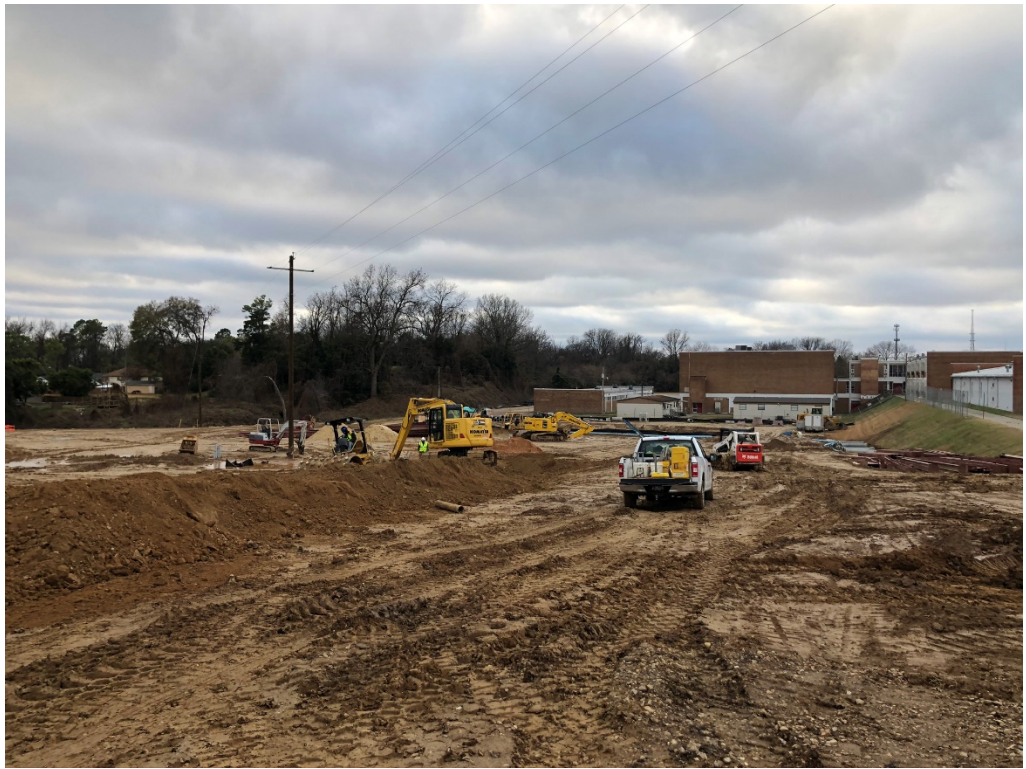
Figure 7 – North Entry Looking WSW

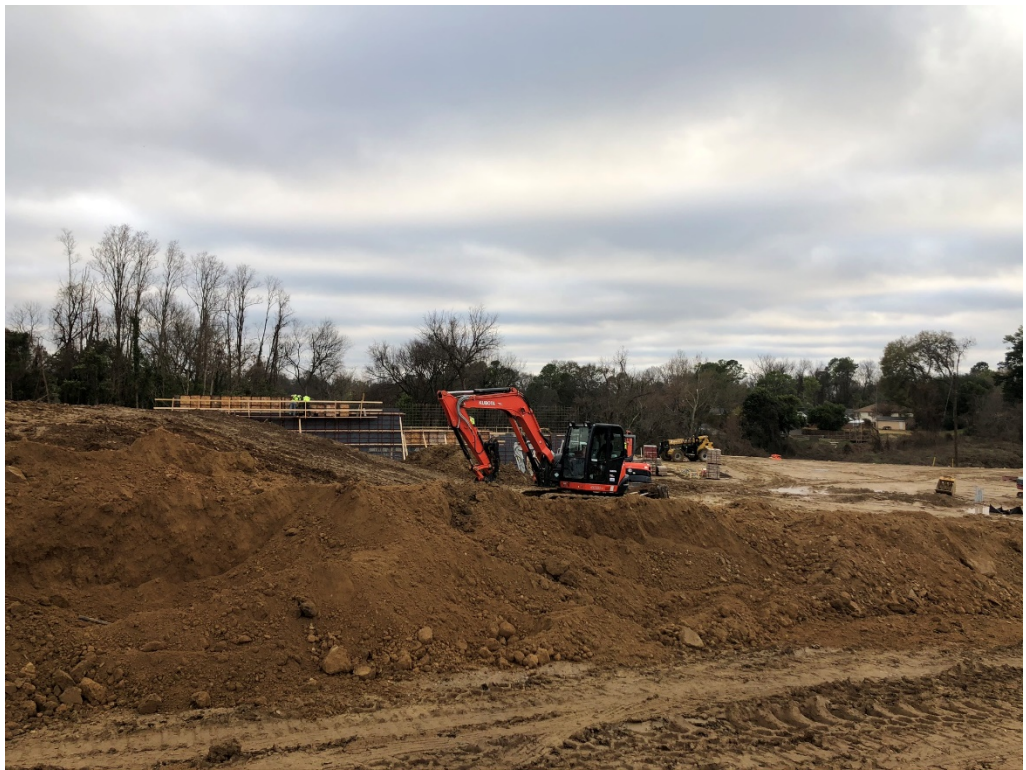
Figure 8 – North Entry Looking S

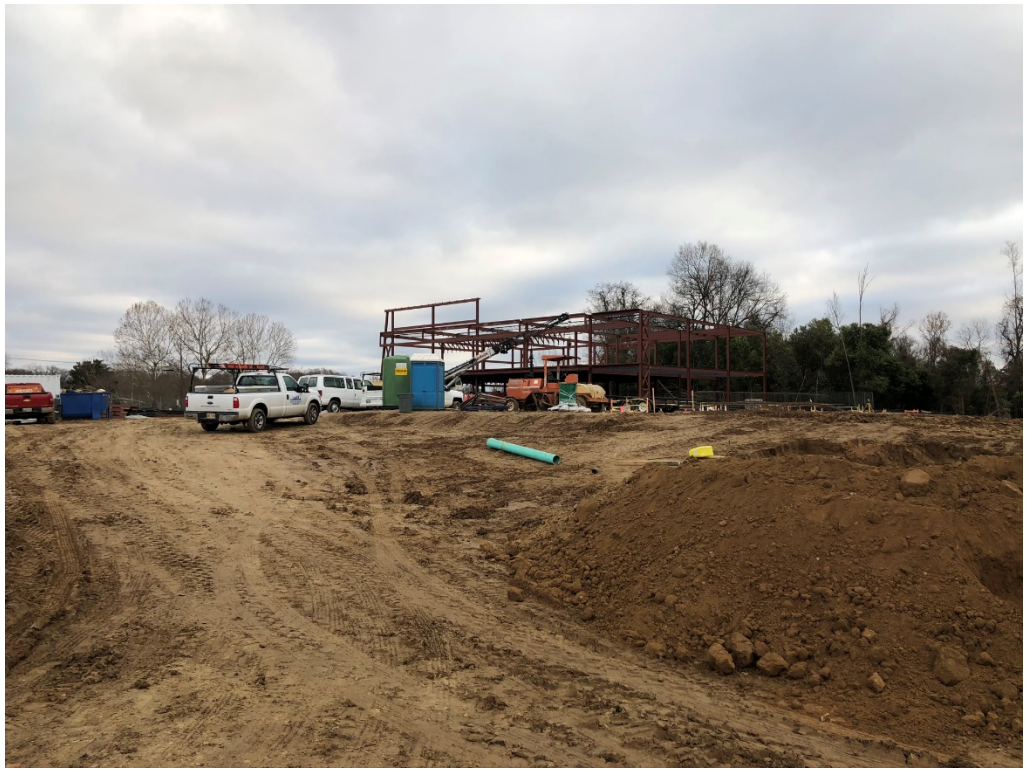
Figure 9 – North Entry Looking ESE

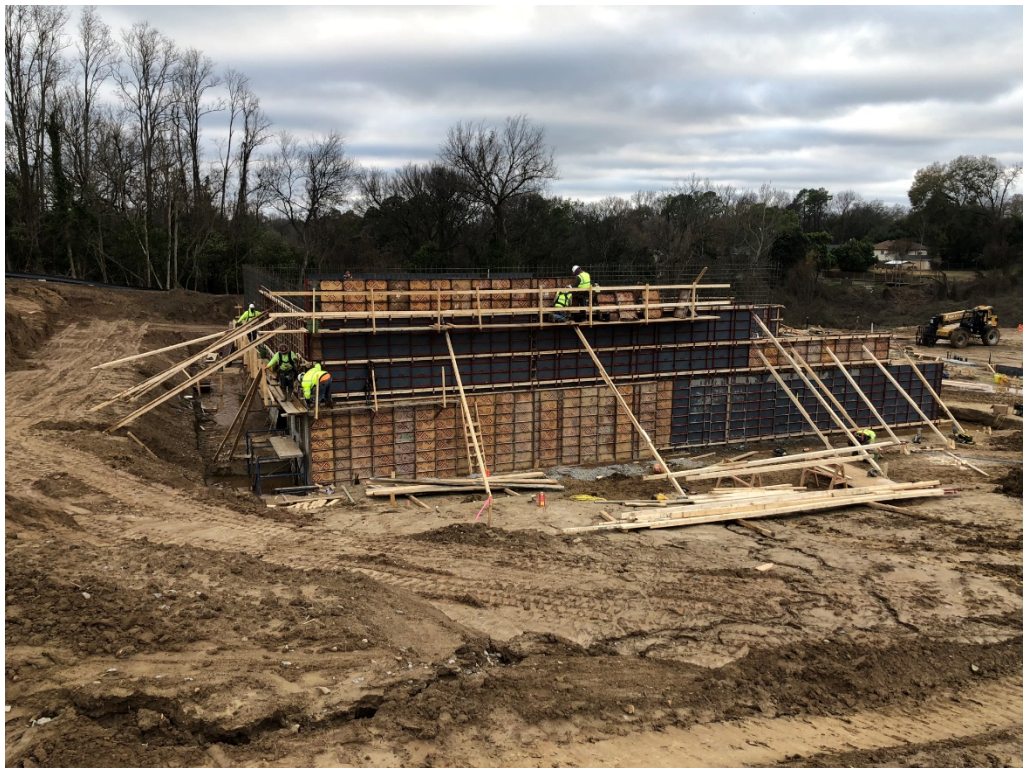
Figure 10 – Foundation Work at Lower Level

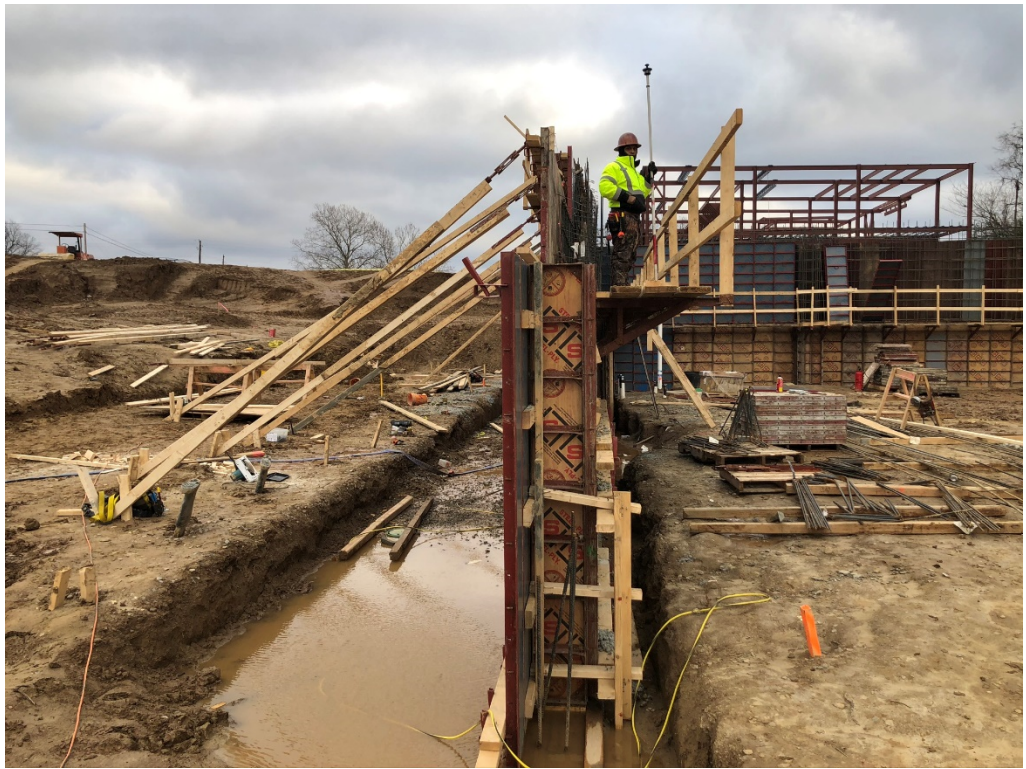
Figure 11 – Bracing and Walk Boards for Foundation Work (typical)

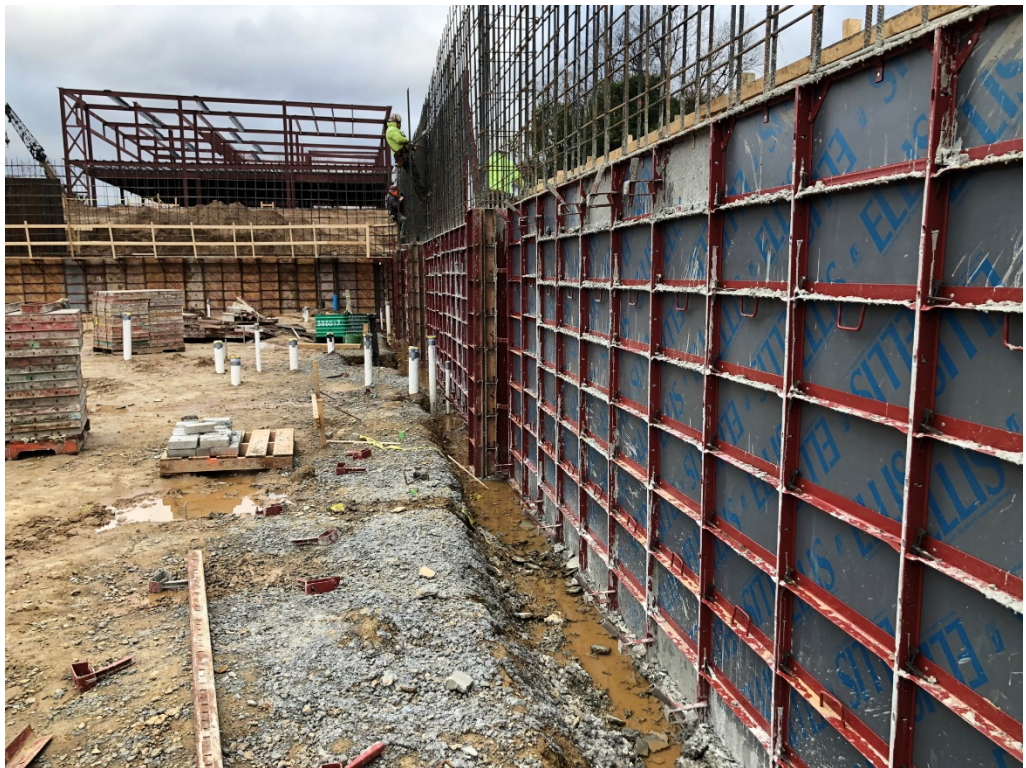
Figure 12 – Lower Level SW Corner looking E

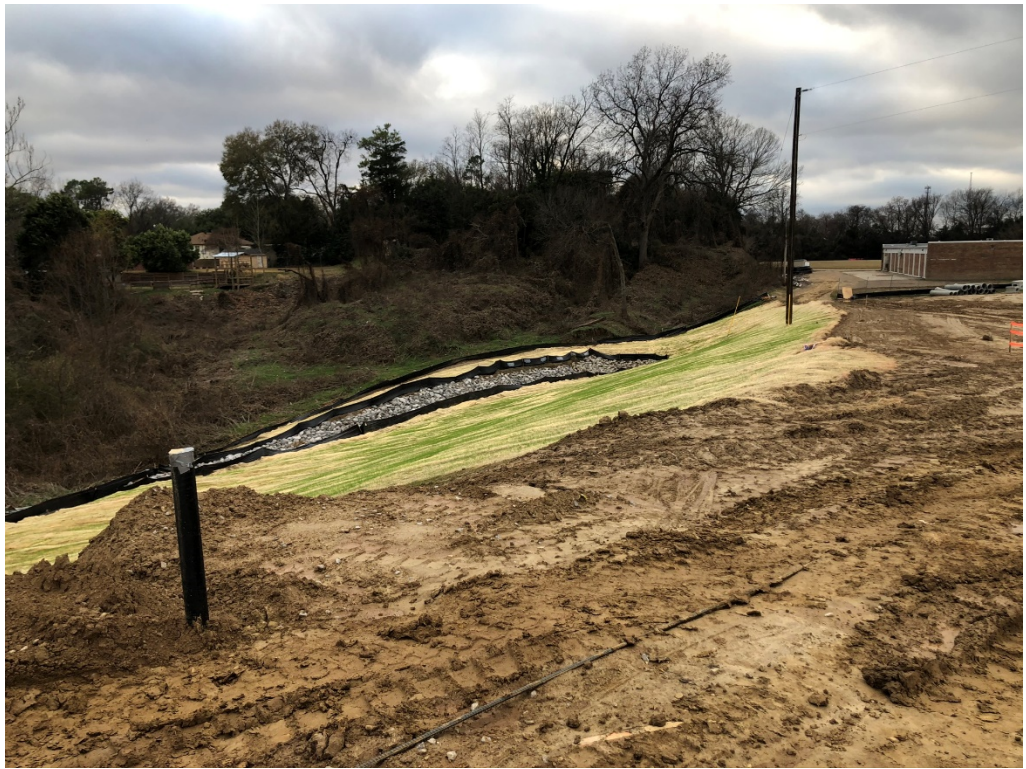
Figure 13 – Grass has Taken Root

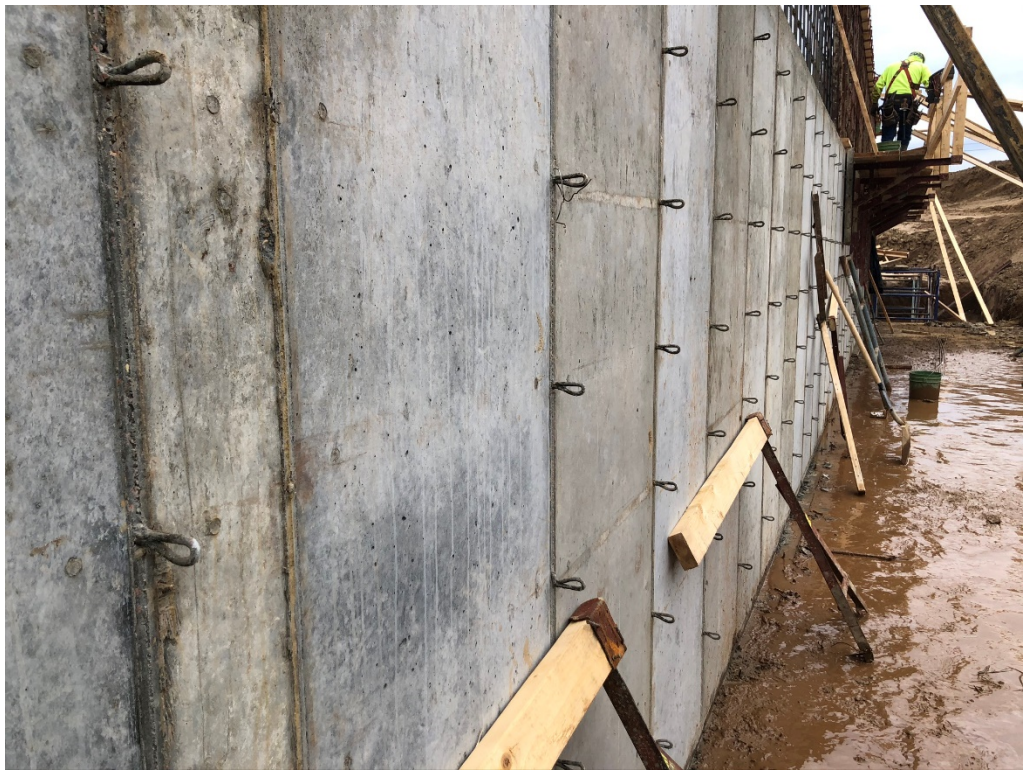
Figure 14 – Removed Forms from Retaining Wall (dirt side)
