Architect's Field Report

| One Jackson Place, Suite 250 188 East Capitol Street Jackson, MS 39201-2100 P 601.352.5411 F 601.352.5362 | 18059-AOI Academy of Innovation / Report Number 014 |

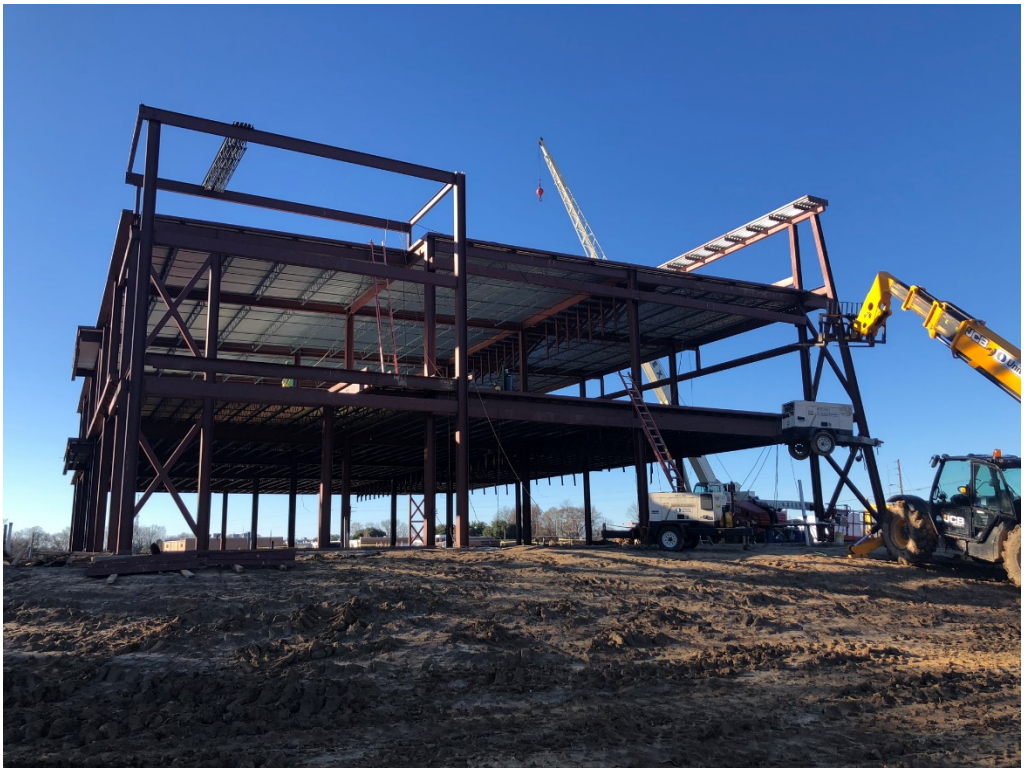
Figure 1 – Red Steel Erected

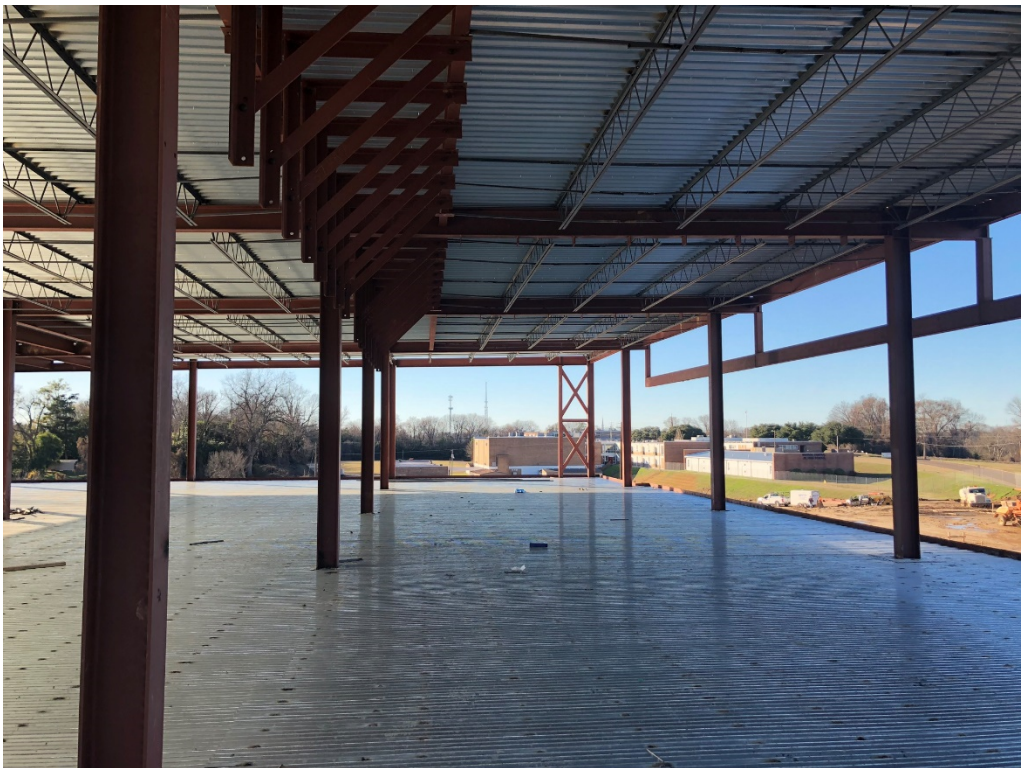
Figure 2 – 2nd Floor Platform from East Looking West

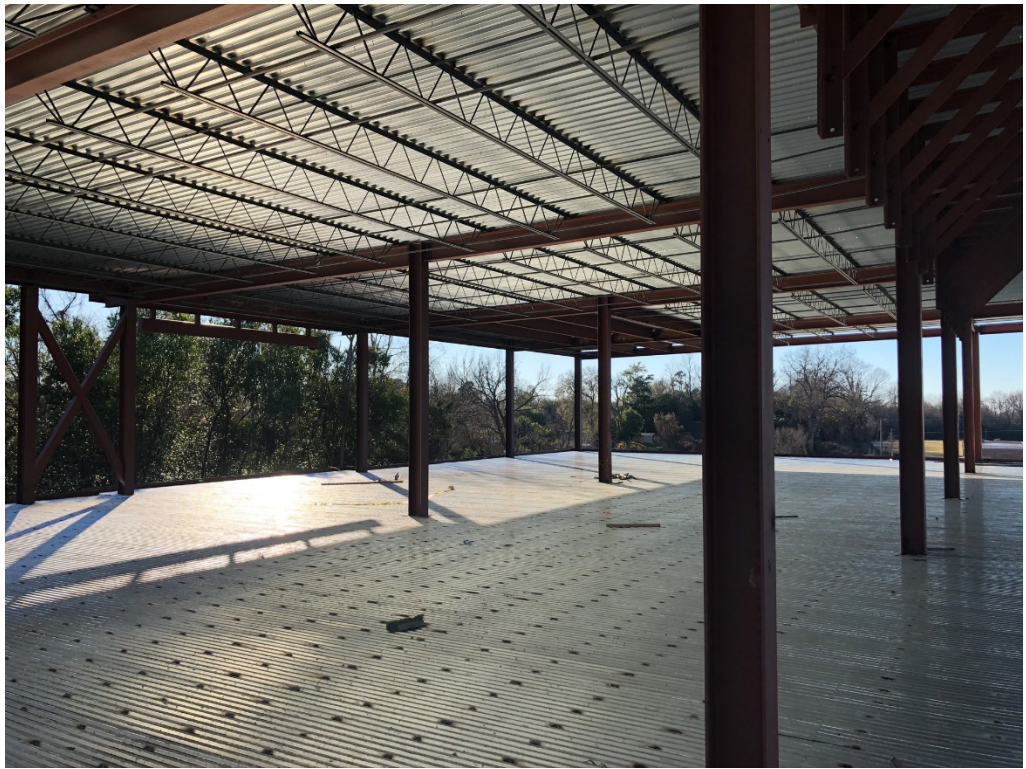
Figure 3 – 2nd Floor Platform from East Looking Southwest

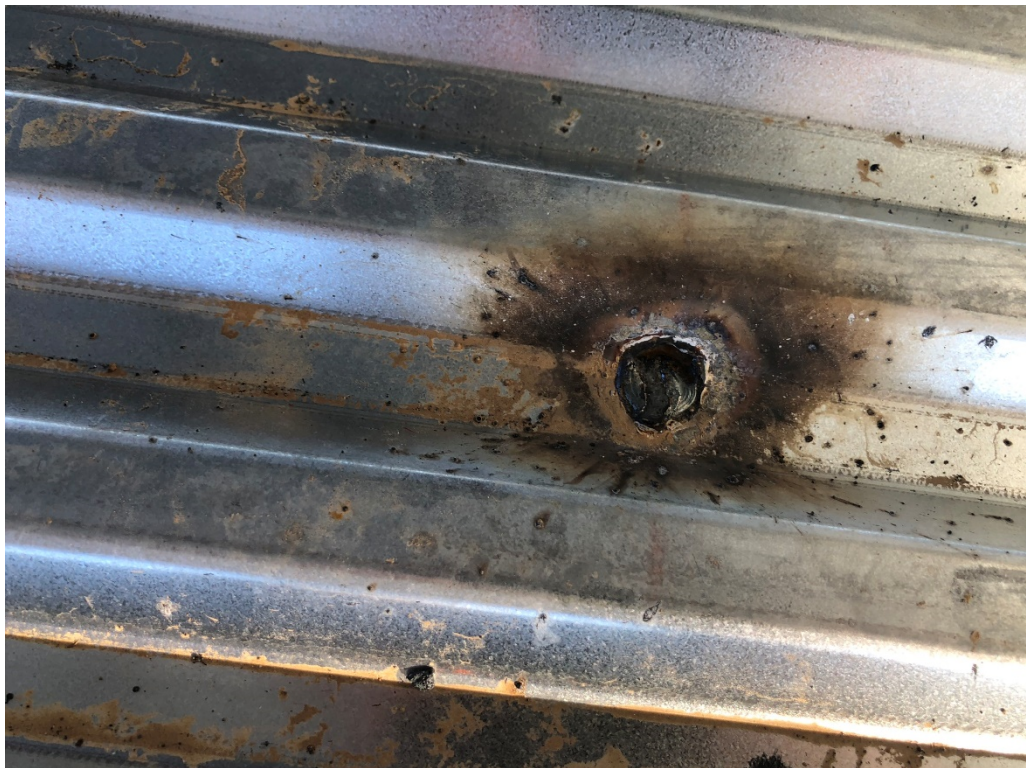
| 161 Lameuse Street, Suite 201 Biloxi, MS 39530 P 228.374.1409 F 228.374.1414 | Contract Century Construction Date / Time 30 December 2019 / 3:15 PM Weather / Temp Clear / 55 ° F Est % Complete 25% Sched Conformance +/- 00 days Work in Progress Foundation Work – Formwork Steel Decking Present at Site Foundation Crew Steel Team Paul Purser, DBA Observations When I arrived, the steel welding crew were packing up for the day. I saw that they have made progress on the upper portions of the Eastern Building, setting furr-down steel and roof decking. I noted a high consistency of burn out in deck welds at the 2 nd floor level towards the West End. Moving westward, I saw the foundation work has progressed and is near completion for the main wall at the lower level. Workers were removing forms. Items to Verify Are welds at second floor deck acceptable? Action Required None Report By: |

Figure 4 – Spot Welds through Decking (typical)

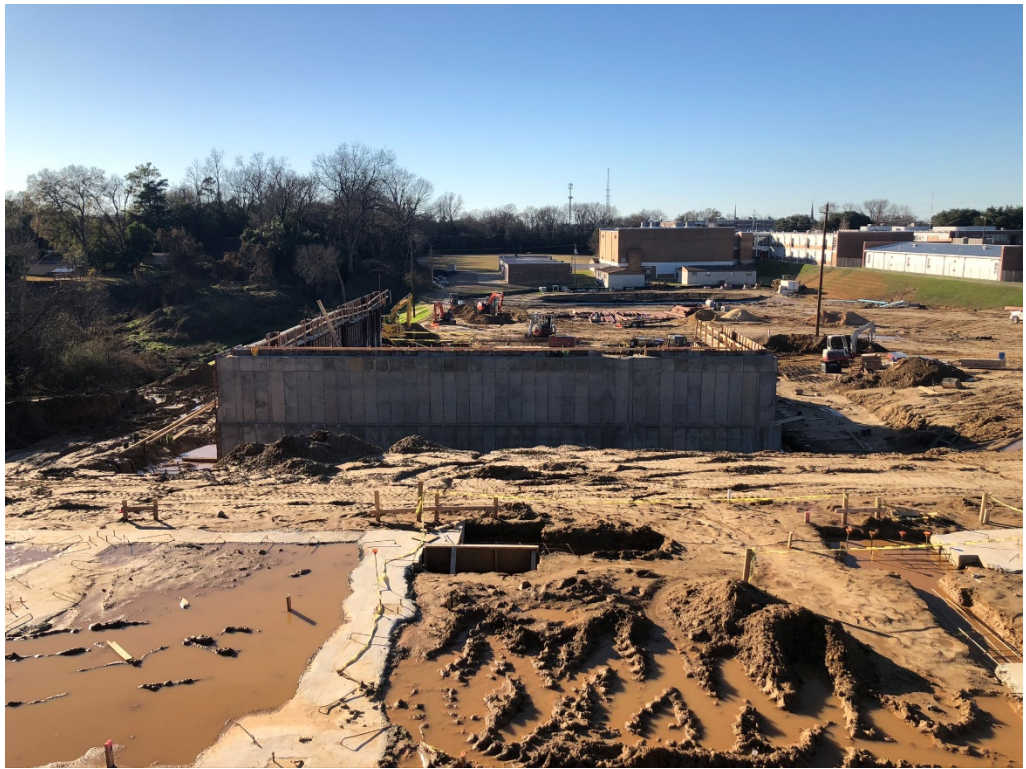
Figure 5 – Foundation Wall Progress

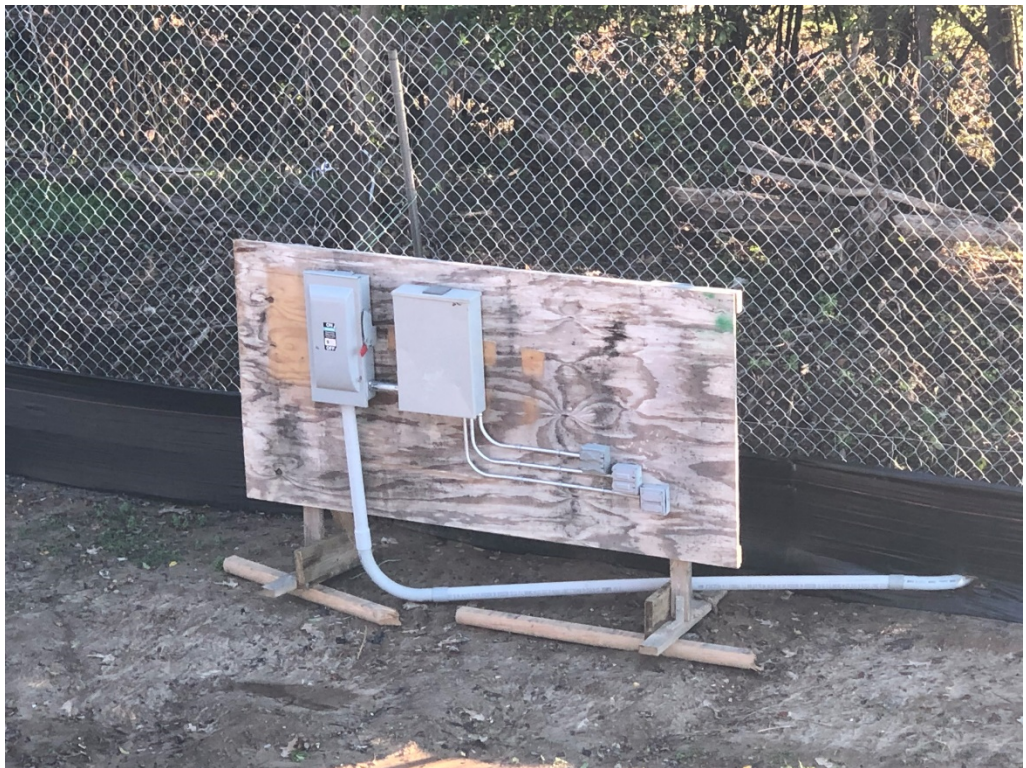
Figure 6 – Onsite Temporary Electrical Service

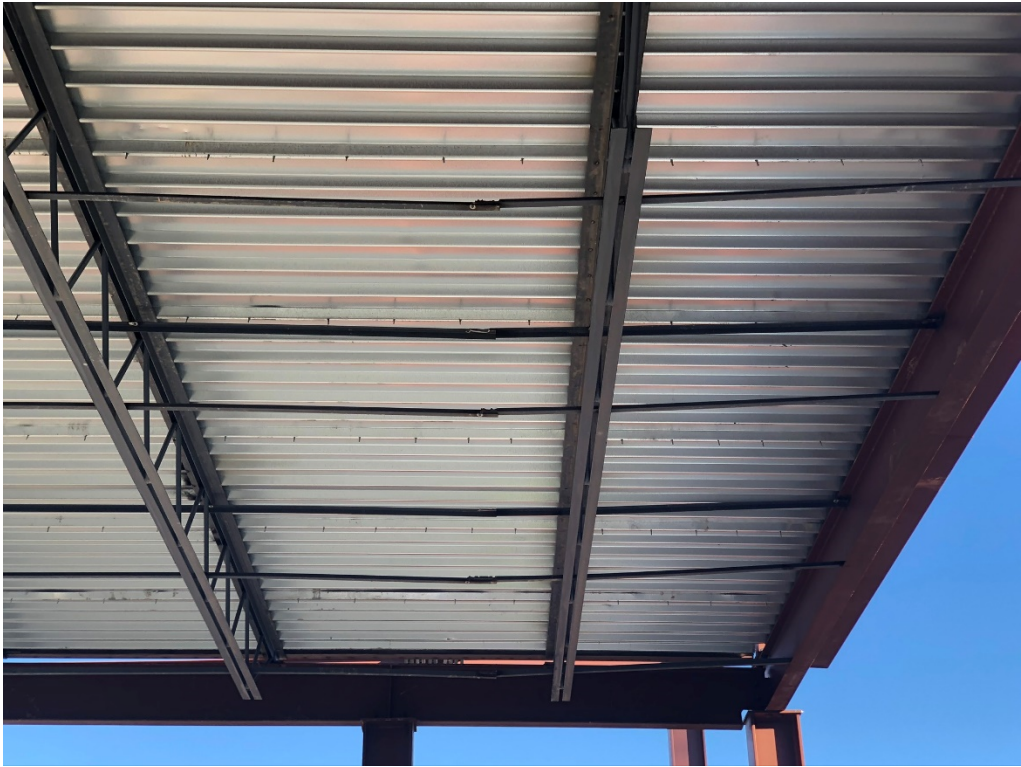
Figure 7 – 2nd Floor Roof Decking from Below

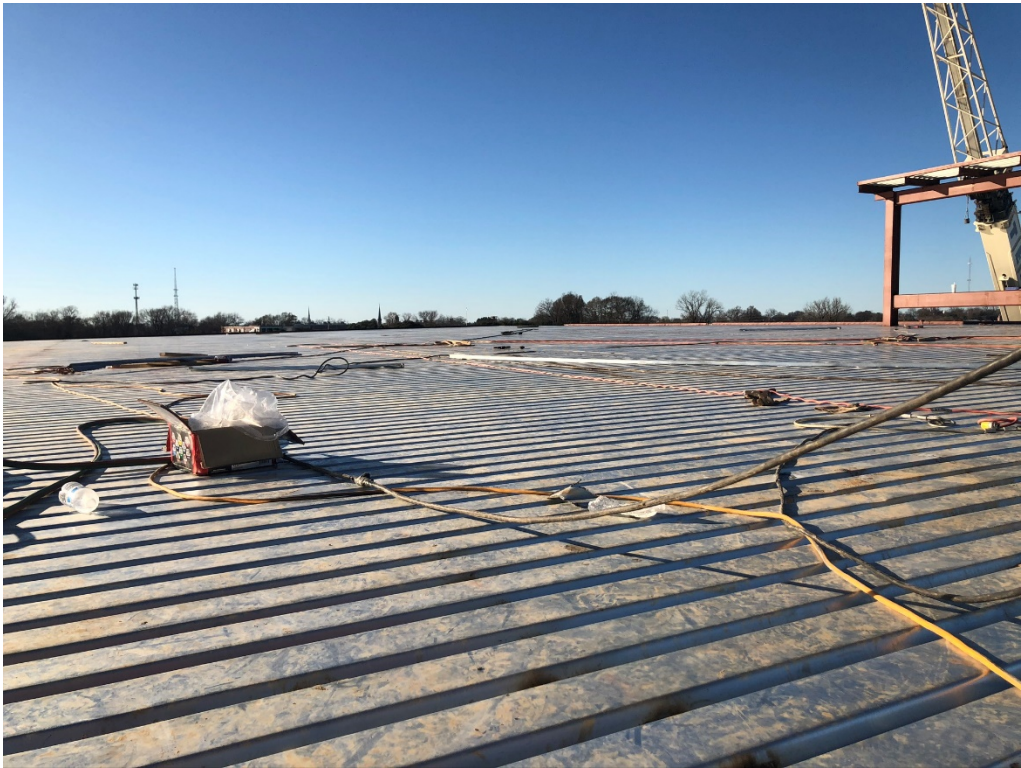
Figure 8 – Roof Deck Platform East Looking Northeast

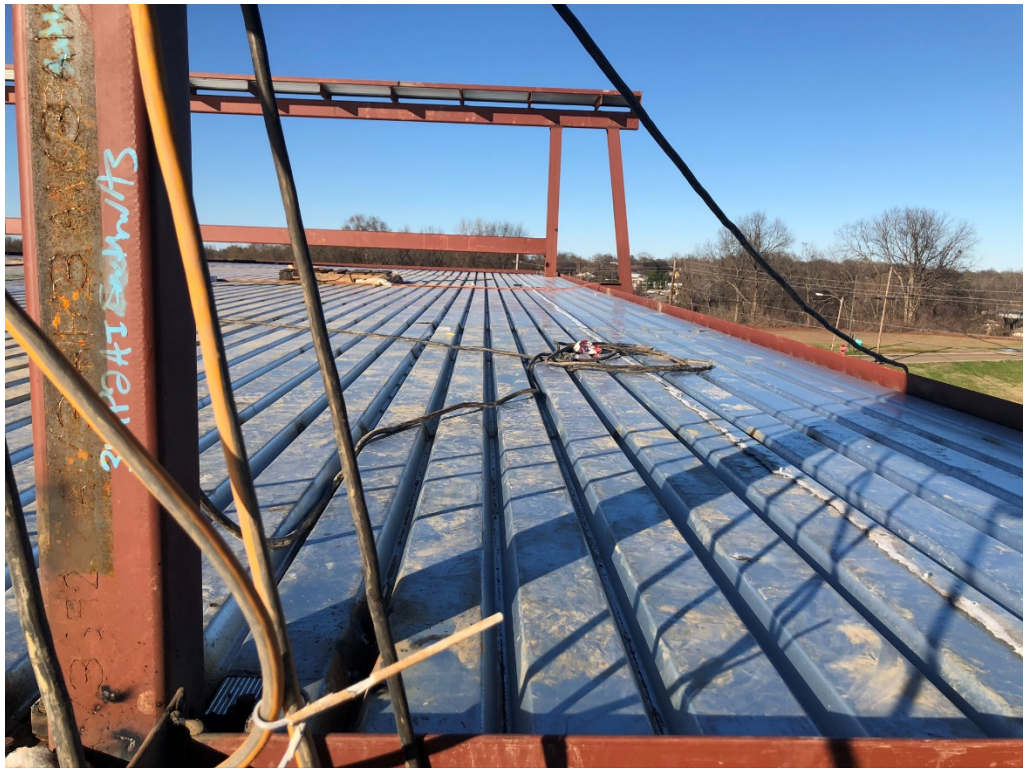
Figure 9 – Roof Deck Platform East Looking North

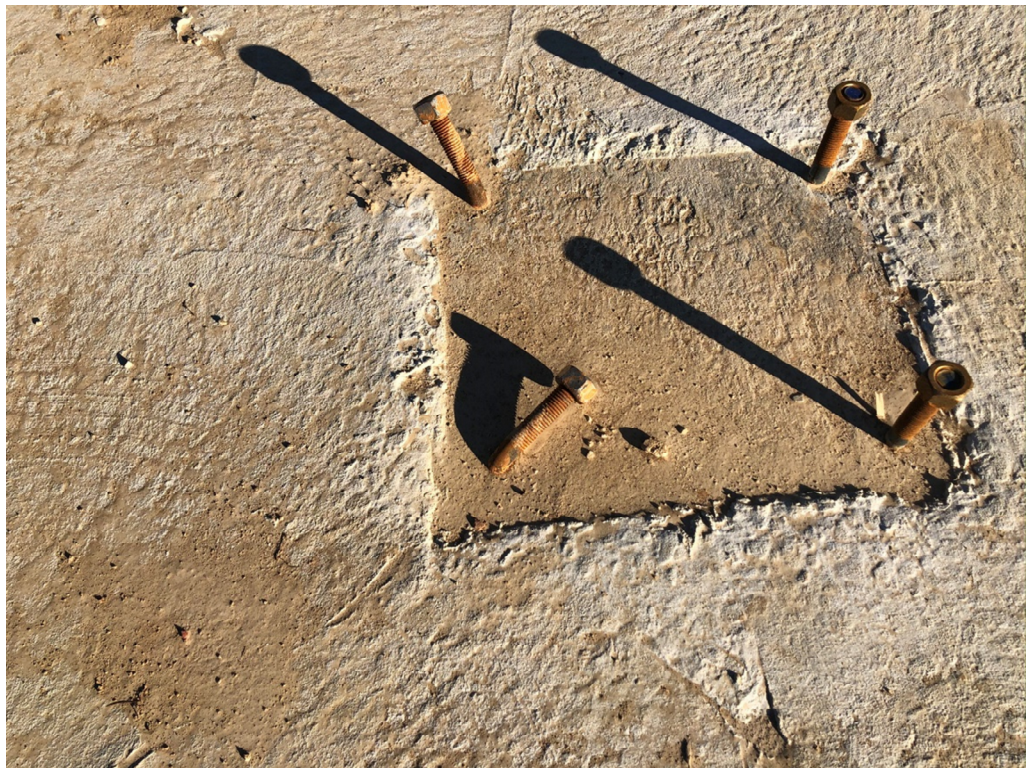
Figure 10 – West Side Upper Slab (damaged bolts @ structural connection)

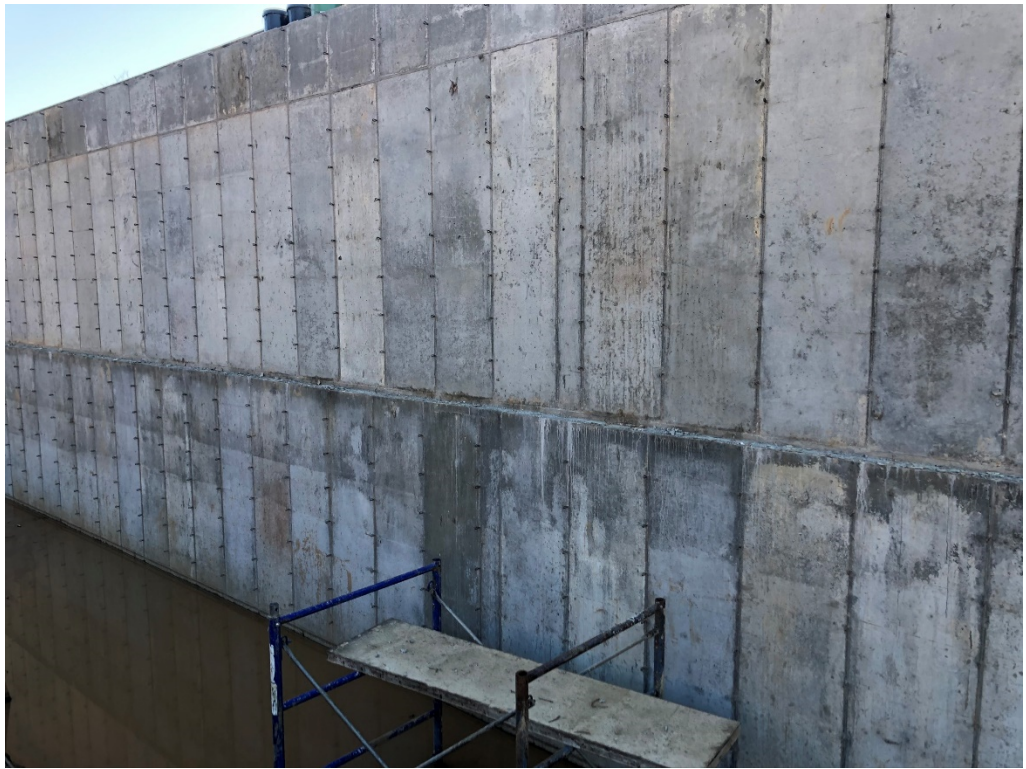
Figure 11 – Foundation Wall, Earth-side

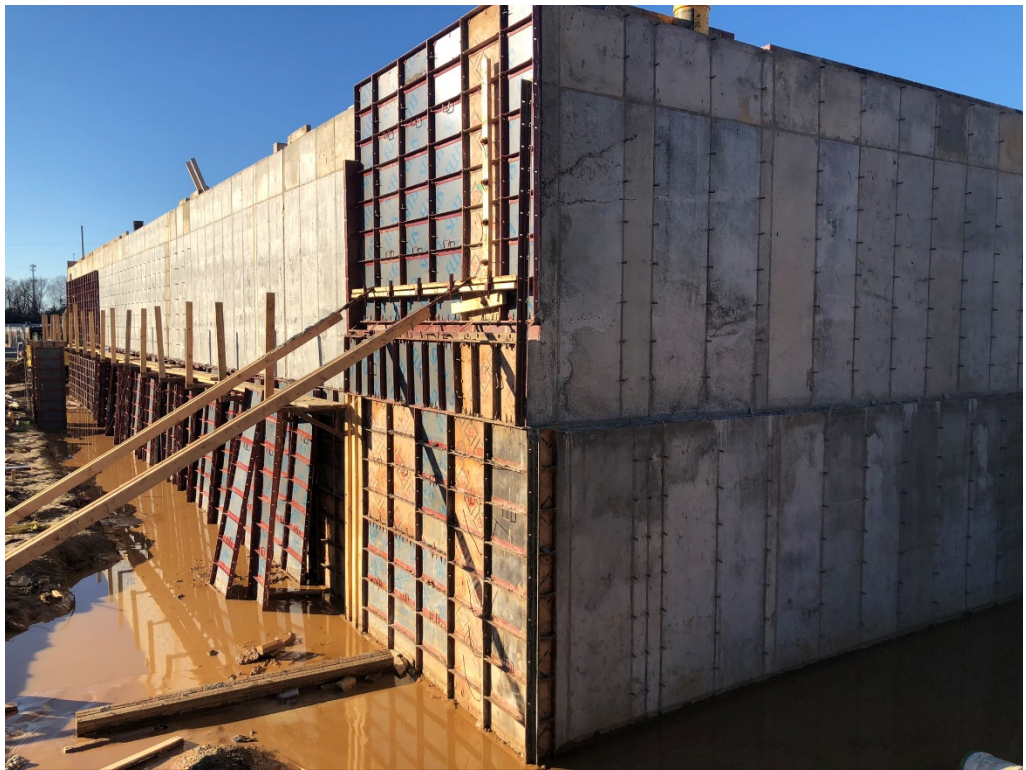
Figure 12 – Foundation Wall, Earth-side, Southeast Corner

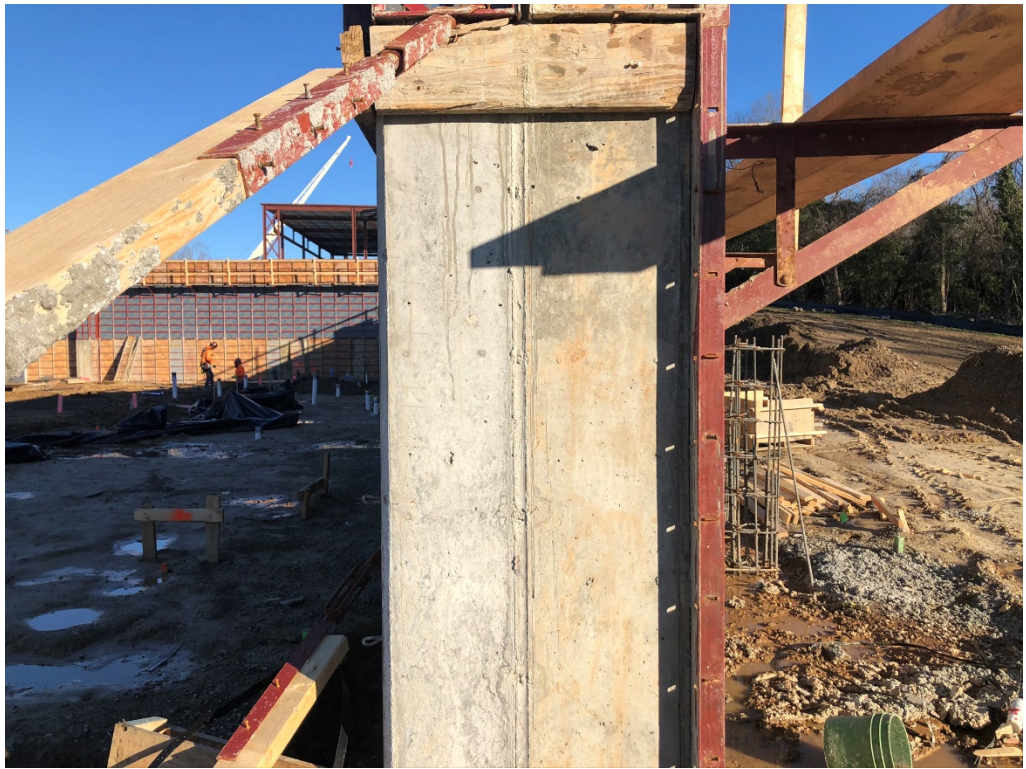
Figure 13 – West Edge of Foundation Wall

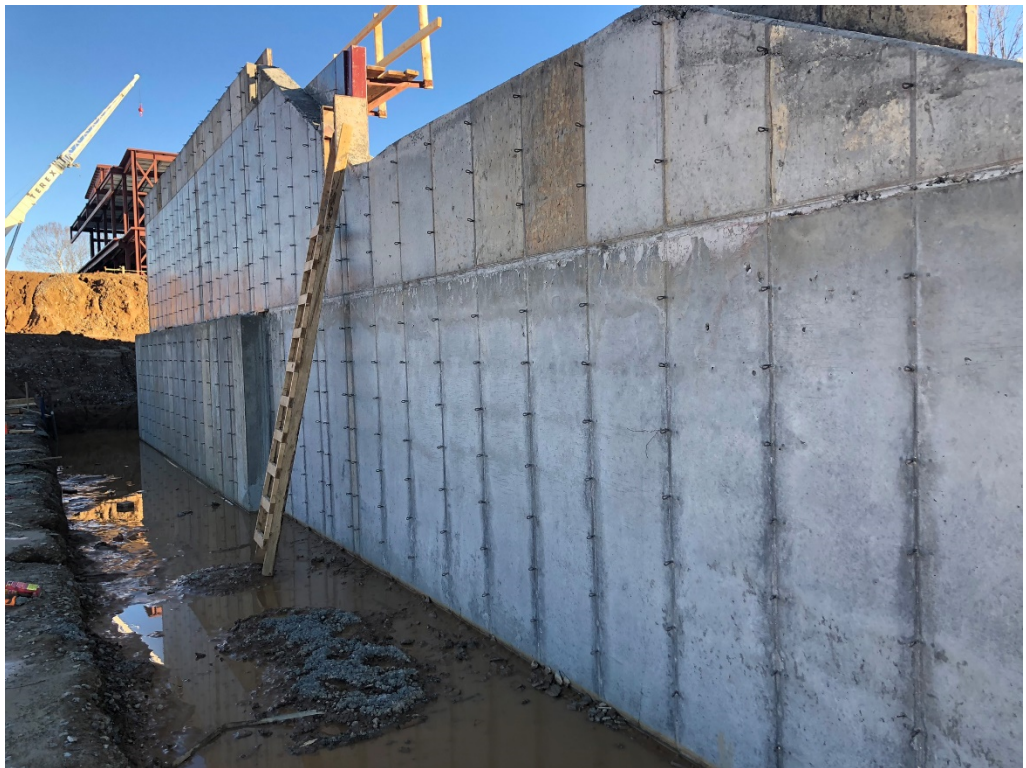
Figure 14 – North Foundation Wall, Earth-side

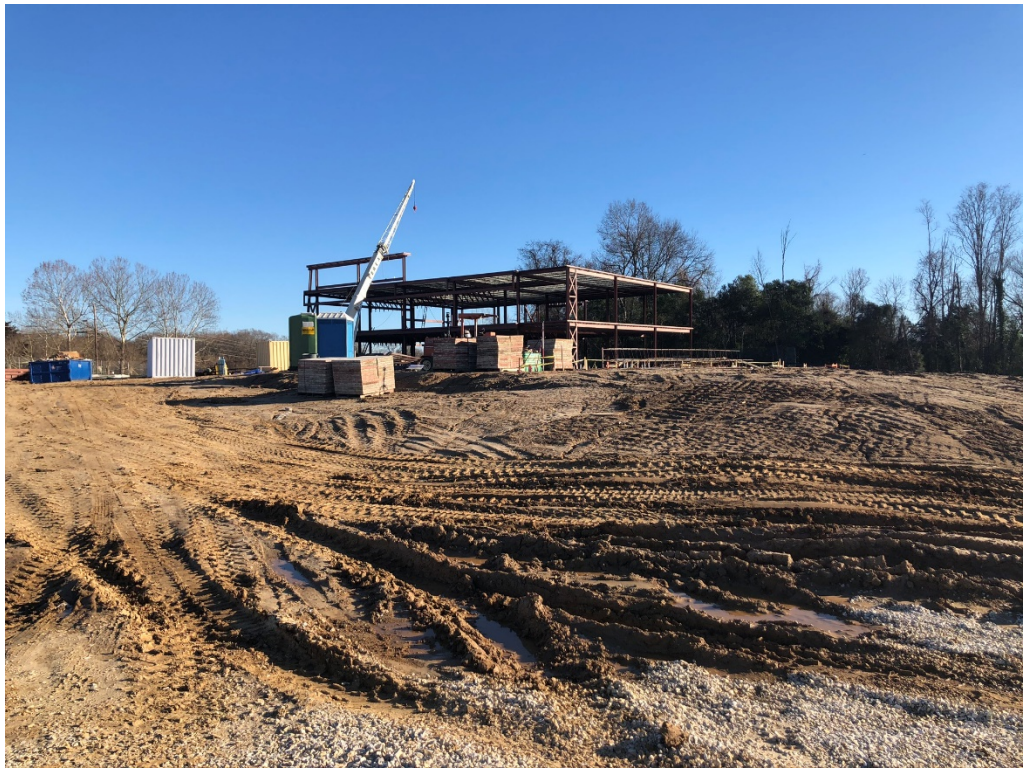
Figure 15 – North Entry Looking East SE

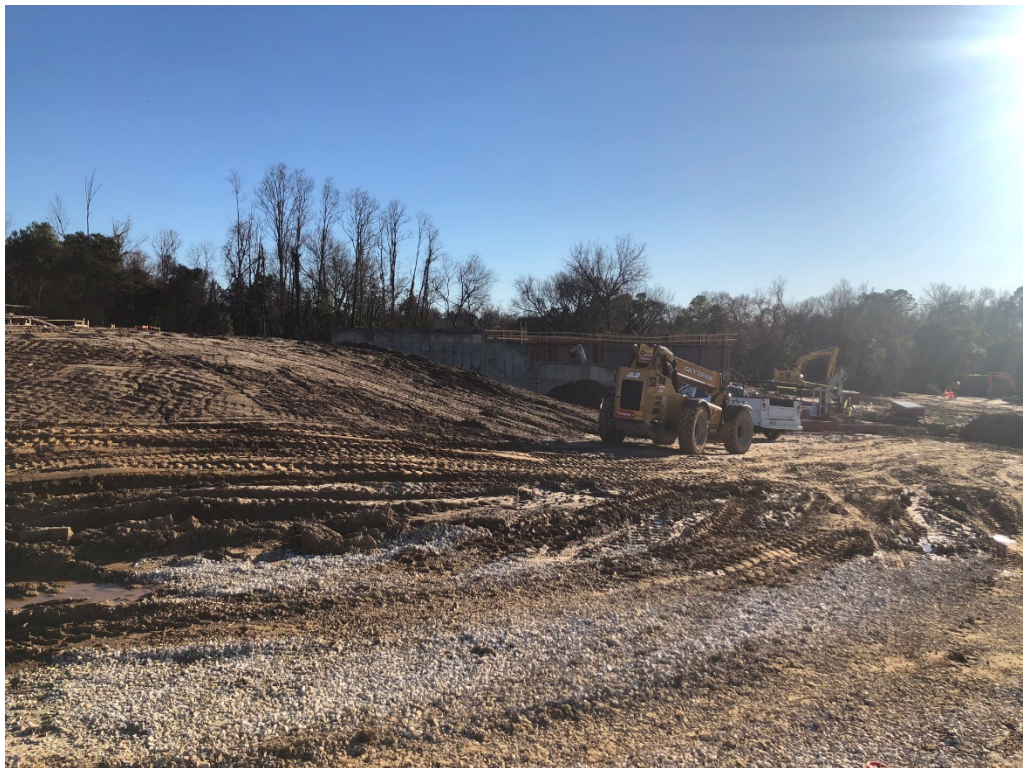
Figure 16 – North Entry Looking South

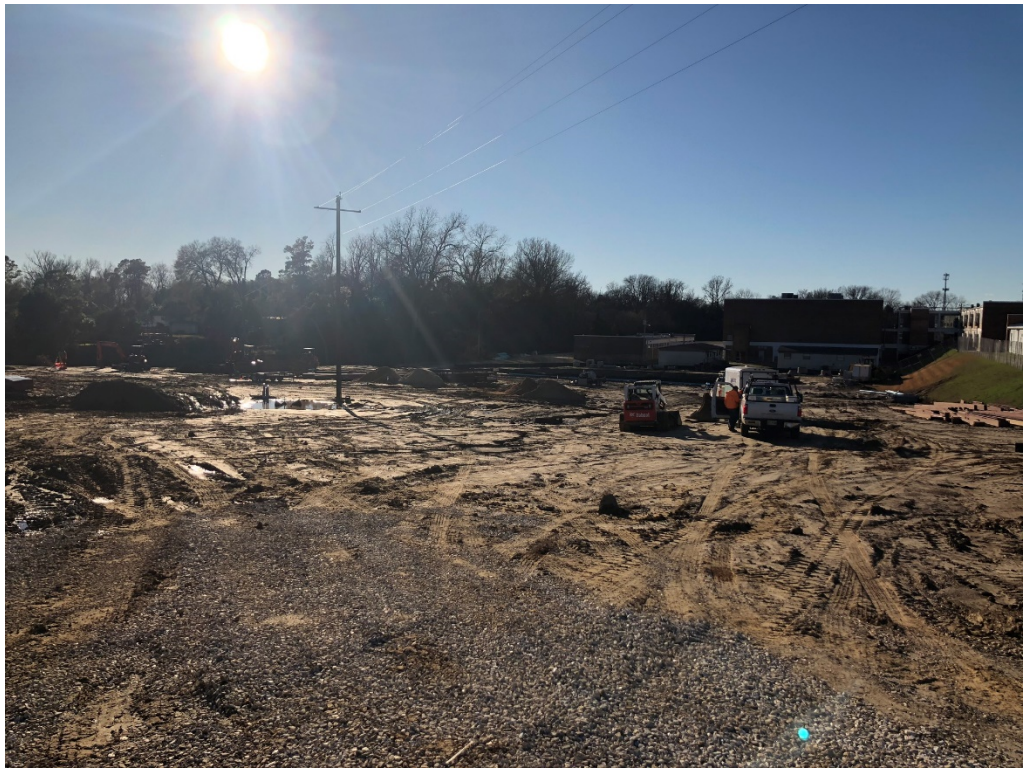
Figure 17 – North Entry Looking West SW

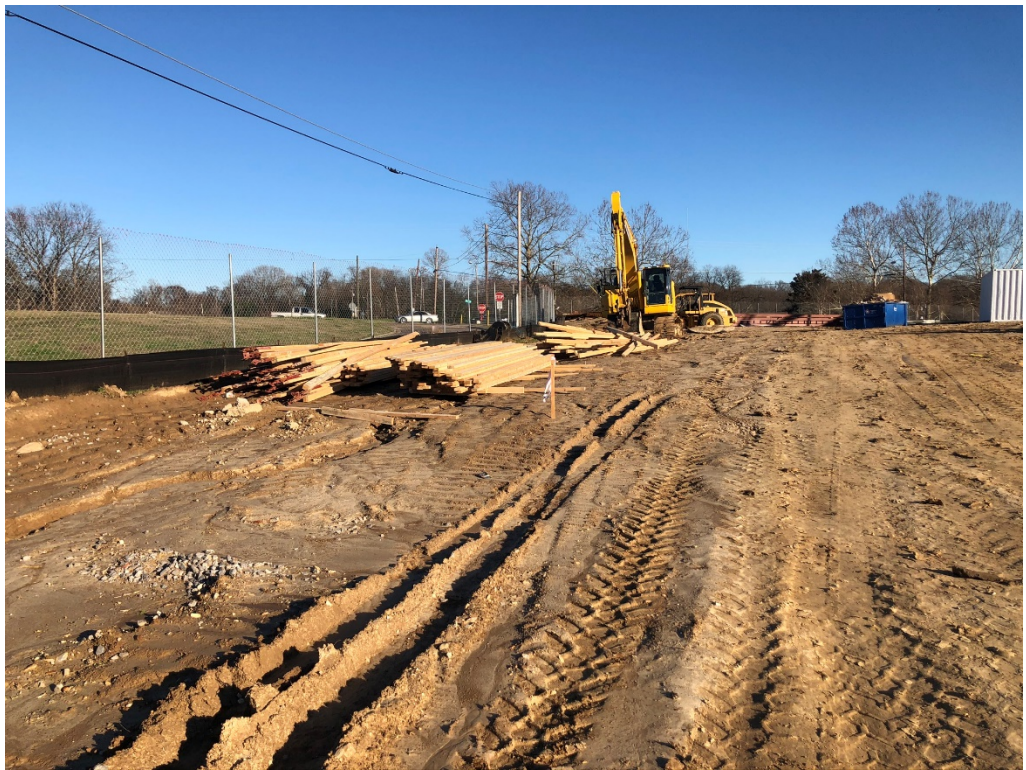
Figure 18 – Stored Lumber On-site
