## Architect's Field Report

09 January 2020

18059-AOI Academy of Innovation / Report Number 015

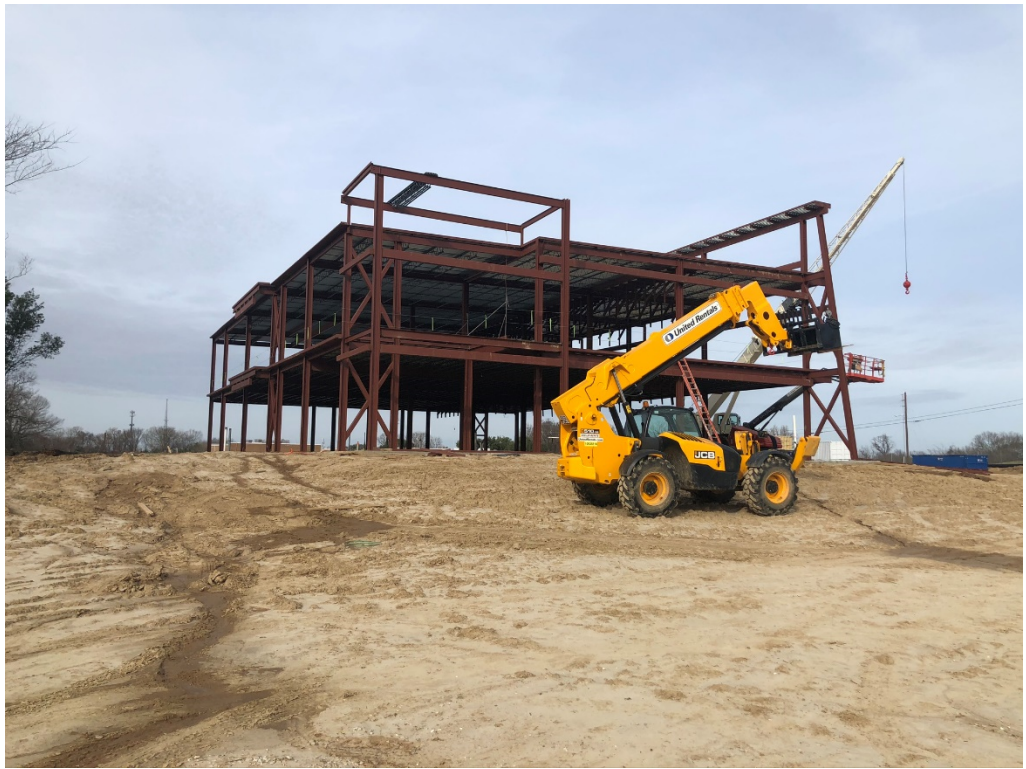
Figure 1 – Red Steel Erected

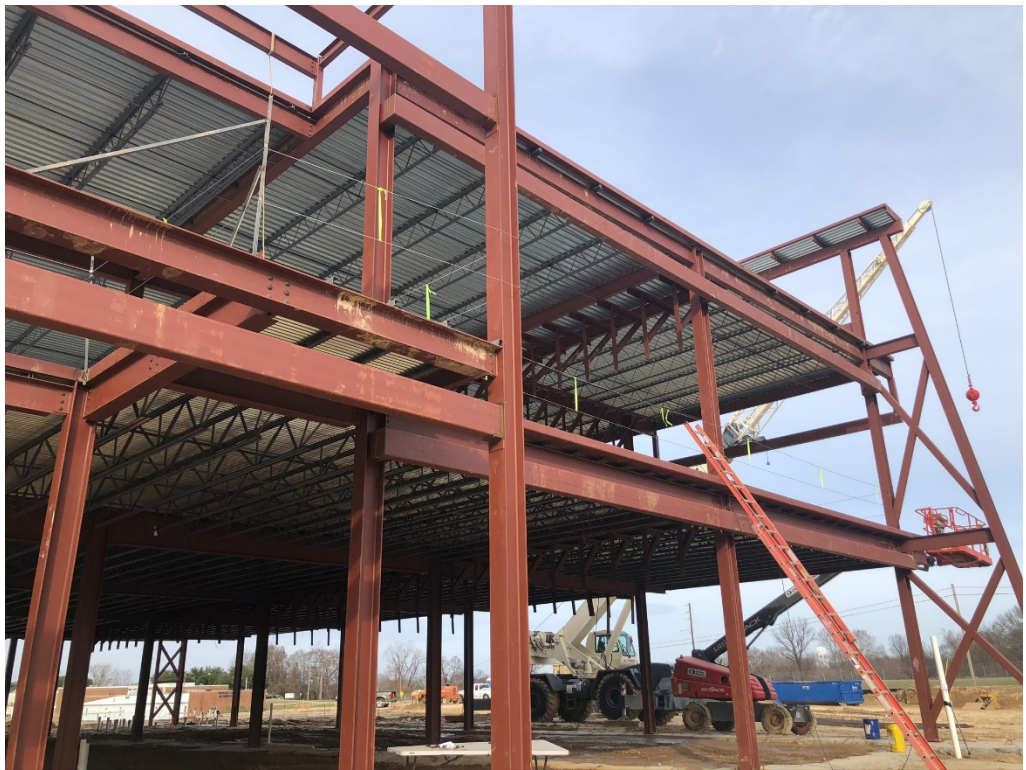
Figure 2 – Safety Wire In Place at 2<sup>nd</sup> Floor

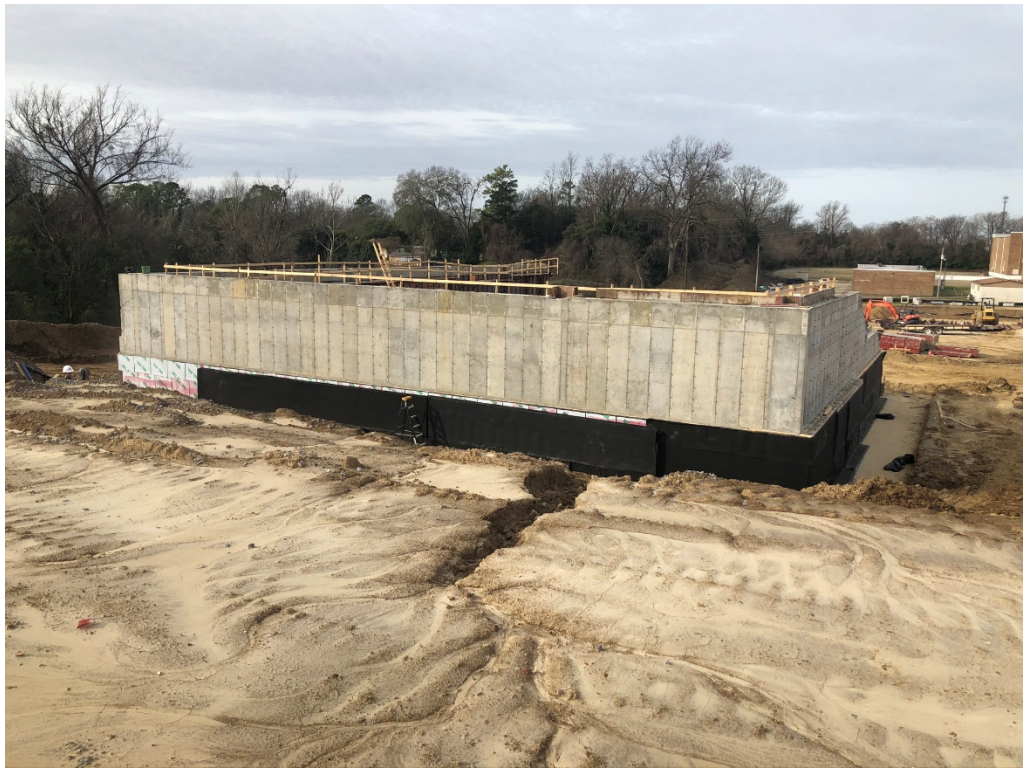
Moving westward, I saw that Foundation Waterproofing had begun. A base layer had been applied to the foundation concrete wall up to 8 feet on the east (dirt) side. A large amount of form work was still in place and currently being removed.

Figure 3 – Foundation (Dirt Side)

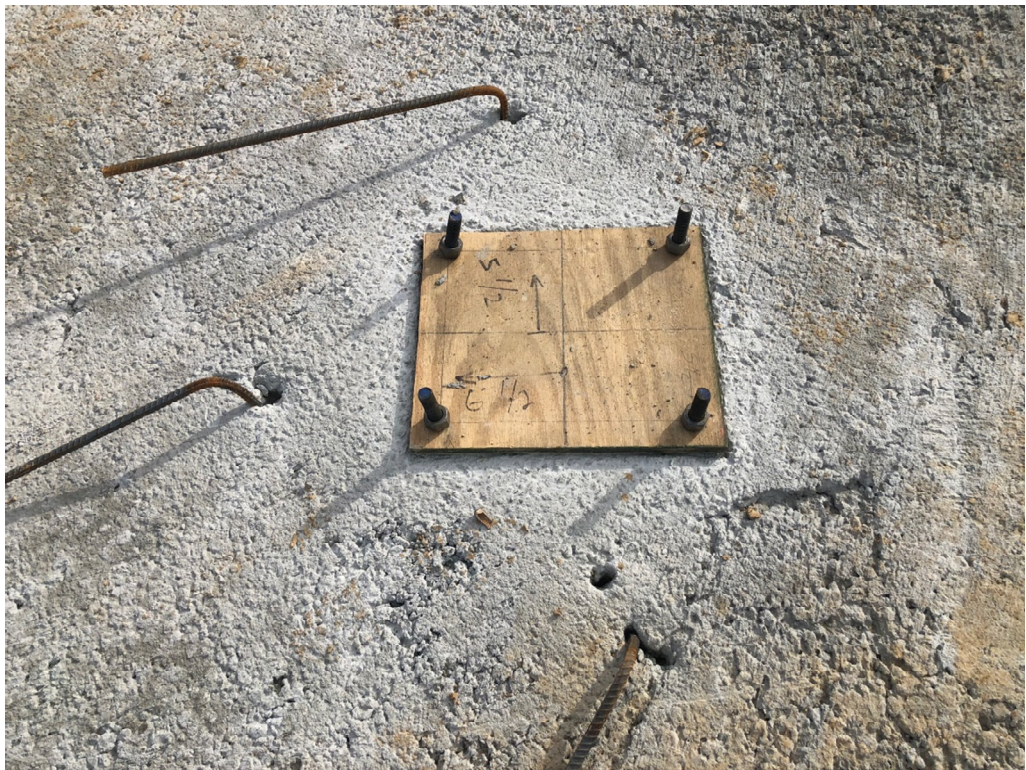
Figure 4 – Bolts for Steel Structure in Place @ Lower Level

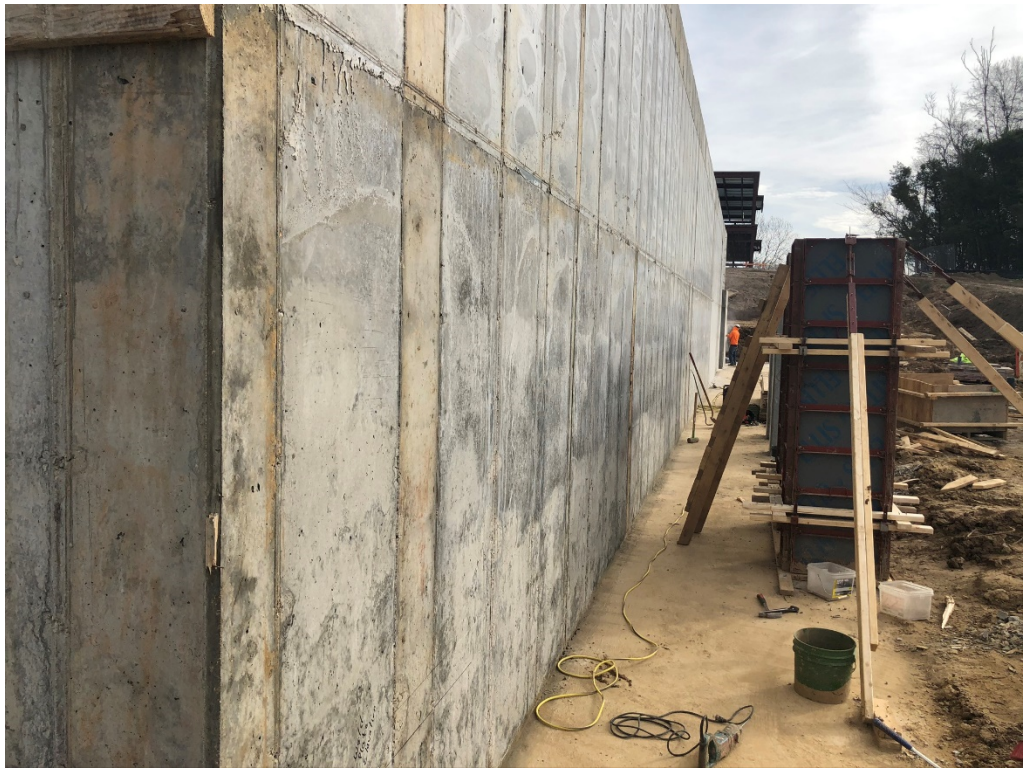
Figure 5 – Formwork Removed @ Exterior of Foundation Wall

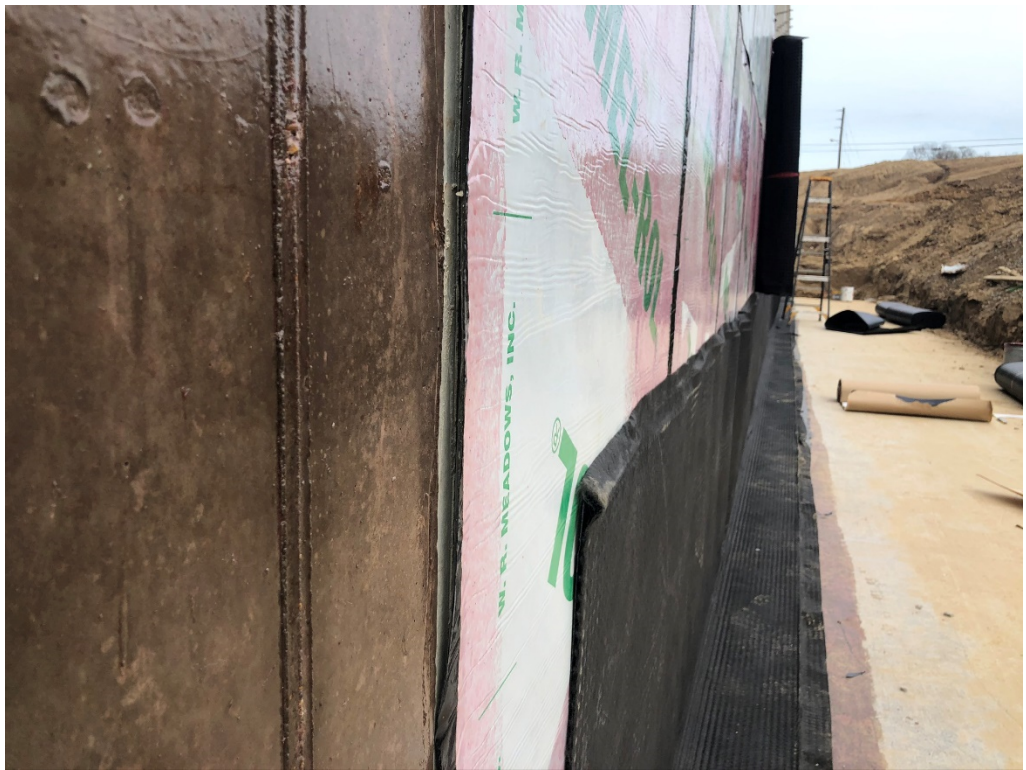
Figure 6 – Mel-Rol Sheet Drainage Assembly

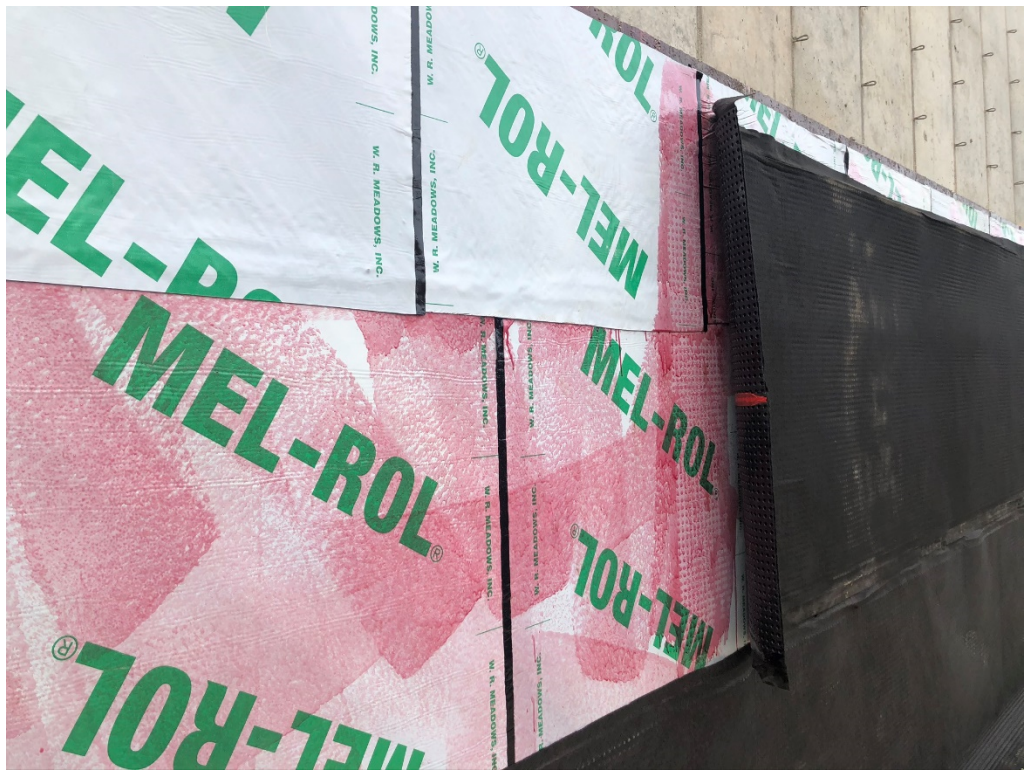
Figure 7 – Bitumen Self Adhering Sub Sheet with Fabric Drainage Plain in Place
