## Architect's Field Report

16 January 2020

18059-AOI Academy of Innovation / Report Number 016

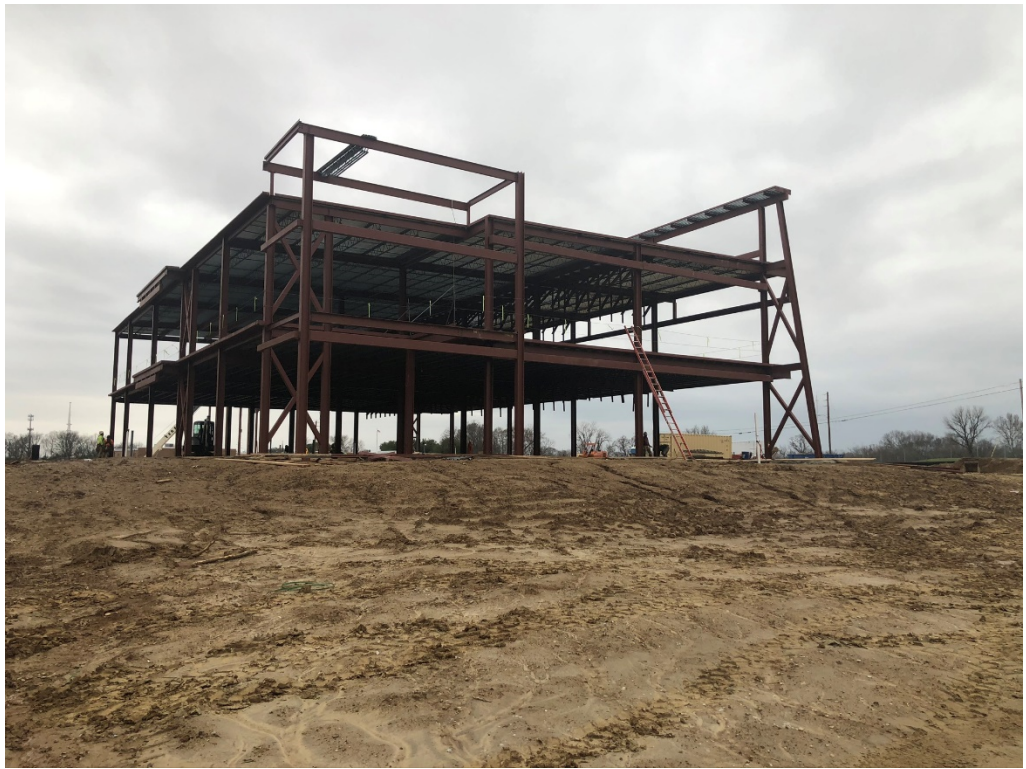
Figure 1 – Red Steel Erected

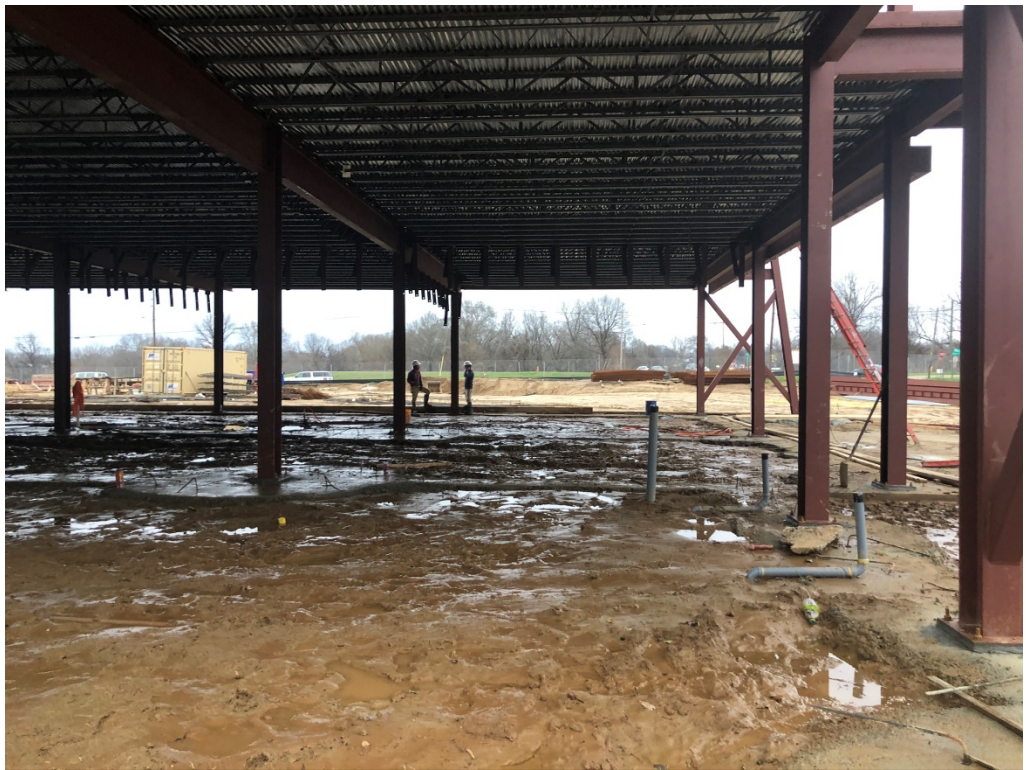
Observations Arriving, met Mr. Billy Burwell. We walked the site. Mr. Burwell mentioned that they've spent the last few days pumping water out of East Building in preparation for substrate install.

Figure 2 – Upper East Building Site Condition

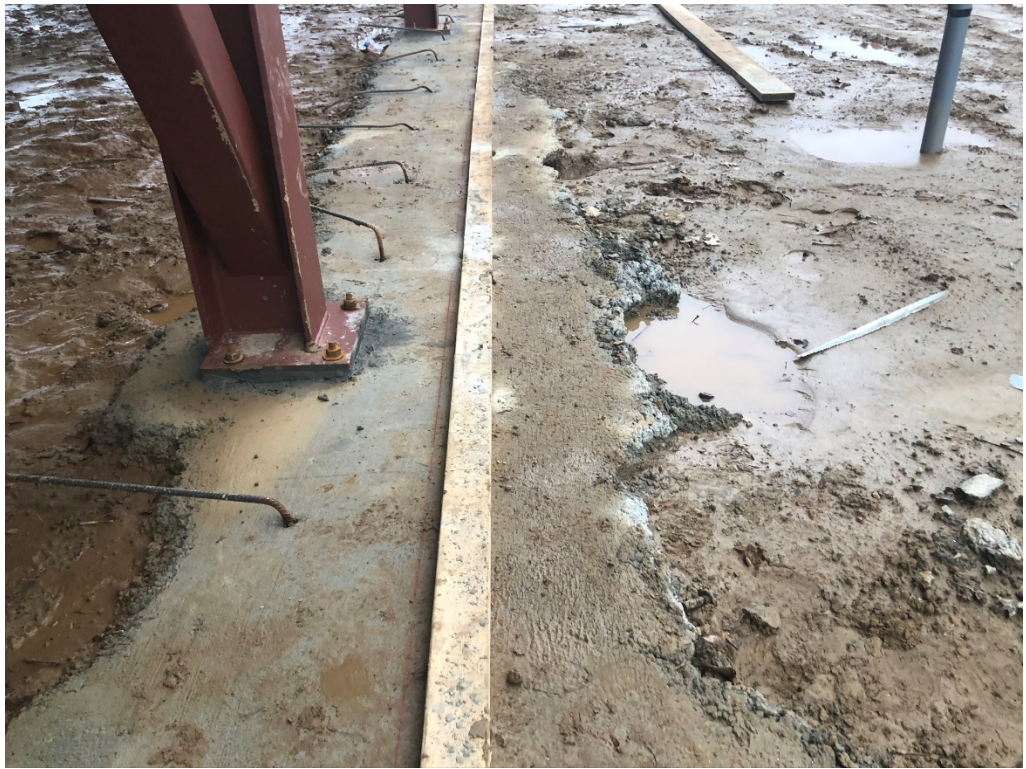
Figure 3 – Formwork Bracing @ Upper Building

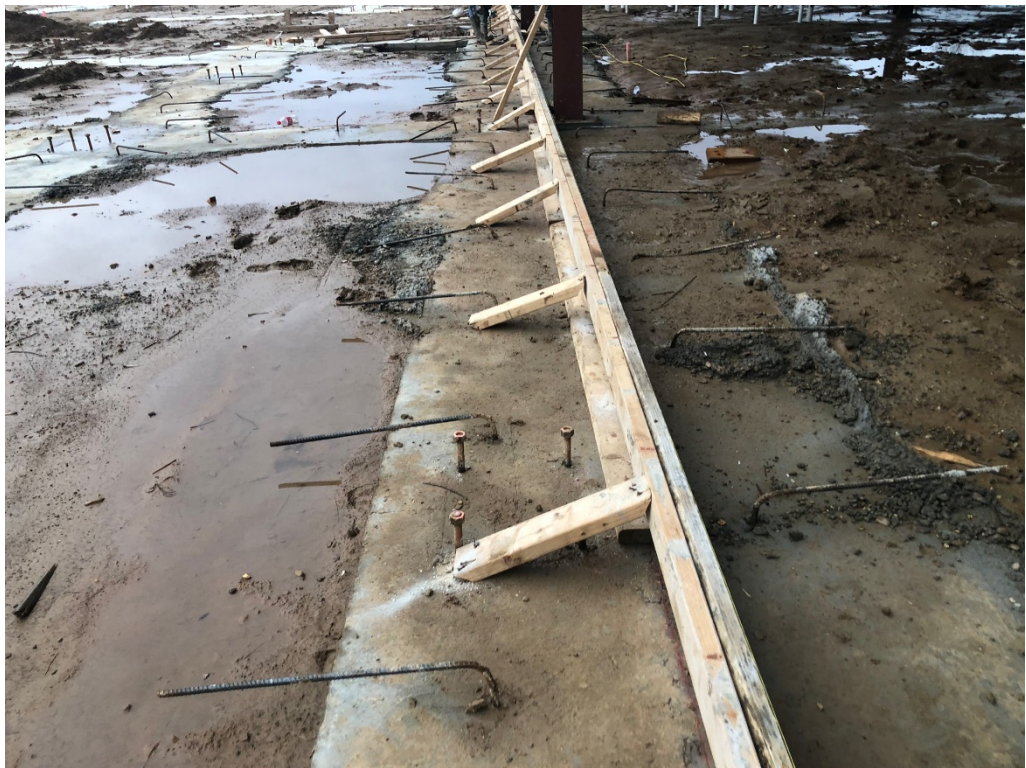
I noted formwork being set at the east building section. At the west building section, steel is currently being installed.

Figure 4 – Formwork @ Upper East Building for Topping Slab

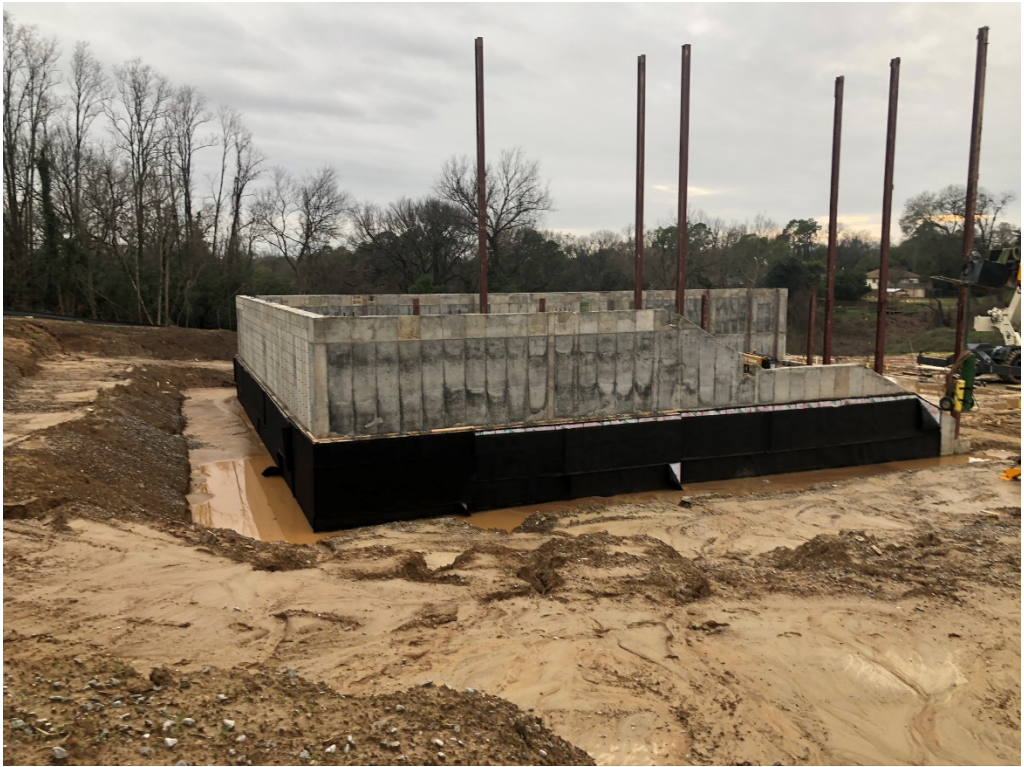
Figure 5 – Lower Level Progress, Steel Erected

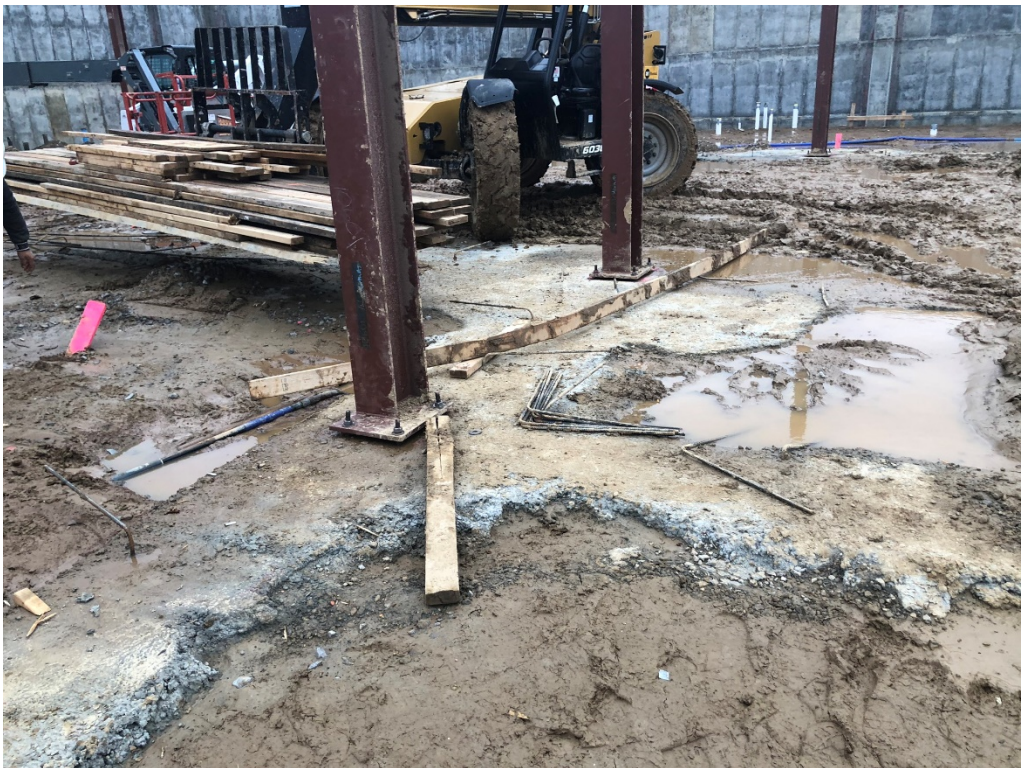
Figure 6 – Steel @ Lower Level Footings

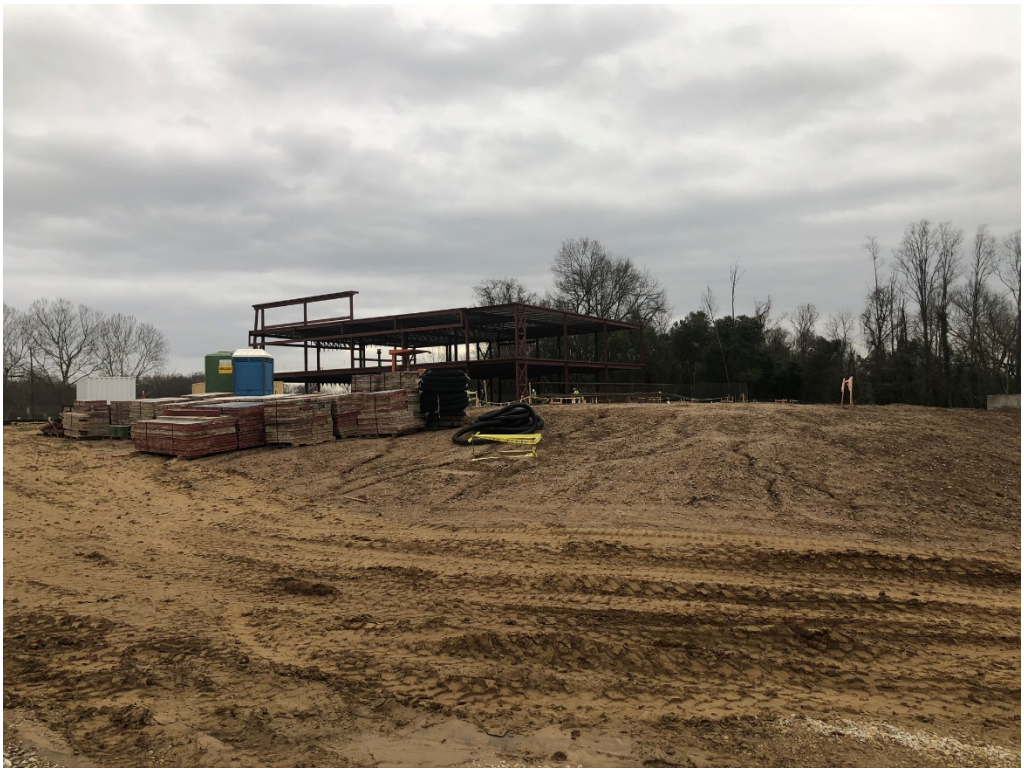
Figure 7 – North Entry Looking ESE

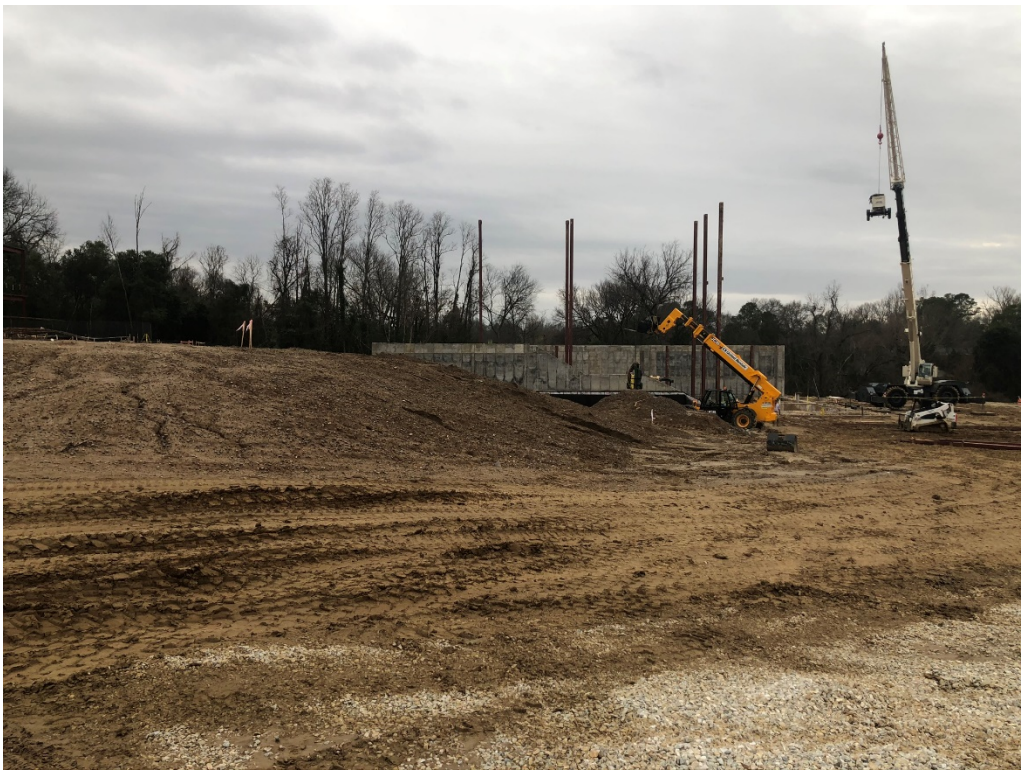
Figure 8 – North Entry Looking S

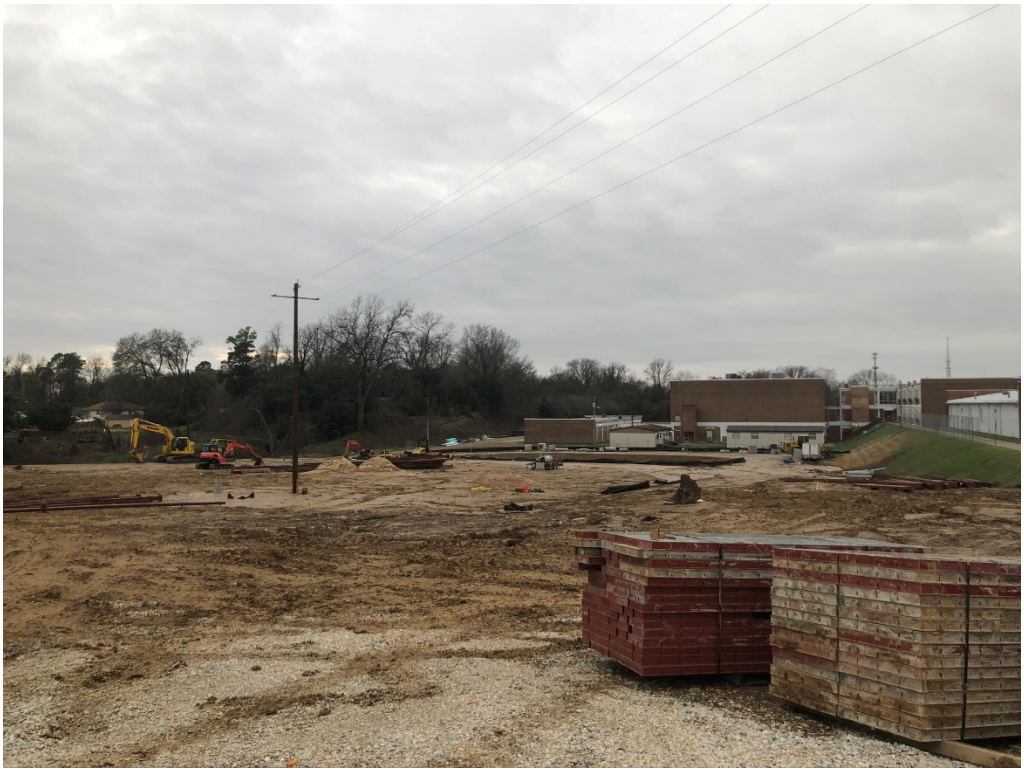
Figure 9 – North Entry Looking WSW

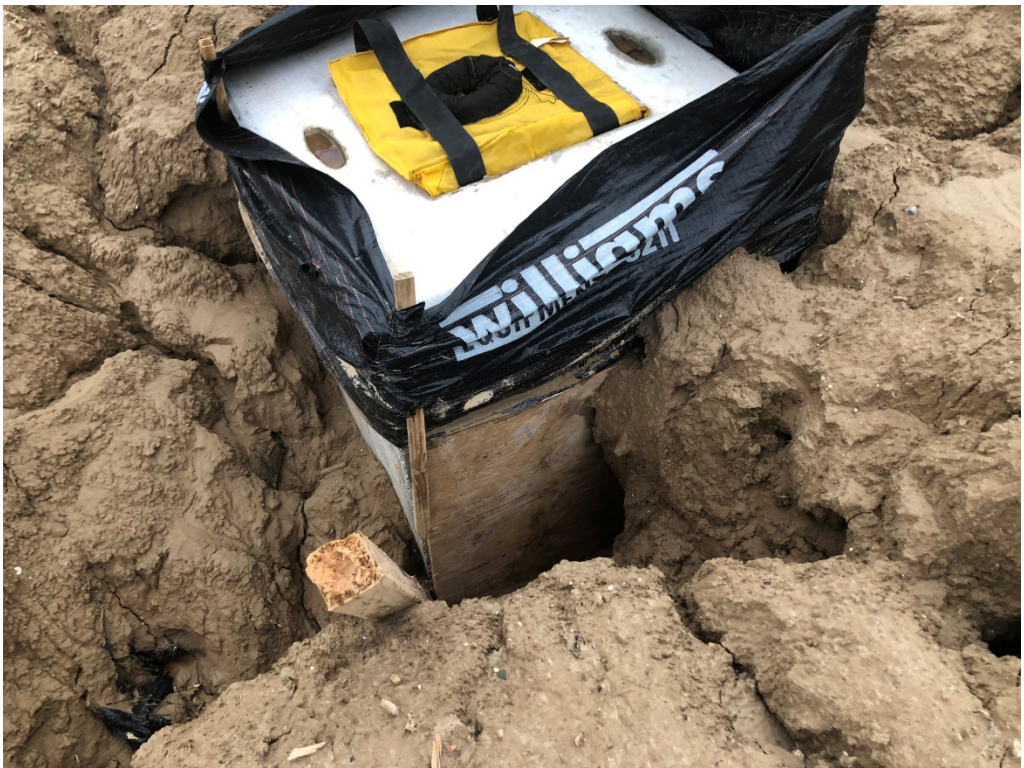
Figure 10 – Northeast Storm Sewer Set
