## Architect's Field Report

21 January 2020

18059-AOI Academy of Innovation / Report Number 017

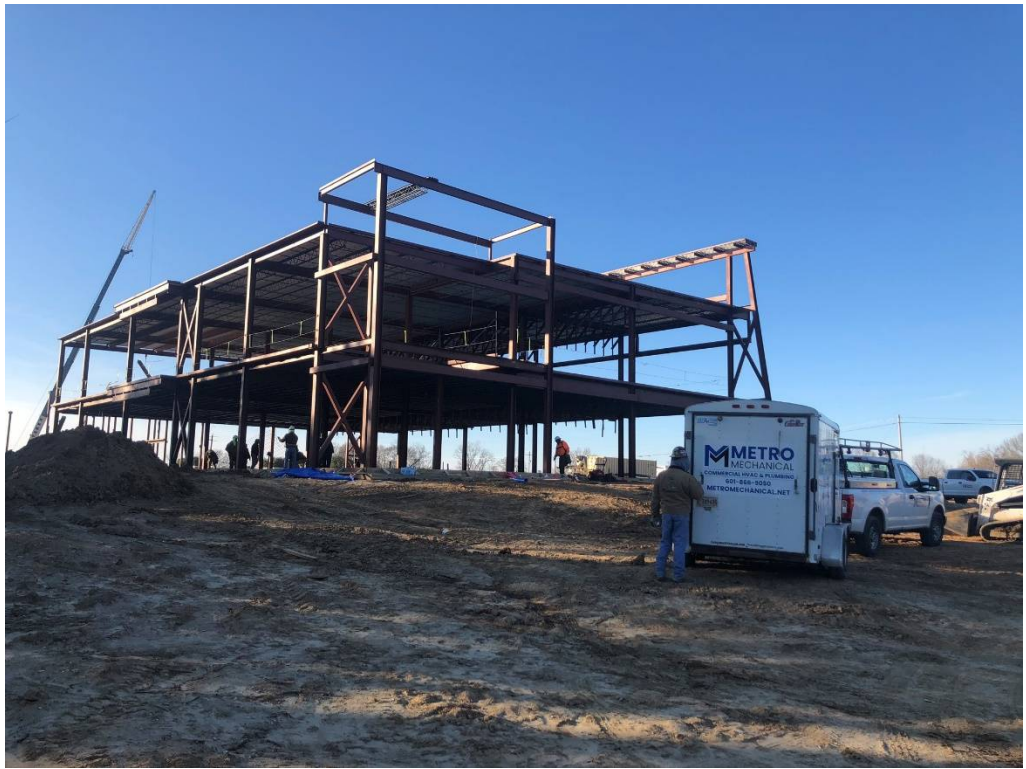
Figure 1 – Red Steel Erected

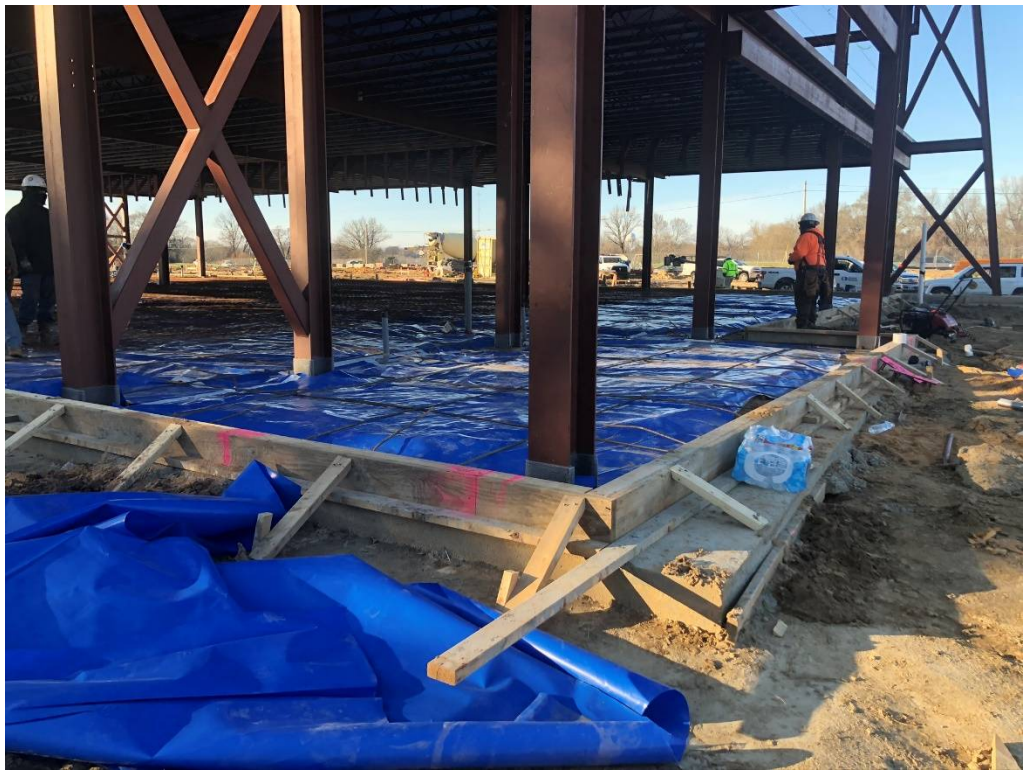
Observations Arriving, I walked the site. The foundation crew was busy setting rebar and mesh per structural drawings. Formwork for the upper East slab has been complete and plans to pour are for tomorrow. Metro Mechanical Employees were shooting levels for the installation of floor drains.

Figure 2 – Formwork in place

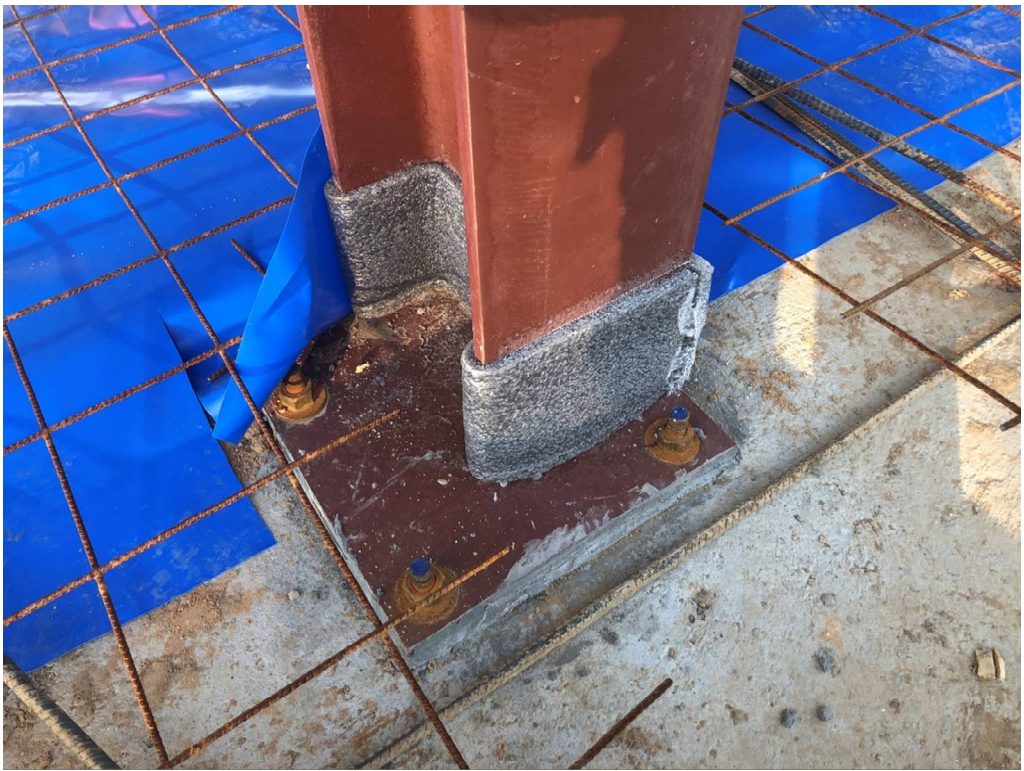
Figure 3 – Typical Isolation around steel

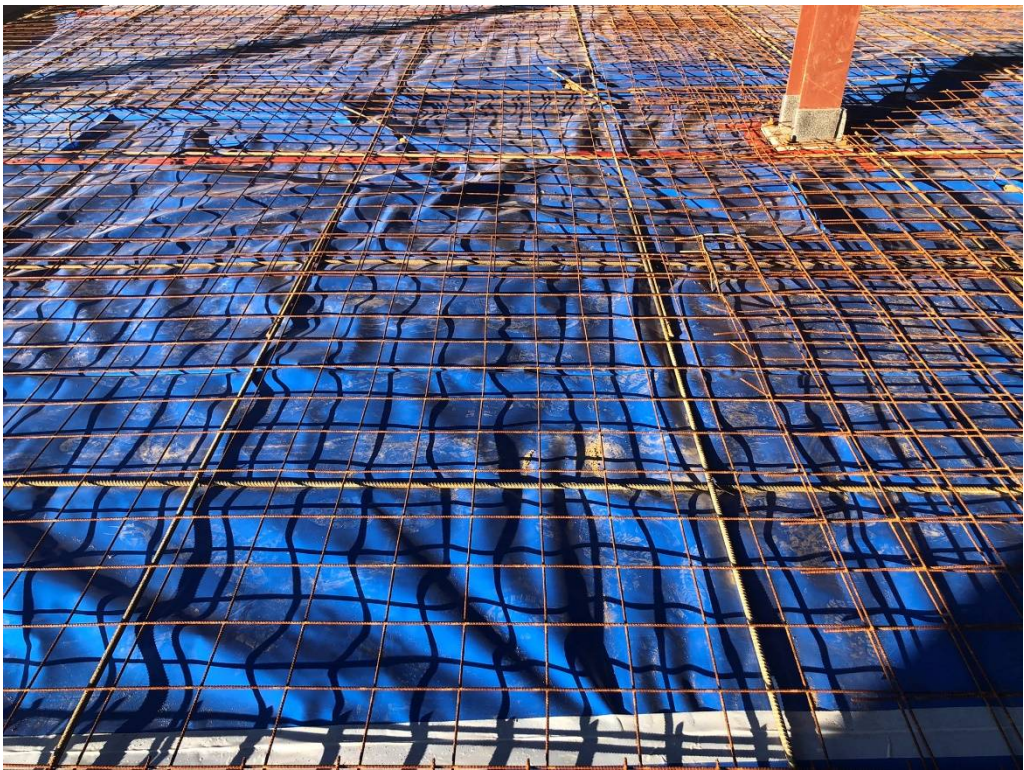
Figure 4 – Typical reinforcing

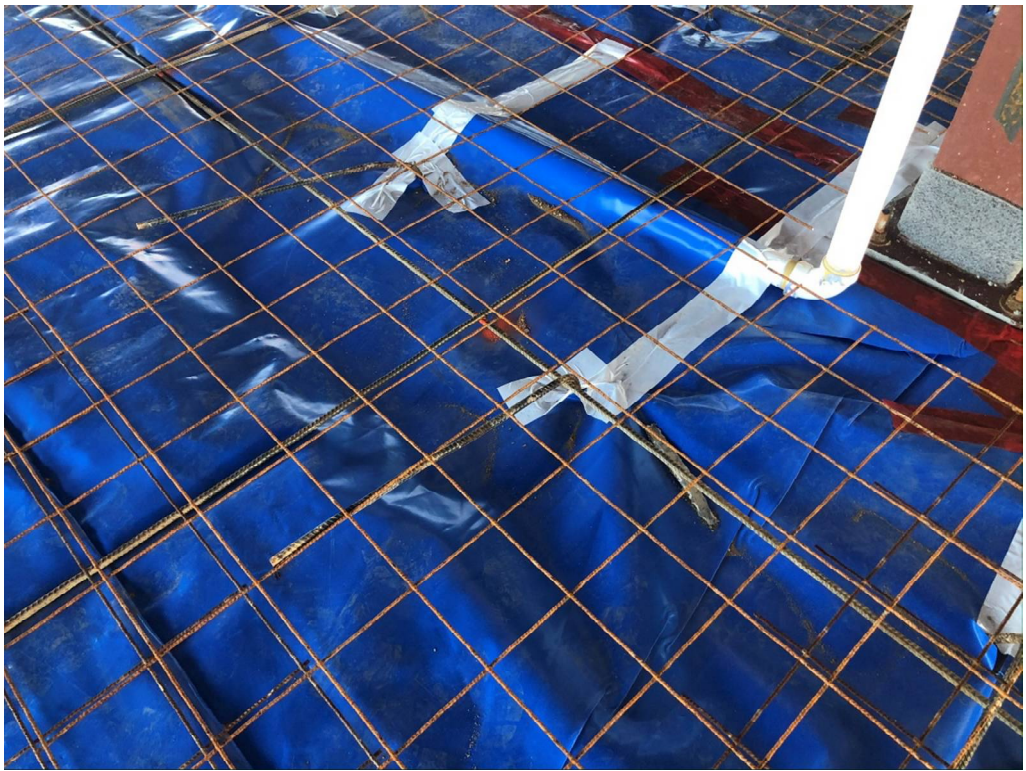
Figure 5 – Tear in moisture barrier repaired

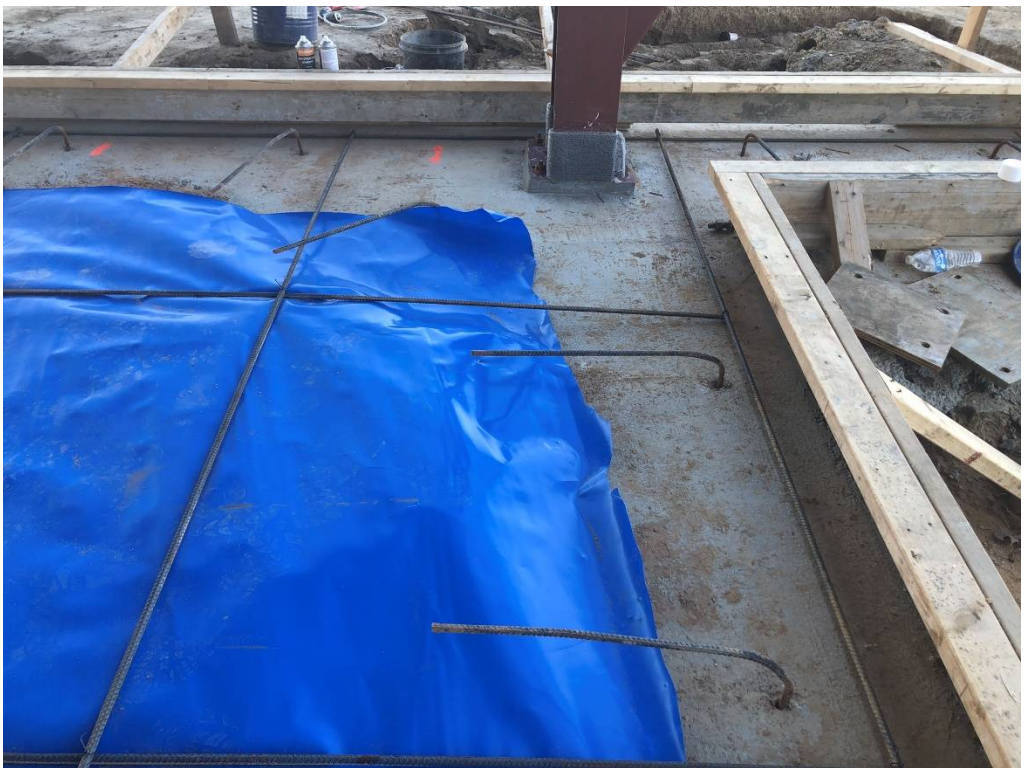
Figure 6 – North East corner of Upper Structure

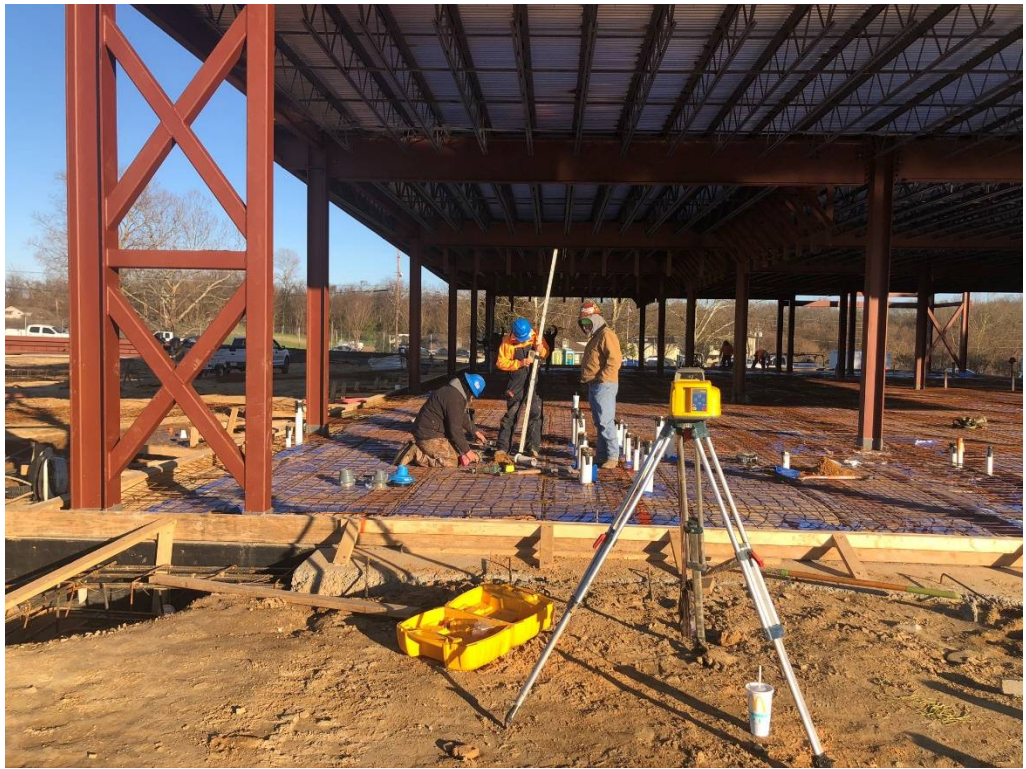
Figure 7 – Plumbers setting floor drains

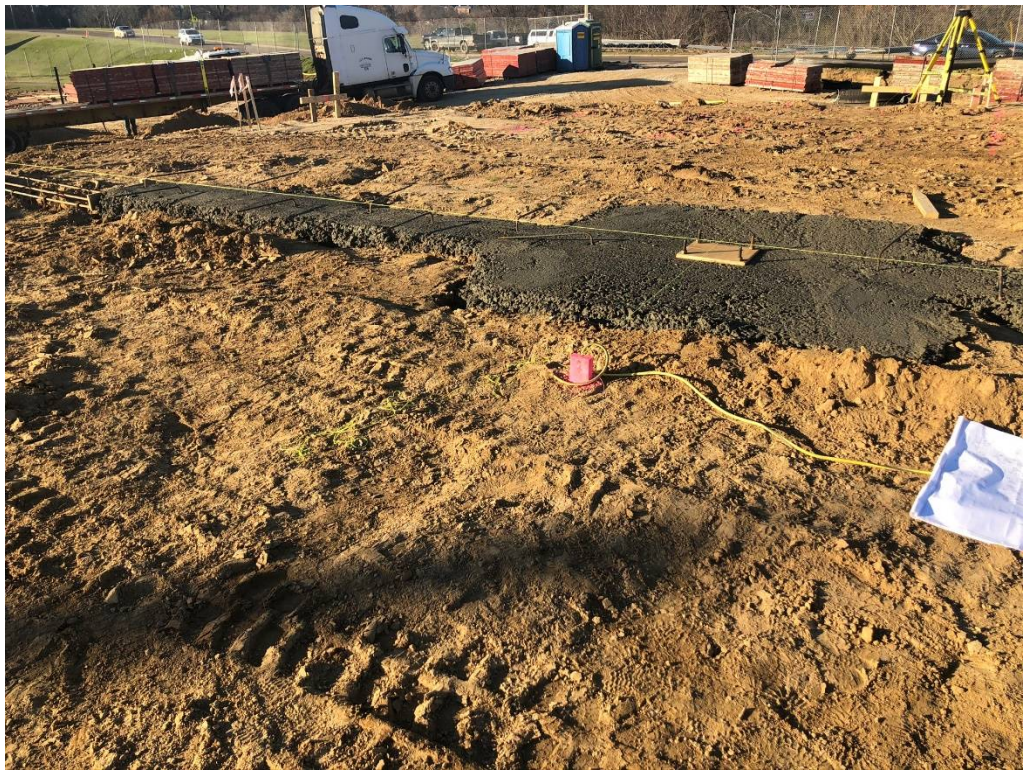
Some Concrete footings were poured today on the North Central section of building.

Figure 8 – Newly poured Concrete Footings

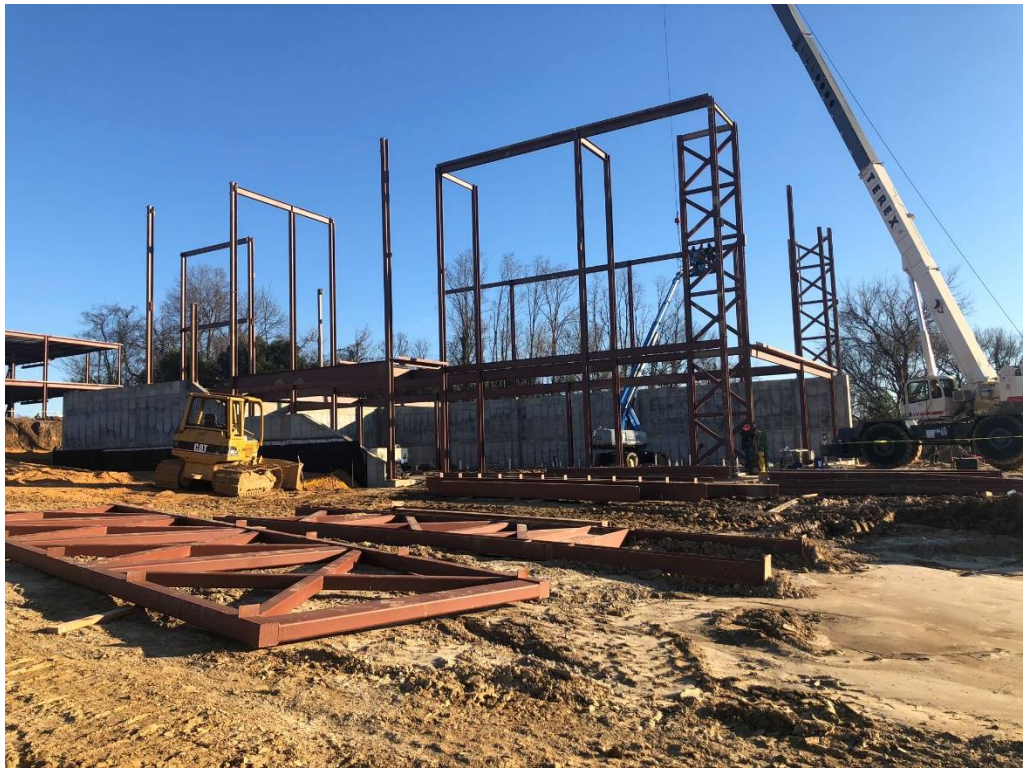
Figure 9 – Steel Erected; view from north west corner looking SSE

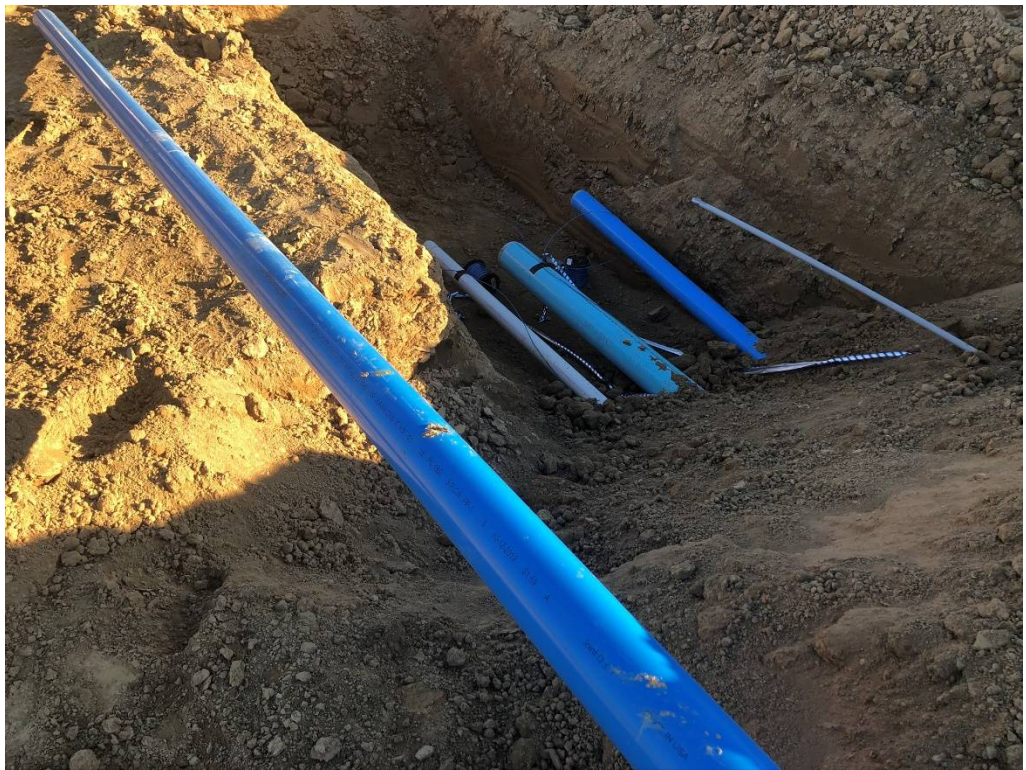
Figure 10 – Underground Utilities to west of lower structure

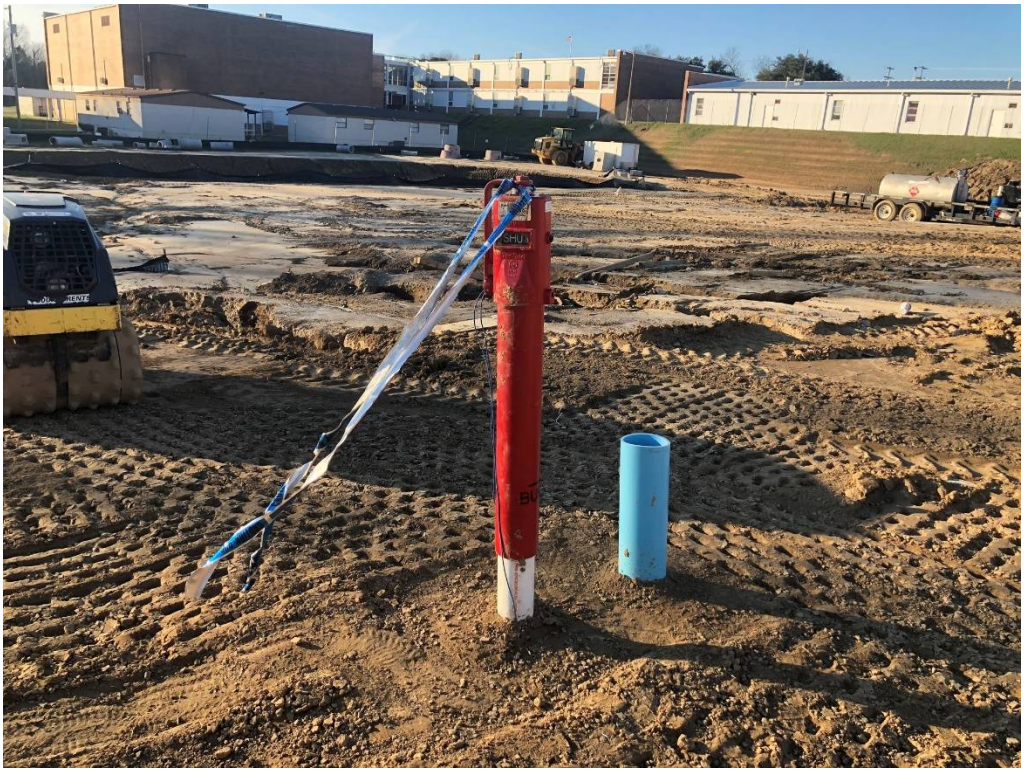
Figure 11 – Underground Utilities

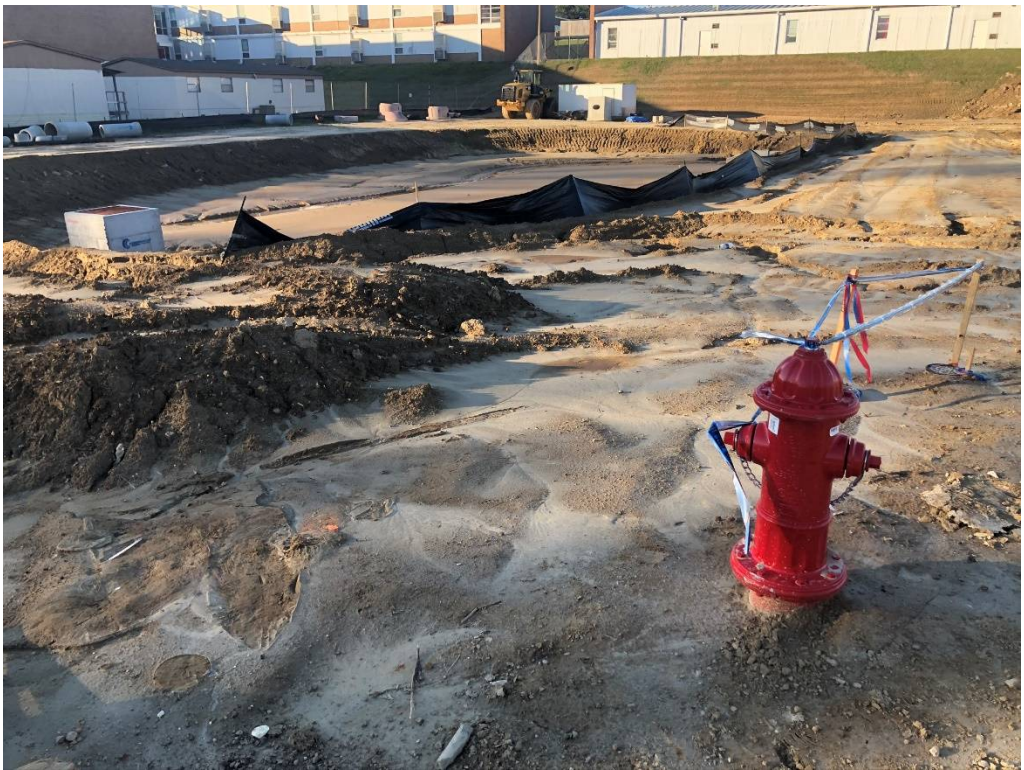
Hydrant work has been performed in the parking area as well as some underground utilities on the south side of the parking lot.

Figure 12 – Hydrant set

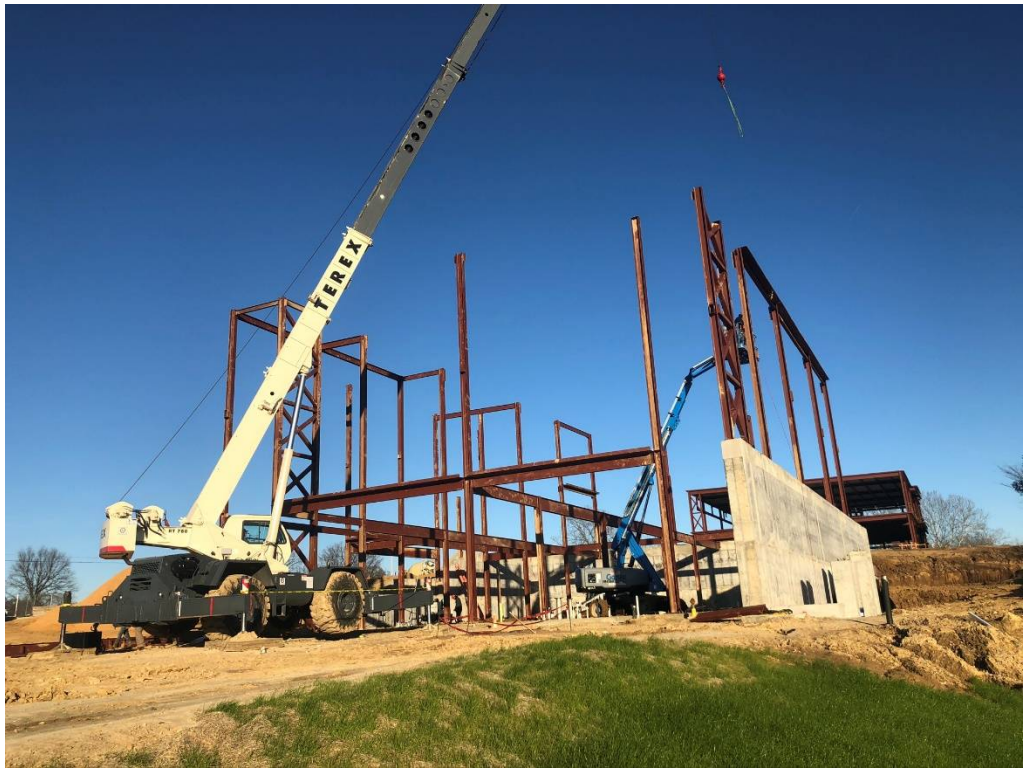
Figure 13 – Steel Erected; View From Southwest corner looking WNW

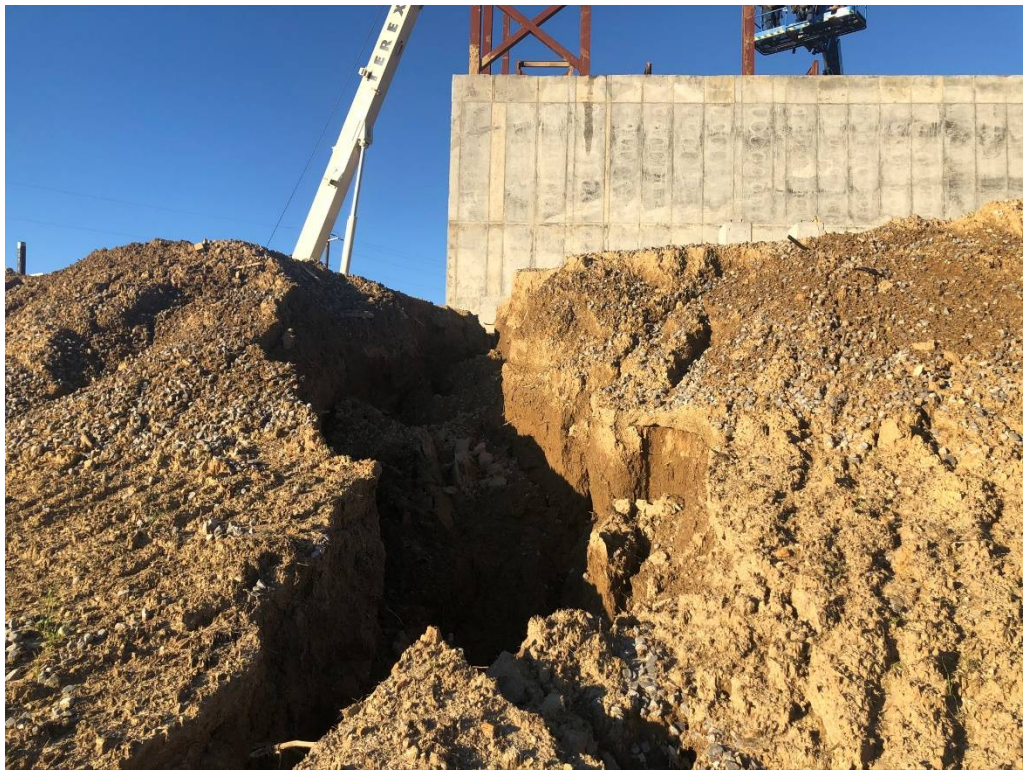
There has been a large amount of erosion at the Southwest corner of the building that requires immediate attention. I spoke with Mr. Moore (century) and he said that the dirt crew has been instructed to excavate, re fill and compact this corner tomorrow. There is an underground pipe already set in this location and will require special attention with dirt rework.

Figure 14 – Erosion at Southwest Corner of building (approx. 5-6 feet deep)

Items to Verify      Proper rework method for re-compaction of southwest corner involving installed underground pipe.

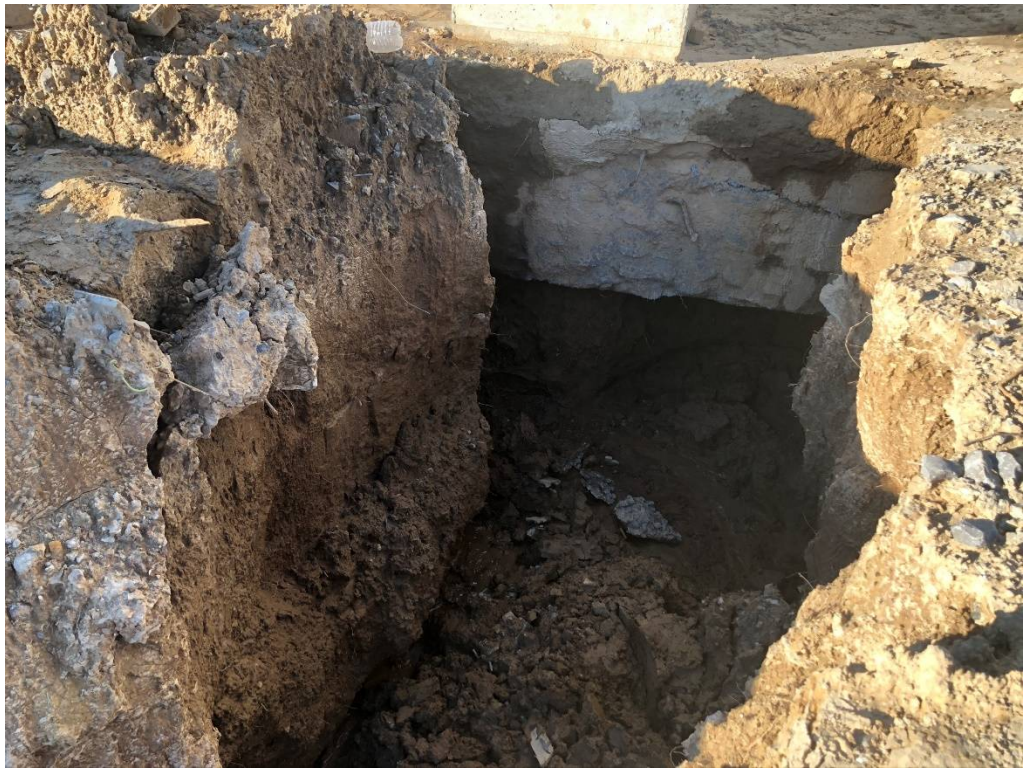
Figure 15 – Underside of footing exposed

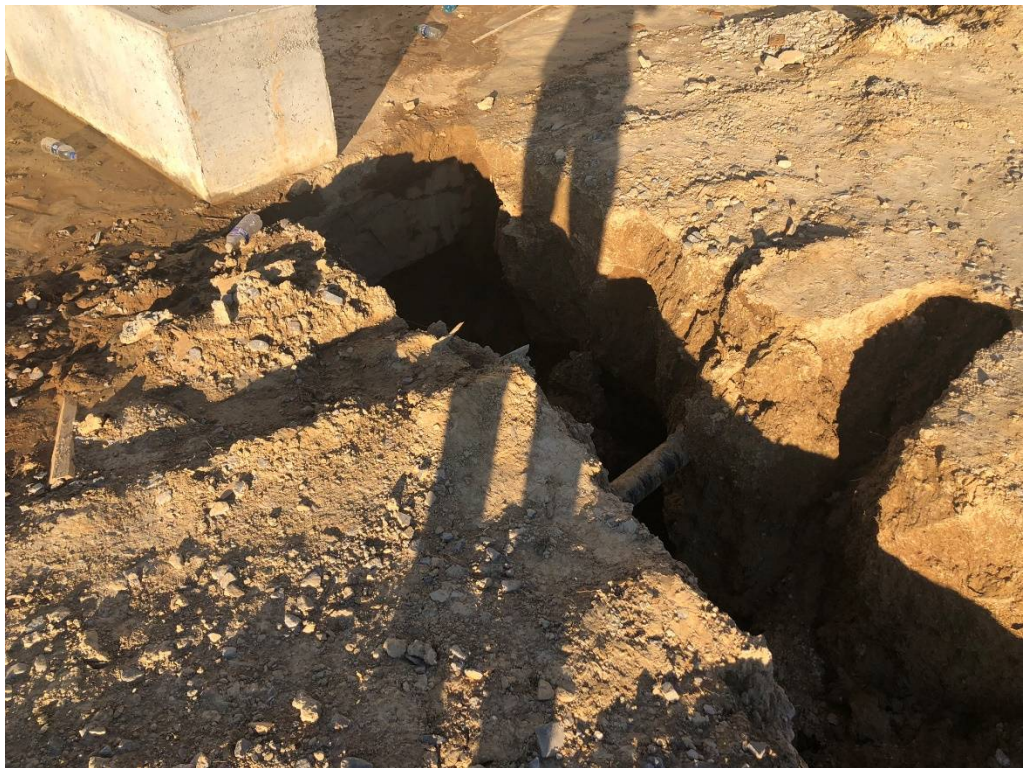
Figure 16 – Note Pipe in center right of picture

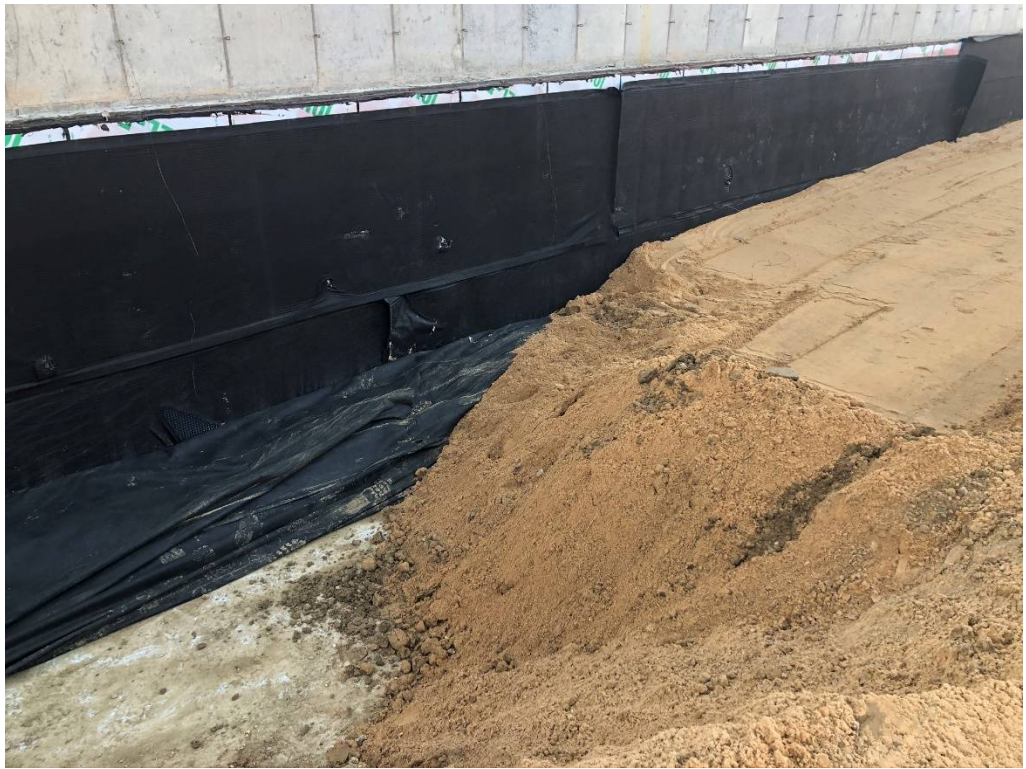
Figure 17 – Select Fill Installed at foundation wall

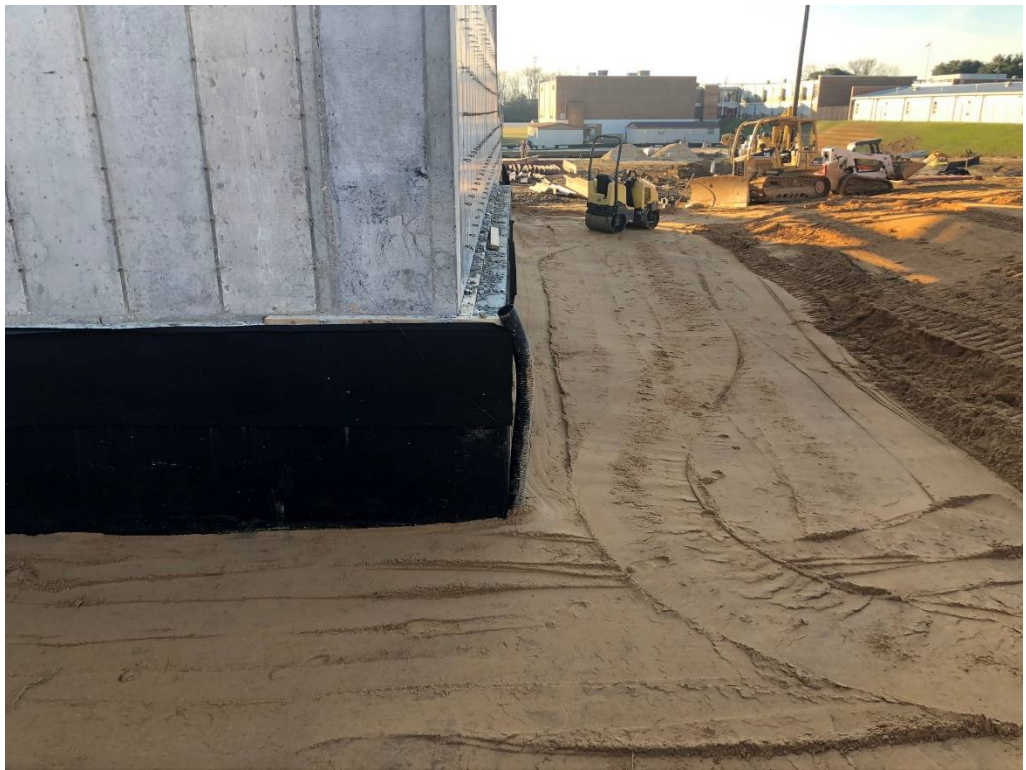
On the Southwest section of building, steel crews were erecting members. Select Fill has been placed on the northeast corner of the lower level and appears to be compacted.

Figure 18 – Select fill compacted
