Architect's Field Report

201 Park Court, Suite B Ridgeland, MS 39157 P 601.790.9432 F 888.281.0547	24 January 2020	18059-AOI Academy of Innovation / Report Number 018
One Jackson Place, Suite 250 188 East Capitol Street Jackson, MS 39201-2100 P 601.352.5411 F 601.352.5362	Contract Date / Time Weather / Temp Est % Complete Sched Conformance Work in Progress	Century Construction 24 January 2020 / 4:15 PM Overcast / 47 ° F 32% + 02 days Foundation Work – Formwork Steel Erection
161 Lameuse Street, Suite 201 Biloxi, MS 39530 P 228.374.1409 F 228.374.1414	Present at Site	Foundation Crew Steel Crew Joey Moore, Century Billy Burwell, Century Paul Purser, DBA
	Observations	I have 2 dates in this field report concerning today's and Wednesday's concrete pours. Wednesday, concrete work was performed at lower level for East building. Rebar was in place per drawings. Century also filled southwest erosion with select fill. Crews were pumping out water at the lower level of the structure as well. Today, concrete was poured at second level of East structure. A crew was also cleaning the lower slab in preparation for application of sealer. I spoke with Mr. Burwell who said intentions were to apply

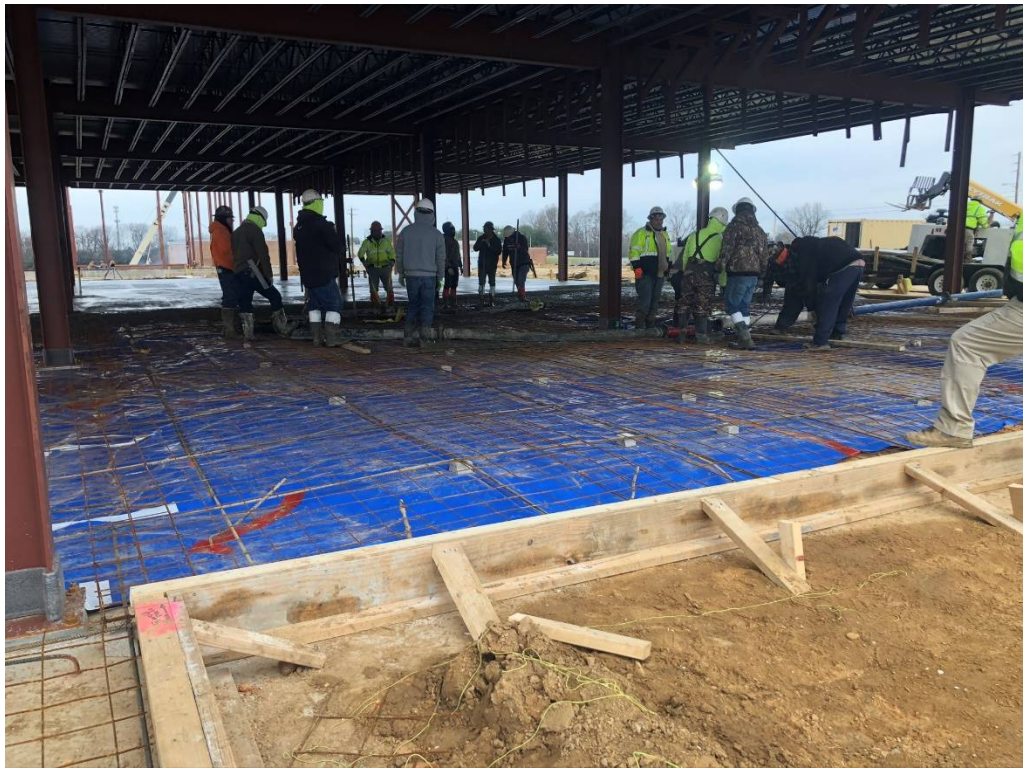
Figure 1 – Concrete work at Lower Level (Wednesday)

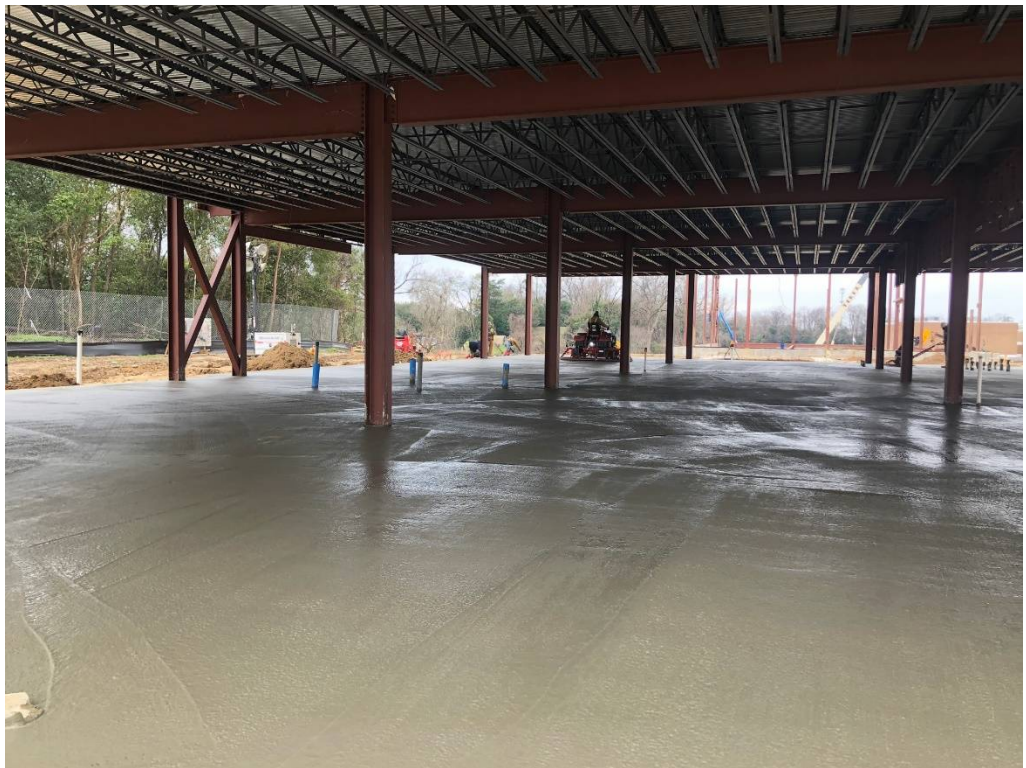
Figure 2 – Poured Slab, ready for Troweling (Wednesday)

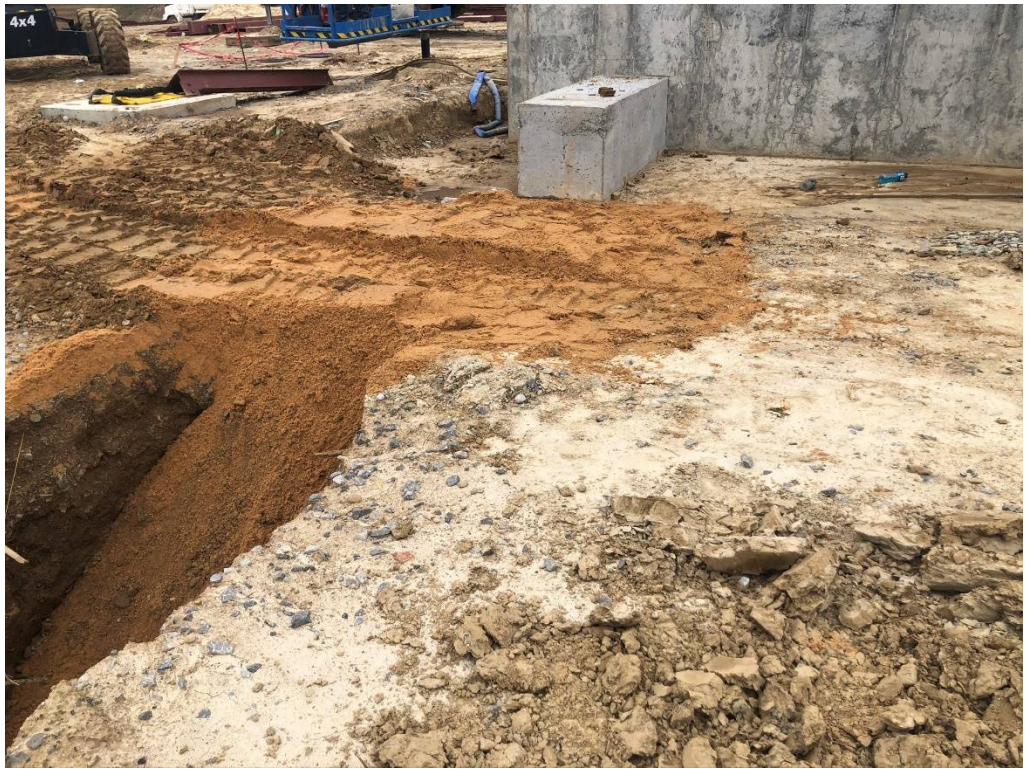
Figure 3 – Compacted Fill @ Southwest Corner (Wednesday)

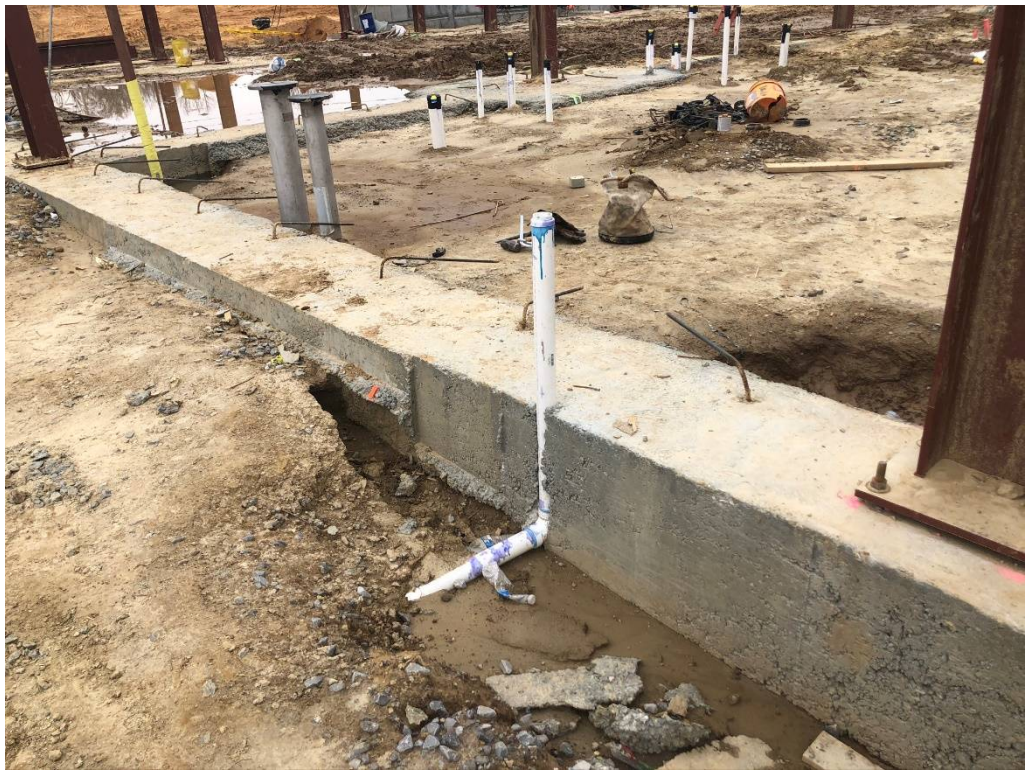
Figure 4 – Erosion @ Southwest Footing (Wednesday)

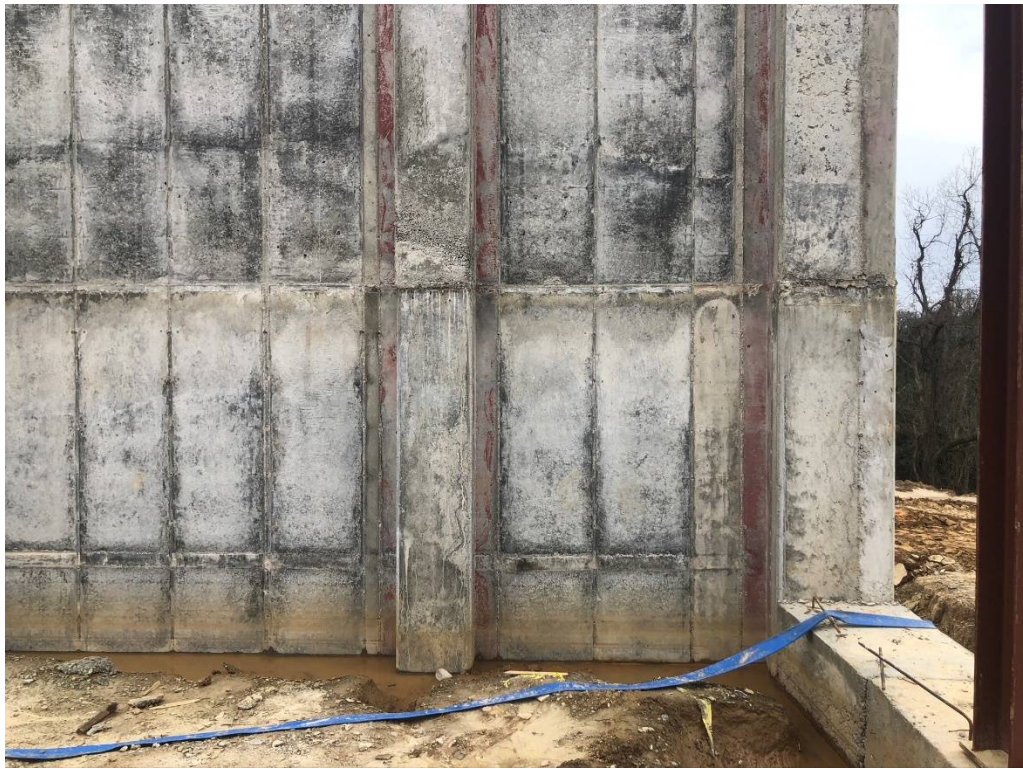
Figure 5 – Inside of Section where Erosion Occurred (Wednesday)

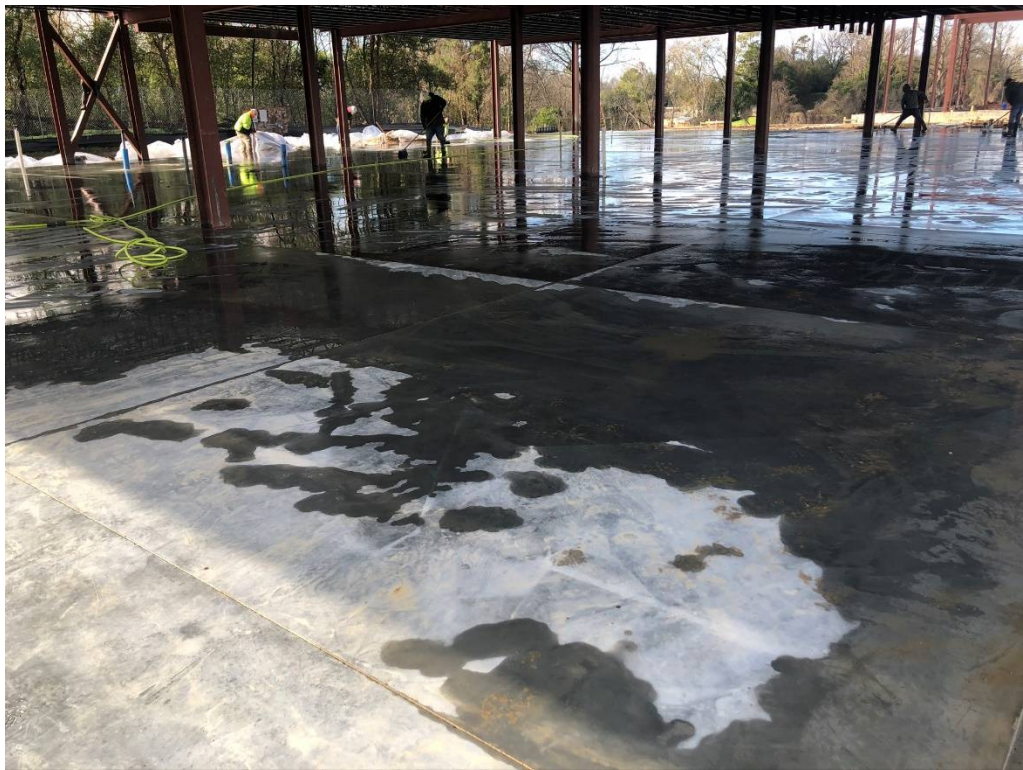
Figure 6 – Finished Slab @ Lower Level (Today)

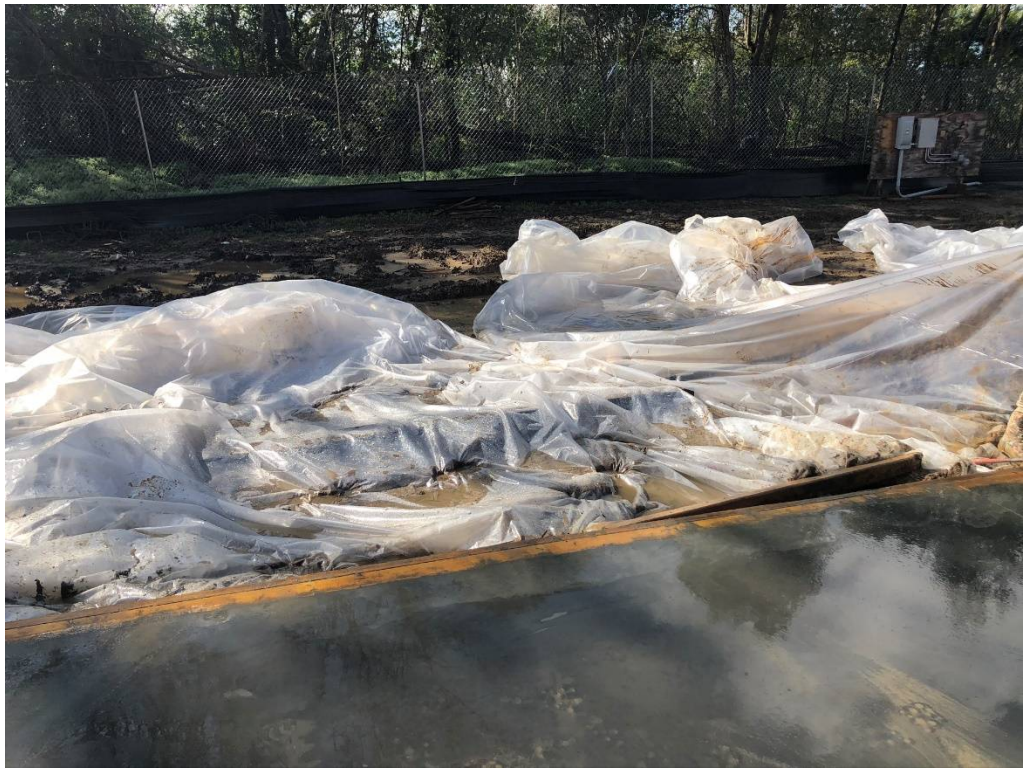
Figure 7 – Plastic Used to Cure Slab (Today)

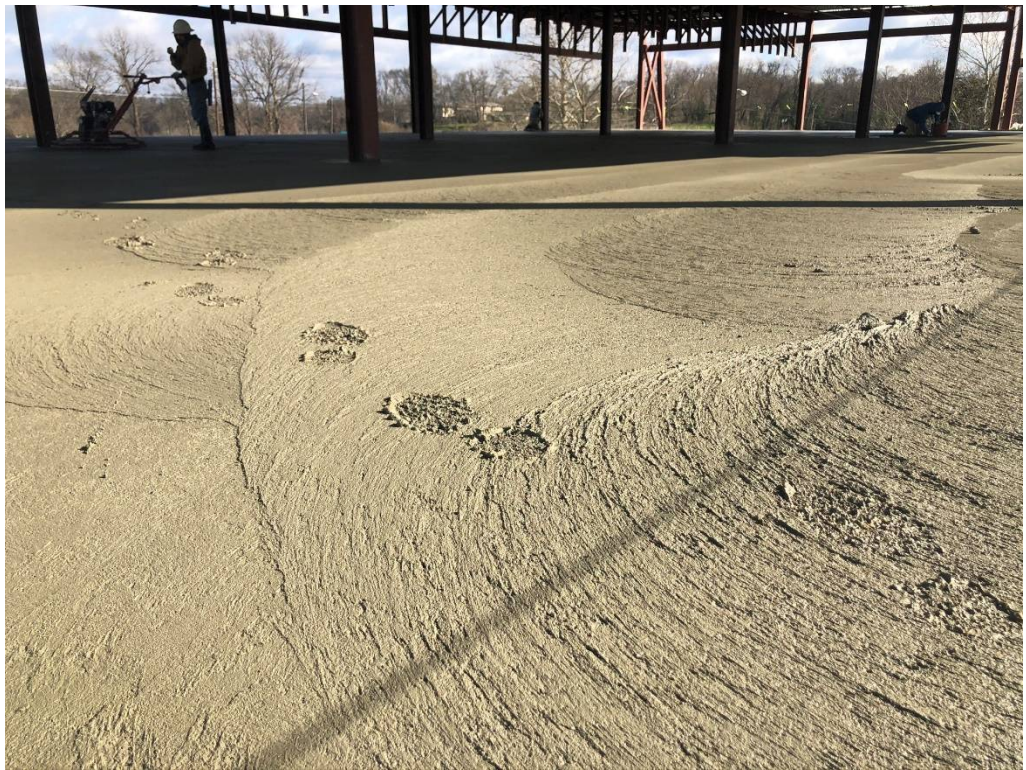
Figure 8 – Second Floor Slab, Ready for Troweling (Today)

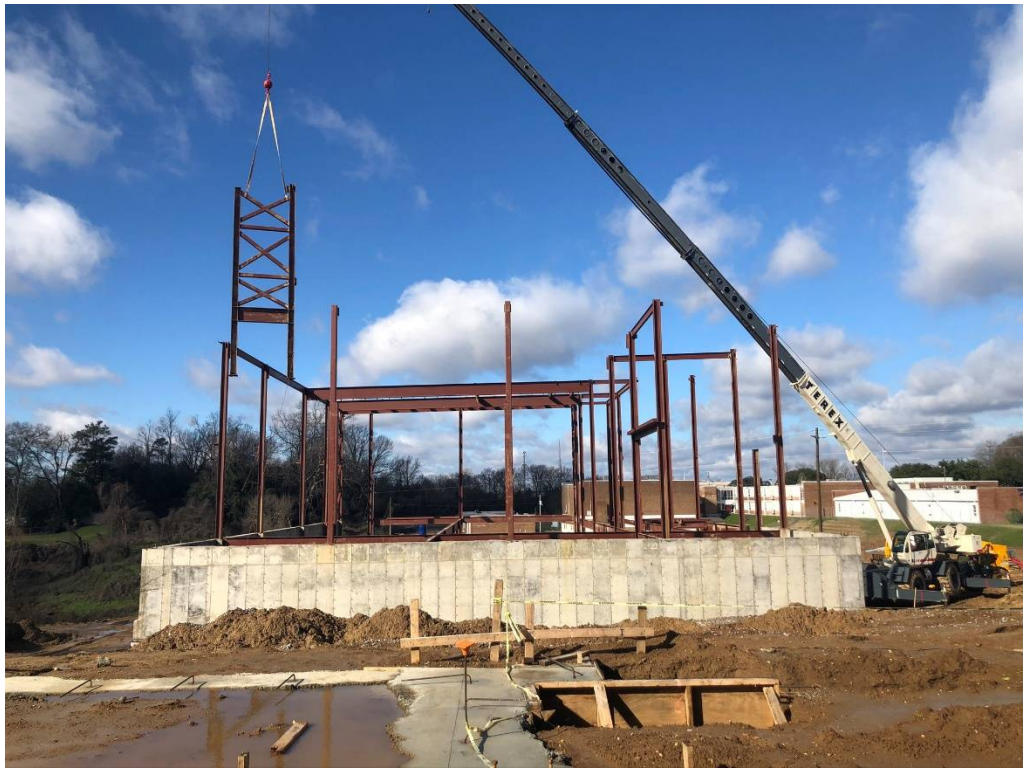
Figure 9 – Continued Steel Work @ Lower Level
