## Architect's Field Report

201 Park Court, Suite B Ridgeland, MS 39157 P 601.790.9432 F 888.281.0547	29 January 2020 18059-AOI Academy of Innovation / Report Number 019
One Jackson Place, Suite 250 188 East Capitol Street Jackson, MS 39201-2100 P 601.352.5411 F 601.352.5362	Contract Century Construction Date / Time 29 January 2020 / 3:45 PM Weather / Temp Overcast / 47 ° F Est % Complete 34% Sched Conformance + 02 days Work in Progress Foundation Work – Formwork Steel Erection
161 Lameuse Street, Suite 201 Biloxi, MS 39530 P 228.374.1409 F 228.374.1414	Present at Site Foundation Crew Steel Crew Joey Moore, Century Paul Purser, DBA
	Observations Arriving on site, I walked the site from East to West and Then Back. I met Joey Moore along the way and he said everything was going well. He mentioned that the slabs were kept wet using sprinklers.  Footing Work, digging and rebar installation were ongoing at the north central, upper section of building.  Most work was being performed at the lower level in preparation for concrete and completion of steel erection. Welders were installing joists, and crane work was being performed. Rebar work at this level and some form work were ongoing.

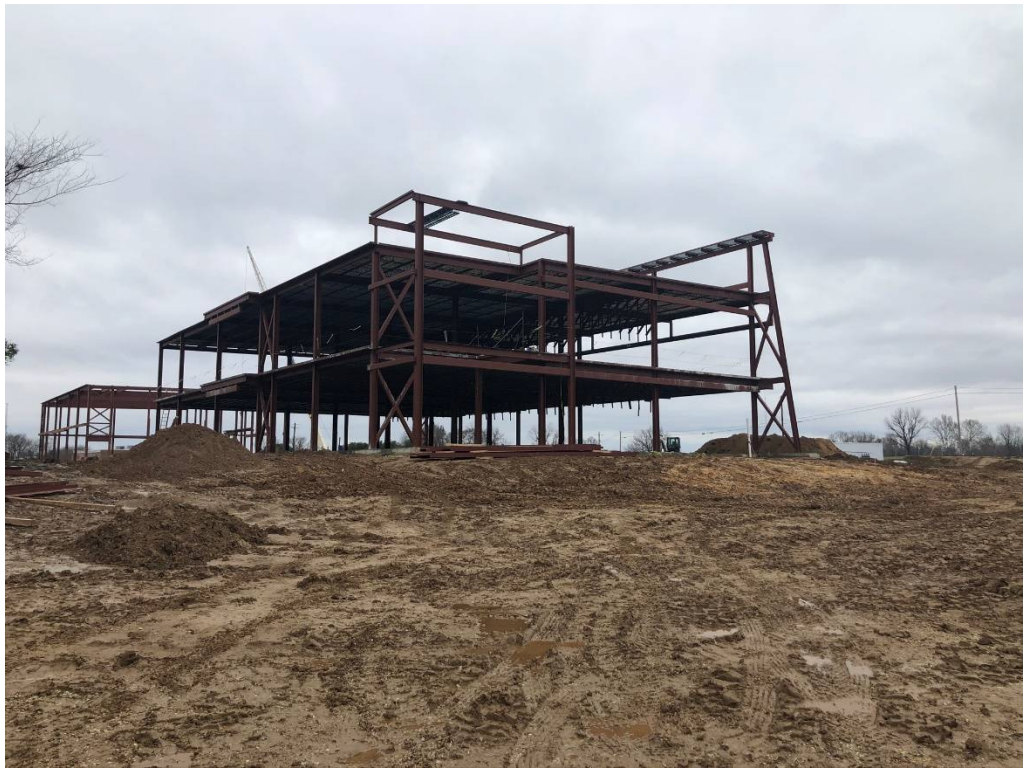
Figure 1 – East Building Erected

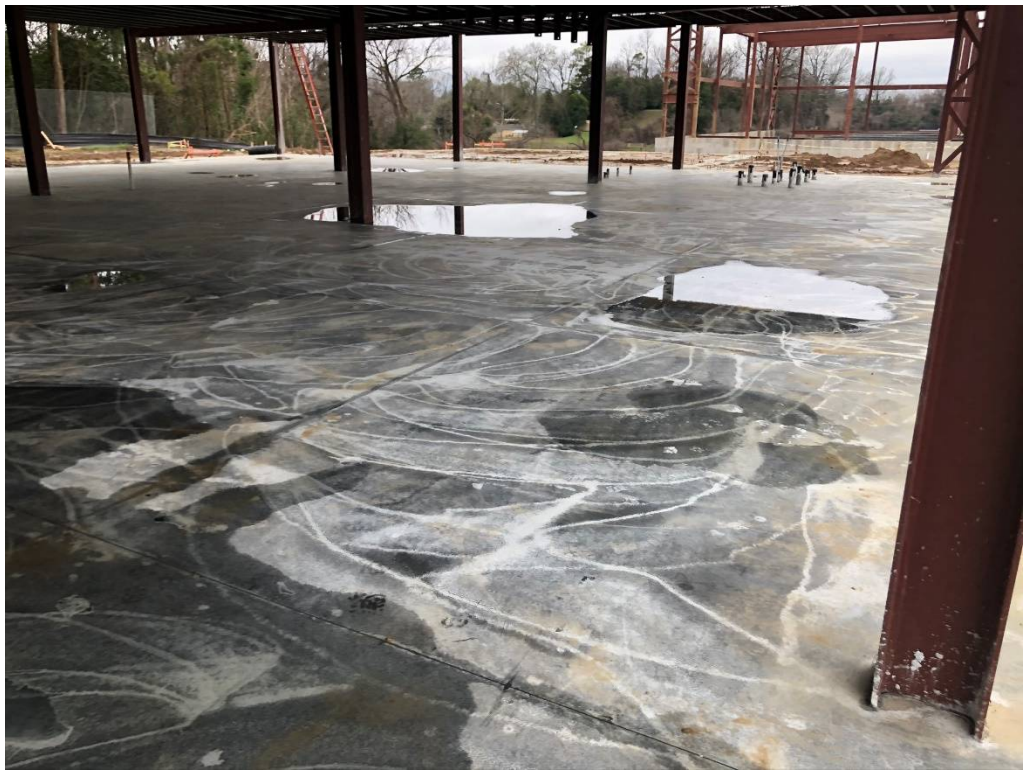
Figure 2 – Lower Slab Day 7

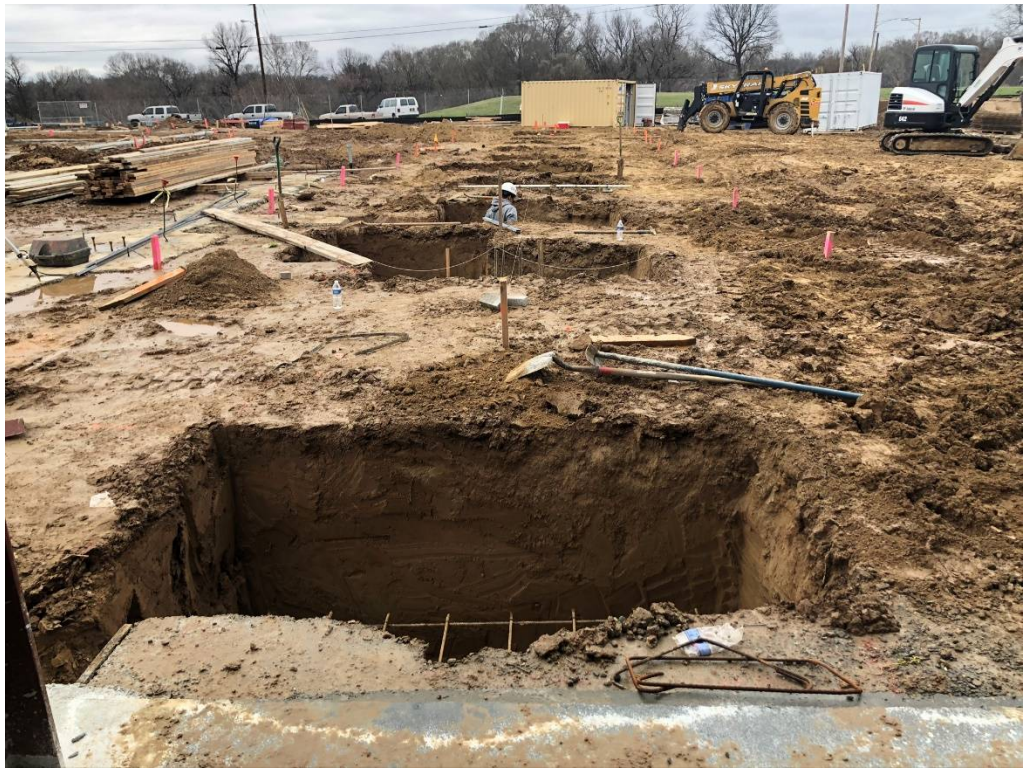
Figure 3 – Footing Dug for North Out Stretch of Buidling

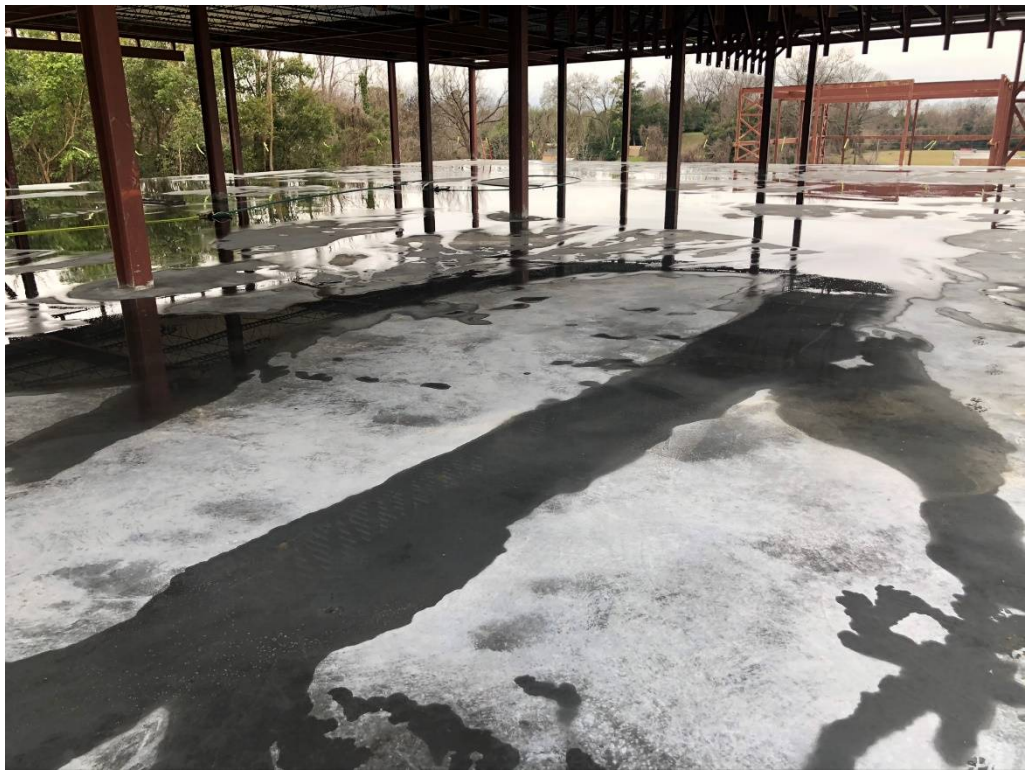
Figure 4 – Upper Slab Day 5

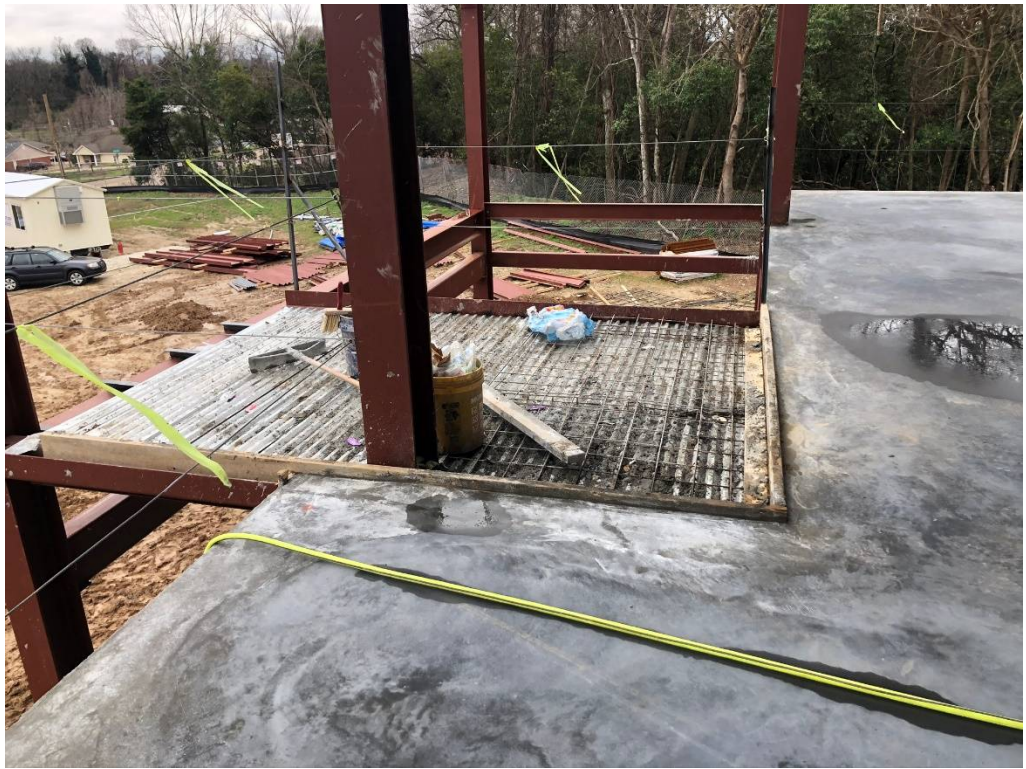
Figure 5 – Section Un-Finished (Awaiting Steel Egress Stair Installation)

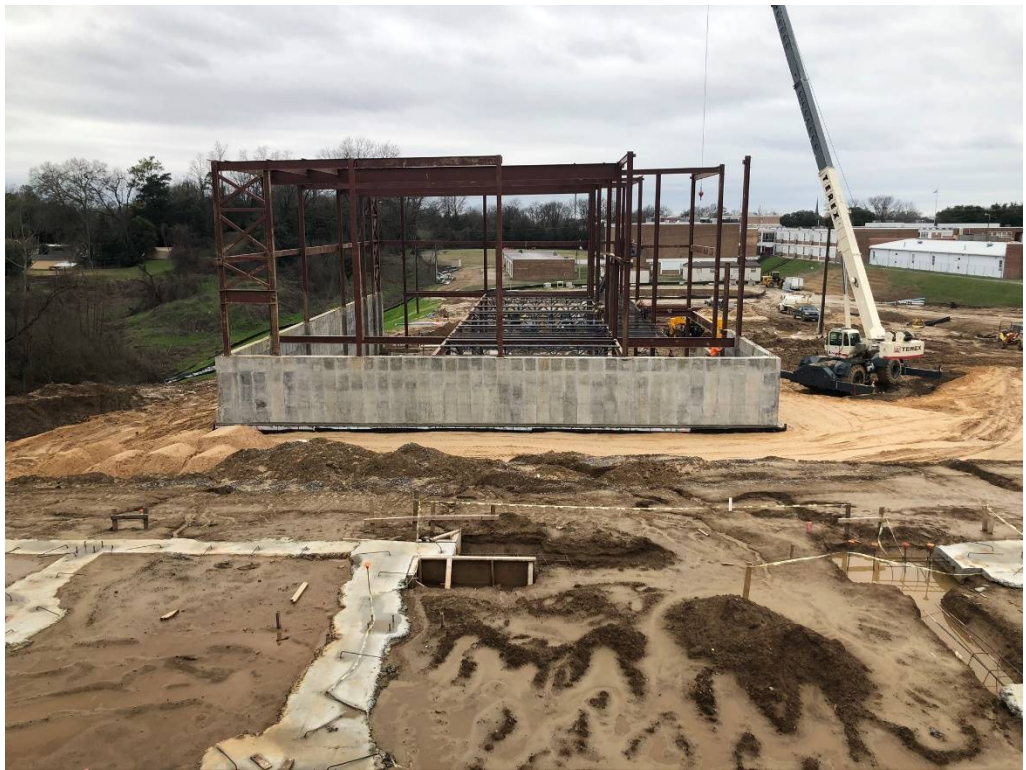
Figure 6 – West Building Steel Erection Progress

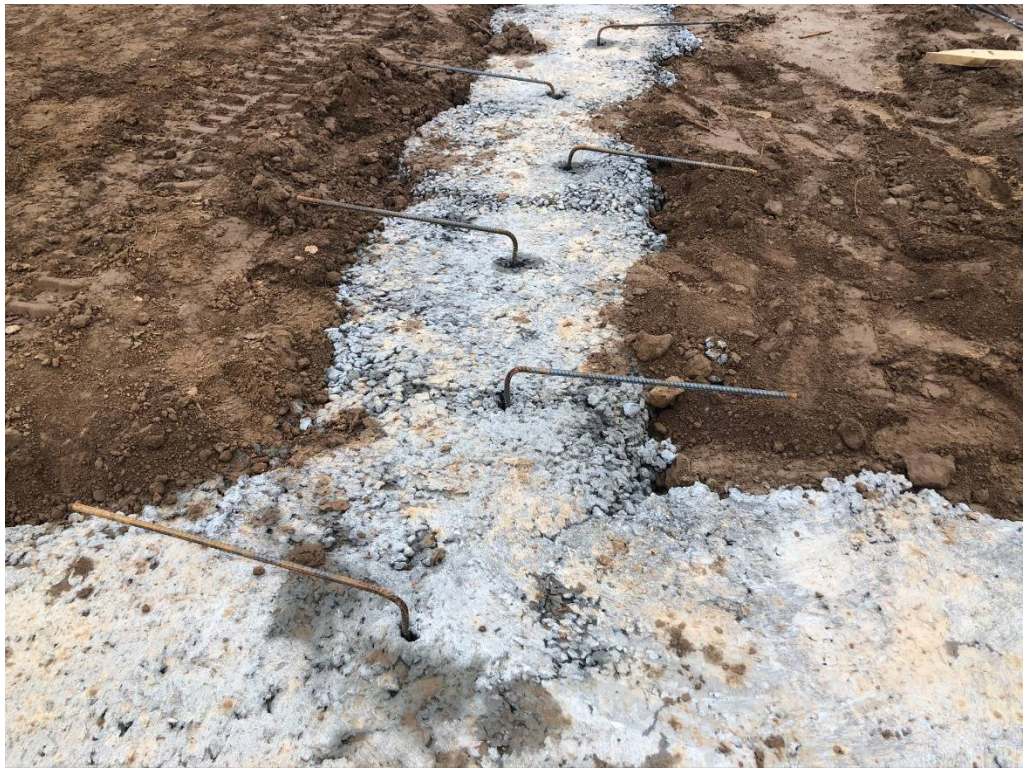
Figure 7 – New Footings Poured on North Central Section of Building

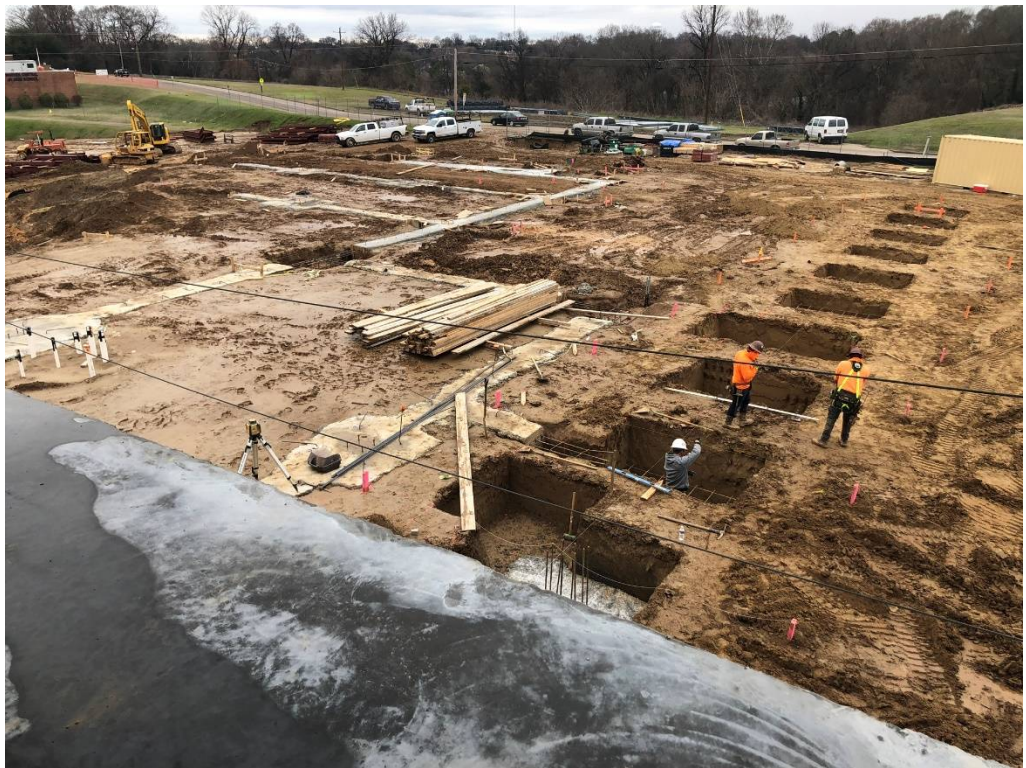
Figure 8 – North Stretch Of Structure from The Second Level of East Building

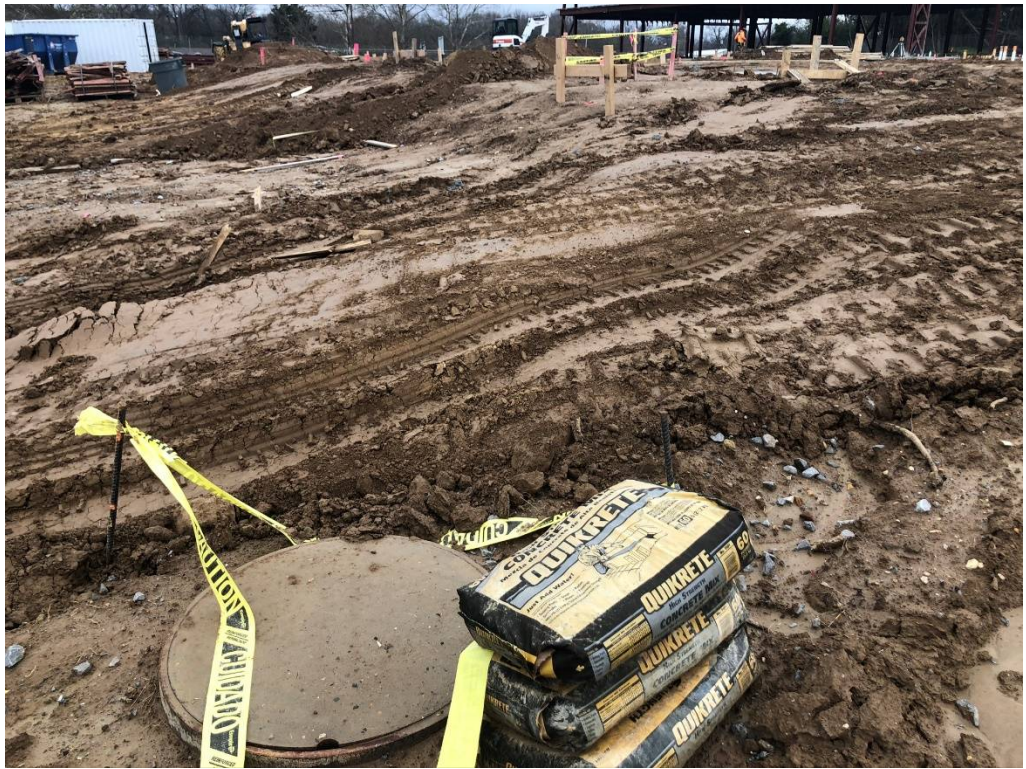
Figure 9 – Man Hole Installed at North Section of Site

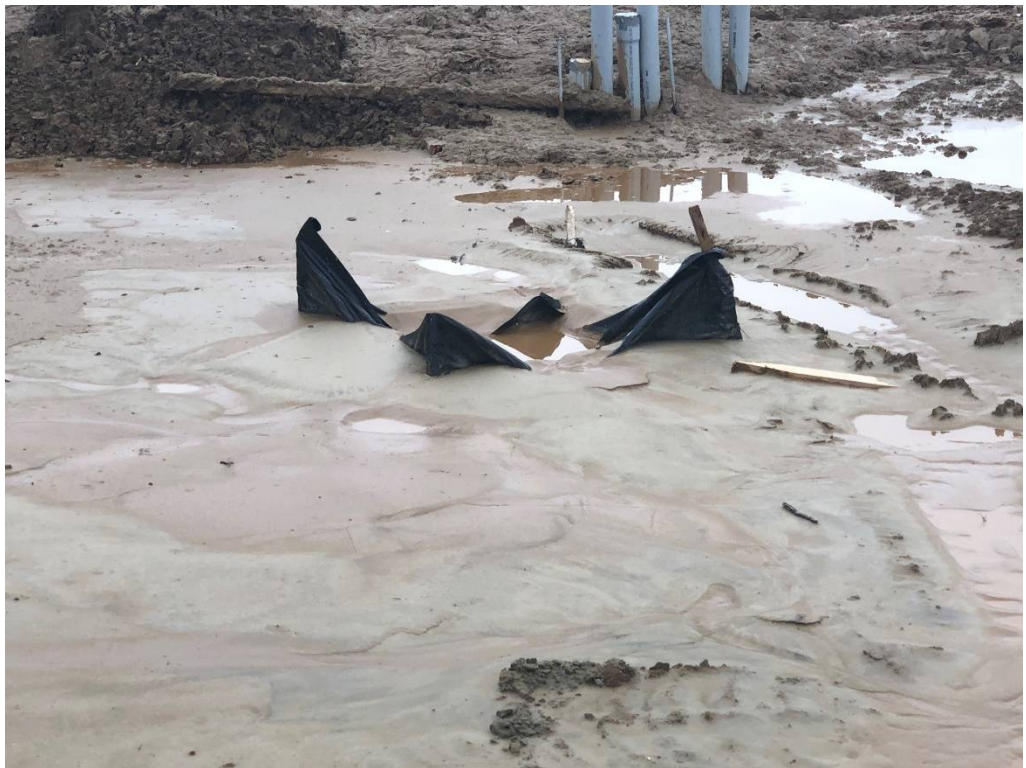
Figure 10 – Storm Sewer Overwhelmed at West Edge of Building Near Parking

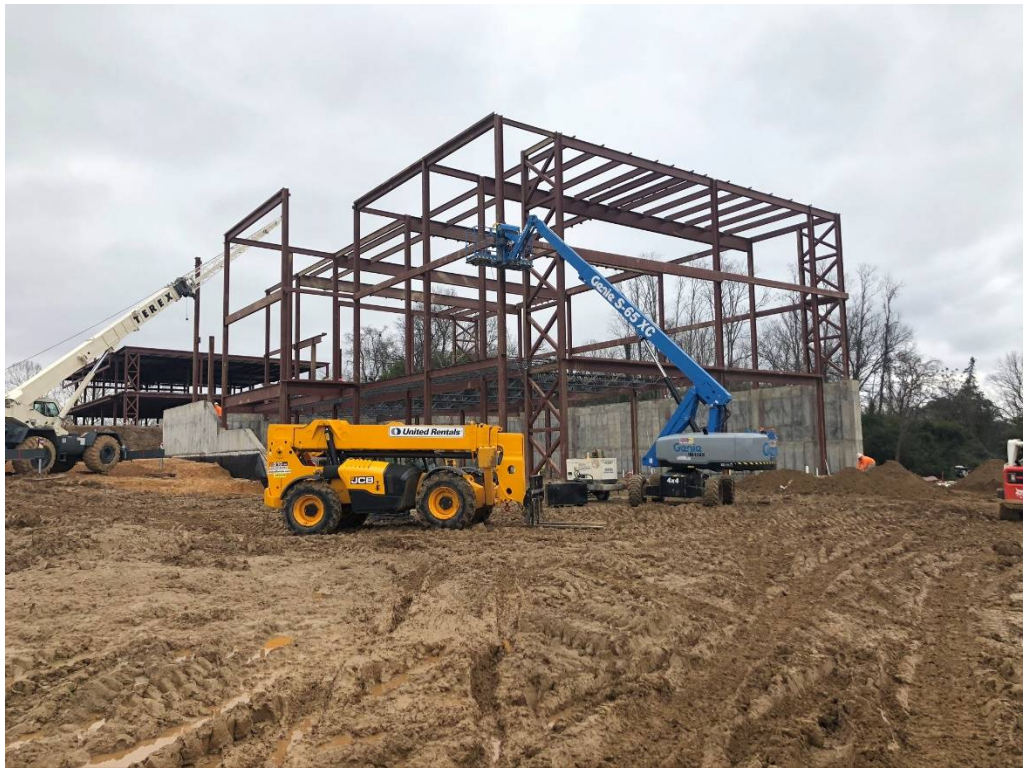
Figure 11 – Progress on Steel Erection from NW of Structure

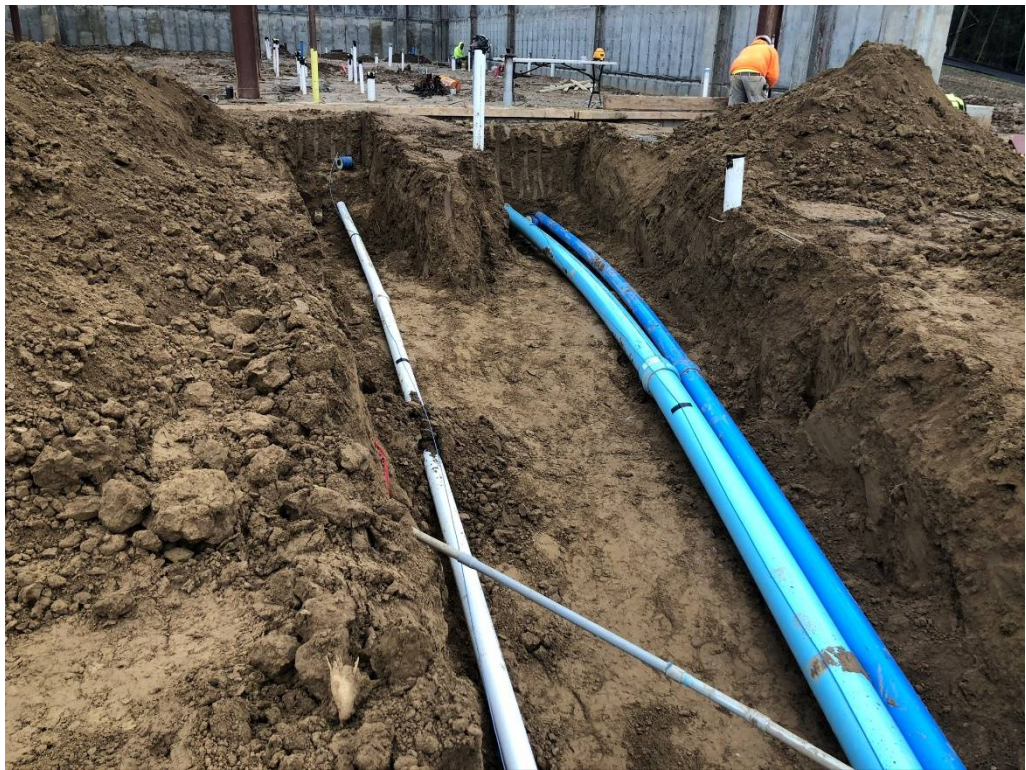
Figure 12 – Services Coming into Building

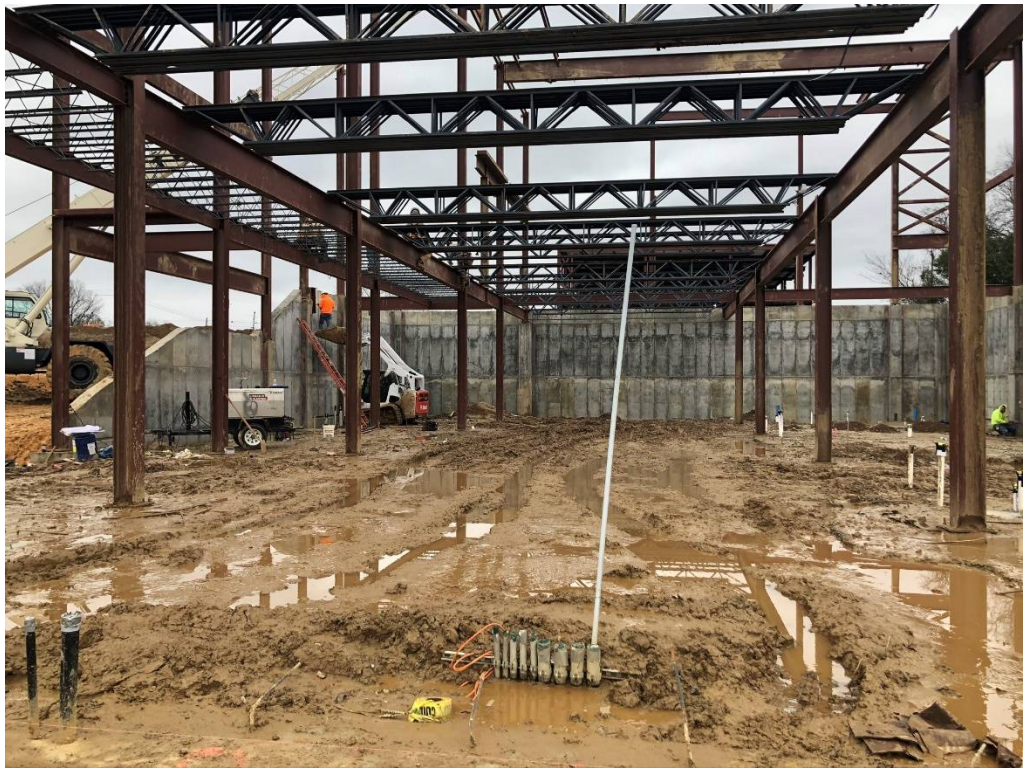
Figure 13 – Lower West Section of Building Looking East

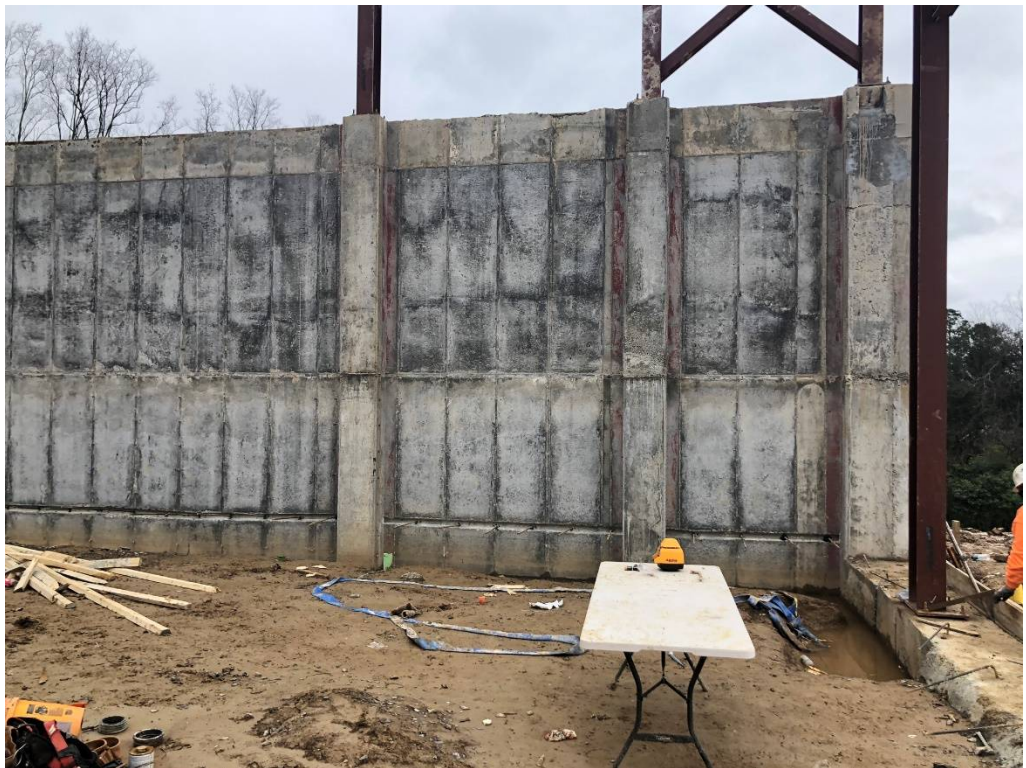
Figure 14 – Southwest Corner of Structure

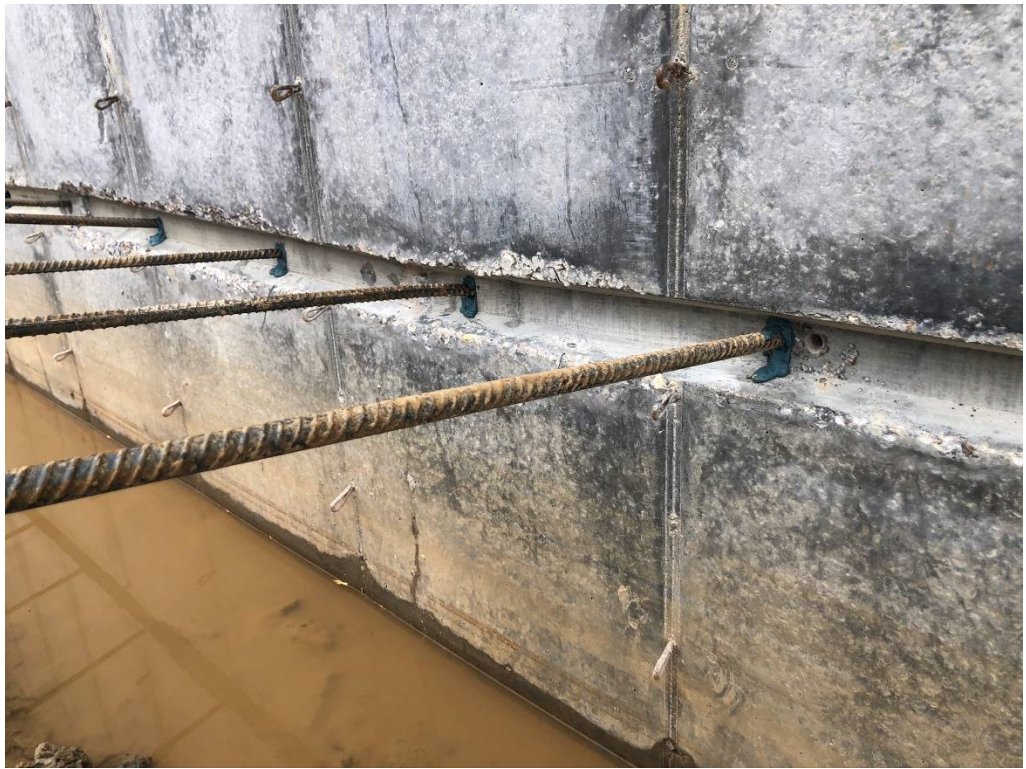
Figure 15 – Rebar Installed with Epoxy at Lower Level

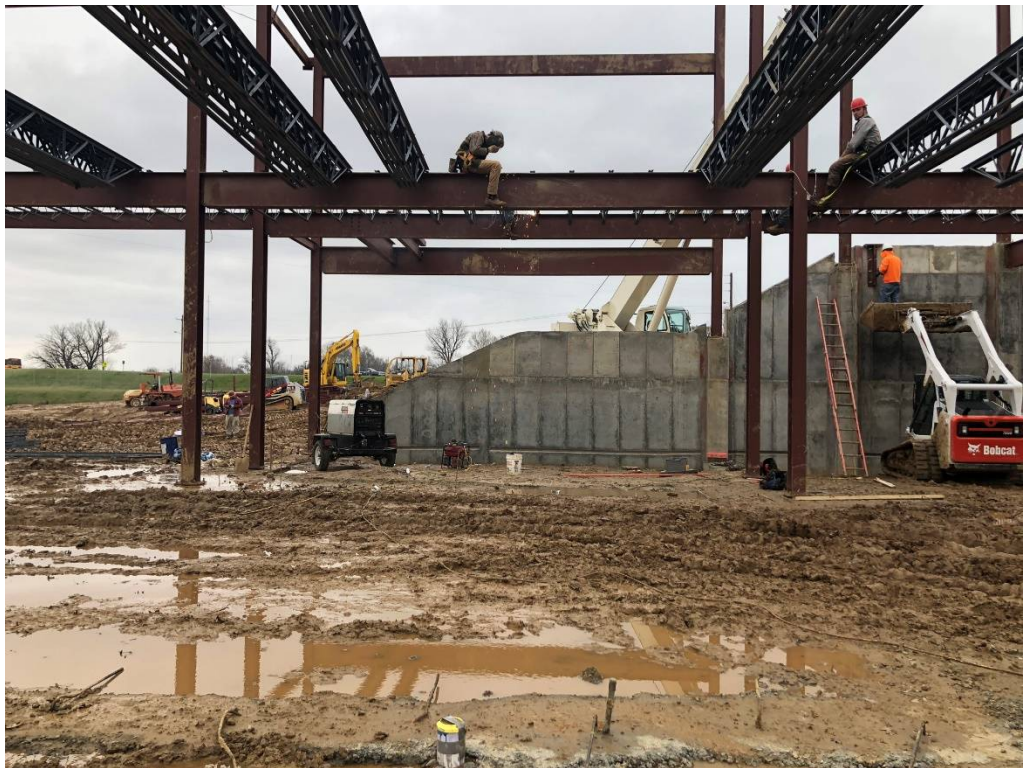
Figure 16 – Welders Installing Floor Joists

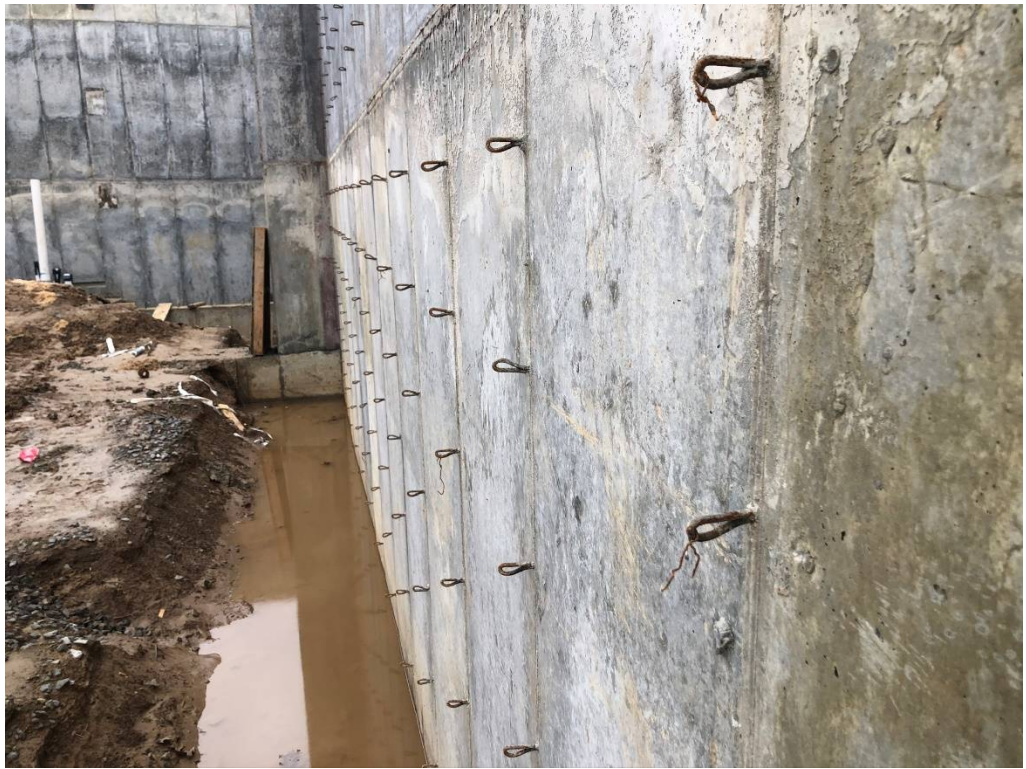
Figure 17 – Concrete Work and Mechanical Attachments at Foundation Wall

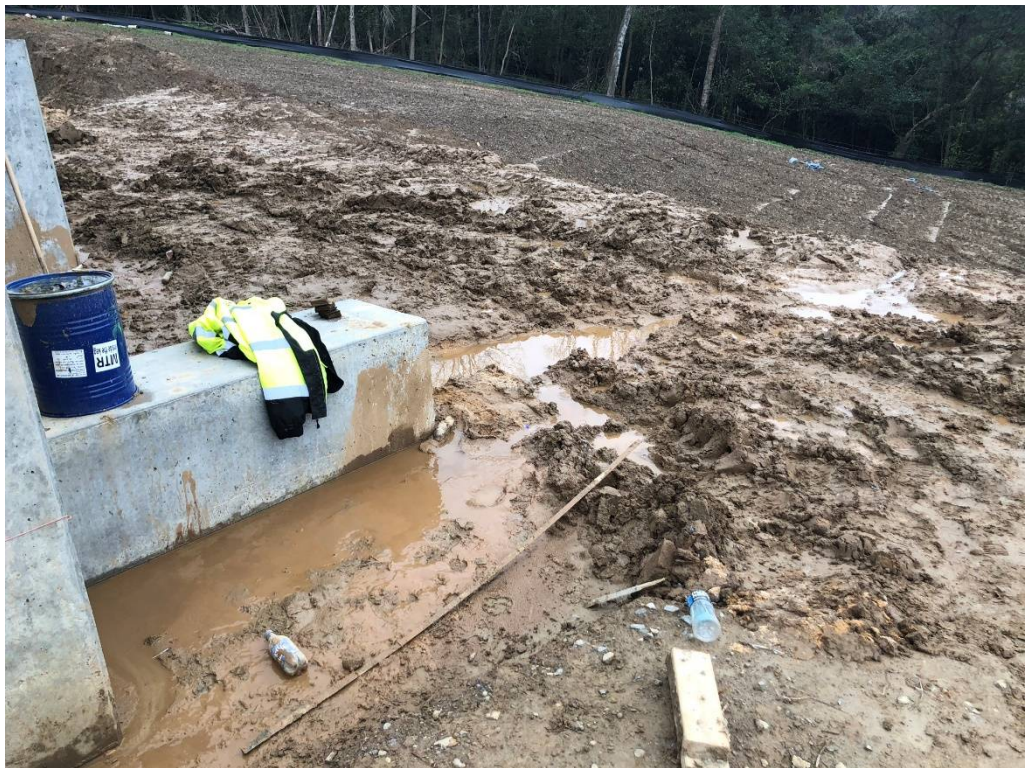
Figure 18 – Southwest Footing Where Previous Erosion Occurred

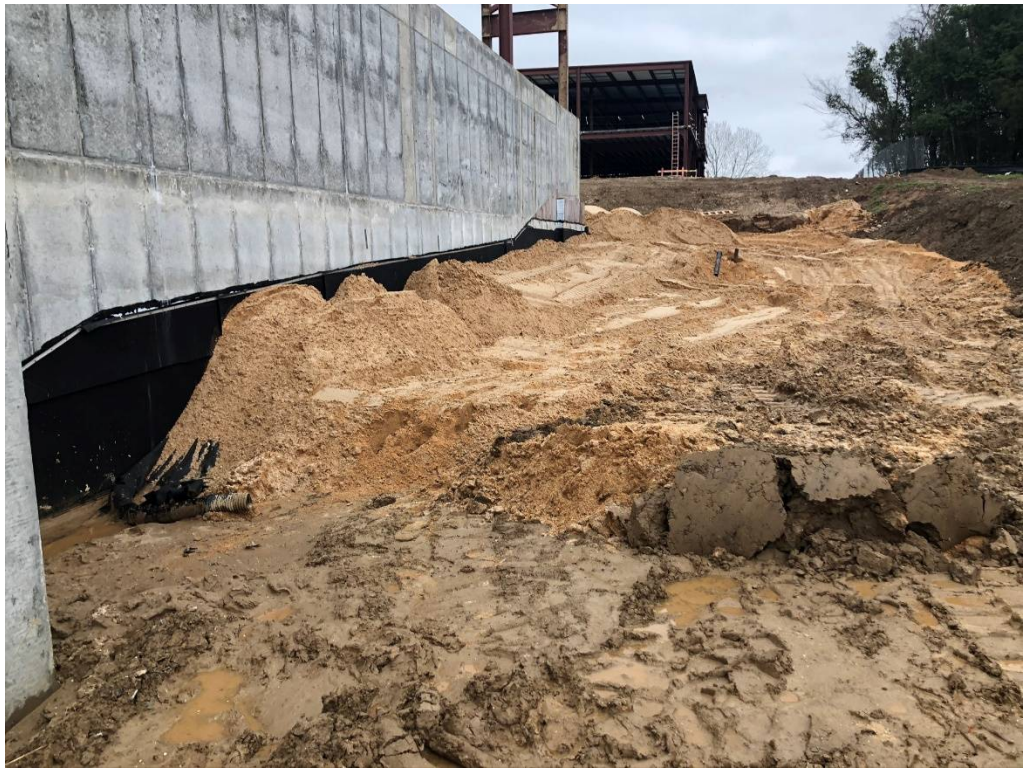
Figure 19 – Select Fill Installed at South Section of Lower West Building

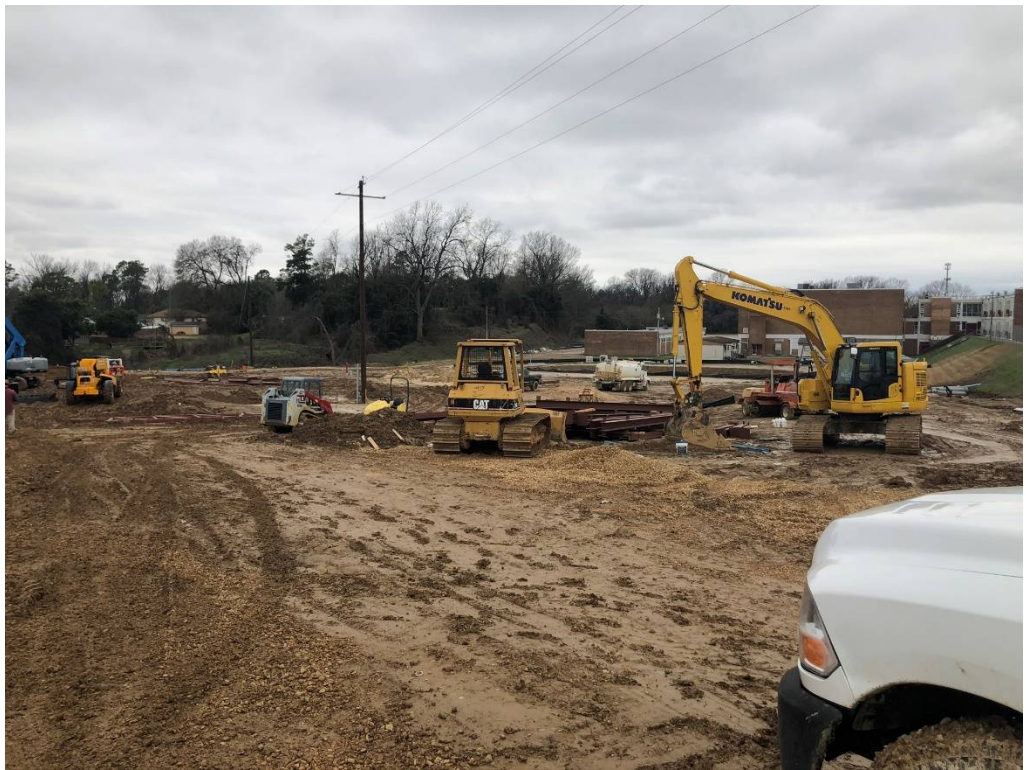
Figure 20 – North Entry Looking WSW

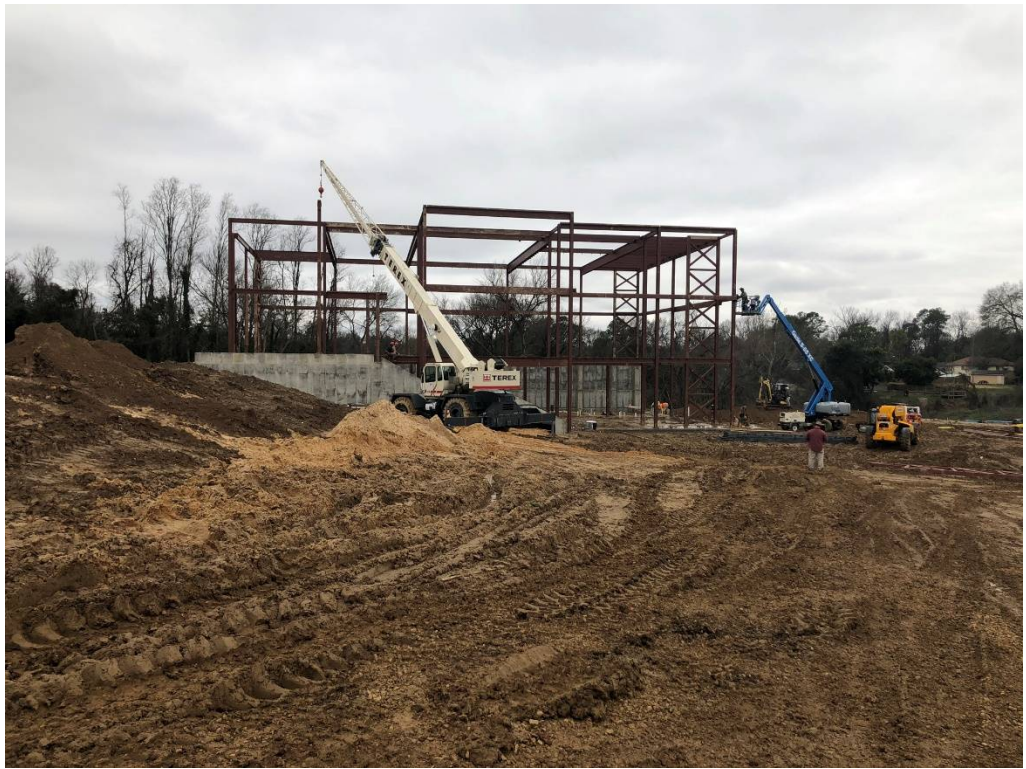
Figure 21 – North Entry Looking S

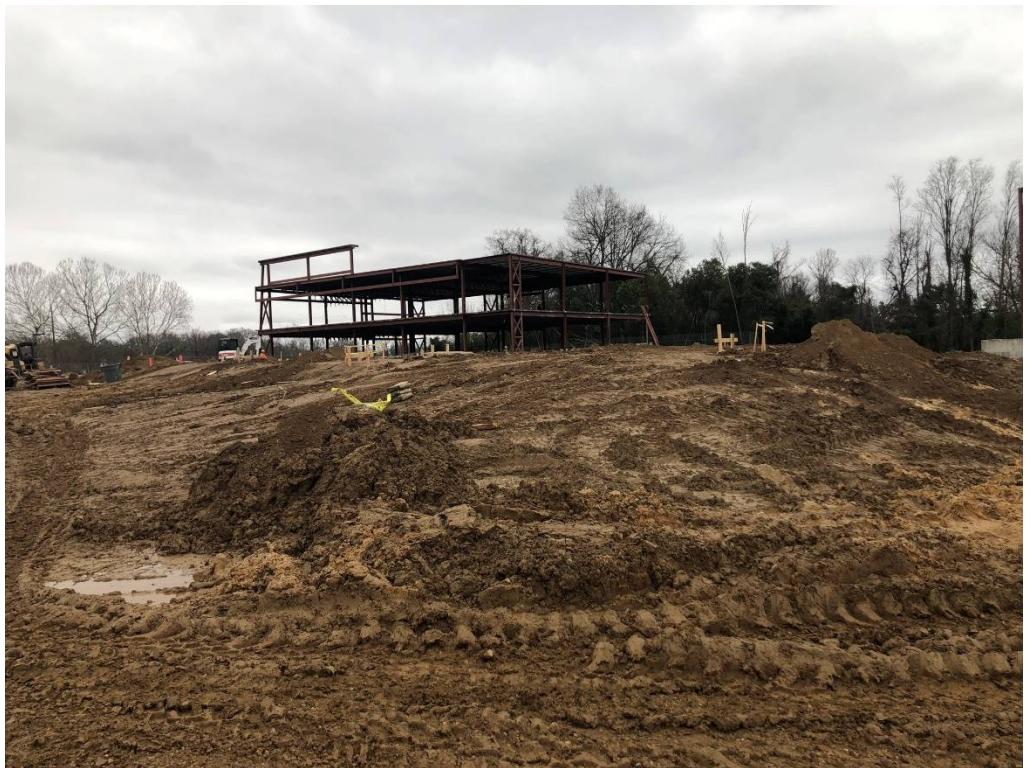
Figure 22 – North Entry Looking ESE

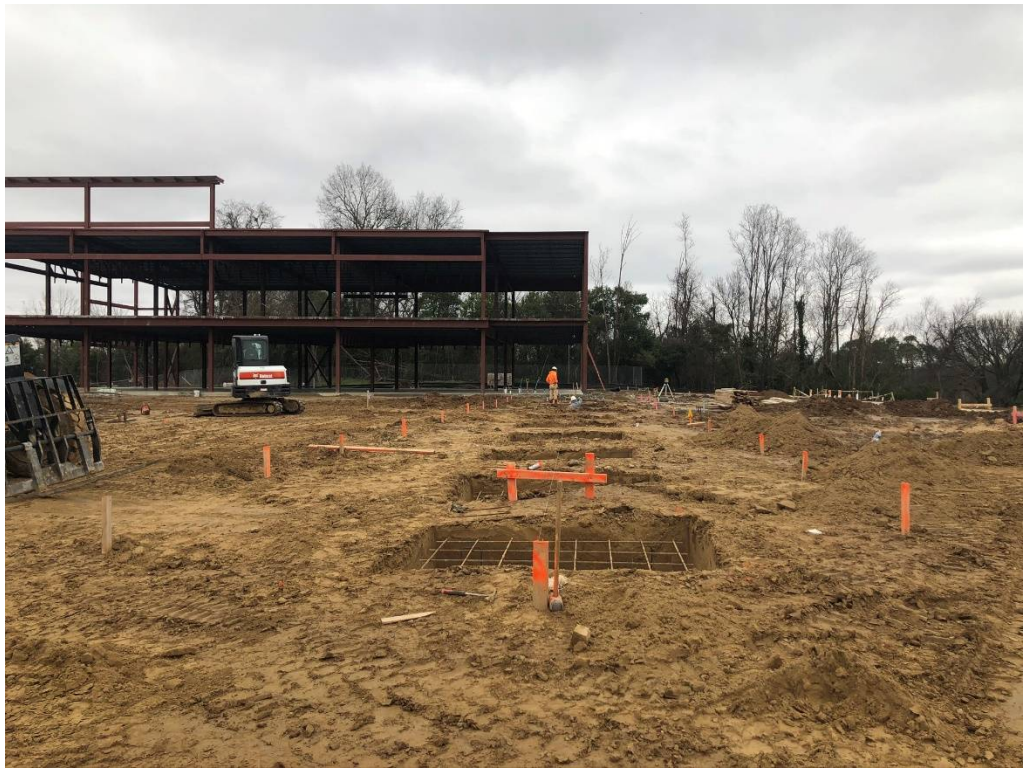
Figure 23 – Out Stretch of Structure from North Perspective

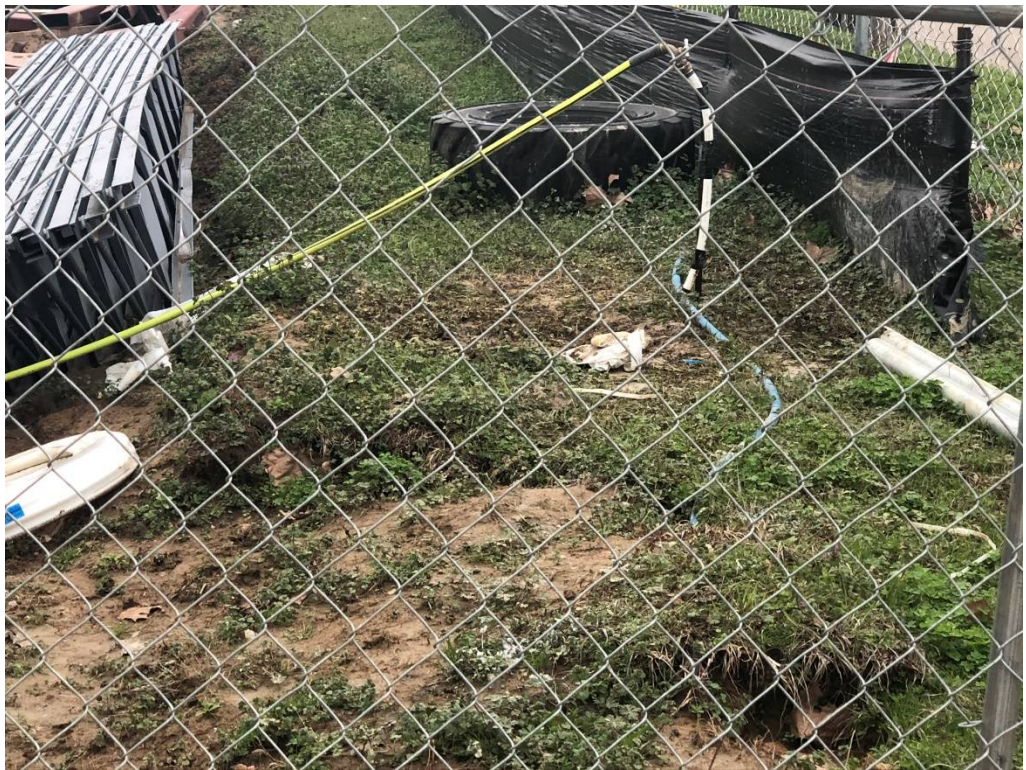
Figure 24 – Temp Water
