## Architect's Field Report

06 February 2020

18059-AOI Academy of Innovation / Report Number 020

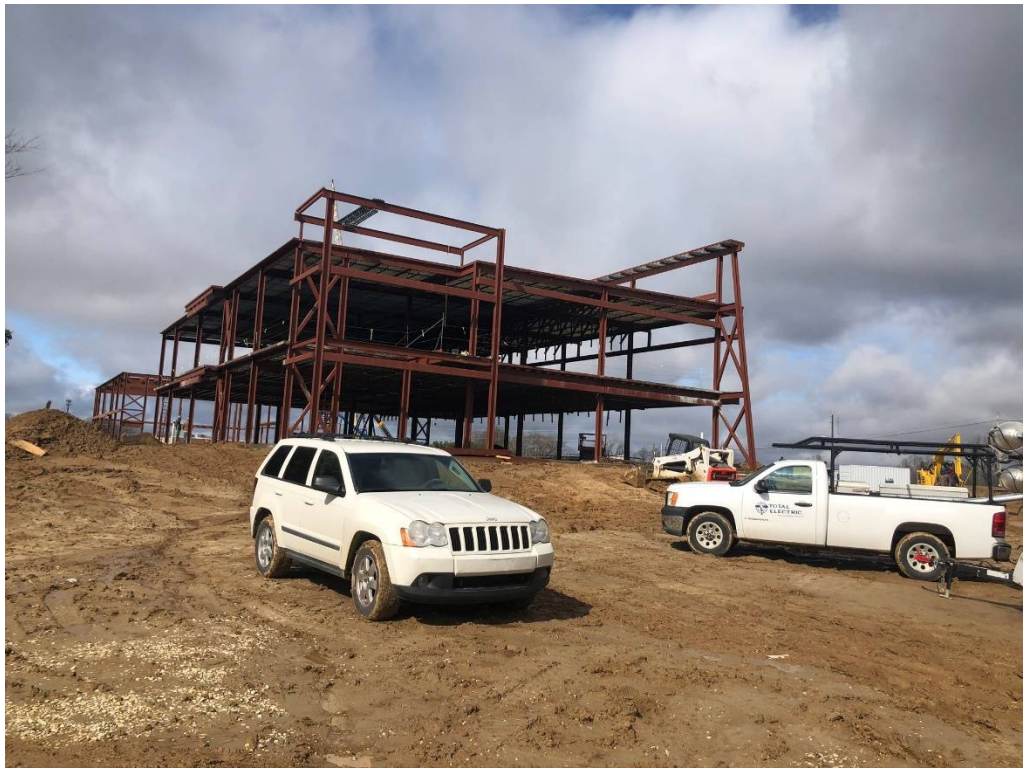
Figure 1 – East Building Erected

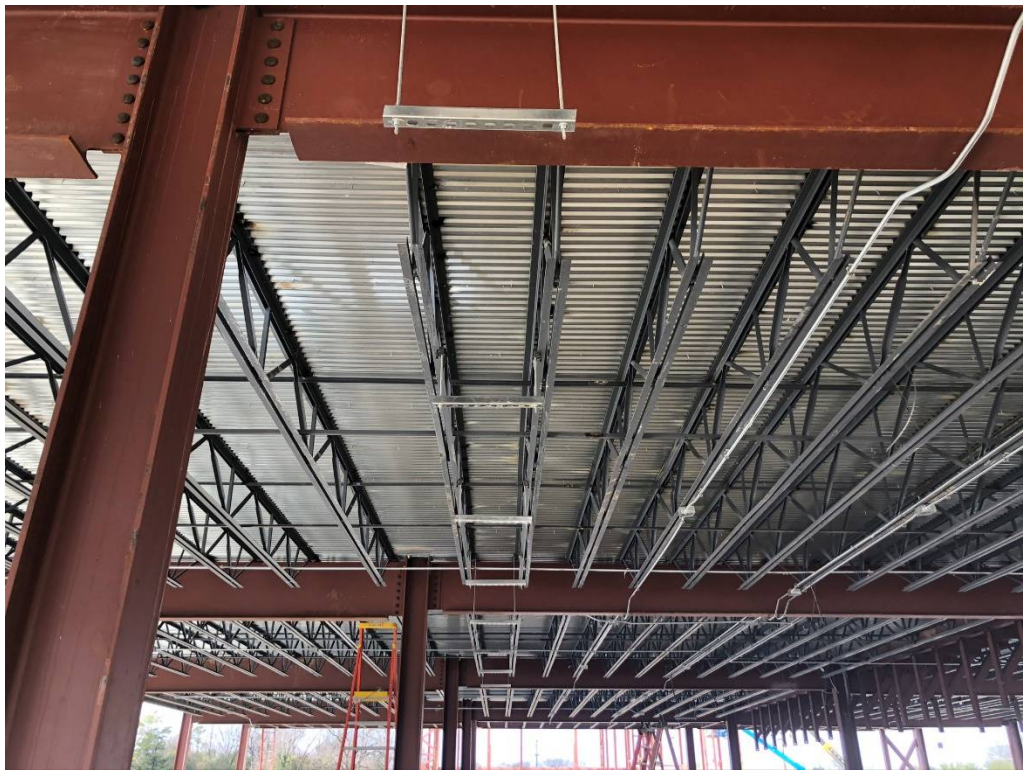
Figure 2 – Electrical Rough-In Ongoing

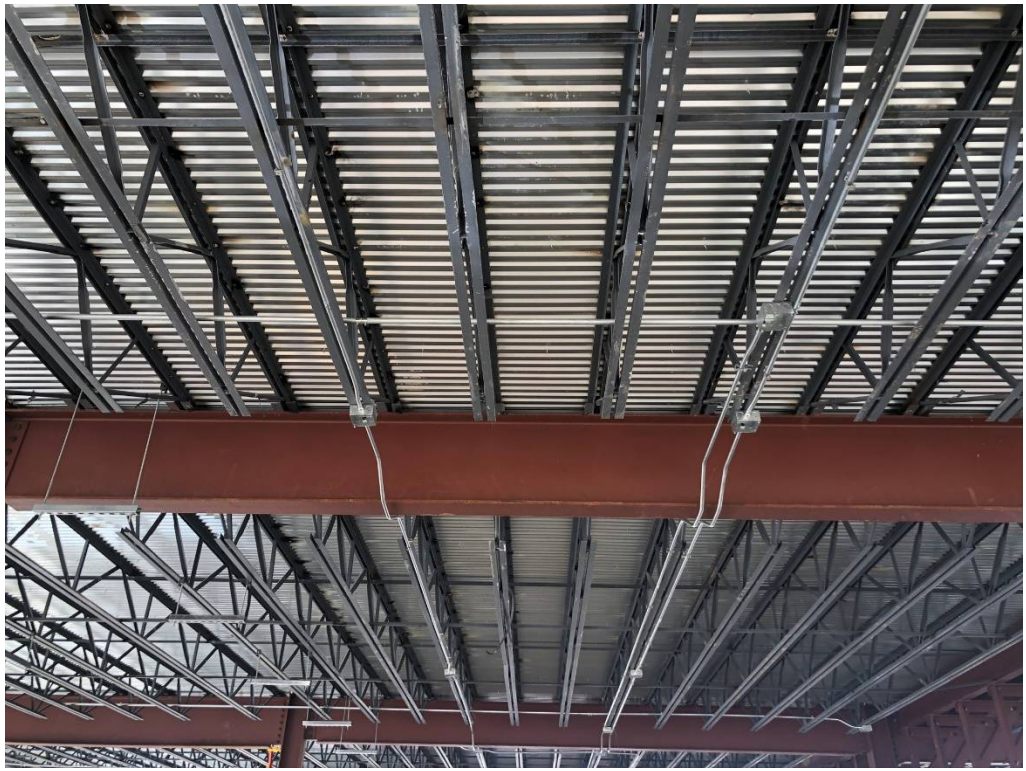
Figure 3 – Electrical Rough-In Ongoing

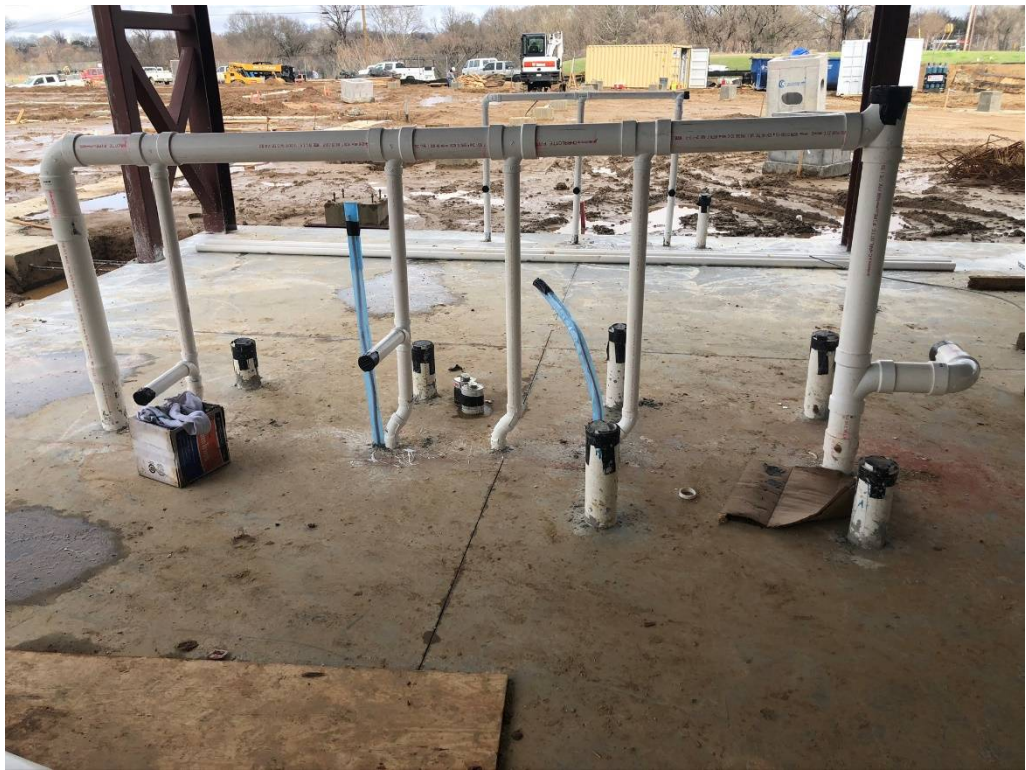
Figure 4 – Plumbing Rough-In Ongoing

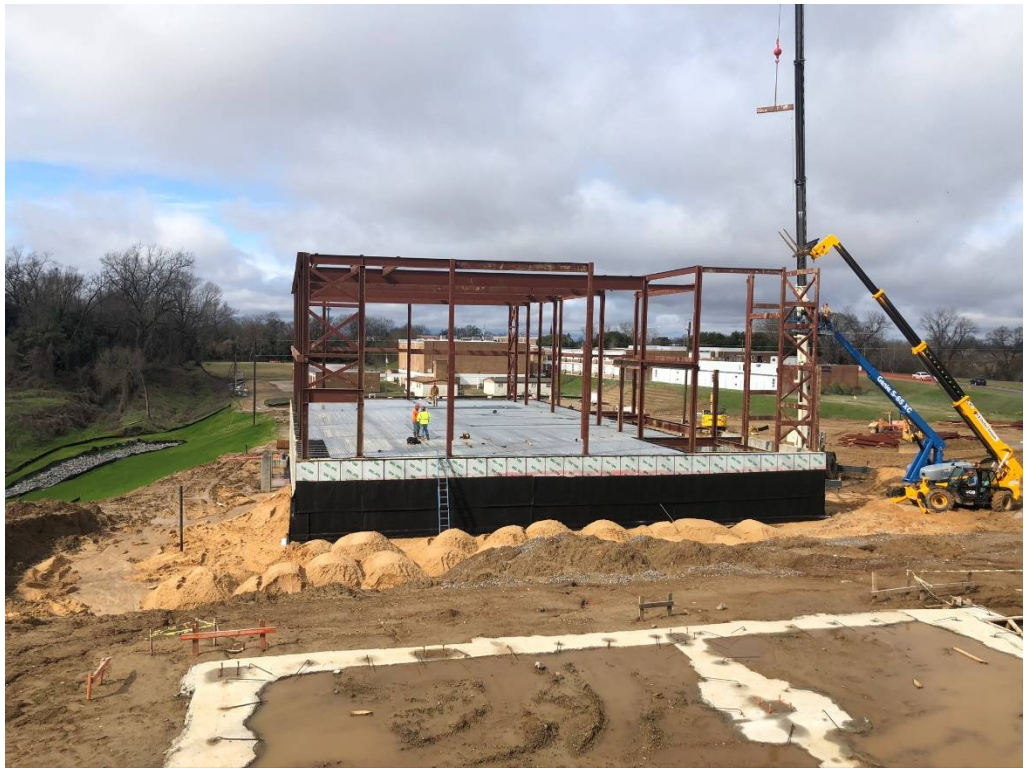
Figure 5 – West Building Platform

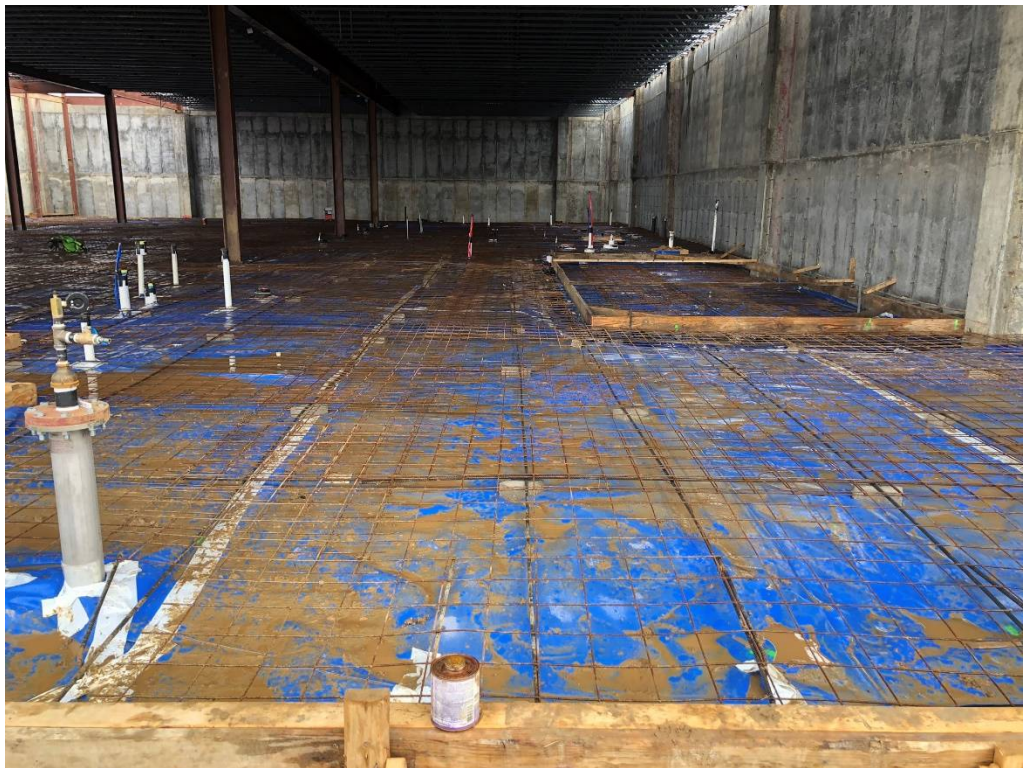
Figure 10 – Rebar @ West Bottom Floor

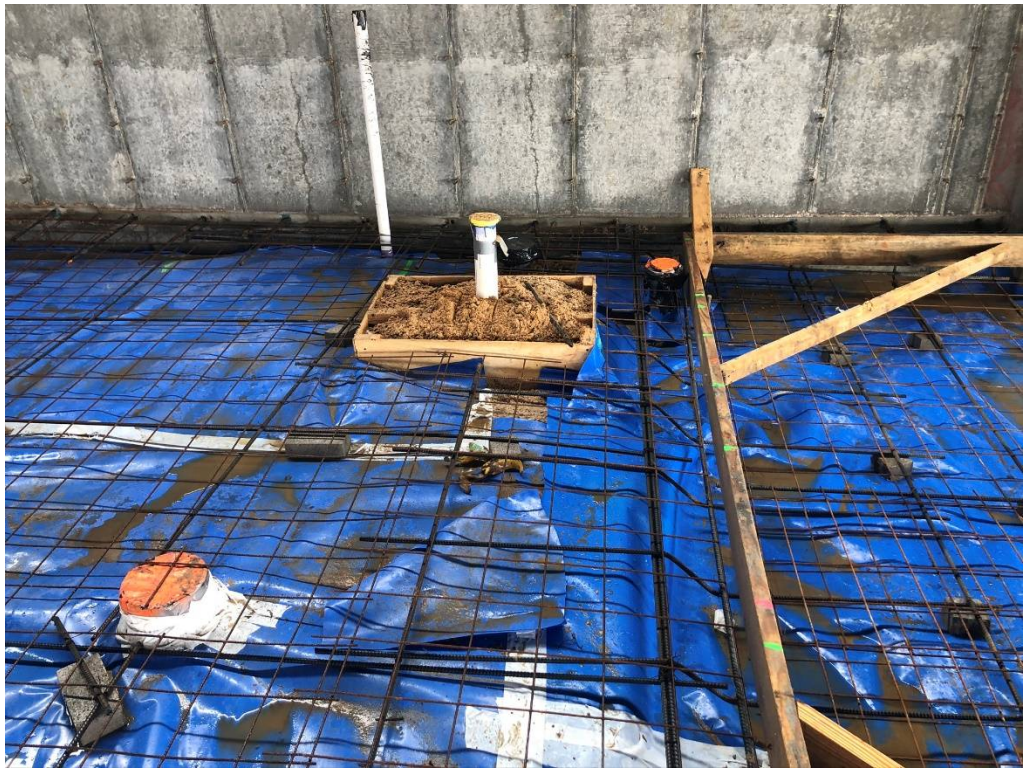
Figure 11 – Rebar and Form @ South Wall in West Lower Building

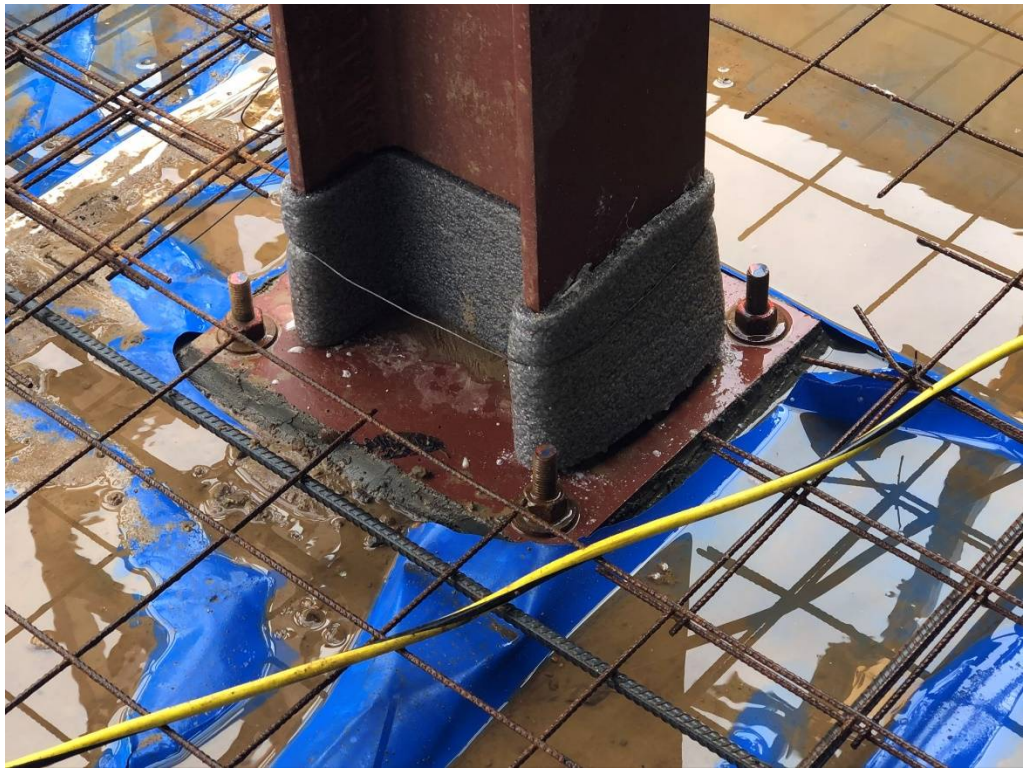
Figure 13 – Break Between Concrete & Steel

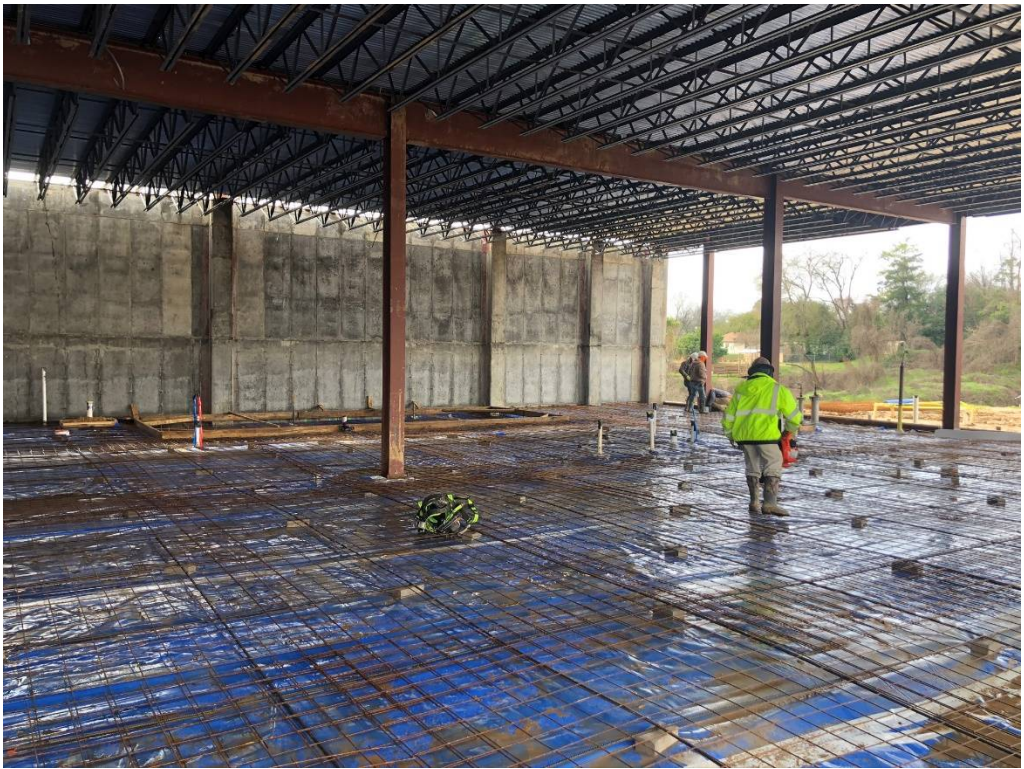
Figure 15 – Rebar at Lower Level

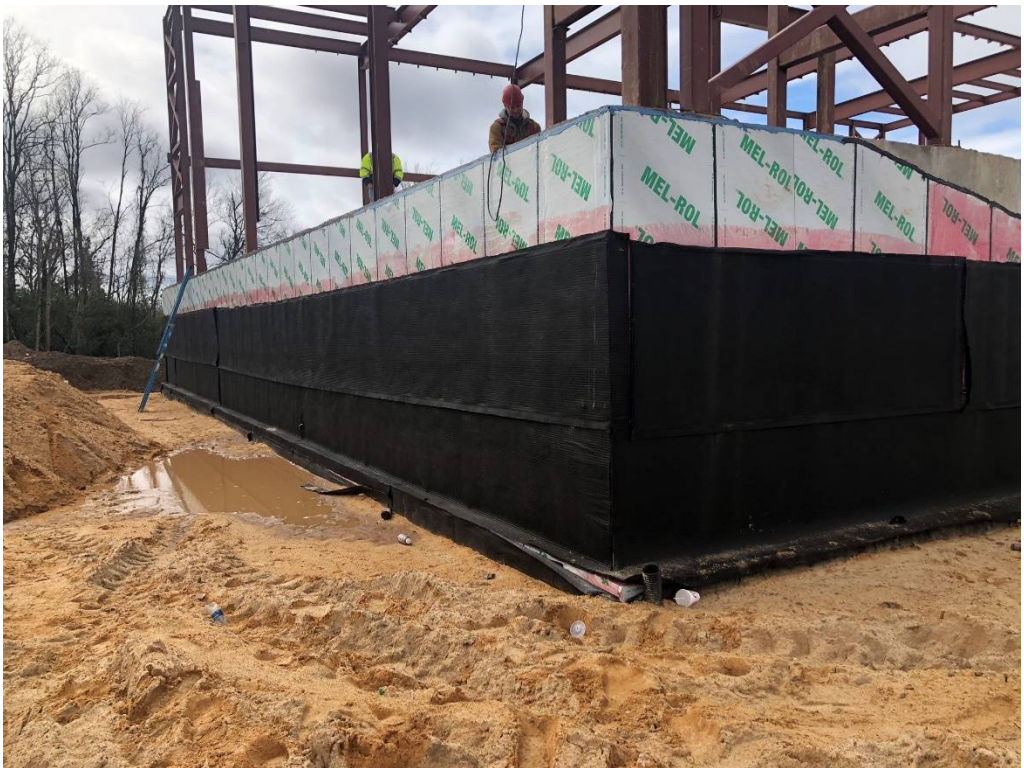
Figure 16 – Note Potential Drainage Pad Break at Corner
