## Architect's Field Report

11 February 2020

18059-AOI Academy of Innovation / Report Number 021

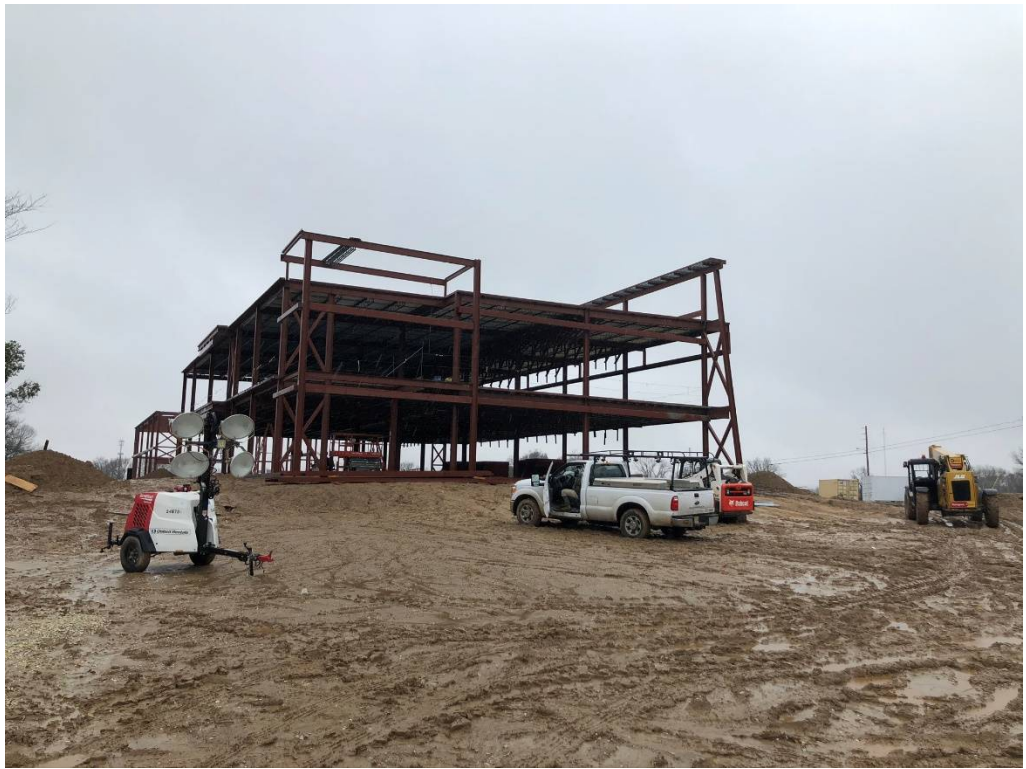
Figure 1 – East Building Erected

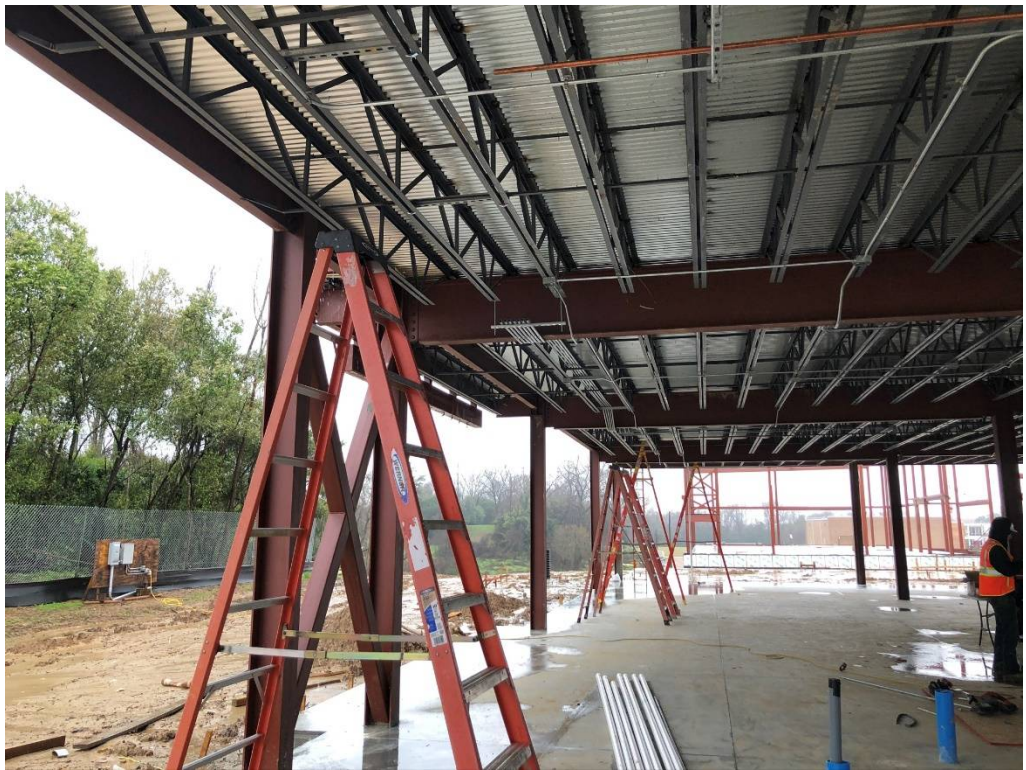
Figure 2 – Plumbing Rough-In Ongoing

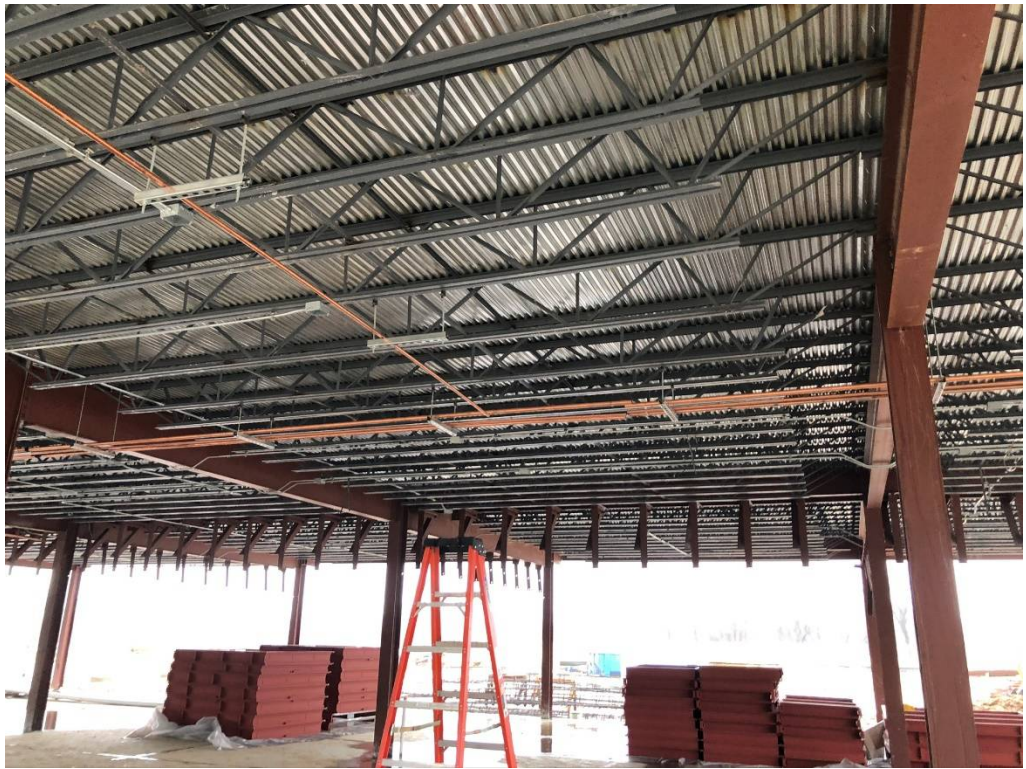
Figure 3 – Plumbing & Electrical Rough-In Ongoing

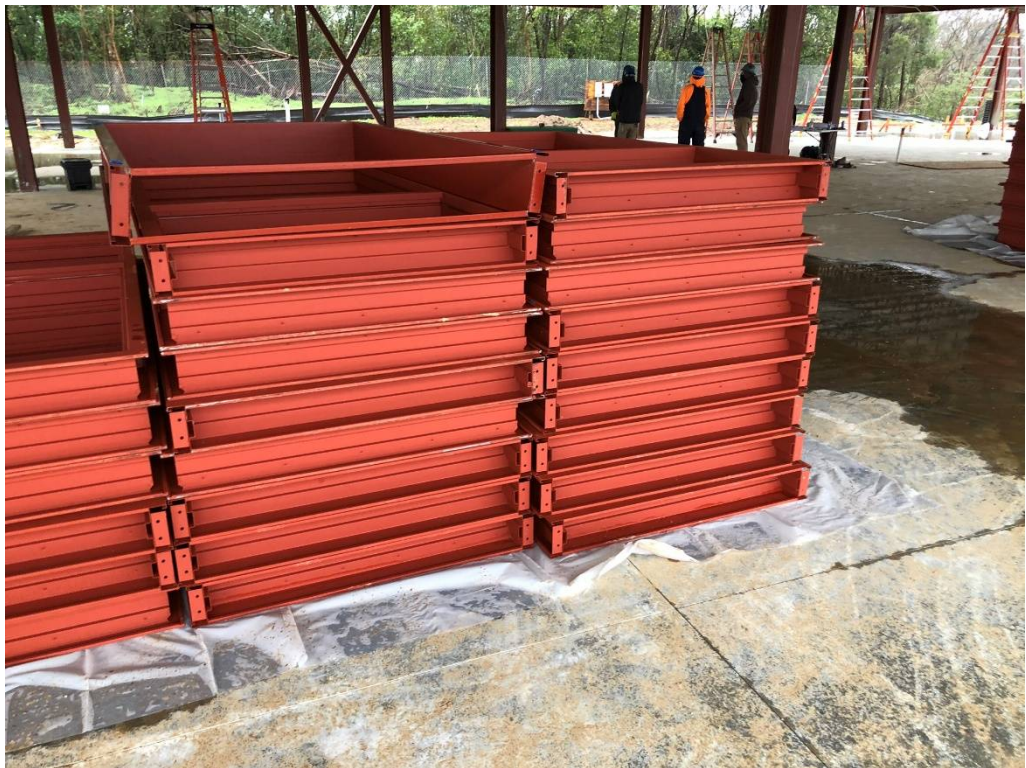
Figure 4 – Doors & Windows on Site

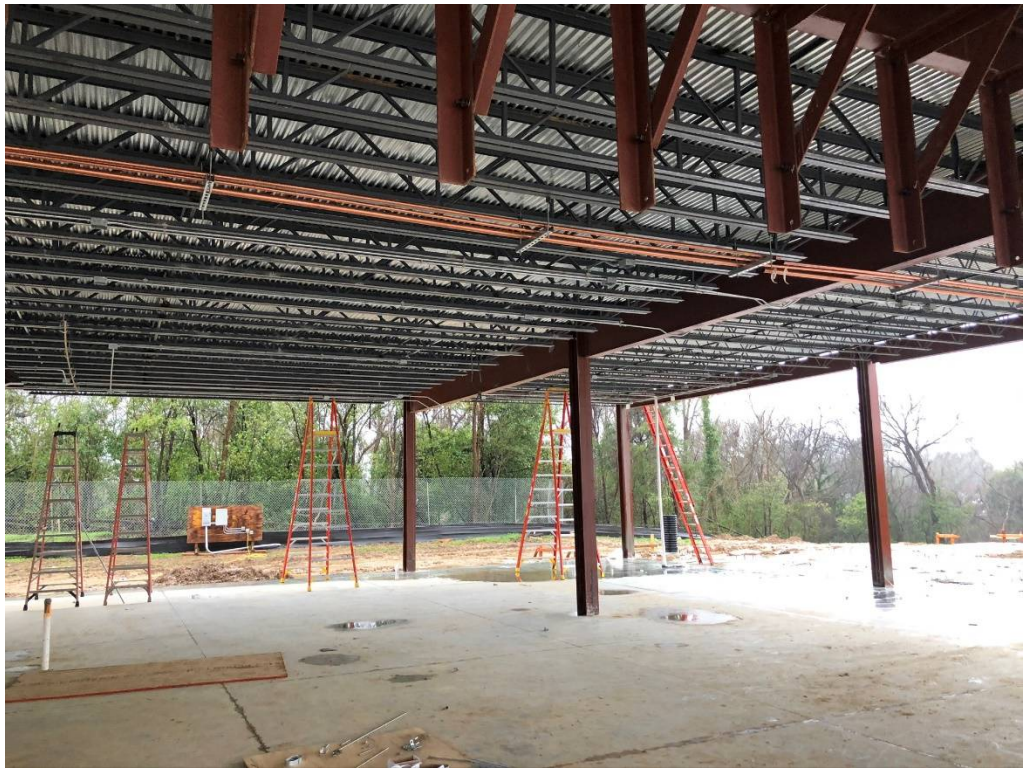
Figure 5 – Plumbing Rough-In Ongoing

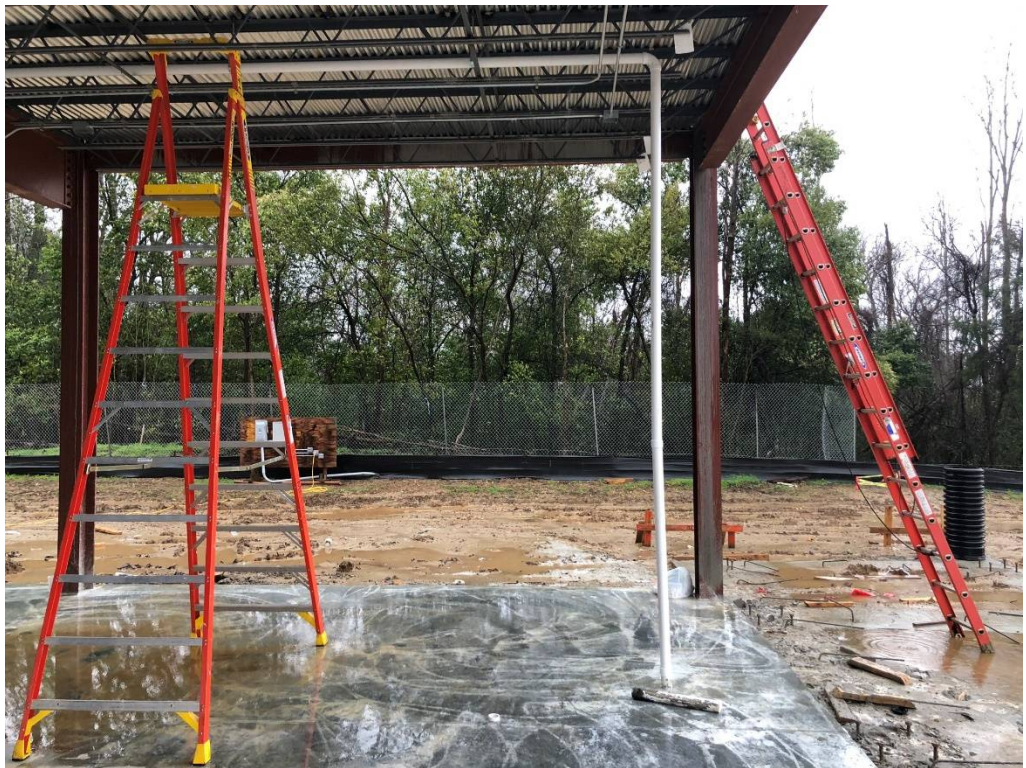
Figure 6 – Plumbing Rough-In Ongoing

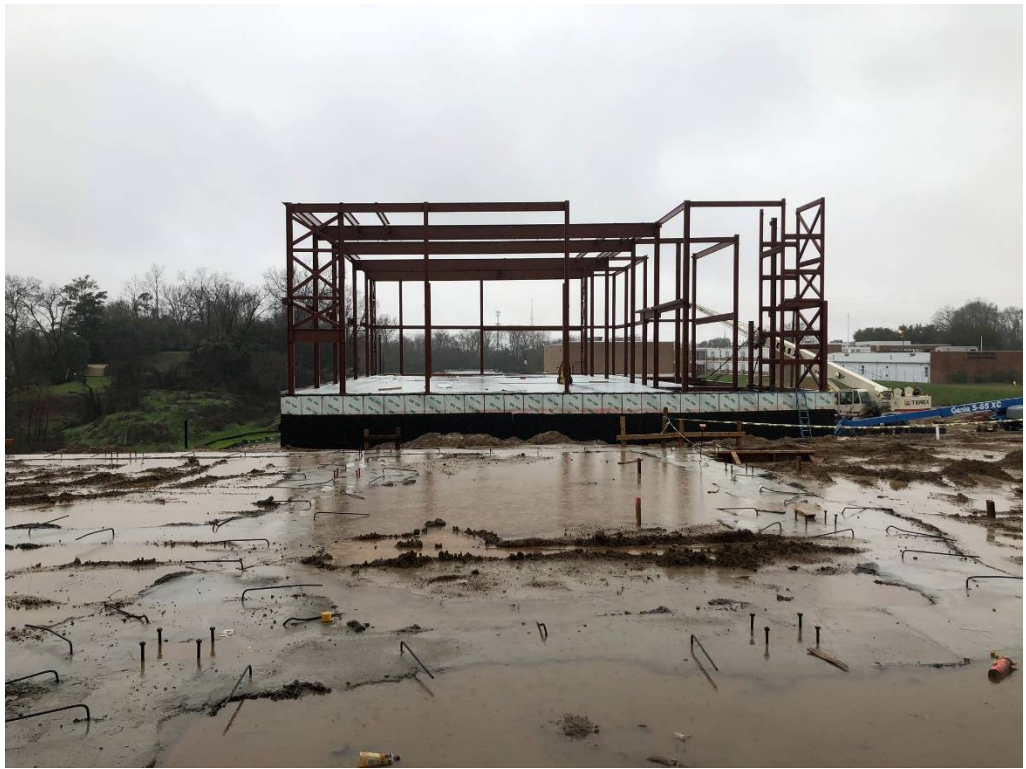
Figure 7 – West Building looking from West edge of East Structure

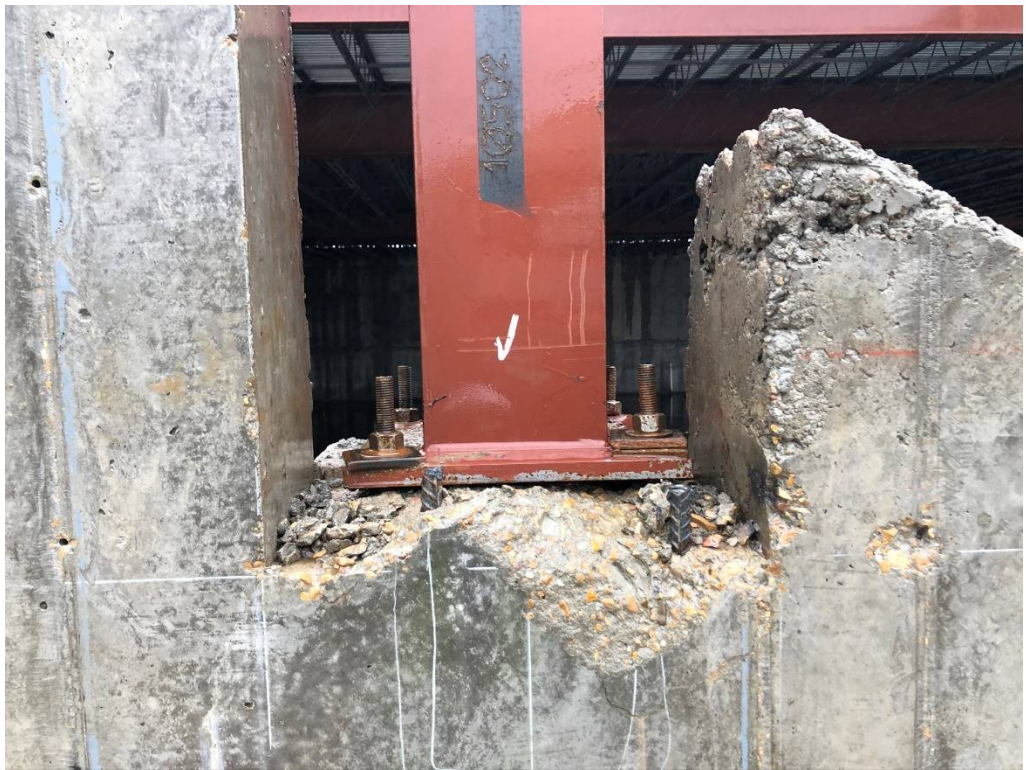
Figure 8 – Structural Connection @ West Building (North Center)

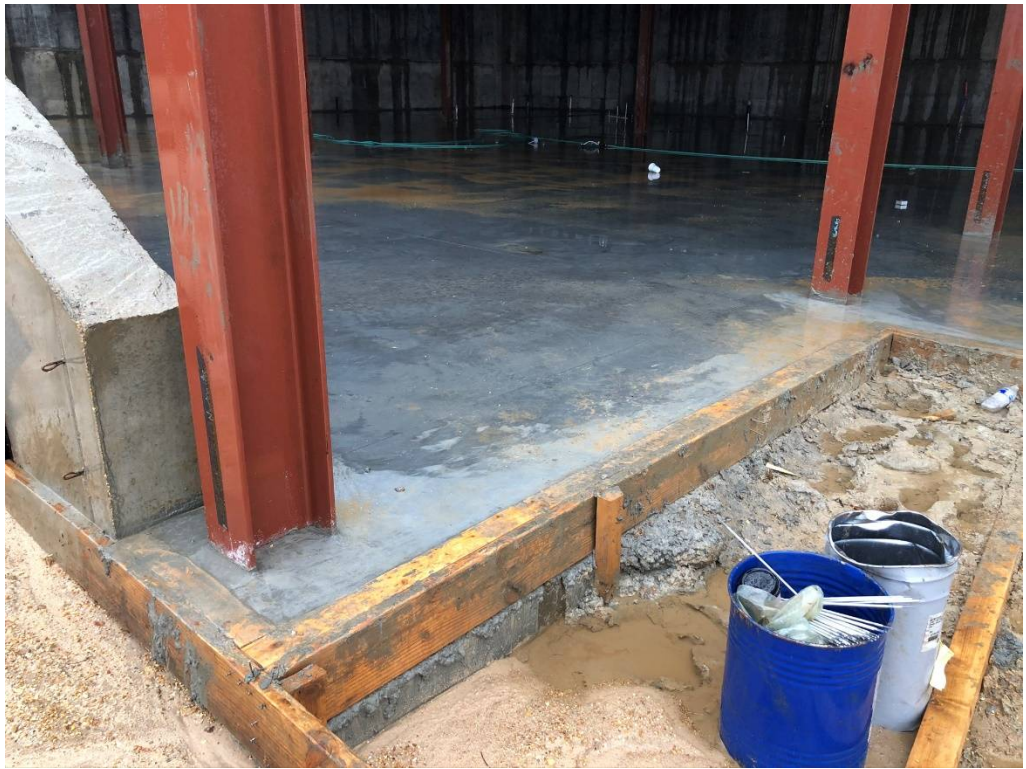
Figure 9 – Newly Poured Slab @ West Lower Level

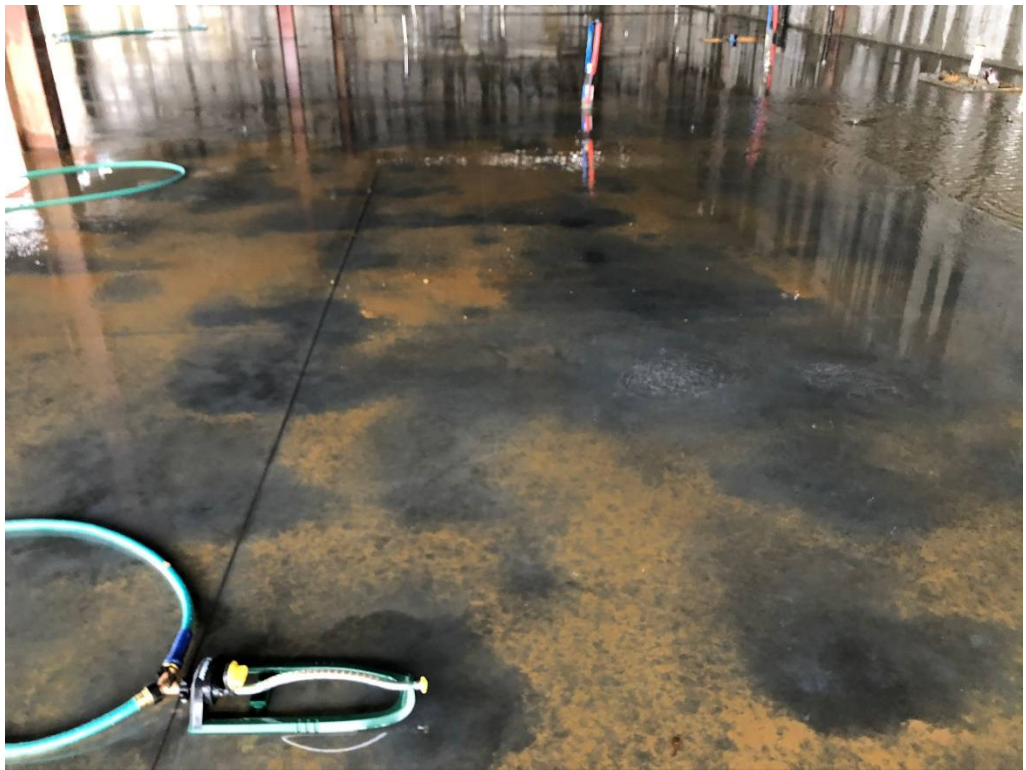
Figure 10 – Evidence that Slab has been kept Sprinkled (4<sup>th</sup> Day Since Pour)

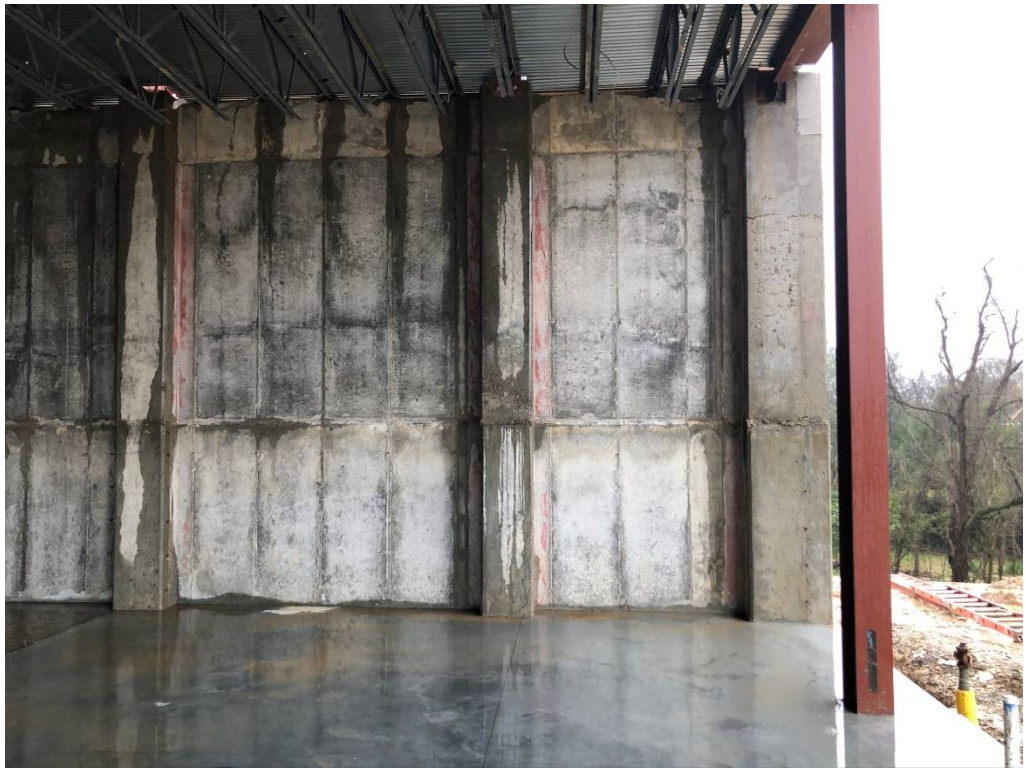
Figure 11 – South Wall in West Lower Building

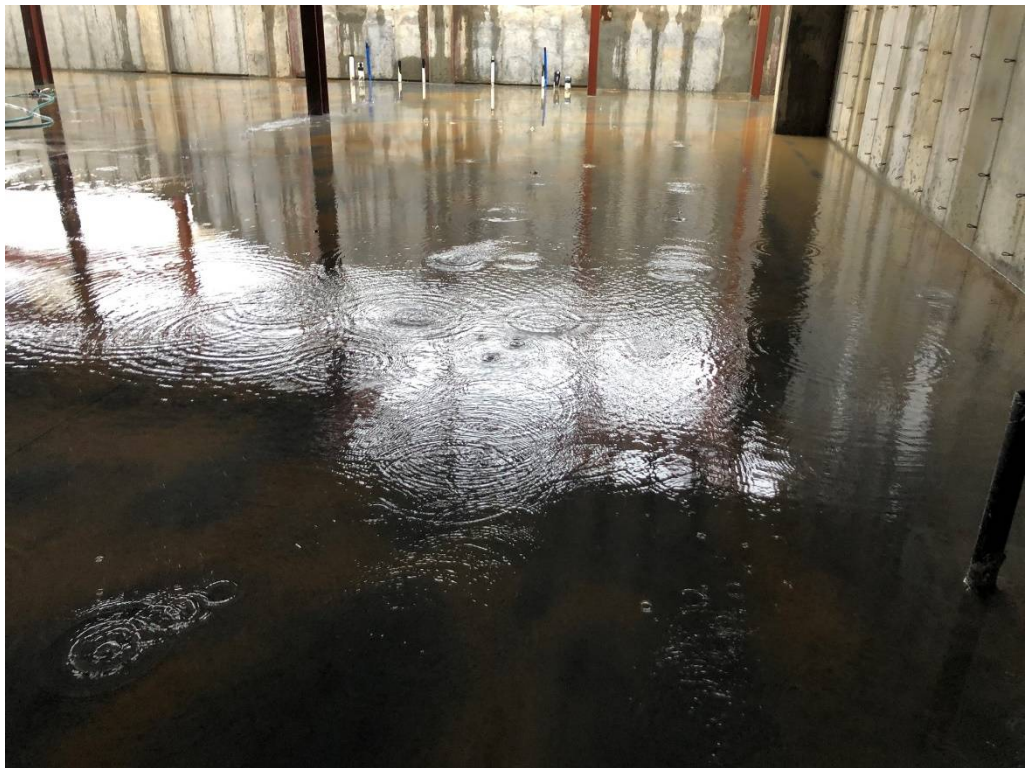
Figure 12 – Potential Low Area in Slab @ East Wall in Lower West Level

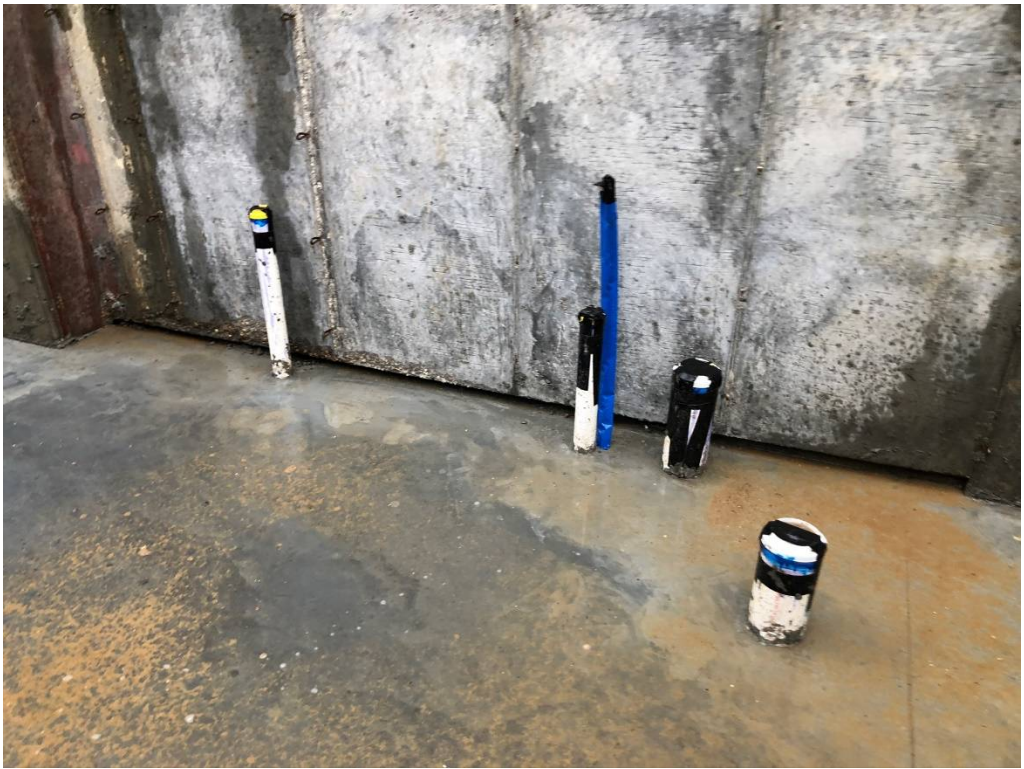
Figure 13 – Thru-Slab Penetrations

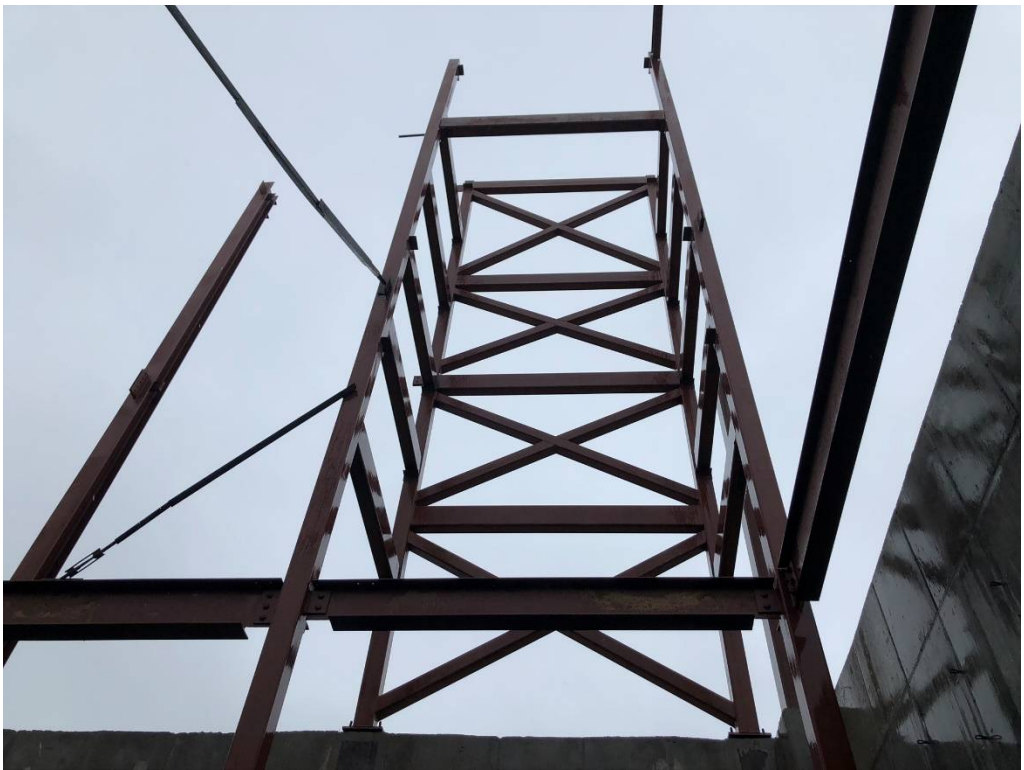
Figure 14 – Elevator Framework

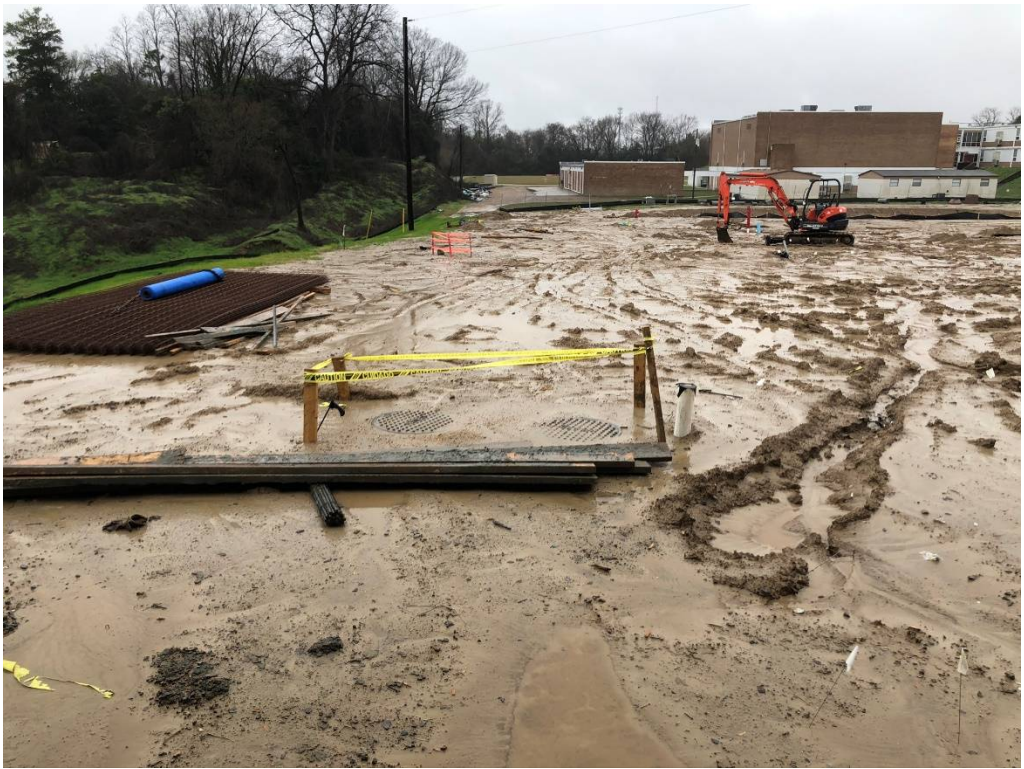
Figure 15 – Manholes Set

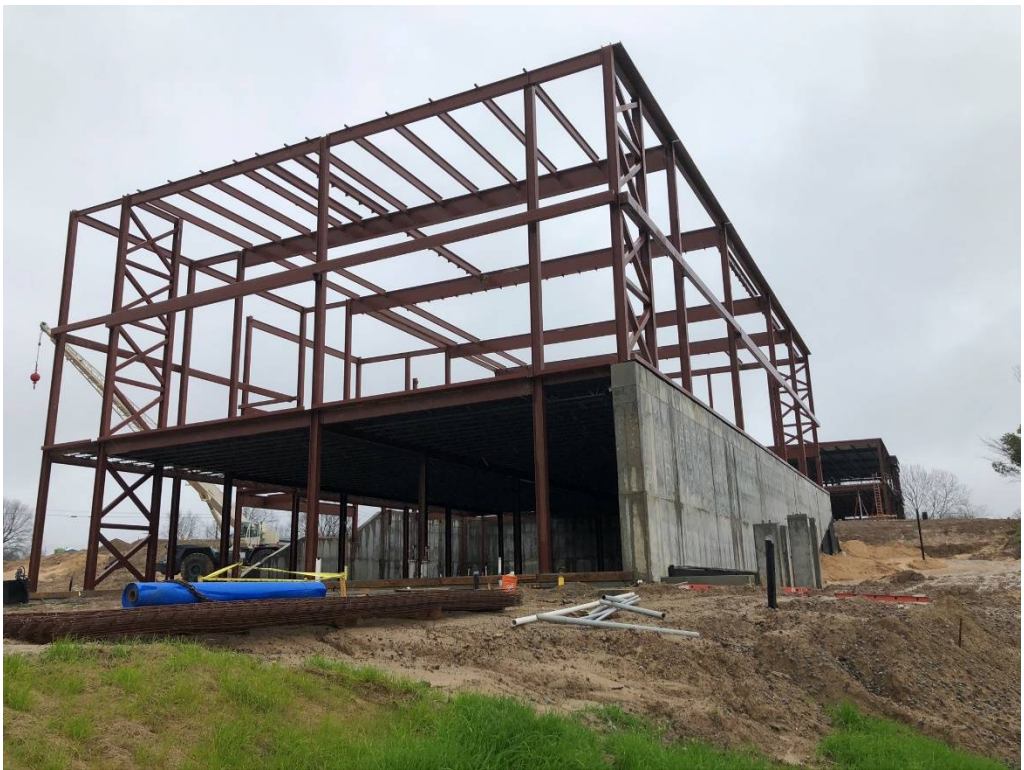
Figure 16 – West Structure from Southwest Vantage

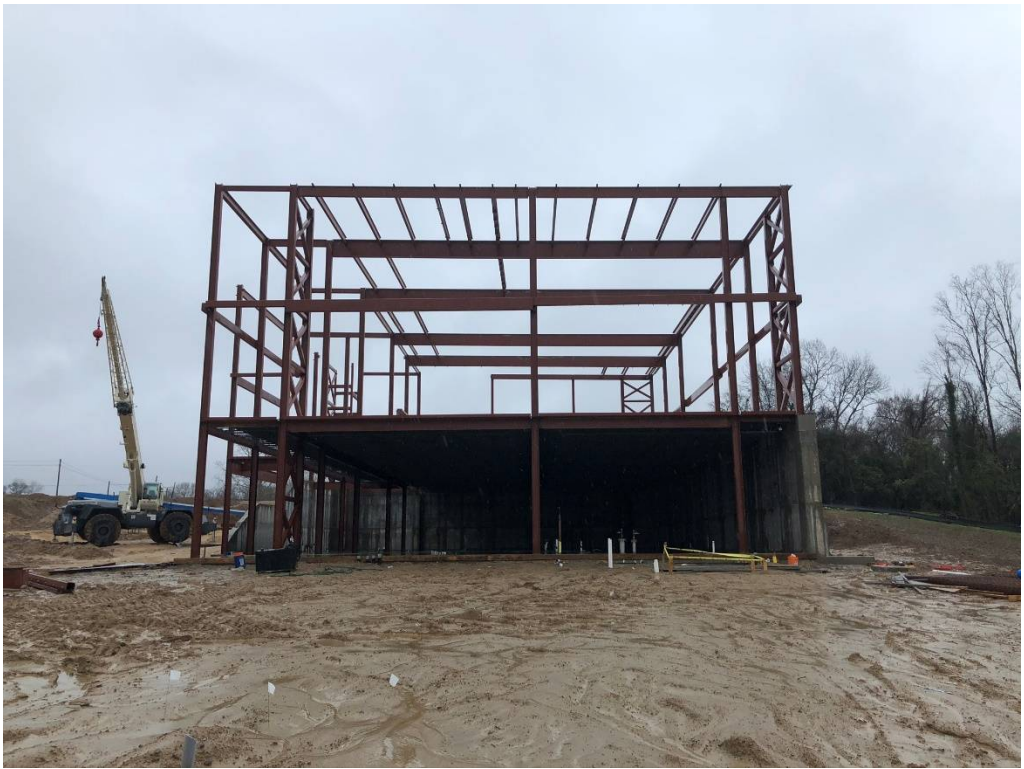
Figure 17 – West Structure from West Vantage

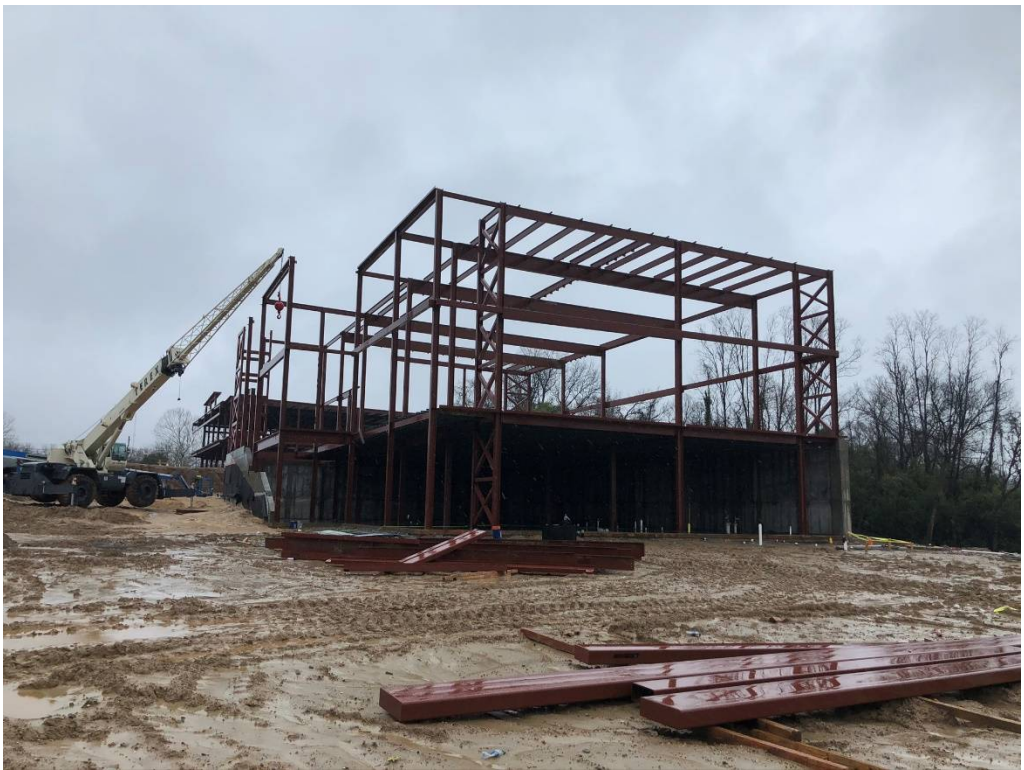
Figure 18 – West Structure from Northwest Vantage
