Architect's Field Report

19 February 2020

18059-AOI Academy of Innovation / Report Number 022

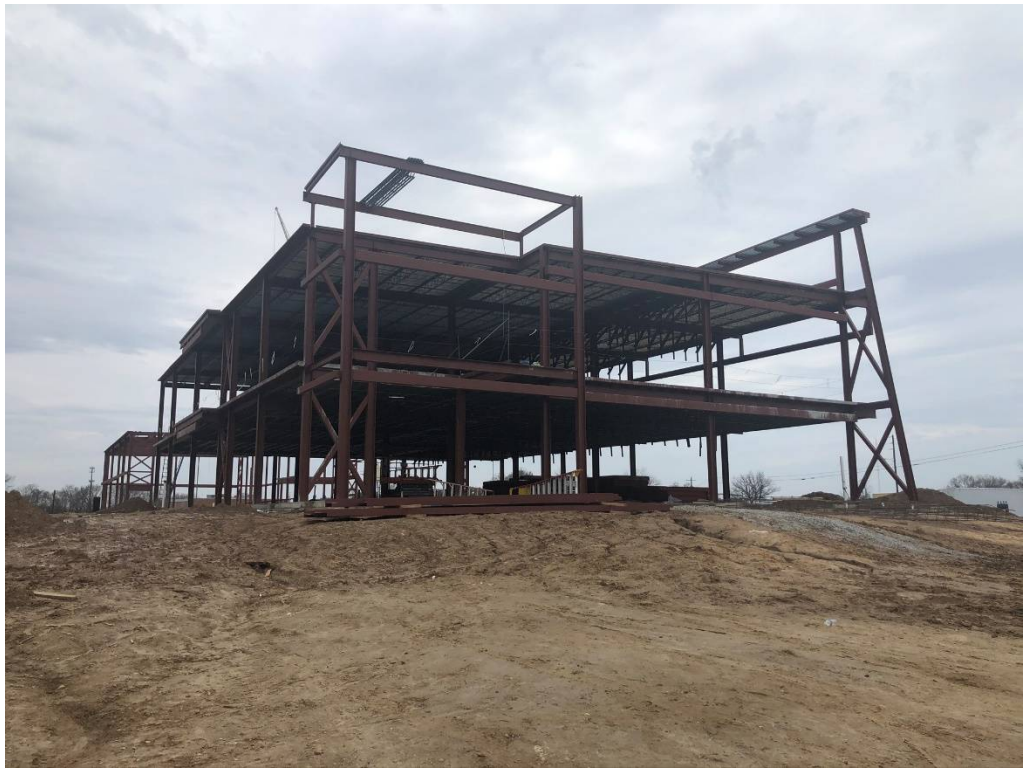
Figure 1 – East Building Erected

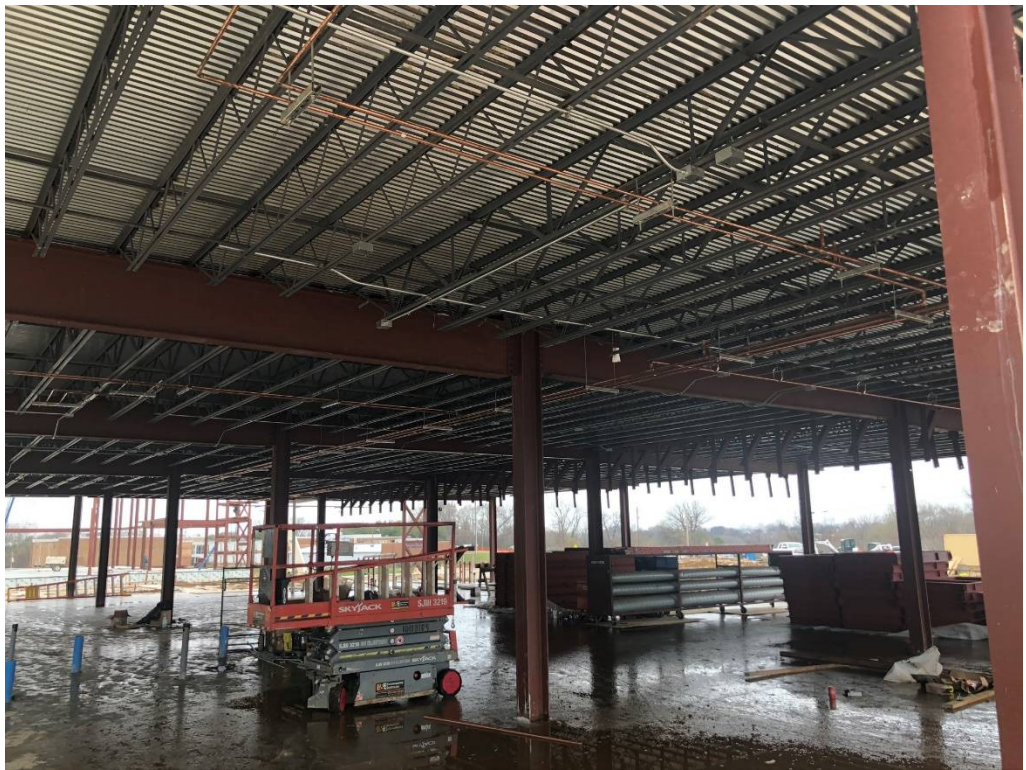
Figure 2 – Plumbing & Electrical Rough-In Ongoing

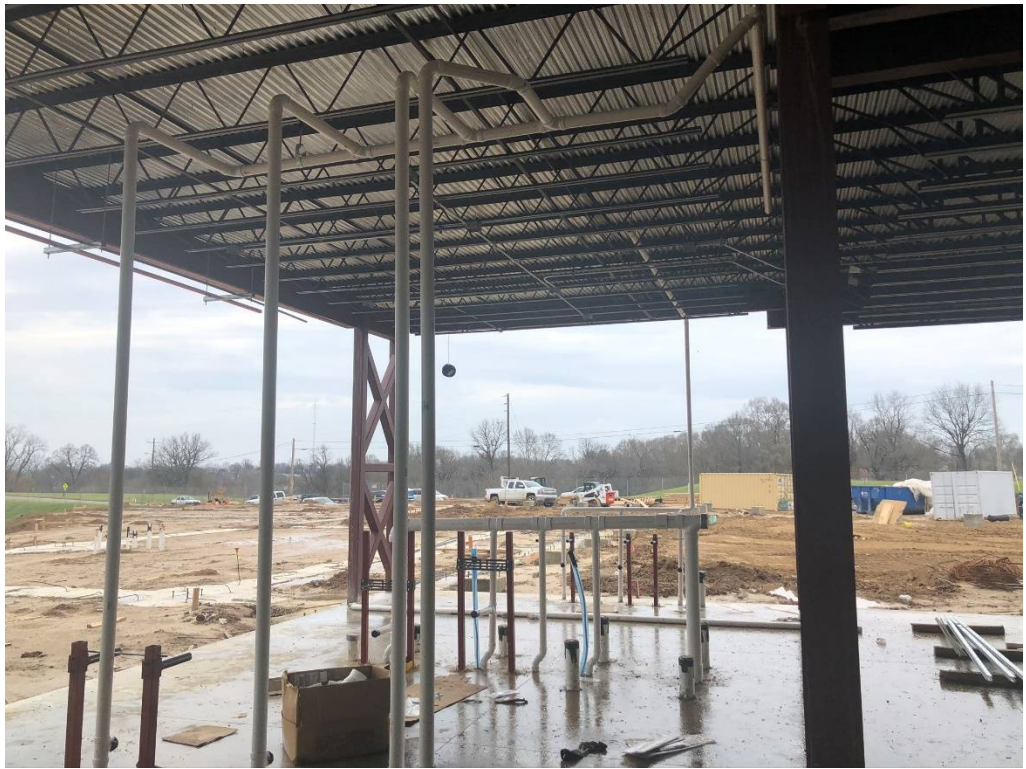
Figure 3 – Plumbing Rough-In Ongoing

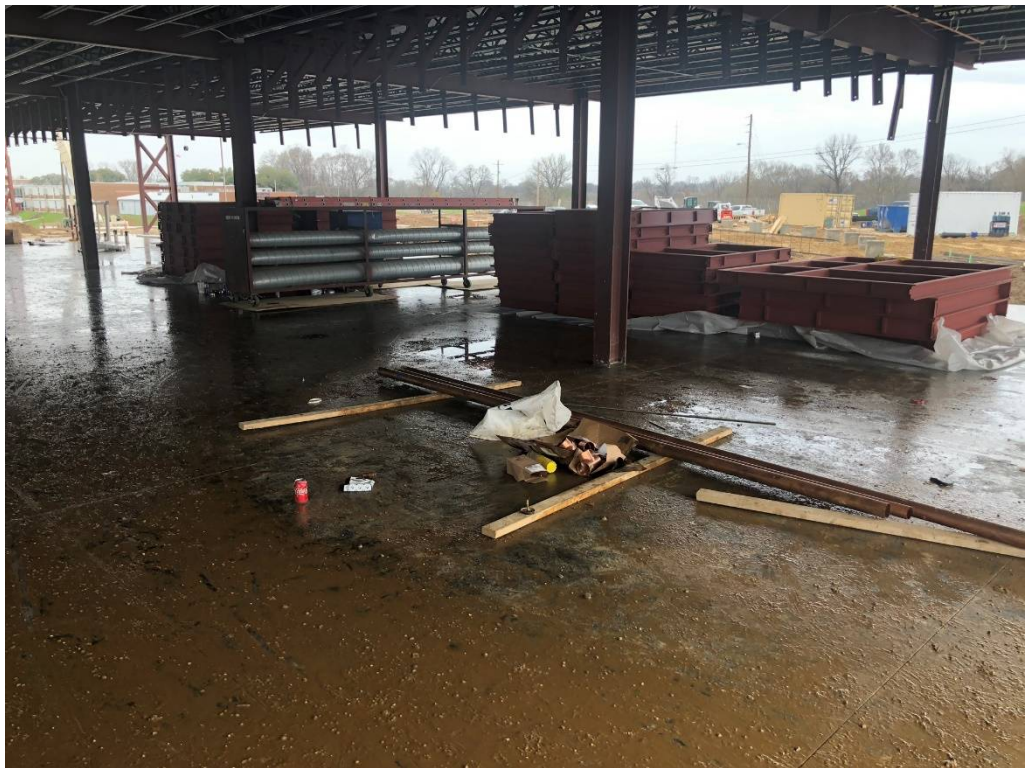
Figure 4 – Spiral Duct On Site

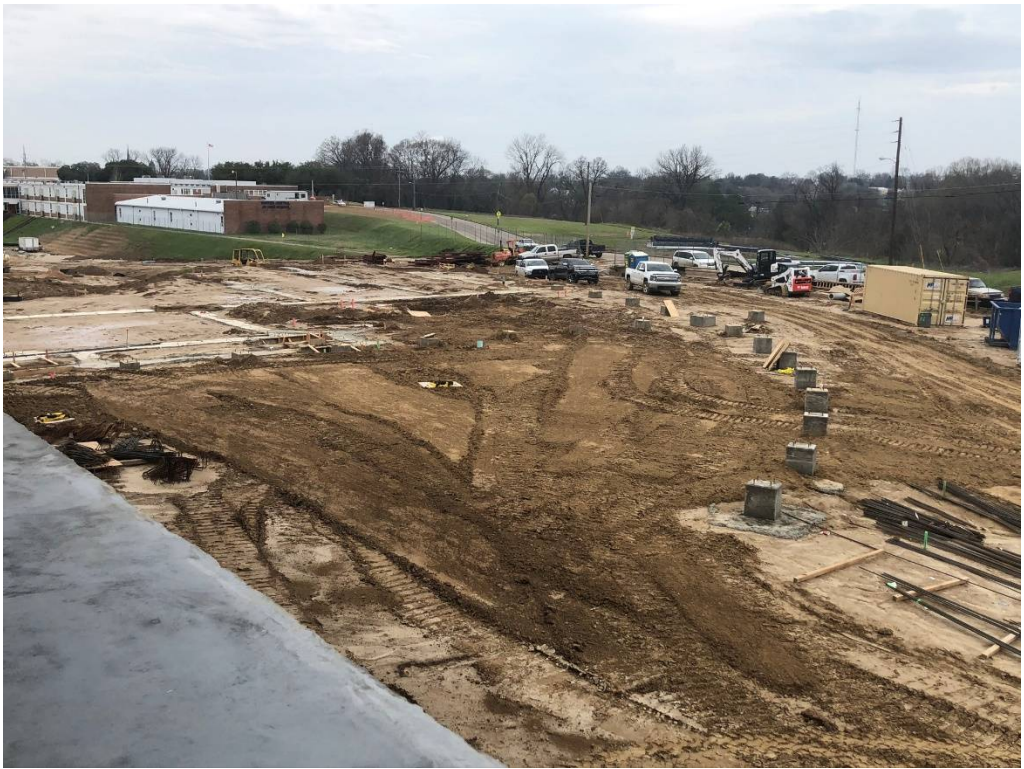
Figure 5 – Concrete Piers at North Curvature

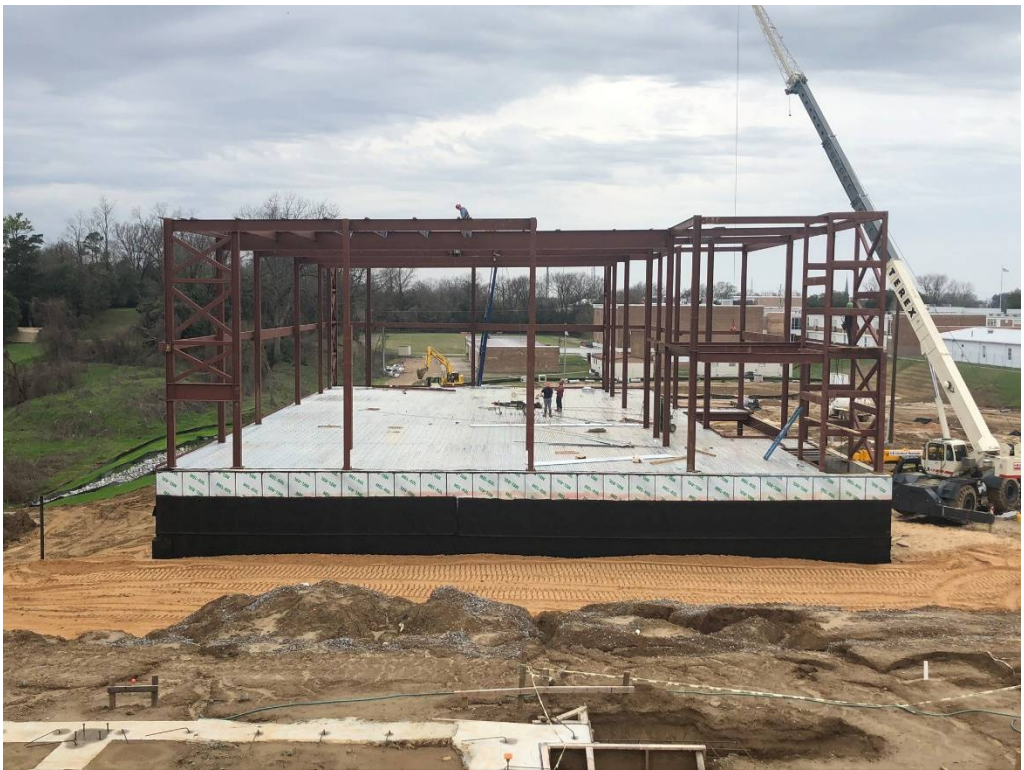
Figure 6 – West Building Progress

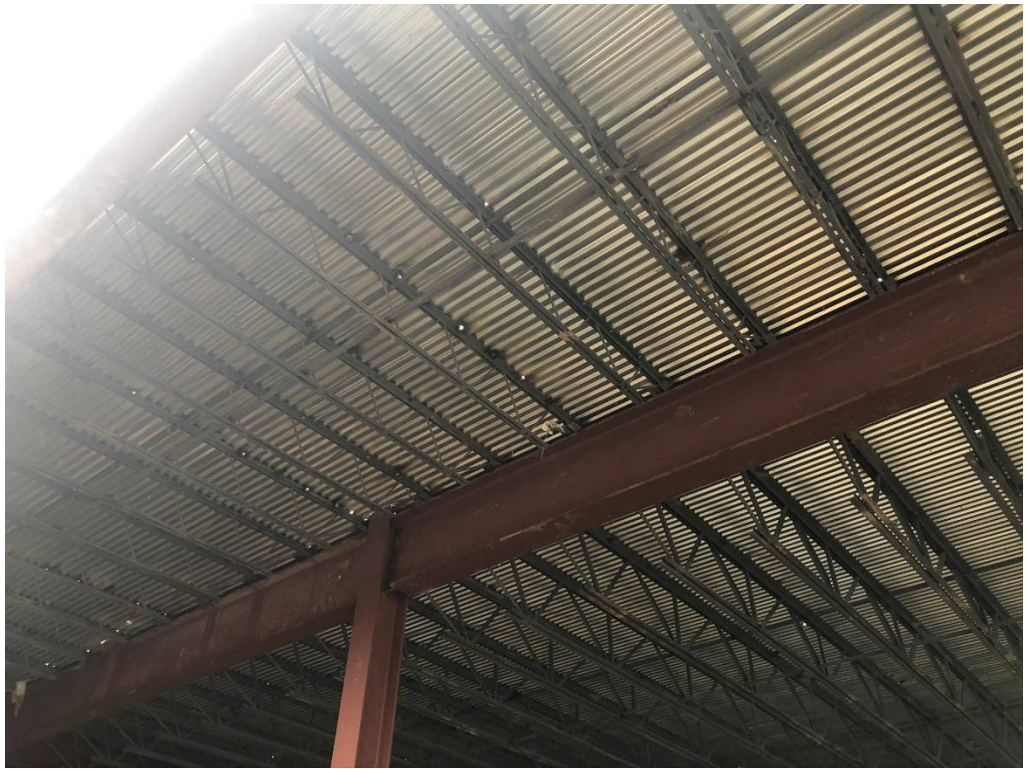
Figure 7 – Increased Burn Out on Deck Platform

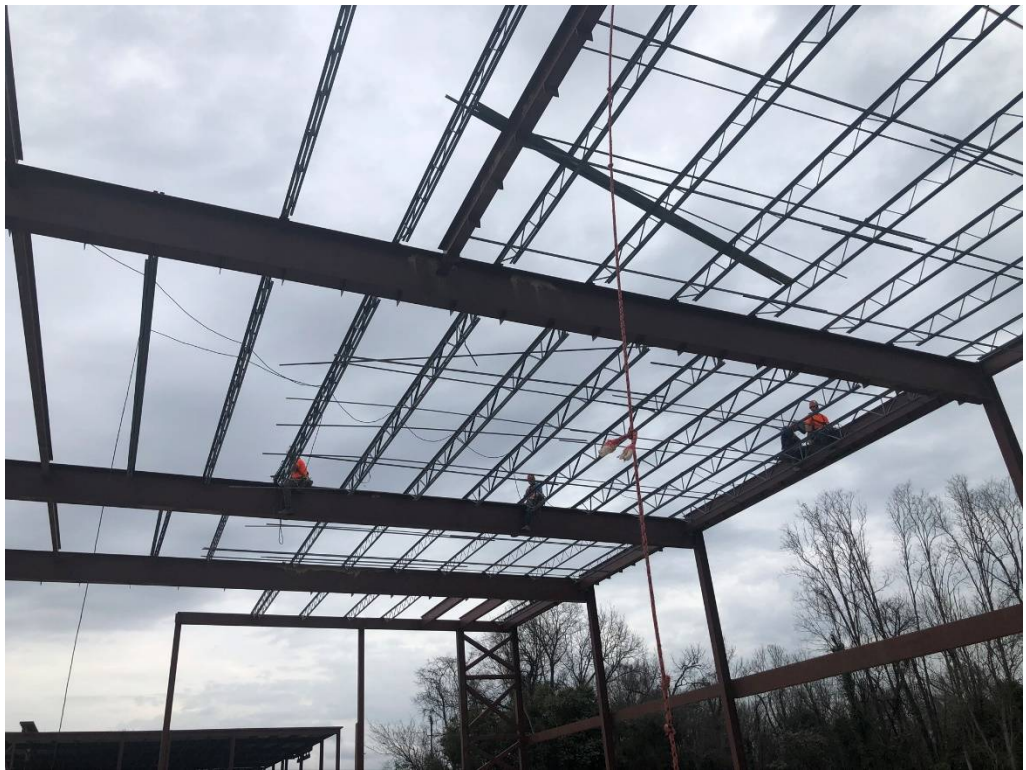
Figure 8 – Roof Joist Setting at West Building

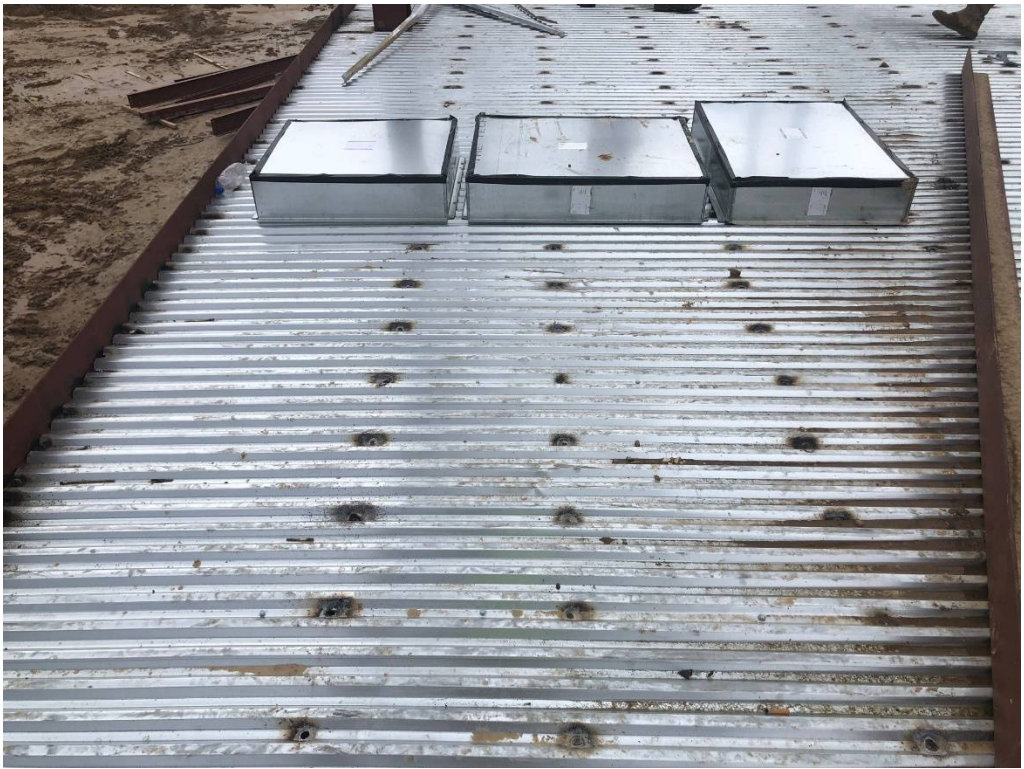
Figure 9 – Contractor Noted Conflict Between Mech & Floor Joists Here

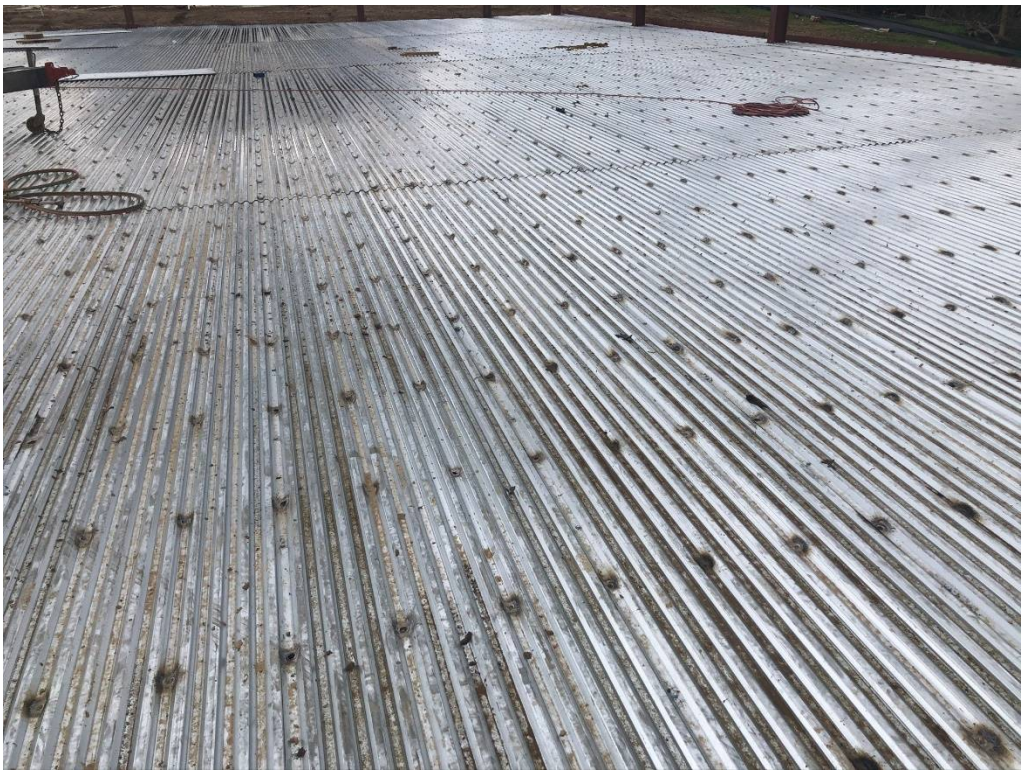
Figure 10 – Floor Steel Decking Prepped for Concrete

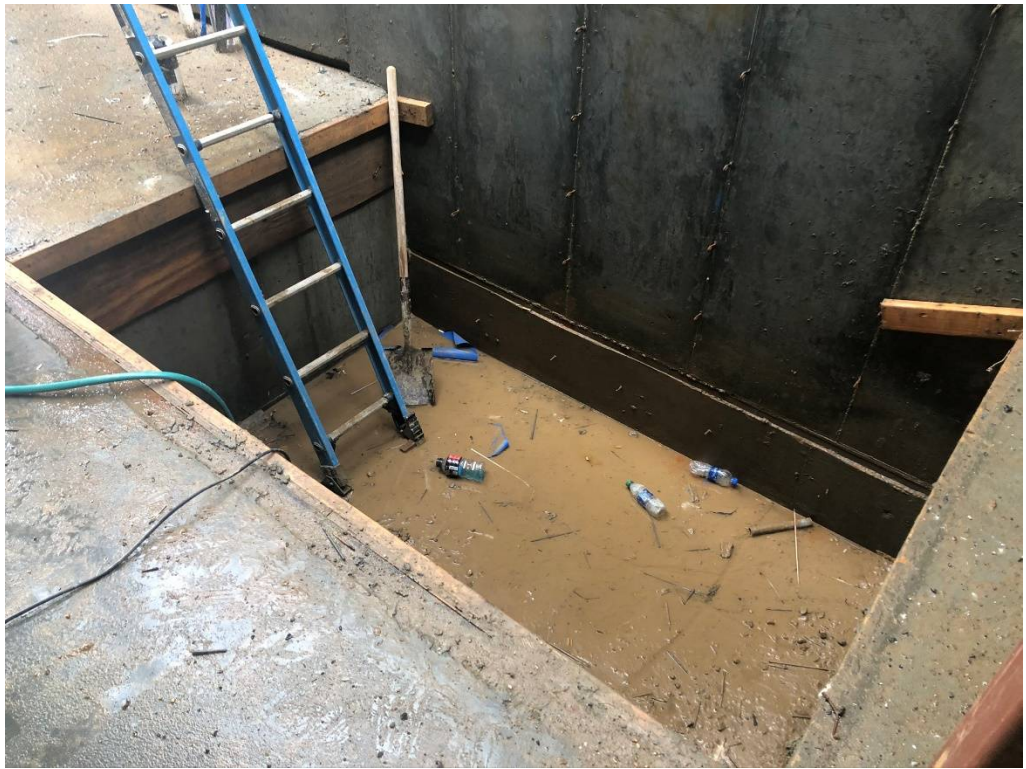
Figure 11 – Elevator Pit Drained

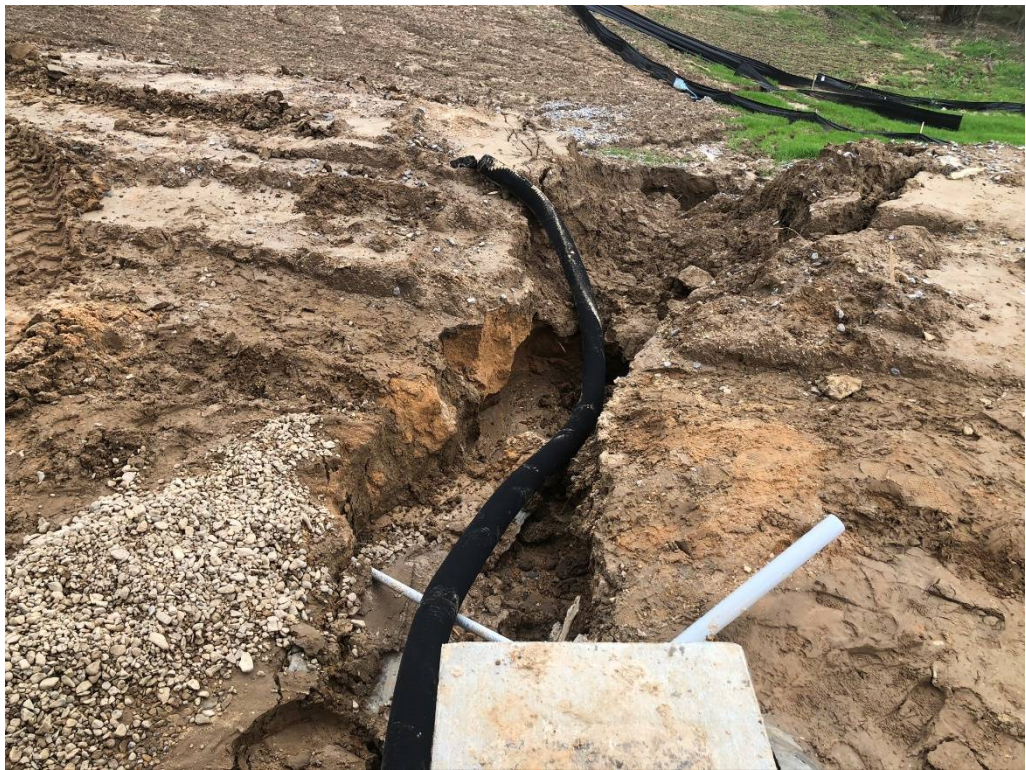
Electrical rough-in continued on the second floor of the East building. Mr. Moore mentioned backfill of the west structure has been held up by rain, but as soon as they have some dry days in succession, they will be able to fill the backside of the west structure and seed the back slope to prevent further wash out.

Figure 12 – Continued Wash Out @ Southwest Corner of Lower Building

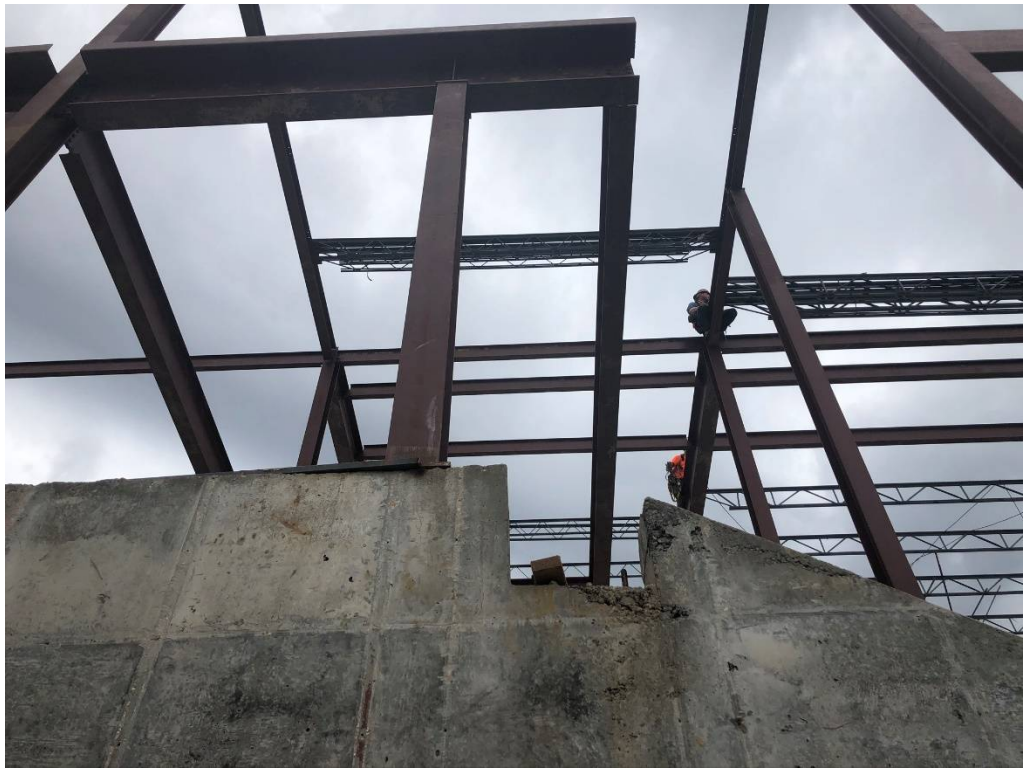
Figure 13 – Mis-Alignment of Concrete Recess and Steel Column

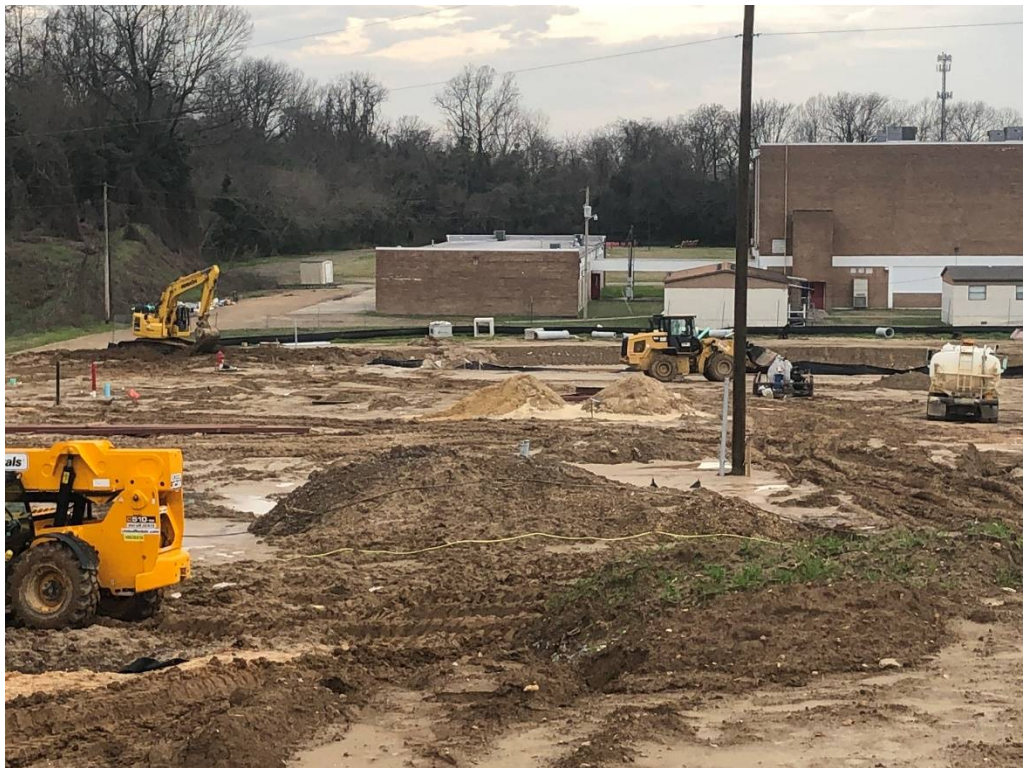
Figure 14 – Continued Sewer Work
