Architect's Field Report

201 Park Court, Suite B Ridgeland, MS 39157 P 601.790.9432 F 888.281.0547	26 February 2020 18059-AOI Academy of Innovation / Report Number 023
One Jackson Place, Suite 250 188 East Capitol Street Jackson, MS 39201-2100 P 601.352.5411 F 601.352.5362	Contract Century Construction Date / Time 25 February 2020 / 3:48 PM Weather / Temp Sunny and clear / 63 ° F Est % Complete 38% Sched Conformance + 02 days Work in Progress Plumbing Rough-IN Electrical Rough-IN Concrete Reinforcing Prep Steel Structure Erection
161 Lameuse Street, Suite 201 Biloxi, MS 39530 P 228.374.1409 F 228.374.1414	Present at Site Total Electric Joey Moore, Century Steel Crew / Rebar Crew / Plumbing Crew Paul Purser, DBA Observations I arrived on site on a nice sunny day, one of few lately. Light gauge framing has kept them from installing roof, and it has finally begun. This is also the first day in a while that they have been able to move dirt for the backfill between the structures. New steel in being installed and prep for concrete is being made.

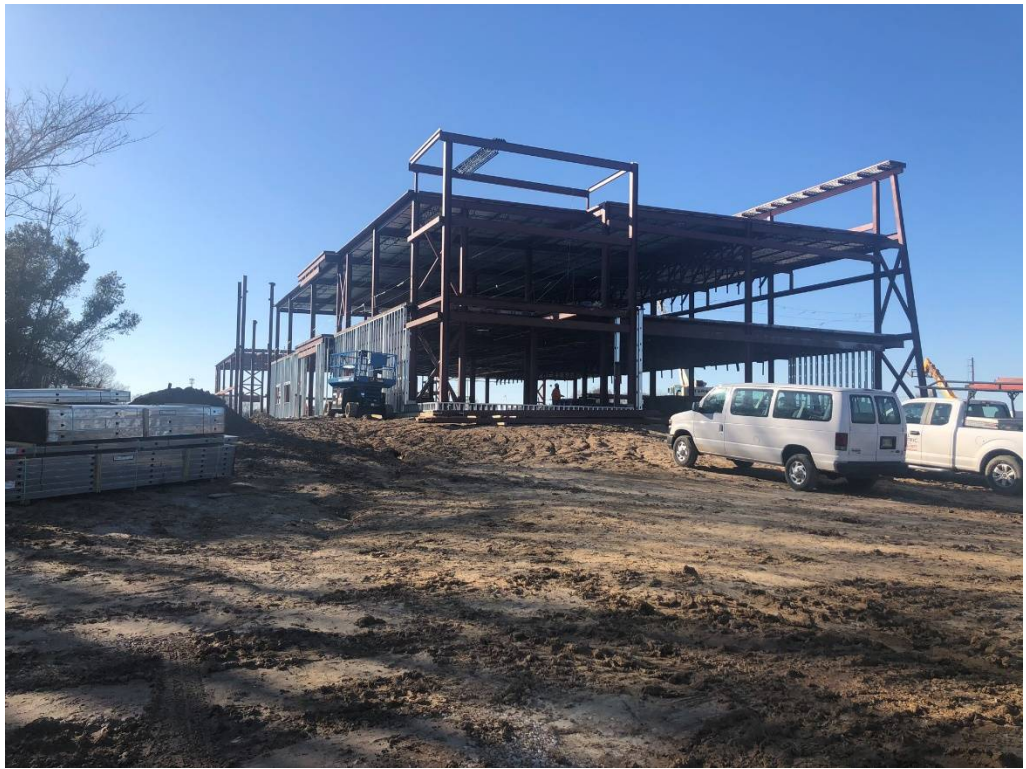
Figure 1 – East Building Erected

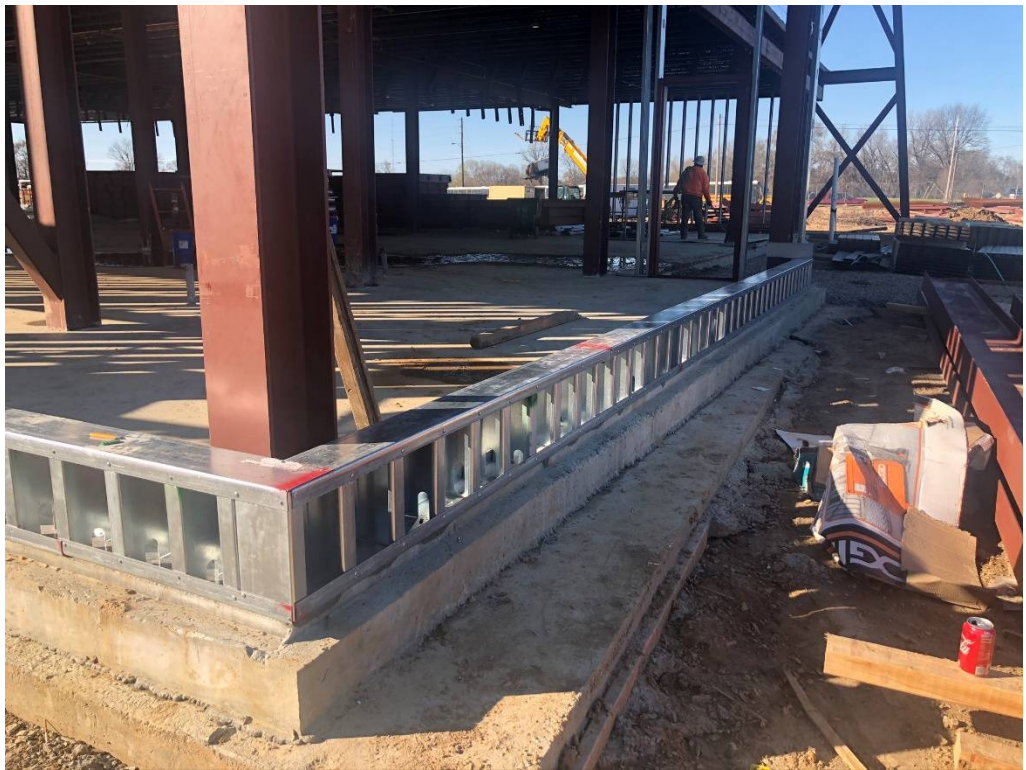
Figure 2 – Light Gauge Framing Started

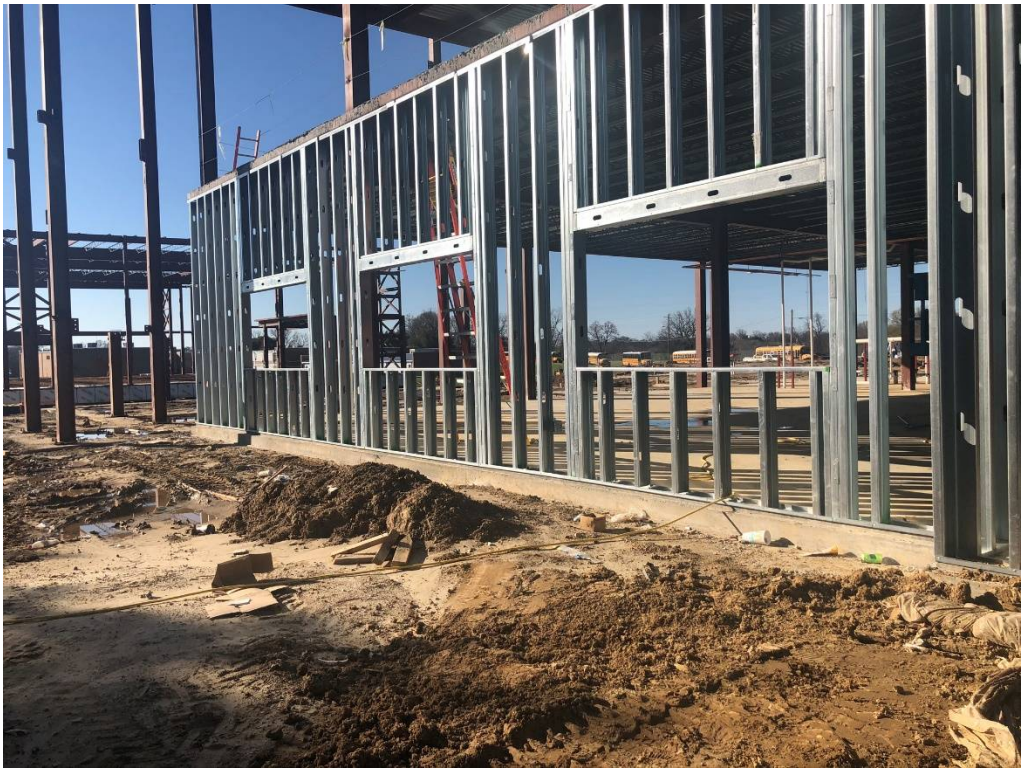
Figure 3 – Light Gauge Framing

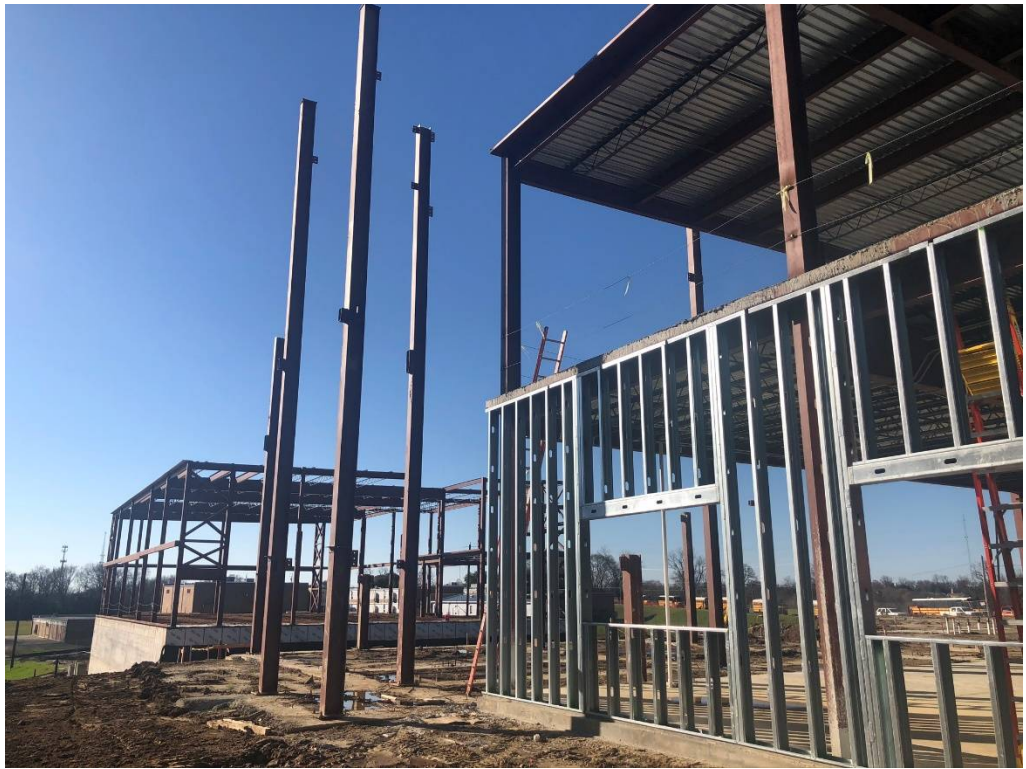
Figure 5 – New Steel at Connection Between Previously Erected Steel

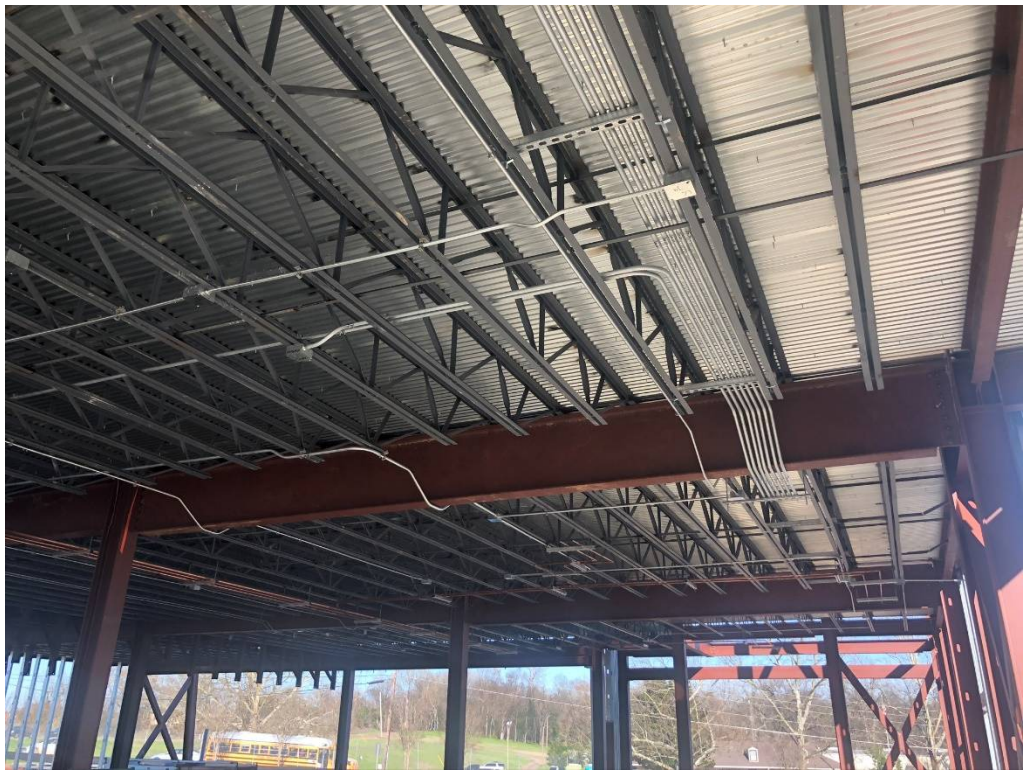
Figure 6 – Electrical & Plumbing Rough-in Ongoing in East Structure

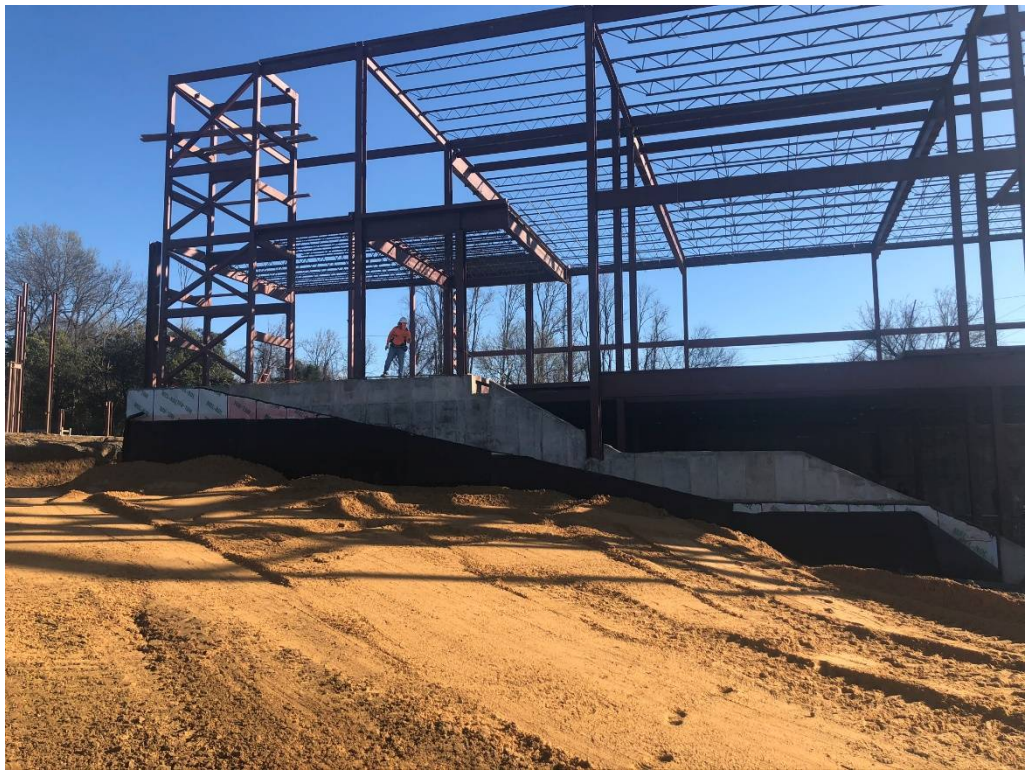
Figure 12 – West Structure Backfill Continued

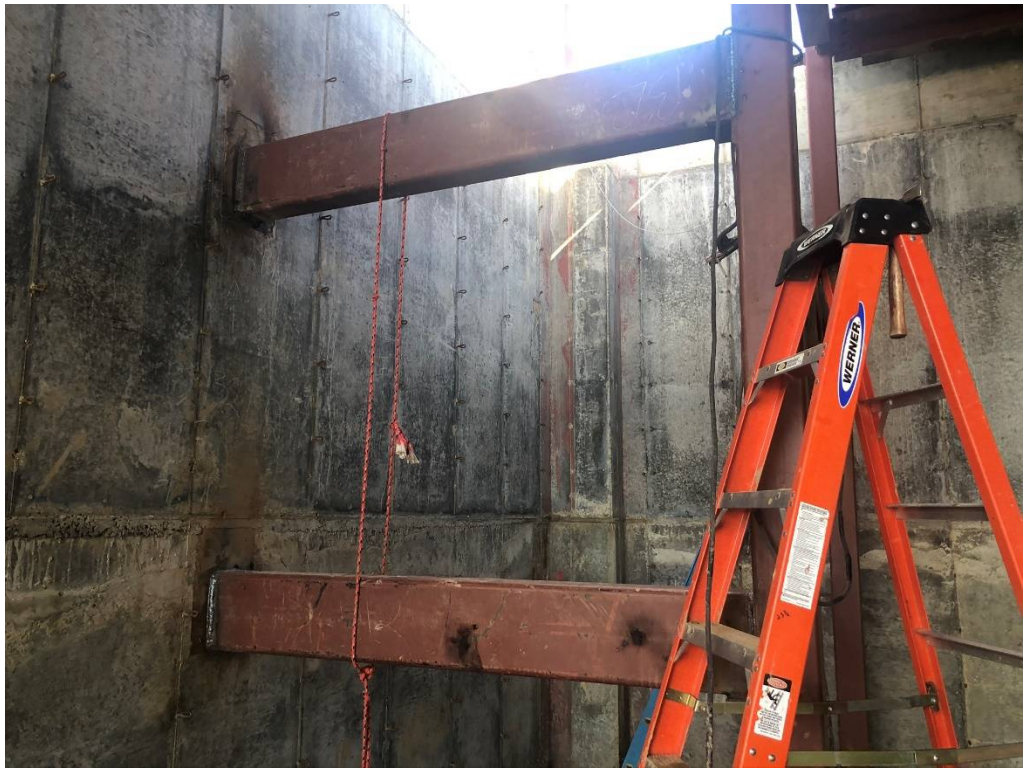
Figure 13 – Elevator Shaft Horizontal Supports Welded to Embedded Plates

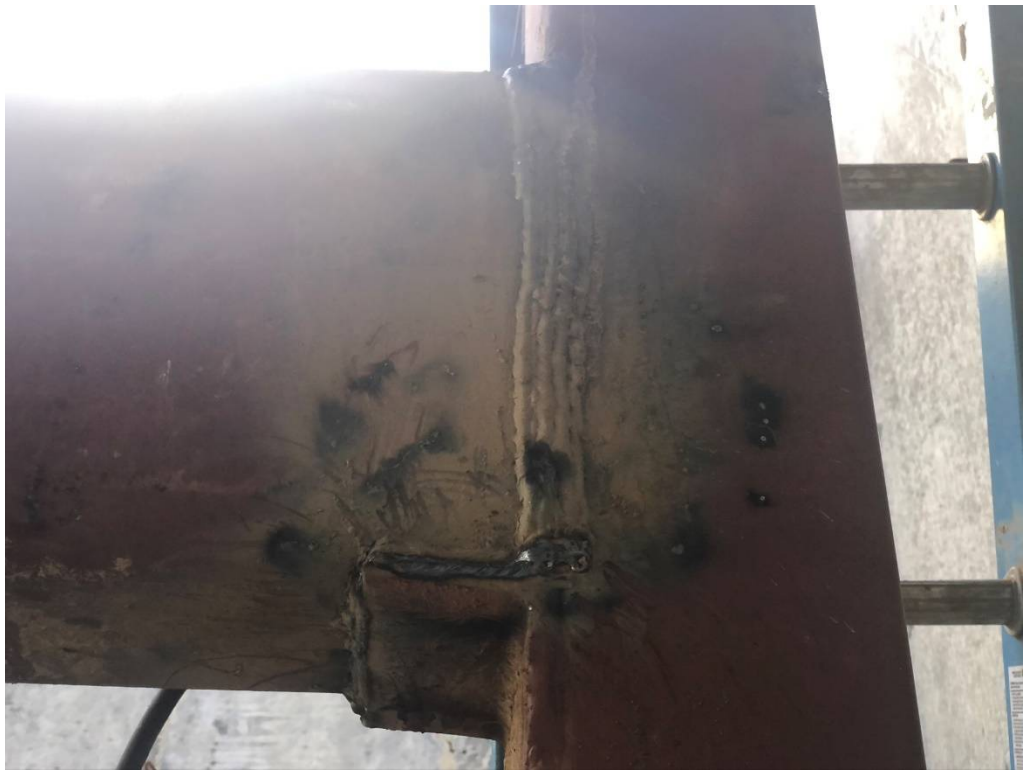
Figure 14 – Welding @ Elevator Shaft Structure

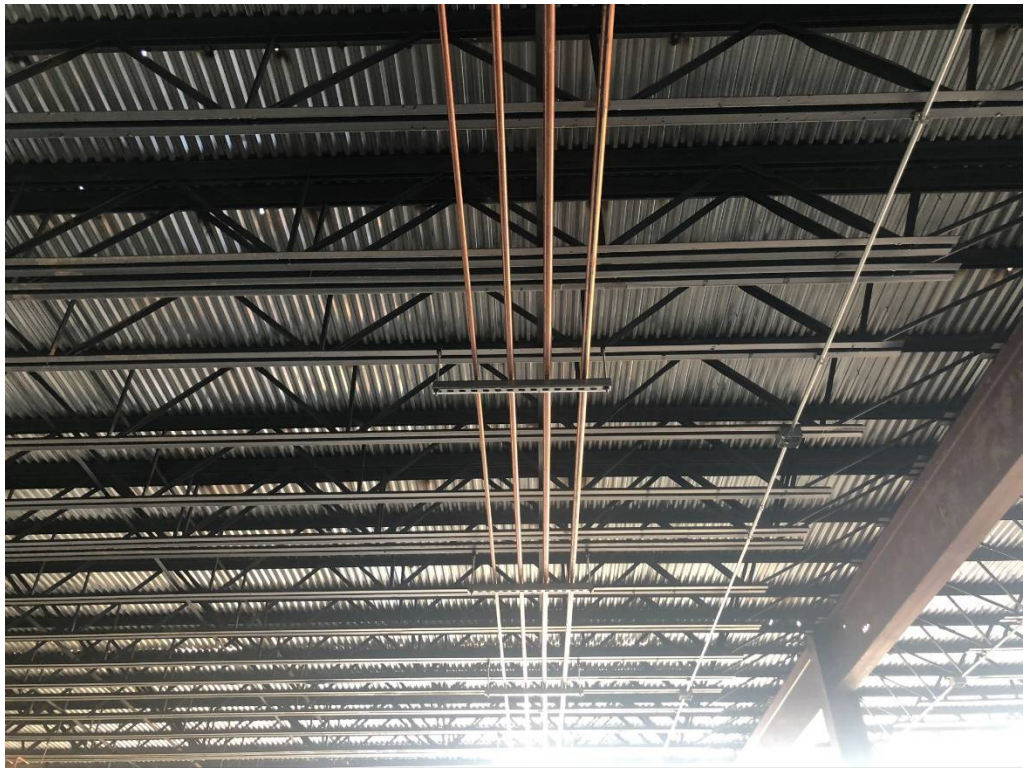
Figure 15 – Plumbing Rough-In Ongoing in West Structure

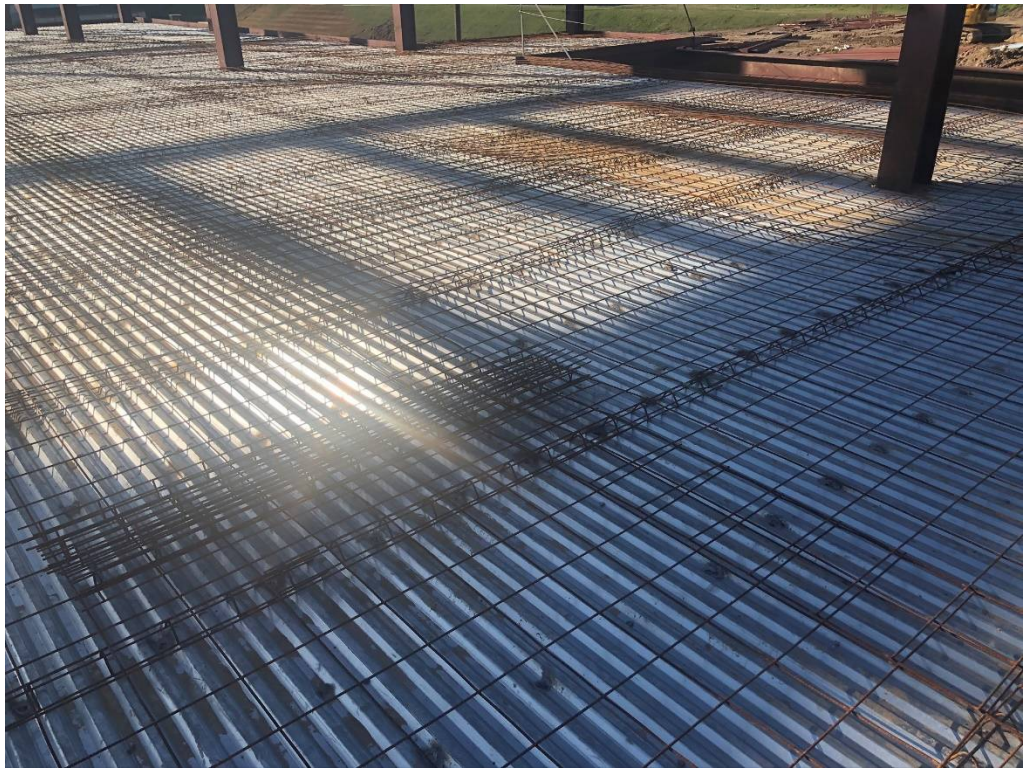
Figure 19 – Slab Prep for Concrete Pour

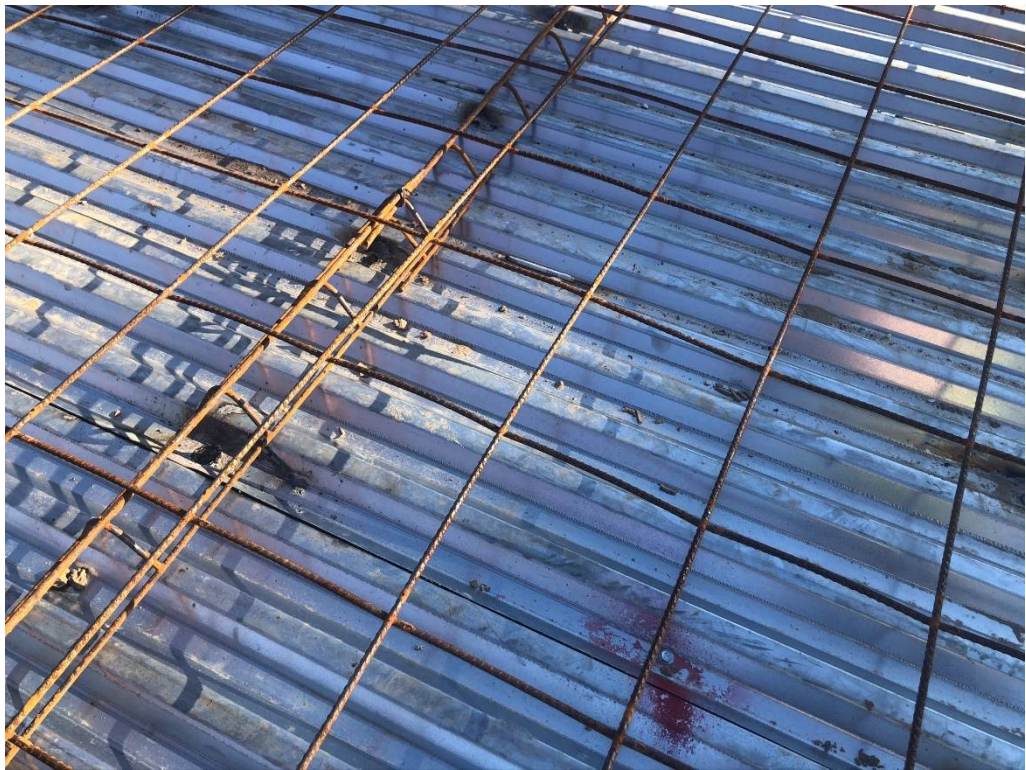
Figure 20 – Rebar Standoffs in use for Mesh

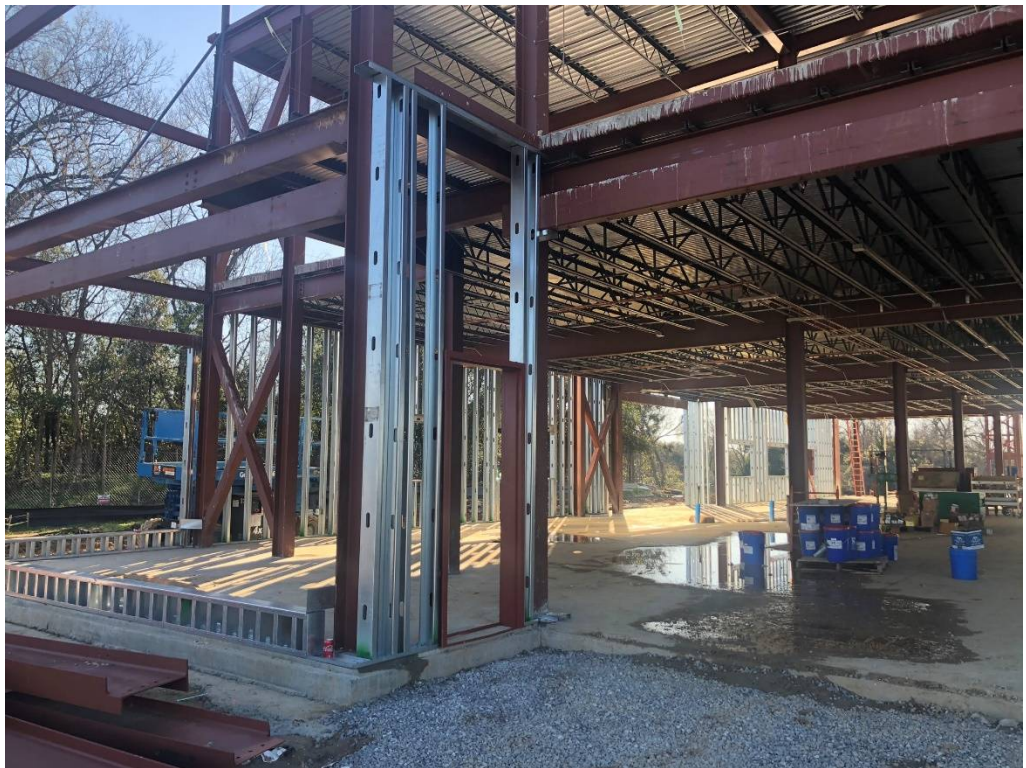
Figure 22 – East Building Door Set in Place
