Architect's Field Report

03 March 2020

18059-AOI Academy of Innovation / Report Number 024

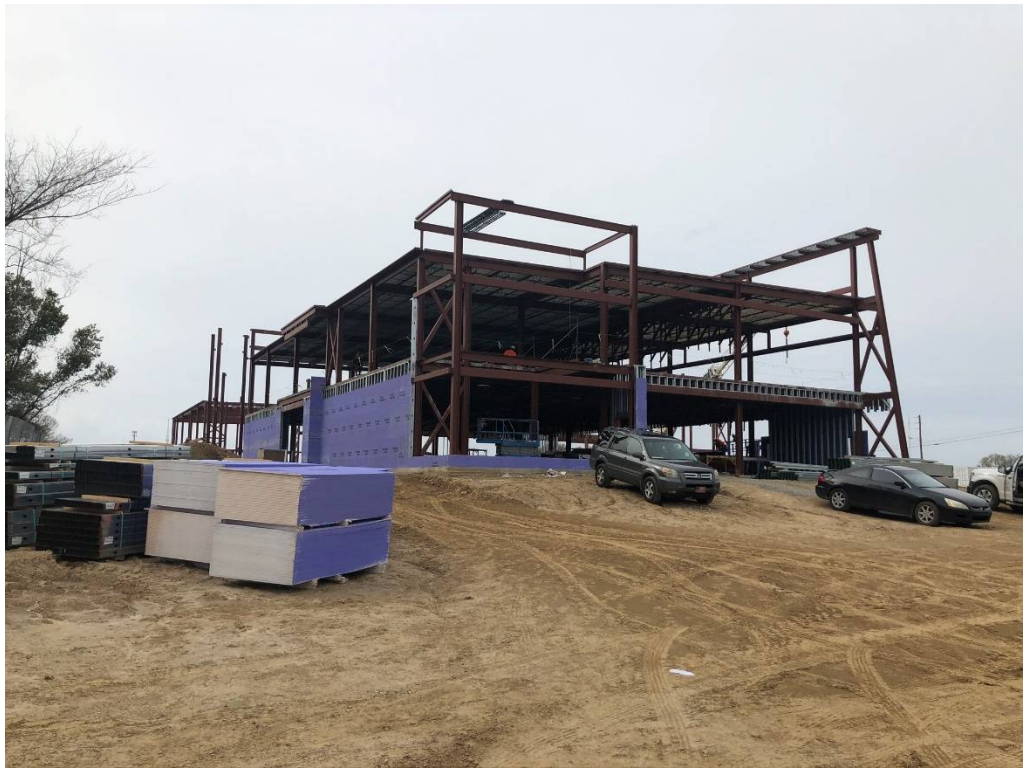
Figure 1 – East Building Erected

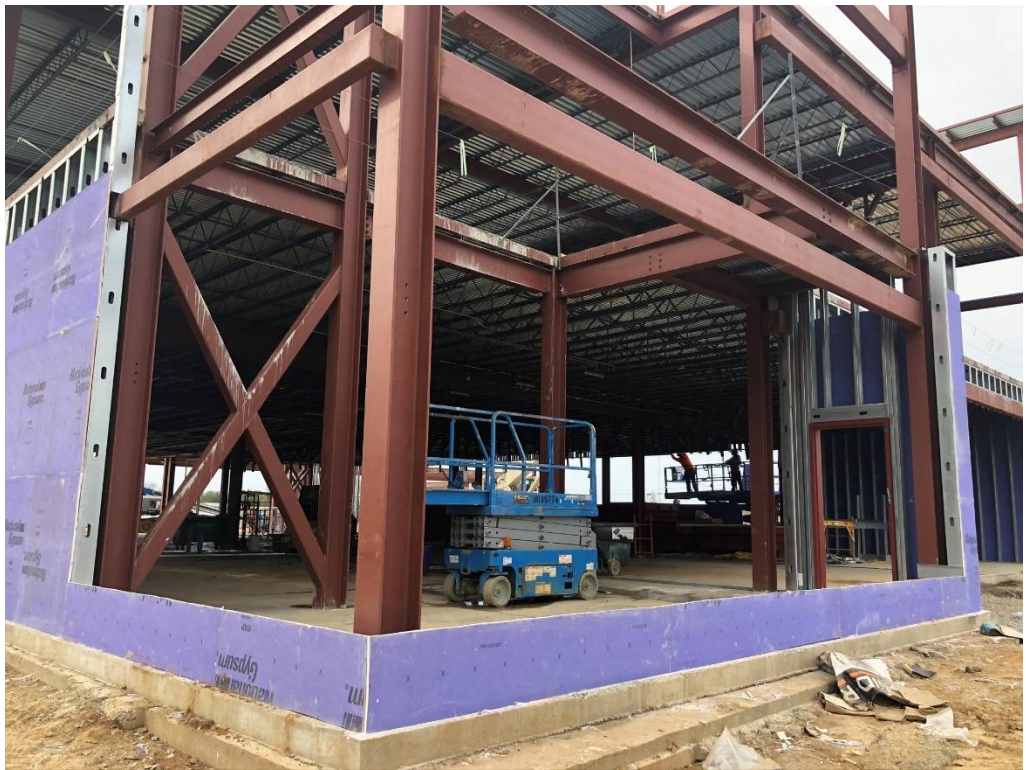
Figure 2 – Sheathing Started at installed Light Gauge Framing

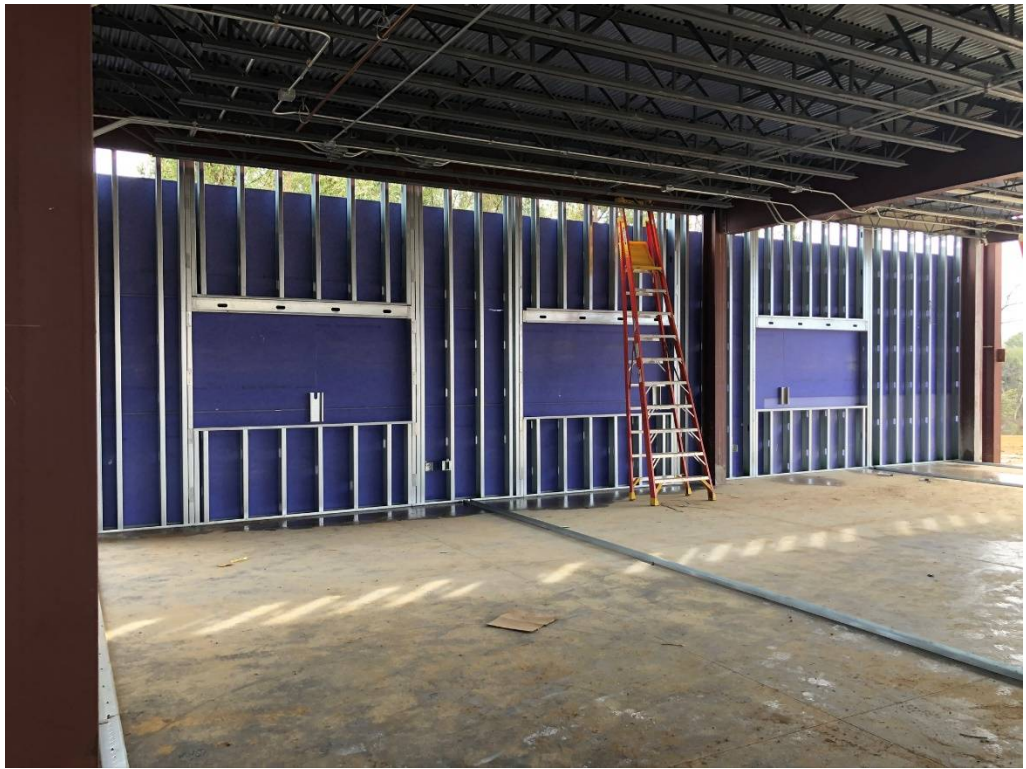
Figure 3 – Sheathing at Framing

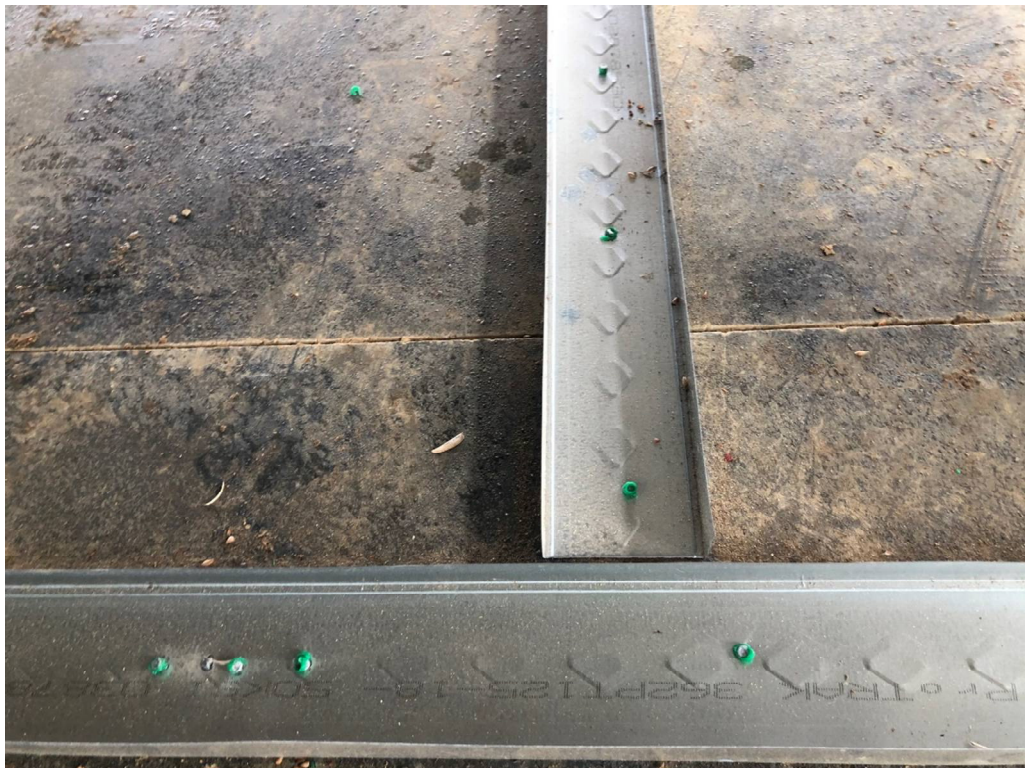
Figure 4 – Some Interior Wall Plates have been set

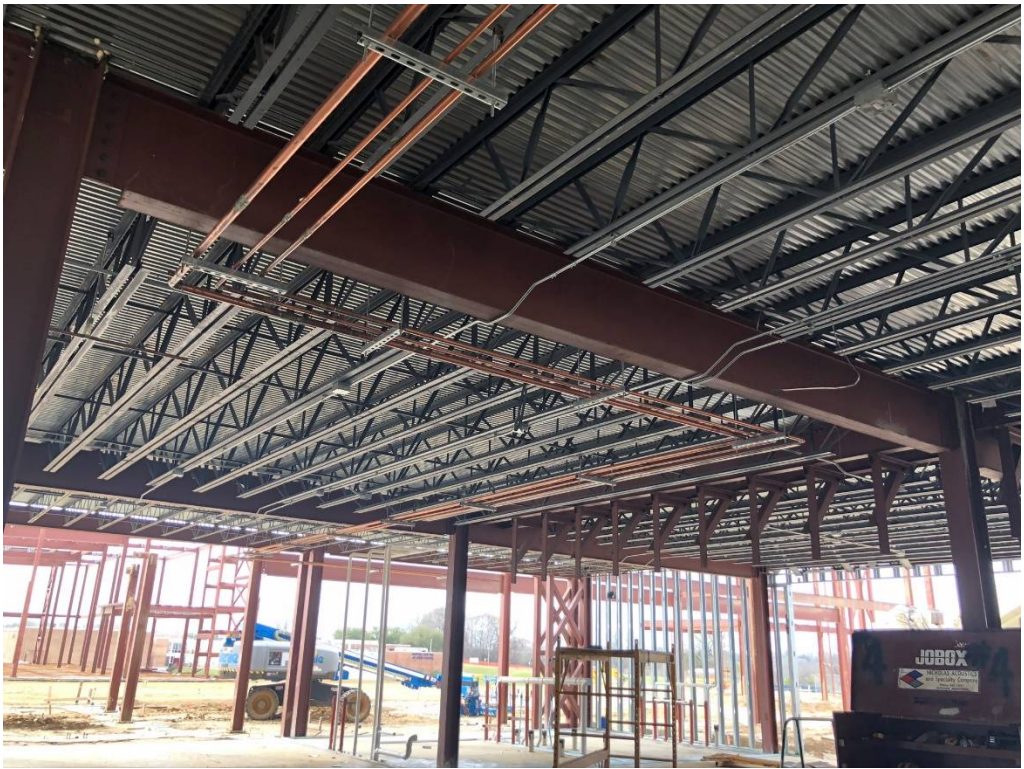
Figure 5 – Electrical & Plumbing Rough-in Ongoing in East Structure

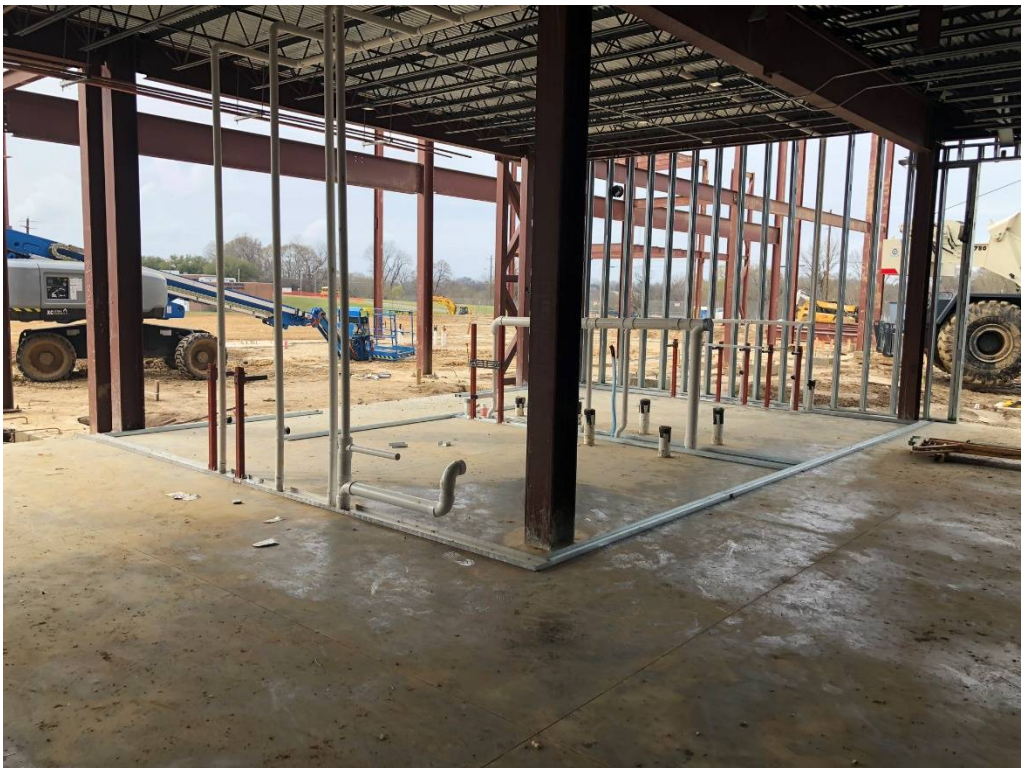
Figure 6 – Electrical & Plumbing Rough-in Ongoing in East Structure

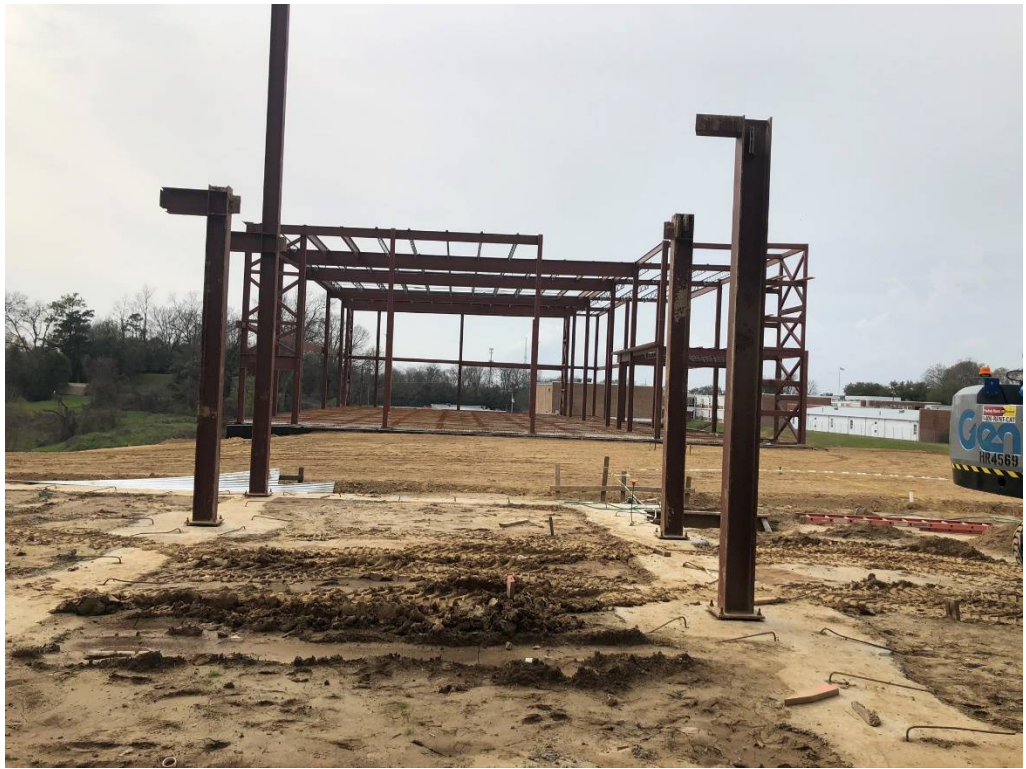
Observations Arriving on site, I met Billy Burwell, CC. He and I walked the site, reviewing work completed. It has dried enough to backfill and that is up to grade. There is a footing to dig in the backfilled area that supports a key double column that spans between the center section of building and the west section. Not having this footing in place and the double column associated with it is preventing the upper slab pour on the west section.

Figure 7 – West Structure

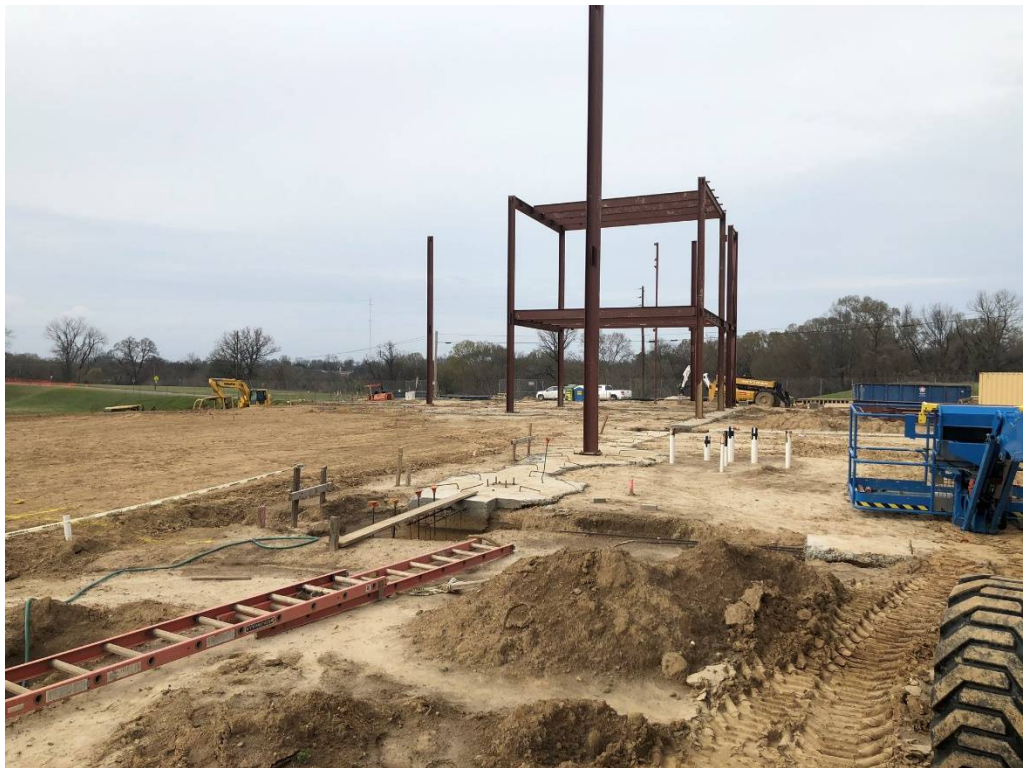
Steel erection is ongoing in the central area and foundation work at this section of structure will start after plumbing groundwork is complete.

Figure 8 – North/Central Structure Erection has Begun

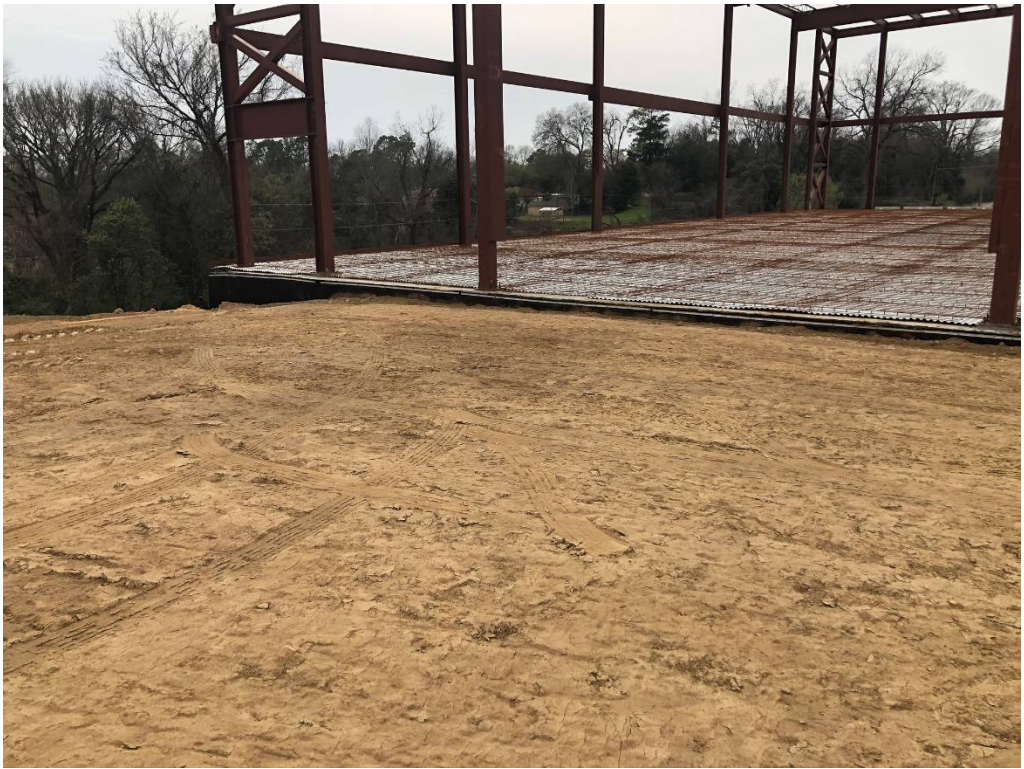
Figure 9 – Backfilled Central Portion of Building

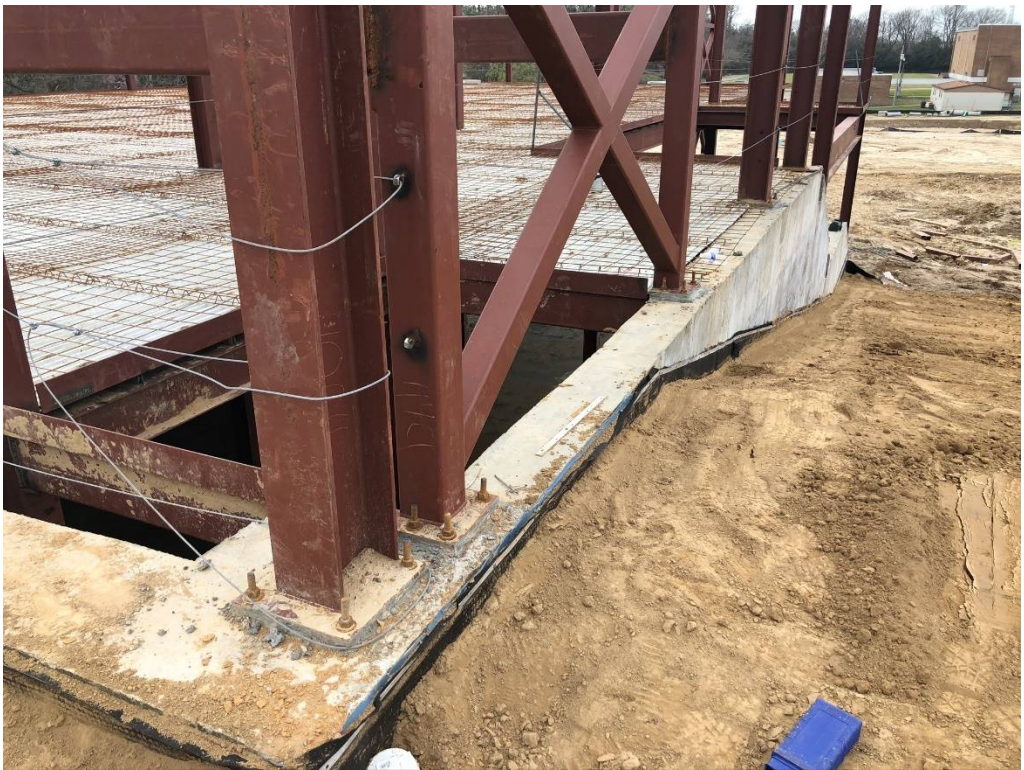
Figure 10 – Backfill @ North Side of West Structure
